ORNL-5347

Blast Tests of Expedient Shelters in the DICE THROW Event

Cresson H. Kearny
Conrad V. Chester

OAK RIDGE NATIONAL LABORATORY
OPERATED BY UNION CARBIDE CORPORATION · FOR THE DEPARTMENT OF ENERGY

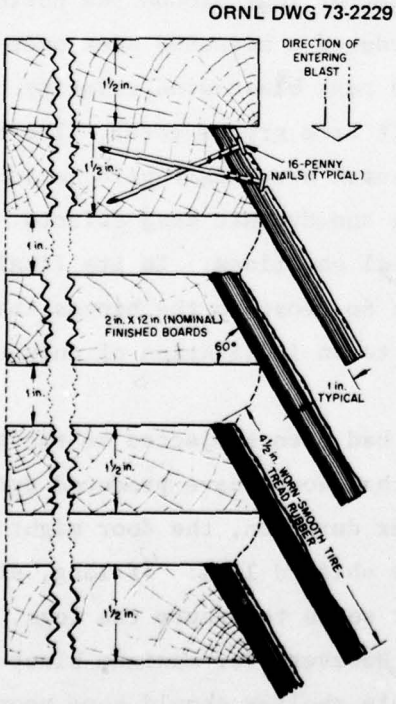
Fig. 4.5. Vertical cross section through an overlapping-flaps blast valve. The tested valve had four open-air slots, each 1 in. high and 10 in. wide. The overall width of the housing was 18 in.

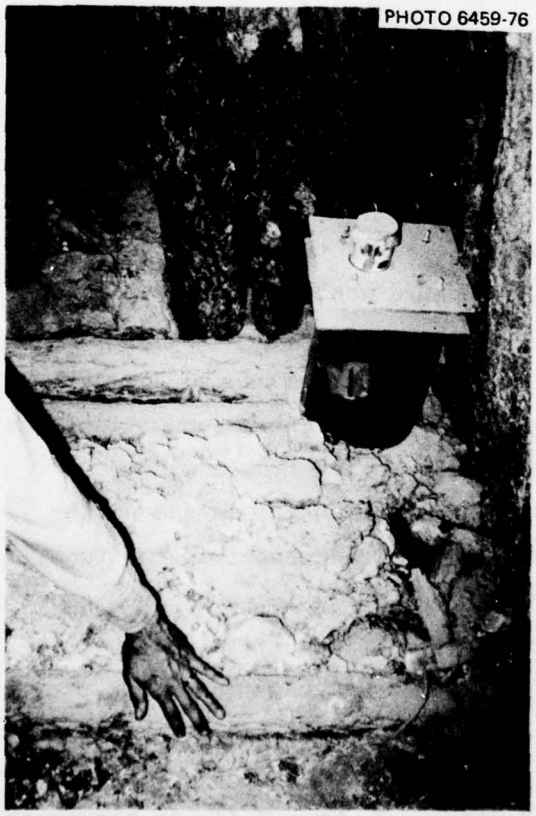
Figure 4.9 shows how the floor "puffed up" about 6 in. in the northeast corner of the shelter in the east entryway; pressurized earth caused some earth to "flow" up into the closed room, in which the measured peak

Fig. 4.9. "Puffed-up" part of the floor of Small-Pole Shelter due to the start of earth flow under moderately long-duration blast overpressure at the 53-psi overpressure range.

4.4.2. A modification of this shelter with a continuous pole floor under the wall poles should not fail as a possible result of a large amount of pressurized and destabilized earth flowing up into it through its floor when subjected to the long-duration overpressures and large movements caused by a megaton explosion.

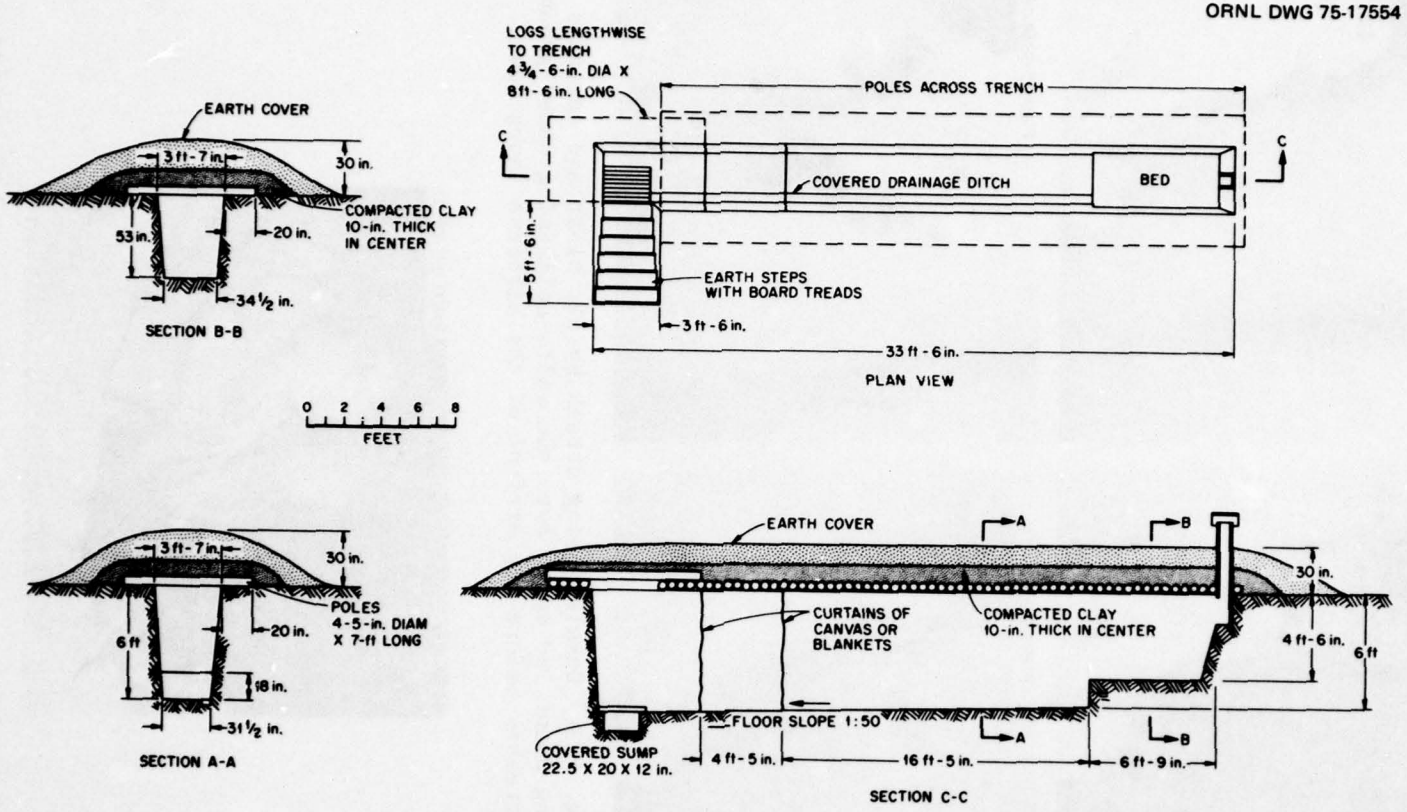
In the shelter at 20 psi, two anthropomorphic dummies (supplied by the Lovelace Foundation) were seated side by side just inside the inner curtain (see Figs. 5.2 and 5.3). A movie camera was installed by Denver Research Institute for the U.S. Army's Ballistic Research Laboratory. This camera was farther inside the shelter, mounted on a concreted-in-the-ground post. This camera took 400 frames/sec; the four photographs of Fig. 5.3 were taken in 1/100 sec. The first photograph shows only a slight movement of the innermost blanket-curtain. The second shows the earth walls beginning to crumble under the forces of a ground shock wave, induced by the airwave slap overhead before the airborne shock wave reached these walls or the dummies. The third and fourth photographs show the innermost blanket-curtain being torn, revealing the torn outermost curtain, that was darker colored, being blown behind and against it. The collapsing walls trapped the two dummies before the entering blast wind, which was shown by the four movie frames to have a velocity of about 180 mph, could blow them over. (The blast wind peaked at about 470 mph outside this shelter.)

Fig. 5.2. Russian Pole-Covered Trench Shelter in stable earth.

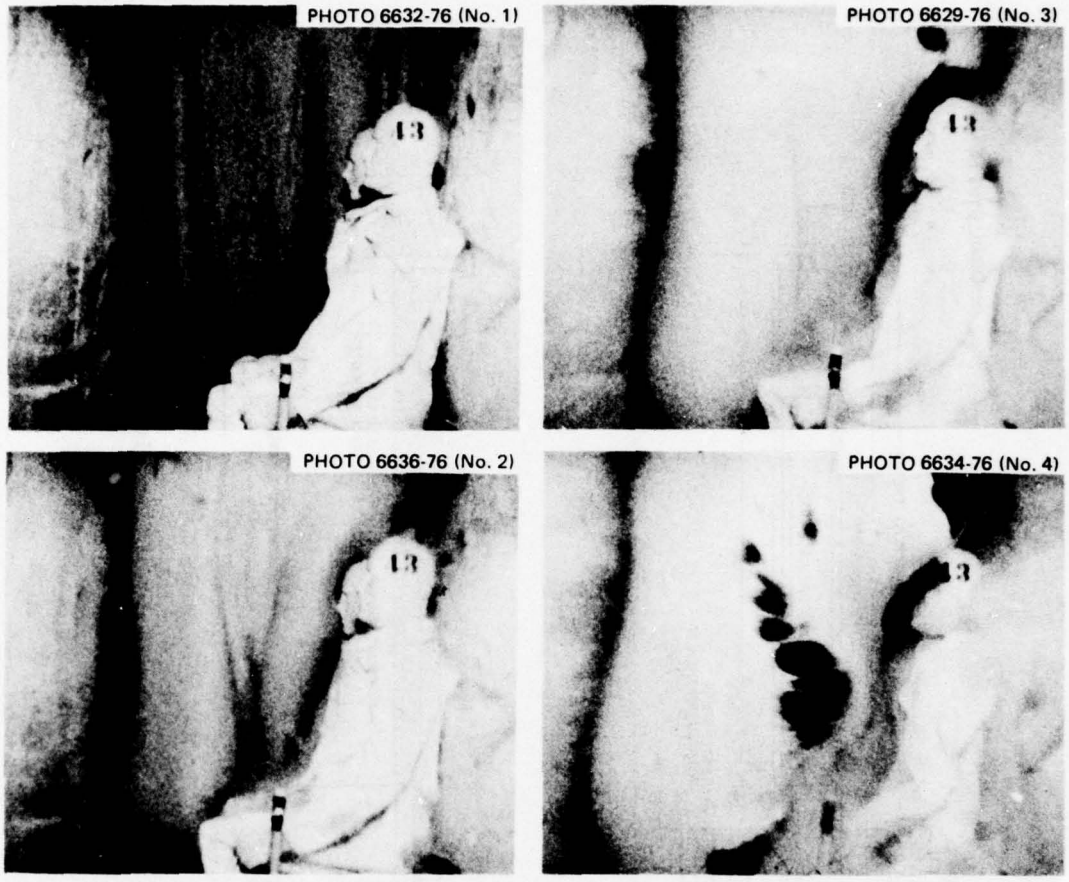
Figure 5.4 shows the dummies trapped by the collapsing walls.

Fig. 5.3. Dummies being struck by air blast and curtains traveling about 180 mph. Note the walls collapsing under ground-shock stresses before the arrival of the airborne shock wave.

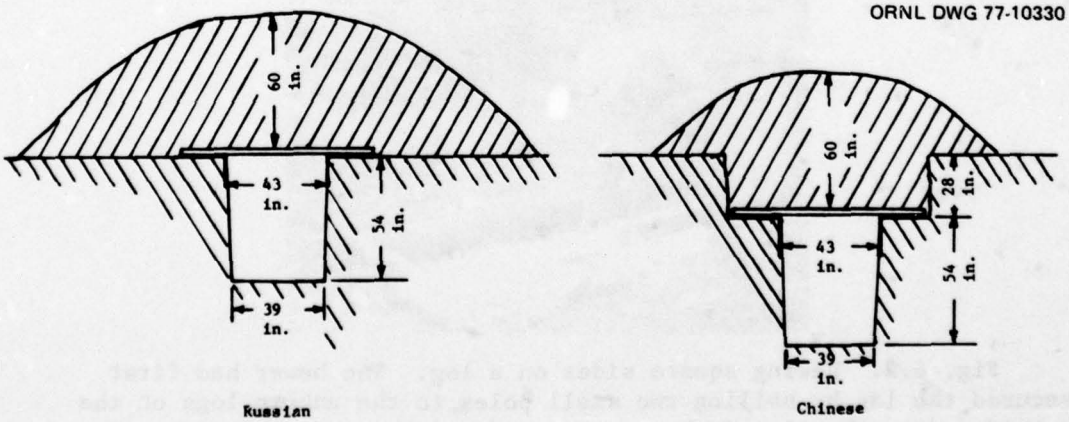
Fig. 6.1. Comparison of Russian way and Chinese way of positioning poles to roof a trench shelter. Note that the Chinese way requires about 35% less earth to be moved in order to make a 5-ft-thick covering — about the thickness specified in a Chinese handbook for shielding against initial nuclear radiation.

two halves as modified from the original designs in order to permit a better comparison between the merits of the two different ways of positioning roof poles. (The room of the Russian half was made 16 in. less in height than in the original Russian design, and the Chinese half was made 4 in. less in width than specified in the Chinese handbook.[17])

As shown in Fig. 6.1, the Chinese half was built with its roof poles resting on earth shelves 28 in. below ground level, cut into the hard caliche. All roof poles (logs) were ponderosa pine. The poles averaged about 5 in. in diameter, not including their bark; all were cut 7 ft long. Earth was mounded about 5 ft above ground level over this whole shelter. This resulted in about 4-1/2 ft of earth covering the roof logs of the Russian half and about 6 ft covering the roof logs of the Chinese half. Blast-wind scouring removed a foot of this mounded dry, loose earth. If blast-wind scouring by a very large explosion had blown away almost all the dry earth mounded above ground level, the Chinese shelter would still have had adequate cover to provide good fallout protection.

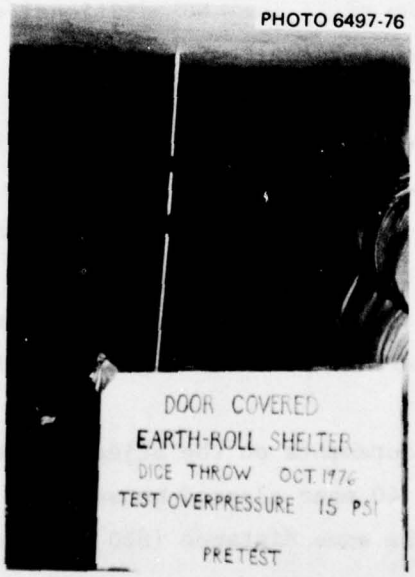
Fig. 8.1. Bed-sheet "earth-roll" walls 36 in. apart before test.

roof deflection gauge, with its upper end consisting of nothing but a thin cylinder of household aluminum foil, an unsatisfactory device if exposed to blast wind. Figure 8.2 gives details of the construction of these shelters.

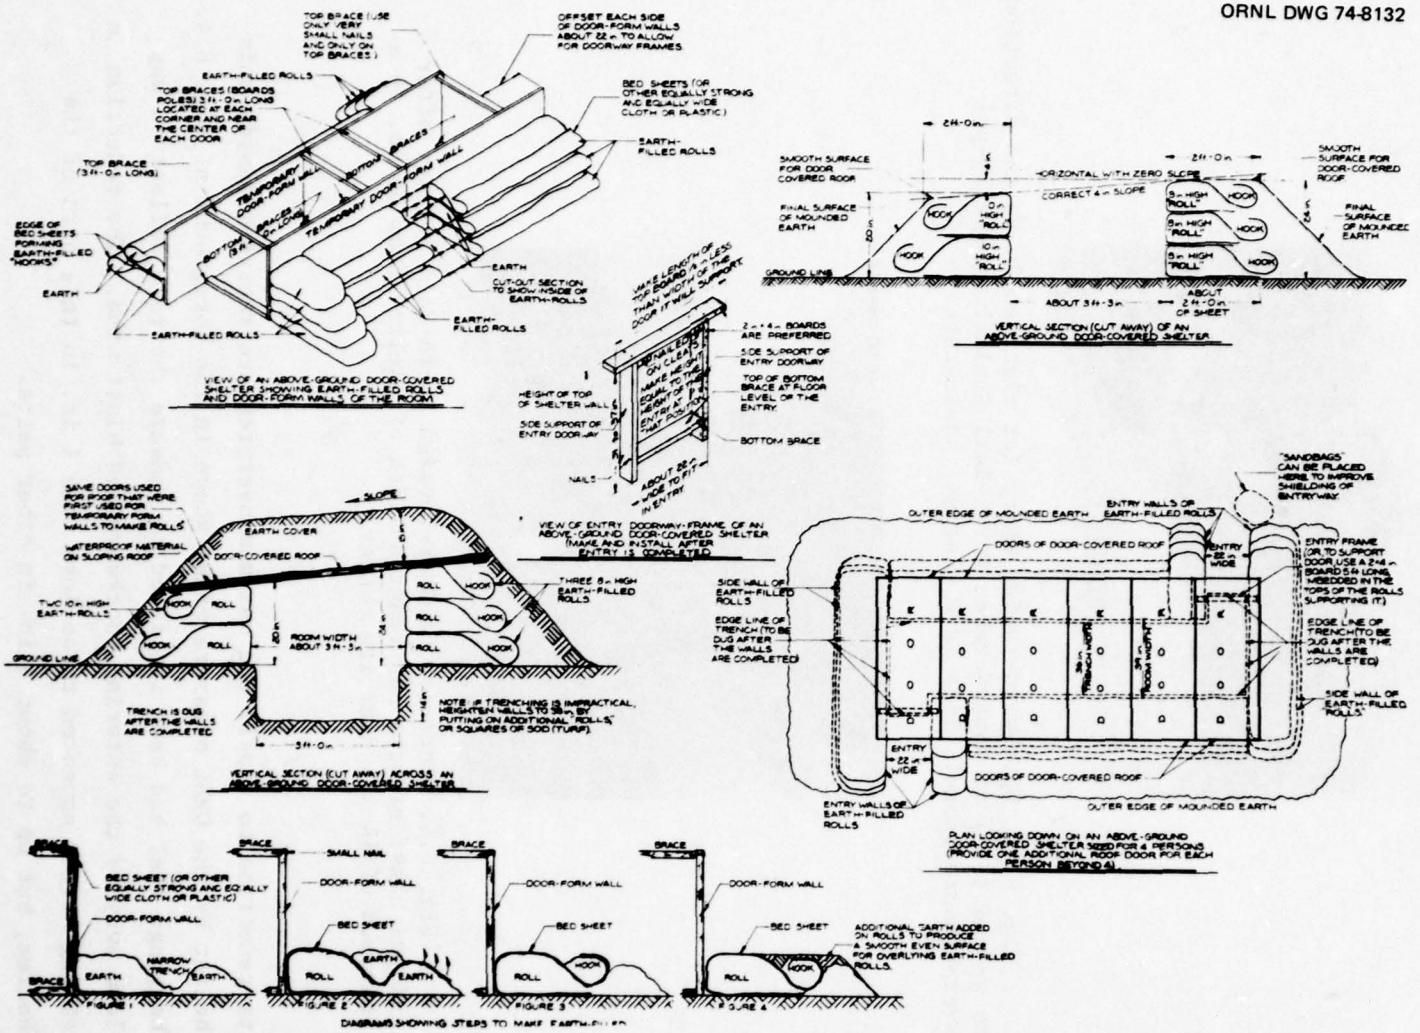
Fig. 8.2. Door-Covered Earth-Roll Shelter, tested at 15 and 5.8 psi.

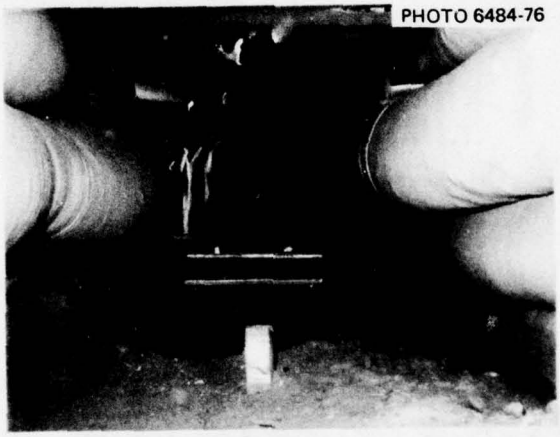
Fig. 8.4. Interior of Door-Covered Earth-Roll Shelter after 15-psi blast effects had reduced width of shelter from 36 in. to a minimum of 14 in. near its center.

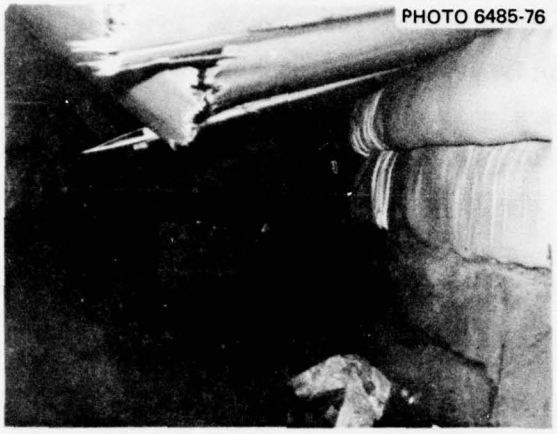
At the 5.8-psi overpressure range, the Door-Covered Earth-Roll Shelter was still habitable for weeks after the test. Figure 8.5

Fig. 8.5. Posttest interior of Door-Covered Earth-Roll Shelter at 5.8-psi overpressure range. The lower 1/8-in. veneer of the doors had been badly broken by impact before the test, due to a front-end loader having dumped tons of earth onto this yielding roof.

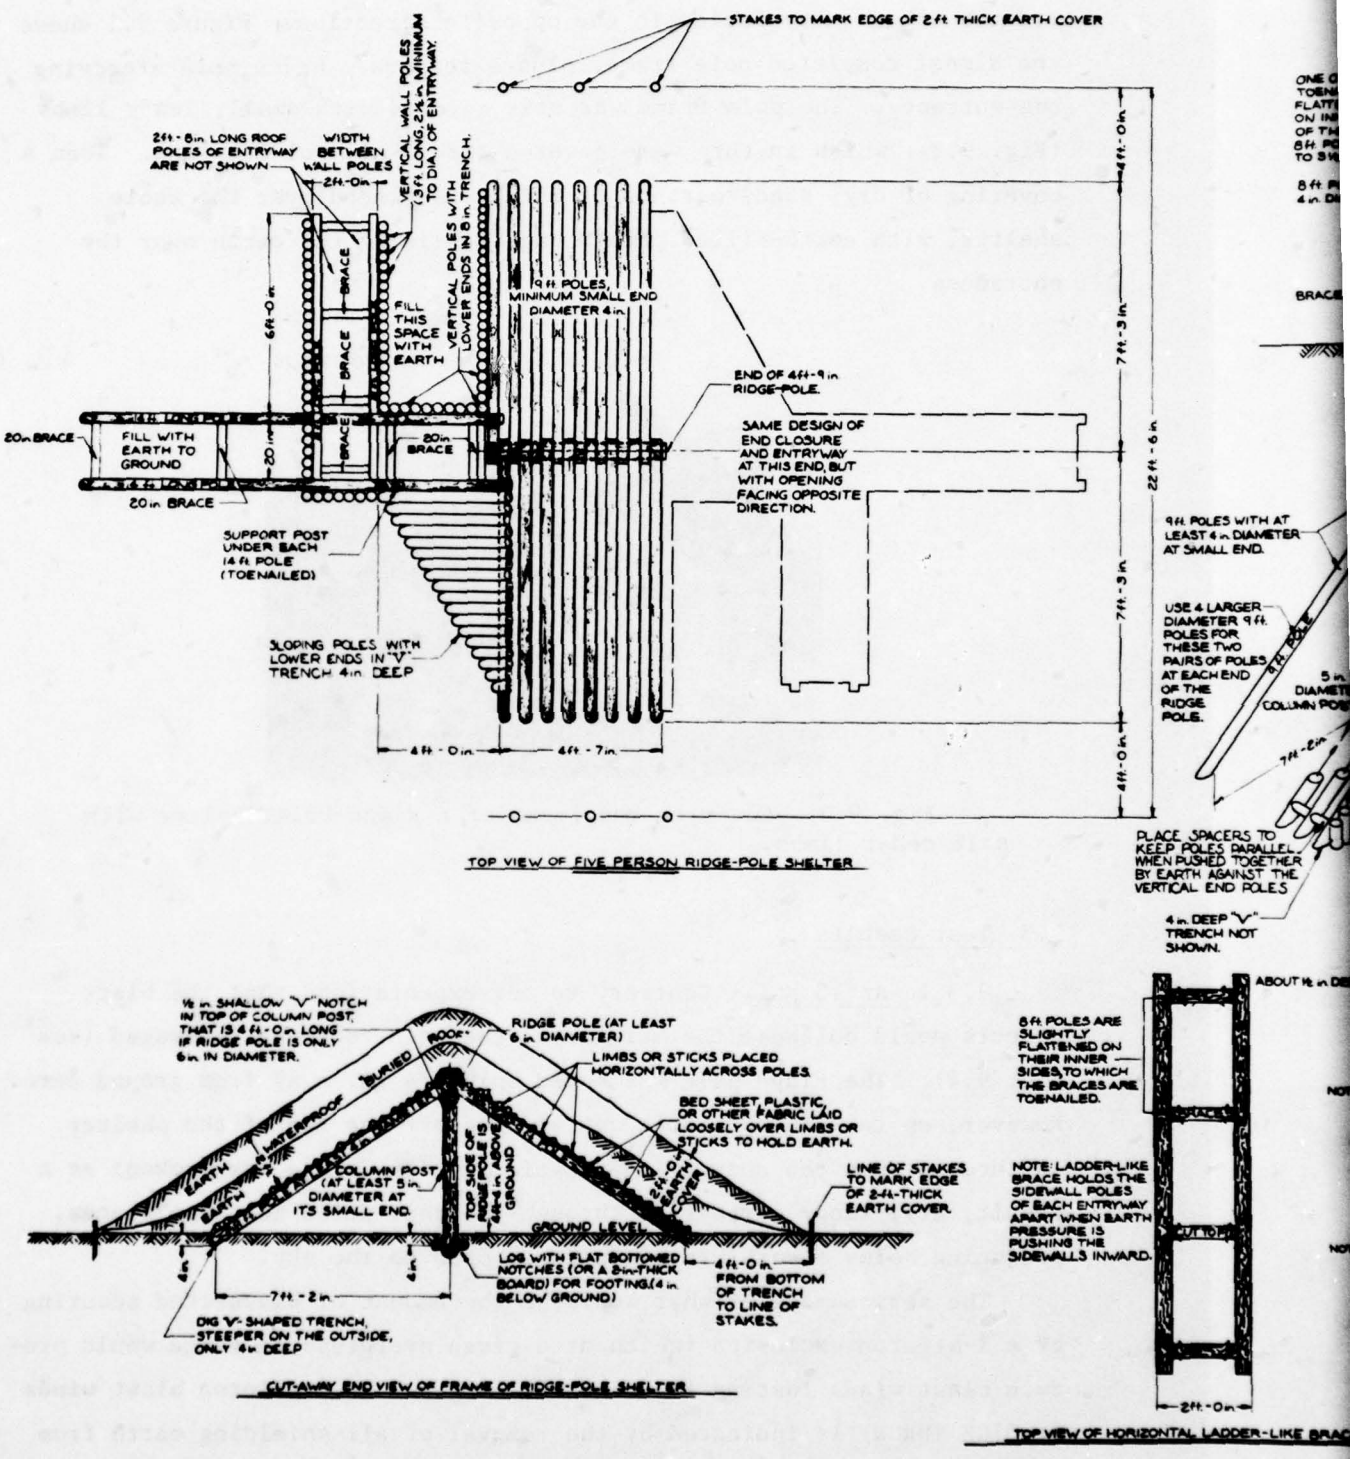
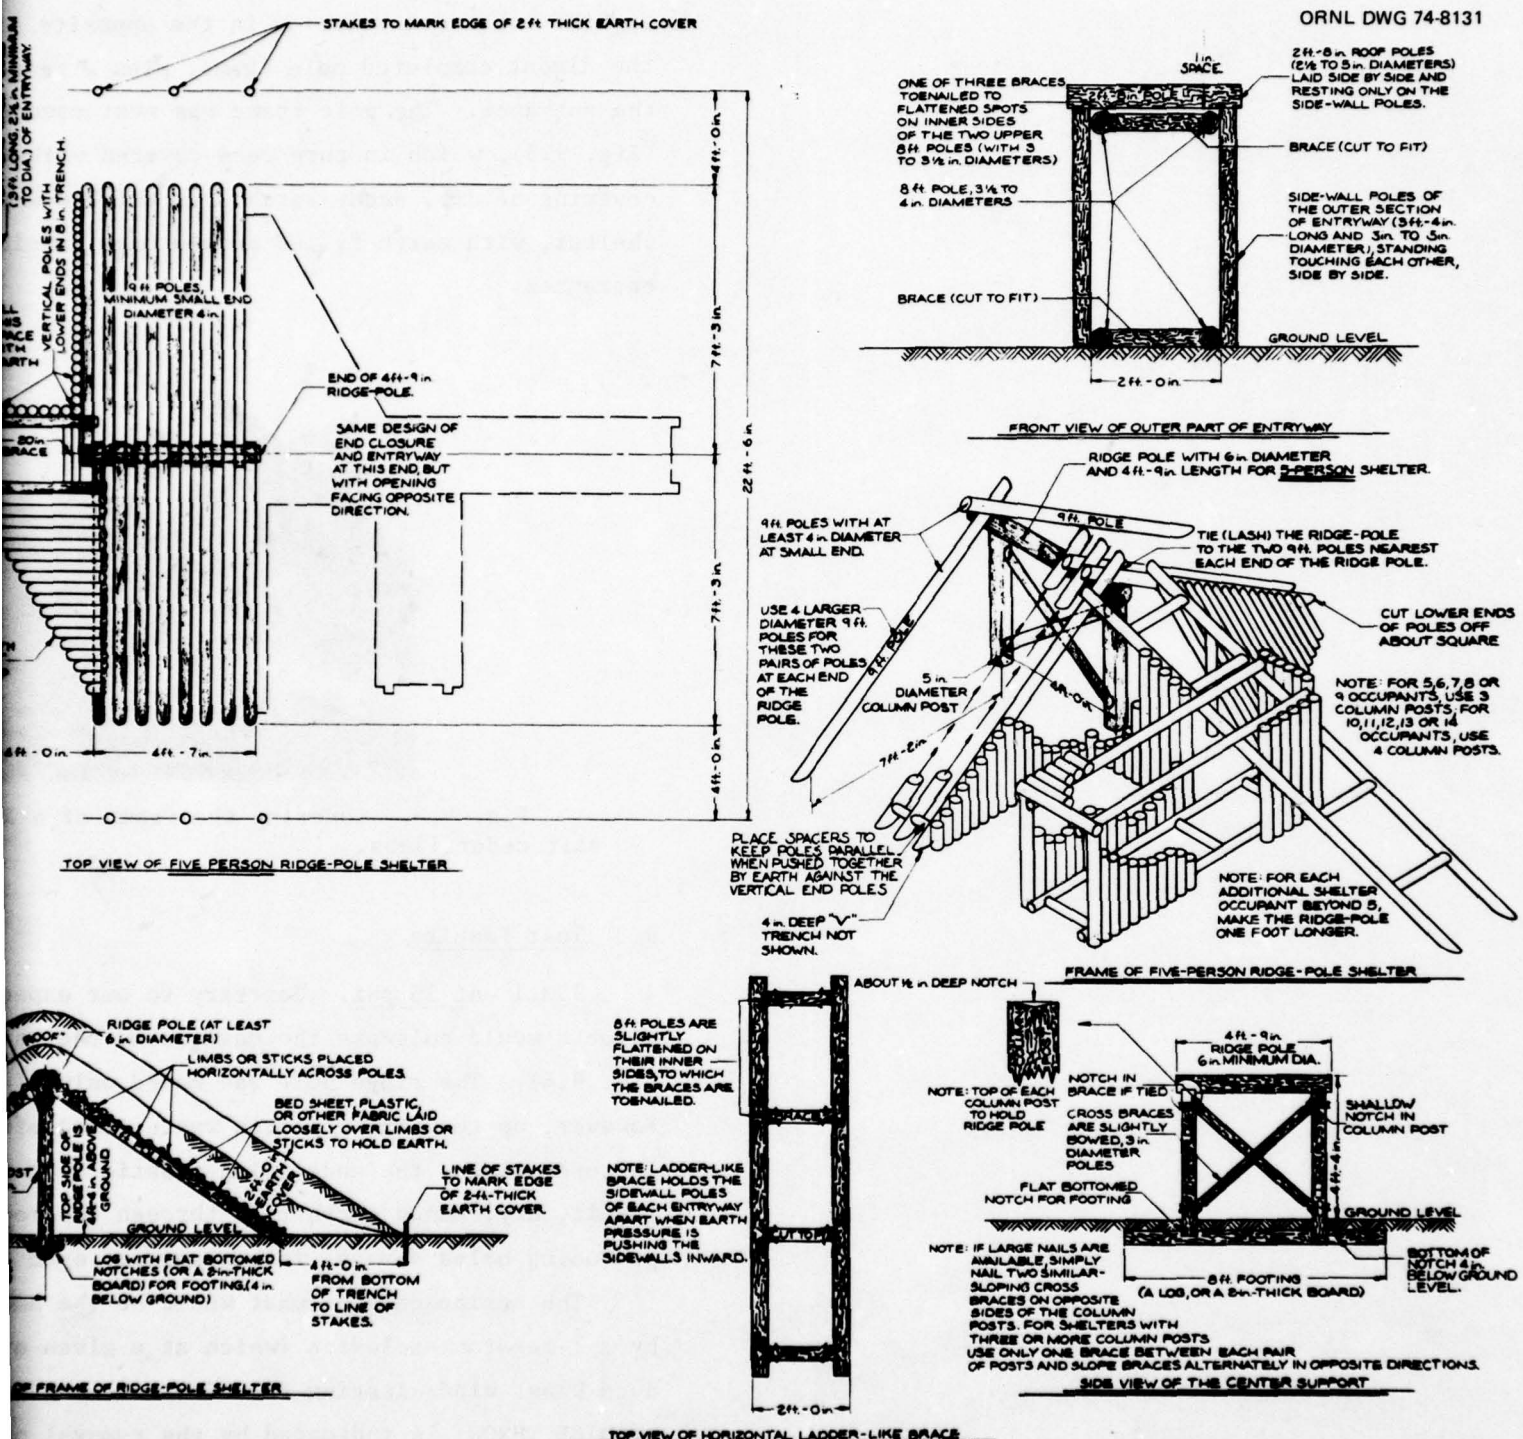
Two identical Ridge-Pole Shelters were built, each having the dimensions shown in Fig. 9.2. One was tested at the measured 15-psi overpressure range and the other at the 5.8-psi overpressure range. Each was positioned with its ridge pole perpendicular to a radius from ground zero, with one of its two crawl-in entries facing ground zero

Fig. 9.2. Ridge-Pole Shelter tested at 15 and 5.8 psi.

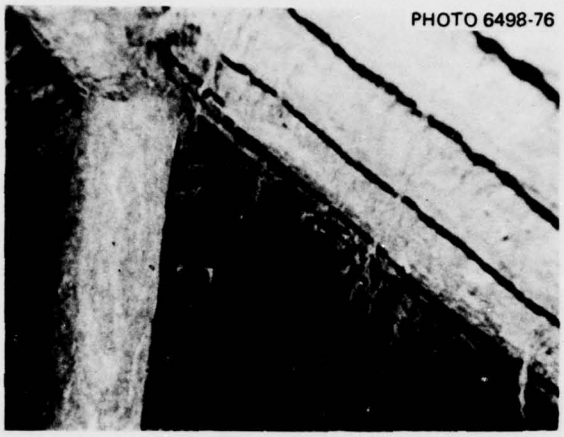
Fig. 9.4. Posttest interior of Ridge-Pole Shelter at 15 psi. The main room was undamaged; the ridge pole had been moved only 3/4 in. away from ground zero.

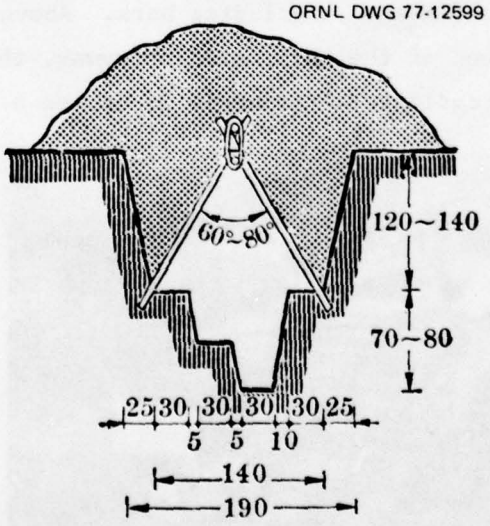
In the first Chinese handbook[17] on nuclear defense that came into our hands, we saw the shelter illustrated by Fig. 11.1. Previously, we had never seen or conceived a blast shelter of this design or one built of such thin poles. If such thin poles could safely be used, it would reduce the labor of obtaining the poles for an expedient blast shelter — one of the chief constraints on the practicality of such shelters. Therefore, we decided to blast test this Chinese design.

Fig. 11.1. Chinese "Man" Shelter tested at 20 psi. This shelter is called "Man" Shelter in a Chinese civil defense handbook because a cross section of its frame resembles the Chinese character "人" for "man."

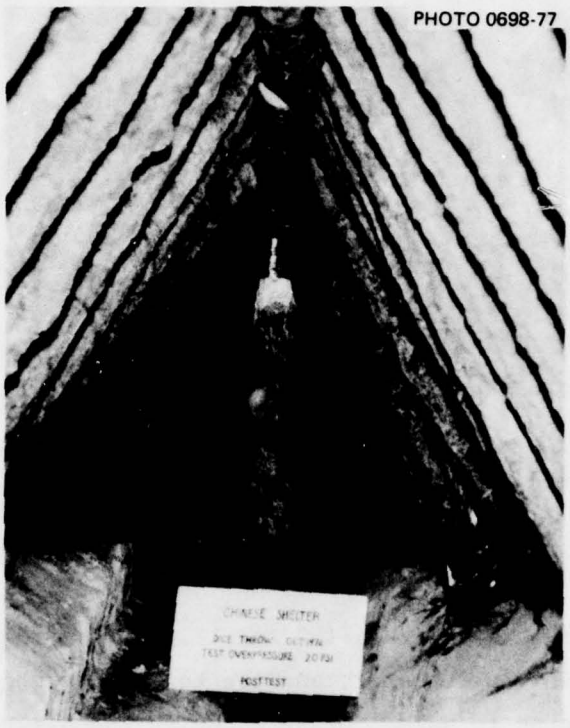
Fig. 11.3. Undamaged interior, showing earth bench on one side and roof deflection gauge on post.

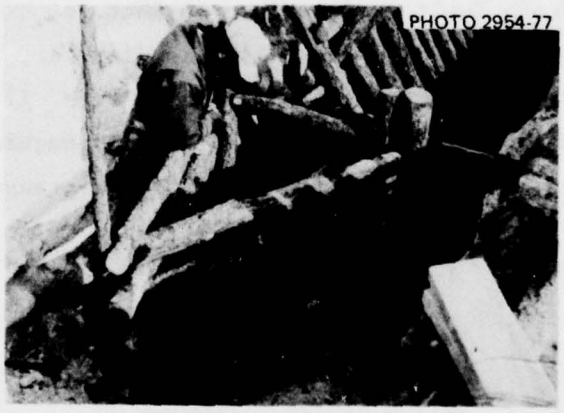
Fig. 11.4. The lower part of the vertical triangular entry is pressed horizontally against two pairs of vertical posts. Each pair is wired together. The two pairs are held apart by two horizontal spacer poles toenailed in place to frame the rectangular opening between the horizontal and vertical parts of the entry. The pairs of vertical posts are pressed against two horizontal poles (the uppermost is shown) that in turn press against both the outermost two poles of the horizontal part of the entry and the earth in two slots dug in the sidewalls of the excavation.

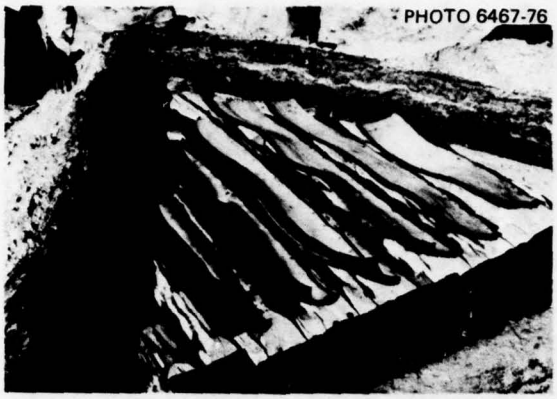
Fig. 11.5. Posttest undamaged triangular blast door, made of three 5-in.-diam peeled poles covered with seven 4-in.-diam peeled poles. Between these covering poles were six 2-in.-wide ventilation slots, protected by six flap valves made of strips cut from worn tire treads.

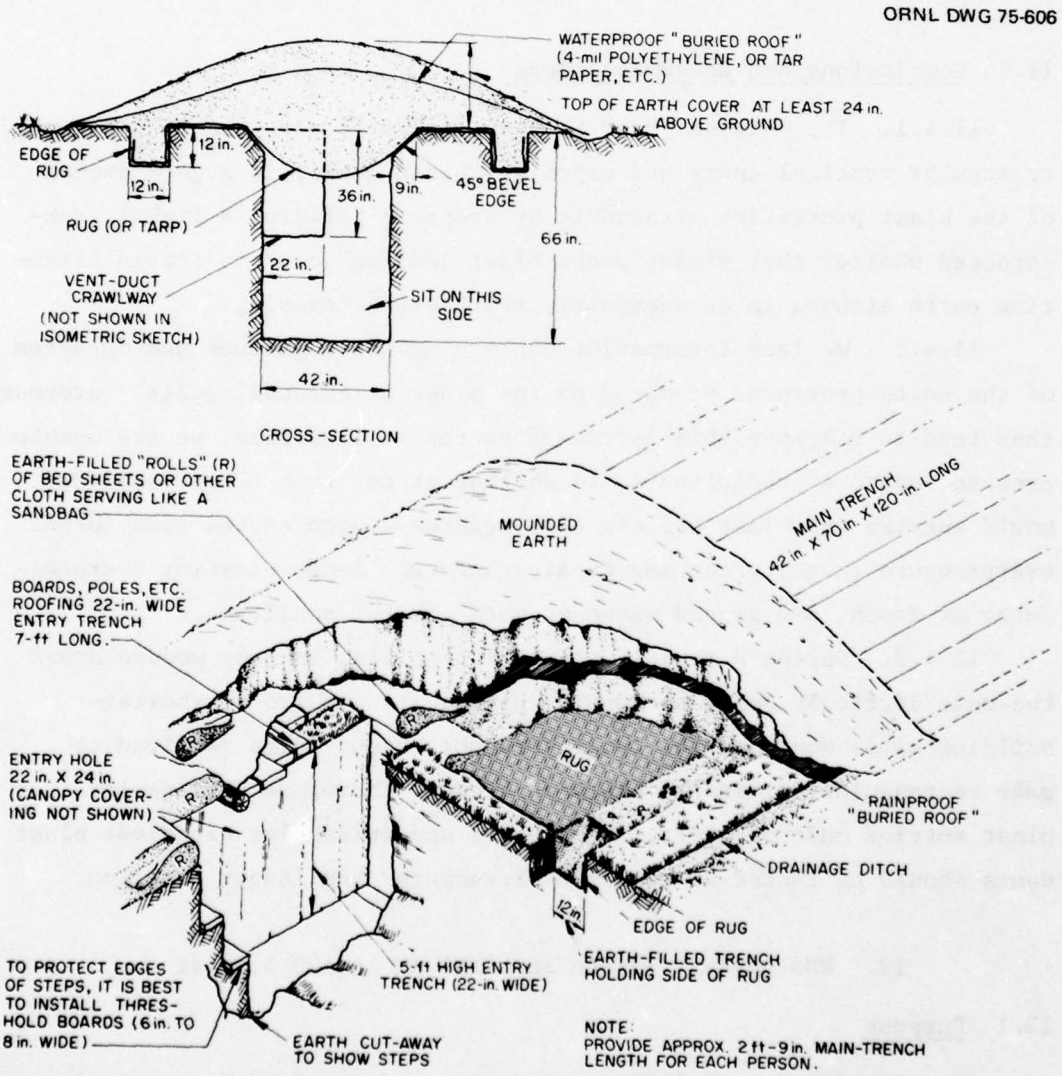
Fig. 12.1. Construction of Rug-Covered (or Tarp-Covered) Trench Shelter.

trenches 40 in. wide, 6 ft deep, and 11 ft long. The roofing rugs were each 12 ft wide by 11 ft long. These rugs had a double-laminated jute backing over nylon — typical low-cost wall-to-wall carpeting. No difficulties were experienced in covering the rugs with earth to a depth of 48 in. over the midline of the trench, nor in completing the 20-in.-wide entrances at each end (see Figs. 12.2 and 12.3).

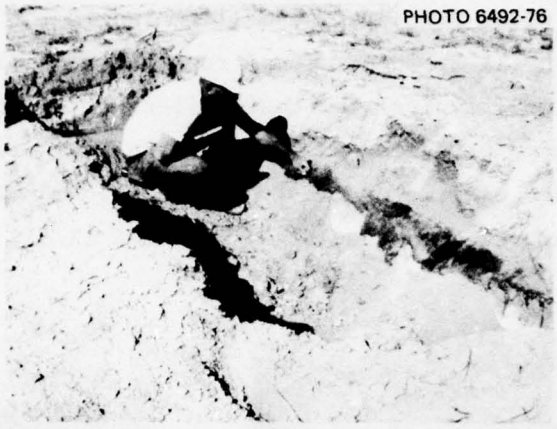
Fig. 12.4. Demolished Rug-Covered Trench Shelter at 15 psi. The edges of the rug were not pulled loose by blast effects; it was torn lengthwise.

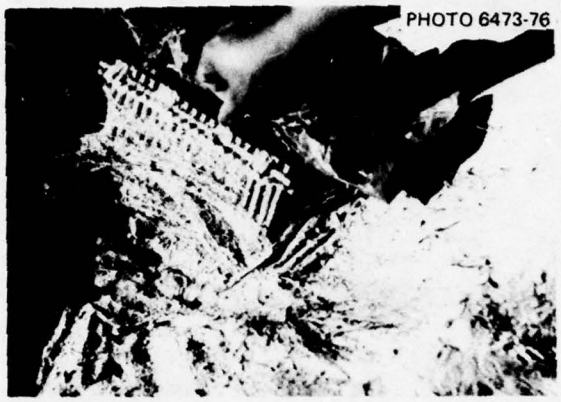
Fig. 13.2. One-tenth-scale room of Chinese "Man" Shelter at 31 psi, photographed posttest. The frame had remained adequately covered, was undamaged, but had been pushed about halfway into the ground.

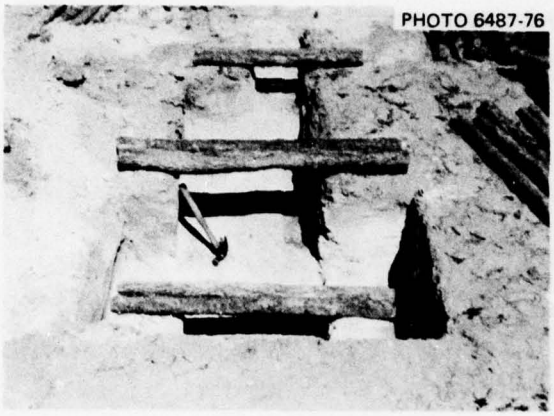
The blast damage suffered by both parts of this closed shelter indicated that occupants probably would have been injured, but was less serious than the damage suffered by its full-scale counterparts tested at 53 and 31 psi. In the Russian half, the upper parts of the earth walls were broken off, and the unbroken roof poles came to rest sloping,

Fig. 13.3. Construction of one-half-scale Log-Covered Trench Shelter at 53 psi. The Chinese way of placing roofing poles below ground level is shown in front; the Russian way, to the rear.

with a reduction of 3-3/4 in. in midceiling height. In the Chinese half, the roof poles remained horizontal, although they were lowered 2-1/4 in. in the center.

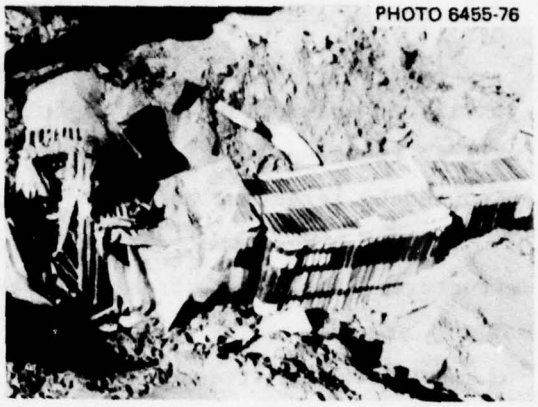
Fig. 13.5. One-tenth-scale Small-Pole Shelter, posttest at 106 psi, shown after being carefully uncovered.

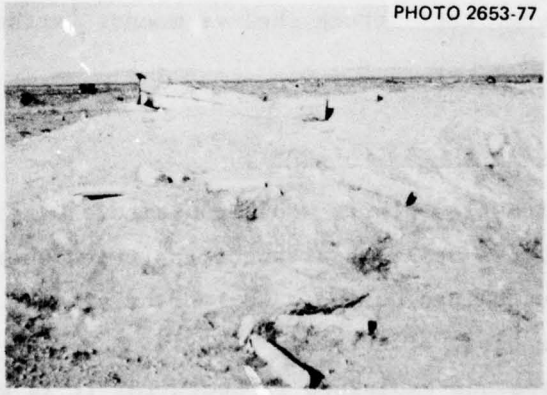
Fig. 14.1. Some of the fireplace-size logs hurled from a woodpile and embedded in the 5-ft-high mound at 53 psi. Apparently, the blast winds of the negative phase had uncovered the two small logs in the foreground and moved them toward ground zero.

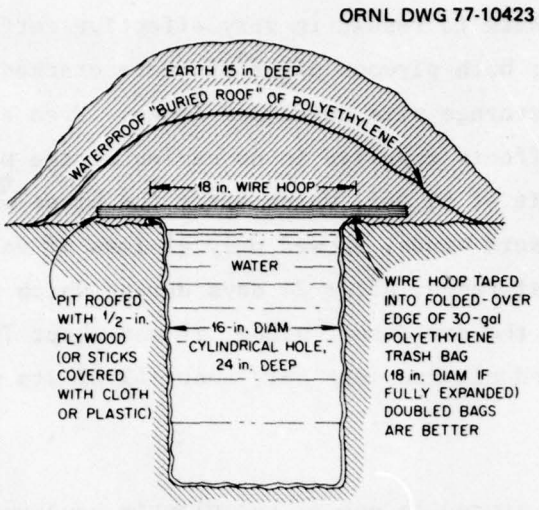
16.2.1 Water stored in plastic bags lining cylindrical pits in the earth.[12] As anticipated, lined cylindrical pits proved to be the most blast-resistant way to store water outside of blast shelters (see Fig. 16.1). Ordinary 30-gal polyethylene trash bags were used for waterproof liners. One bag was placed inside another, since a very small fraction of polyethylene bags not made for water storage have pinhole leaks. Each cylindrical pit was dug so as to have a diameter about 2 in. smaller than the diameter of its waterproof liner bag, when its liner bag was inflated.

Fig. 16.1. Vertical section of cylindrical water storage pit lined with waterproof plastic bag, or two bags.

Before the test, the lined pits, each approximately 2 ft deep, were filled almost full and then roofed and covered as illustrated by Fig. 16.1. Each lined pit contained about 20 gal of water. The earth cover

16.3.1. If blast is expected in a shelter area, plastic-lined cylindrical pits, filled almost full and protected from blast and contamination as illustrated in Fig. 16.1, would usually be the most practical method of expedient water storage.

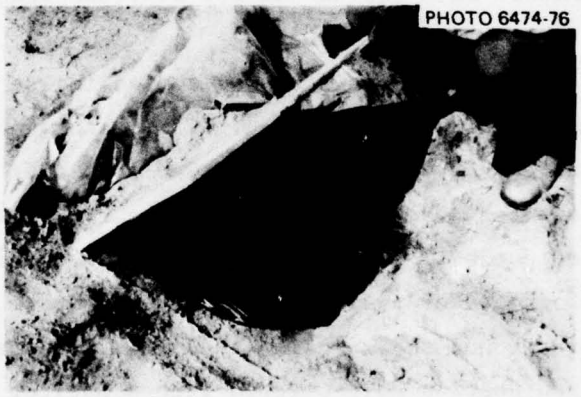
Fig. 16.2. Cylindrical water storage pit lined with two polyethylene trash bags. After exposure to blast effects at 20 psi, this pit was undamaged and still full of water.

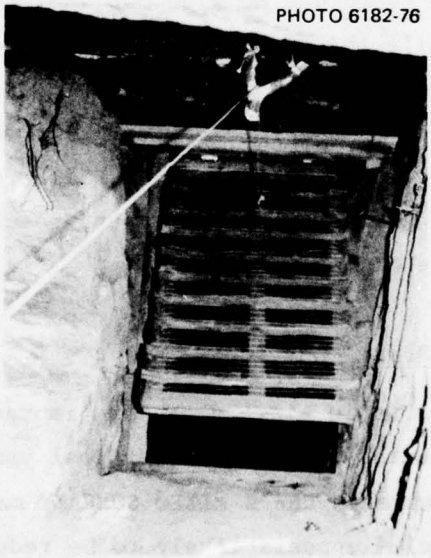
Fig. 17.1. Expedient shelter ventilating pump (a 20 × 36 in. KAP) in an entry of the Log-Covered Trench Shelter at 53 psi. Tested pre-blast, it pumped 177 cfm through the valves of the two closed blast doors and 412 cfm with the doors open. This entry was demolished by blast effects.

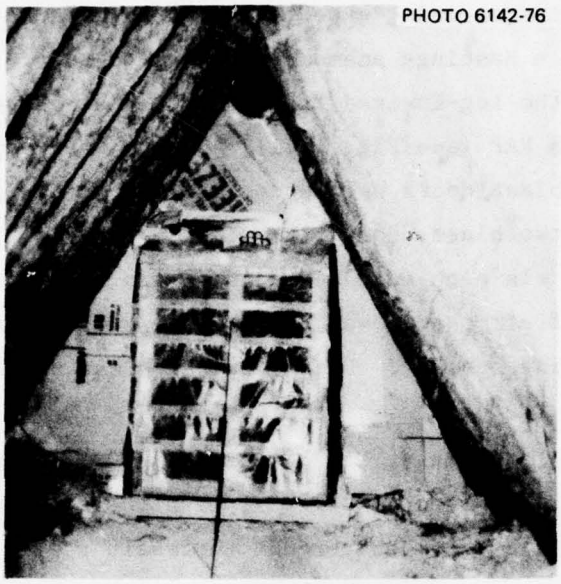
Fig. 17.2. Expedient KAP (20 x 24 in.) tested in the Chinese "Man" Shelter at 20 psi, after the blast.

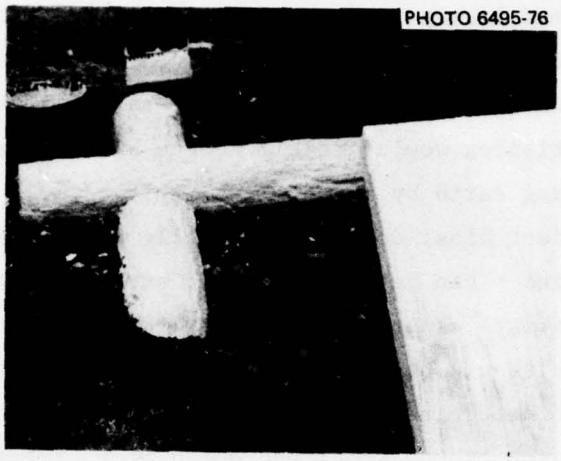
18.4.3. ORNL tests of this method included painting half of a dry, debarked log with a paste of slaked lime and then exposing the whole log to intense radiant heat from a very hot fire. The unpainted half burst into flames before the painted white part began to smoke much. If lime or white cement is not available, coating exposed wood, sandbags, etc., with ordinary neat cement, plaster, or even clayey mud should prove useful. Figure 18.1 illustrates blast-protector logs being quickly whitewashed. If water is available, keeping the exposed flammable parts of an earth-covered shelter wet, or even damp, will prevent their ignition by thermal pulse.

Fig. 18.1. Parts of a blast door and its blast-protector logs whitewashed with a thick slaked-lime paste. This is a proven effective means for making wood much more difficult to ignite.

18.4.2. Whenever practical, shelters should be built well removed from buildings, flammable woods. and other readily ignitable materials, and the parts of shelters that are flammable and may be exposed to thermal pulse should be covered with a heat-reflective and/or fire-retardant coating. One of the means advocated in both Chinese and Russian civil defense handbooks for preventing thermal pulse or a nearby fire from igniting exposed flammable parts of expedient shelters is to paint these parts with a thick coating of slaked lime.[6,17] The World War II fire bombing of Kassel was less effective than in other German cities in producing fire storms because the roof timbers had been so treated.[18]
