Technical Report

R 711S

PROTECTIVE COATINGS FOR STEEL PILING: ADDITIONAL DATA ON HARBOR EXPOSURE OF TEN-FOOT SIMULATED PILING

Robert L. Alumbaugh, PhD and A. F. Curry

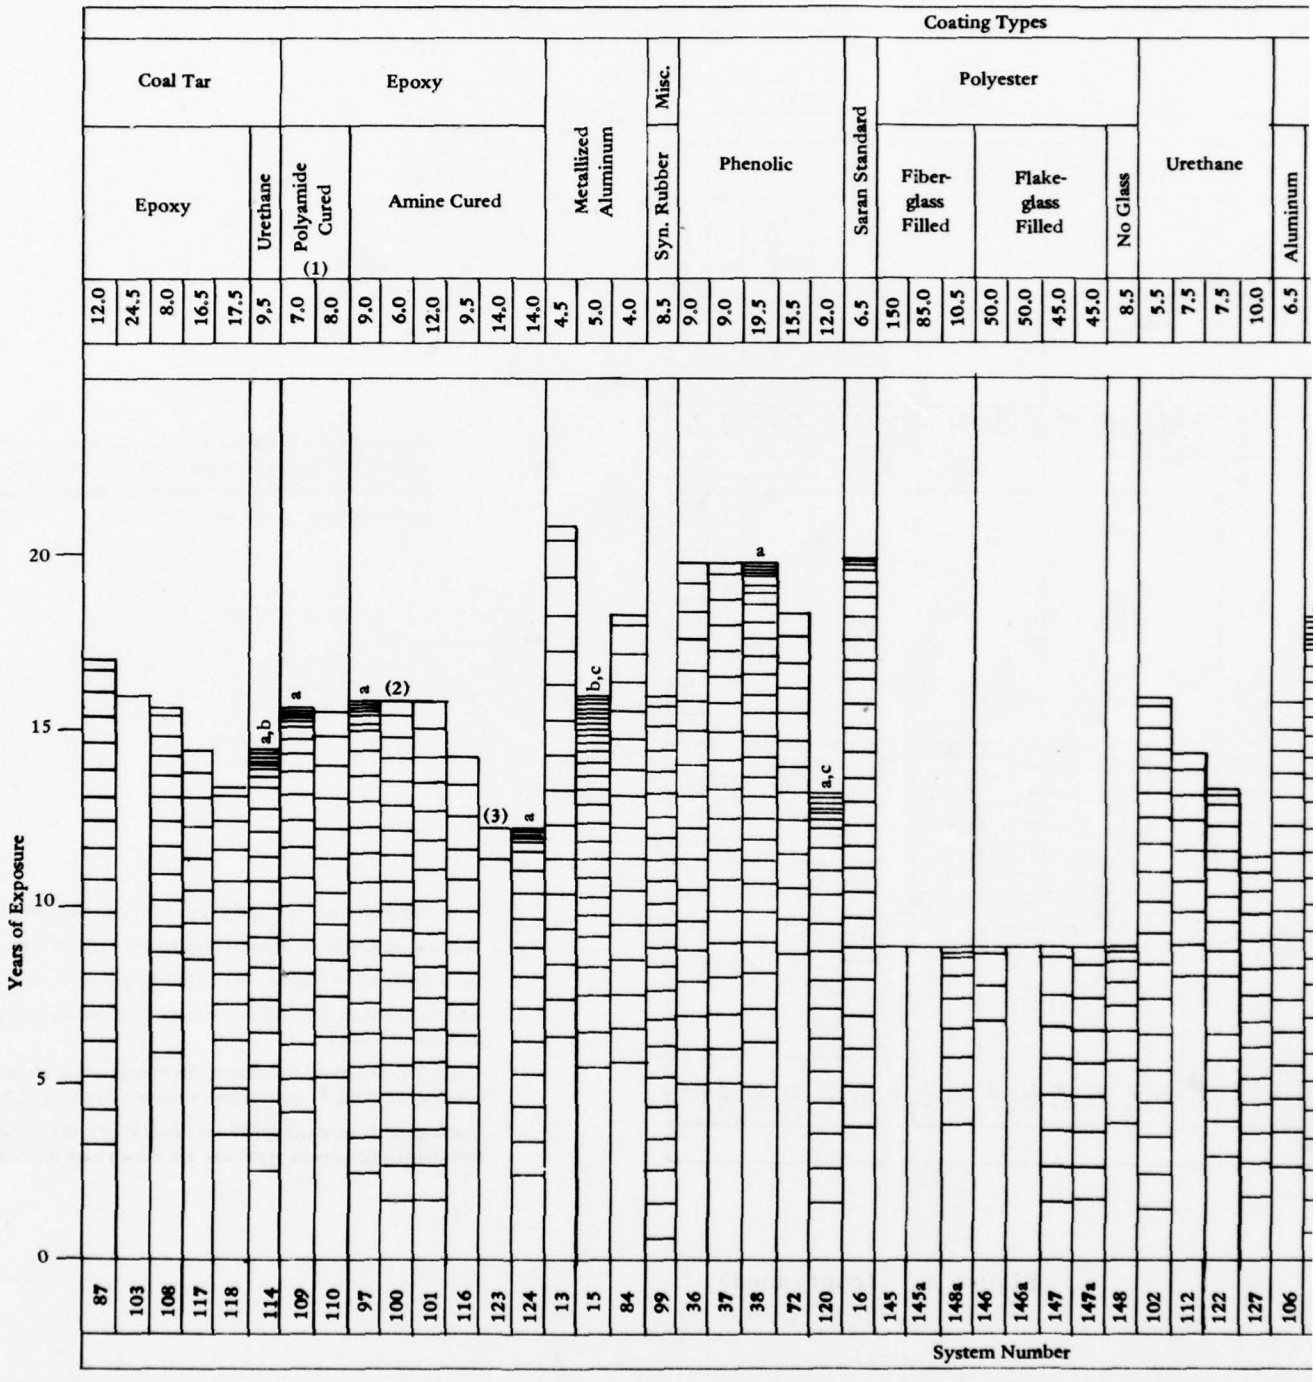
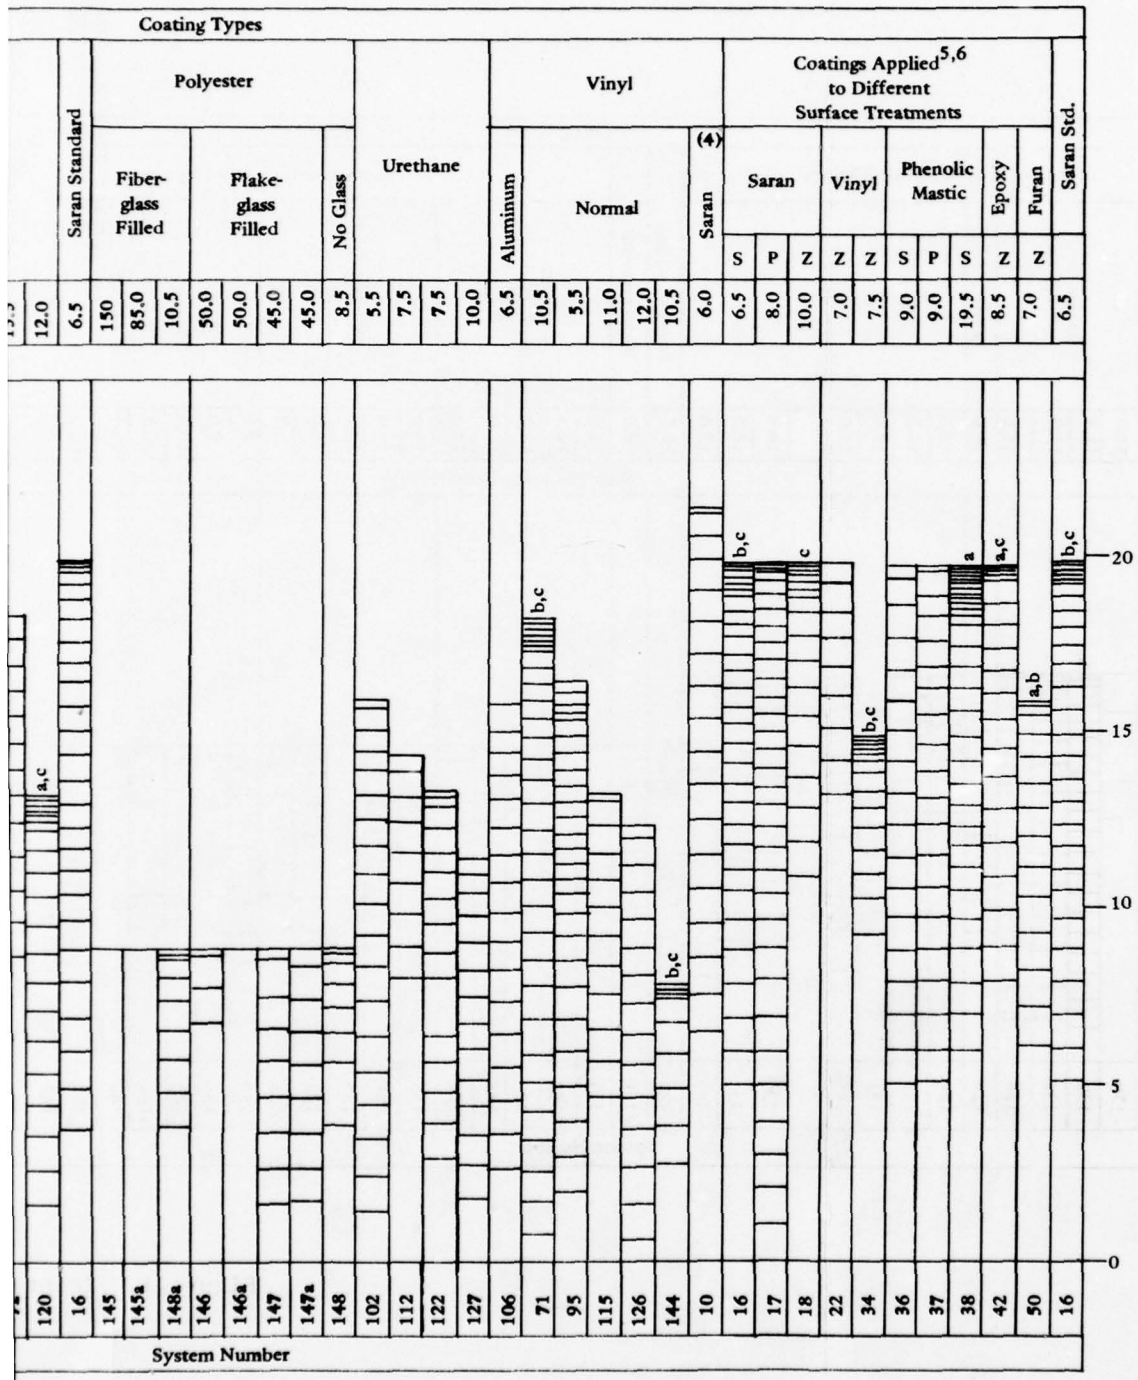
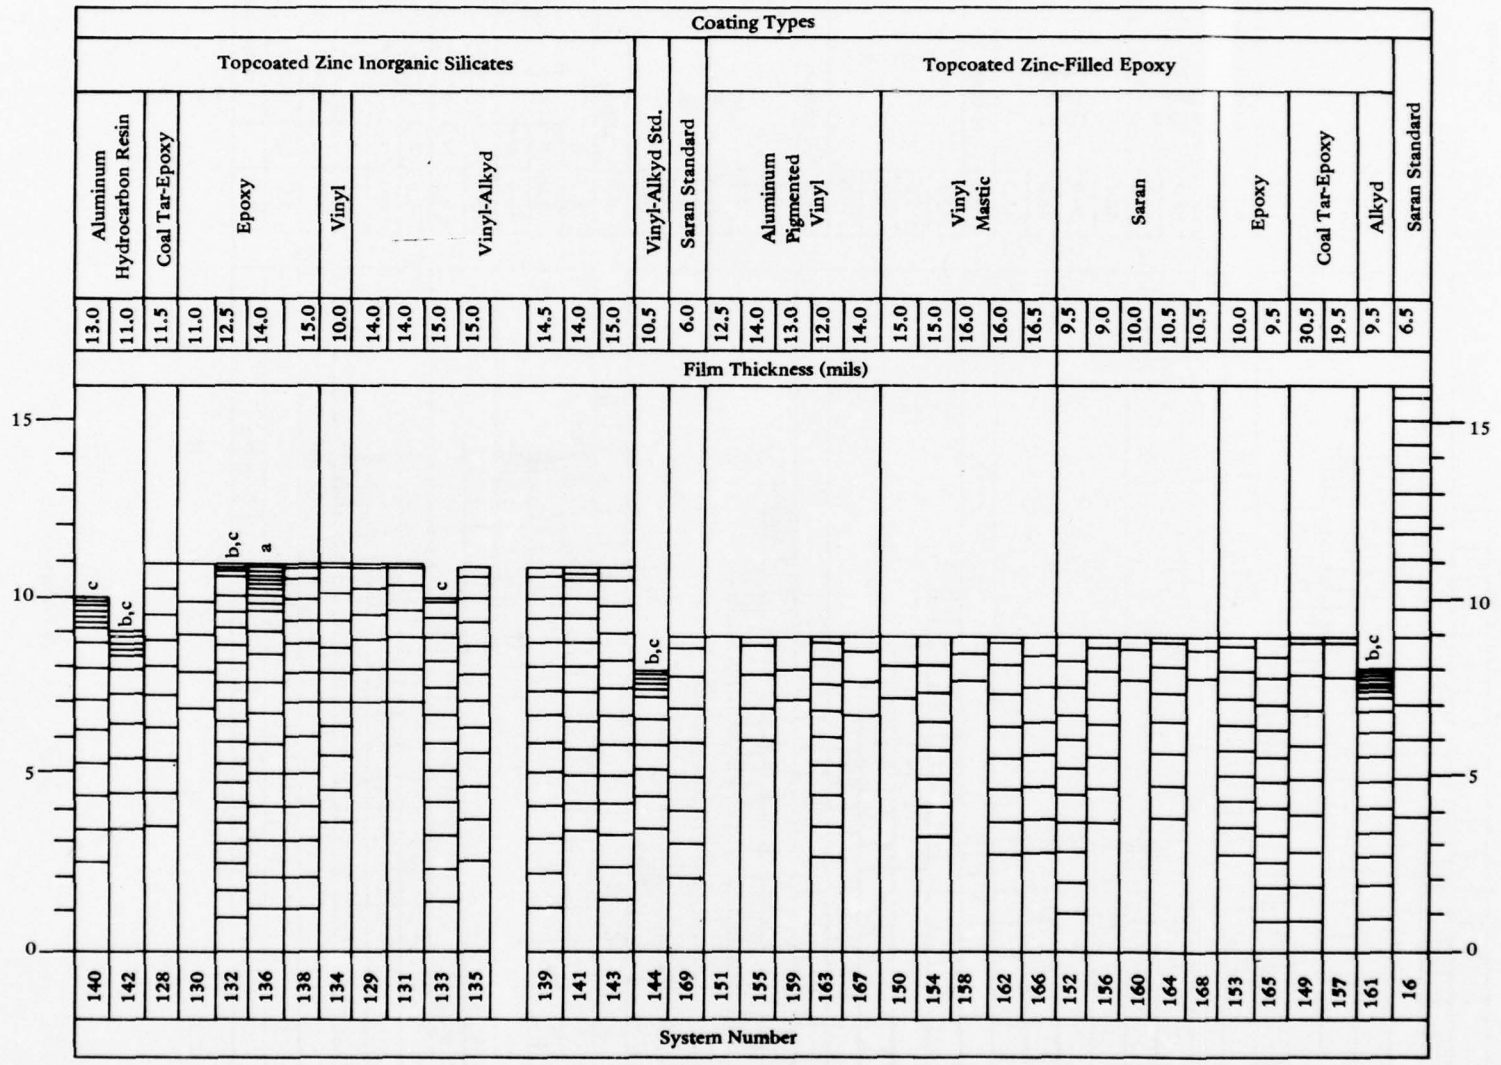
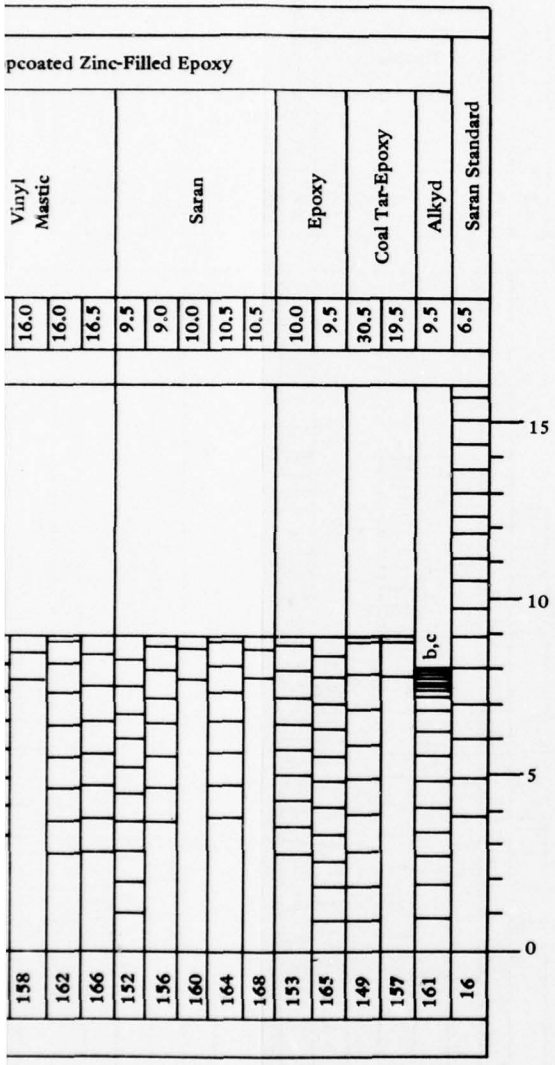
Figure 1. Comparative protection provided to corrosion dock panels by th

In Figure 1, the degree of system deteriorating or failure is denoted by a series of parallel lines within the bar. If the system was providing complete protection, the bar is only an outline. Within a given bar, and thus in a given system, the first line from the baseline of the graph indicates the approximate time of initial system deterioration (rusting). As the system deteriorates, the lines within the bar become progressively closer together; a completely darkened area at the end of the bar represents failure and removal of the system from exposure. It should be noted that, if a system provided relatively good protection to the panel, the spacing between the end of the bar graph and the line immediately next to it is not significant. Zones in which failure occurred are listed at the top of the bar graph for the corrosion dock panels.

(Complete protection denoted by outlined bar; initial system deterioration indicated by line nearest the baseline of the graph. As system deteriorates, lines become progressively closer together until they coalesce at failure and removal of the system from exposure.)
