**TN no. N-1516**

**title:** REPAIR SYSTEM FOR DAMAGED COATINGS ON NAVY ANTENNA TOWERS — PART I

**author:** L. K. Schwab and R. W. Drisko

**date:** March 1978

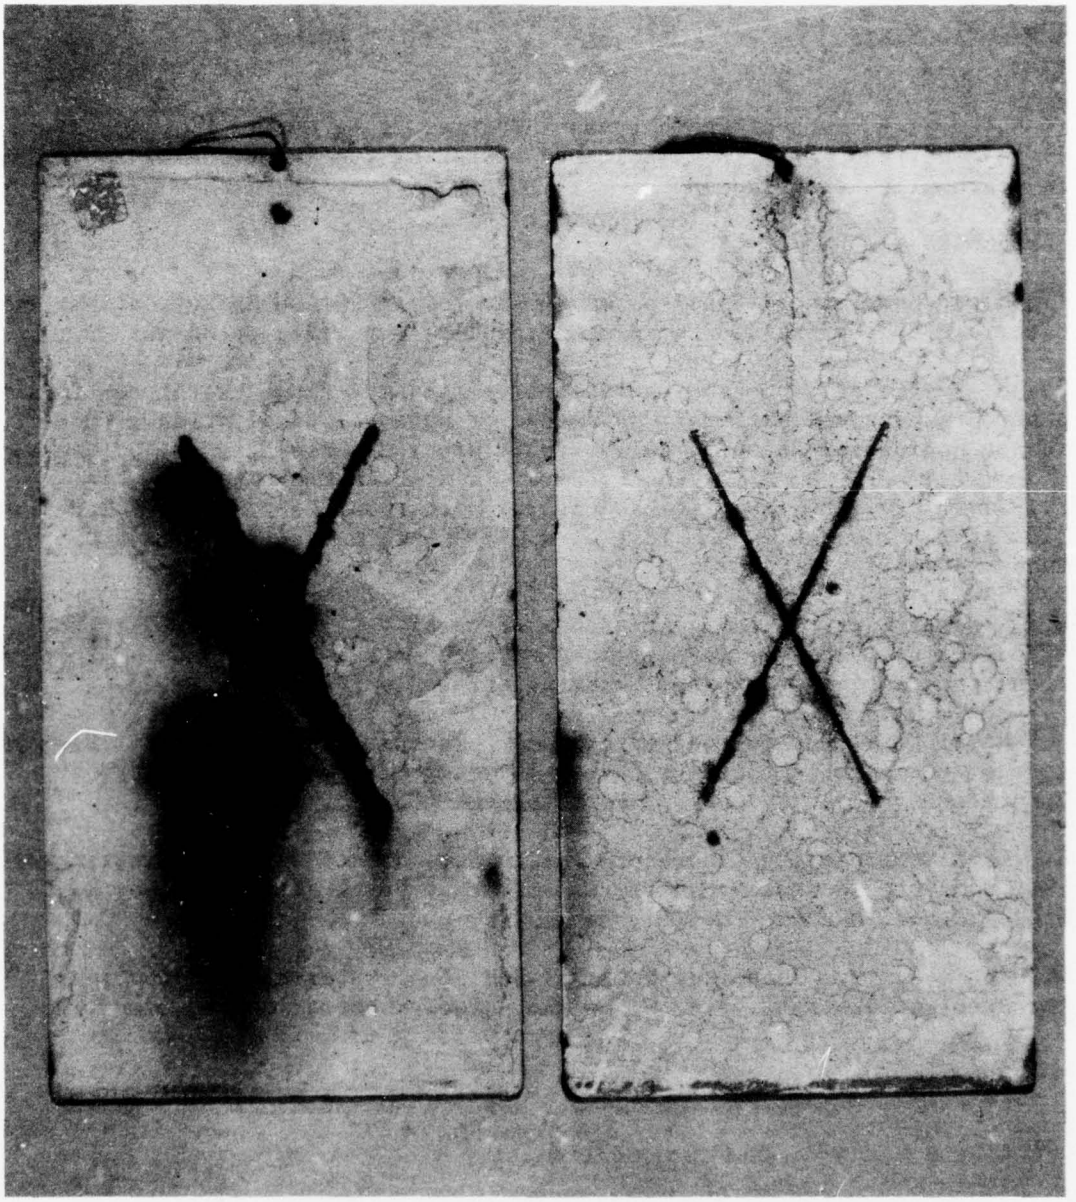
Figure 1. Weathered paint panels (left to right, Systems II and I).

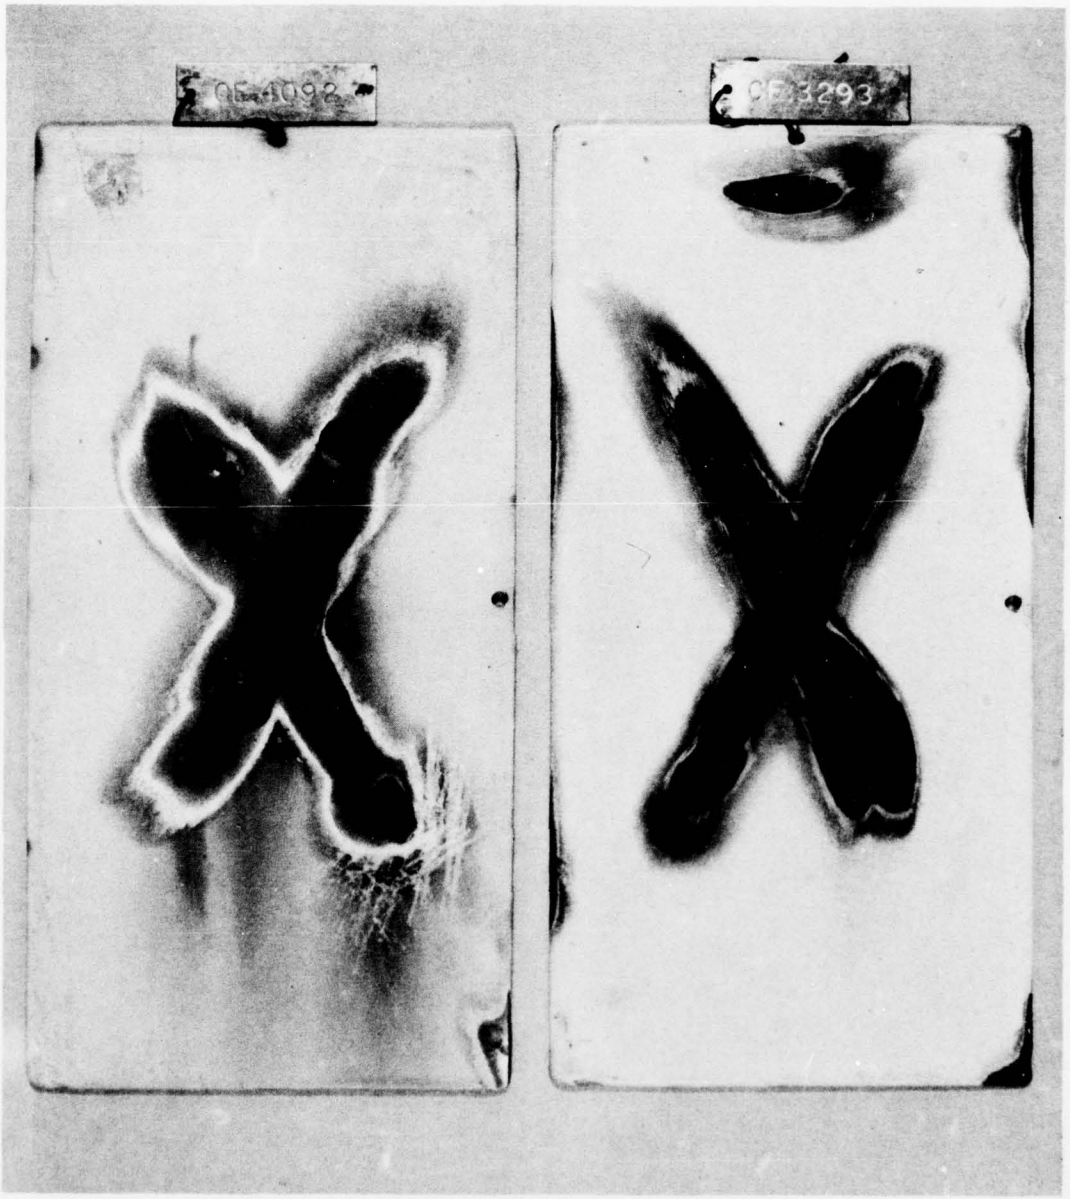
Figure 2. Wire-brushed, weathered paint panels (left to right, Systems II and I).

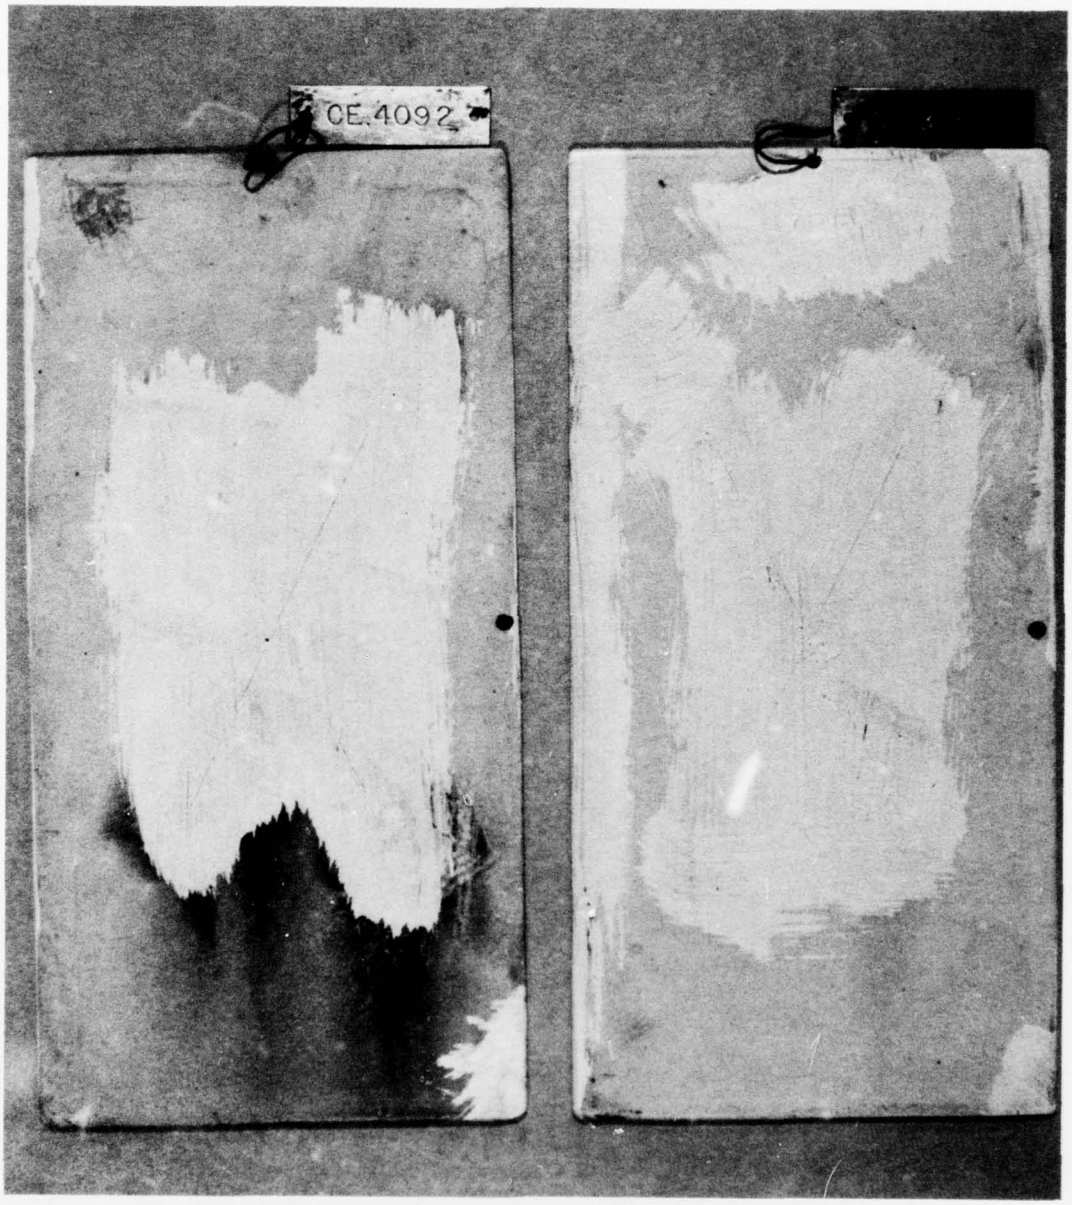
Figure 3. Spot-primed, weathered paint panels (left to right, Systems II and I).

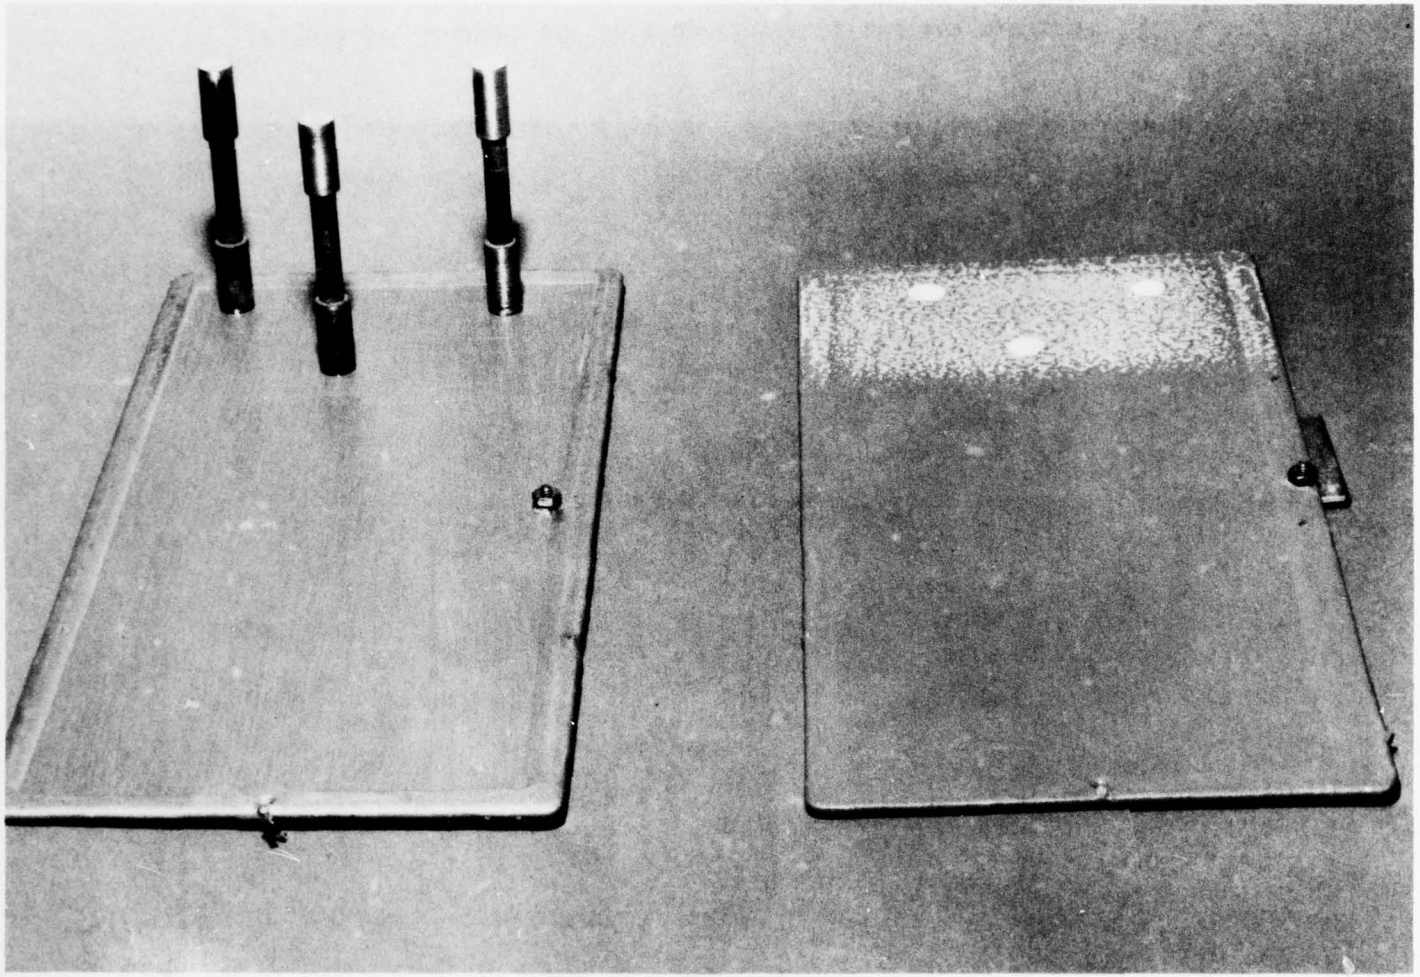
Figure 4. Painted panels before and after steel probes attached for bonding strength test.

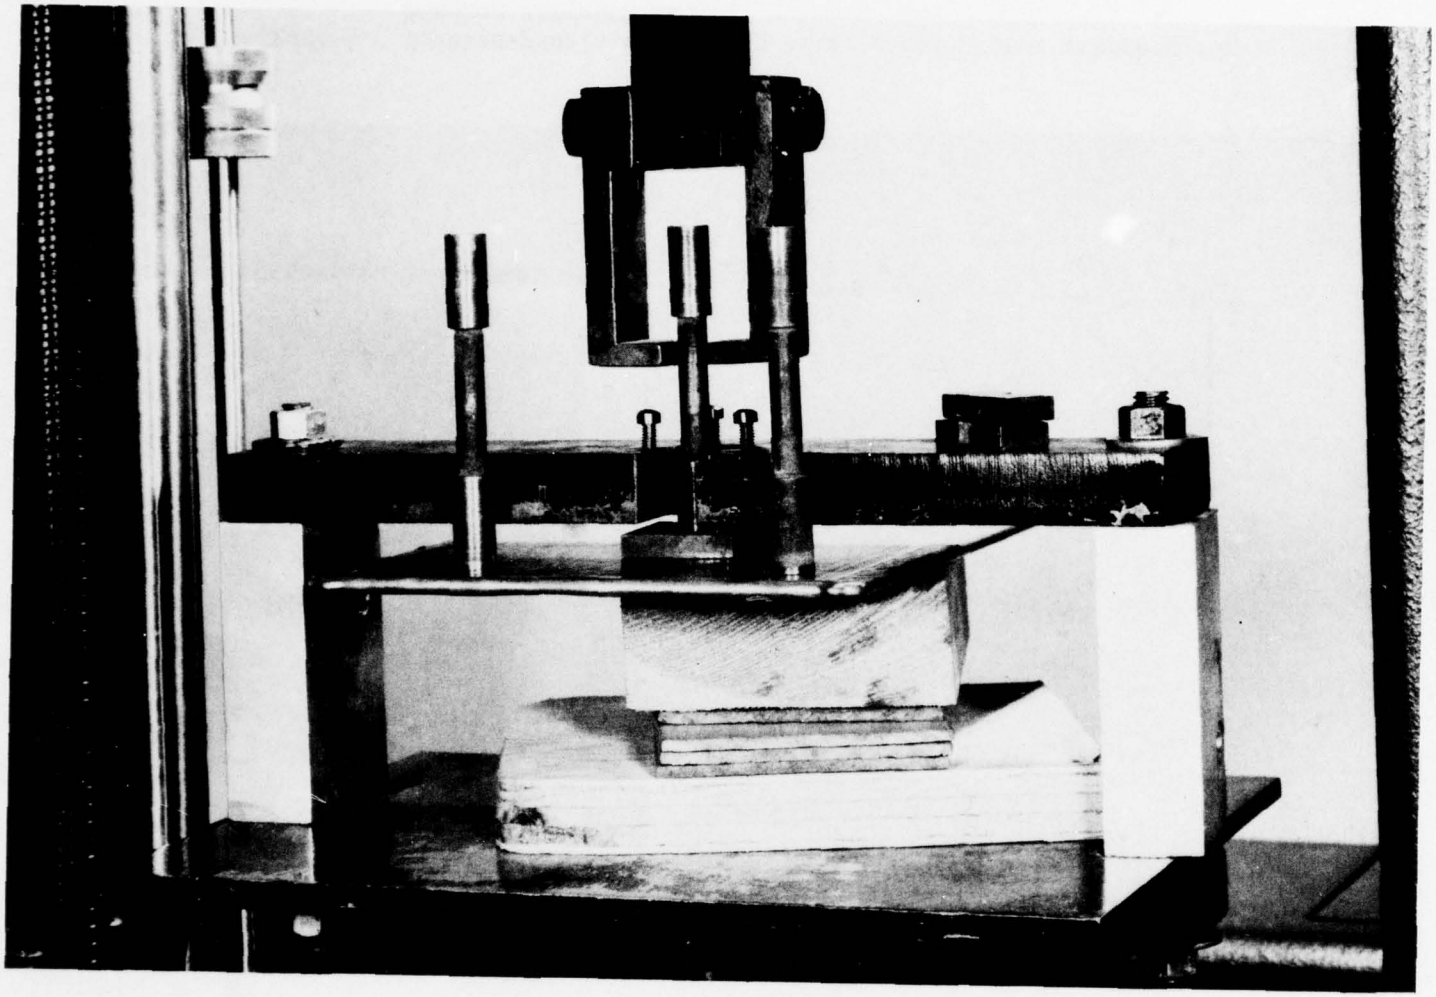
Figure 5. Bonding strength specimens in testing machines.

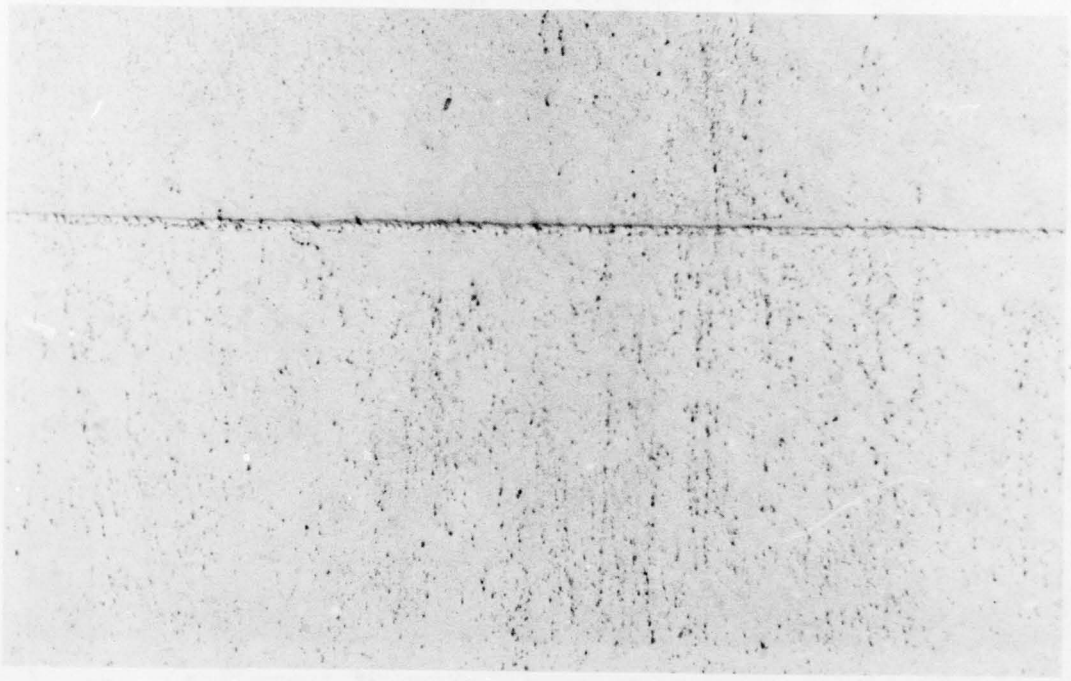
Water tank coating failures at the Off-lying Landing Field (OLF), San Nicolas Island, presented an opportunity for a field experiment in comparing methods for repair of failed coatings; different surface treatments and primers underlying the same high quality topcoat were used (Table 8). The previous coating system (Coating System 1) on the experimental tank had been applied over a steel surface that was given a very deep surface profile when sandblasted, resulting in minimal thicknesses of coats that allowed only marginal amounts of cover over the profile peaks. Pinpoint rusting had started even before the final coat was applied, presumably because of the frequent fogs and adverse weather at the time of application. This pinpoint rusting led to the condition illustrated in Figure 8 that existed when the tank was inspected for coating failure.

Figure 8. Pinpoint rusting on coated water tank exterior at San Nicolas Island.

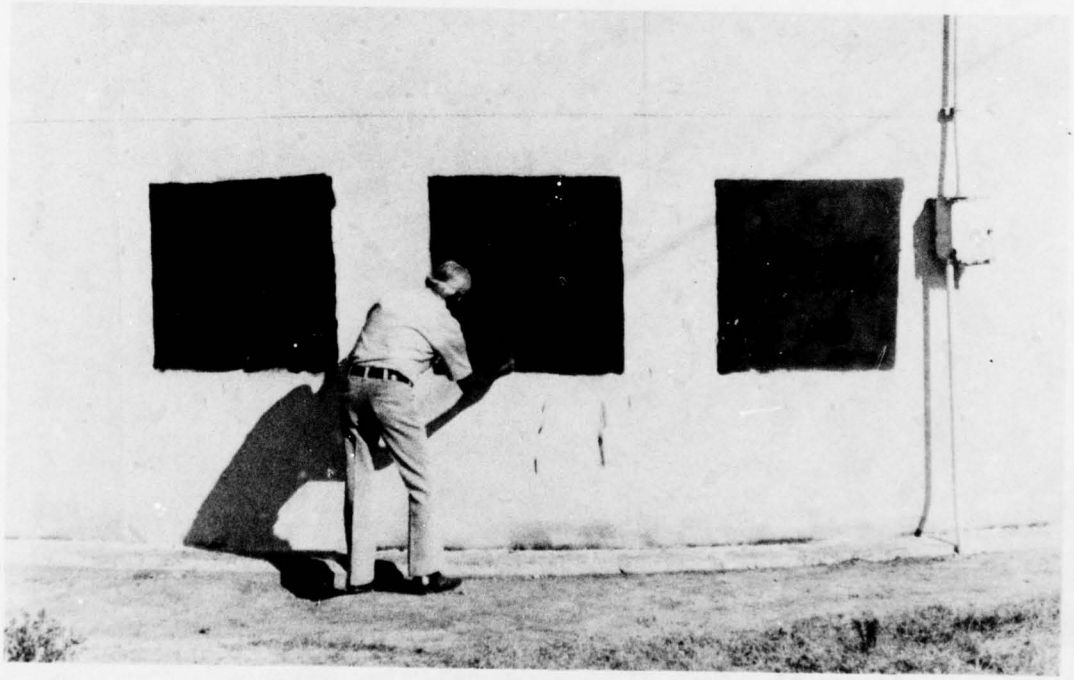
Figure 9. Brush-priming of Plot II.

Performances of three candidate systems for repair of the water tank coating were to be compared; a superior epoxy topcoat (based on previous experience) was applied after different surface treatments and over different primers. The test area selected had heavy, uniform pinpoint rusting; the three 1-sq-yd plots were scrubbed with a wire brush to remove much of the rusting, its streaking, and other contamination. The area was allowed to dry for at least 1/2 hr before further treatment. Plot I (System 7) was first treated with a rust-converting primer, scrubbed with a brush, and allowed to stand for 2 hr; it was then thoroughly washed with water and air-dried. In addition to this surface preparation, Coating System 7 had an amine-cured epoxy primer coat applied. On Coating System 9, the same primer was used but without application of the rust-converting primer. Coating System 8 had an epoxy primer applied. All three used the same polyamide-cured epoxy topcoat. Figure 9 shows the plots after application of primer, and

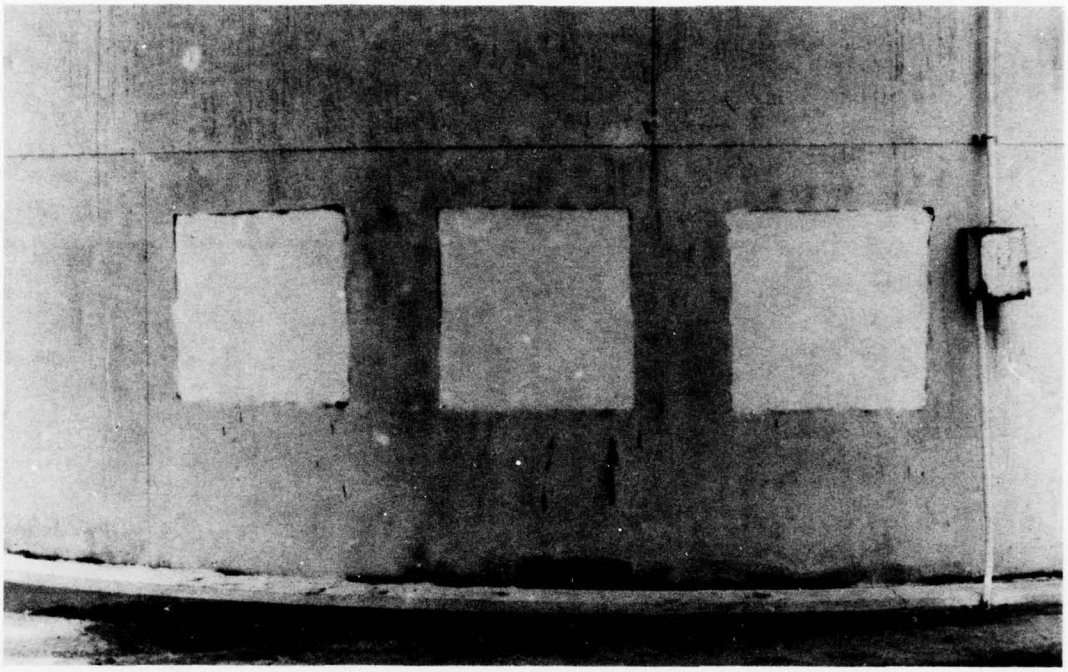
Figure 10. Tank plots immediately after topcoating.

Figure 10, after topcoat application; the primer and topcoat applications were made on successive days. The products used in each of these three coating systems are identified and their sources given in Appendix B. Each coat added about 3 mils of dry film thickness to the previously existing 7-1/2 mils.

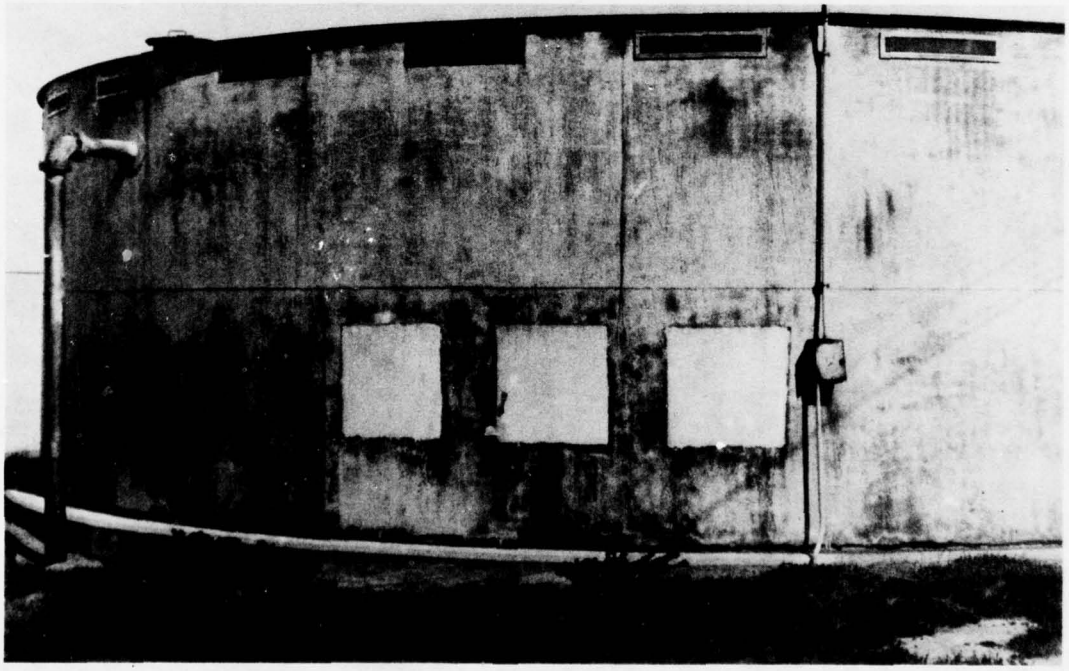
The test plots were examined after 1/2, 1, and 1-1/2 yr. After 1/2 and 1 yr the only coating deterioration noted was a heavy chalking (ASTM rating 2). After 1-1/2 yr, Plot III (Coating System 9) had only one very small pinpoint rust spot; Plot I (Coating System 7) had two very small rust spots, and Plot II (Coating System 8) had some topcoat cracking and peeling (Figures 11 and 12). All had some yellowing of the topcoat. Coating System 9 performed slightly better than Coating System 7 (identical systems except Coating System 7 was treated with a rust converter). Thus, it appears that this rust converter treatment is unnecessary.

Figure 11. Tank plots after 1-1/2 yr exposure.

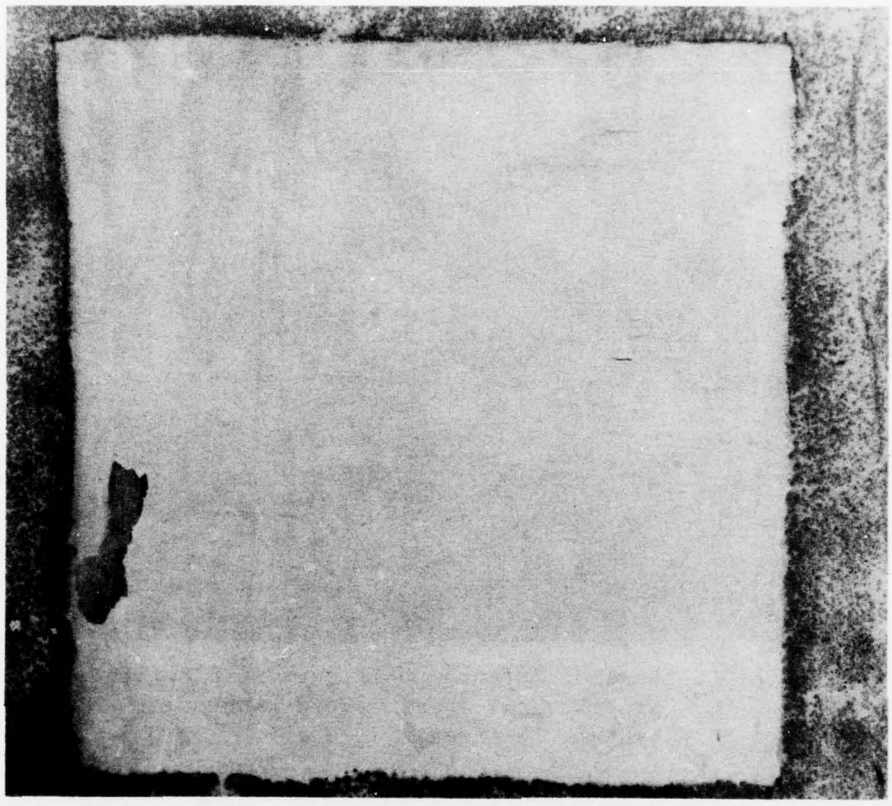
Figure 12. Plot II (System 8) after 1-1/2 yr exposure.

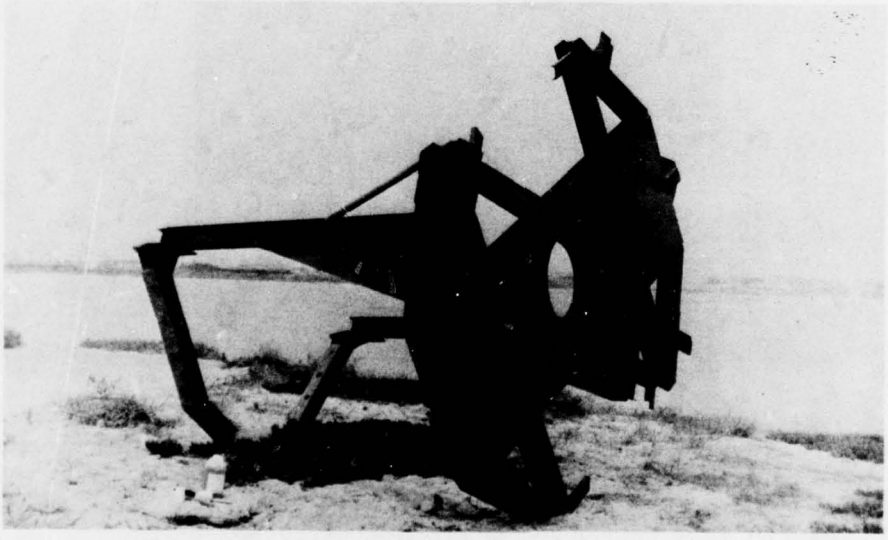
An antenna positioner at the Pacific Missile Range, Point Mugu, Calif., was used as the substrate for a field experiment on antenna coating repair systems. This steel structure (Figure 13) had been coated 15 mo earlier with a red-lead pigmented alkyd paint applied at a 2-mil dry film thickness. The painted surface was chalky and dirty but, except for a few localized rust spots, was providing good protection from corrosion. The location of the positioner on a spit between a lagoon and the ocean provided exposure to sea spray.

Figure 13. Antenna positioner at PMR after treatment of lower half of base with manganese-phosphalten no. 7.

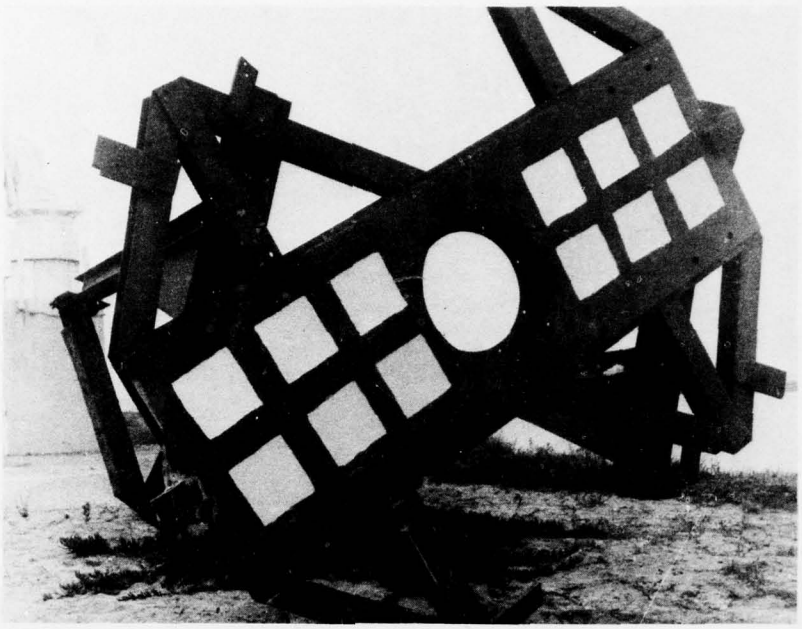
In the experimental design, 32 square areas (16 x 16 in.) were used: 16 located on the top side of the positioner's base, 12 on the bottom of the base (Figure 14), and 4 on the arms. All 32 areas were cleaned preparatory to coating by scrubbing with a wire brush. Sixteen of the cleaned areas were treated chemically with the metal conditioner and rust converter as described in the previous section of this report, which had been shown (6) to provide a good base for painting wire-brushed steel. The brushed chemical was allowed to remain on the surface for 2 hr, rinsed with water, and allowed to dry. The other 16 areas were only wiped free of dirt or dust particles with a cloth after cleaning with the wire brush. The well-mixed paints were applied with a 1-in. wide brush to the test sections.

Figure 14. Base of antenna positioner with twelve experimental areas coated with paint systems 10 through 21.

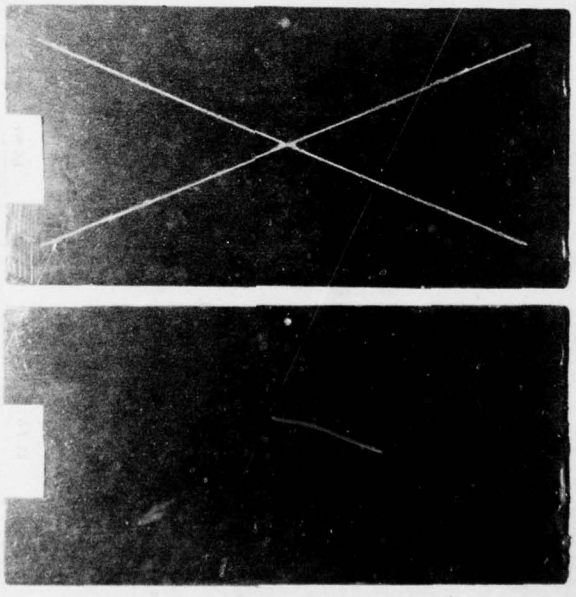
Figure 15. Untreated panel with ultraviolet-cured coating (System 42) before salt spray exposure.

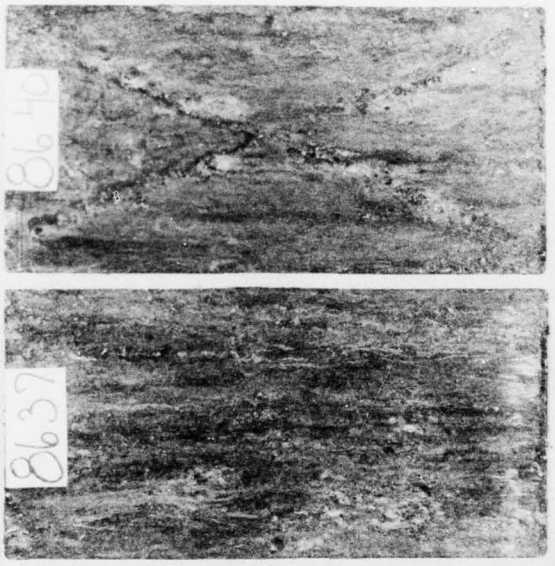
Results. The two CEL underwater epoxies performed very well and provided good general protection for all 180 days of testing. The ultraviolet-cured coating provided good general protection for only about 86 days. Overall, the panels that received treatment with the surface conditioner performed no better than the ones that did not.

Figure 16. Untreated panel with ultraviolet-cured coating (System 42) after salt spray exposure.

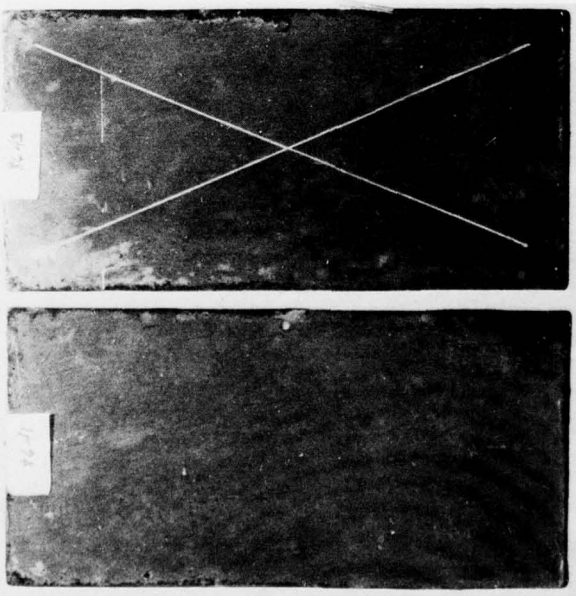
Figure 17. Treated panel with ultraviolet-cured coating (System 43) before salt spray exposure.

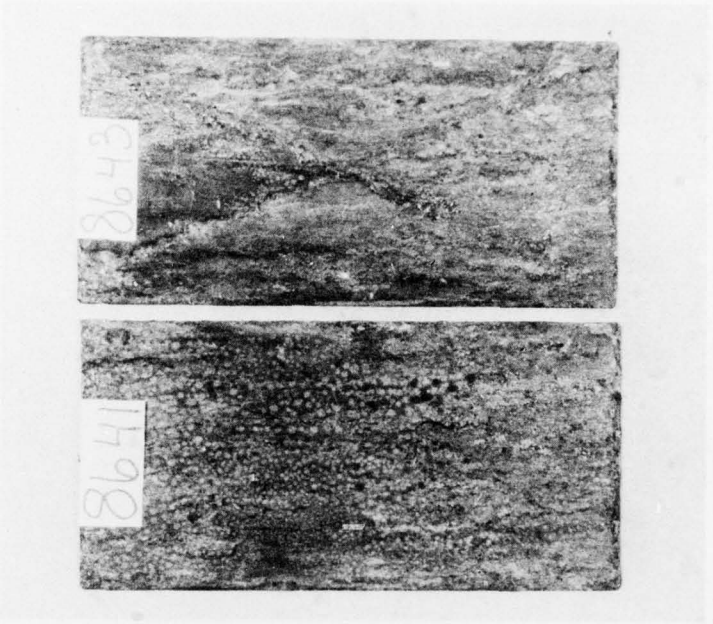
Figure 18. Treated panel with ultraviolet-cured coating (System 43) after salt spray exposure.

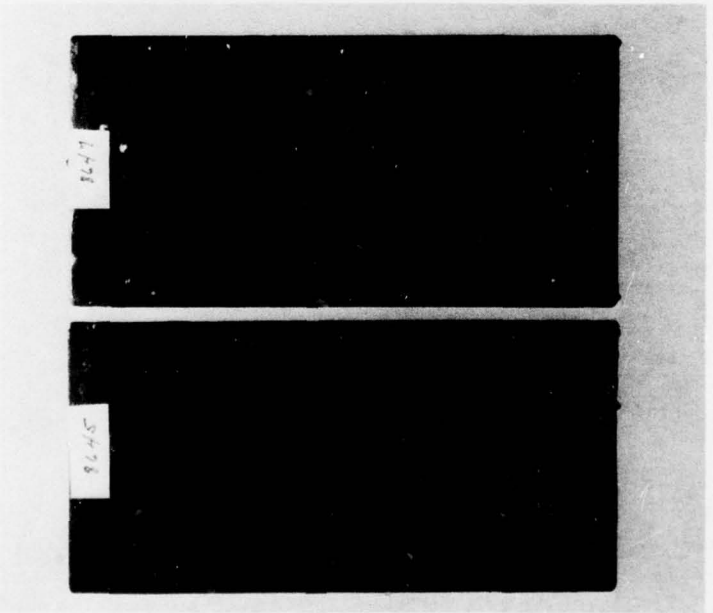
Figure 19. Untreated panel, CEL underwater epoxy (System 44), before salt spray exposure.

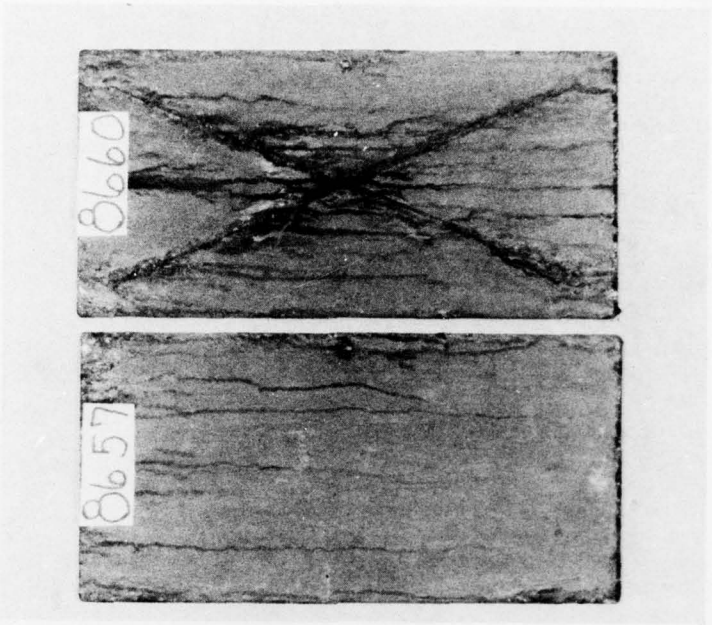
Figure 20. Untreated panel, CEL underwater epoxy (System 44), after salt spray exposure.

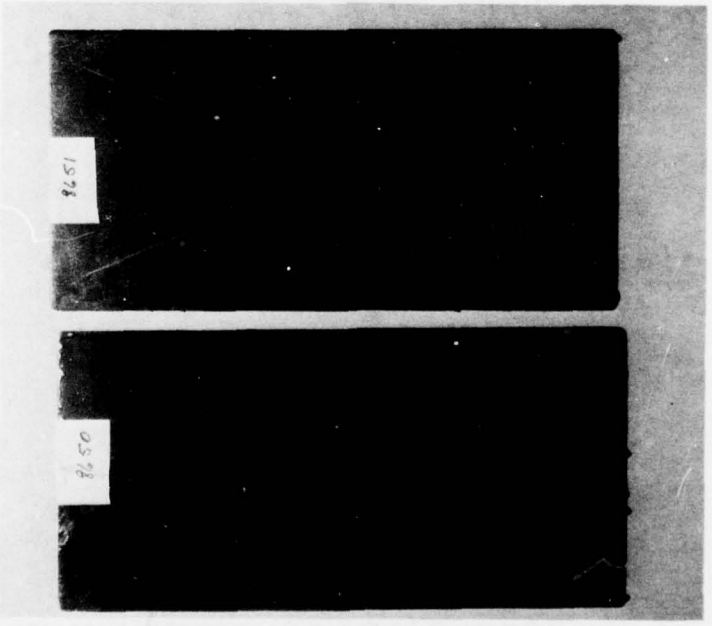
Figure 21. Treated panel, CEL underwater epoxy (System 45), before salt spray exposure.

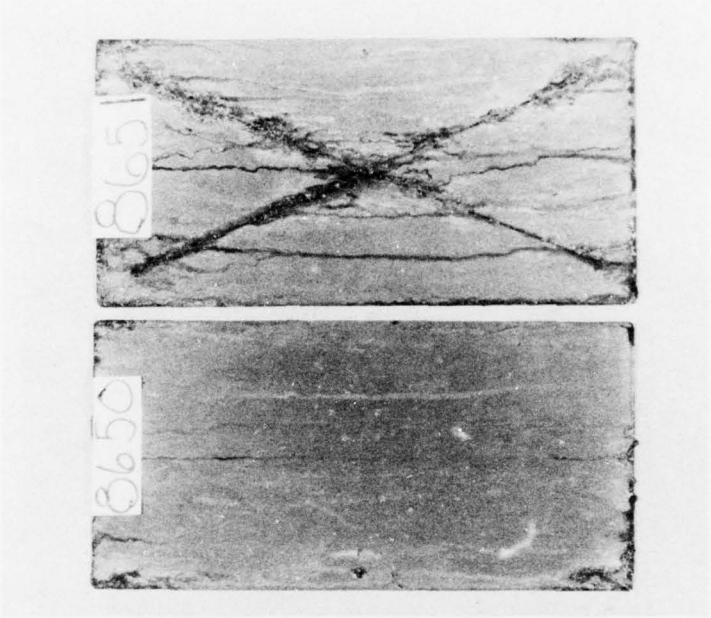
Figure 22. Treated panel, CEL underwater epoxy (System 45), after salt spray exposure.

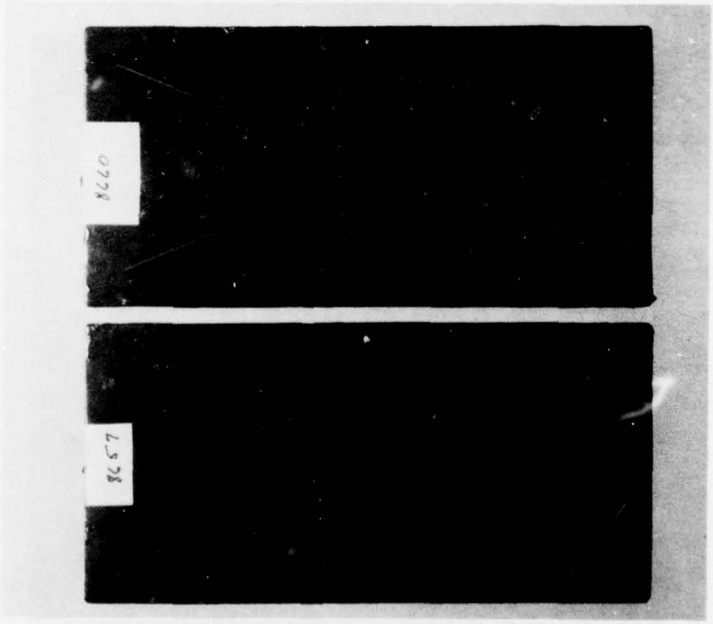
Figure 23. Untreated panel, CEL underwater epoxy (System 46) with organotin, before salt spray exposure.

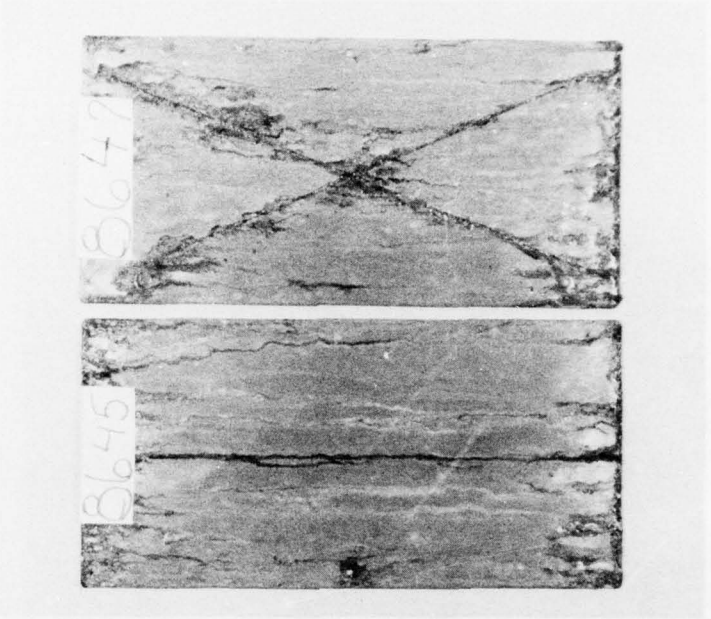
Figure 24. Untreated panel, CEL underwater epoxy (System 46) with organotin, after salt spray exposure.

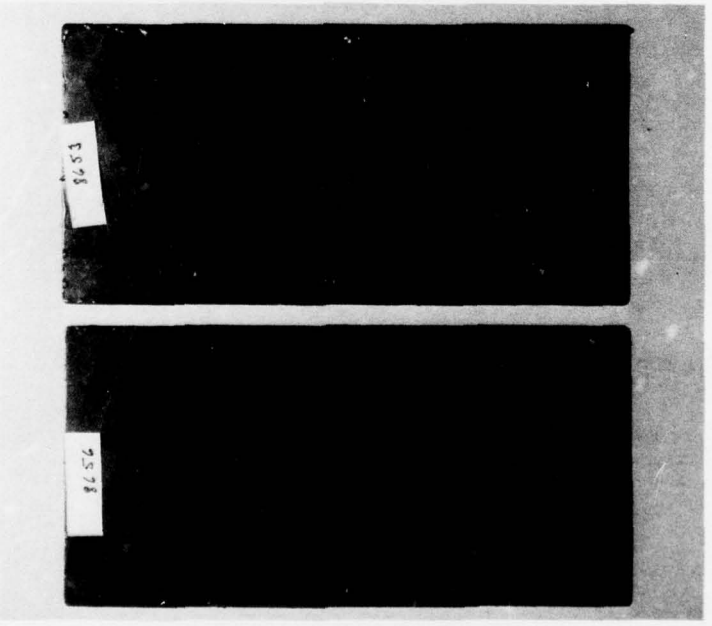
Figure 25. Treated panel, CEL underwater epoxy (System 47) with organotin, before salt spray exposure.

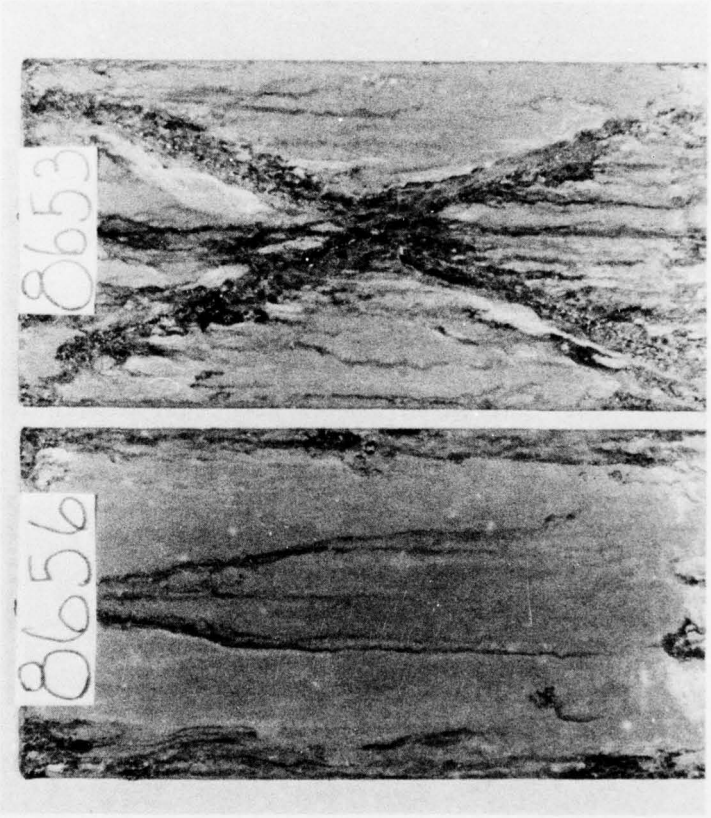
Figure 26. Treated panel, CEL underwater epoxy (System 47) with organotin, after salt spray exposure.
