R 863

EFFECTIVENESS OF OVER-RUST PRIMER FOR USE AT NAVAL SHORE FACILITIES

By E. S. Matsui

January 1978

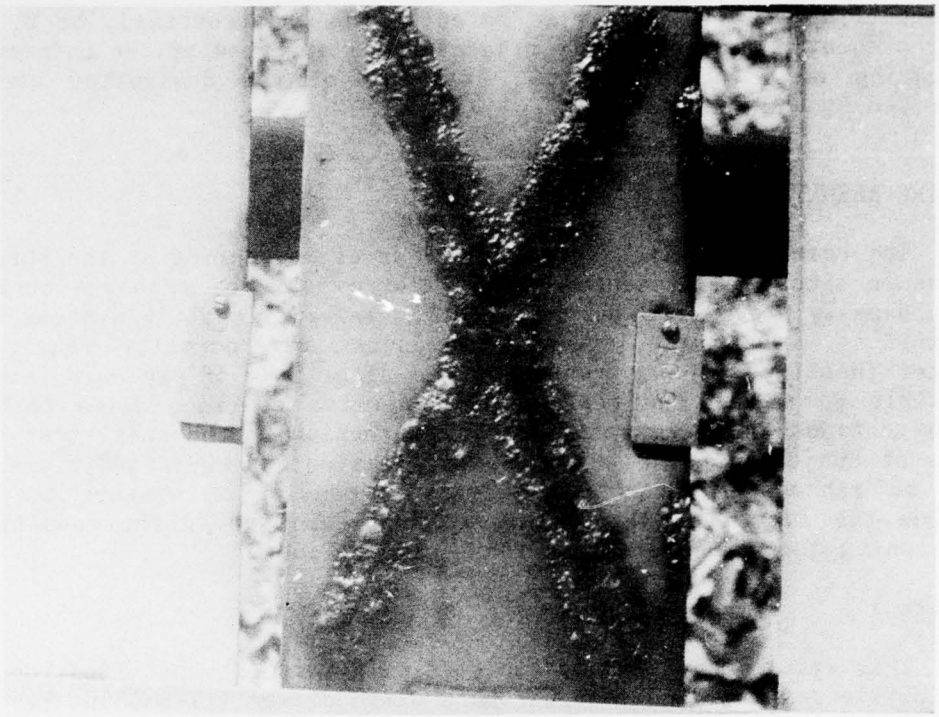
The scribed panels at Kwajalein and Kaneohe failed during the second year of exposure and in Port Hueneme during the third year. The failures were attributed to dense blistering, rusting, and tuberculation in the scribed areas (Figure 2).

Figure 2. TT-E-485E primer over brush-off sandblasted System 1 panels after 2 yr at Kwajalein.

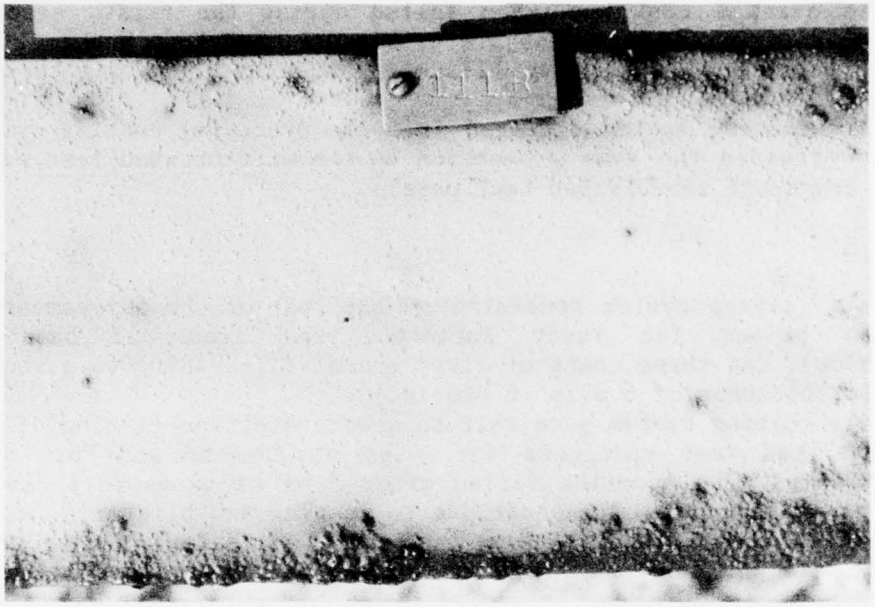
Figure 4. Blisters on System 3-R (TT-P-645 primed panel) after 2 yr at Kwajalein.

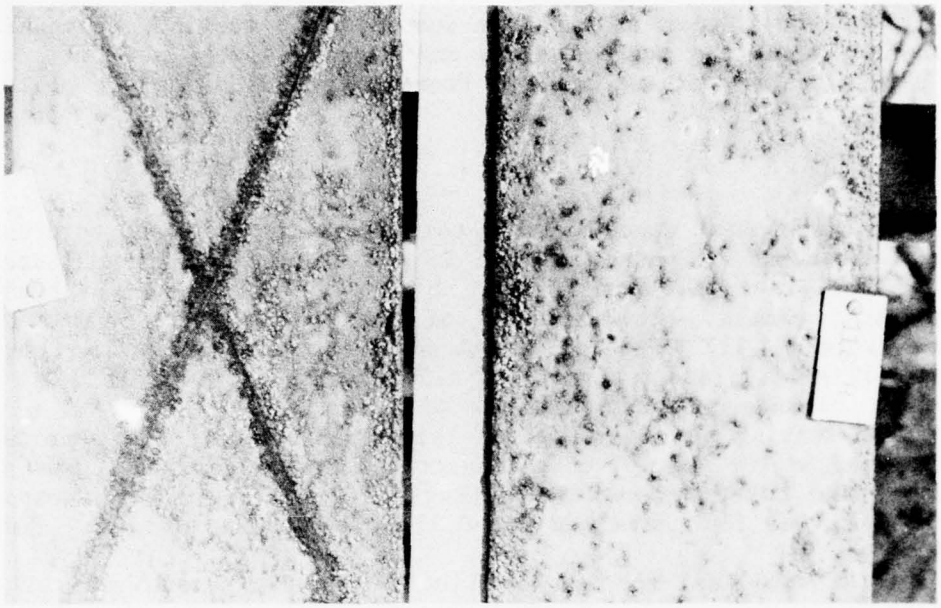
The unscribed test specimens failed at Kwajalein and Kaneohe during the first year of exposure because of moderate to heavy rust accompanied by blisters over the entire surface of the test specimens (Figure 5). The specimens were rated 6 and 7 at Kwajalein and Kaneohe, respectively. The system has given fair protection (rating of 8) to the unscribed test specimen during the 5 yr of exposure at Port Hueneme. Chalking of the top coats was rated 6 to 4.

Figure 5. Dense blistering accompanied by rust of System 10-R panel after 1 yr at Kwajalein.

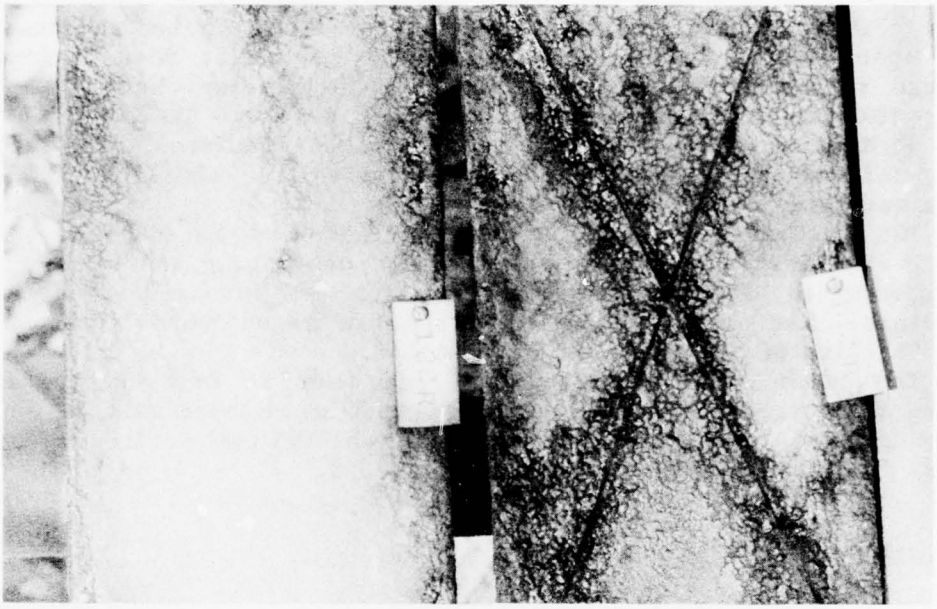
Figure 6. System 14-R (TT-P-645 primed over wire-brushed panels) after 1 yr at Kwajalein.

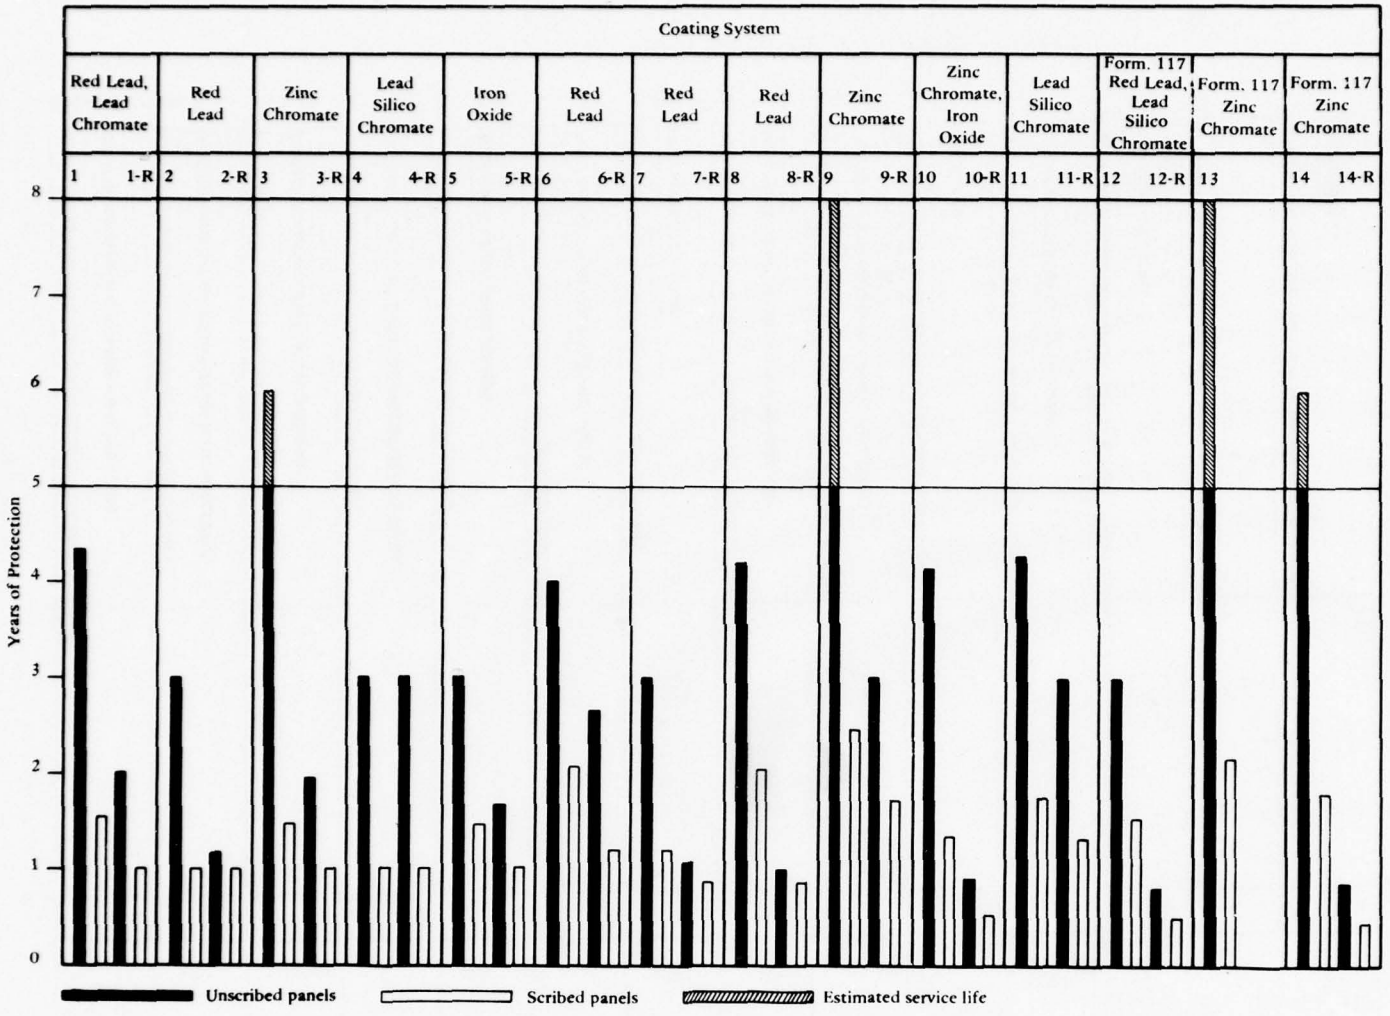
Unscribed Panels. Figure 7 shows that only three of the 13 over-rust primer coating systems, along with control System 13, were providing satisfactory protection beyond the 5 yr of exposure at Kwajalein. These were Systems 3, 9, and 14, all of which were zinc chromate-pigmented alkyd primers. Systems 2, 4, 5, 7, and 12 failed at the end of 3 yr of exposure. Figure 8 shows that 8 of the 13 over-rust primer coating systems, along with control System 13, were providing satisfactory protection after 5 yr of exposure at Kaneohe. These eight systems and their types are listed below:

Figure 7. Relative performance of over-rust primers at Kwajalein after 5 yr of exposure.
