TECHNICAL REPORT N-78-1

EXPEDIENT UPGRADING OF EXISTING STRUCTURES FOR FALLOUT PROTECTION

William L. Huff

April 1978
Final Report

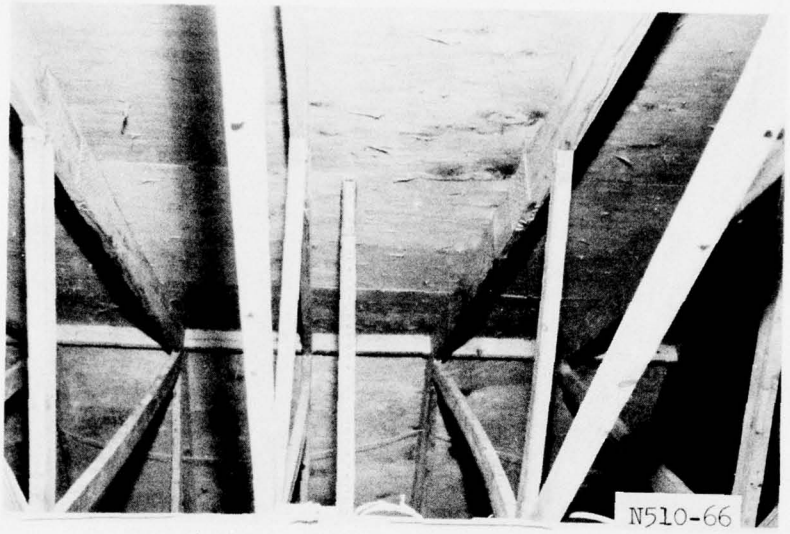
Figure 2.26 Bowed truss members.

With the weight of the wet soil for several days, the deflection increased to 15/16 inch. Figure 2.25 shows the house after the rain. Water seeped under the soil roll around the edge of the roof; however, none of the soil had washed off. When the roof was inspected on Monday, the 2 by 4 braces at the center of the truss were bowing as much as 1-1/2 inches. Some of the bowed braces can be seen in Figure 2.26. When the house was inspected on Tuesday, one of the truss braces had broken (Figure 2.27) at the location of a knot. The roof in that area sagged approximately 2 inches, and the recorded deflection locations showed an average deflection of 13/16 inch. Apparently, when the roof sagged over the broken truss, it bowed up slightly in the areas in which deflections were being recorded.

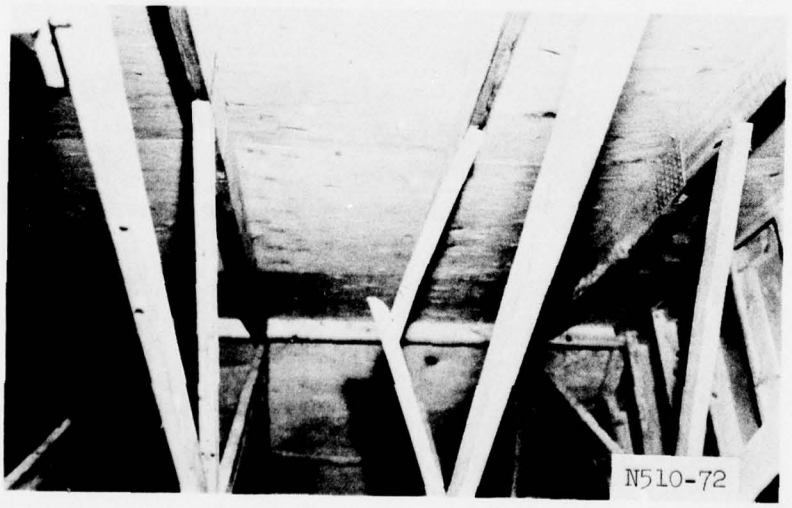
Figure 2.27 Broken truss member.

From soil density measurements, the loading on the frontside and backside of the roof in the structural test area was 180 and 130 psf, respectively. Since one of the braces in a truss had broken under this loading, no additional soil was added to the roof. The 3/8-inch-thick plywood sheathing had not bowed sufficiently between the trusses to obtain reliable deflection measurements. At most, the plywood had sagged 1/8 to 1/4 inch between the trusses.

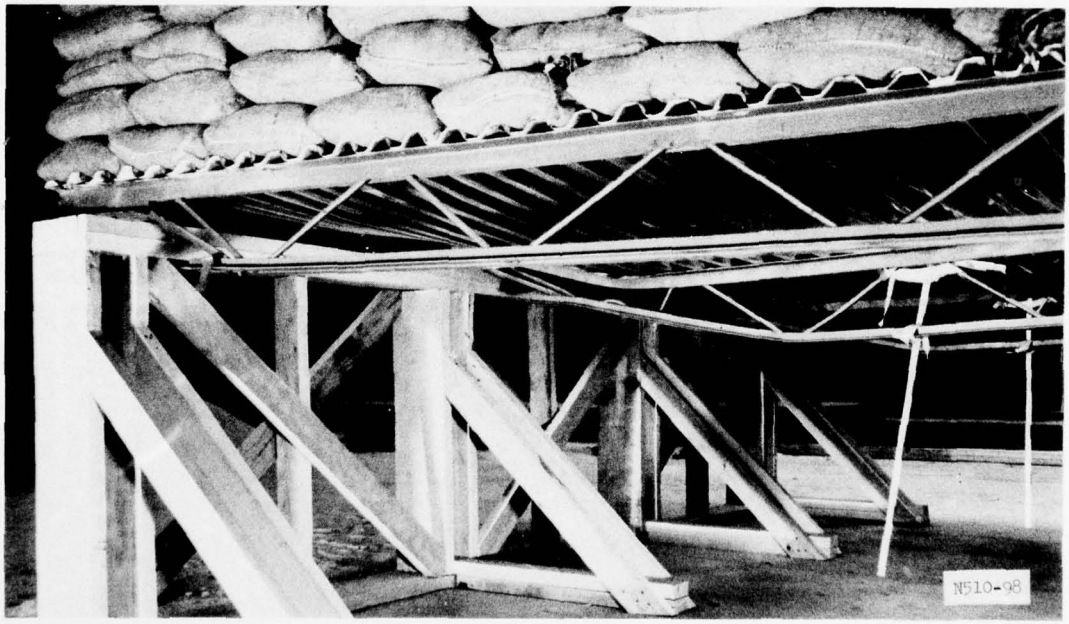
Figure 3.7 Initial buckling of the OWJ.

Since the decking was failing rather than the joists, the test was stopped. As the sand was being removed for a closer inspection of the metal roof decking, the two center joists started to fail. Figure 3.7 shows the initiation of the failure at the second web member from the end of the joist. The two middle joists of the roof system are shown in Figure 3.8 after removal from the roof. The two outside roof joists were undamaged.

From the truss analysis, the web member that failed was being subjected to an axial force of 8000 pounds. Assuming pinned connections, the calculated critical buckling load from the Euler formula was 4600 pounds. If the ends are assumed fixed, the critical buckling load is 18,500 pounds. Although the web members of the joists are continuous and welded at each intersection with the top and bottom chords, they are acting more as a pinned end member than a fixed end member.

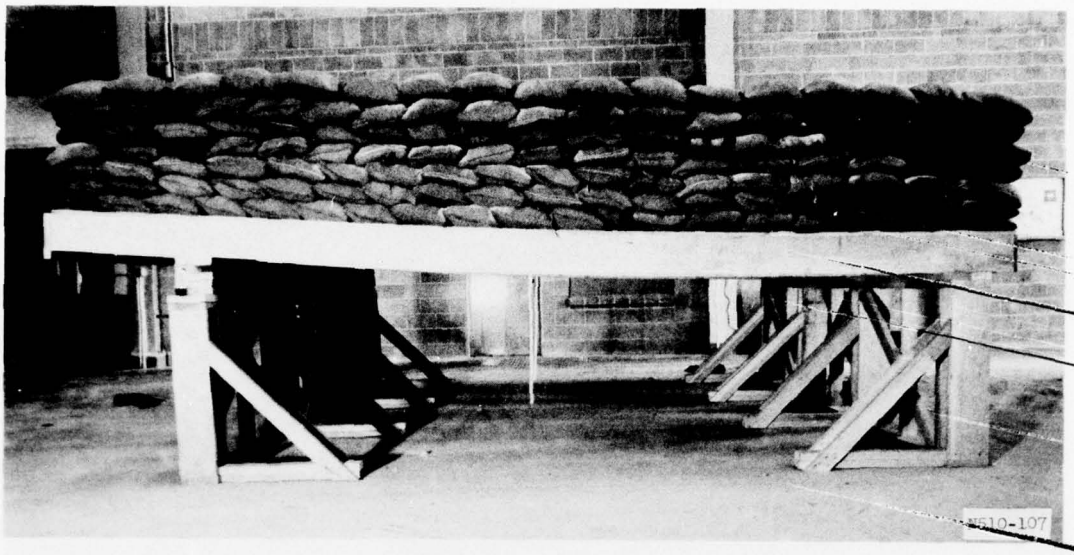
a. Edge view with 24 inches of sand on roof.

b. Oblique view with 36 inches of sand on roof.

Figure 3.25 Wood joist roof after joist failure.

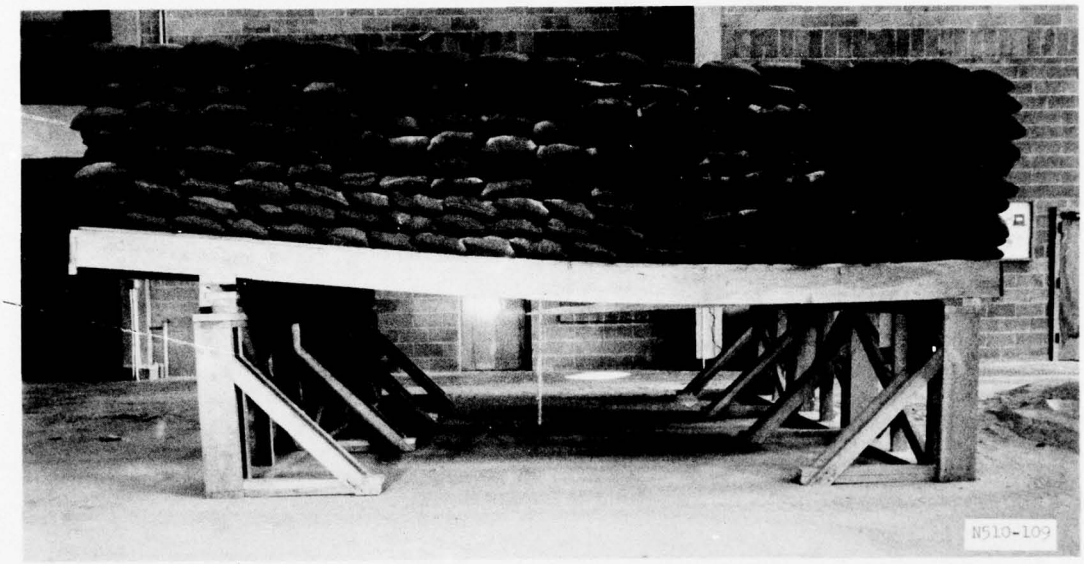
a 24-hour period with a loading of 24 inches of sand. When the load was increased to 36 inches of sand (300 psf), the roof supported the load for several hours before one of the joists failed. The split section of the failed joist can be seen in Figure 3.25. The failure occurred in the joist next to one of the edge joists of the roof.

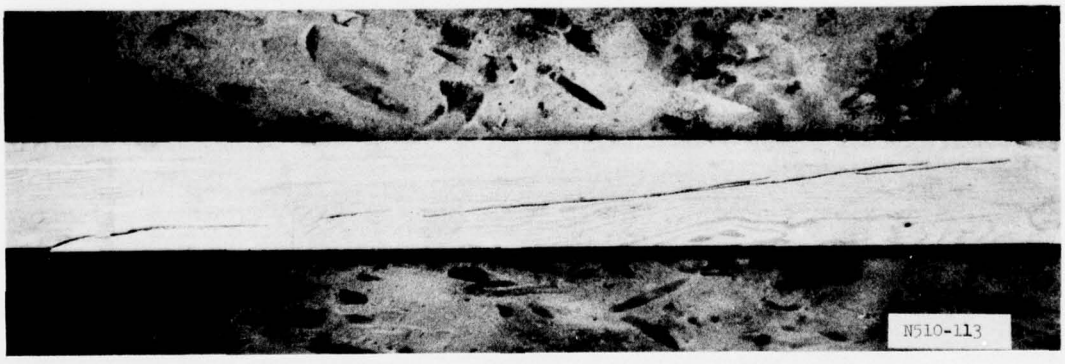
Figure 3.26 Closeup of broken joist.

The failure plane of the broken joist extended along the wood grain from near midspan on the underside of the joist to within 1-1/4 inches of the top of the joist at approximately 4 feet from midspan. Figure 3.26 shows a closeup of the broken joist after it was removed from the roof section.

required for radiation protection. Before loading any wood floor or roof system, the joists and decking should be inspected closely for obvious defects in materials or construction.

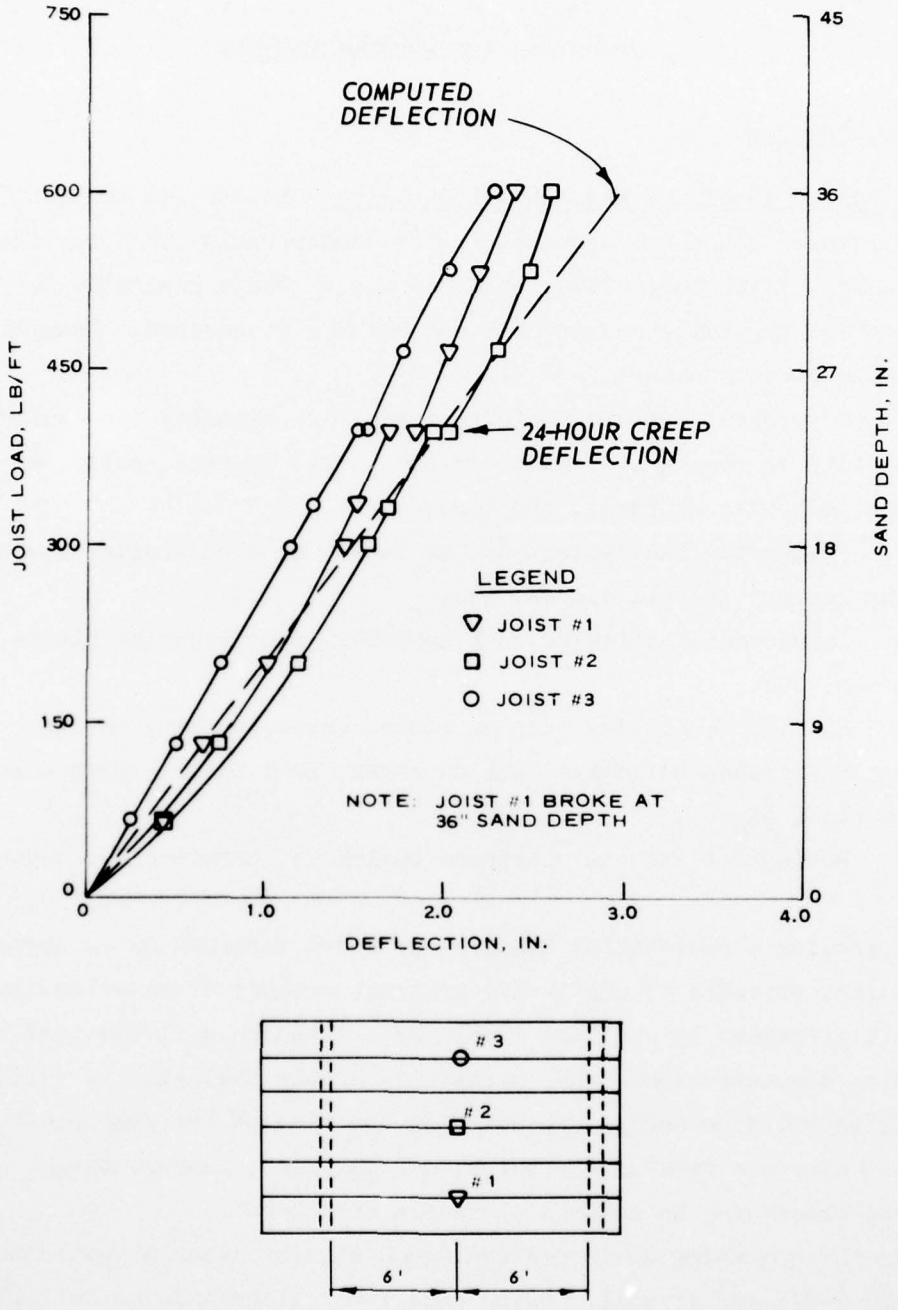
Figure 3.27 Midspan load-deflection curve for wood joist roof system.

Load-deflection curves for three of the joists for which deflection measurements were reported are shown in Figure 3.27. The surveyor's level used to measure deflections of the joists was moved after recording the deflections with 36 inches of sand on the roof. Therefore, no deflection measurements were recorded after the joist failure. The roof appeared to deflect considerably when the joist broke; however, none of the remaining joists showed any signs of failure after sitting under load for several more hours. The roof system was stiffer than predicted by the computed load-deflection curve, which could be due either to the modulus of elasticity of the fir joist being around 2,000,000 psi rather than the 1,760,000 psi given in handbooks or composite action being developed between the plywood decking and the joist. The stiffness of the roof system assuming composite action between the joist and the decking is twice that of the actual roof system. Therefore, if composite action did develop it was only to a small degree. These results are similar to those presented in Reference 5 where 14-foot-span wood joist floor sections were tested.
