USAAMRDL-TR-77-38

HLH DRIVE SYSTEM

Boeing Vertol Company
P.O. Box 16858
Philadelphia, Pa. 19142

September 1977

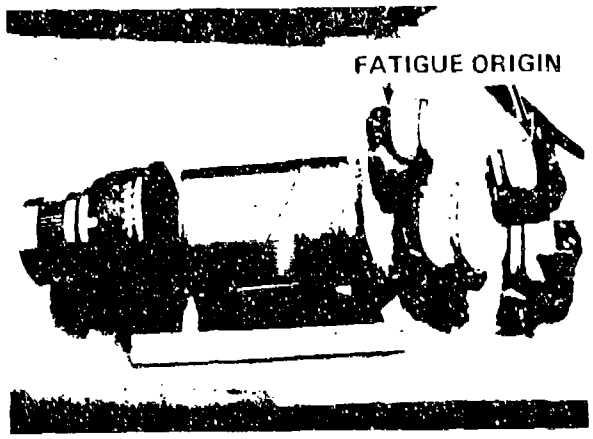
FAILED INPUT PINION P/N 301-10428-1
WITH ARROW INDICATING FATIGUE INITIATION
SITE

To eliminate the possibility of gear response as a failure mechanism, a tuning or stiffening ring was fabricated and fitted into the mouth of the pinion bore (Figure 25). The ring raised the exciting frequency of the pinion outside the operating rpm.

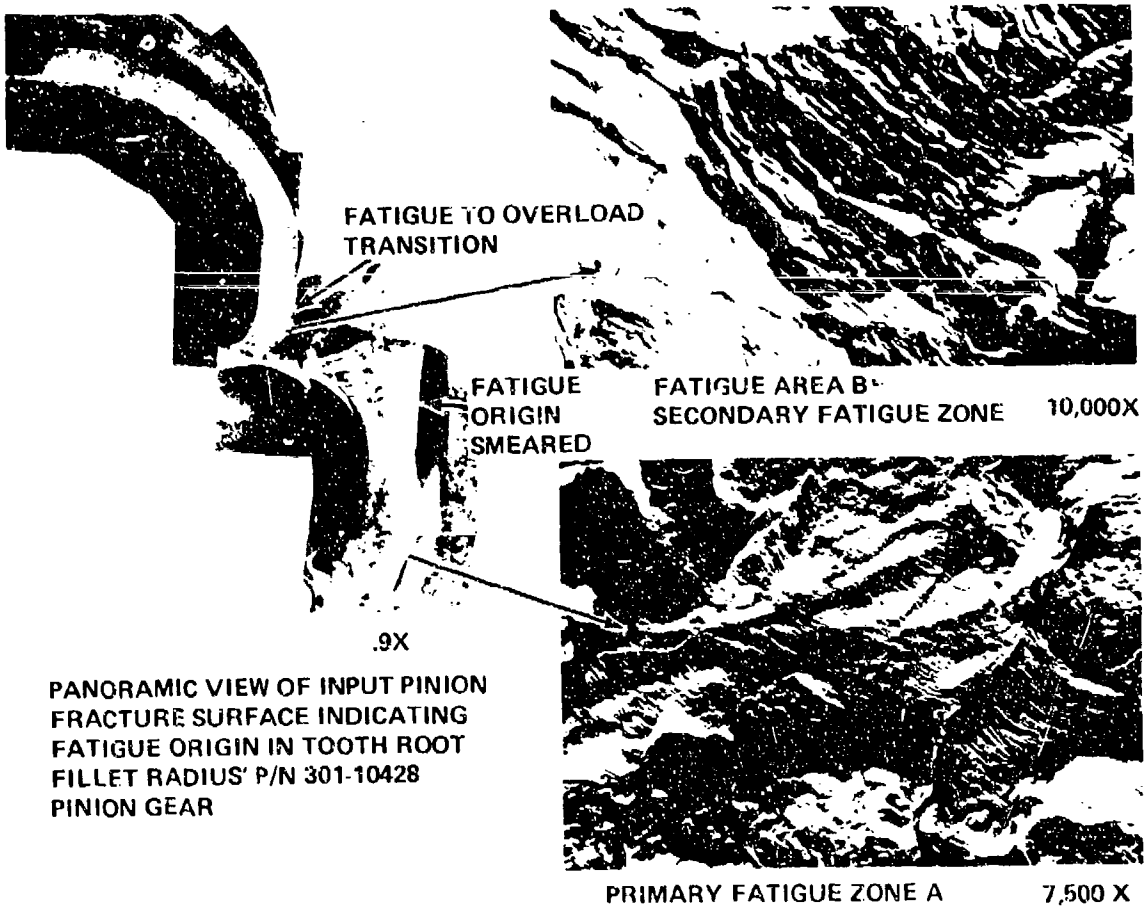
PANORAMIC VIEW OF INPUT PINION
FRACTURE SURFACE INDICATING
FATIGUE ORIGIN IN TOOTH ROOT
FILLET RADIUS' P/N 301-10428
PINION GEAR

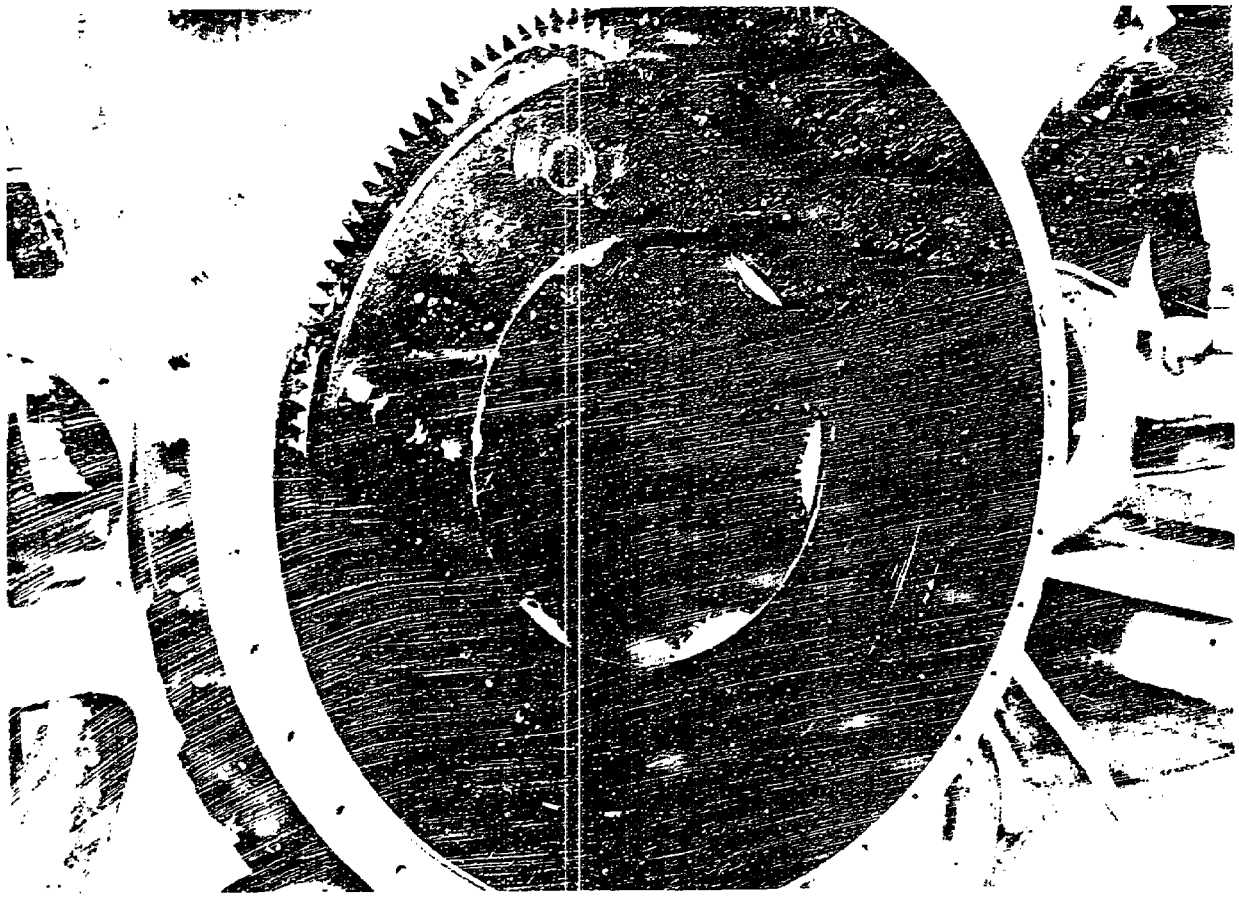
Figure 26. Aft Transmission Second-Stage Planetary Subassembly with Straddle Plate.

A strain survey was performed. The sun/bevel gear showed marked improvement of its gear response with no apparent amplification from gear resonance. Following the strain survey and teardown inspection, the endurance test was restarted. After 4.5 hours of test (approximately 9 hours total transmission time, and 13.5 hours total pinion time), the pinion

failed. Operating conditions were 100% design torque and speed and 50% applied rotor loads. The failure mode was similar to that which occurred earlier in the program.

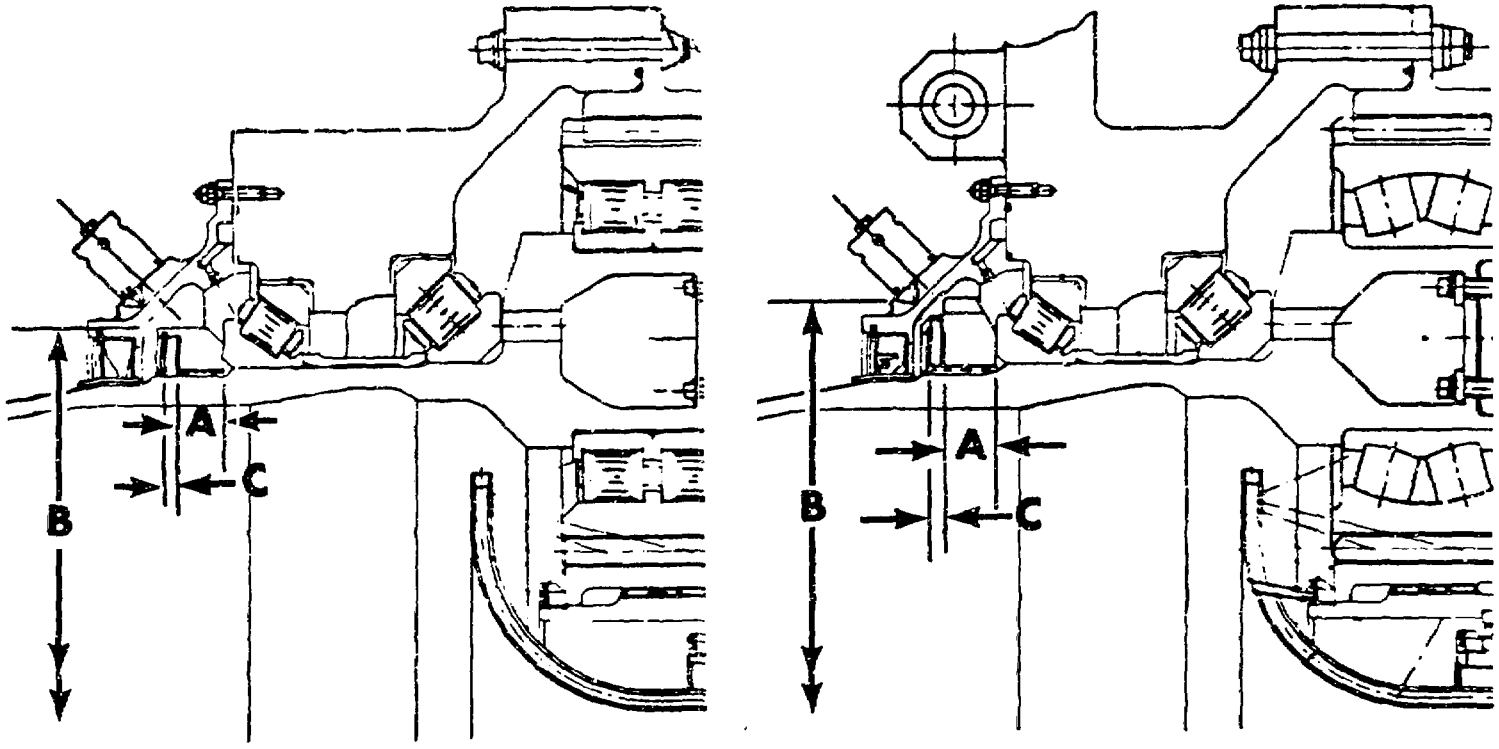
Figure 27. Rotor Shaft Bearing Locknut Comparison.

During initial testing on the closed loop test stand this nut moved in a tightening direction, breaking the two inner tangs of the washer. The washer thickness was increased from .050 to .250 for DSTR testing. Figure 27 shows the major features and dimensions of the assembly and illustrates the design progression.

The prototype nut and locking assembly was redesigned as a result of the DSTR experience. The criterion for the locking devices was that they should accept twice the installation torque, using conservative assumptions of load sharing among tangs. As Figure 27 shows, the lockwasher thickness remained at .25 inch but the number of tangs increased, as did their depth of penetration into the shaft. The nut slots were redesigned for a significant increase in strength.

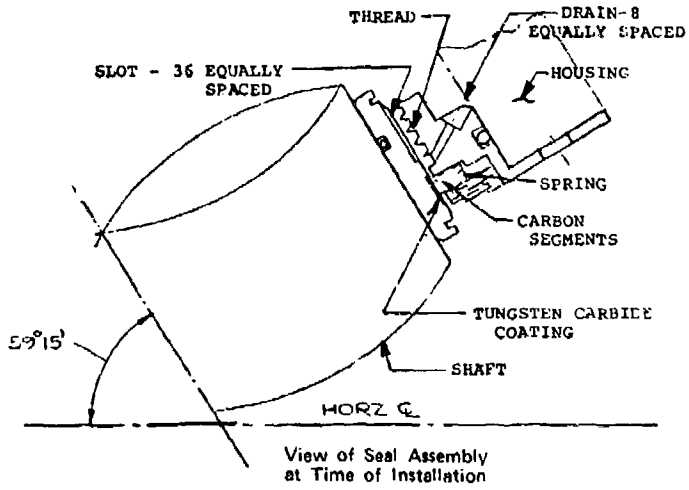
Figure 28. Aft Input Shaft Seal.

Initial leakage problems were masked by assembly damage caused by driving the pinion support housing into the main housing and breaking the carbon elements by the impact. This was corrected by installing the seal after the pinion assembly was installed.

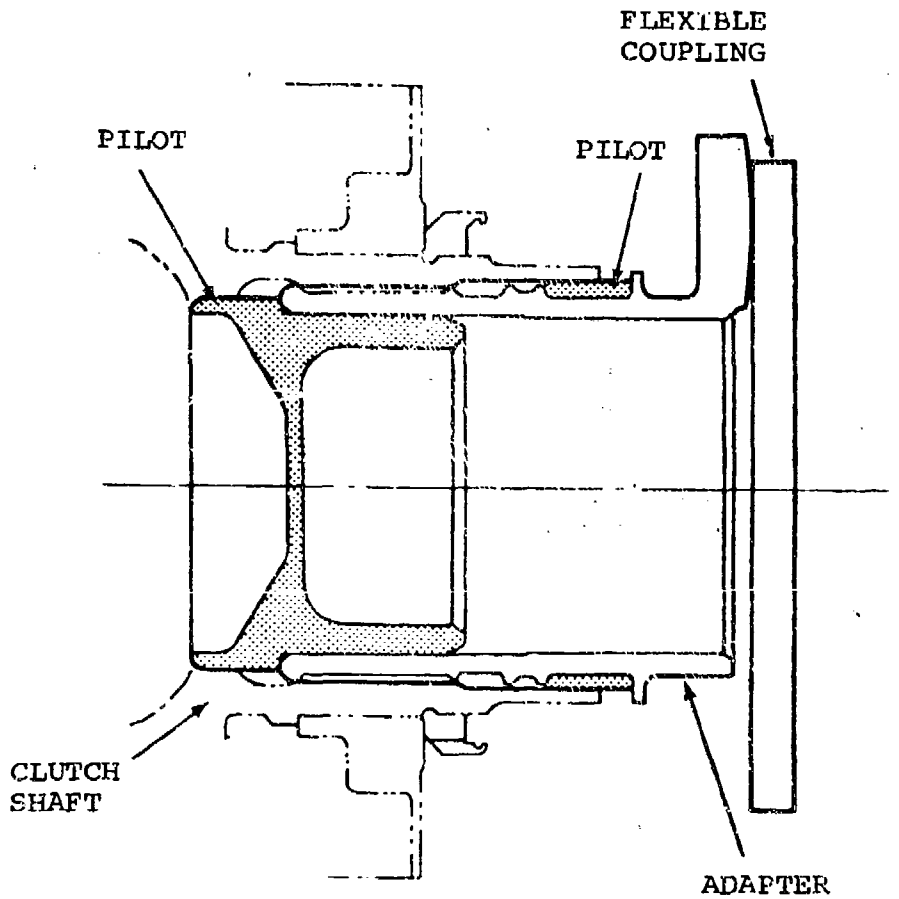
Figure 30. Modified Combiner Input Adapter

Broken studs and severe fretting and wear were noted in the clutch housing area. It was initially believed that test stand shaft misalignment was responsible. Alignment was rechecked and corrected where necessary. In later tests, the clutch housings cracked after a few hours of running. With instrumented shafts, it was then determined that a nonsynchronous whirl was primarily responsible for these failures. The condition was corrected by addition of piloting surfaces to the adapter (Figure 30).

It was theorized that the splined input adapter represented the most probable source of excitation due to the angular freedom permitted by the adjacent flexible coupling. The mitigating effect of torque also suggested the presence of a low-frequency critical speed due to low initial stiffness of bearings and splines in the input pinion/clutch/shaft assembly. In this regard, the splined input adapter was again believed to be one of the major contributors.

On the basis of the above, the modified input adapter of Figure 30 was designed for test evaluation. The addition of pilot surfaces on each end of the spline restricts the angular bending motion across the spline. Axial freedom of the spline, which is a principal design requirement, is not impaired. Response at the engine shaft operating speed with the piloted spline is presented in Figure 34. There is no indication of any resonance, and comparison with the original adapter configuration shows a dramatic reduction in the response level.

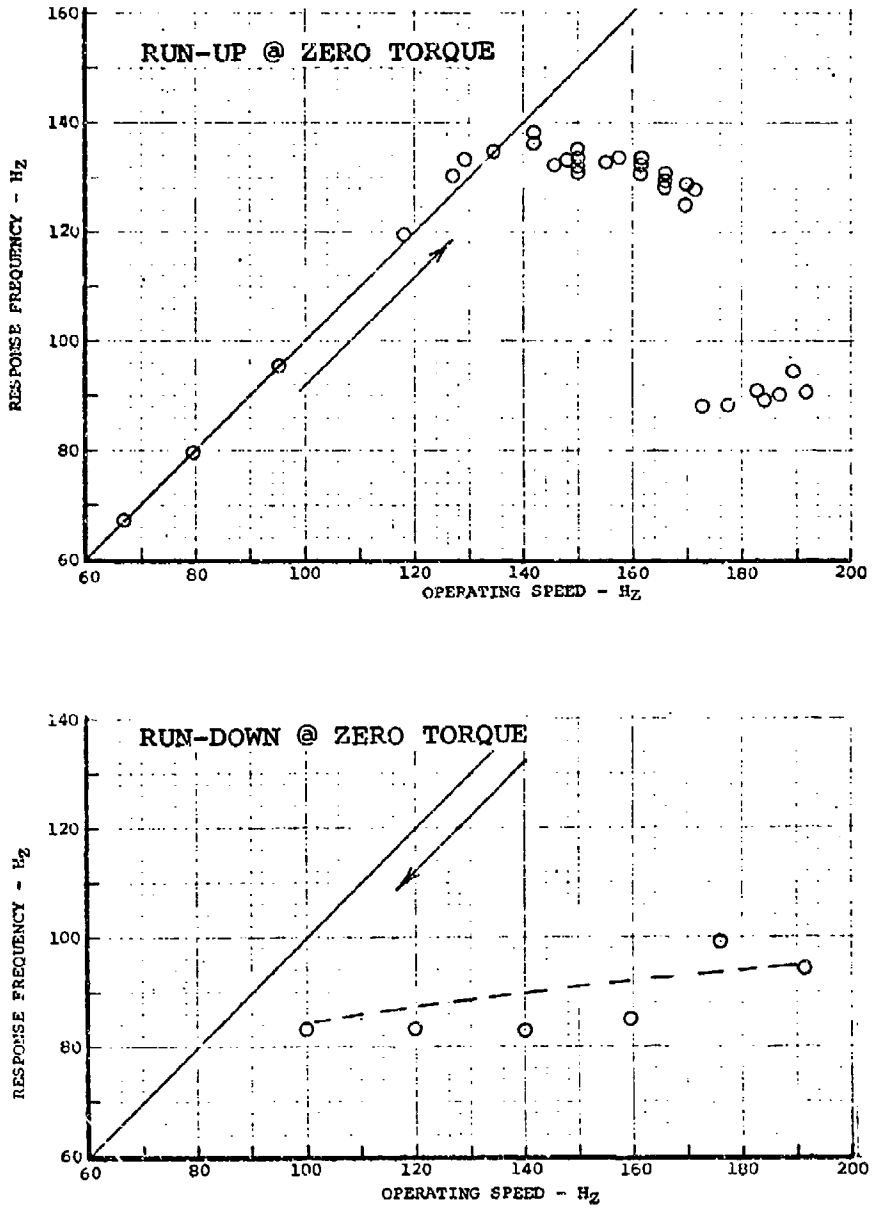
Figure 31. Response Frequench vs Operating Speed.

During initial testing of the HLH Combiner Transmission, fatigue cracks were observed (after only a short period of operation) at the base of the magnesium castings which house the input pinion/clutch assemblies. The units were replaced, and subsequent runs with the housings instrumented revealed both high vibration and stress levels over a broad range of operating speeds. It was further established that the problem only existed below 50% torque and was most severe at zero torque.

Examination of the overall vibration levels indicated that the problem area was confined to the engine shaft speed range from 134 to 172 Hz (8040 to 10,320 RPM). An analysis of the frequency content of an accelerometer mounted at the free end of the cantilevered housing is shown in Figure 31 for the zero torque condition. During run-up, the frequency of vibration coincides with the engine shaft (combiner input shaft) operating speed up to approximately 134 Hz. For speeds between 134 and 172 Hz, the predominant frequency of vibration remains nearly constant at 134 Hz, and above 172 Hz the frequency shifts abruptly to approximately 90 Hz. During the

subsequent deceleration, the low-frequency component, 83 to 95 Hz, persisted down to operating speeds below 100 Hz.

Together, the plots of Figures 31 and 32 point to a phenomenon referred to as nonsynchronous whirl; i.e., a whirling motion which does not correspond to the speed of rotation. Published literature on the subject of nonsynchronous whirl is limited; however, the material of References 13 and 14 appears applicable. Briefly, this document indicates that nonsynchronous whirl is a frictionally excited instability associated with large angular motions (bending) of splined joints. Implicit in this situation is the proximity of a critical speed with a bending mode shape displaying large angular deflections at the spline.

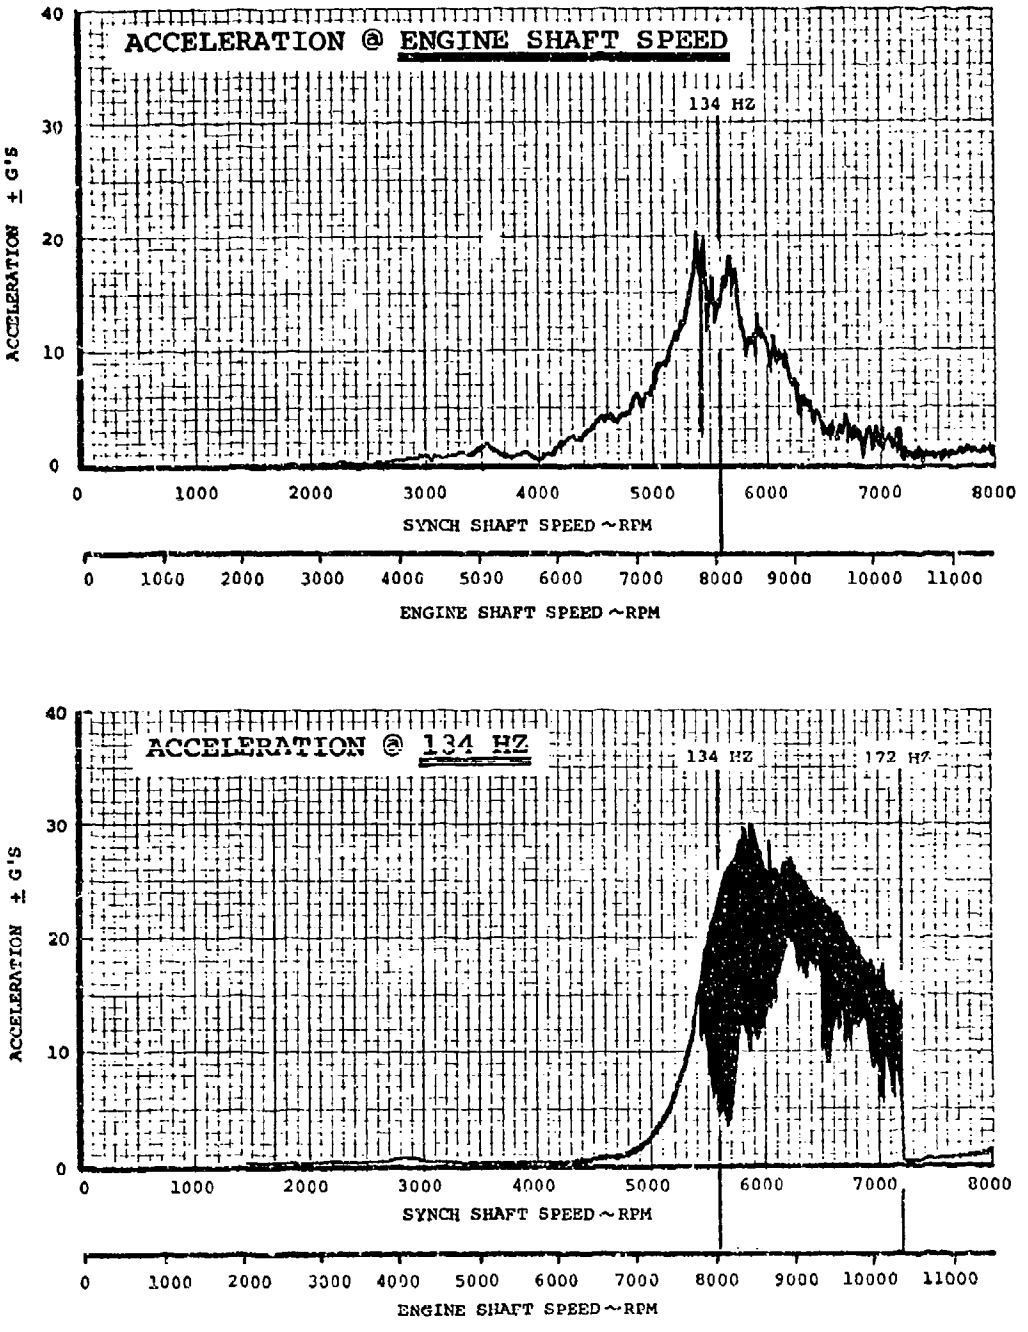
Figure 32. Clutch Housing Acceleration at Zero Torque.

Filtered acceleration response plots for the zero torque condition are shown in Figure 32. The upper plot illustrates the vibratory component at the engine shaft operating speed and indicates a peak response centered at an engine shaft speed of approximately 8040 RPM (134 Hz). The lower plot shows the vibratory component at 134 Hz, and significant response at this frequency is observed over the engine speed range from slightly below 8040 RPM (134 Hz) up to 10320 RPM (172 Hz). Note also that within this range, the magnitude of the response at 134 Hz is generally greater than the response at the operating speed.

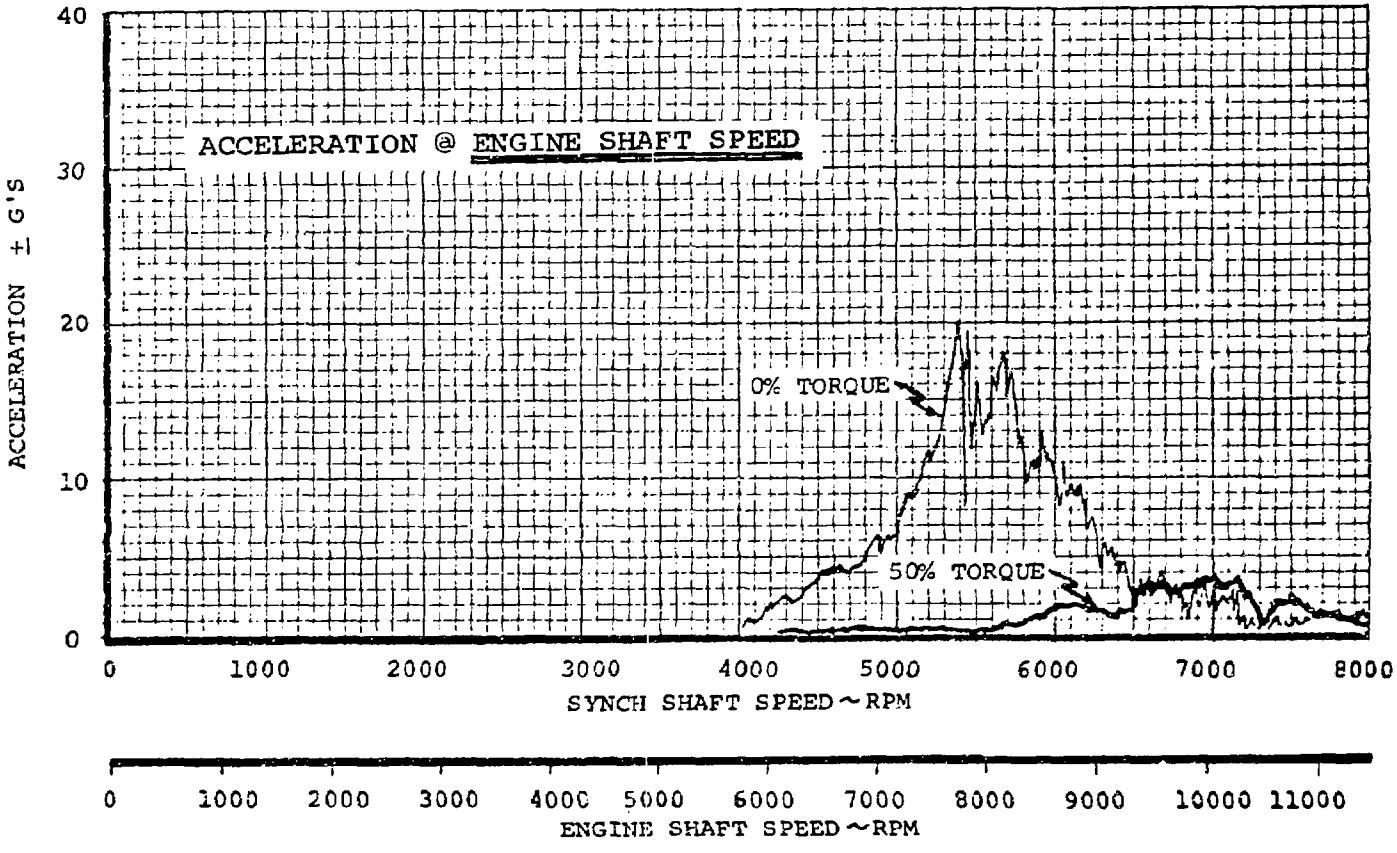
Figure 33. Clutch Housing Acceleration at 50% Torque.

An acceleration response plot displaying the vibratory component at the engine shaft operating speed with 50% torque is shown in Figure 33. The maximum level is only 5G's compared to 20G's observed for the zero torque condition.

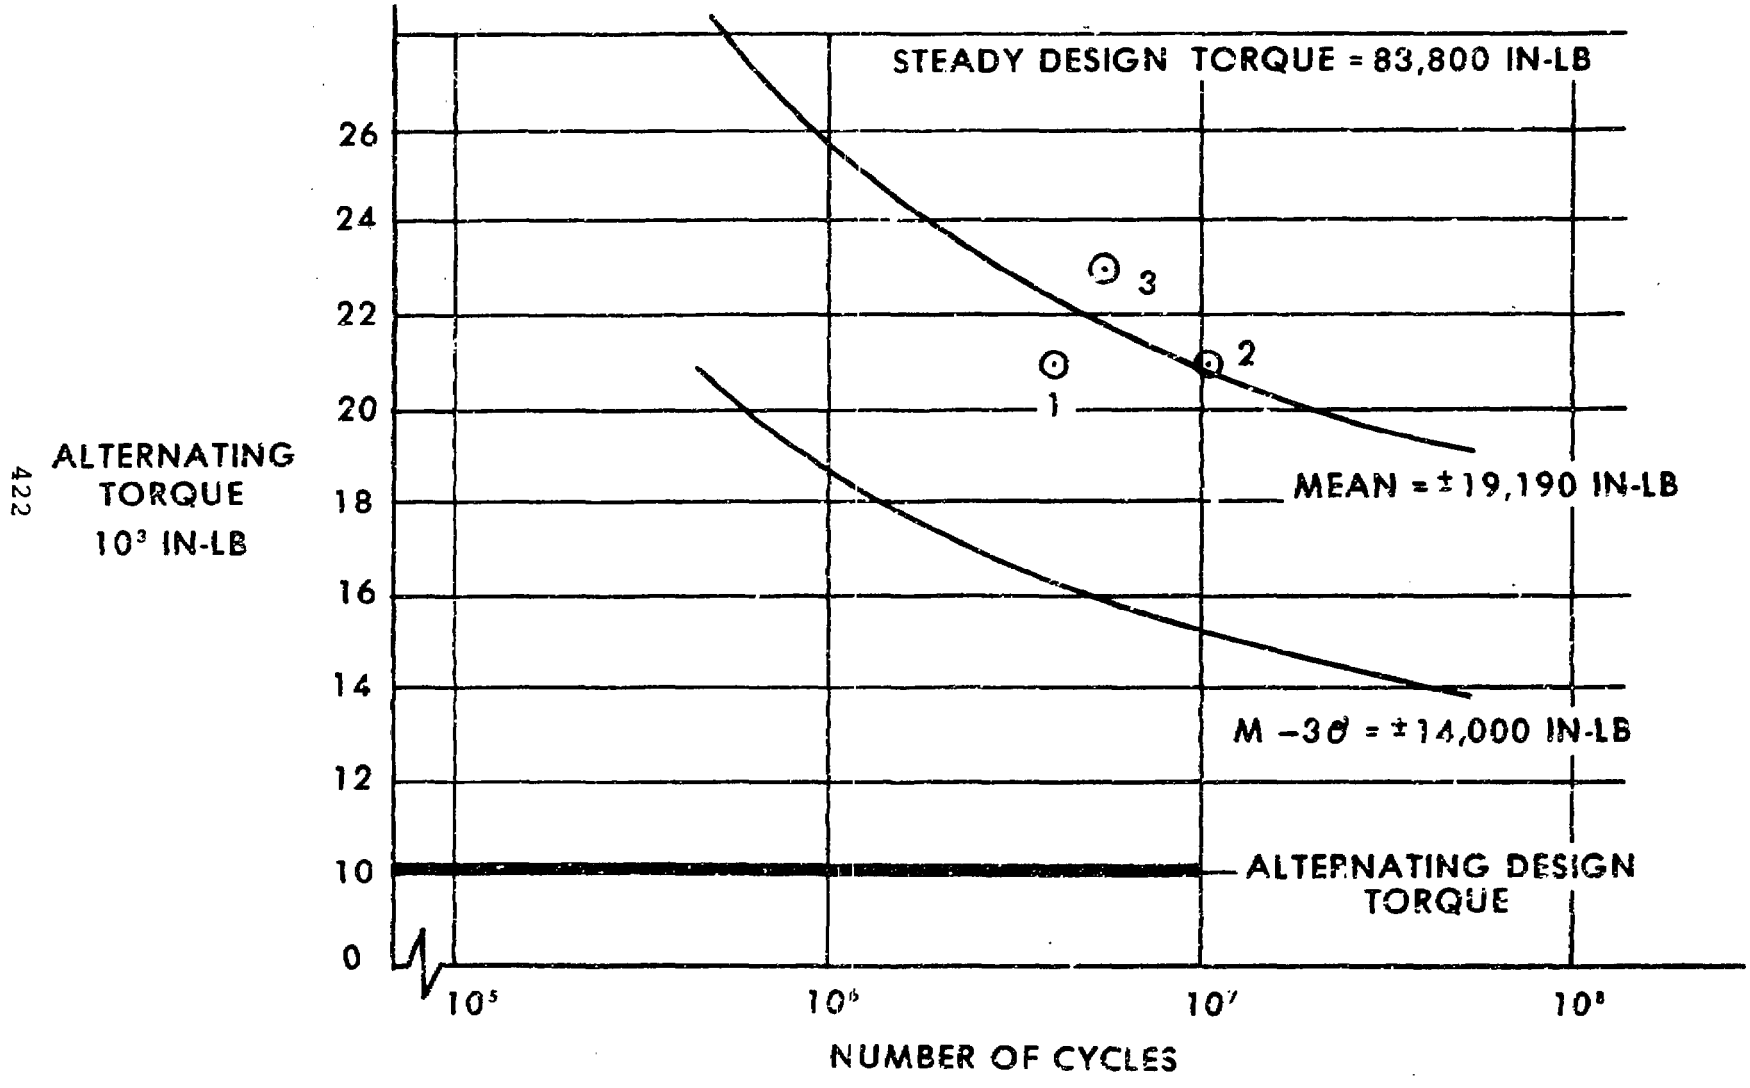
Figure D-53. HLH Synch Shaft Fatigue Test.

The load was increased again to 83,800 in-lb. ± 21,000 in-lb. and at 4.07 million cycles the 301-11000-6 tube cracked.

This crack emanated from under the 301-11008-1 adapter and had progressed to .25 inch beyond the edge of the adapter where the crack detection wire was broken stopping the test.

With the crack closely monitored, the test was restarted, maintaining the same load. Complete failure of the tube occurred at 4.374 million cycles. During this time a crack-growth was recorded and is shown in Table D-19.

Specimen No. A107 was subjected to a fatigue loading of 83,800 in-lb. ± 23,000 in-lb. After 5.396 million cycles a crack developed in the 301-11006-6 tube, emanating from under the 301-11008-1 adapter. The length of the crack at the time of discovery was .5 inch.

At 3.637 million cycles the 301-11007-1 adapter failed, terminating the test. The crack in the tube had grown to 2.4 inches long.

Reviewing the results of the three fatigue tests it is concluded that in each case the typical mode of failure is tube cracking starting at rivet holes where the 301-11008-1 adapter is secured. In each specimen the crack occurred at the same end of the tube.

By plotting the three points of failure and by applying a standard curve shape for riveted aluminum structures, the value of the mean fatigue strength was determined to be 83,800 in-lb. ± 19,190 in-lb at 50 million cycles.

The results of these tests verify the structural design of the synchronizing shaft. The endurance limit (taken as the mean minus three times the standard deviation) is 83,000 inch-pounds ± 14,000 inch-pounds. This represents a 38% margin of safety over the design torque of 83,800 ± 10,100 inch-pounds. The predominant mode of failure is tube cracking with some adapter cracks also occurring, both at the rivet holes. Burrs at the rivet holes and fretting at the tube/adapter interface were contributing factors to the fatigue failures.
