GROUND SUPPORT EQUIPMENT DEPARTMENT
NAEC-GSED-119 03 MARCH 1978
CODE IDENT NO. 28638

CONTROL OF CORROSION IN GROUND SUPPORT EQUIPMENT

FINAL REPORT

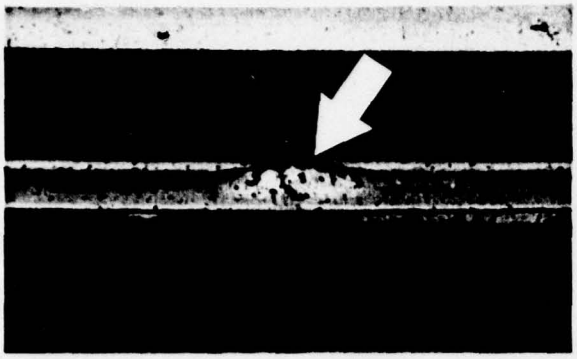
Figure B-1 T-58 Engine Transport Trailer Exfoliation

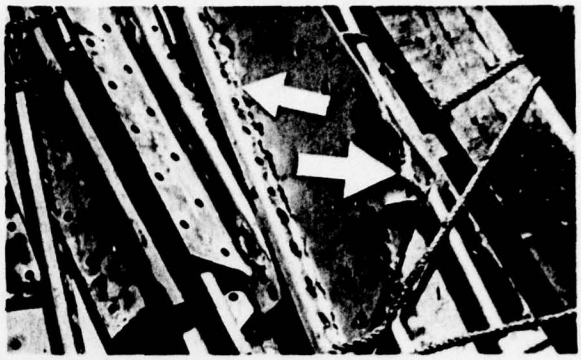
Figure B-2 E2A Aircraft Lifting Sling Exfoliation

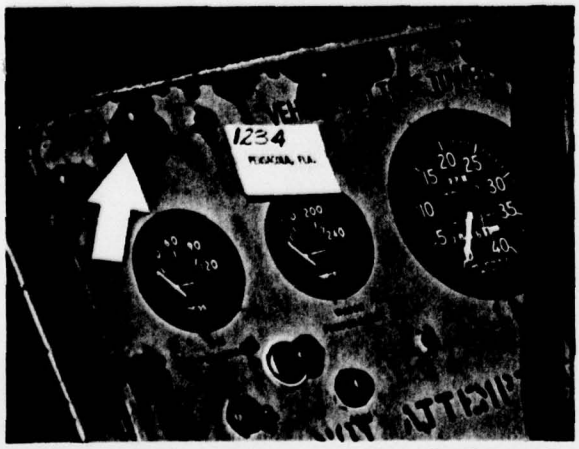
Figure B-5 Instrument Panel Chipped and Rusting in Areas of Fasteners

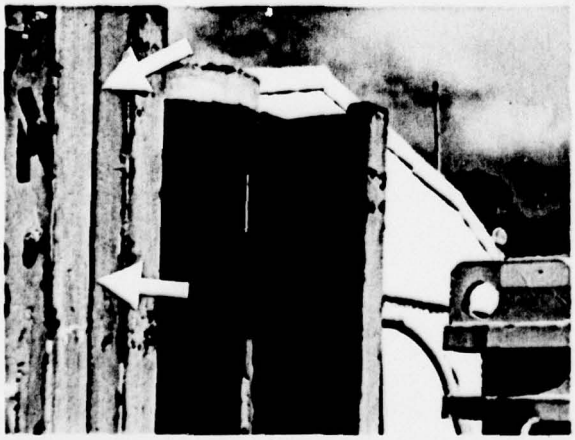
Figure B-11 Water Entrapment Capillary Between Mating Surfaces.

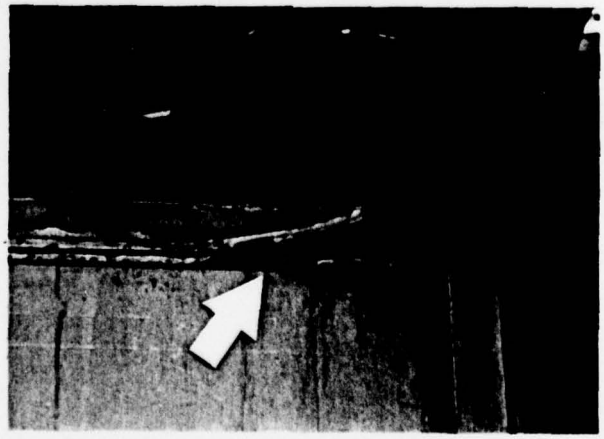
Figure B-12 Water Entrapment Induced Corrosion.

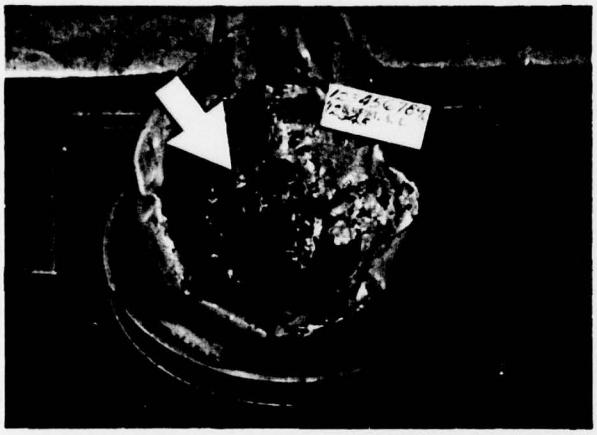
Figure B-15 Impingement - People Induced on TA-75A Tractor Air Filter.

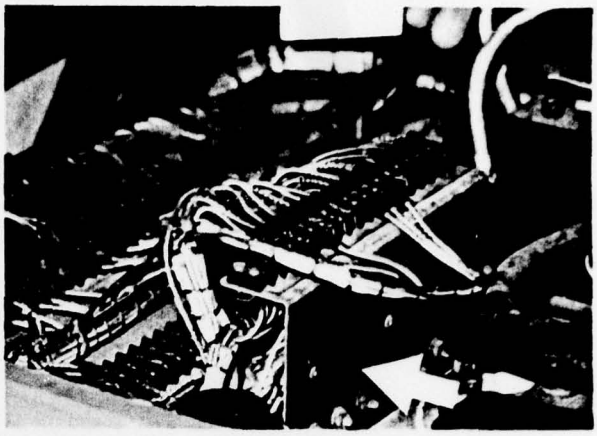
Figure B-20 Electrical Compartment Corrosion of Terminal Strap Support Bracket

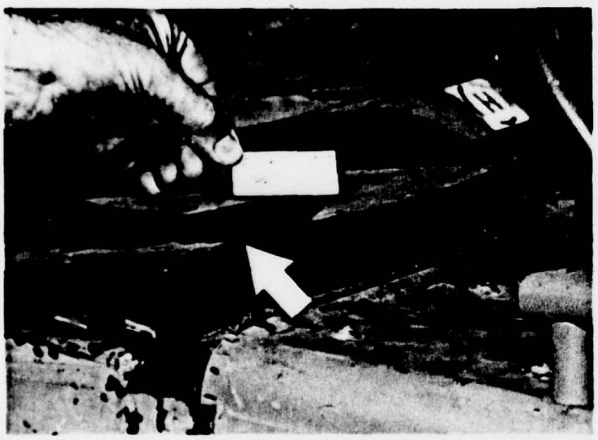
Figure B-21 SATS Weapons Loader - Bent Top Cover

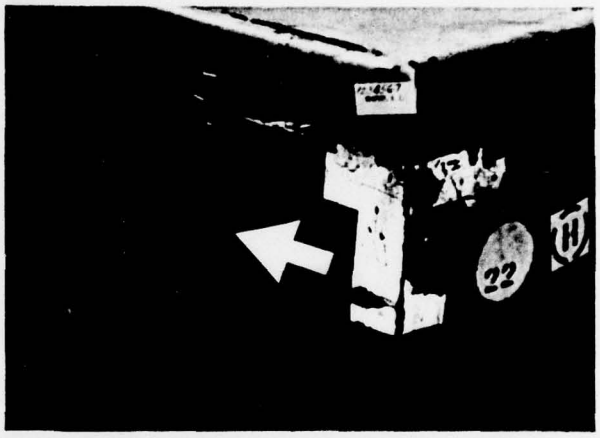
Figure B-22 GHCH Oxygen Recharge Service Trailer - Broken Cover Latch

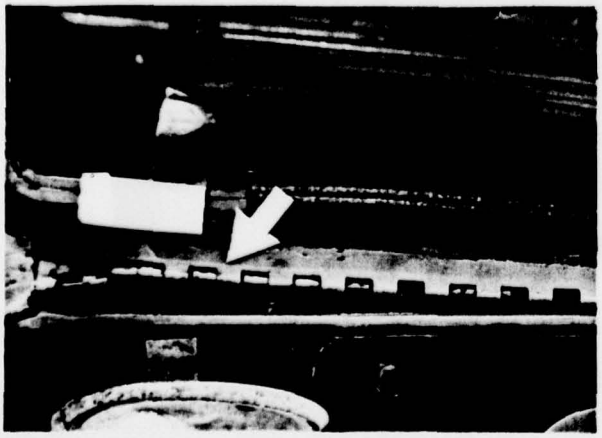
Figure B-23 SATS Weapons Loader - Bent Hinge on Engine Compartment Cover

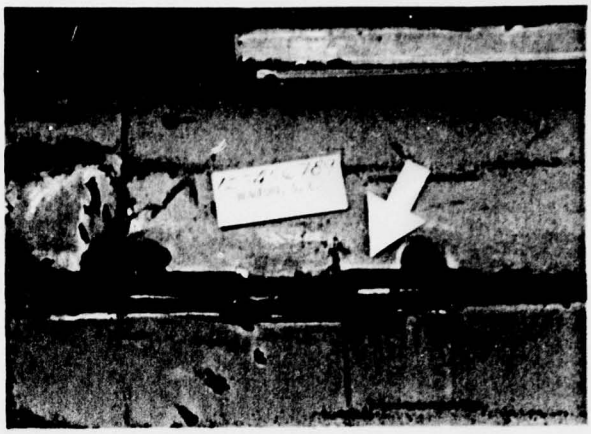
Figure B-26 GFBE Air Compressor - Joy Mfg. Co. - Damaged Door Hinge

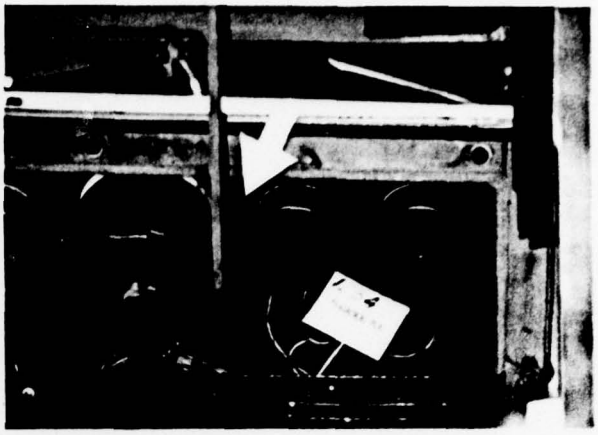
Figure B-32 Mobile Electric Power Plant - Instrument Case Corrosion

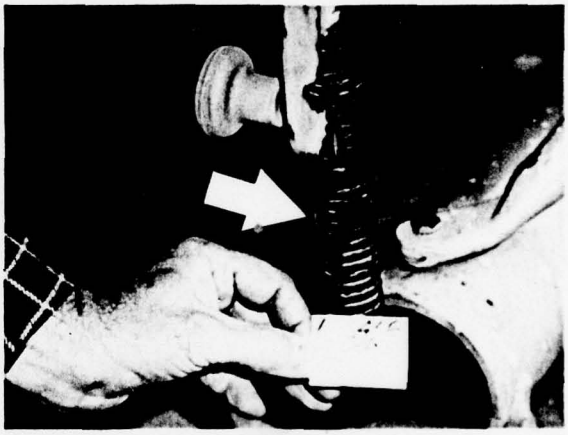
Figure B-34 AERO 51-B Munitions Handling Trailer - Exposed Screw Unprotected

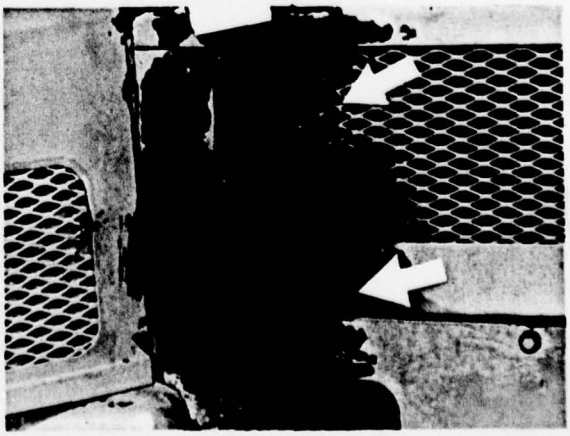
B-36	Design deficiency resulting in shroud corrosion caused by muffler heat on a SATS Weapons Loader
B-37	Frame fatigue crack due to design deficiency in an Air Start Unit from an MD-3 Tow Tractor
B-38	Improper protective coating on fitting on a Breathing Oxygen Charging Cart
B-39	Weathered surface coating on an MD-3 Aircraft Tow Tractor
B-40	Sun, moisture and salt weathering on wheel from an NC-5 Mobile Electric Power Plant
B-41	Pitting of an Aero 33D Bomb Truck lift cylinder piston rod caused by outside storage
B-42	Pitting caused by acid from hand contact on arm rest of a TA-75 Aircraft Tow Tractor

Figure B-36 SATS Weapons Loader - Corrosion from Muffler

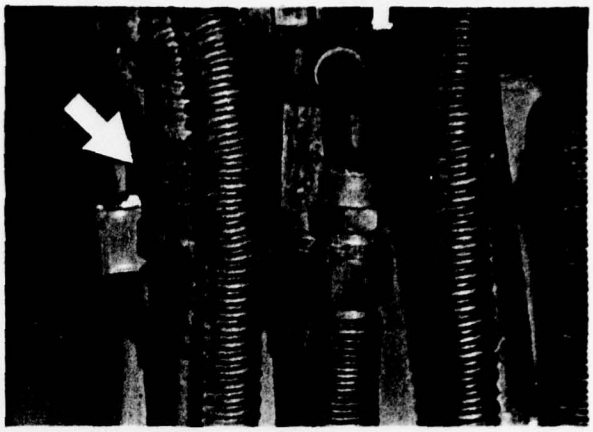
Figure B-38 O_2 Charging Cart - Fitting Corrosion

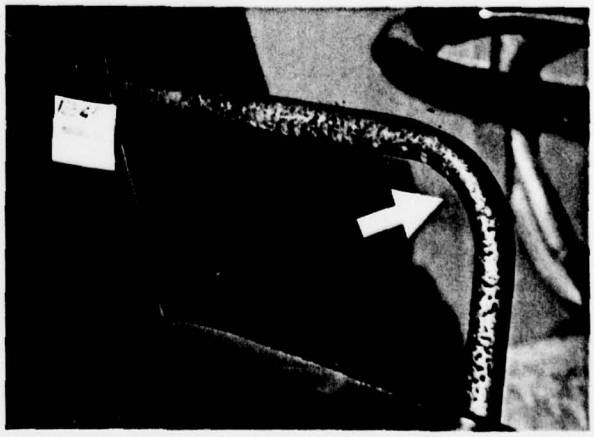
Figure B-42 TA-75 Aircraft Tow Tractor - Pitted Arm Rest
