AN/TPS-59(XN-1) EDM
RADAR SET, MARINE LIGHTWEIGHT TACTICAL 3D
ENGINEERING DEVELOPMENT MODEL

PRE-SERVICE ACCEPTANCE TEST REPORT.

VOLUME I.

Department of the Navy
Naval Electronics Systems Command
Washington, DC 20360

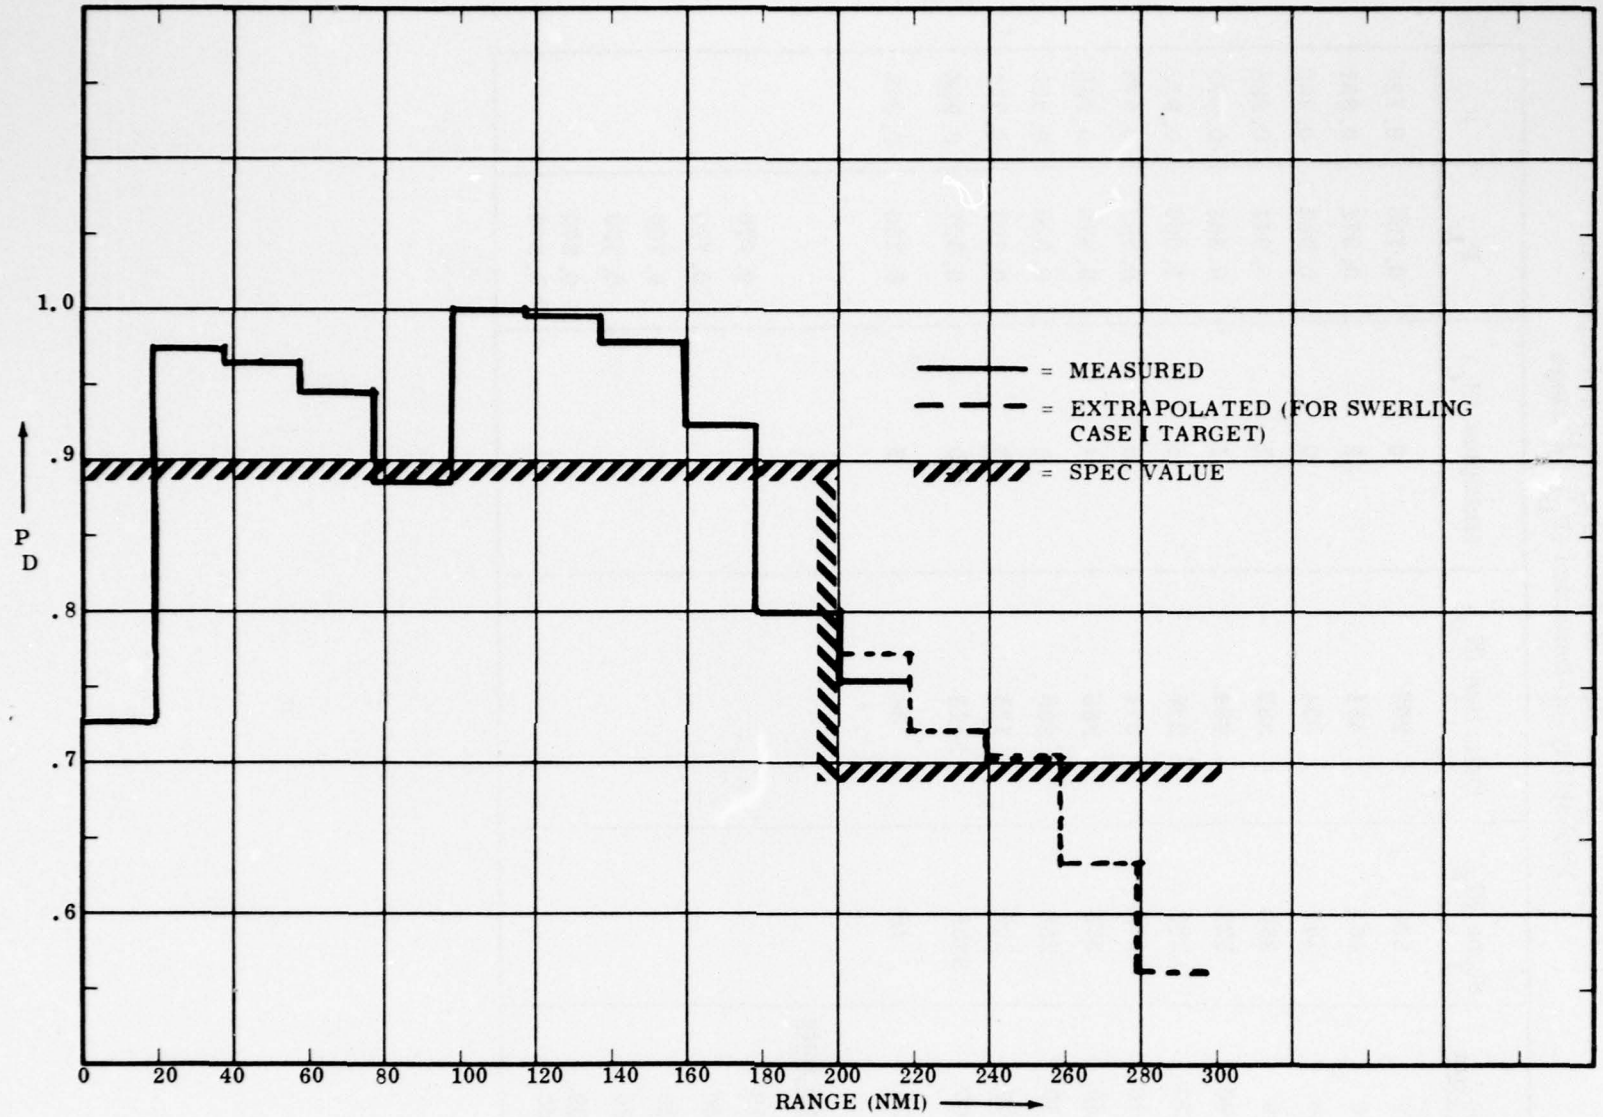
Figure 2-1. Probability of Detection vs Range

Comparison of the flight data with an analytical prediction which assumes a 0.7m^2 steady (i.e., nonfluctuating) target, indicates that the radar is 2 dB low in sensitivity relative to its condition as determined in our April sensitivity evaluation (presented to NRL on 21 April 1976). The conclusion of a lack of sensitivity is hard to accept in face of the exhaustiveness of the April evaluation. An alternative explanation is that the target is not steady, but actually fluctuates. For example, the signal-to-noise ratio required to achieve a 90% detection probability on a 0.7m^2 (Swerling Case I) fluctuating target is 8.0 dB greater than that required against a 0.7m^2 steady reflector.

One argument supporting the notion that the target cross section fluctuates stems from a comparison between the performance achieved at 80 to 100 nmi and 180 to 200 nmi. At the longer range, including the higher atmospheric absorption loss, 12.3 dB more energy is required to achieve the same signal-to-noise ratio. The long range pulse has four times the energy of the short range pulse, hence the signal-to-noise ratio achieved at 200 nmi is less by 6.3 dB.

Thus, it appears that the radar sensitivity exhibited during flight testing is very nearly that predicted as a result of the April sensitivity evaluation. There are, however, several simple changes that can be made to the transmit template which should enhance performance in the range intervals beyond 180 nmi for a Swerling Case III target as well as overcome the turn-on difficulties associated with predrivers in the 0 to 20 nmi range interval. These changes are given in the recommendations paragraph below.

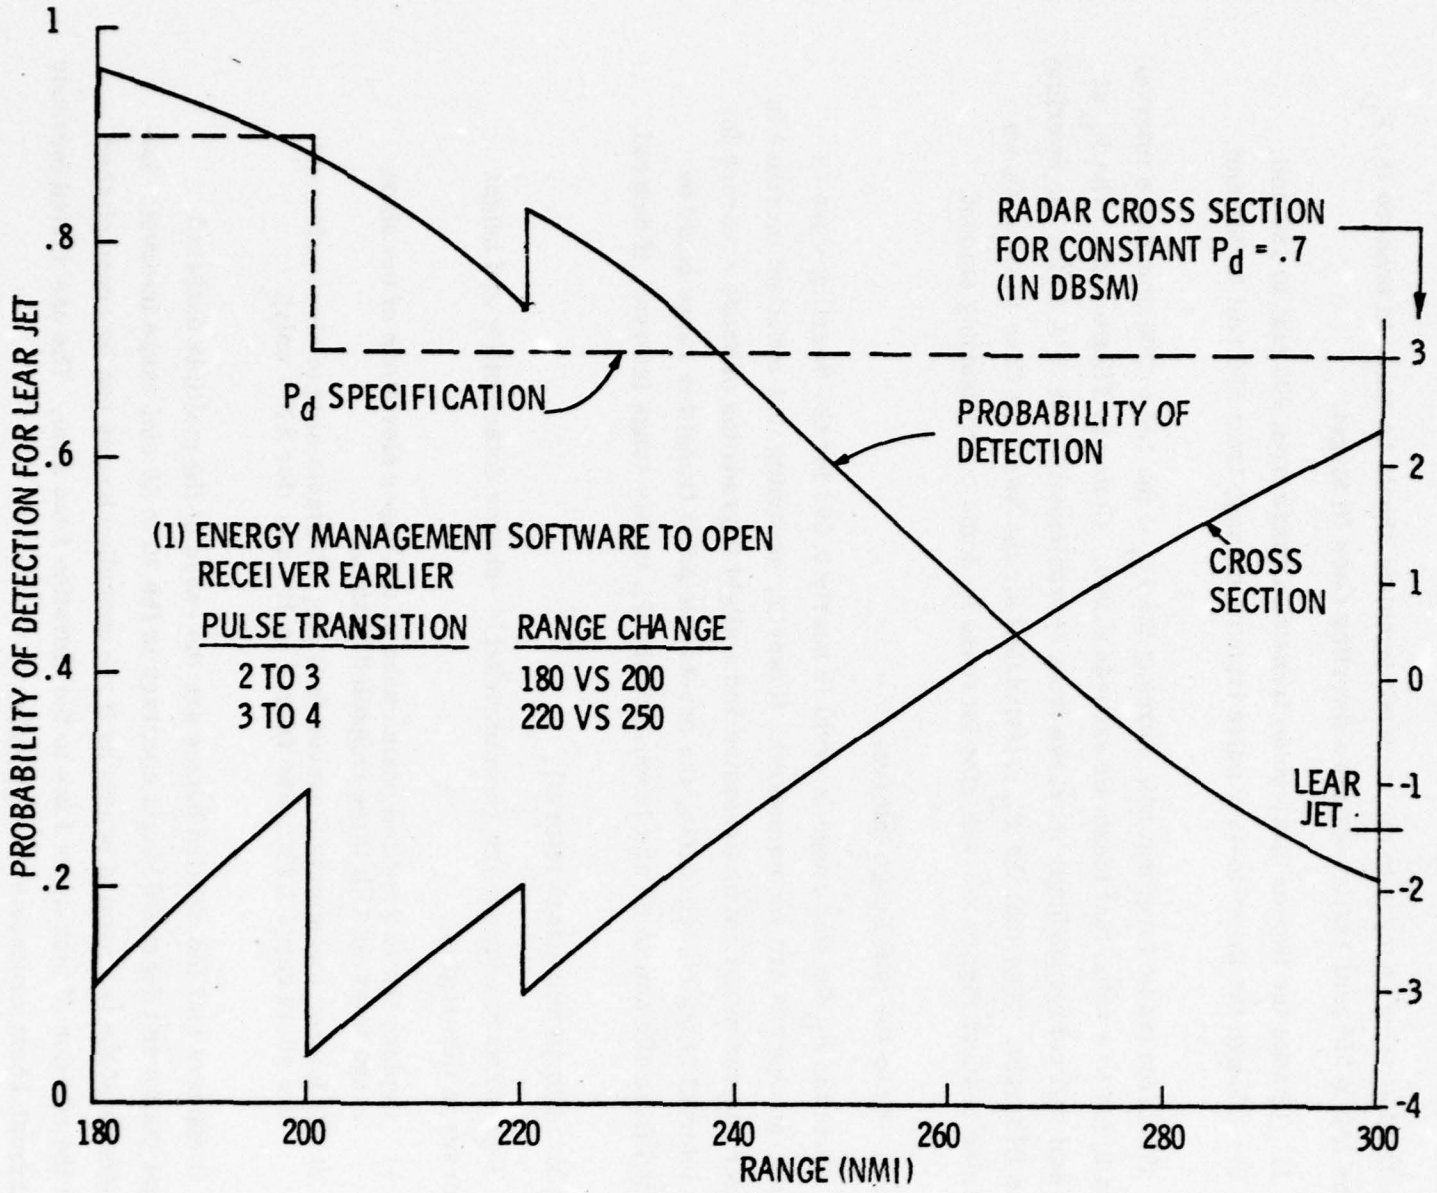
Figure 2-2. Detection Extrapolations for High Altitude Targets

Note that improvements of the P_D for the 180 to 200 nmi range interval will cause a corresponding increase in the extrapolated P_D (based on Swerling Case I target) for the 200 to 300 nmi region. The resulting increases should cause the average P_D to meet or exceed the overall specification P_D requirement of 0.700 for the 200 to 300 nmi region.

Two software changes are recommended to enhance detectability and height accuracy in this region.

1) Replace the two spoiled beams used at the upper elevations of the short range interval with three unspoiled beams.
2) If further investigation proves feasible, eliminate simple short pulse and use short range LFM pulse from 4 to 100 nmi (for XN-1 only).

It appears that the spoiled beams are the cause of the multiple declared target marks and degraded height accuracy in the 20 to 40 nmi range interval. Replacement of the two spoiled beams by three unspoiled beams can be accomplished with the addition of just under 1 ms to the elevation scan time. The associated increase in azimuth beam crossover is negligible.

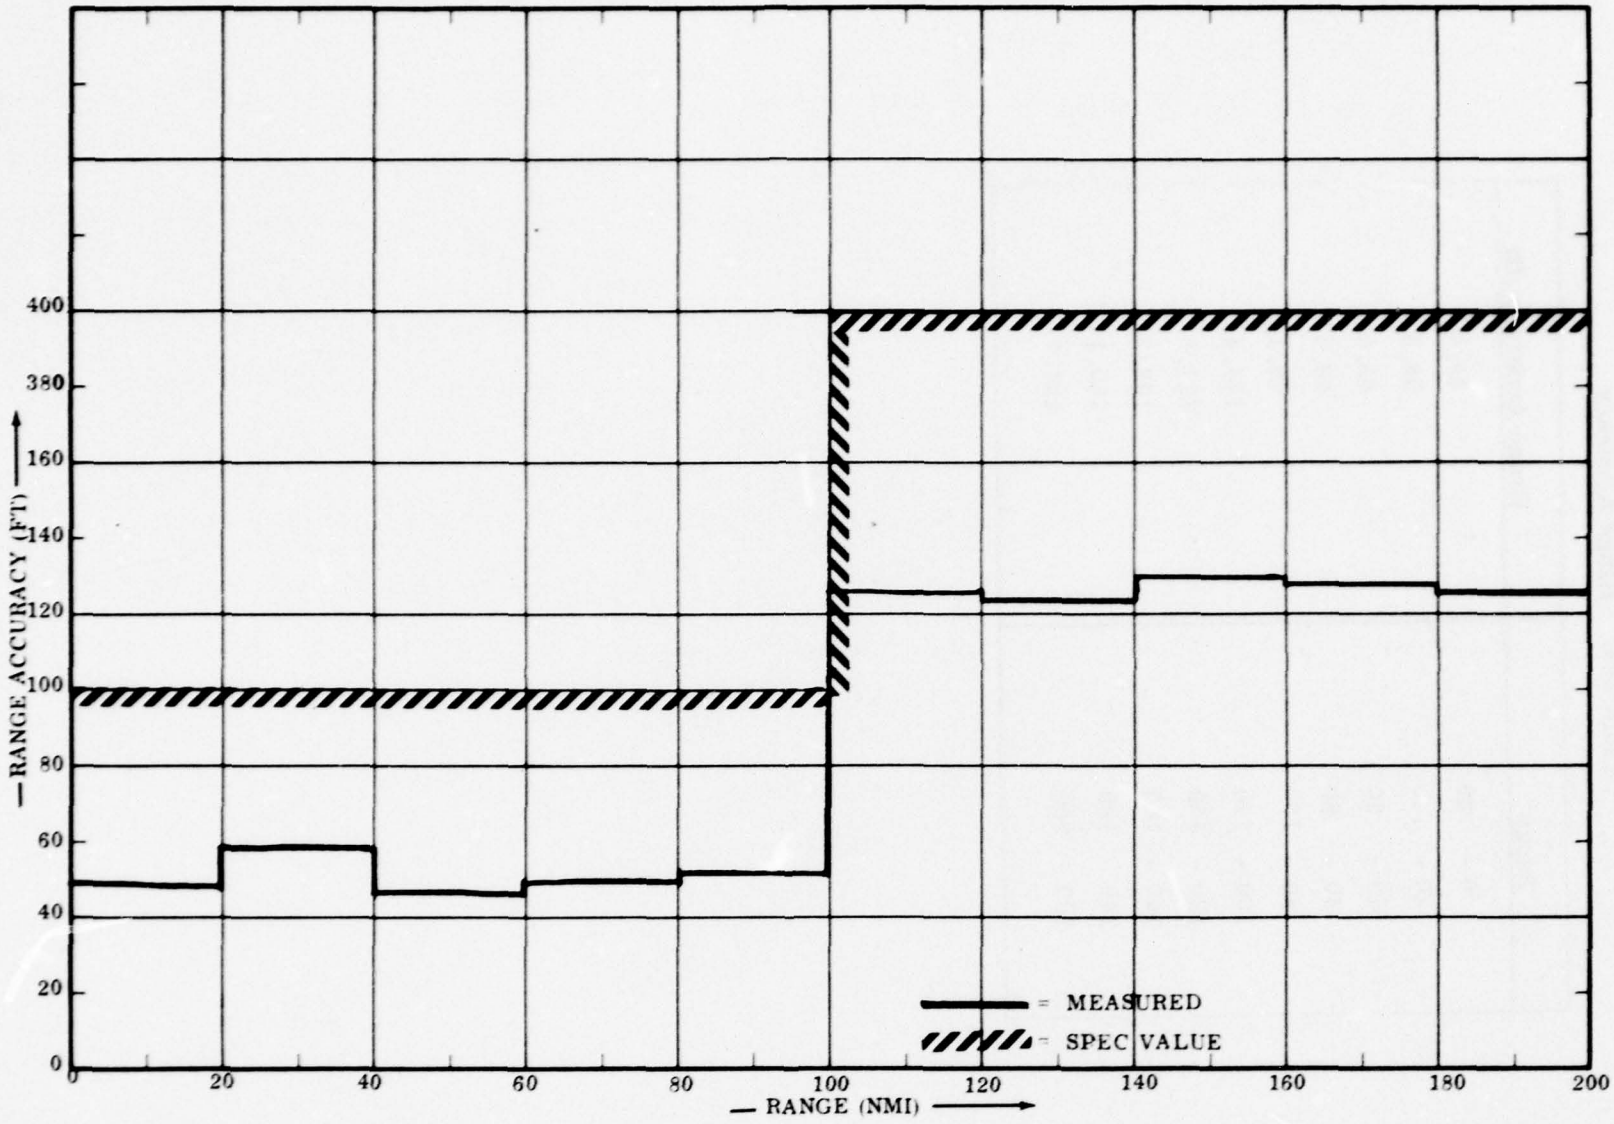
Figure 2-4. Range Accuracy vs Range

The summary of range accuracy (error) versus range is given in Table 2-8. and is shown graphically in Figure 2-4..

Assuming that the rms range error of the AN/FPS-16 is negligible, the most stringent case, than the inequalities given in paragraph 2.6.1.1 reduce to a range accuracy requirement of 100 ft from 0 to 100 nmi and 400 ft beyond 100 nmi for the AN/TPS-59(XN-1). Examination of Table 2-8 or Figure 2-4 shows that the AN/TPS-59(XN-1) is nearly twice as accurate as required from 0 to 100 nmi and over three times as accurate as required beyond 100 nmi.

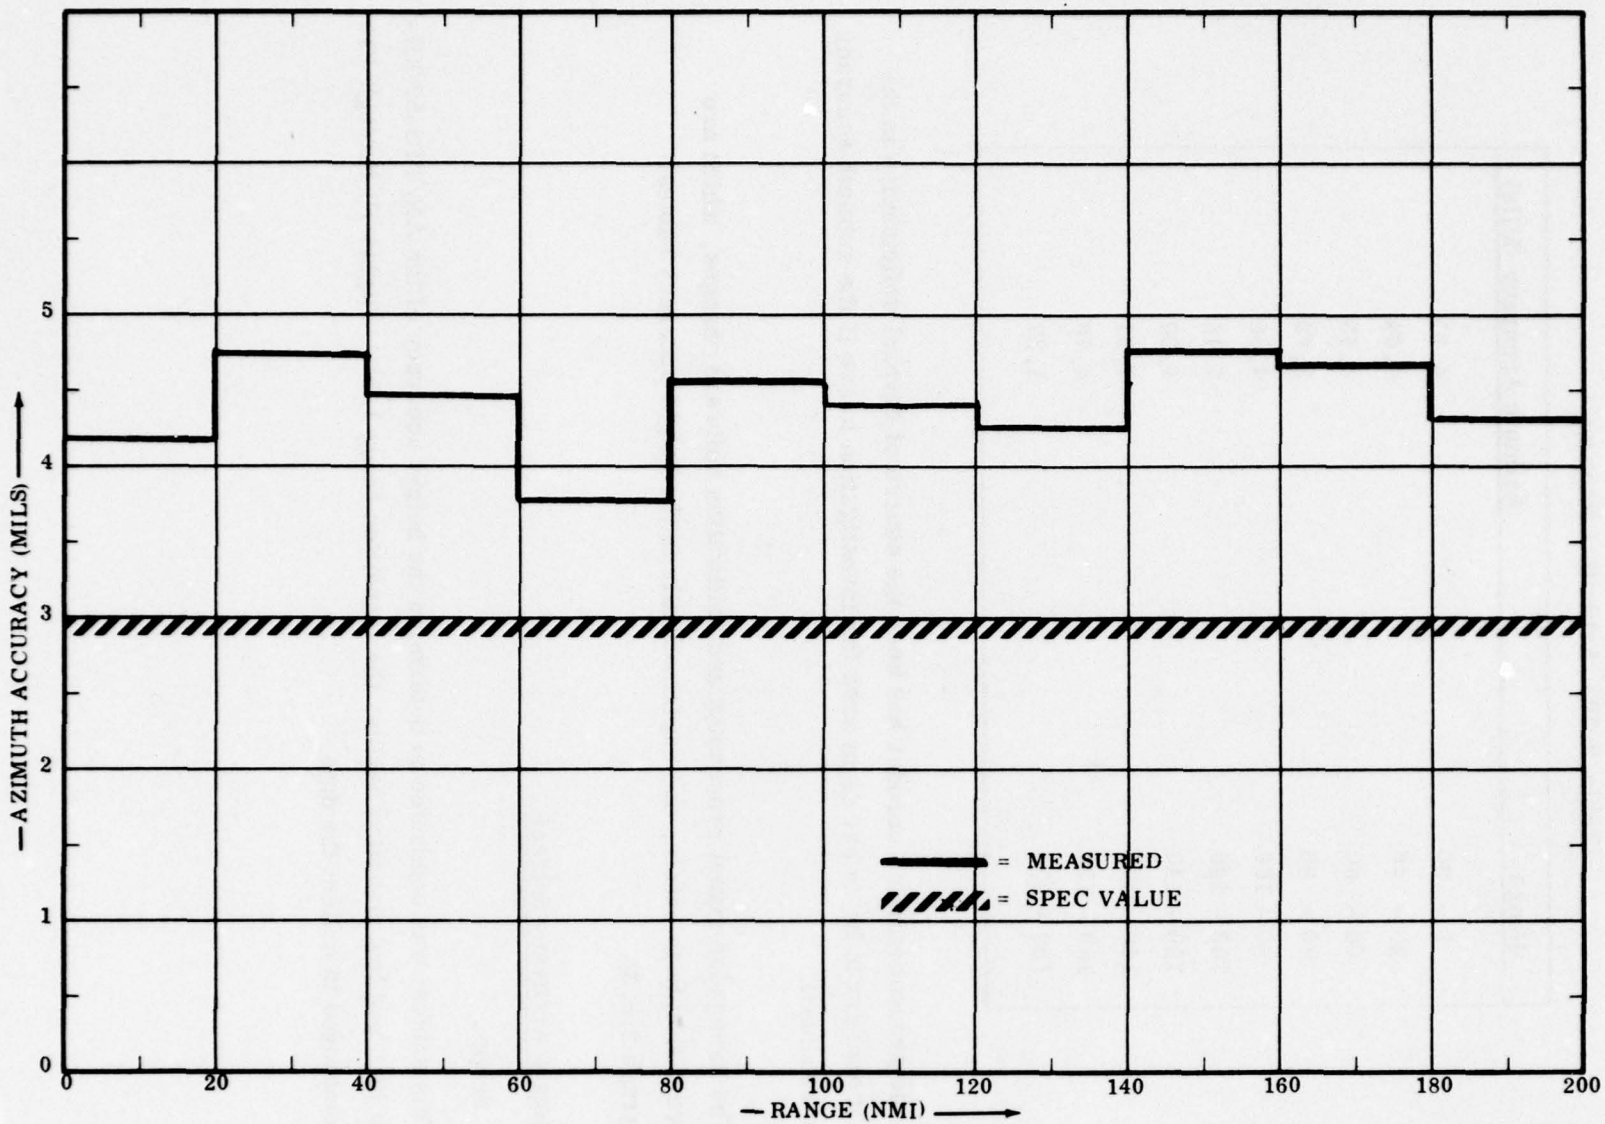
Figure 2-5. Azimuth Accuracy vs Range

An azimuth accuracy of 4.41 mr averaged over a 0 to 200 nmi range, was obtained on the test aircraft on ten flight paths at altitudes that varied from 200 to 40,000 feet. The measured accuracy is degraded from the specified value of 3 mr by 47%. The azimuth accuracy is relatively constant with range and recommended software modifications to improve the accuracy are included in this report.

Two changes are recommended to enhance the azimuth accuracy of the AN/TPS-59(XN-1).

Since the present azimuth encoder has been the source of several deficiencies in the past, it appears to be an excellent area for investigation to see if the azimuth accuracy can be enhanced.

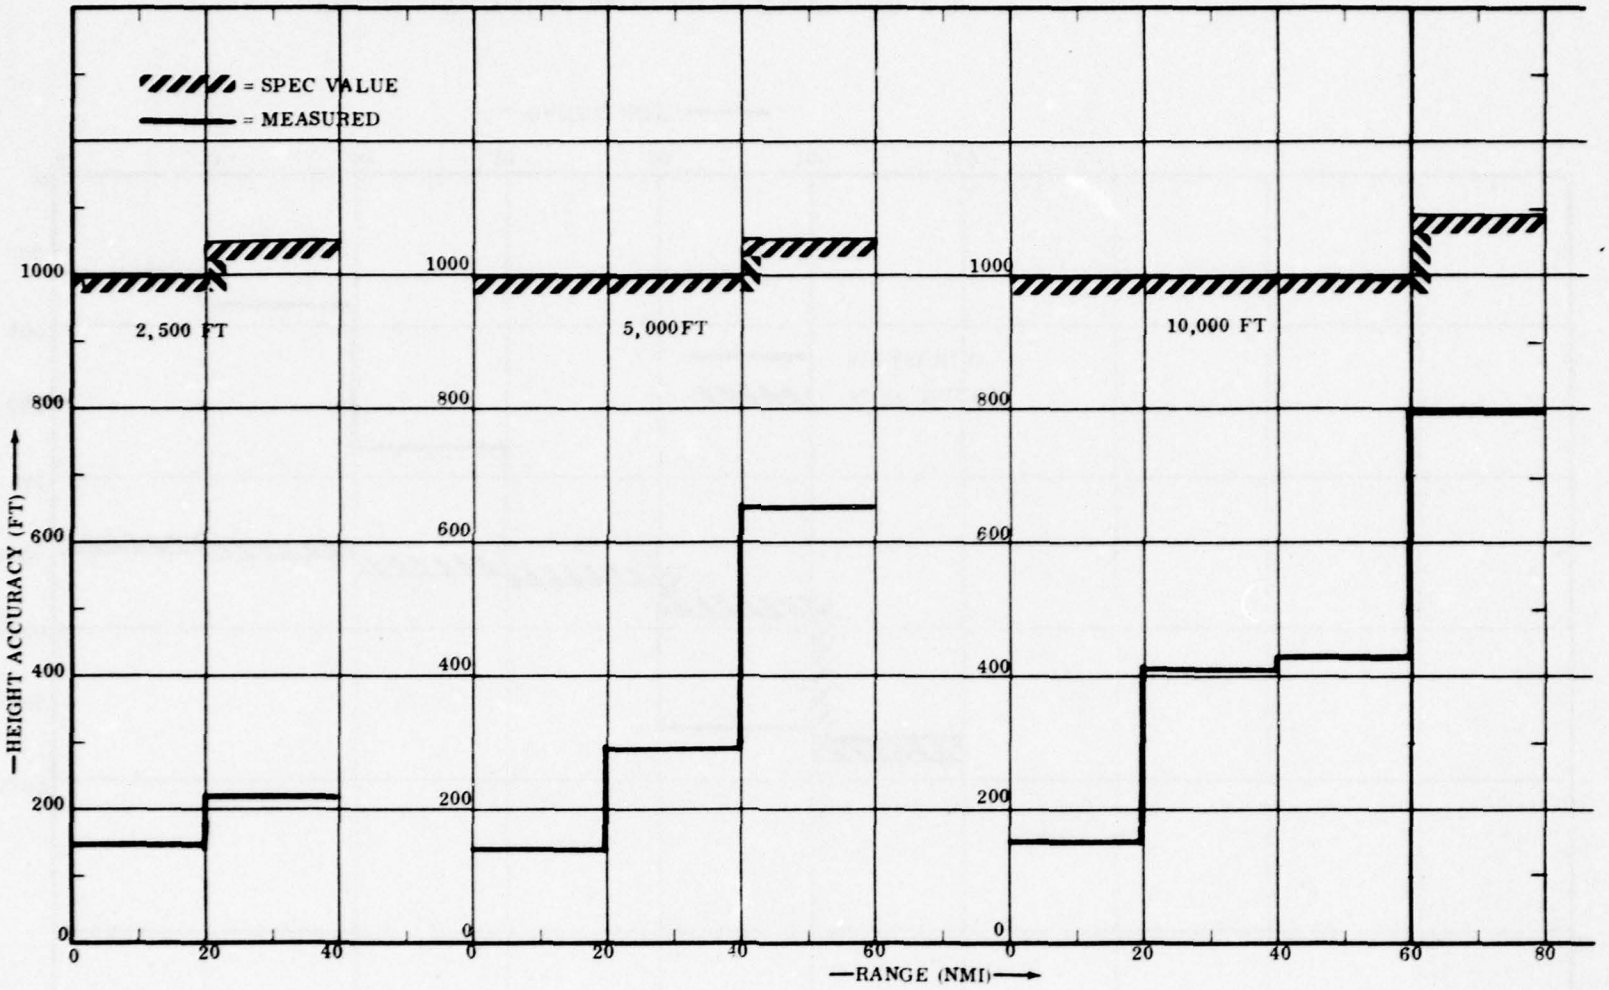
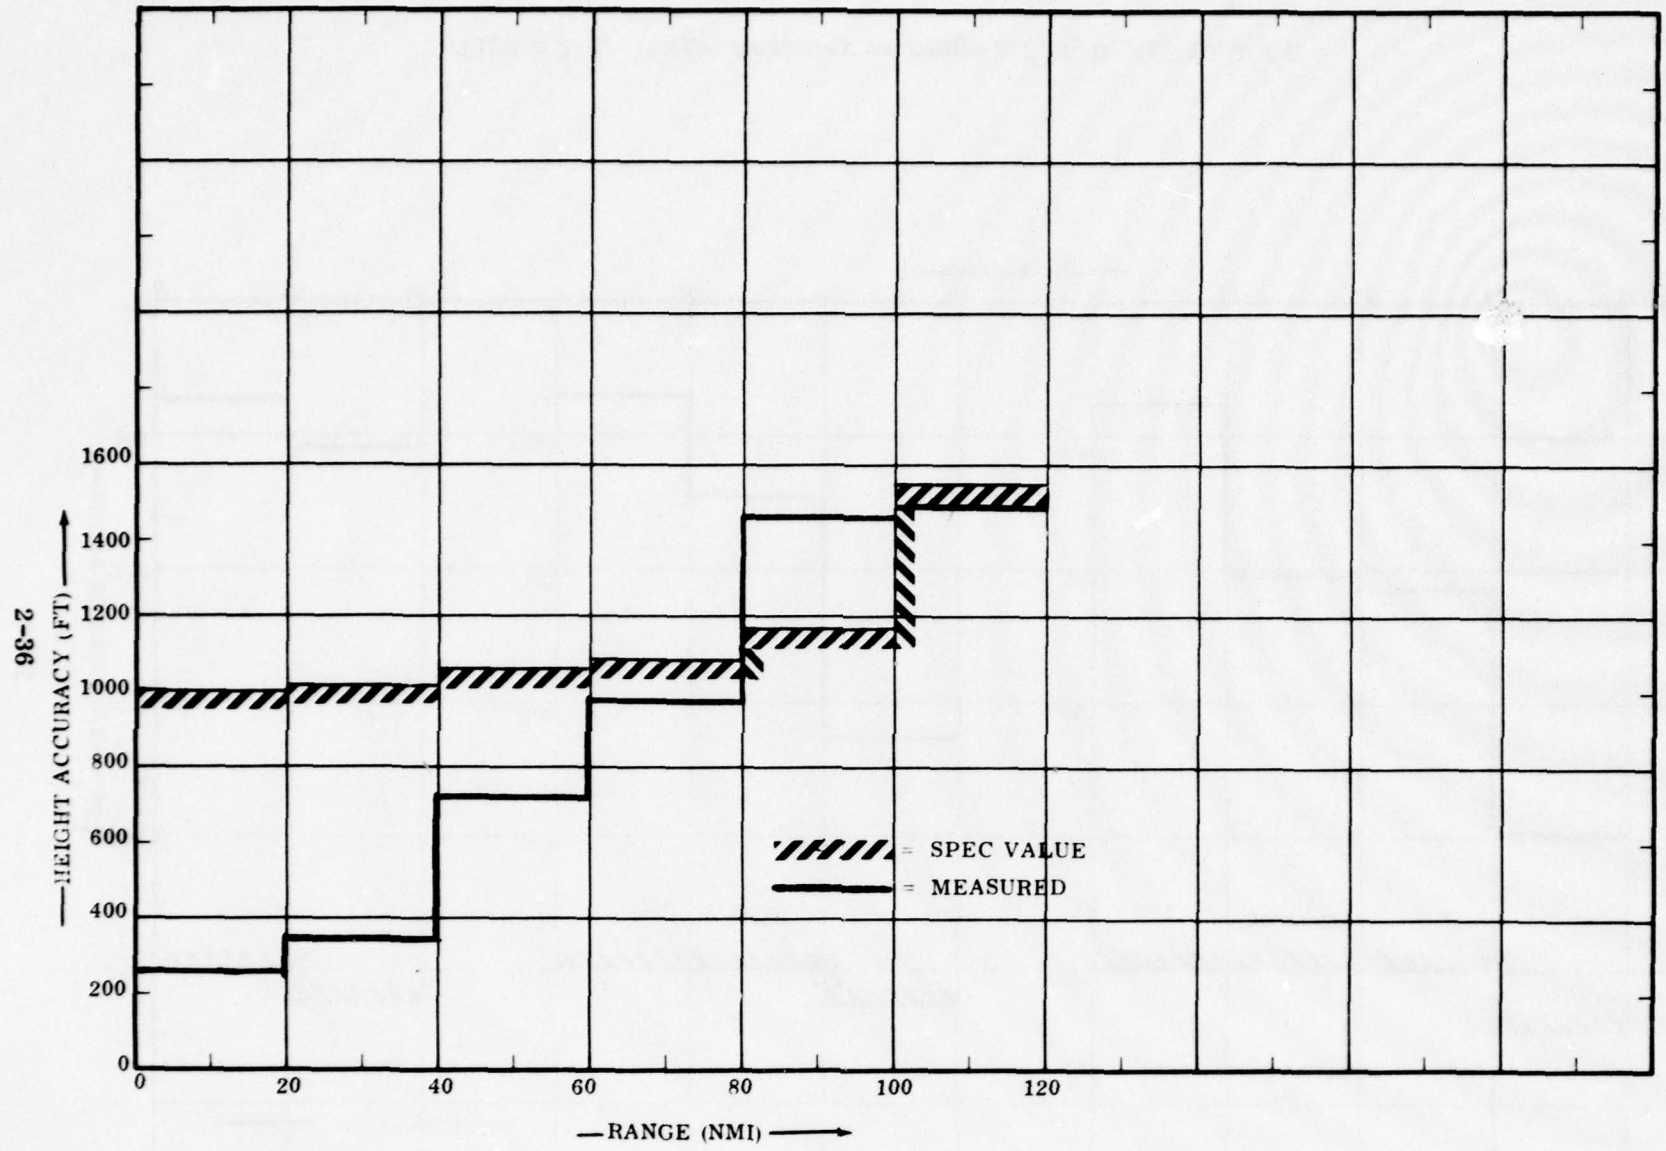
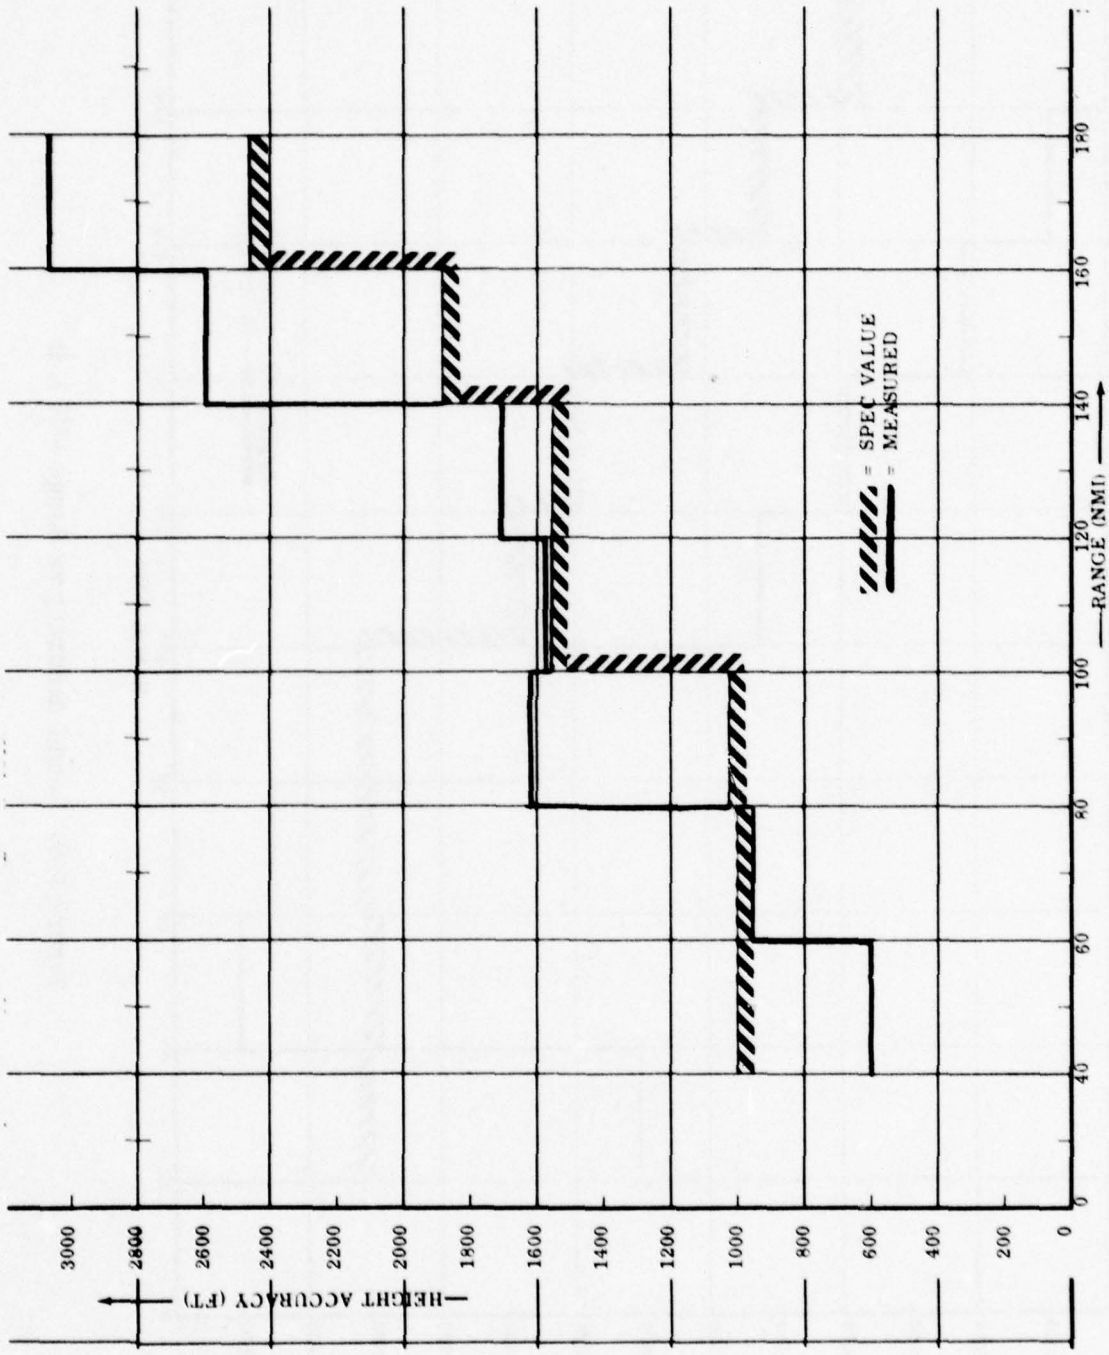
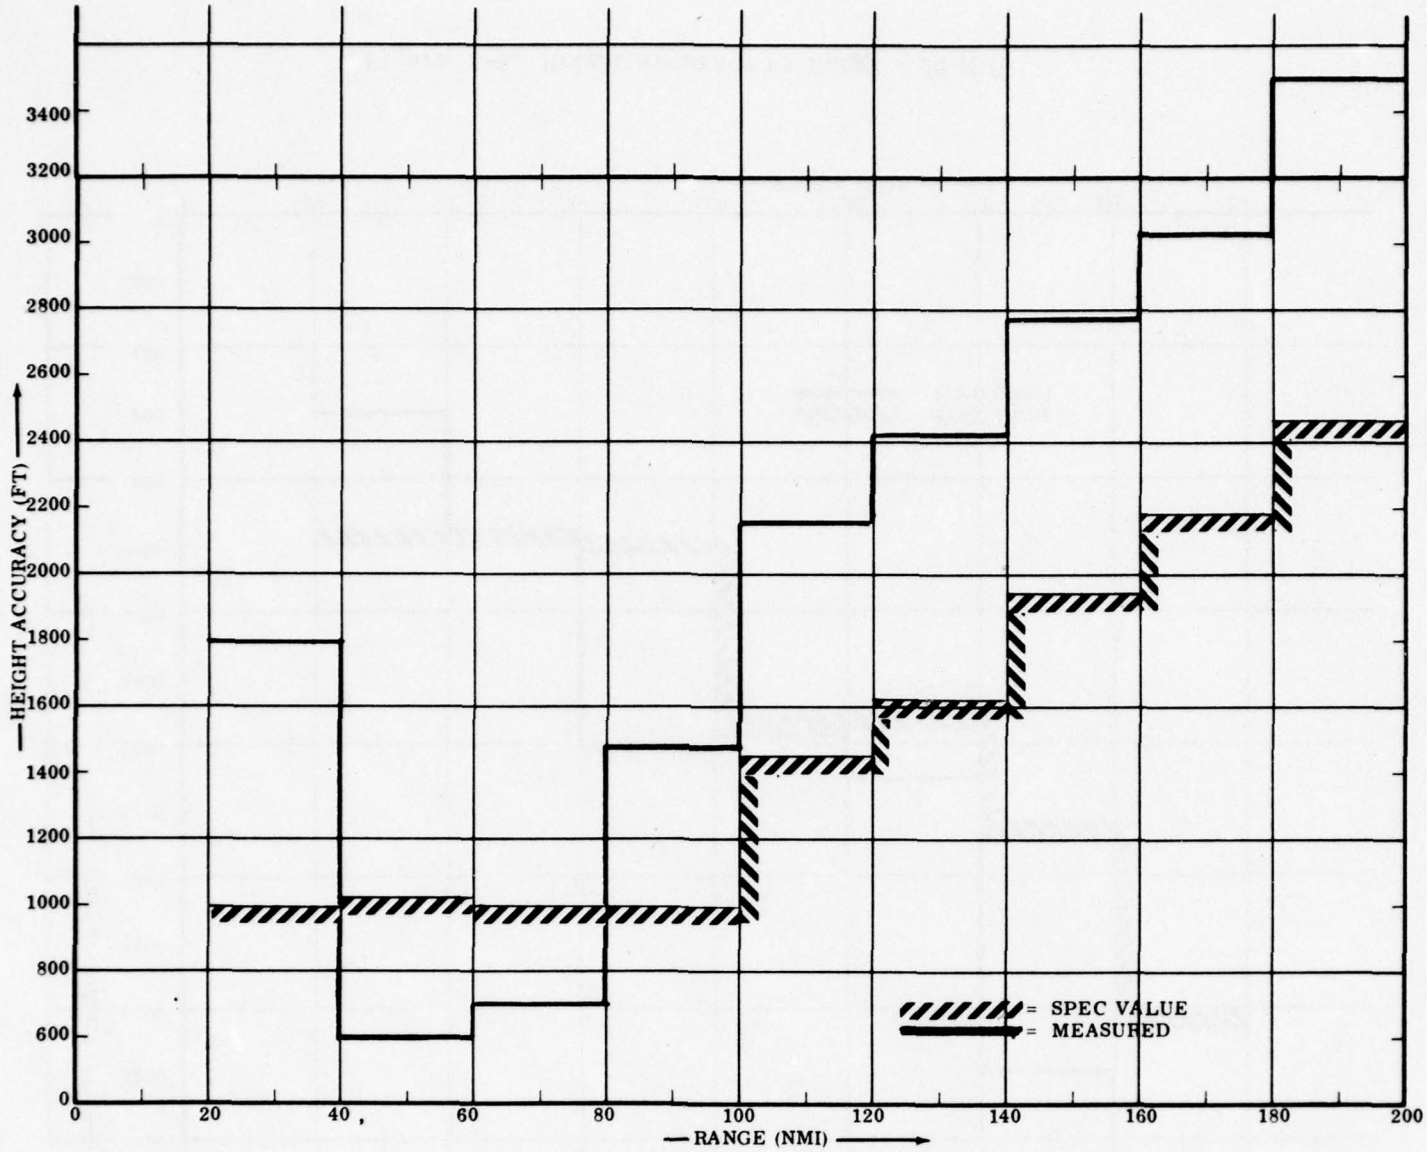
Examination of Table 2-13 or Figures 2-6 through 2-9 shows that the AN/TPS-59(XN-1) is more accurate than required for all ranges and altitudes out to 80 nmi except for the 40,000 ft altitude in the 20-40 nmi range interval. As discussed in the aircraft detectability subtest, the multiple DTM's that appear to be caused by the spoiled elevation beams in the 40 K ft/20-40 nmi region are also affecting the height accuracy. Beyond 80 nmi, the AN/TPS-59(XN-1) height accuracy was degraded about 60% from the required height accuracy except for the 20,000 and 30,000 ft altitudes in the 100 to 120 nmi range interval where it meets the accuracy requirement.

The gradual increase in degradation of the height accuracy with increasing range is low enough to suggest that it is not related to system sensitivity; i.e., increasing the signal-to-noise ratio will not substantially affect height accuracy.

To enhance height accuracy at 40,000 ft in this range interval, it is recommended that the two spoiled beams used at the upper elevation be replaced with three unspolied beams as discussed in the aircraft detectability subtest.

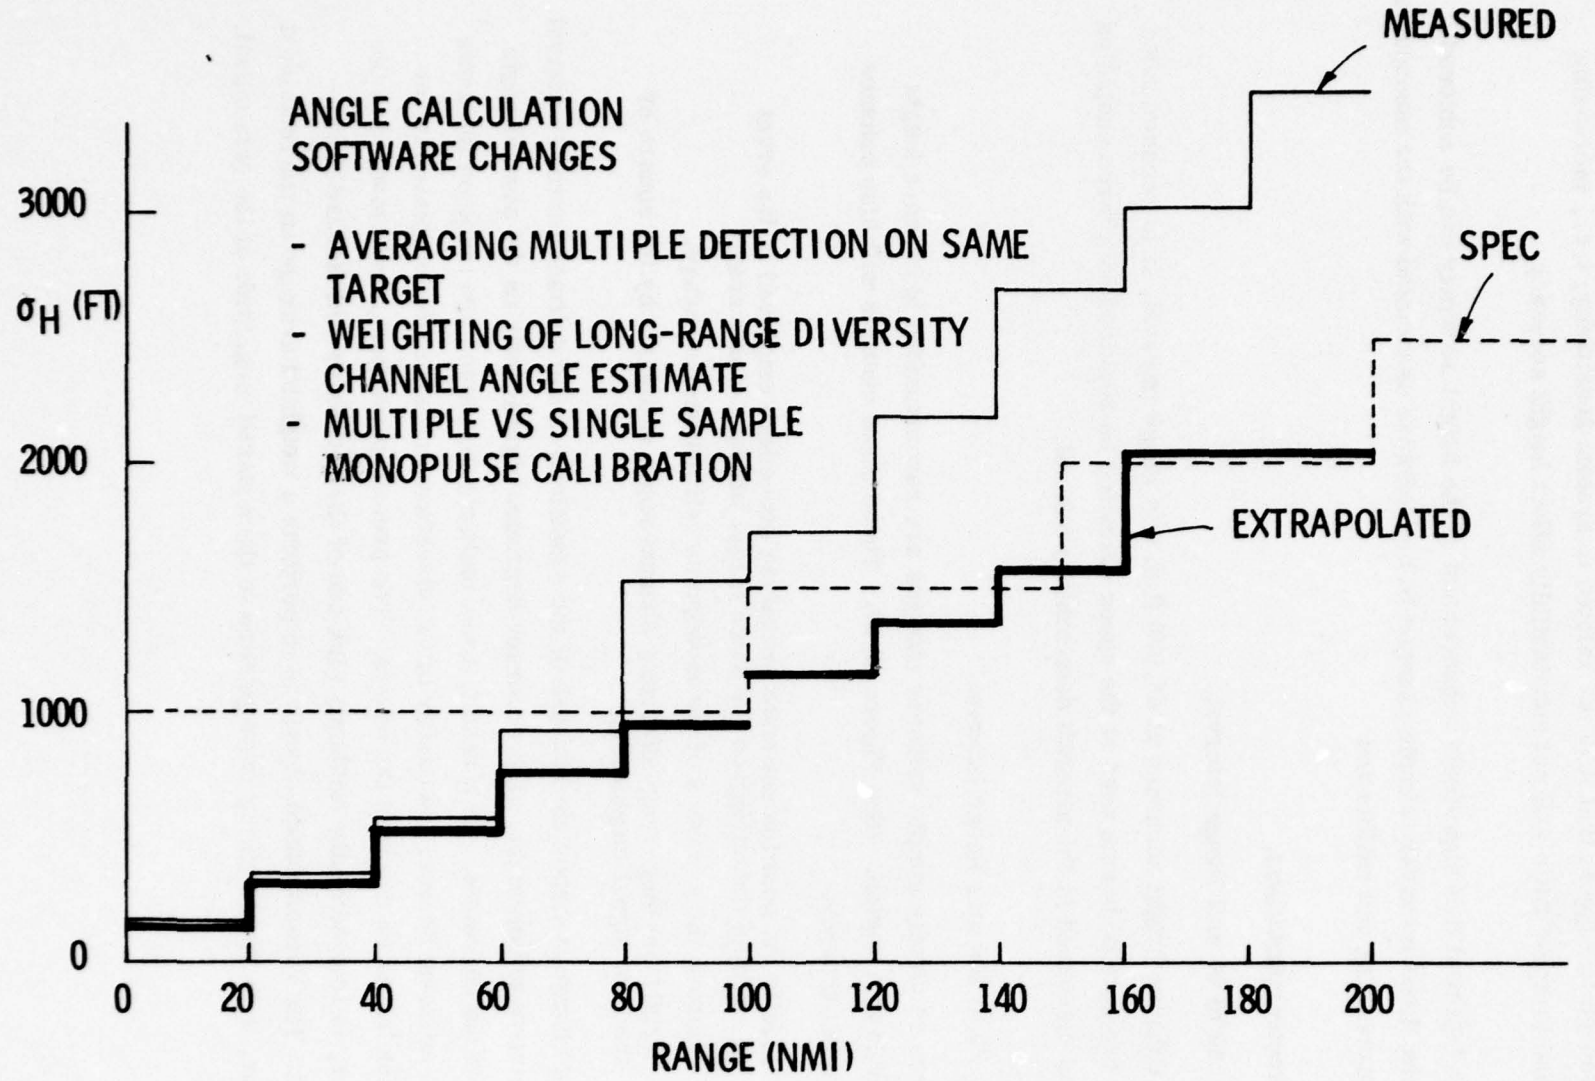
Figure 2-10. Height Accuracy Extrapolation

The first change is important because of the sensitivity of the estimate error to arrival angle relative to boresight. The accuracy degrades significantly as the arrival angle moves off the boresight. As a result, when multiple detections are made on the same target in adjacent beams, the quality of the elevation (and azimuth) estimate may be very much better on one than the others. The present procedure, implemented in the computer, is to essentially randomly pick one of the estimates and discard the remainder. The recommended change is to perform a weighted average on the individual estimates, with the weighting in proportion to the squared magnitude of the sum signal.

The second change is important because of the extreme sensitivity of the angle estimate error on channel mismatch, especially the phase mismatch between the Σ and $\Sigma + i\Delta$ channels (i.e., after the hybrid in the preprocessor which converts Σ and Δ to Σ and $\Sigma + i\Delta$). The monopulse calibration process is designed to measure the pertinent channel amplitude and phase mismatches and properly compenstate the elevation and azimuth estimates for these mismatches. The present monopulse calibration procedure is probably not accurate enough. It can be improved by averaging the results of multiple calibration cycles and by allowing array noise to enter the preprocessor when performing the Loop B part of the monopulse calibration procedure. The array noise will reduce the quantization noise. The effect of the former can be reduced by averaging multiple cycles, the effect of the quantization cannot.

Three relatively simple software changes are recommended to enhance height accuracy in this region. (See Figure 2-10.) These three changes will also enhance the azimuth accuracy.

1) Modify the position estimate averaging procedure employed in the event of multiple detections on the same target within a single scan.
2) Improve the accuracy of the monopulse calibration procedure.
3) Weight the long-range diversity channel angle estimates by the square of the sum signal magnitude.

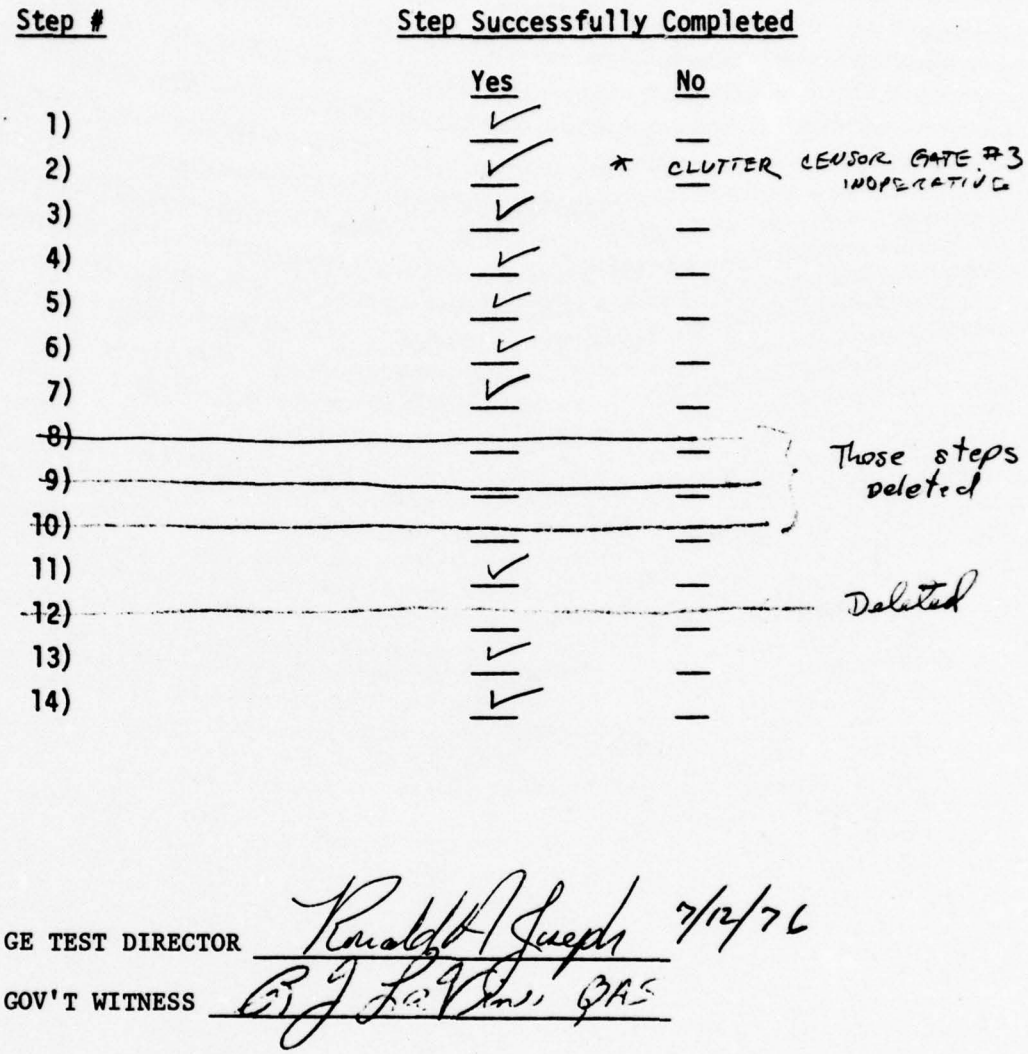
Figure 2-14. Control and Control Circuits Test, Ancillary Controls Subtest Data Sheet (Figure 4.1-11 of ATP)

The specified data sheet, completed at the time of the subtest, is shown in Figure 2-14.

Examination of Figure 2-14 shows that the AN/TPS-59(XN-1) successfully passed this subtest except for a portion of step 2.

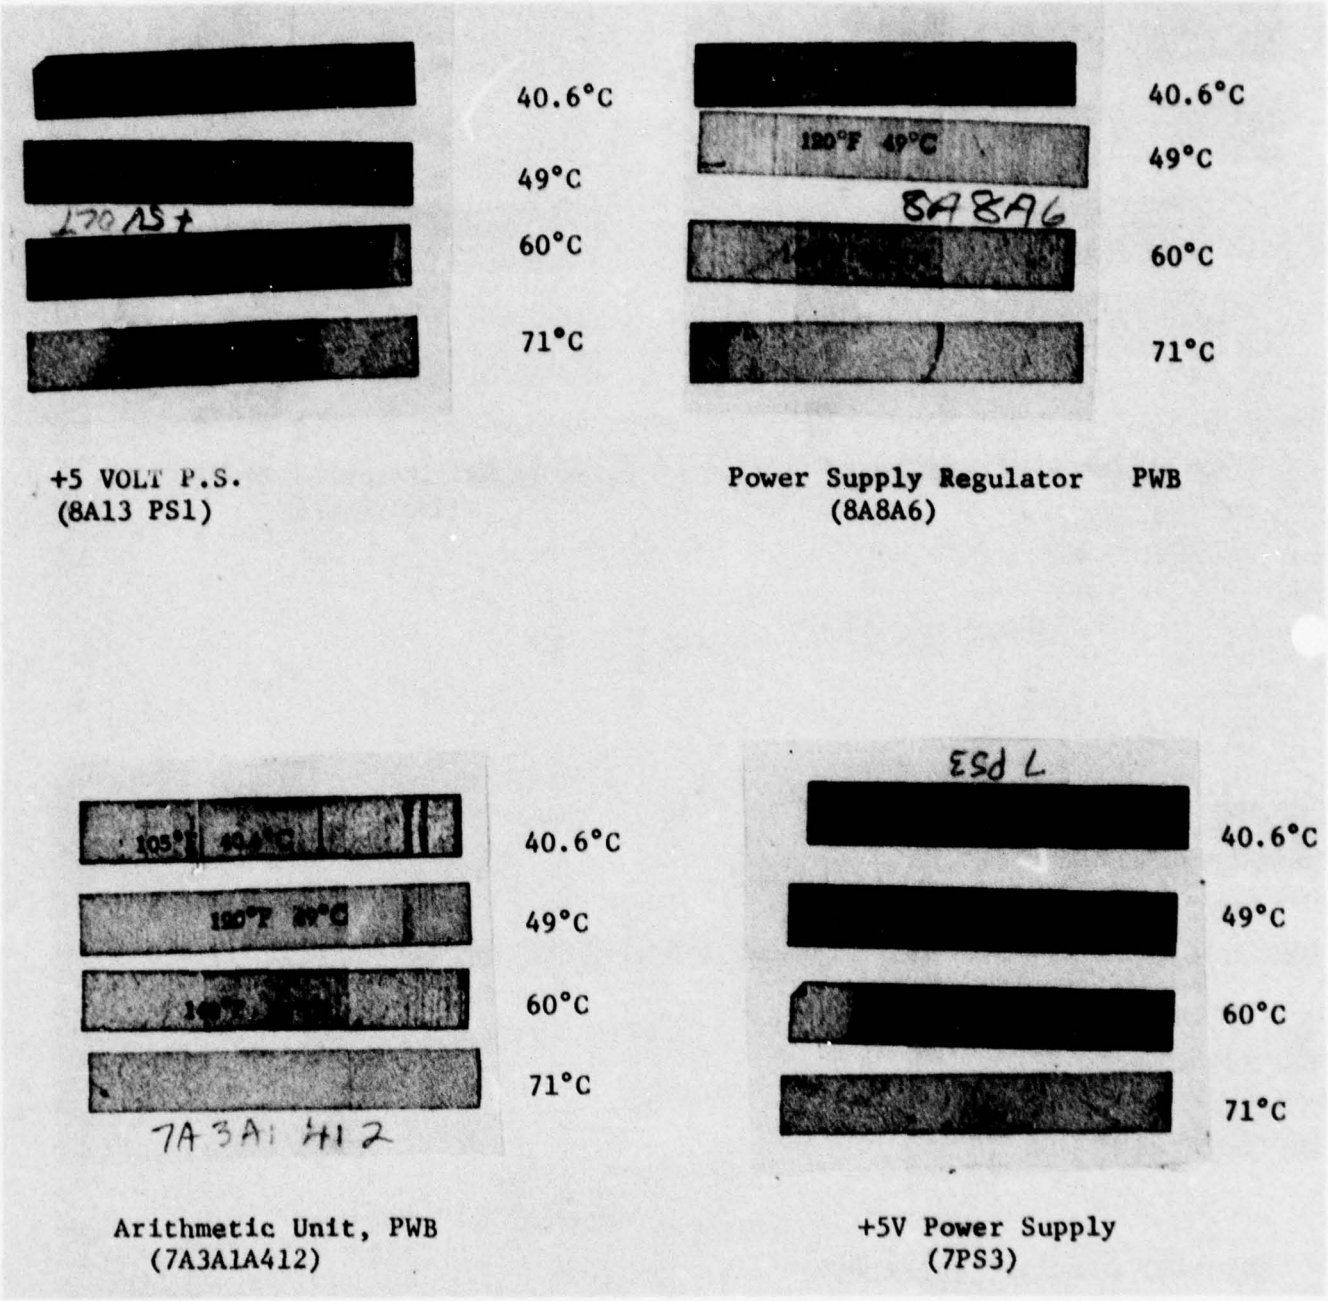
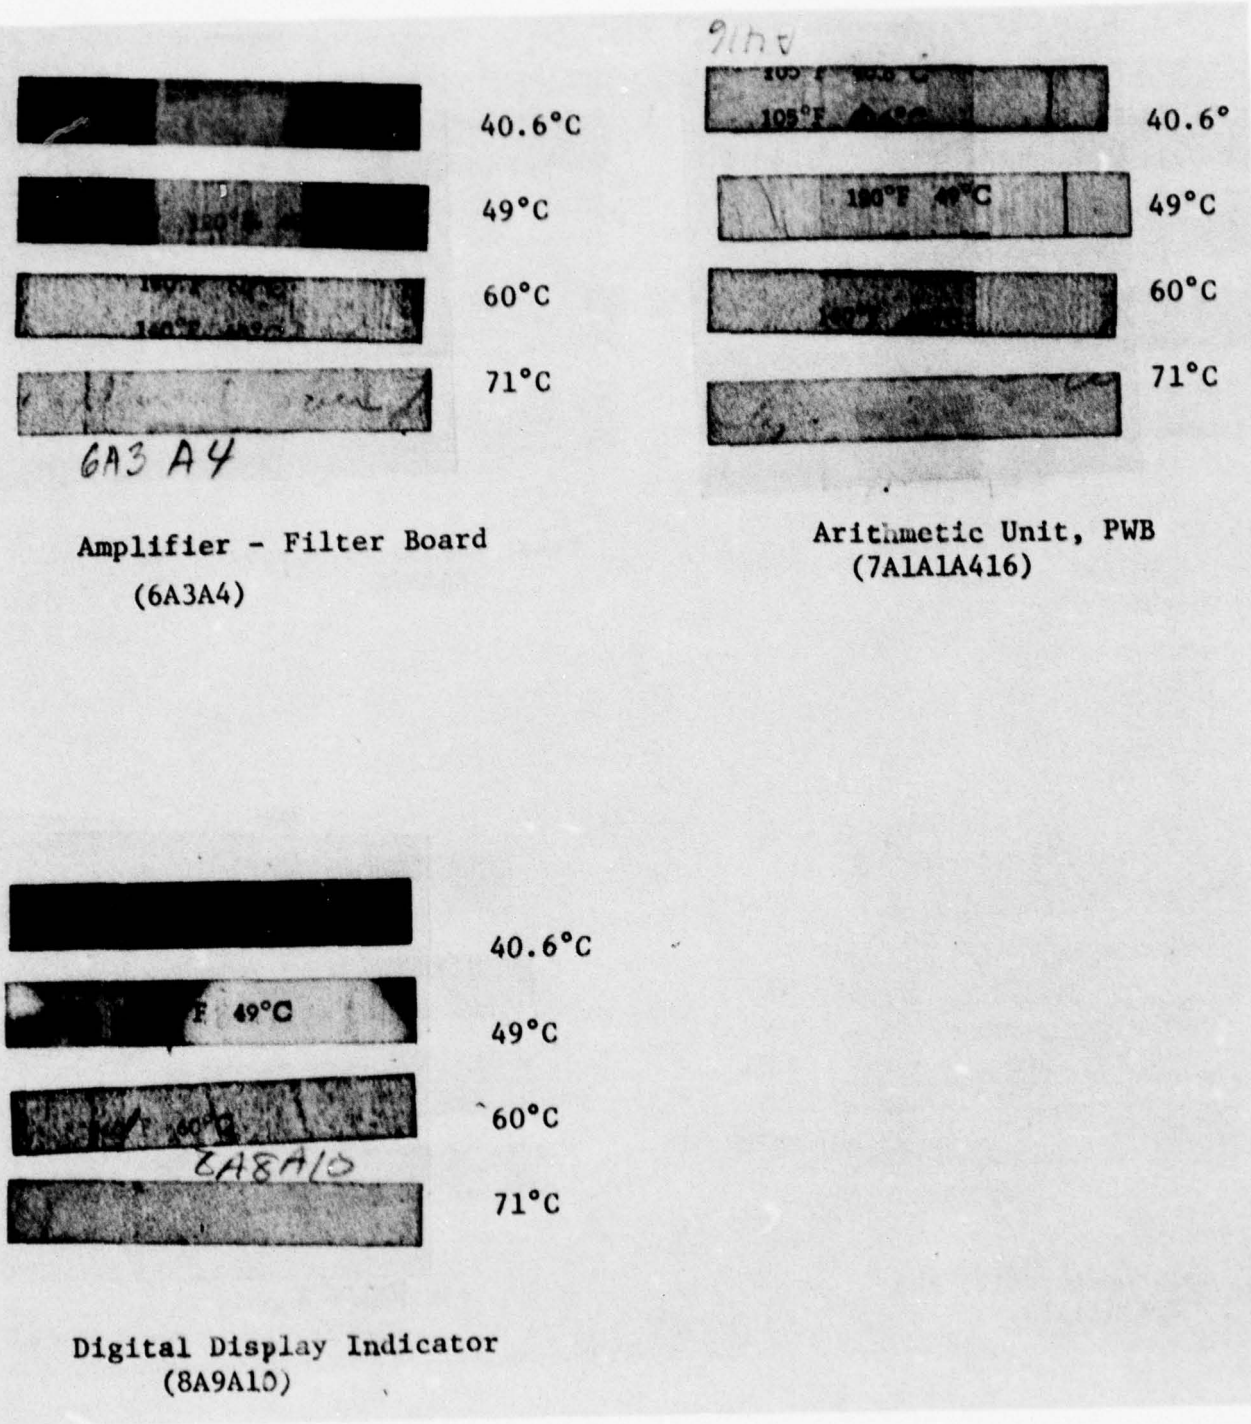
The shelter equipment operated satisfactorily for 3.5 hours with only one air conditioner before an over temperature condition resulted. Additional air baffling in the Radar Console was added to correct this problem.
