AN/TPS-59(XN-1) EDM
RADAR SET, MARINE LIGHTWEIGHT TACTICAL 3D
ENGINEERING DEVELOPMENT MODEL

PRE-SERVICE ACCEPTANCE TEST REPORT.

VOLUME I.

Department of the Navy
Naval Electronics Systems Command
Washington, DC 20360

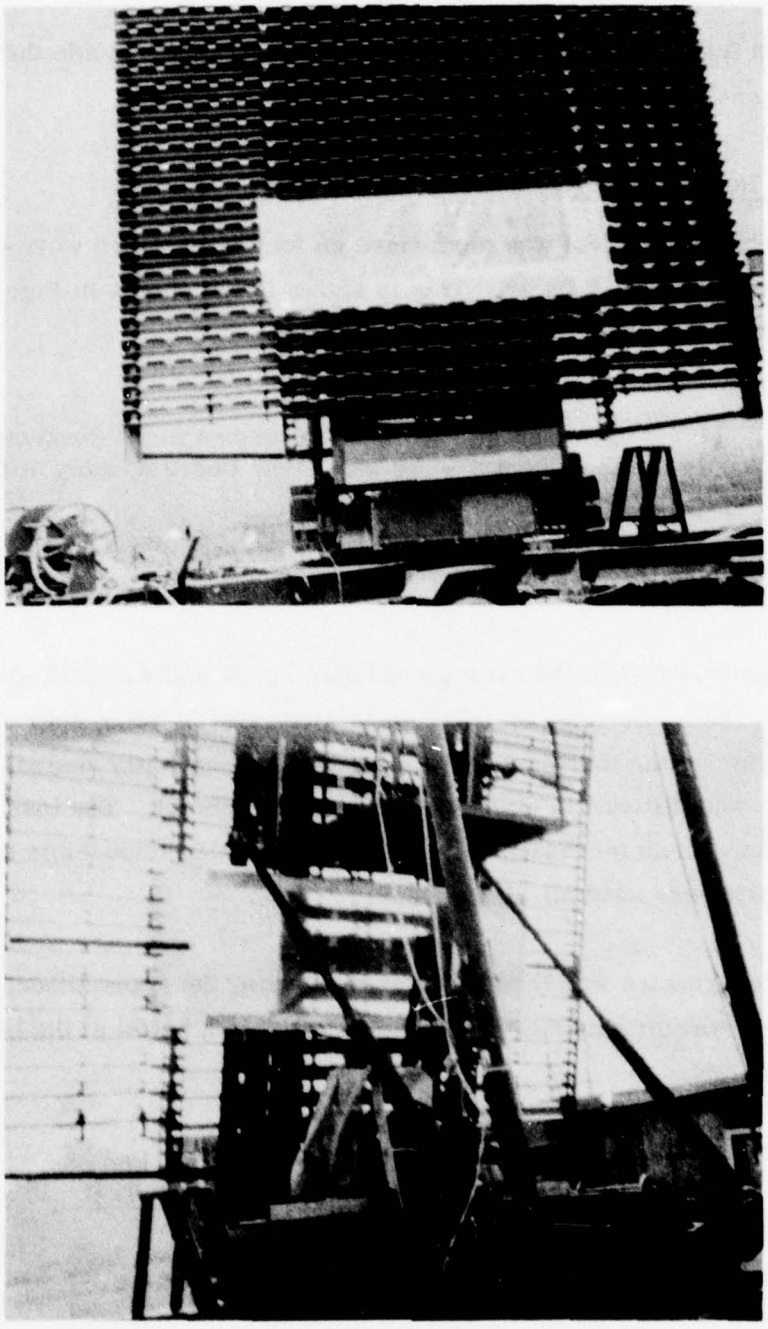
Figure 7-3. Four Row Temperature Enclosure

Four rows of electronics operated satisfactorily for 4 hours in a sealed 50°C environment. One row power supply failed, but subsequent analysis indicated a HIC inverter had failed because of a process problem.

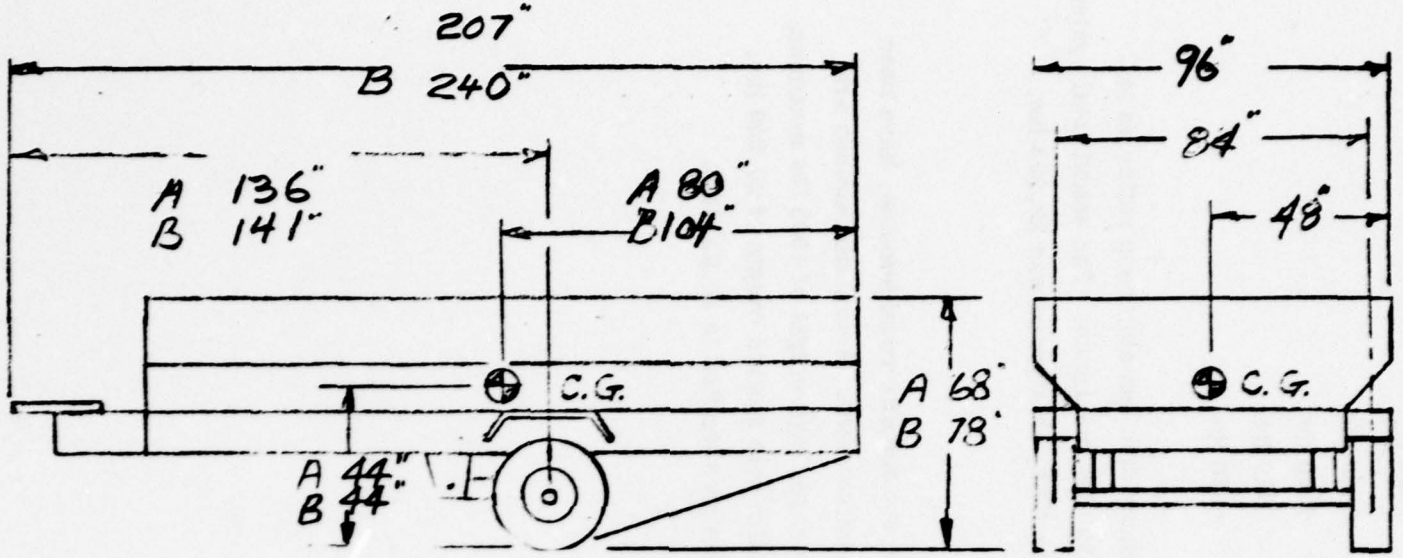
Figure 10-5. AN/TPS-59 Shelter CG's and Dimensions

The dimensional measurements, although not specific requirements, have been demonstrated satisfactorily in the transport environment. Actual dimensions are shown in Figures 10-5 and 10-6. The transport package weight of 5000 lbs maximum was exceeded on all packages along with the allowable system weight of 20,000 lbs; therefore, the equipment does not meet weights as specified in ELEX-R50.

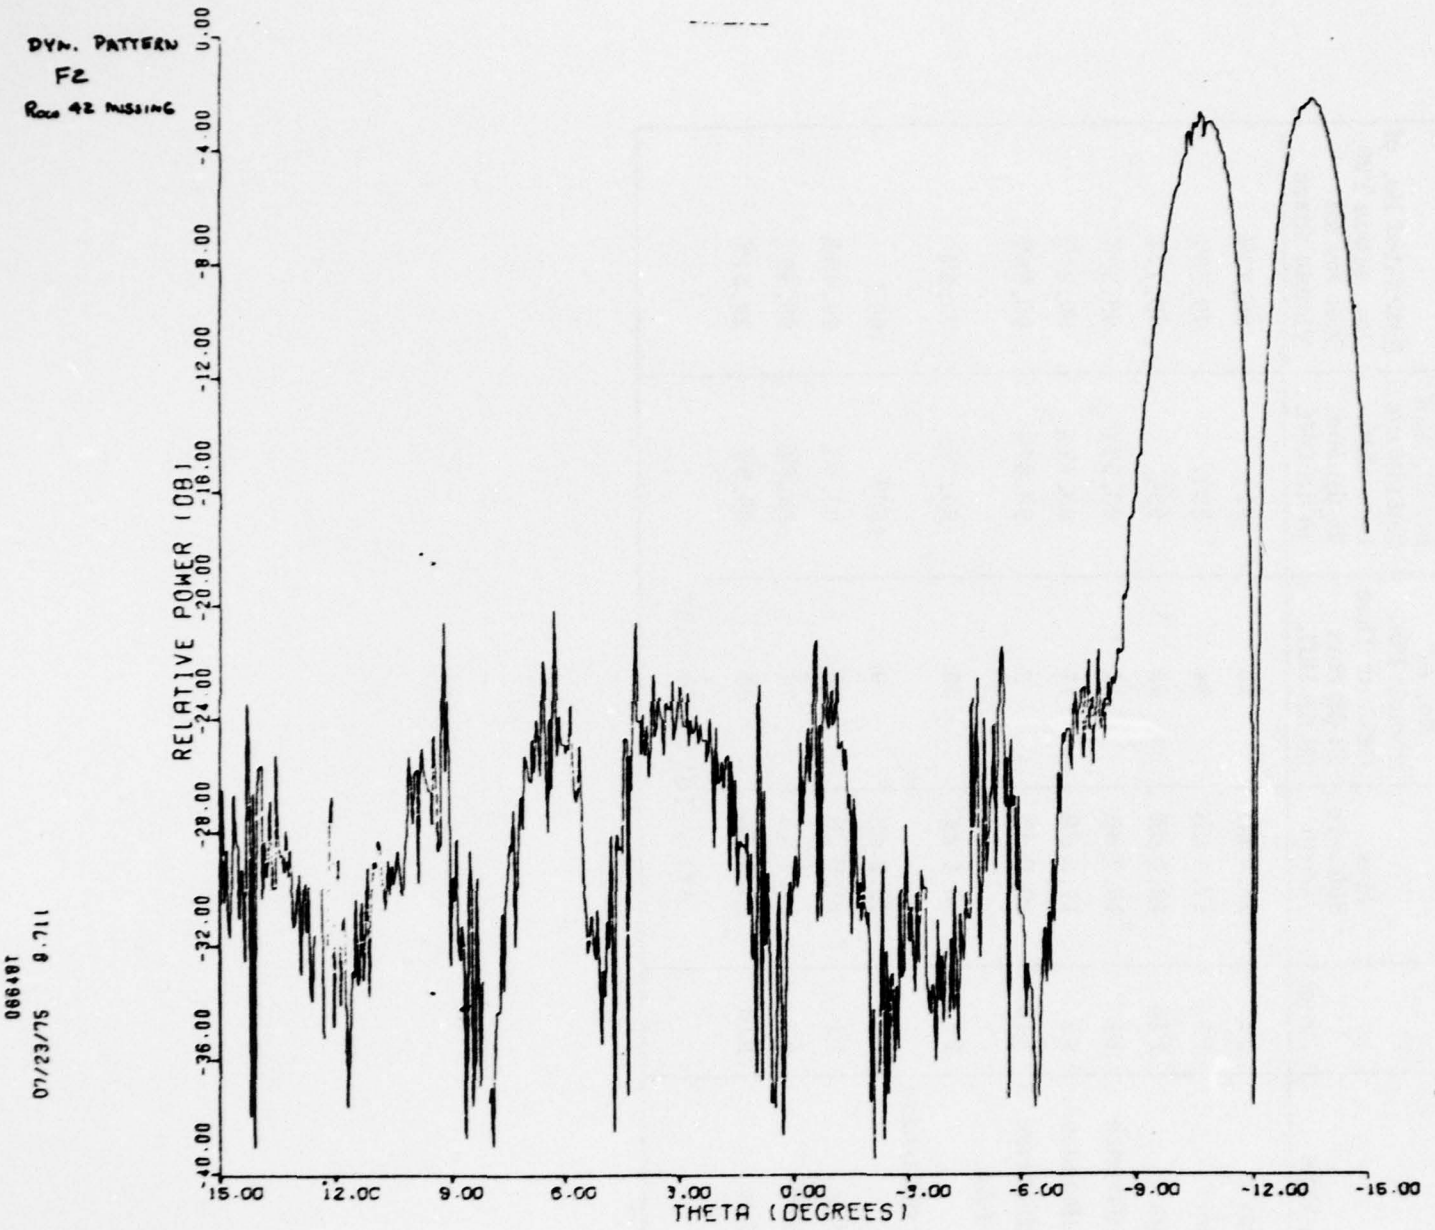
Figure 12-5. Calculated Elevation Dynamic Sum Pattern

For all electronically scanned (dynamic) patterns the beam is scanned from -16 degrees to +16 degrees with respect to the array normal direction. Note that -16 degrees is the right extreme of each dynamic pattern. The range of the scan angle listed in the indices in Figures 12-5 and 12-6 is that for which multipath effects from the valley floor are negligible.

In an effort to determine how close the AN/TPS-59(XN-1) measured sidelobe performance compared to the expected values several receive elevation pattern calculations made with the aid of a digital computer. A set of amplitude and phase readings for each row path were generated at F2 by the use of the sum monitor test channel for each row. It should be noted that this measurement does not include the row feed networks, the circulators, and the bandpass filters. This test data was generated on 6/27/75. Both static and dynamic elevation sum and difference patterns were then calculated from this data. The calculated elevation static sum and difference patterns at frequency F2 are shown respectively in Figures 12-3 and 12-4. The calculated elevation dynamic sum and difference patterns at frequency F2 are shown respectively in Figures 12-5 and 12-6.

The calculated dynamic patterns were generated assuming a 4-bit phase shifter and 0.05 degree elevation scan steps. Only row 42 was missing (zero amplitude) for this calculation. These dynamic pattern calculations (Figures 12-5 and 12-6) compare closely to the measured patterns Number 43 and 44 in Figure 12-1.

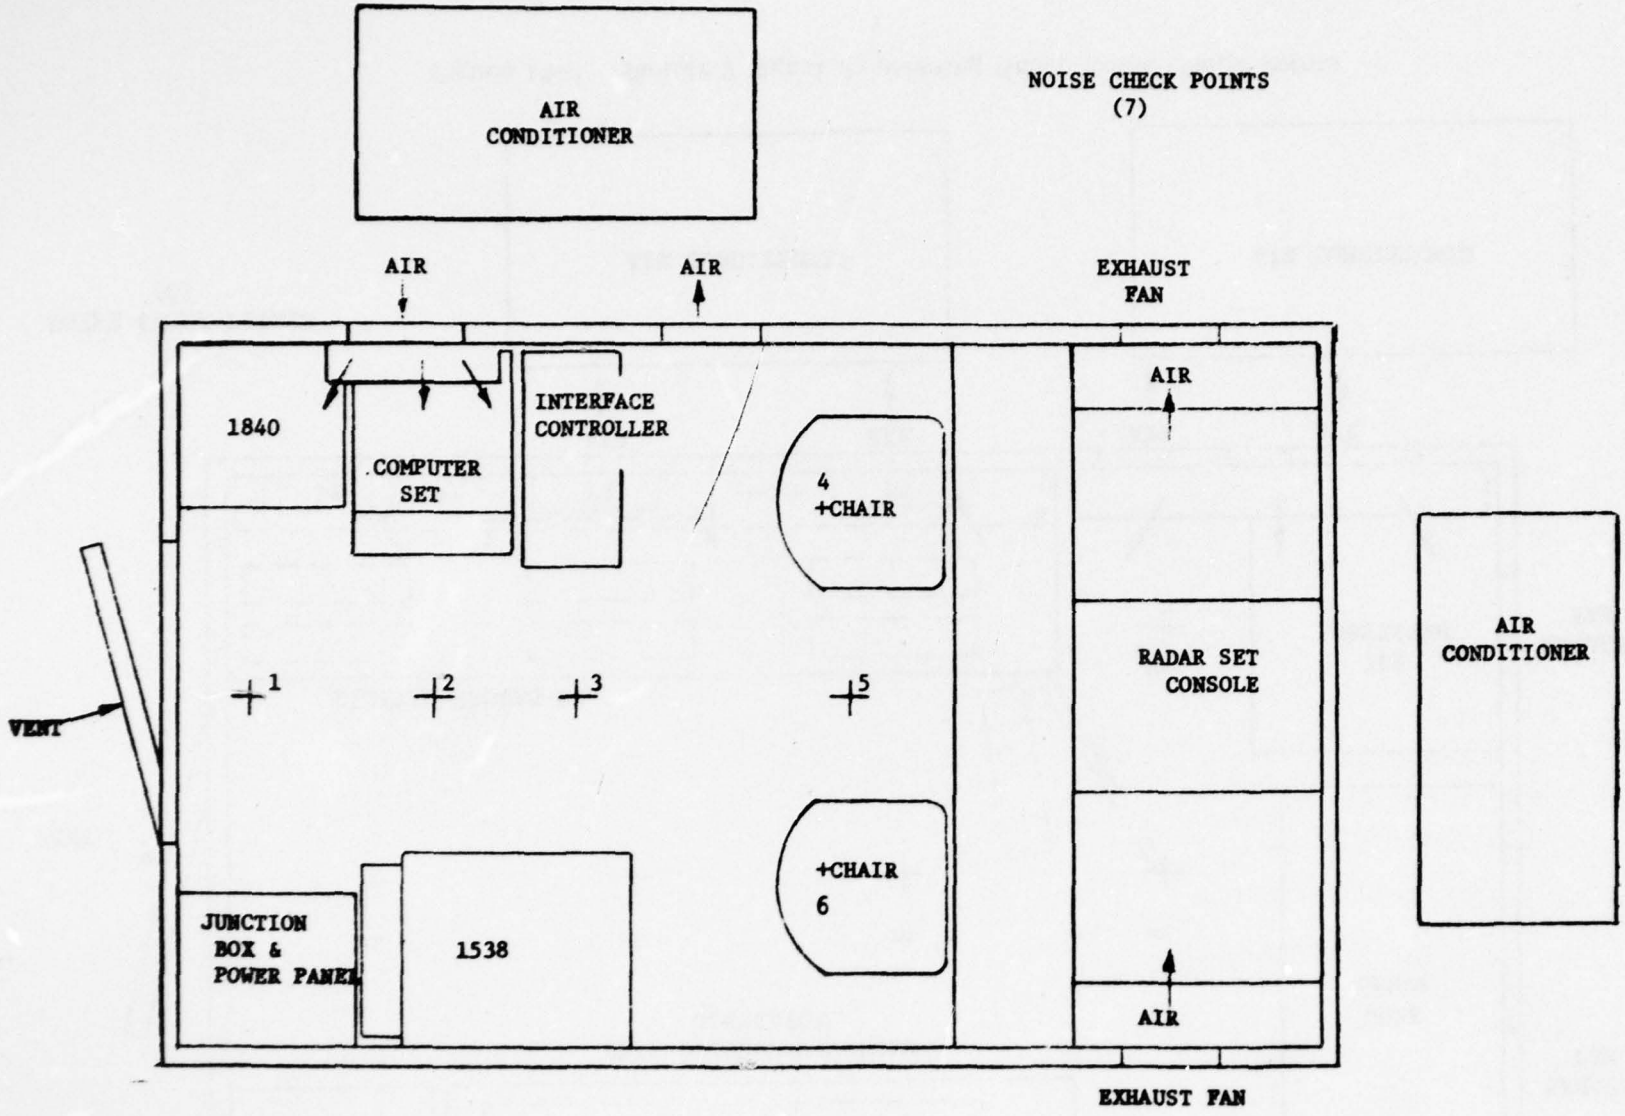
Figure 13-1. Shelter 1 Radar Control Group Noise Check Points

Table 13-1 presents the data measured at the points shown in Figures 13-1 through 13-3. The measurements indicated a background noise level in the shelters, with all equipment off, of 36 dBA. The diesel generators added 16 to 18 dB of noise. The fans increased the noise ratio by another 26 to 28 dB. However, the noise level in the shelters never exceeded the 90 dBA maximum allowable level for continuous exposure. Comparisons of noise levels in the shelter, with the air conditioners and diesels running, with and without the system operating, showed an average increase in noise level of 13 to 15 dB due to the operation of the system.
