PASSAIC RIVER BASIN

PACKANACK LAKE DAM

PHASE I INSPECTION REPORT

NATIONAL DAM SAFETY PROGRAM

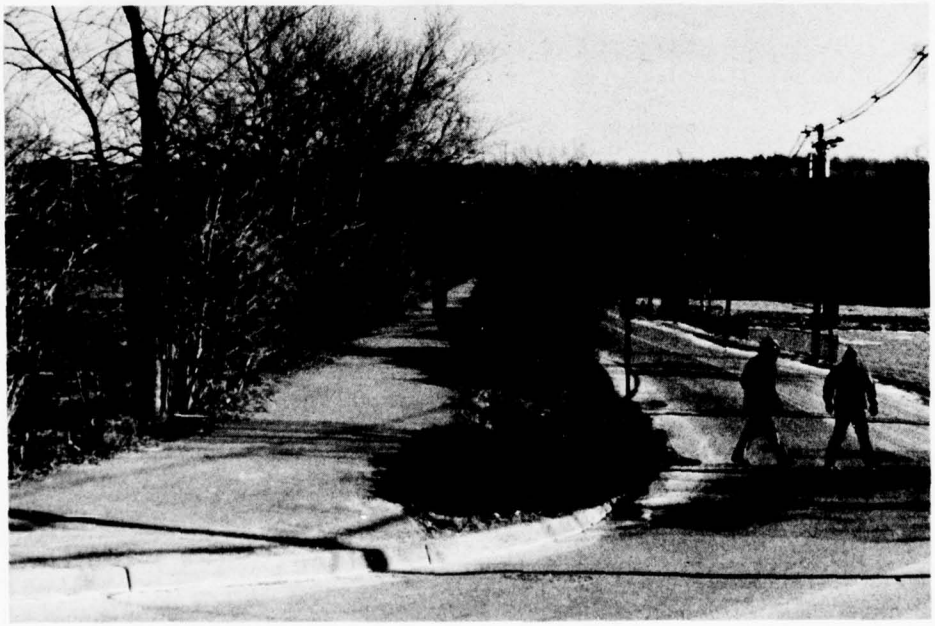
CLOSEUP OF DAM
IMMEDIATELY WEST OF SPILLWAY

WEST END OF DAM

DOWNSTREAM END OF SPILLWAY LOOKING EAST

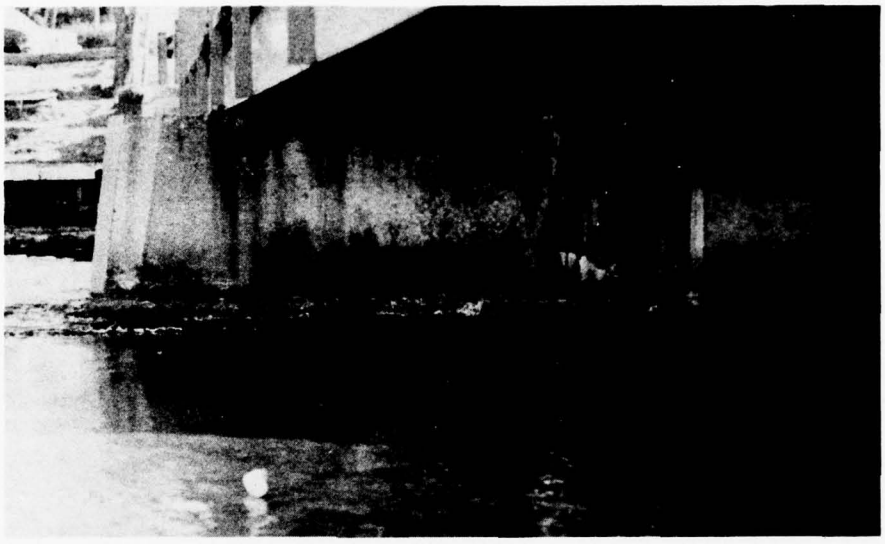
DOWNSTREAM END OF SPILLWAY LOOKING WEST

CLOSEUP OF BRIDGE PIER IN SPILLWAY
