OVERFLOW WEIR

PHASE I INSPECTION REPORT

NATIONAL DAM SAFETY PROGRAM

NJ 00214

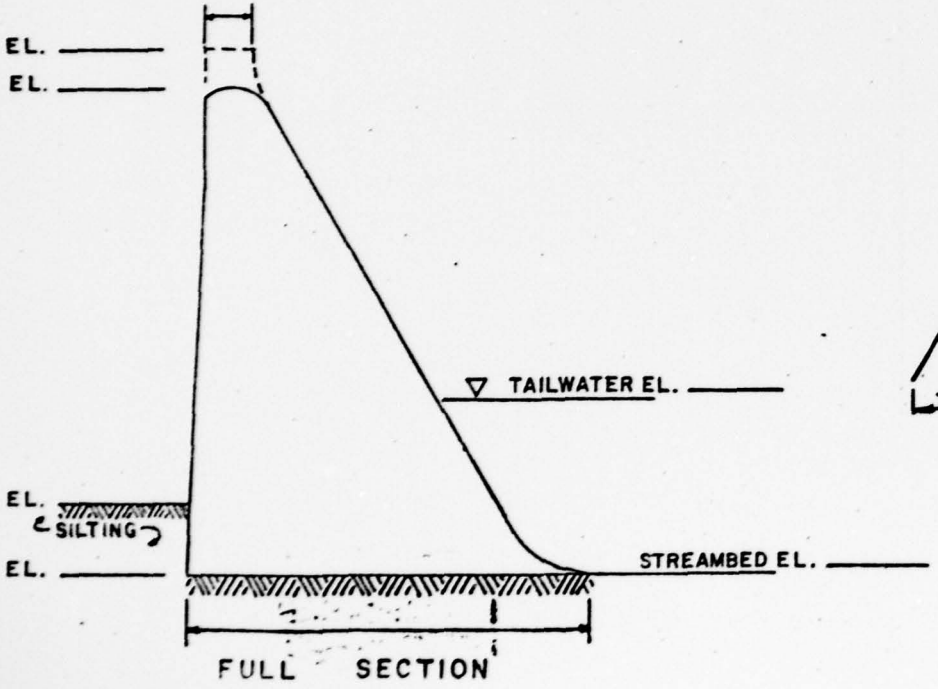
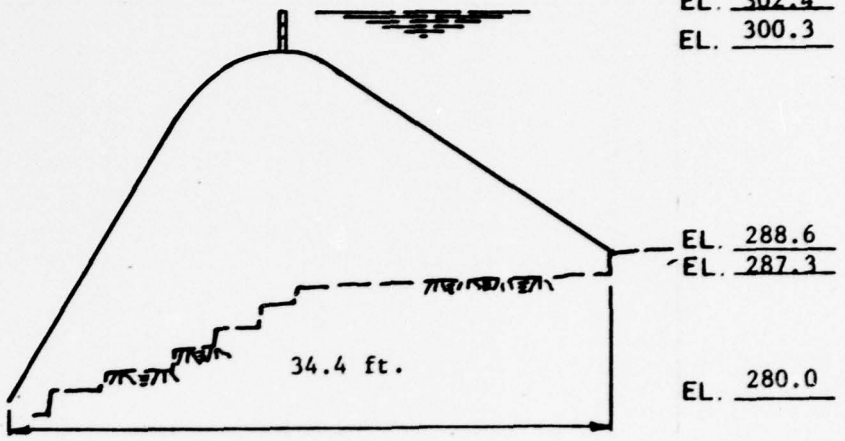
ANALYSIS DONE ON __ FULL SECTION X PARTIAL SECTION
LOCATION OF SECTION Max. Height of Dam
ANALYSIS PREPARED BY R. F. Noll/J. A. Hagen 6/28/78

LOADING CASE	ELEV. HEAD WATER	ELEV. TAIL WATER	ΣV	ΣH	ΣH/ΣV	LOCATION RESULTANT FROM TOE	% BASE IN COMPRESSION	FACTOR SAFETY SLIDING	FOUNDATION PRESSURE	
									TOE	HEEL
PMF	308.6	290.0	18.1 K	9.9 K	0.55	6.24'	54%	333	1.93 K/s.f.	0
1/2 PMF	306.0	287.0	24.1	9.0	0.37	10.1'	88%	483	1.59	0
1' of Ice @ Top StopLogs	302.4	280.0	35.6	12.1	0.34	10.1'	88%	358	2.35	0
