AN INVESTIGATION OF THE PERFORMANCE OF A J52-P-8A ENGINE OPERATING UNDER THE INFLUENCE OF HIGH BLEED FLOW EXTRACTION RATES.

(14) DTNSRDC/ASED-387

(11) August 1977

DAVID W. TAYLOR NAVAL SHIP RESEARCH AND DEVELOPMENT CENTER

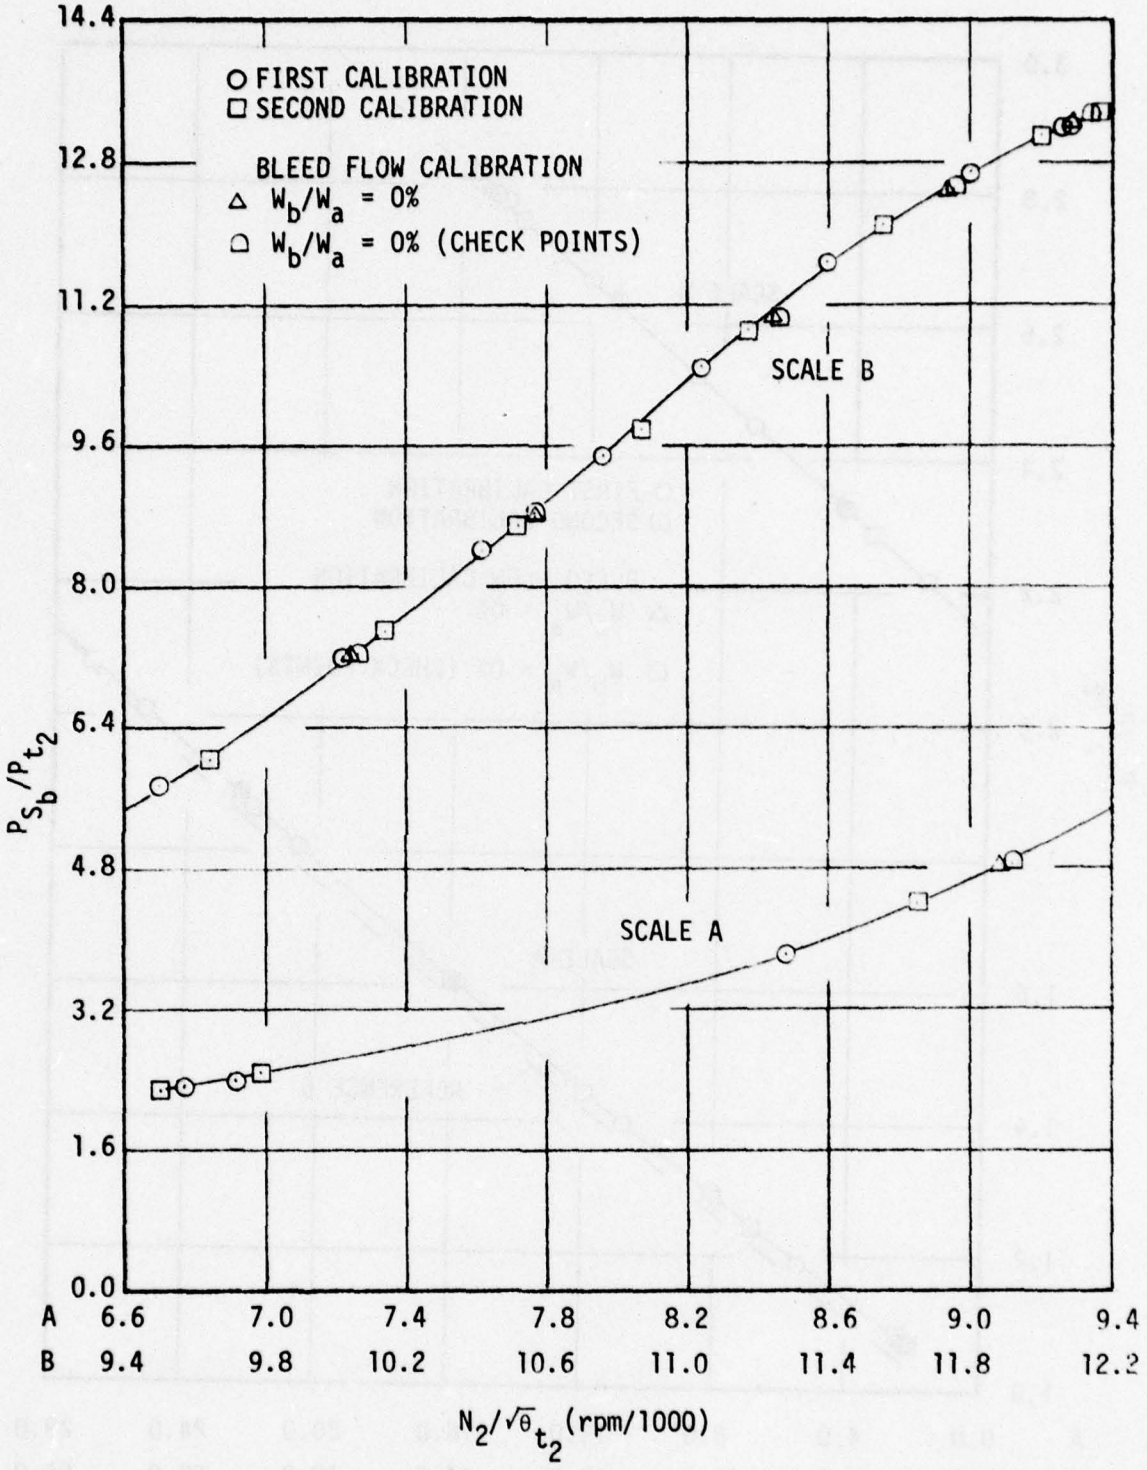
Figure 14 - Burner Static Pressure Ratio as a Function of High Pressure Compressor-Turbine Unit Speed

The burner static pressure ratio characteristics are shown in Figure 14. Although no data were available from Reference 6 for comparison, these characteristics are assumed to be reasonable. This assumption is based on the fact that the engine performance characteristics of the components

located upstream and downstream of the burner cans (with the exception of T_{t_7}/θ_{t_2} discussed later in this section) are in order.

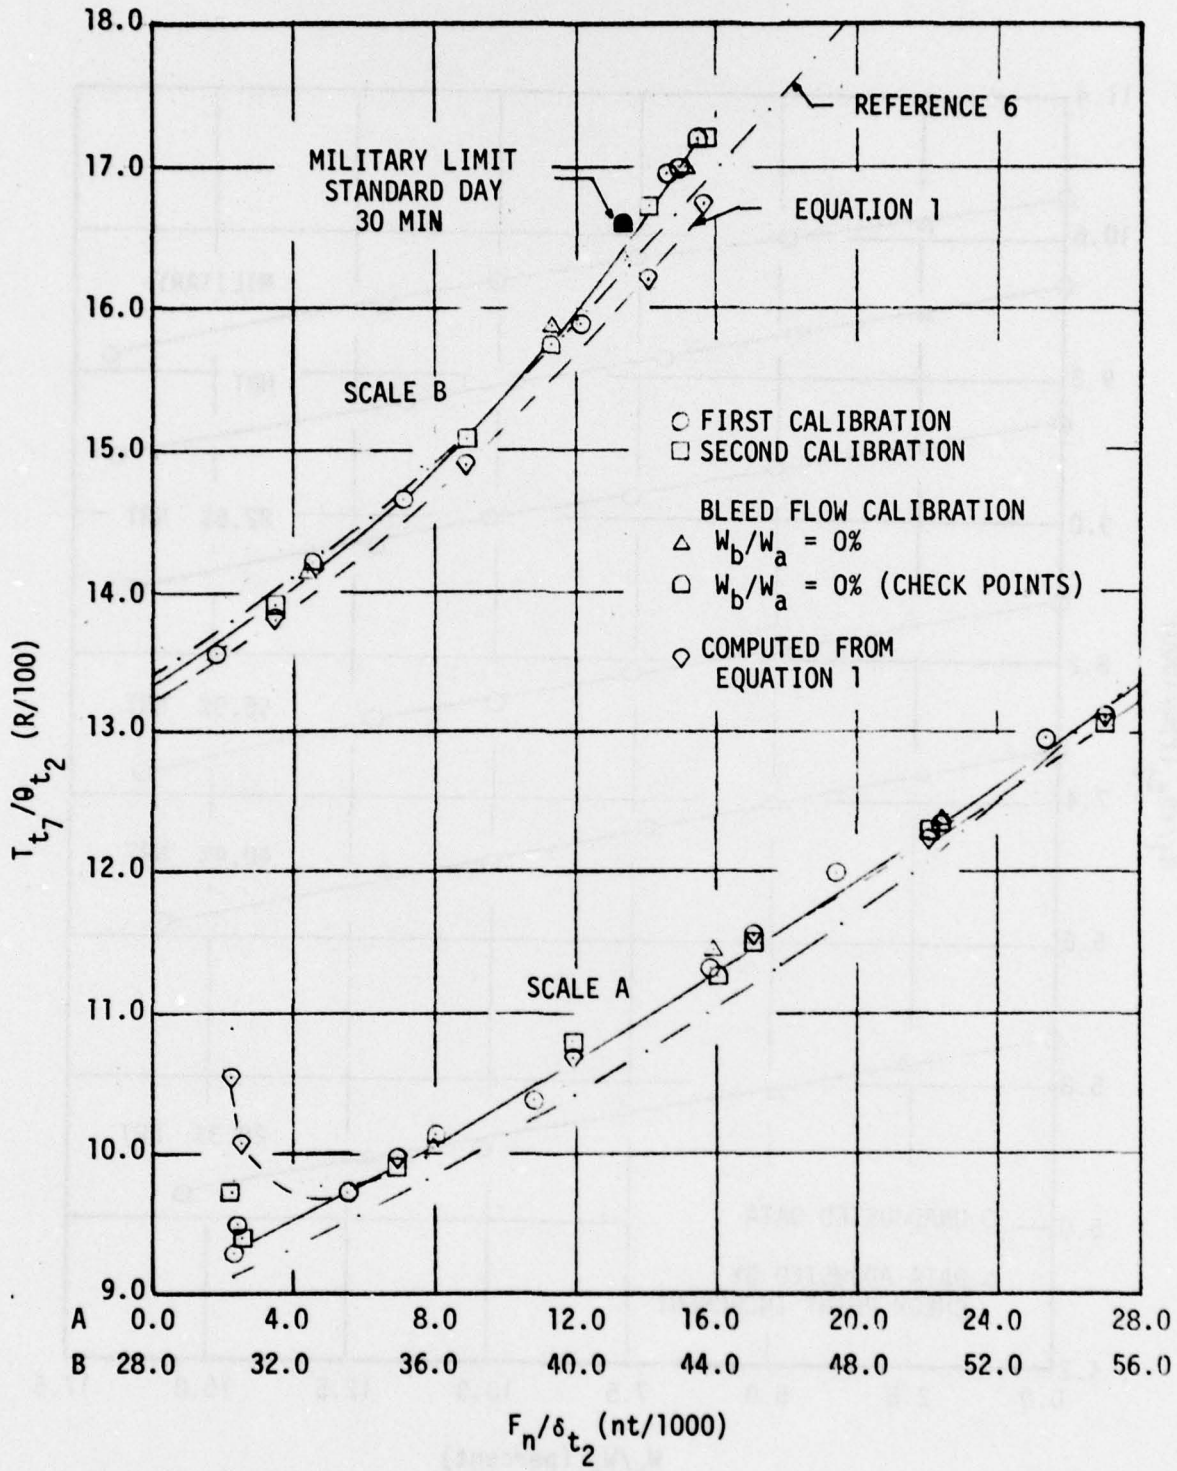
Figure 16 - Turbine Exit Temperature as a Function of Net Thrust

The corresponding turbine exhaust gas temperature characteristics are shown in Figure 16. The T_{t_7}/θ_{t_2} data, as obtained from the basic engine calibrations, are slightly higher than the baseline levels in the low to moderate thrust range. This trend is consistent with the trends found in the airflow data in this thrust range, i.e., a reduced amount of airflow must be at a higher T_{t_7} to obtain the same thrust output. The T_{t_7}/θ_{t_2} data obtained at the higher thrust levels is questionable, as evidenced by the increase in slope of the curve. The Standard Day Military Thrust (F_n/δ_{t_2} = 9,300 lb = 41,366 nt) turbine exit temperature limit for operation of 30 min is 1660 R (Reference 6) and is shown on the figure. This limit is only 20 R above the level given by the calibration data. This margin is unrealistically too small. Also, since airflow and T_{t_7} determine thrust, it becomes obvious that the T_{t_7} data are inconsistent with the airflow data in the high thrust range. The airflow data discussed earlier in this section were found to be in good agreement with the baseline levels in the high thrust range. Because the T_{t_7} data in this thrust range were questionable, an estimate of the turbine exhaust temperature was computed for the

It should be mentioned that this method of computing T_{t_7} is in concurrence with the methods used by Pratt and Whitney Aircraft. Figure 16 shows that the computed values of T_{t_7}/θ_{t_2} in the moderate thrust range agree very well with the calibration data. The increase in the computed data at the very low thrust level is due to the decrease in burner efficiency occurring at this condition which is not accounted for in the above relationships. At the very high thrust levels, the computer data agree quite well with the baseline data from Reference 6. The previously mentioned change in slope of the curve is not seen in the computed data as is seen in the calibration data. The computed values of T_{t_7}/θ_{t_2} are more representative of the turbine exhaust characteristics in the high thrust range than those values indicated by the calibrations. In reference to the Standard Day Military Thrust level, the computed level of T_{t_7} is 1605 R. This temperature is well within limits in comparison to the 1660 R temperature limit of the engine at this thrust condition.

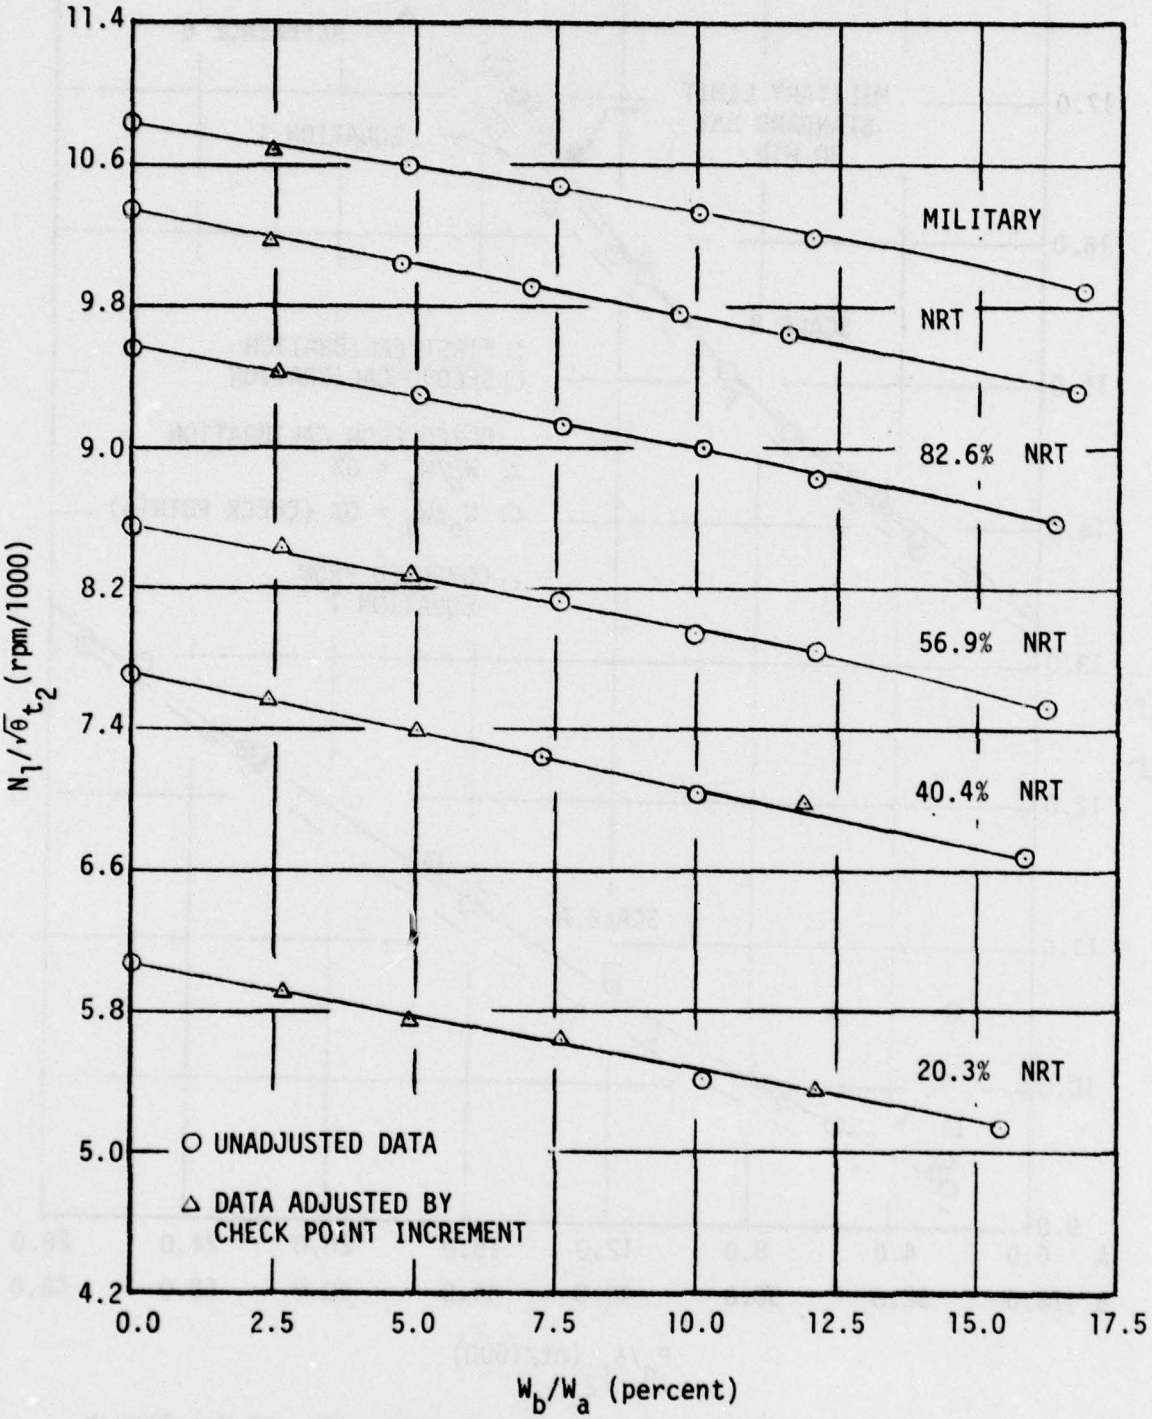
Figure 17 - Low Pressure Compressor-Turbine Unit Speed as a Function of Bleed Flow Extraction Rate

Figure 17 shows the corrected N_1 performance; N_1 is linearly dependent on W_b/W_a throughout the entire thrust range. The slope of the curves indicate that the N_1 penalty is about 60 rpm per percent of bleed flow extraction. In reference to the N_1 penalty associated with W_b, it can be determined by an examination of the airflow data that the N_1 penalty is about 165 rpm/lb (75 rpm/kg) and 452 rpm/lb (205 rpm/kg) for the Military and 20.3 percent NRT conditions, respectively. This is an expected result as an equivalent amount of W_b being extracted at the high thrust condition represents a smaller portion of the working fluid passing through the engine in comparison to the lower thrust conditions and thus results in a reduced N_1 penalty associated with W_b for the high thrust conditions.

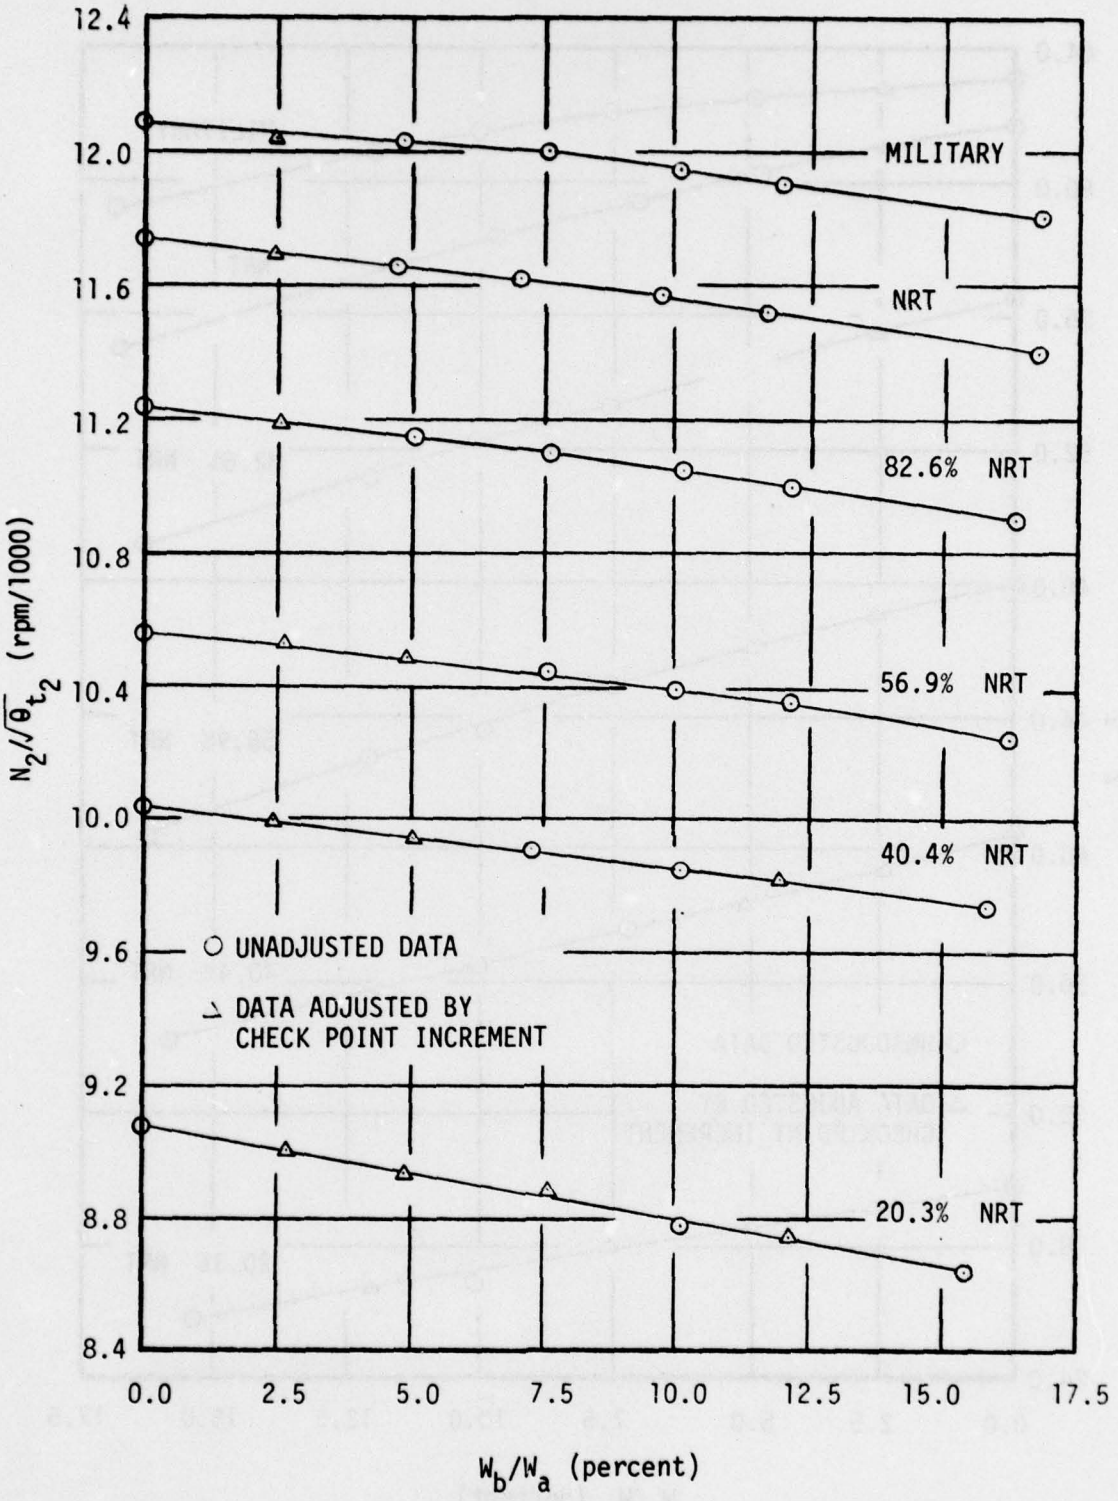
Figure 18 - High Pressure Compressor-Turbine Unit Speed as a Function of Bleed Flow Extraction Rate

The corrected N_2 performance is shown in Figure 18. As in the case of N_1, N_2 is linearly dependent on W_b/W_a. The N_2 penalty associated with W_b/W_a is roughly 23 rpm per percent of bleed flow extraction throughout most of the thrust conditions. At the very low thrust condition, this penalty increases to about 28 rpm per percent; for values of W_b/W_a less than 10 percent at Military Thrust, the penalty decreases to about 12 rpm per percent. This type of behavior is induced by the changing of the droop slope value incorporated into the speed governing system.

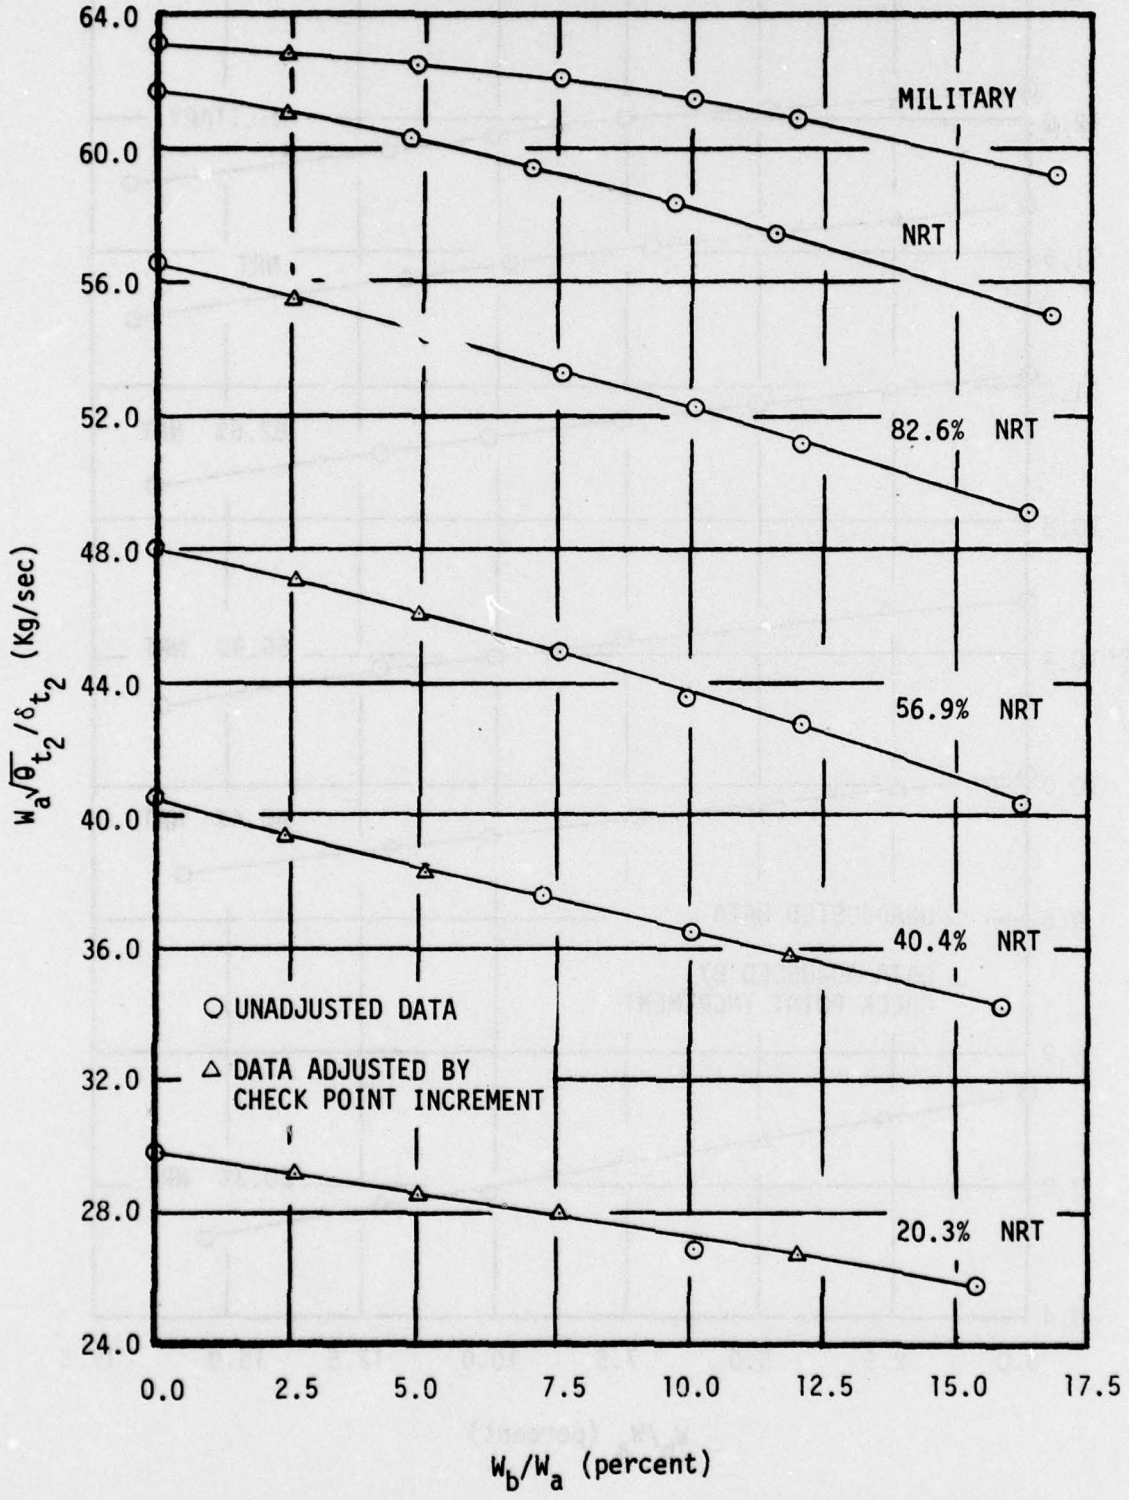
Figure 19 - Engine Airflow as a Function of Bleed Flow Extraction Rate

The corrected airflow performance is given in Figure 19. This parameter decreases linearly with W_b/W_a except at the condition of high thrust and low bleed flow. In this region of operation the penalty in airflow due to W_b/W_a is less severe mainly because the sensitivity of airflow with N_1 and N_2 is reduced. The maximum value of W_b/W_a = 16.84 percent obtained during the bleed flow calibration occurred at the Military Thrust condition where the corresponding maximum $W_b\sqrt{\theta_{t_2}}/\delta_{t_2}$ = 22.01 lb/sec (9.98 kg/sec). As stated in the Introduction, the J52-P-8A is currently limited at this thrust condition to W_b/W_a = 2.5 percent or roughly 15 percent of the amount obtained during the investigation. At NRT the maximum W_b/W_a = 16.77 percent as shown in the figure and represents about a 240-percent increase over the W_b/W_a = 5.0 percent current limitation.

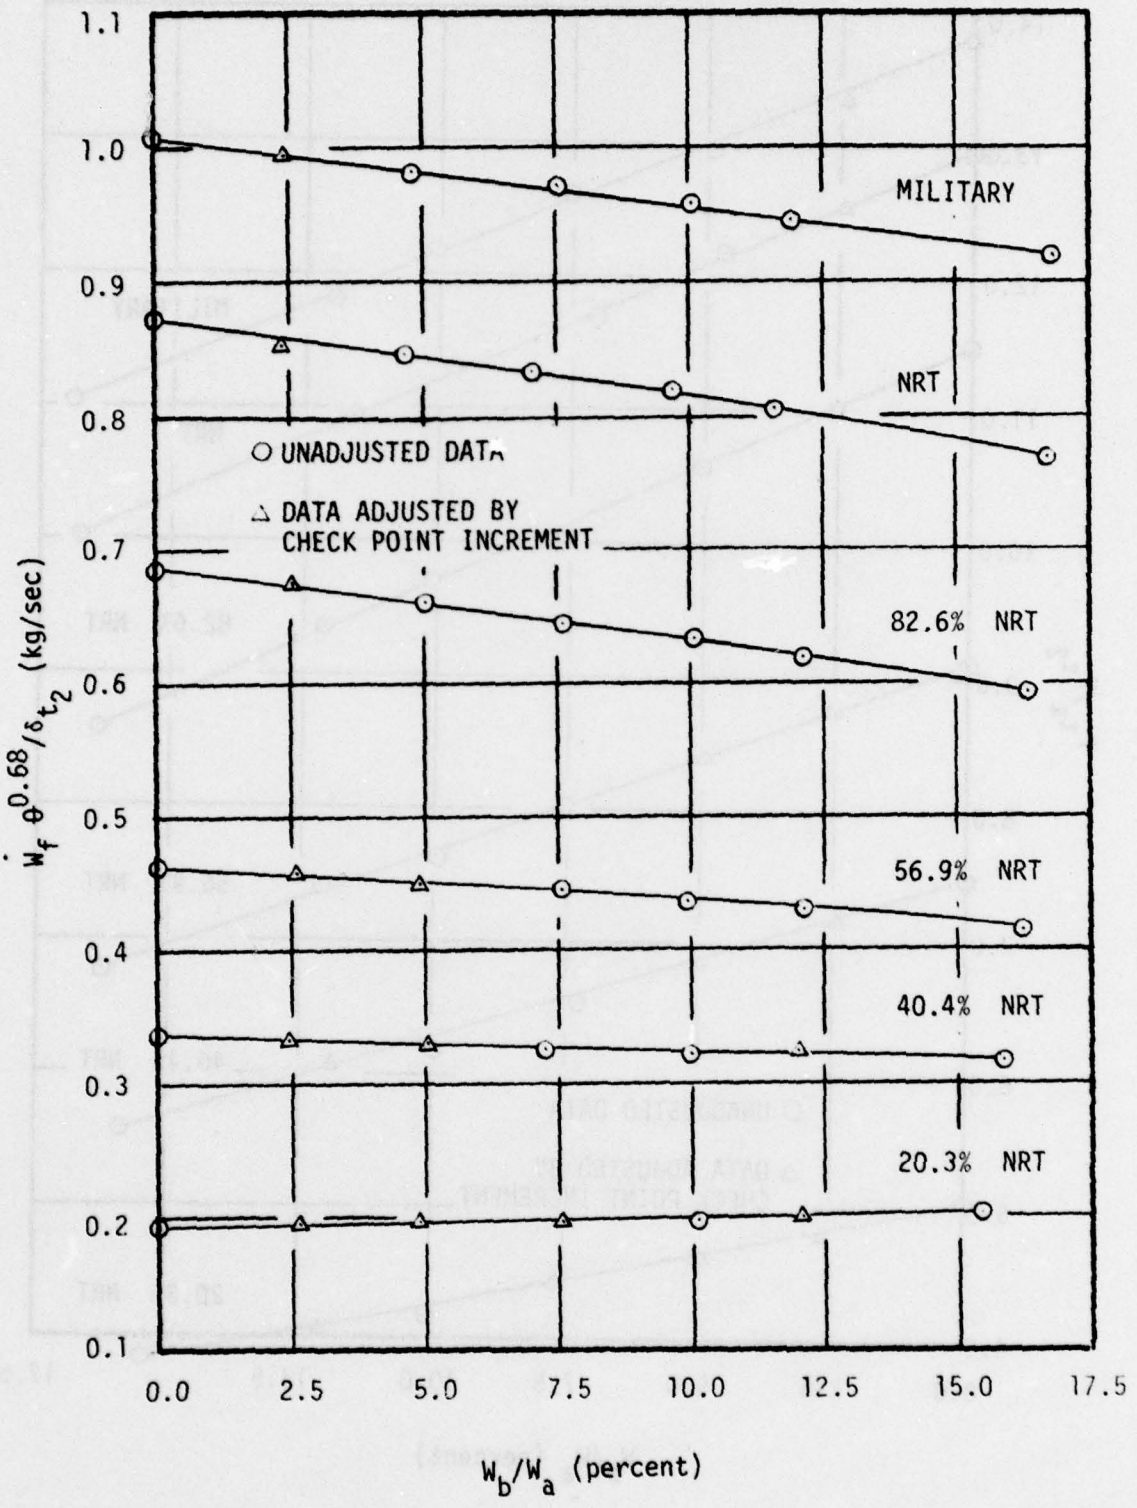
Figure 20 - Fuel Flow Rate as a Function of Bleed Flow Extraction Rate

The corrected fuel flow performance is given in Figure 20. At high thrust levels the fuel flow rate decreases slightly with W_b/W_a. The slope becomes shallower in the moderate thrust range and slightly positive in the low thrust range. This behavior is predominantly governed by N_2, P_{s_b}, and the droop slope. One item of interest is that the specific fuel consumption (sfc) increases significantly with W_b/W_a. This is due to the thrust decreasing noticeably, while the fuel flow is only slightly affected. At the very low thrust condition and W_b/W_a = 0 percent, the sfc = 0.836; whereas, at the maximum W_b/W_a = 15.44 percent, the sfc = 1.415. This difference corresponds to a 69-percent increase in sfc at the low thrust condition. At the Military Thrust condition the sfc = 0.777 and 0.964 for W_b/W_a = 0 percent and 16.84 percent, respectively. At this thrust condition the sfc thus increases by 24 percent due to maximum W_b/W_a.

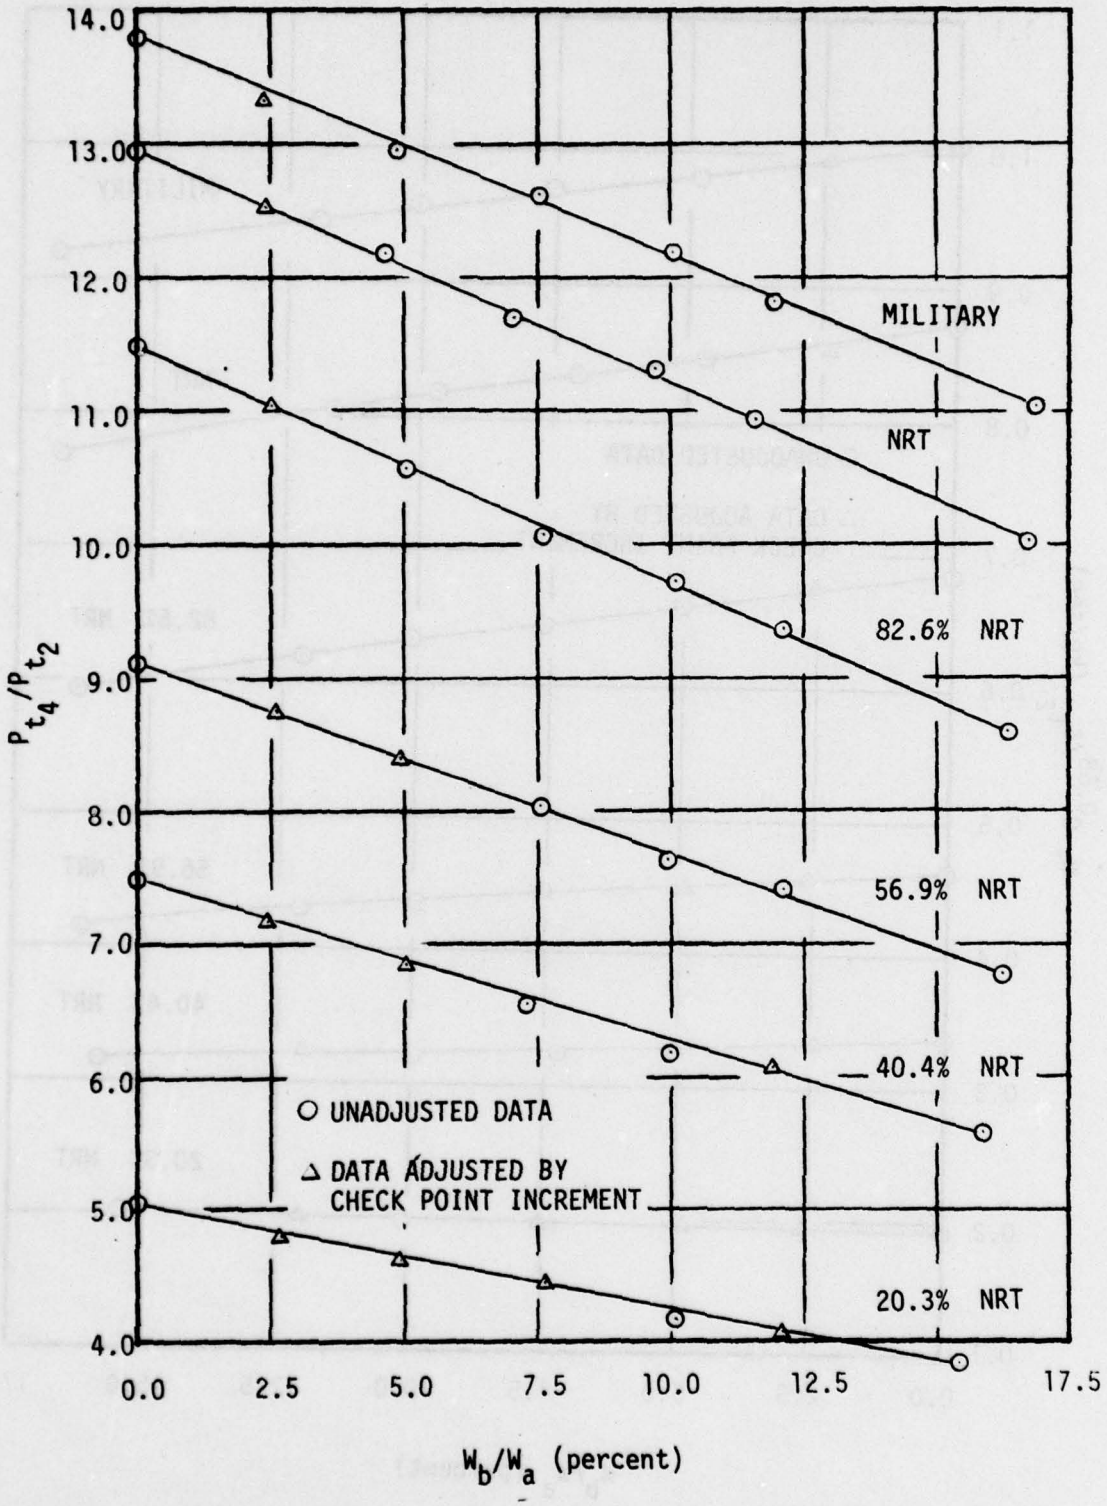
Figure 21 - High Pressure Compressor Discharge Pressure Ratio as a Function of Bleed Flow Extraction Rate

The high pressure compressor discharge pressure ratio characteristics are given in Figure 21. These data also indicate a linear relationship with W_b/W_a. The penalty in performance due to W_b/W_a increases with increased thrust. At the Military Thrust condition and maximum W_b/W_a, the pressure

ratio drops by 20-percent to 11.05 from the value of 13.8 at W_b/W_a = 0 percent. At the very low thrust condition the pressure ratio decreases from a value of 5.05 at W_b/W_a = 0 percent to 3.80 at maximum W_b/W_a. This corresponds to a 25-percent decrease in performance for the low thrust setting.

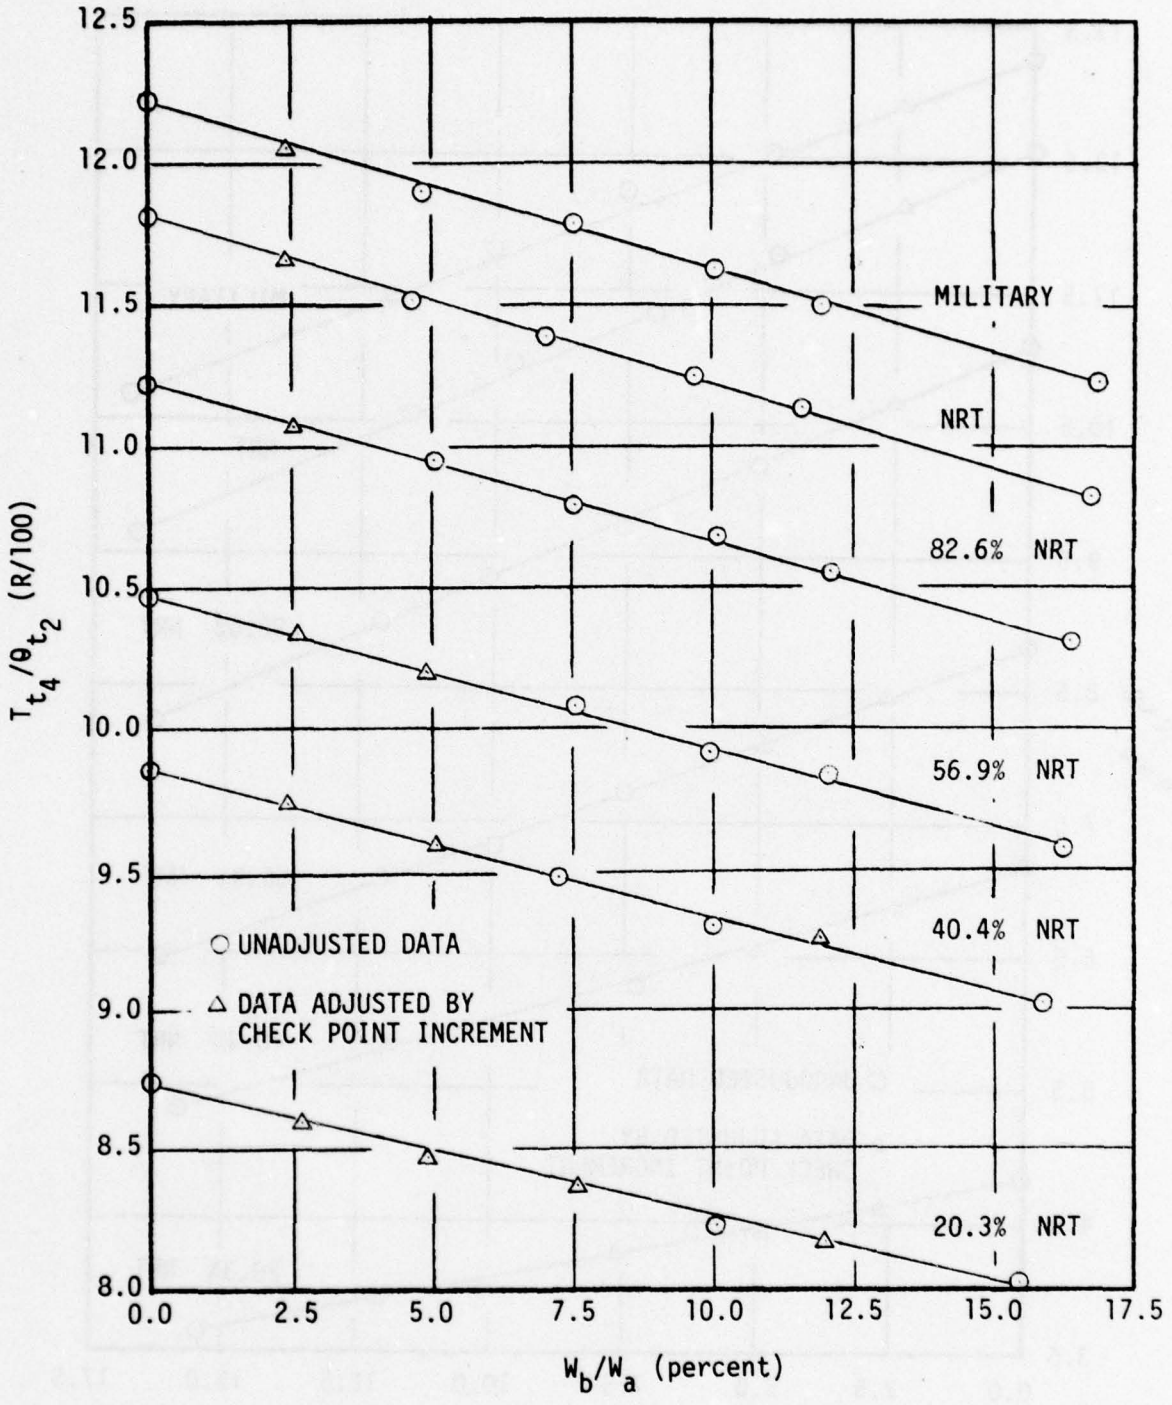
Figure 22 - High Pressure Compressor Discharge Temperature as a Function of Bleed Flow Extraction Rate

The corresponding high pressure compressor discharge temperature characteristics are shown in Figure 22. These data again exhibit a linear dependence on W_b/W_a with the sensitivity increasing with thrust setting. At the low thrust condition, T_{t_4}/θ_{t_2} drops from 873 R at W_b/W_a = 0 percent to 802 R at the maximum W_b/W_a = 15.44 percent. At the Military Thrust condition, T_{t_4}/θ_{t_2} drops from 1220 R at W_b/W_a = 0 percent to 1120 R at maximum W_b/W_a = 16.84 percent.

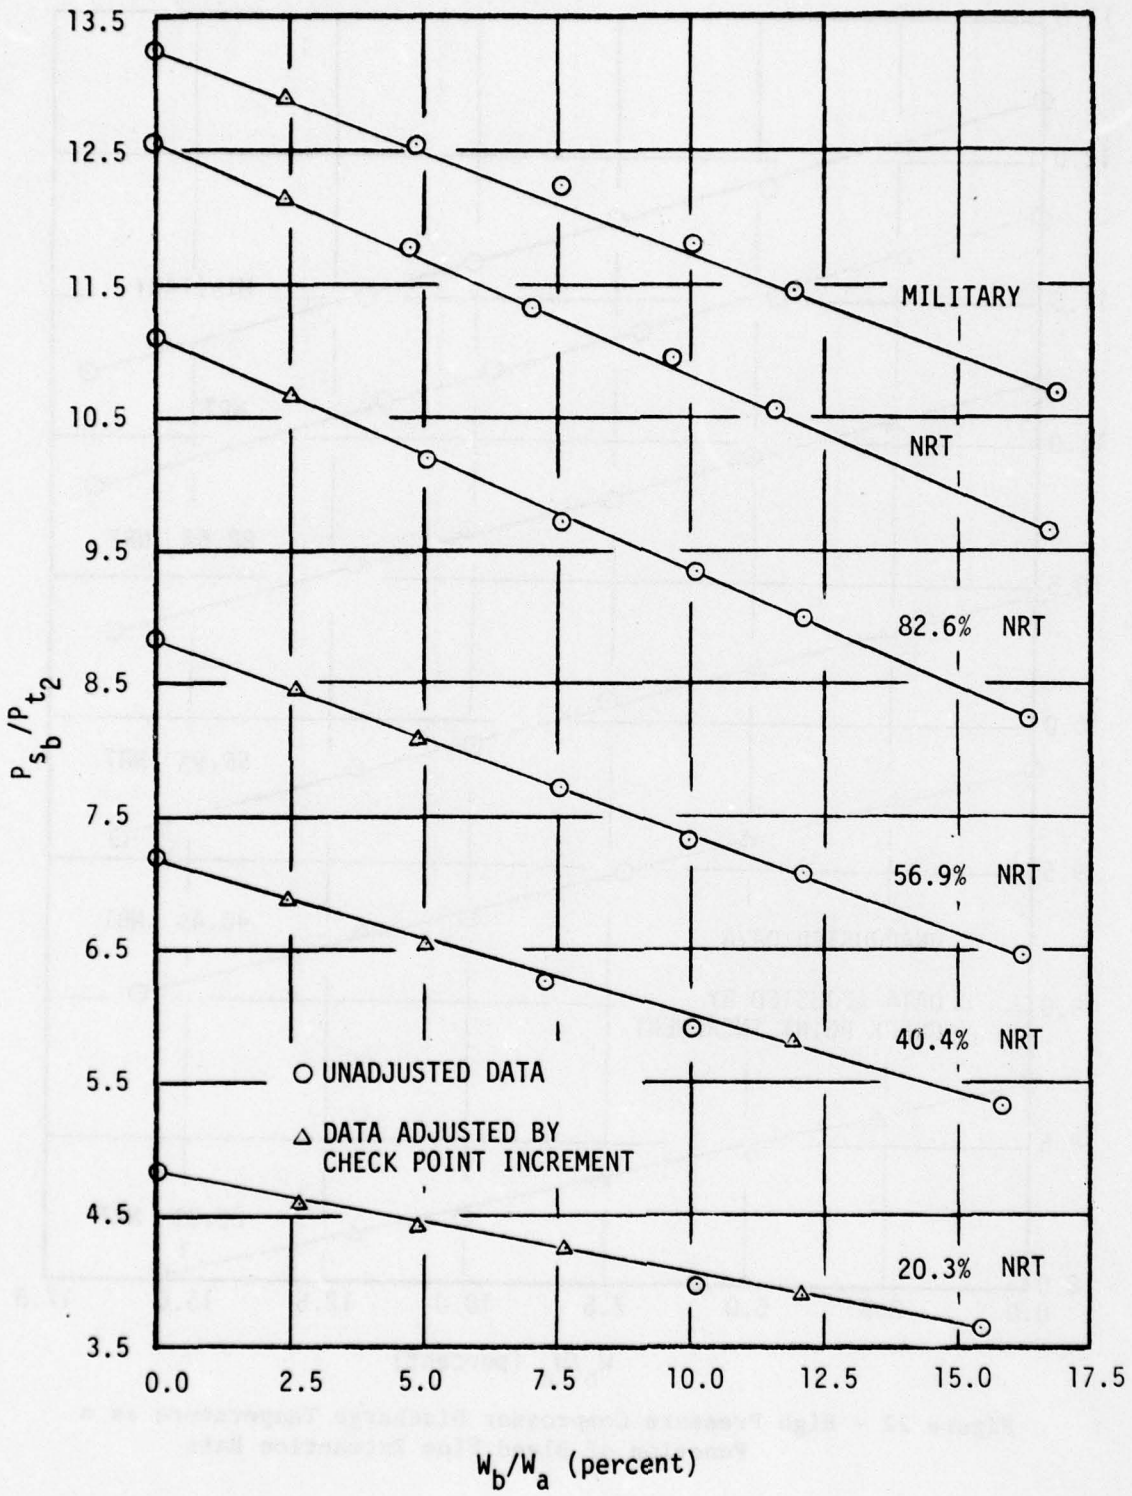
Figure 23 - Burner Static Pressure Ratio as a Function of Bleed Flow Extraction Rate

Figure 23 presents the burner static pressure ratio characteristics. Here again a linear dependence on W_b/W_a is seen throughout the thrust range. The burner pressure decreases by 20 percent at the Military Thrust condition due to maximum bleed flow, as evidenced by P_{s_b}/P_{t_2} = 13.25 and 10.65 for W_b/W_a = 0 percent and maximum W_b/W_a, respectively. At the low thrust condition, P_{s_b}/P_{t_2} = 4.82 and 3.62 for W_b/W_a = 0 percent and maximum W_b/W_a, respectively. This corresponds to a 33-percent decrease in burner static pressure.

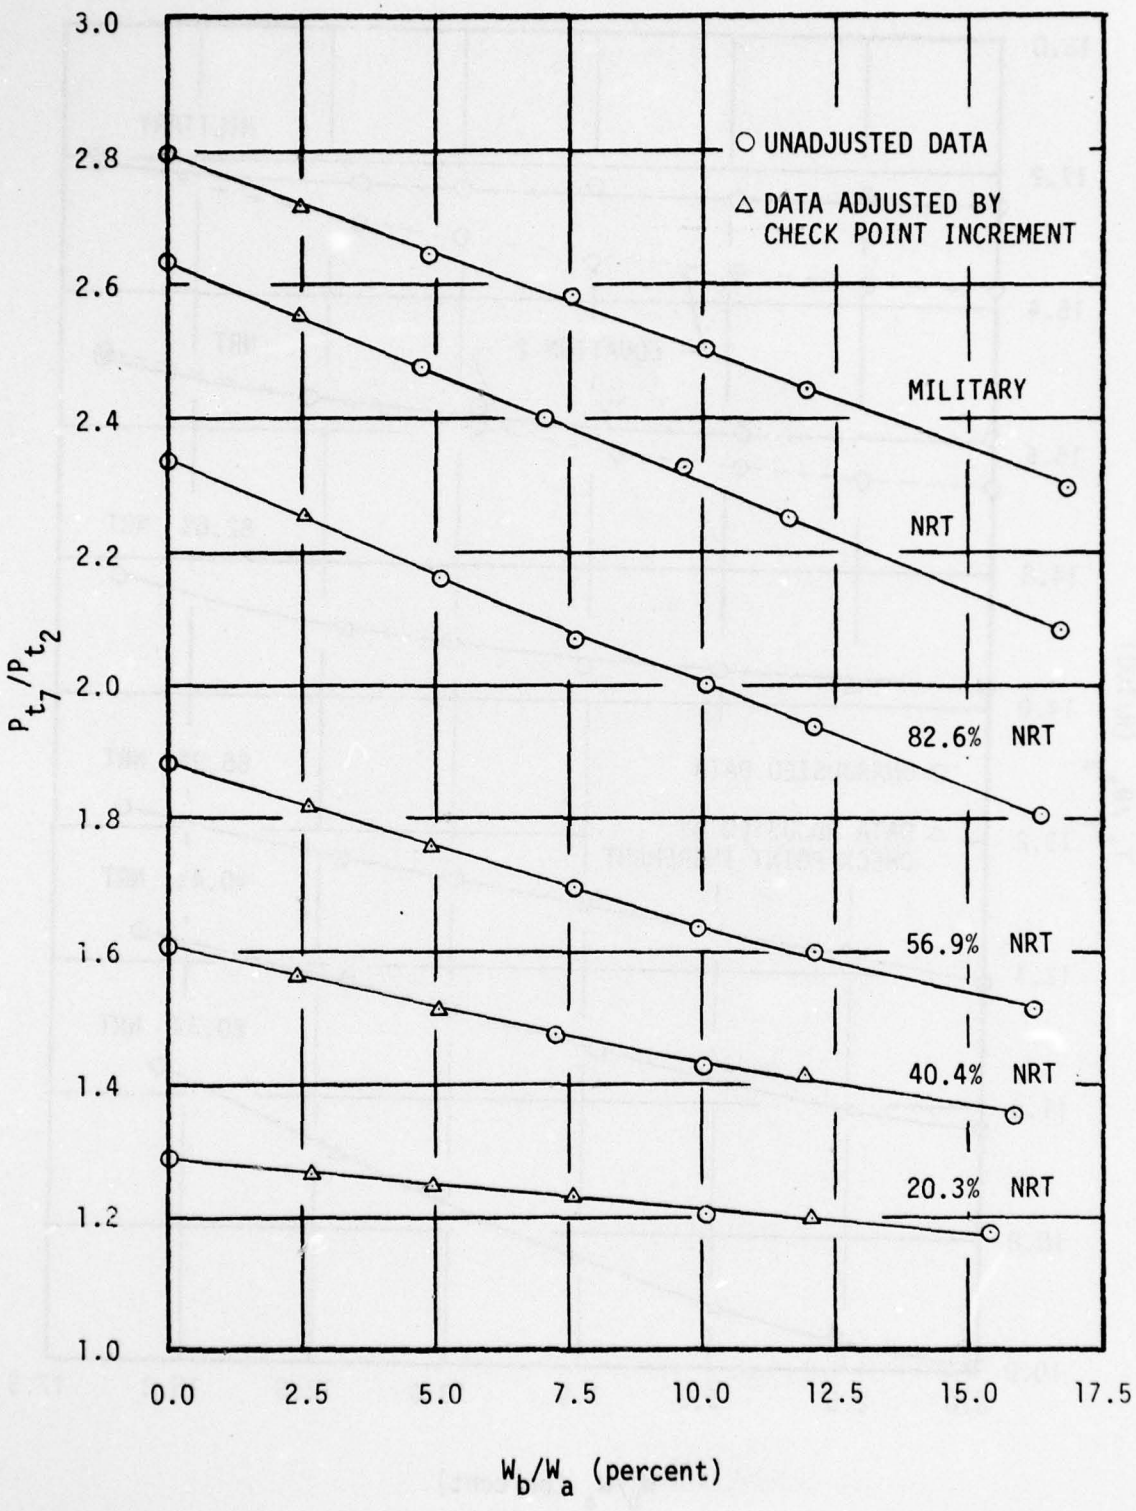
Figure 24 - Turbine Exit Pressure Ratio as a Function of Bleed Flow Extraction Rate

The turbine exhaust pressure ratio characteristics are shown in Figure 24. At NRT and Military Thrust the curves appear to be linear with W_b/W_a. At the Military Thrust condition the P_{t_7}/P_{t_2} drops by 18 percent from 2.79 at W_b/W_a = 0 percent to 2.29 at maximum W_b/W_a. At NRT the corresponding drop in P_{t_7}/P_{t_2} due to maximum W_b/W_a is computed to be 22 percent. The decrease in the performance penalty at Military Thrust is due to the increase in the droop slope of the speed governing system. In the moderate thrust range the curves show a tendency to become less sensitive to W_b/W_a

at large W_b/W_a, and at the low thrust condition the variation in P_{t_7}/P_{t_2} becomes linear again throughout the W_b/W_a range.

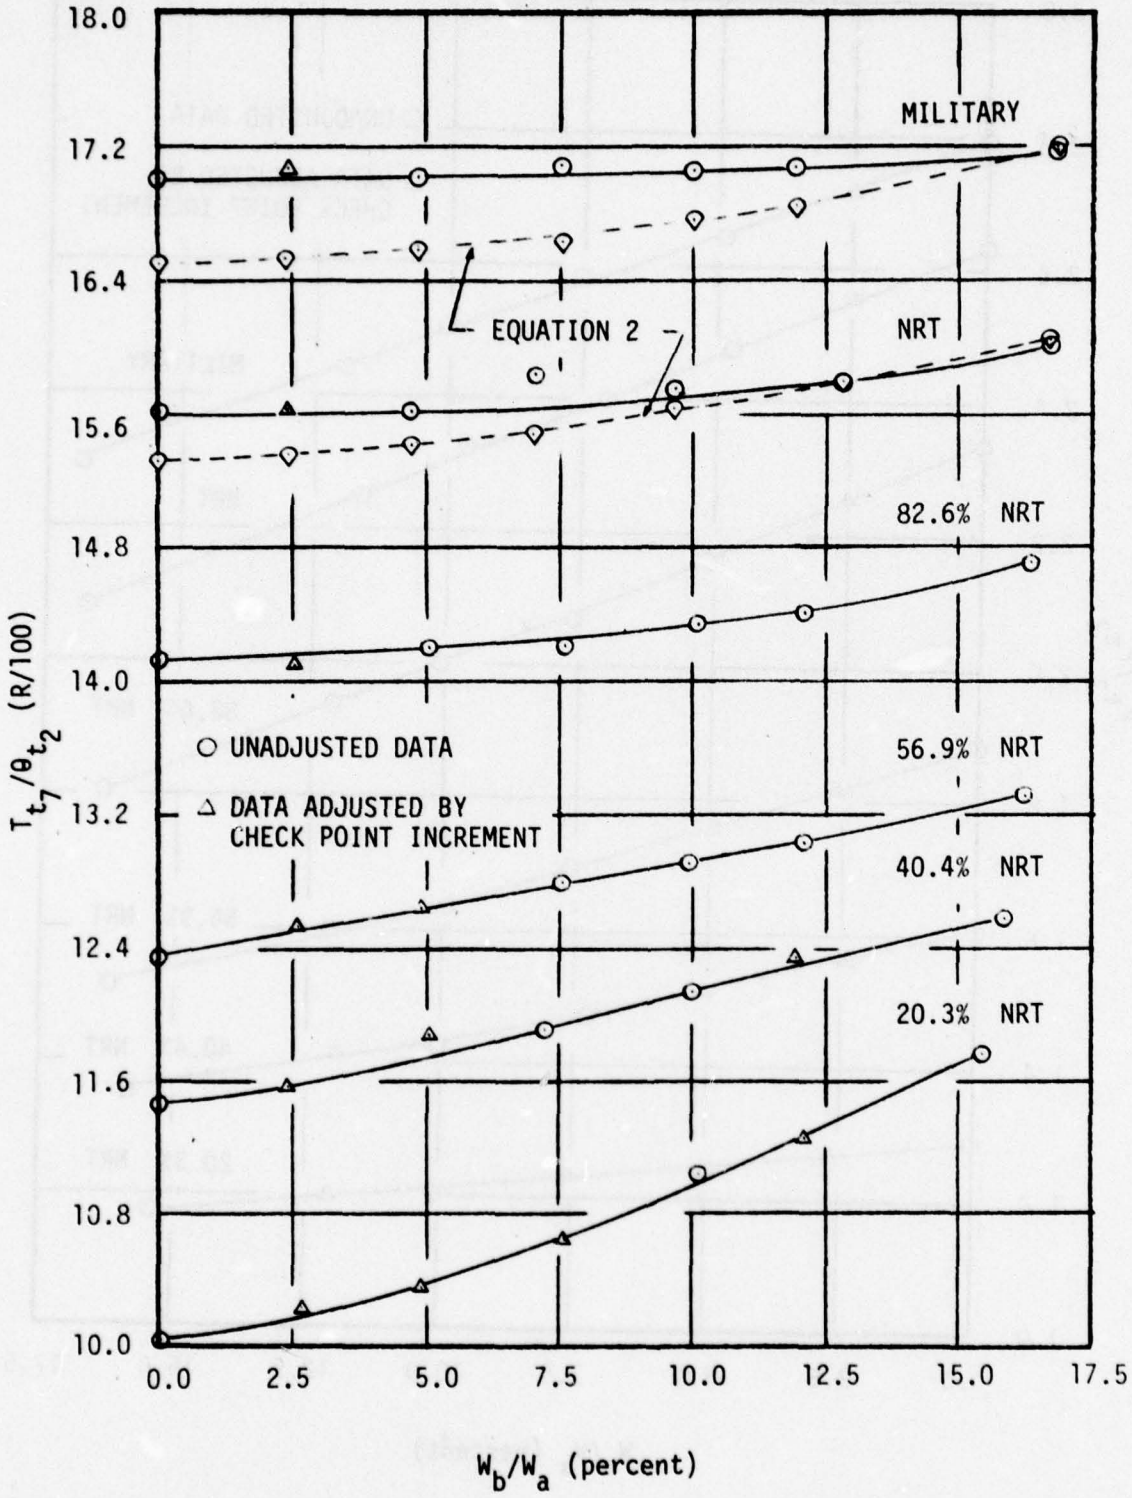
Figure 25 - Turbine Exit Temperature as a Function of Bleed Flow Extraction Rate

The turbine exhaust temperature characteristics are shown in Figure 25. At low thrust settings, T_{t_7}/θ_{t_2} increases with W_b/W_a. This trend is predominantly governed by the increase in fuel-to-air ratio induced by W_b/W_a at these low thrust settings. In this figure the T_{t_7}/θ_{t_2} characteristics have been computed at the NRT and Military Thrust conditions. The data taken during the bleed flow calibration are shown in the figure for these two thrust settings but are questionable. This aspect was discussed in the Basic J52-P-8A Engine Calibration Results section. The computed characteristics are more representative of the actual temperatures occurring at the turbine exit station. The computed performance levels were calculated by using the previously mentioned energy balance equation modified to account for bleed flow being taken from the engine:
