AN INVESTIGATION OF THE PERFORMANCE OF A J52-P-8A ENGINE OPERATING UNDER THE INFLUENCE OF HIGH BLEED FLOW EXTRACTION RATES.

(14) DTNSRDC/ASED-387

(11) August 1977

DAVID W. TAYLOR NAVAL SHIP RESEARCH AND DEVELOPMENT CENTER

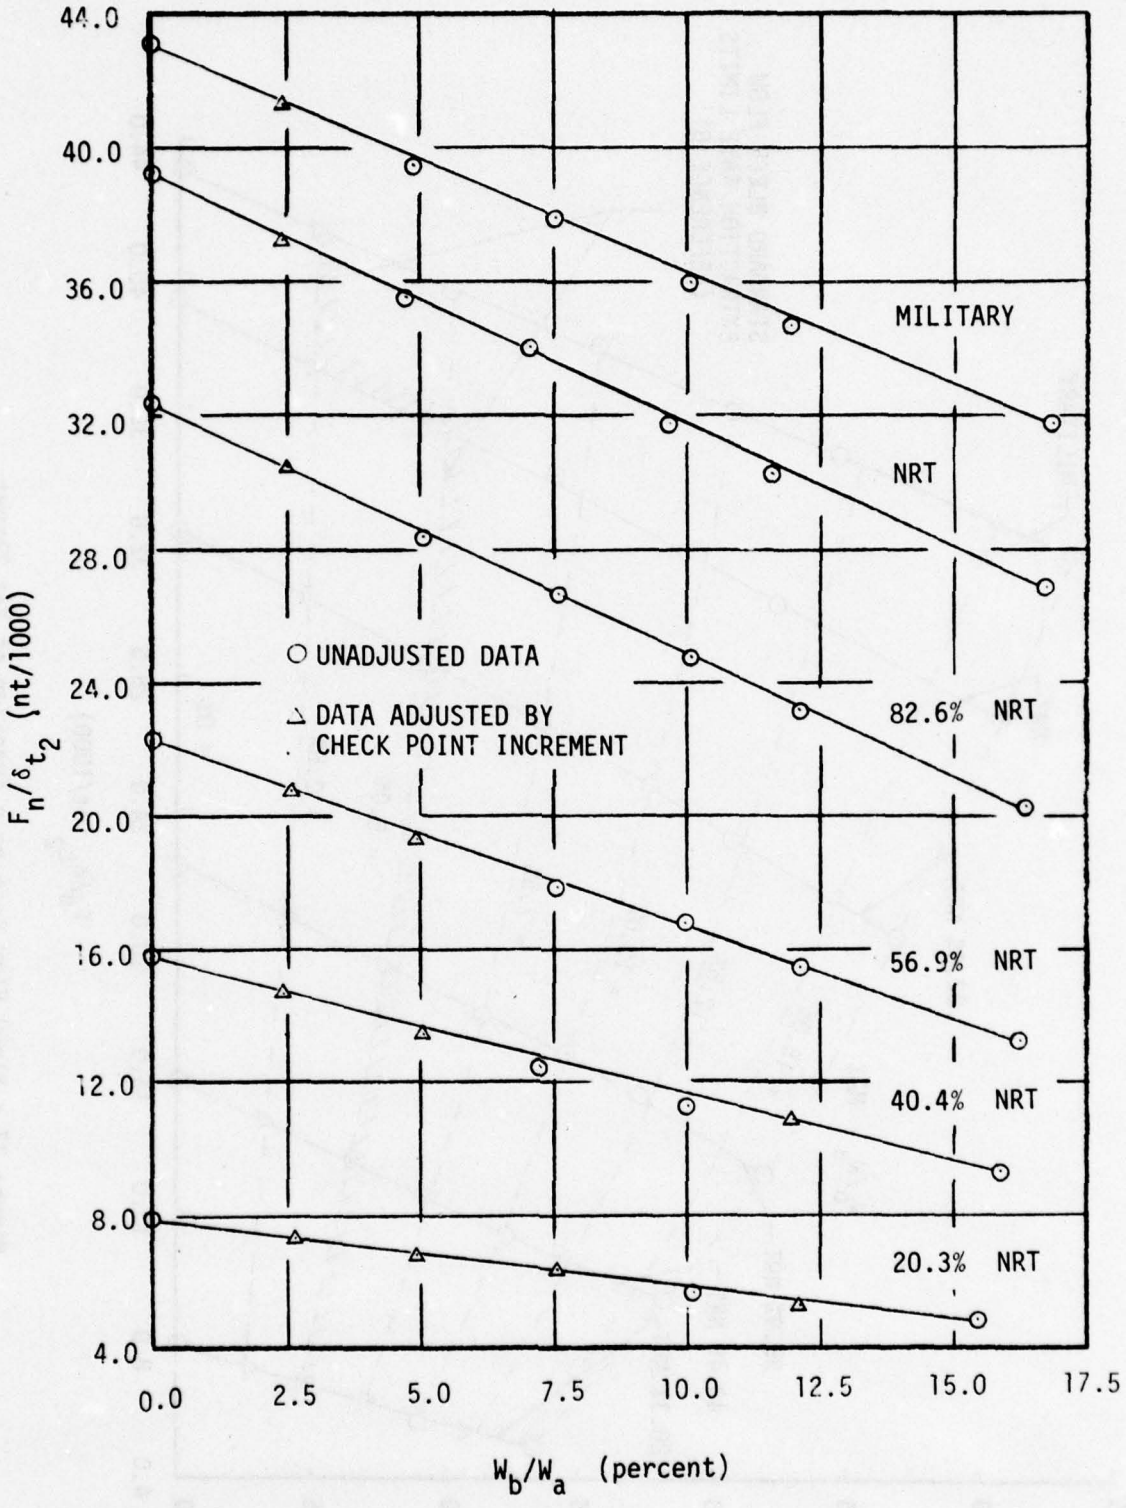
Figure 26 - Net Thrust as a Function of Bleed Flow Extraction Rate

Figure 26 shows the variation in thrust performance with W_b/W_a. At the Military Thrust condition, the thrust decreases from 9,700 lb (43,150 nt) at W_b/W_a = 0 percent to 7,140 lb (31,759 nt) at maximum W_b/W_a. The

associated maximum $W_b\sqrt{\theta}_{t_2}/\delta_{t_2}$ = 22.01 lb/sec (9.98 kg/sec). For an inlet temperature of 38 F, this value corresponds to W_b/δ_{t_2} = 22.45 lb/sec (10.19 kg/sec). The associated thrust loss is 2,560 lb (11,391 nt), and the associated thrust penalty due to W_b/W_a is computed to be 114 lb sec/lb (1,117 nt sec/kg). By the same methodology, the thrust penalty at the NRT condition increases to 135 lb sec/lb (1,320 nt sec/kg); at the very low thrust setting, the penalty decreases to 76 lb sec/lb (744 nt sec/kg). The thrust penalty being larger at NRT than at Military Thrust is primarily due to the reduced level of droop slope at the NRT condition. The significant reduction in the penalty at the very low thrust setting is due to the large increase in T_{t_7} with W_b/W_a as shown in Figure 25.

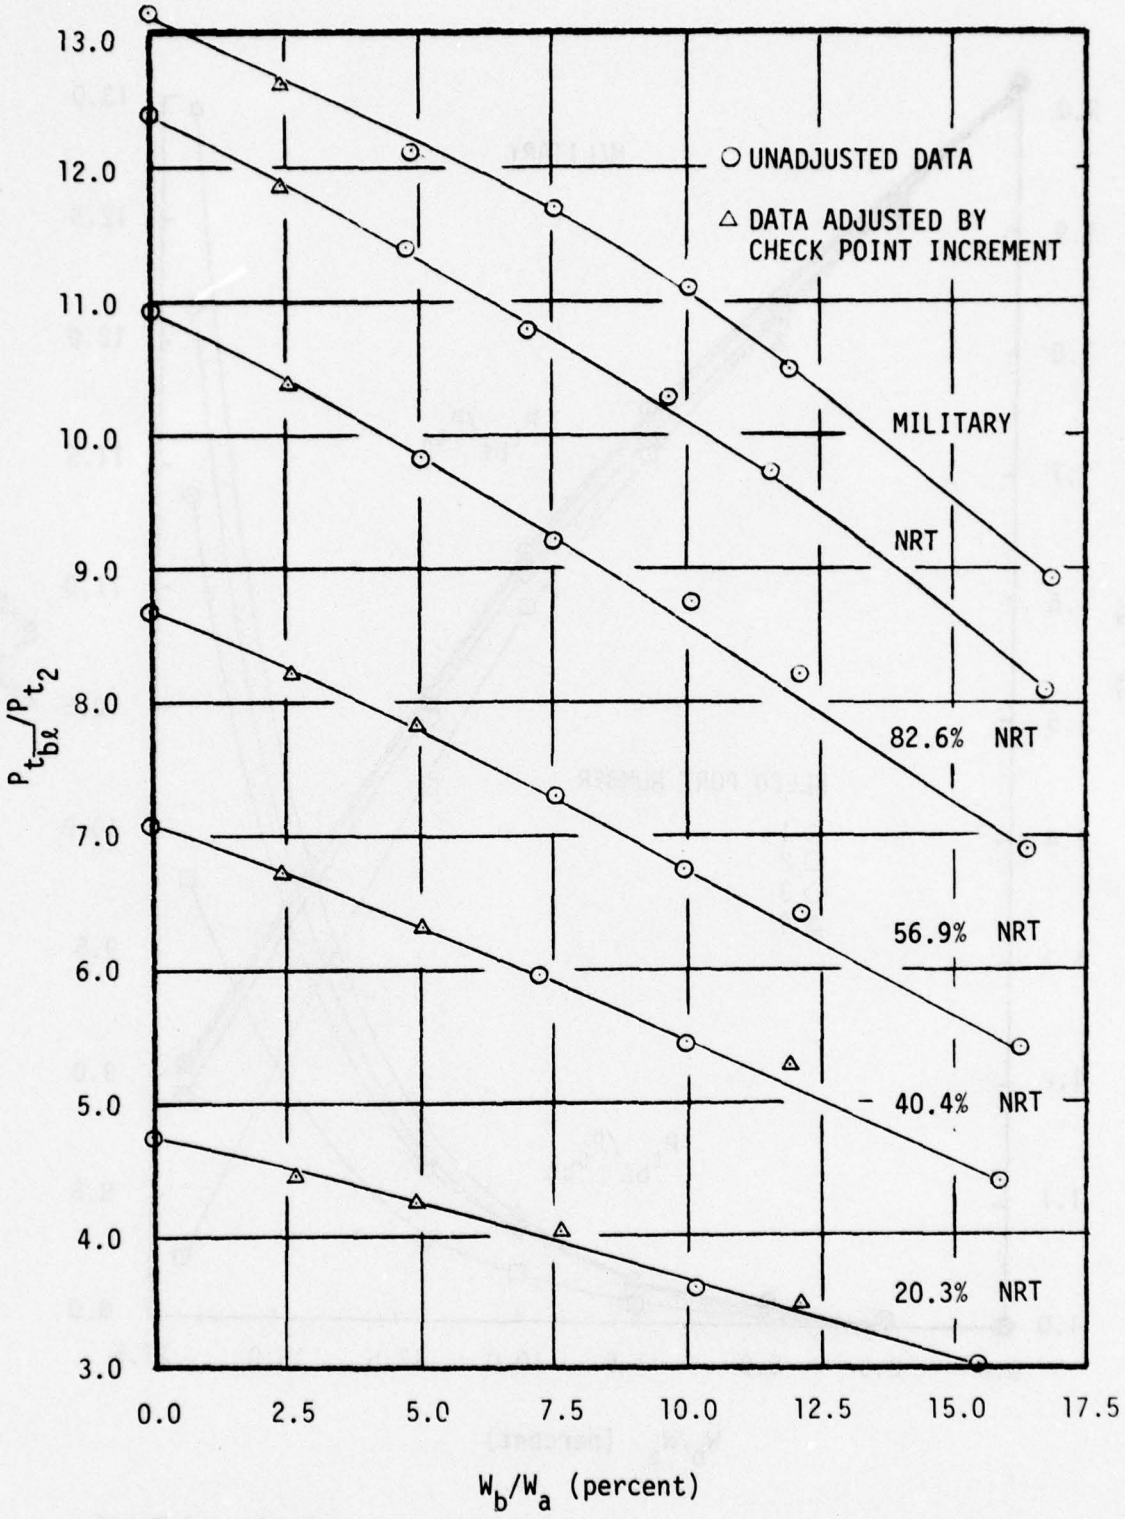
Figure 28 - Average Bleed Port Total Pressure Ratio as a Function of Bleed Flow Extraction Rate

Figure 28 presents the bleed port total pressure ratio. As can be seen, $P_{t_{b\ell}}/P_{t_2}$ reduces from 13.1 at W_b/W_a = 0 percent to 8.9 at maximum W_b/W_a for the Military Thrust condition. This corresponds to a 32-percent decrease in pressure for this thrust condition. The pressure drop through the bleed ports is found with the aid of Figure 21, which presents the high pressure compressor discharge pressure. At Military Thrust with W_b/W_a = 0 percent, the associated P_{t_4}/P_{t_2} = 13.8 while $P_{t_{b\ell}}/P_{t_2}$ = 13.1. This corresponds to a 5-percent loss in pressure external to the bleed ports. At the maximum W_b/W_a for this thrust condition, P_{t_4}/P_{t_2} = 11.05 while $P_{t_{b\ell}}/P_{t_2}$ = 8.9. This corresponds to a 20-percent loss in pressure as the flow passes through the ports. The pressure levels shown in Figure 28 represent adequate levels (Reference 5) for the bleed flow system to be used on the Flight Demonstrator.

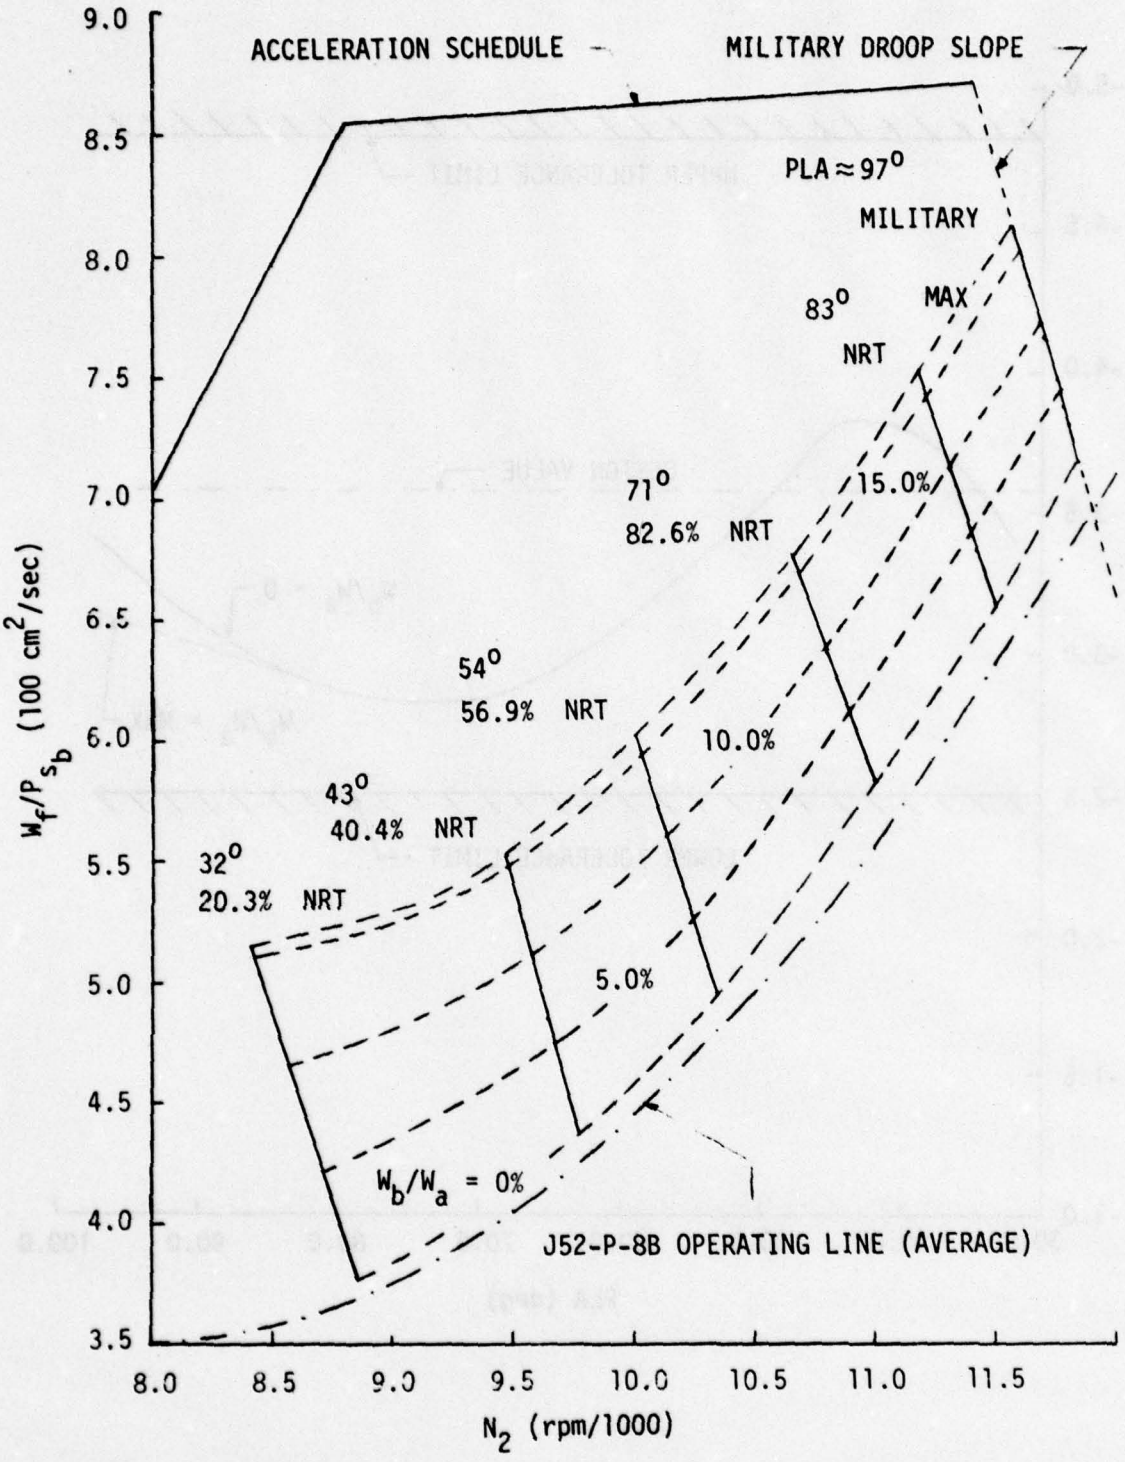
Figure 34 - Steady State Operating Line Performance as a Function of Bleed Flow Extraction Rate

Figure 34 shows the performance and operating characteristics of the fuel controller. The figure presents the ratio of W_f to P_{s_b} as a function of N_2 for various values of W_b/W_a. These data were generated from the uncorrected data taken during the bleed flow calibration. The dashed lines represent the steady state operating conditions; as shown in the figure, the operating line shifts upward with increased W_b/W_a. This upward shift of the operating line is indicative of a deterioration in engine efficiency. Also shown is the steady state operating line of a typical production line J52-P-8B engine. These particular data were supplied through the courtesy of Pratt and Whitney Aircraft. Valid comparisons of these data with those obtained during the investigation can be made since the difference between the J52-P-8A and the J52-P-8B engines is that the J52-P-8B engine incorporates the use of smokeless burner cans. However, these cans do not affect the engine operating line performance. This operating line is somewhat lower than the corresponding one for no bleed flow extraction as determined from the investigation indicating that there is some slight deficiency in the performance of the engine used for this investigation.

The dependence of the steady state operating line performance on W_b/W_a is attributable to the operation of the fuel control and speed governing systems. If the engine is being operated at a steady state condition and W_b/W_a is changed, the engine experiences a change in burner pressure and rotor speed such that the rotor speed has a linear dependence on the change in the ratio of fuel flow to burner pressure. Thus, a new steady state operating condition is determined. The linear dependence described above is the speed governer droop slope (D_S) and is mathematically defined as:

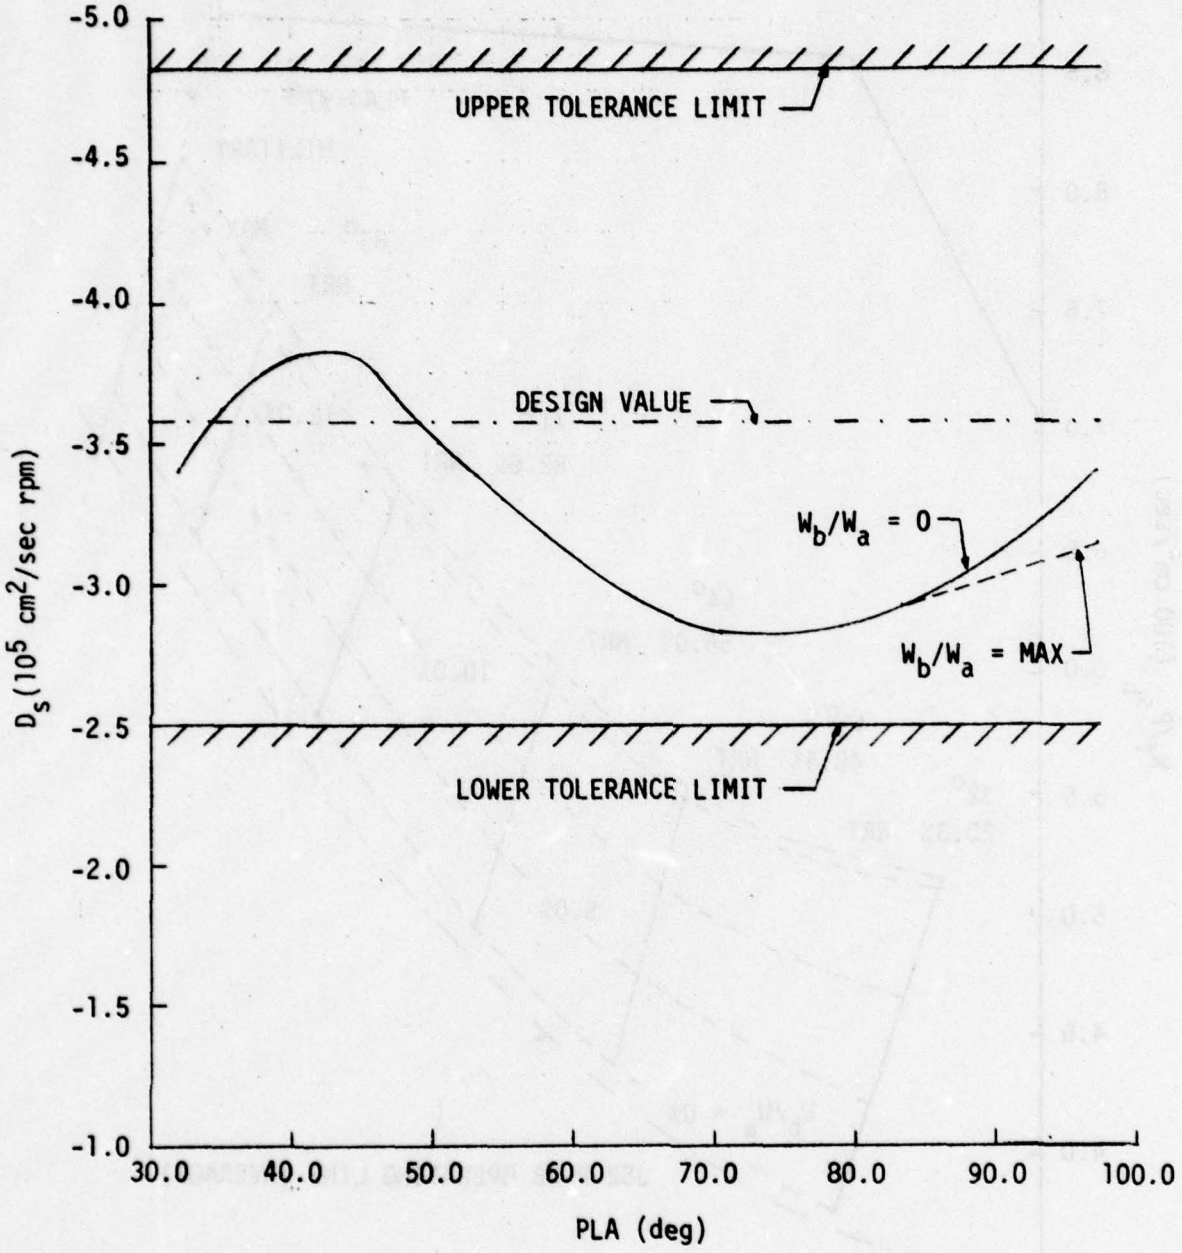
Figure 35 - Speed Governer Droop Slope Performance

Figure 35 presents the variation in D_S as a function of PLA for the zero and maximum bleed flow extraction rate conditions. These data, derived from Figure 34, indicate that D_S deviates substantially from its design value. The maximum deviation is approximately 20 percent and occurs at about 80 percent NRT (PLA $\simeq$ 73 deg). The upper and lower tolerance limits for D_S are shown for comparison and are within limits. No change in D_S occurs due to W_b/W_a at thrust levels less than NRT; but at higher thrust levels, D_S decreases slightly at the maximum W_b/W_a. This trend is due to the steady state operating line at these conditions approaching the engine acceleration schedule. The decrease in D_S at these conditions tends to increase the N_2 drop associated with W_b/W_a. This, in turn, results in a larger thrust penalty associated with high W_b/W_a in comparison to lower values.

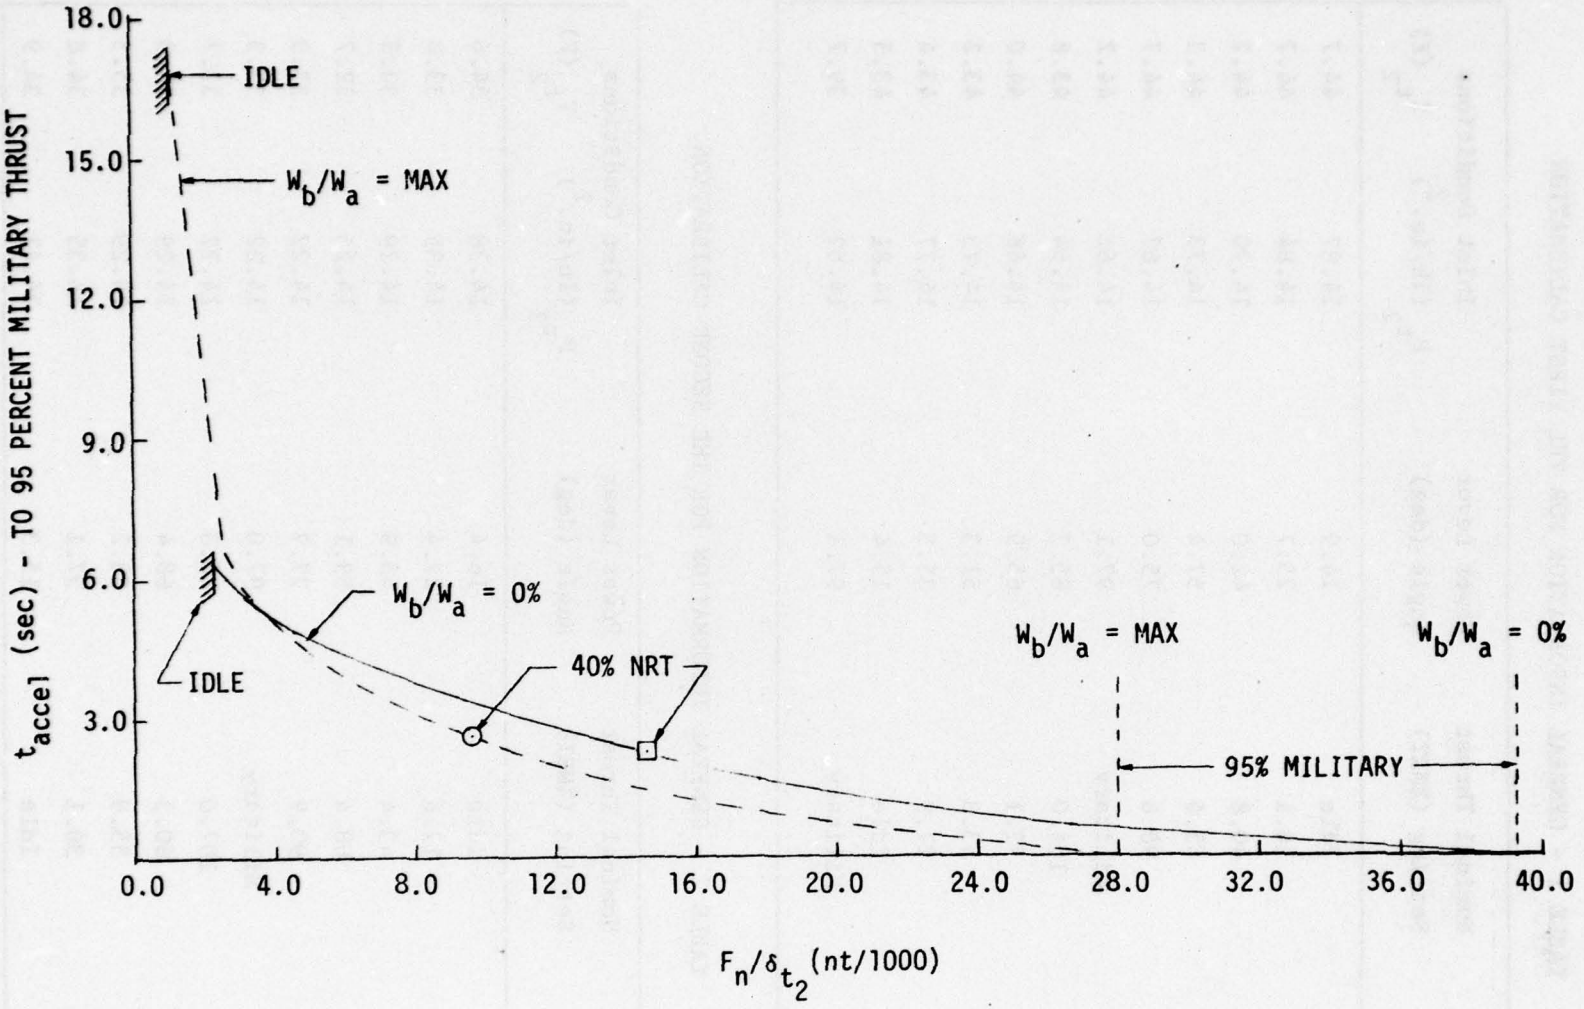
Figure 36 - J52-P-8A Engine Acceleration Performance with Zero and Maximum Bleed Flow

Results of the engine accelerating performance are shown in Figure 36. This figure presents the time required to accelerate from a given thrust level to 95 percent Military Thrust. The specific conditions investigated were the acceleration times from idle with no bleed flow and maximum bleed flow and from 40 percent NRT with maximum bleed flow. These three data points are shown in the figure. Each data point represents the numerical average of three successive engine acceleration runs. In the case of the maximum bleed flow acceleration runs, the thrust levels shown represent the thrust based on the standard day Military Thrust and NRT levels with maximum bleed flow. These values are obtainable from Figures 32 or 33 where the standard day NRT and Military Thrust levels are F_n/δ_{t_2} = 5,396 lb (24,000 nt) and 6,632 lb (29,500 nt), respectively, at the maximum bleed flow condition. The baseline acceleration performance from Idle to the required level is 6.3 sec. The datum point, denoted by a square symbol, is the corresponding acceleration time from 40 percent NRT as supplied by Pratt and Whitney Aircraft. The acceleration time of 6.3 sec from Idle is in agreement with the information supplied by the engine manufacturer. The data taken at maximum W_b/W_a show a drastic increase to 16.7 sec in the acceleration time at the Idle condition. At the 40-percent NRT condition the acceleration time is 2.6 sec, which is only slightly longer than the corresponding case with no bleed flow.
