PASSAIC RIVER BASIN

BEAR SWAMP LAKE
DAM NO. 1

PHASE I INSPECTION REPORT
NATIONAL DAM SAFETY PROGRAM

AUGUST 1978

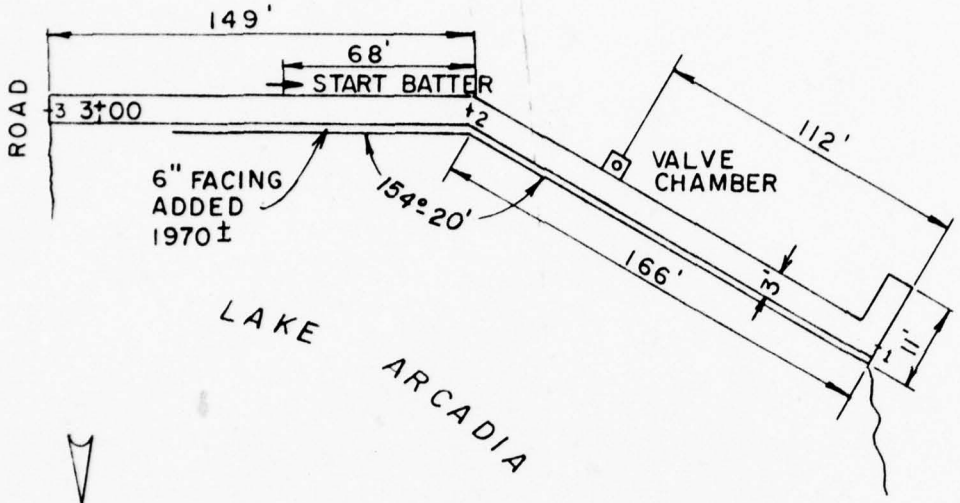
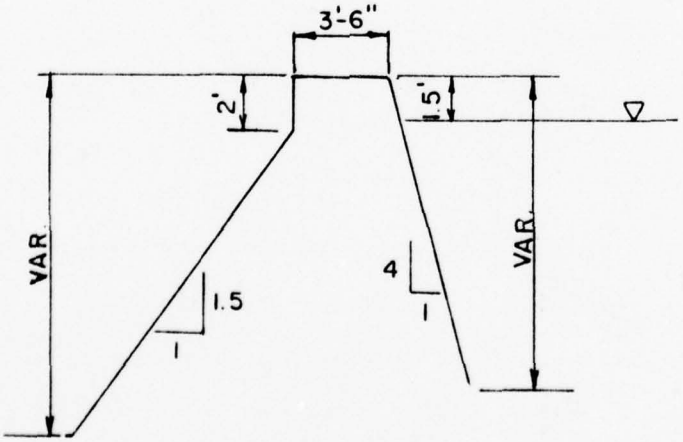
HARRIS - ECI - ASSOCIATES		
BEAR SWAMP LAKE DAM # 1		
FIELD INSPECTION SKETCH		
D.J.K	6-27-78	1 OF 1

TYPICAL SECTION
0+00 TO 2+34

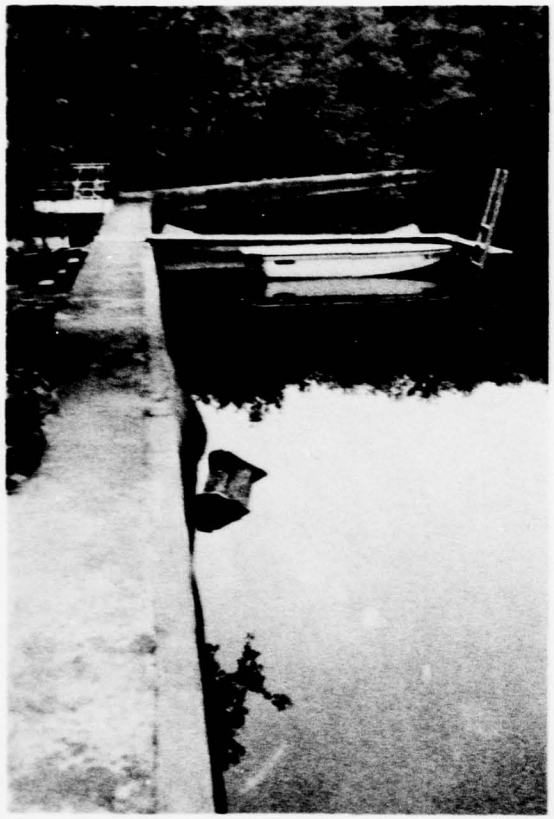
Photo 2 - View of dam from upstream left shoreline.

Photo 3 - View of dam crest from left abutment showing repair slab on upstream.

Photo 4 - View of downstream face and valve chamber showing leakage deposits.

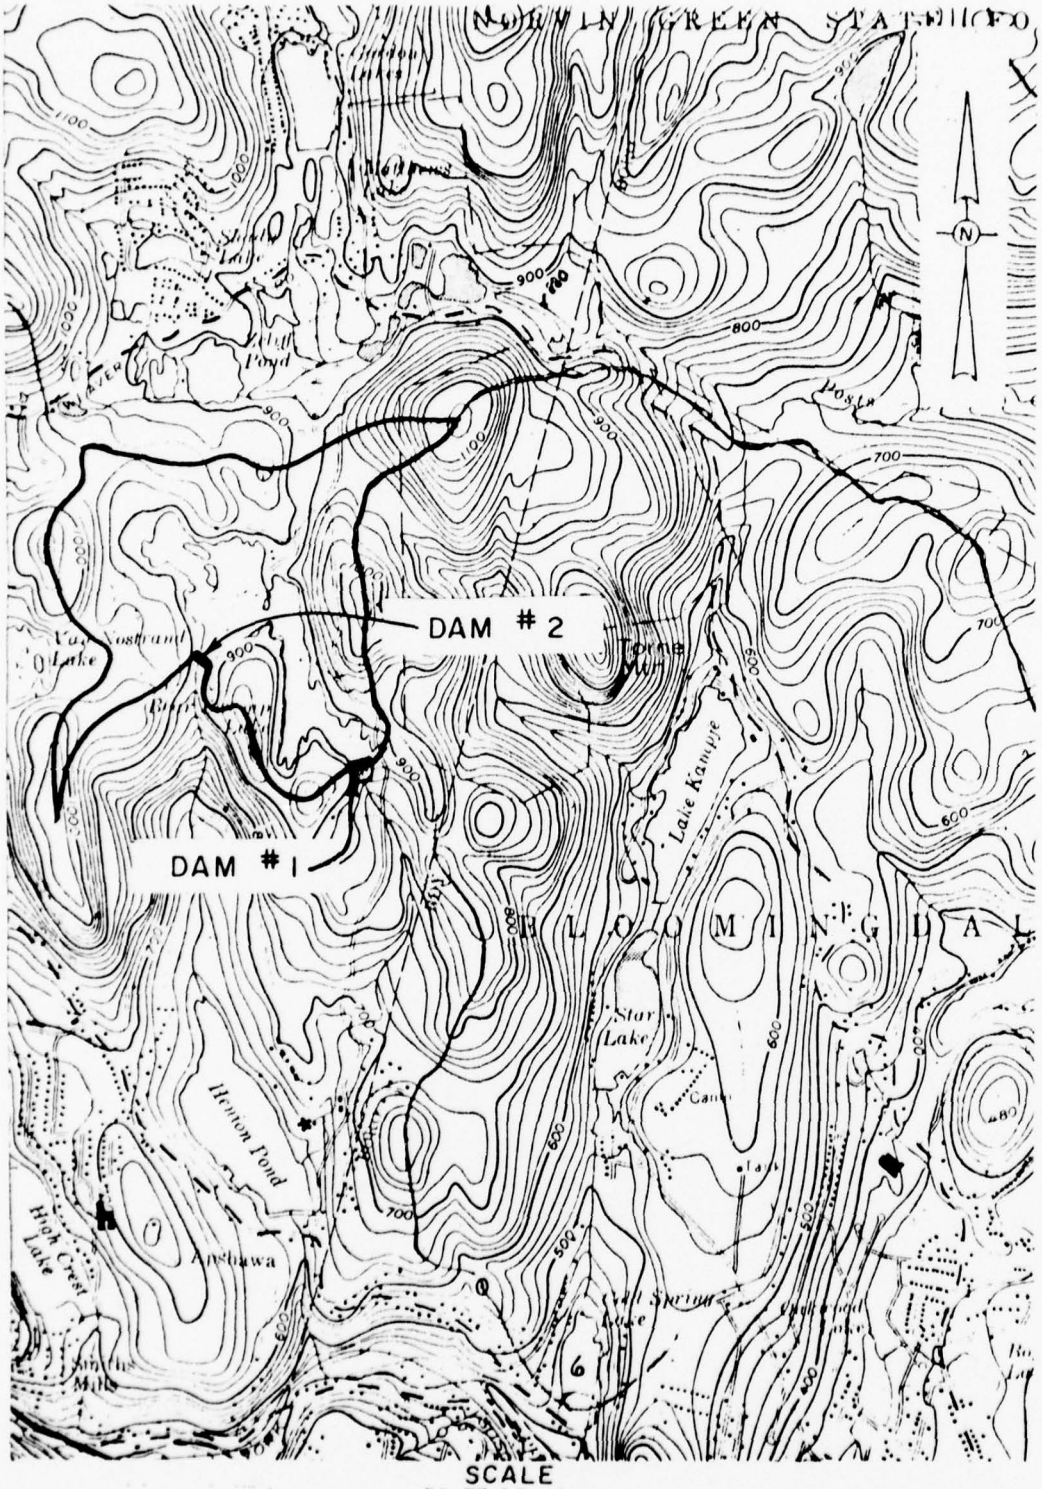
PLATE I APPENDIX D

BEAR SWAMP LAKE DAMS #1 & #2
DRAINAGE MAP

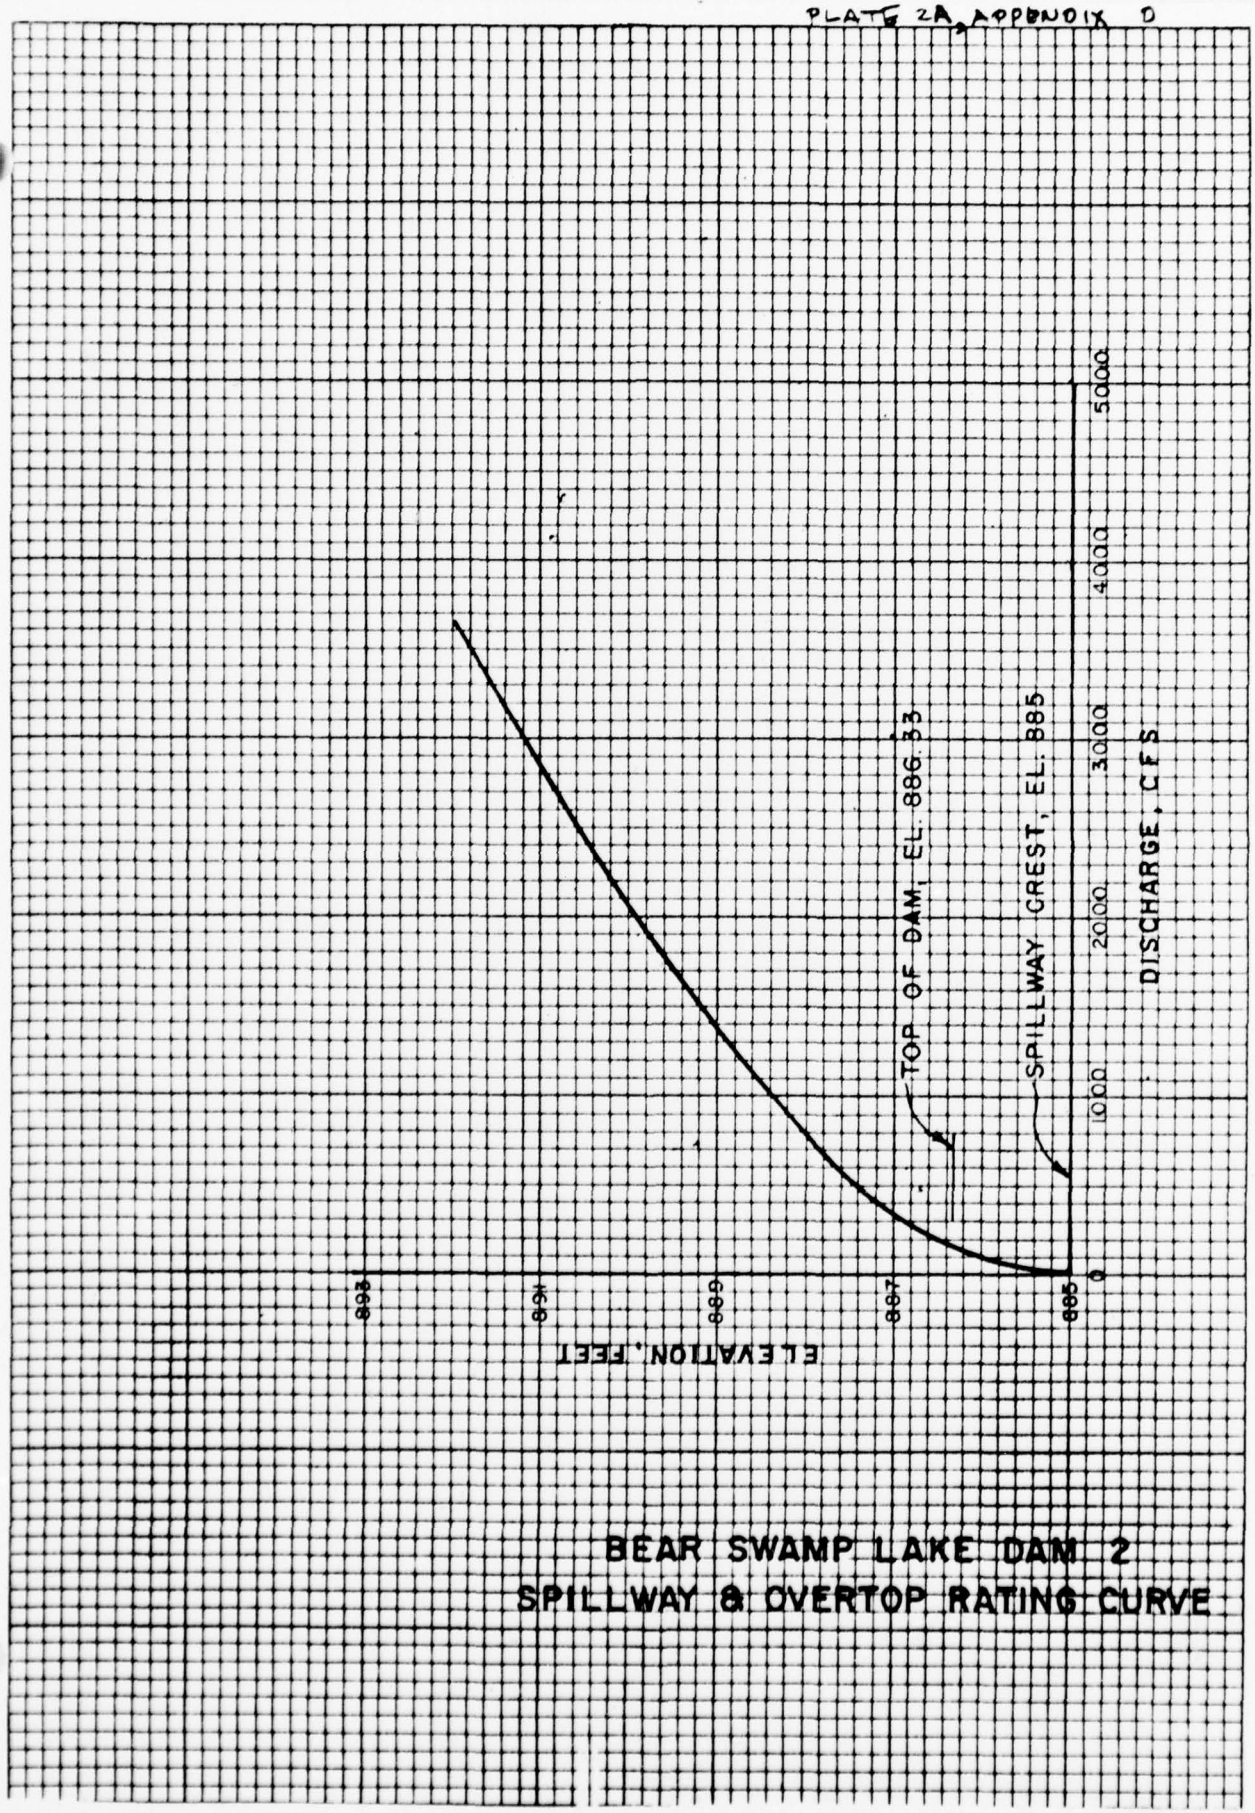
PLATE 2A, APPENDIX D

BEAR SWAMP LAKE DAM 2
SPILLWAY & OVERTOP RATING CURVE

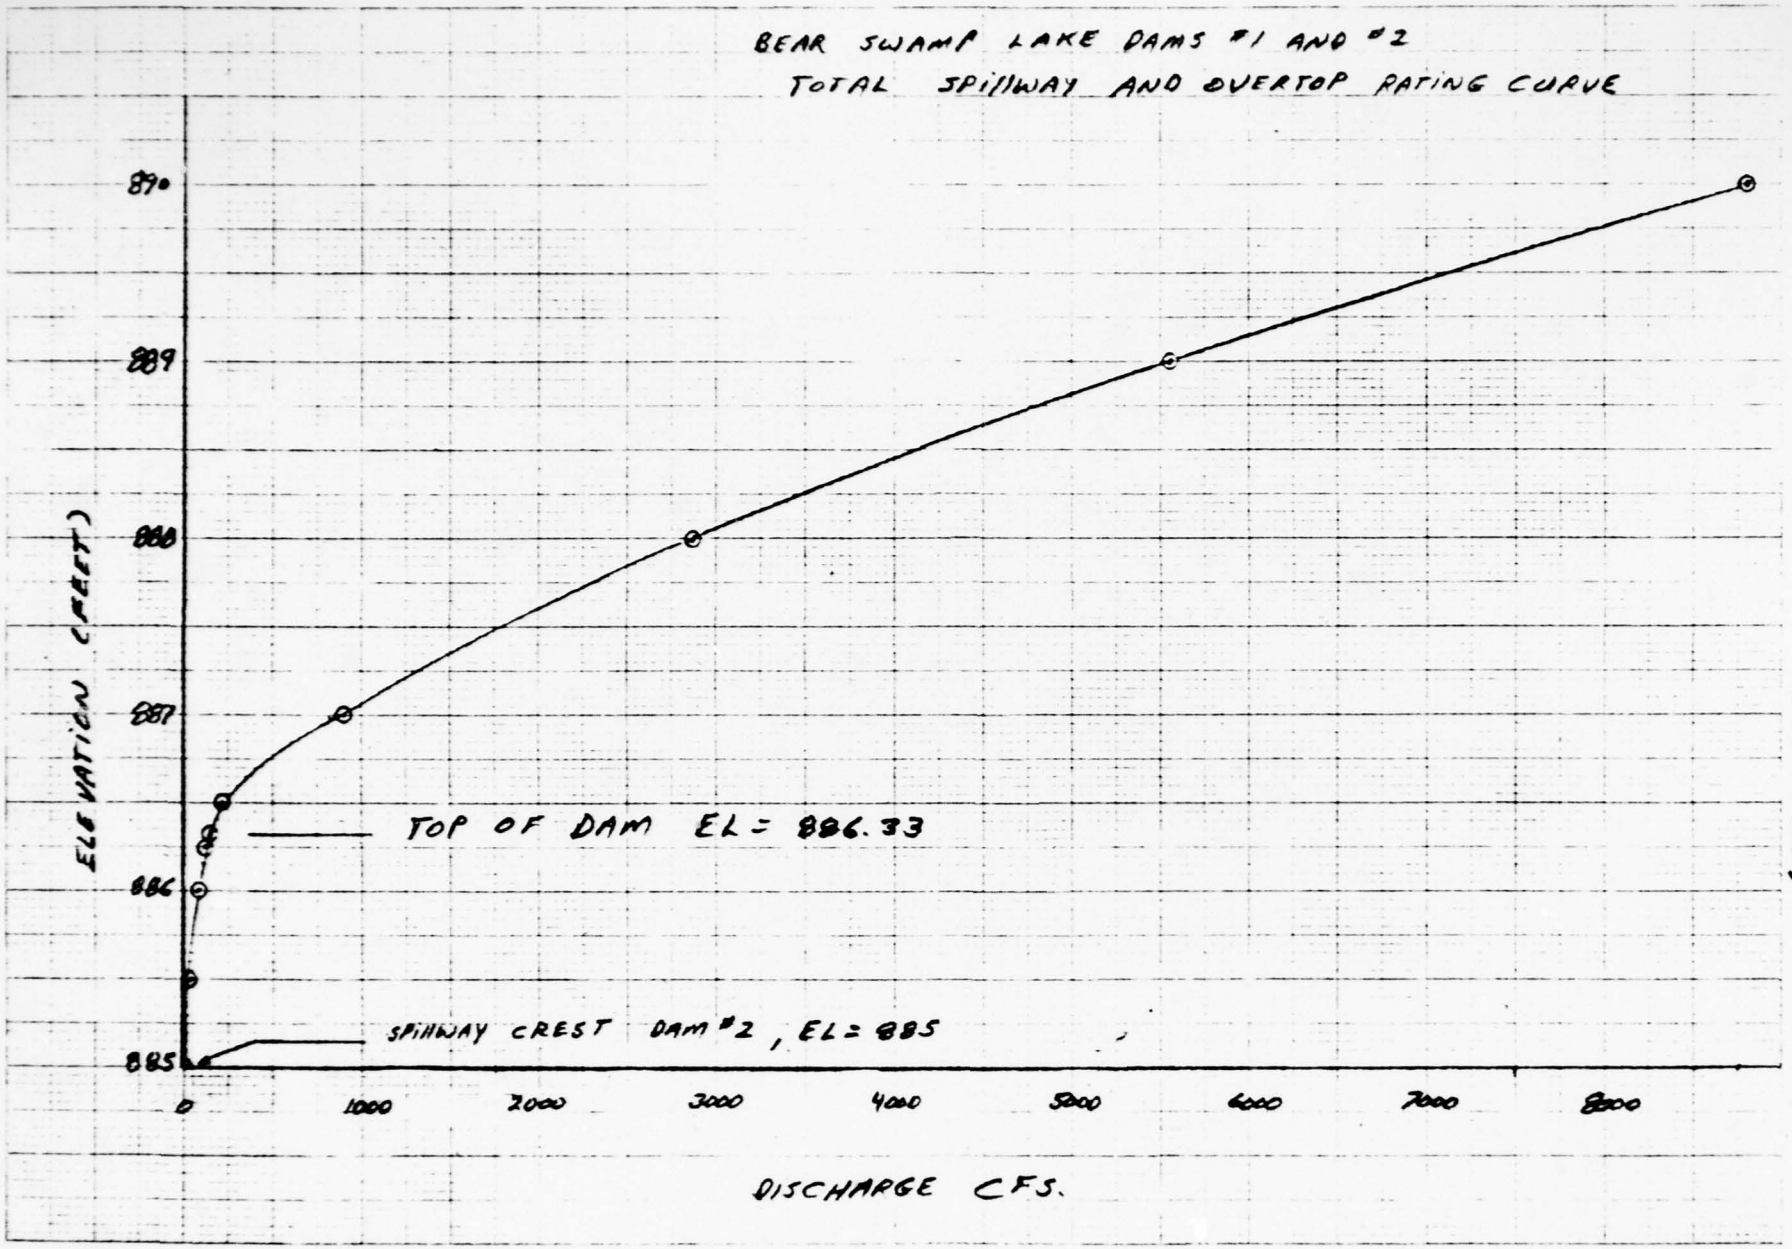
PLATE 2B, APPENDIX D

COMBINED SPILLWAY & OVERTOP RATING CURVE

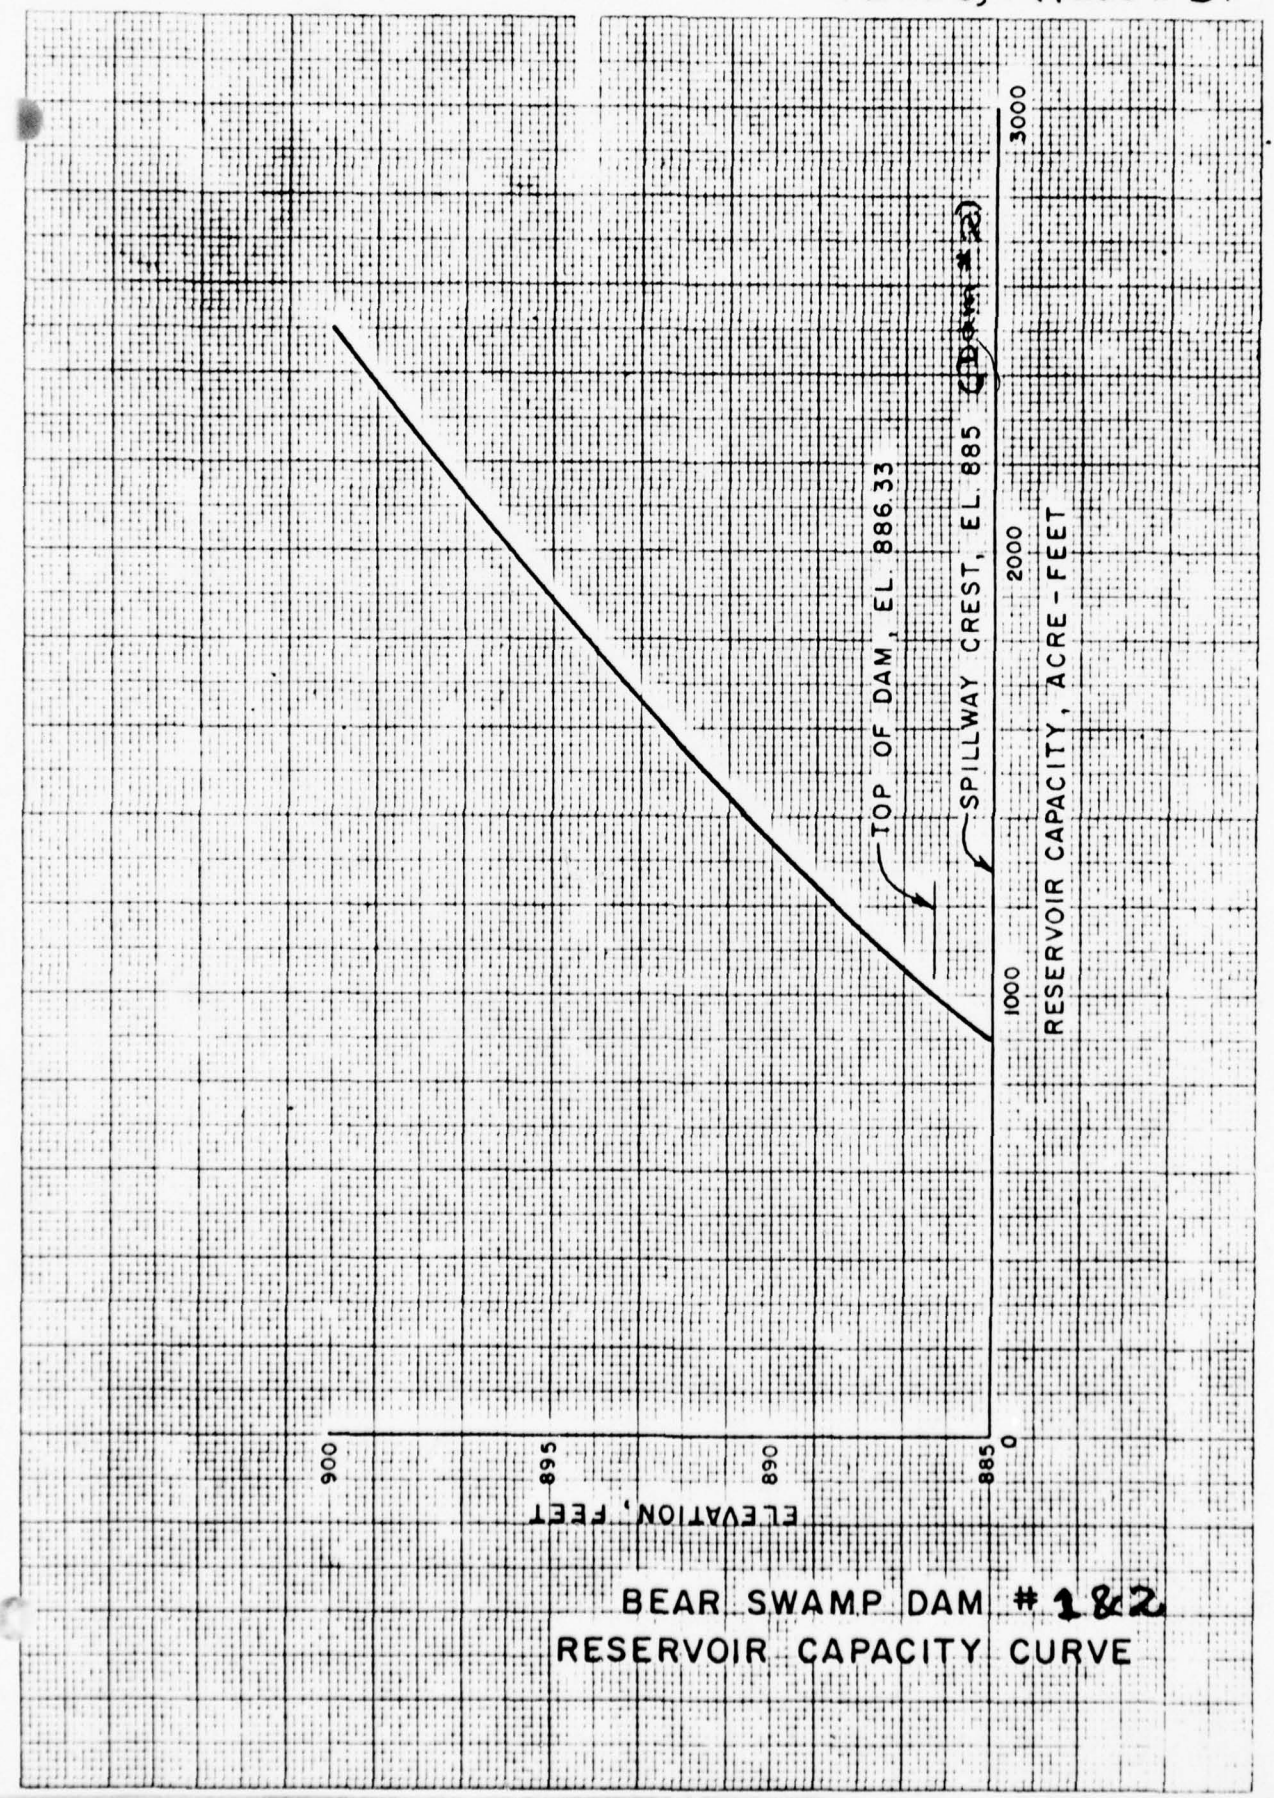
PLATE 3, APPENDIX D.

BEAR SWAMP DAM #1&2
RESERVOIR CAPACITY CURVE

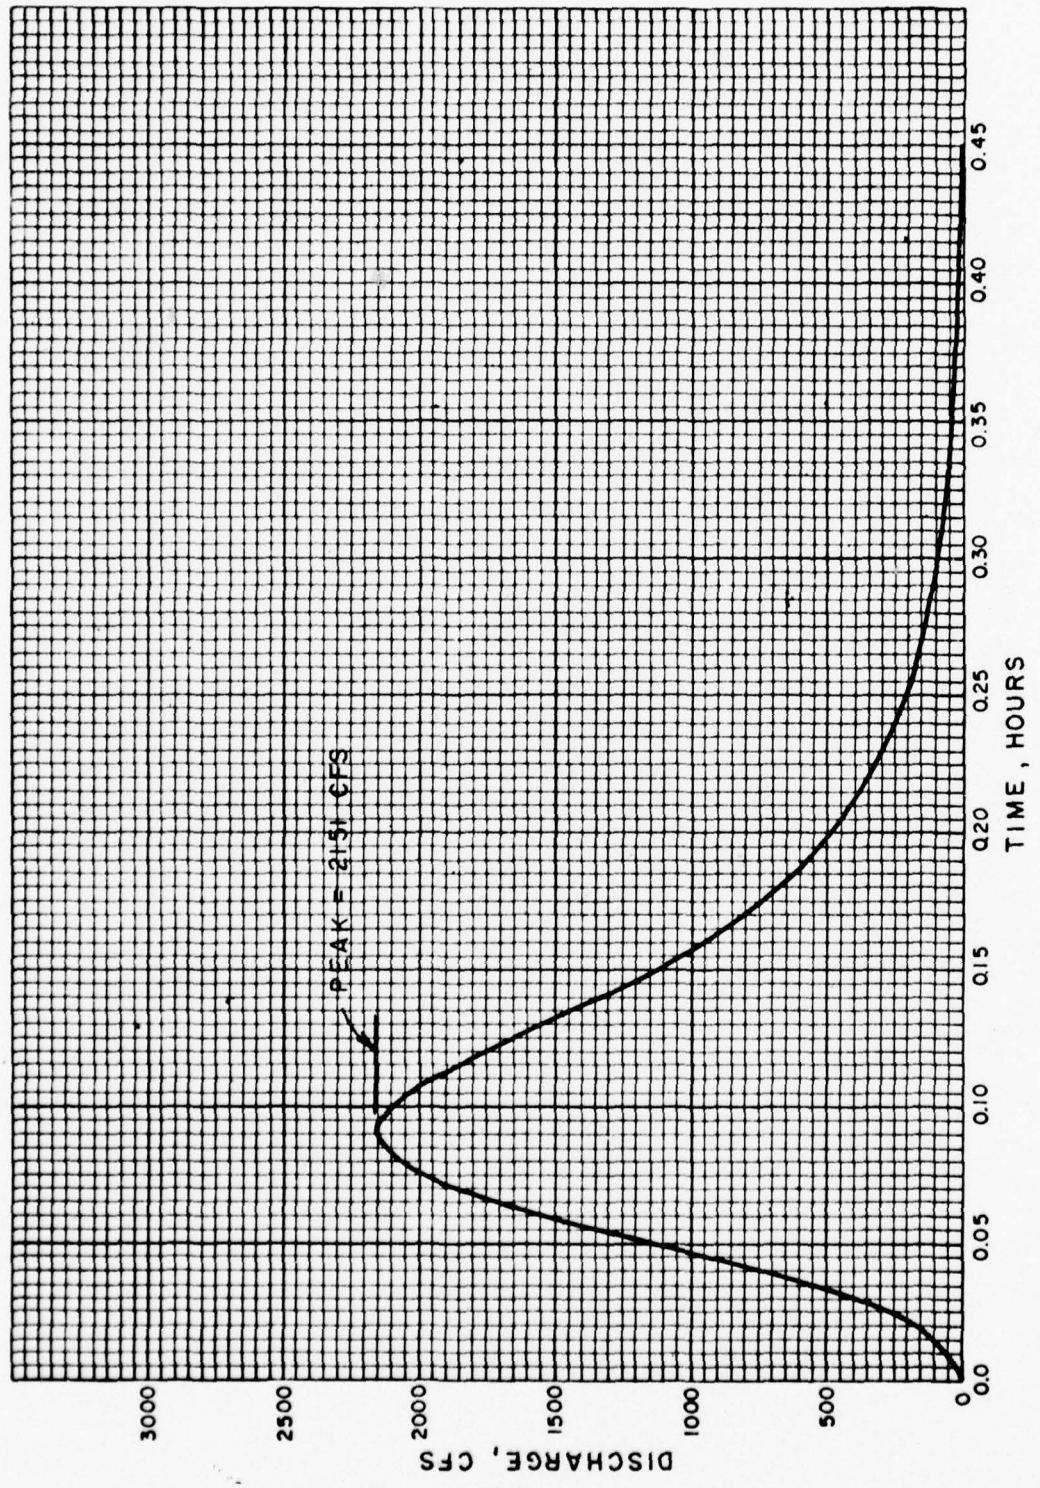
BEAR SWAMP LAKE DAM NO. 1&2
0.05 HOUR UNIT HYDROGRAPH

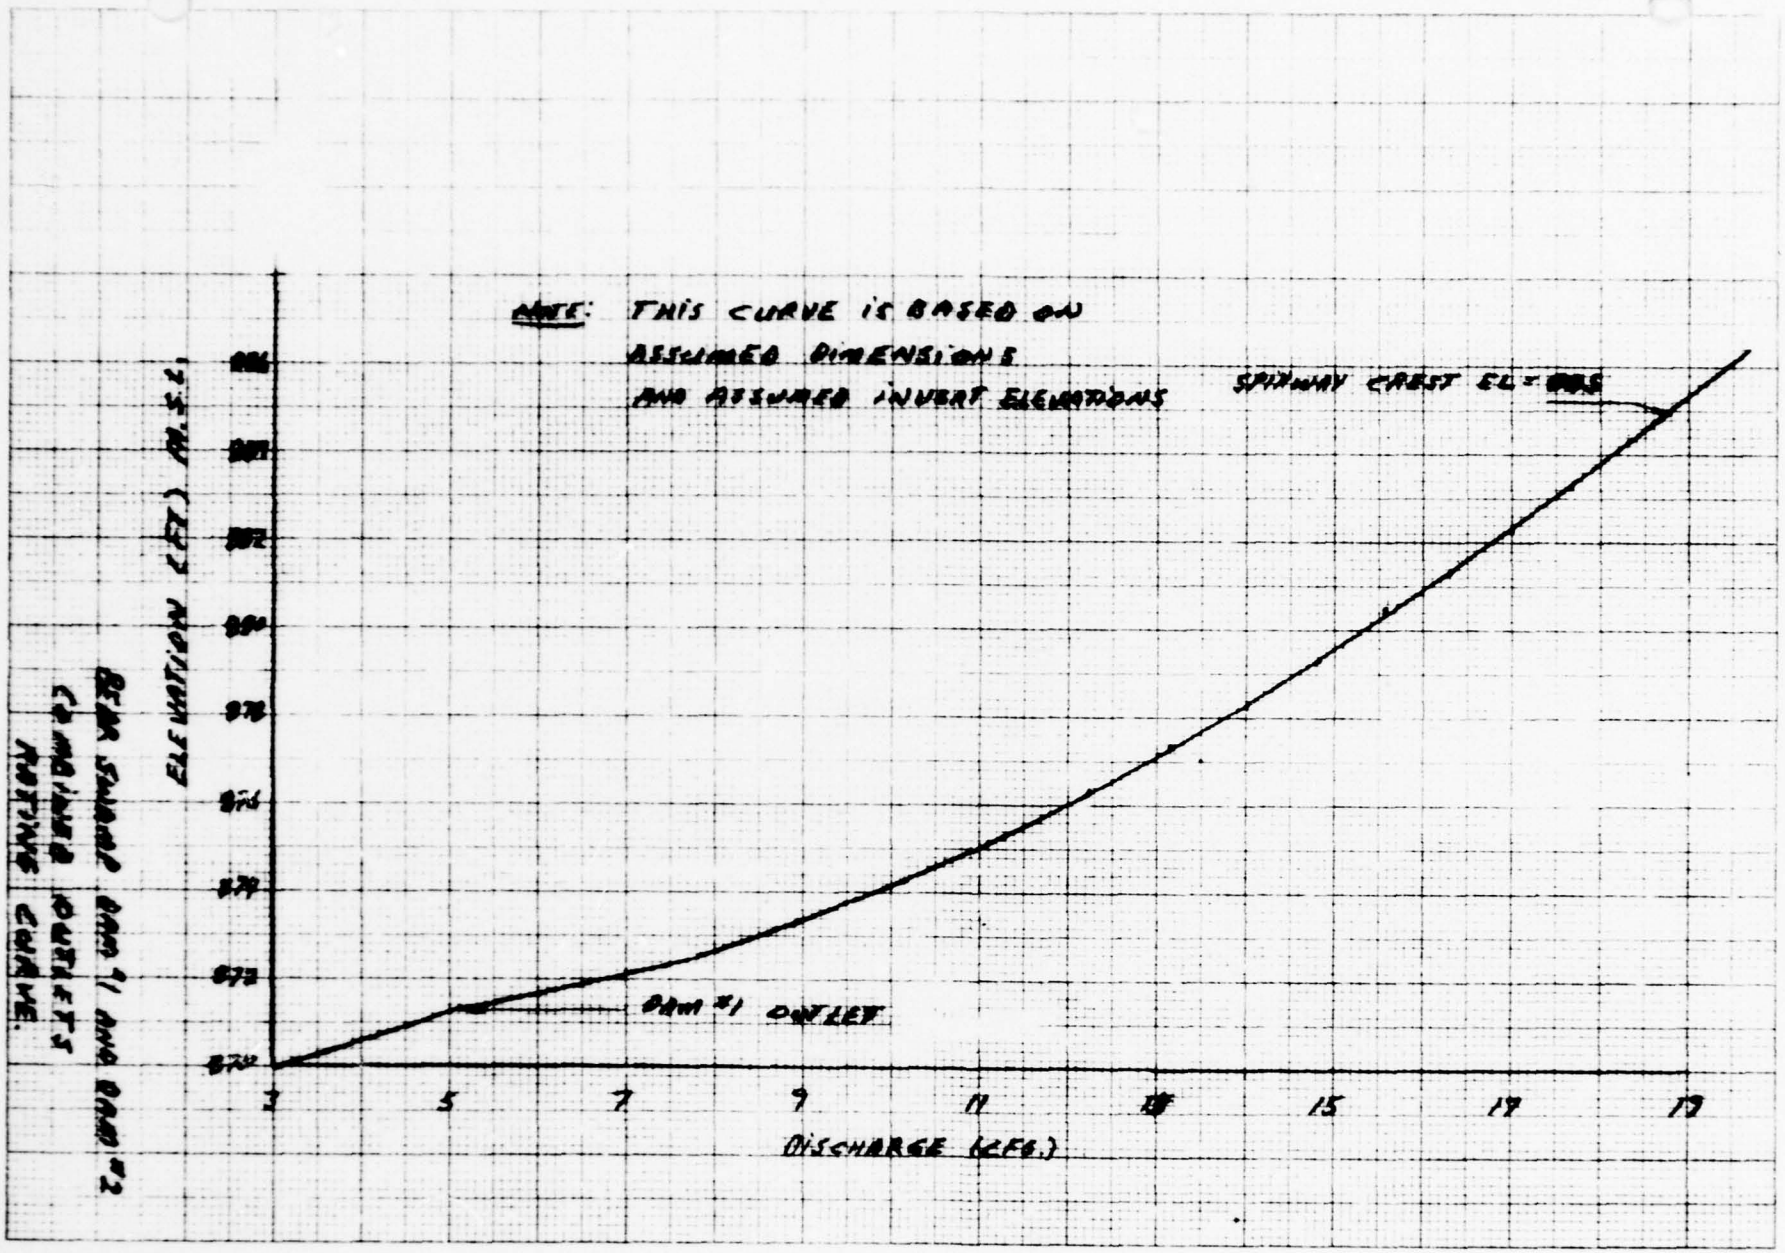
NOTE: THIS CURVE IS BASED ON ASSUMED DIMENSIONS AND ASSUMED INVERT ELEVATIONS
SPILLWAY CREST EL = 886.5
DAM #1 OUTLET
ELEVATION (FT.) M.S.L.
DISCHARGE (CFS.)
3
5
7
9
11
13
15
17
19
REAR SPILLWAY DAM #1 AND DAM #2 COMBINED OUTLETS ROUTING CURVE.
