COLD SPRING LAKE DAM

PHASE I INSPECTION REPORT

NATIONAL DAM SAFETY PROGRAM

NJ 00226

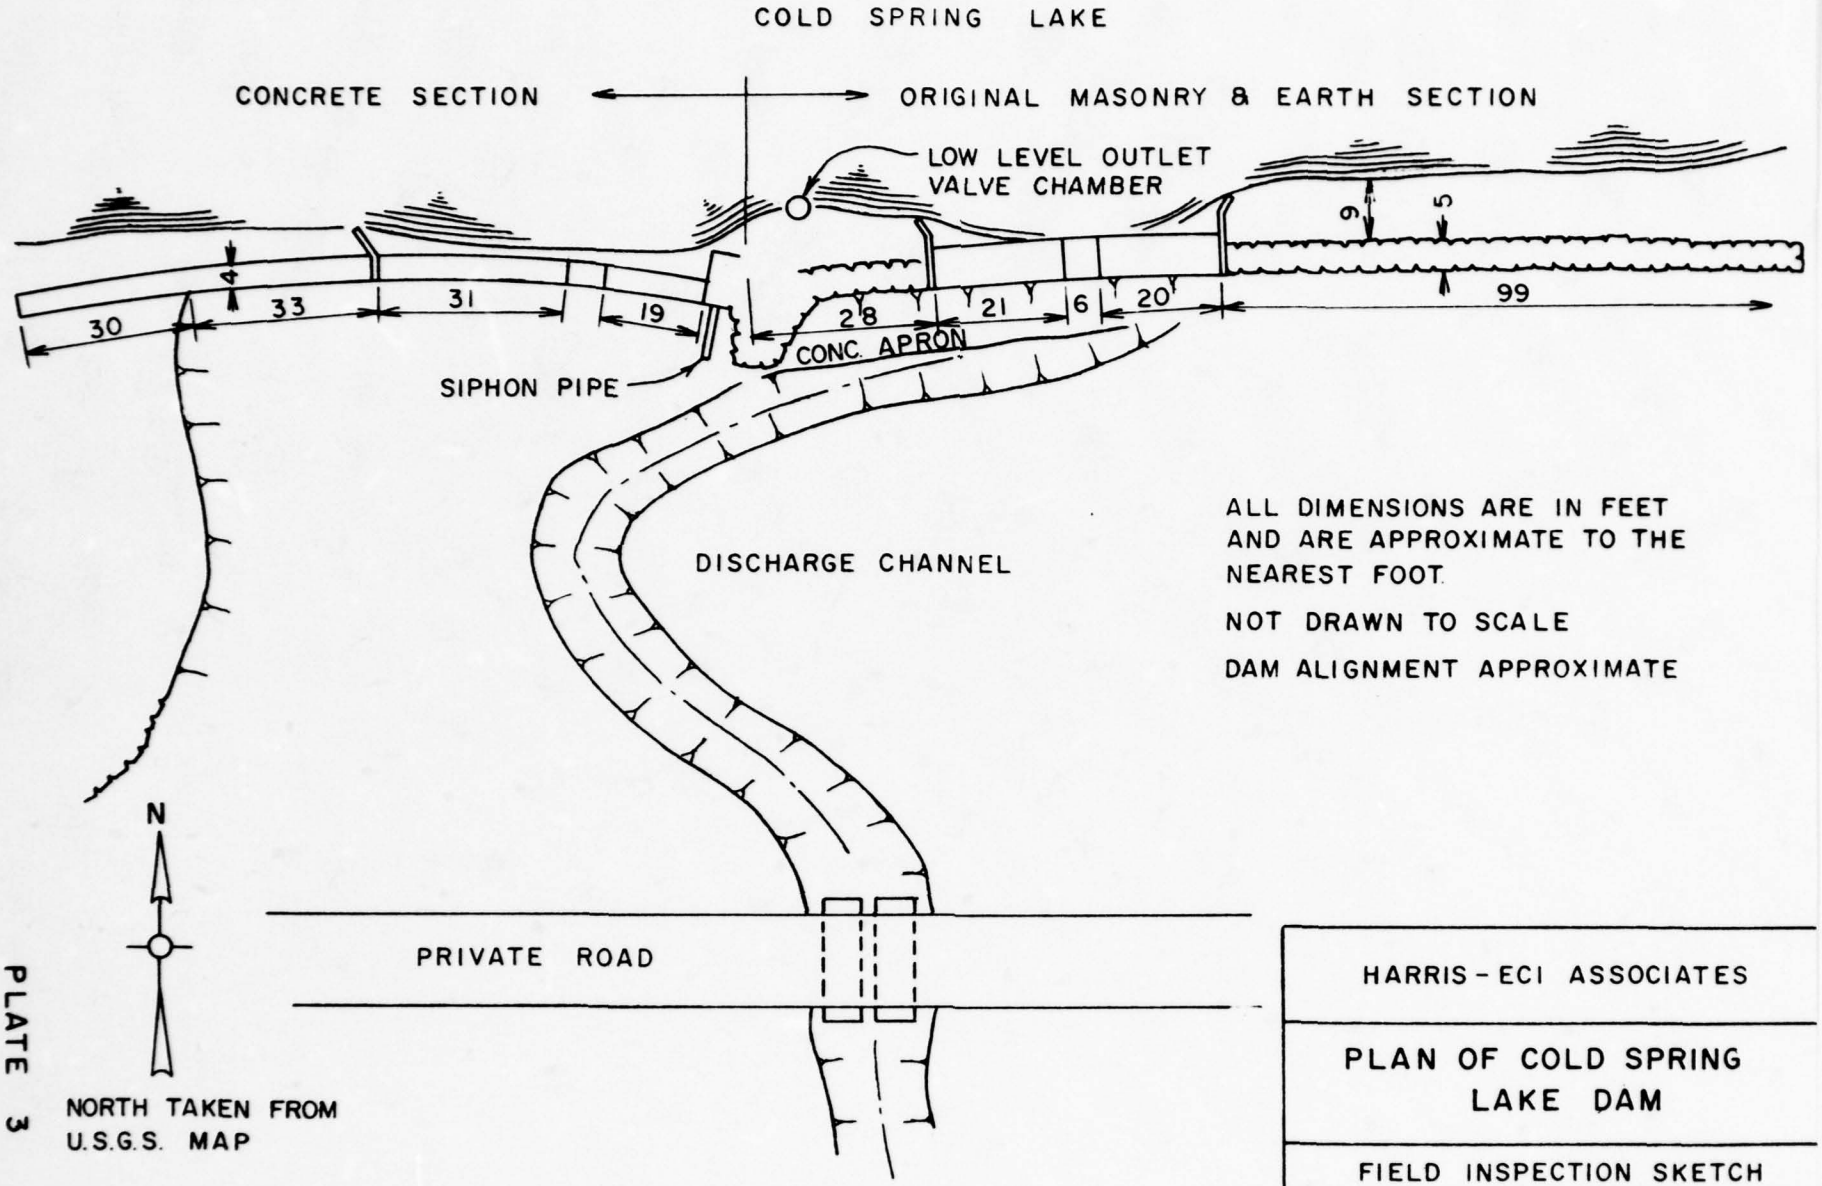
PLATE 3

HARRIS - ECI ASSOCIATES		
PLAN OF COLD SPRING LAKE DAM		
FIELD INSPECTION SKETCH		
D.J.K.	8 - 1 - 78	1 OF 1

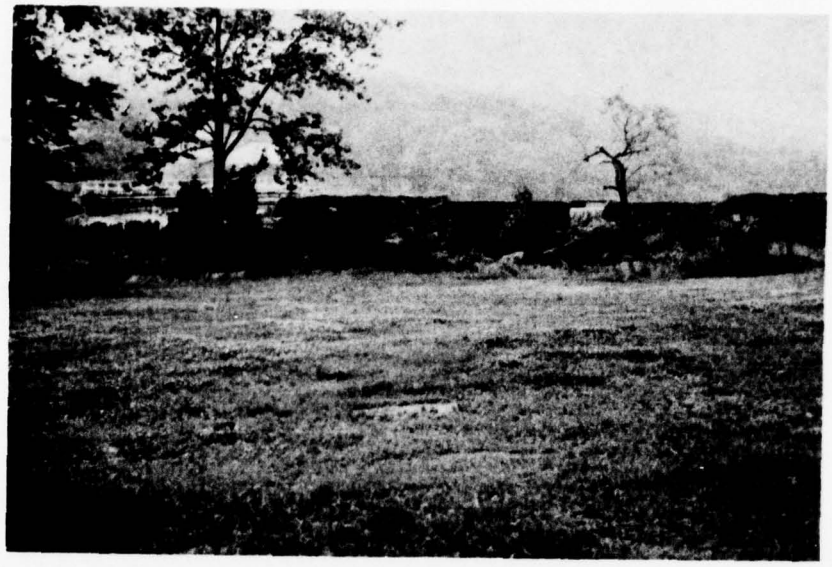
Photo 1 - Overall view of dam.

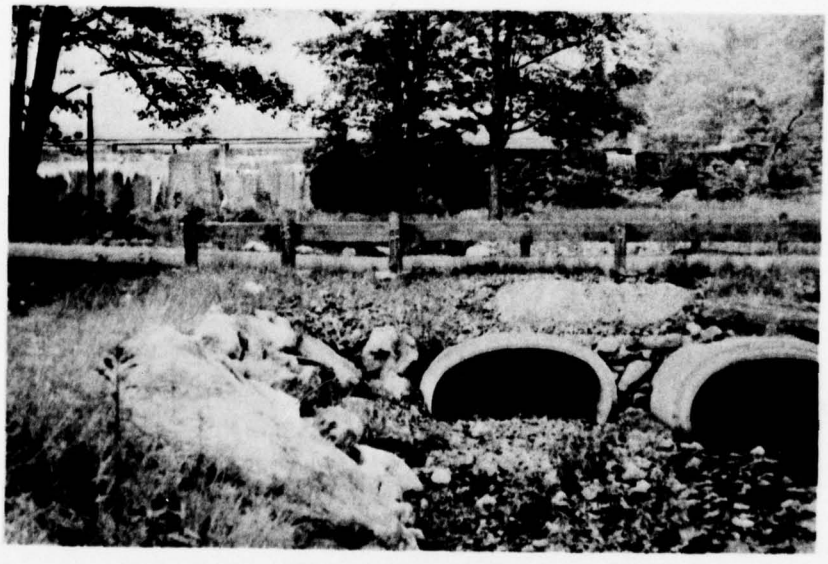
Photo 2 - Overall view of dam and culverts in discharge channel under private road.

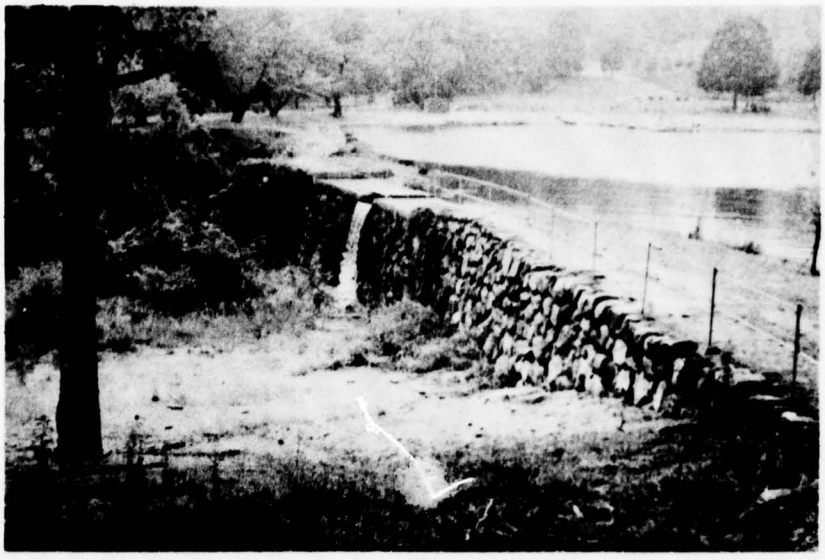
Photo 3 - View of dam from left abutment showing original rock masonry dam.

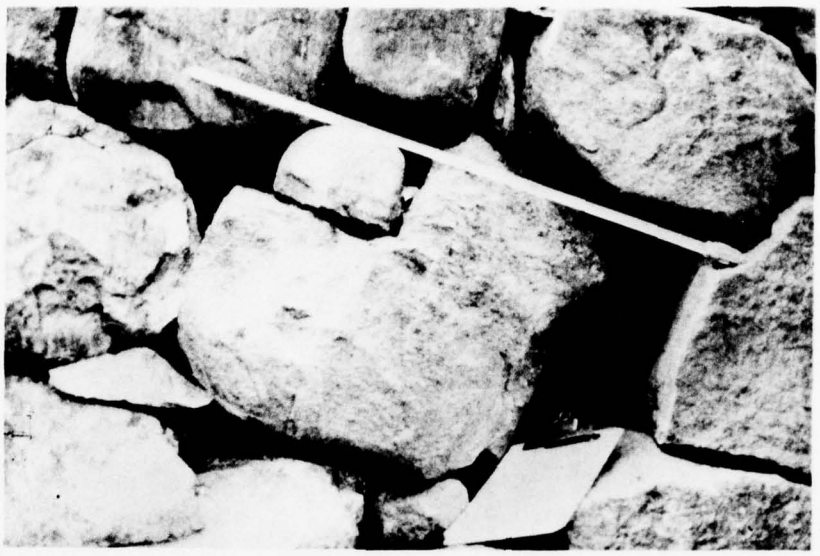
The rock masonry retaining wall appears to be in good condition. No evidence of settlement or movement was apparent. The stones in the wall are of hard, durable rock and show no signs of deterioration. No stones were displaced from the wall.

Photo 5 - Rock wall masonry of original dam.

3. No additional mortar should be added to the face of the masonry dam. Sealing the wall will alter the free draining characteristics of the wall and could allow for a build up in hydrostatic pressure at the back of the wall.

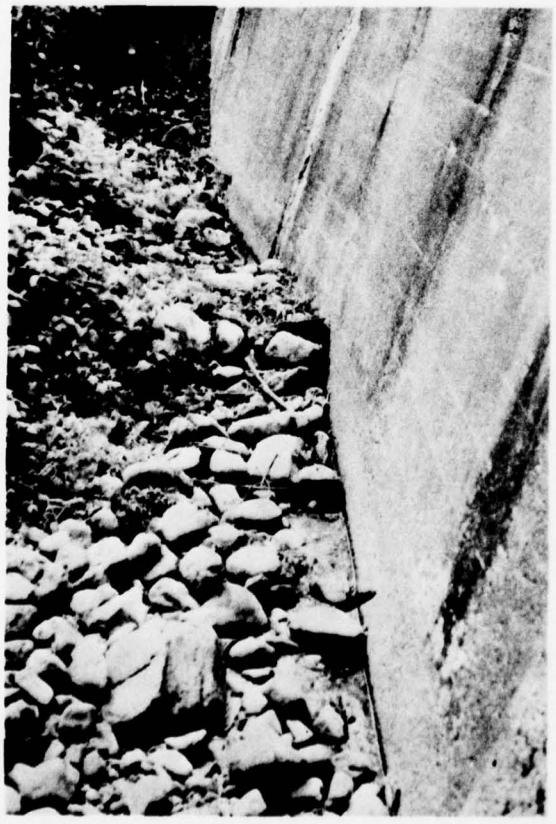
Seepage was observed flowing from beneath the apron at the base of the original section. Seepage was also observed immediately downstream of the concrete arch. In both locations the seepage appeared to be free of fine-grained soil (as well as coarse-grained soil). The seepage in the area of the concrete section was estimated at about 5 gpm. This seepage is believed to be occurring through the soil foundation under the section. No estimate of total seepage quantity could be made in the area of the original section due to discharge over the spillway. This seepage is believed to be occurring through both the embankment behind the wall and through the soil foundation under the dam.

Photo 6 - Seepage at base under spillway of concrete dam.

1. A program should be developed to monitor the seepage through and under the dam. Depending on the information provided, the need for corrective measures can be considered and, if necessary, undertaken.

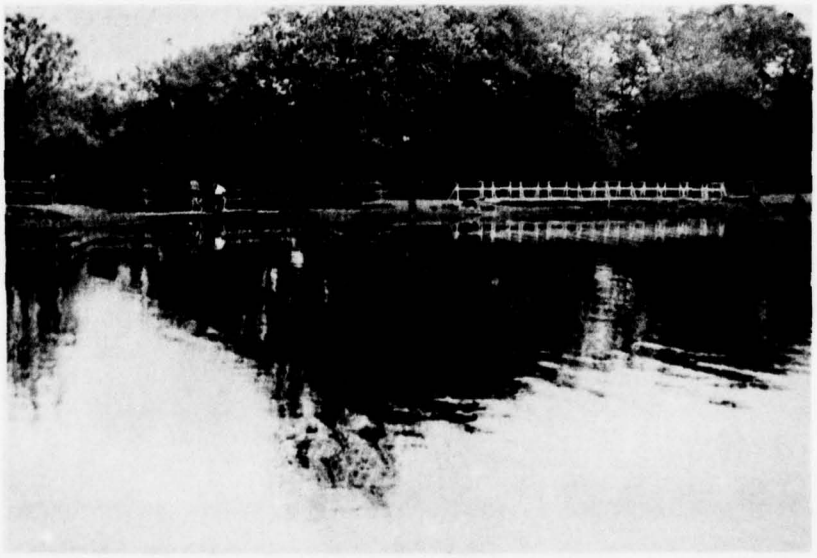
Photo 10 - View of spillways from upstream left shoreline.

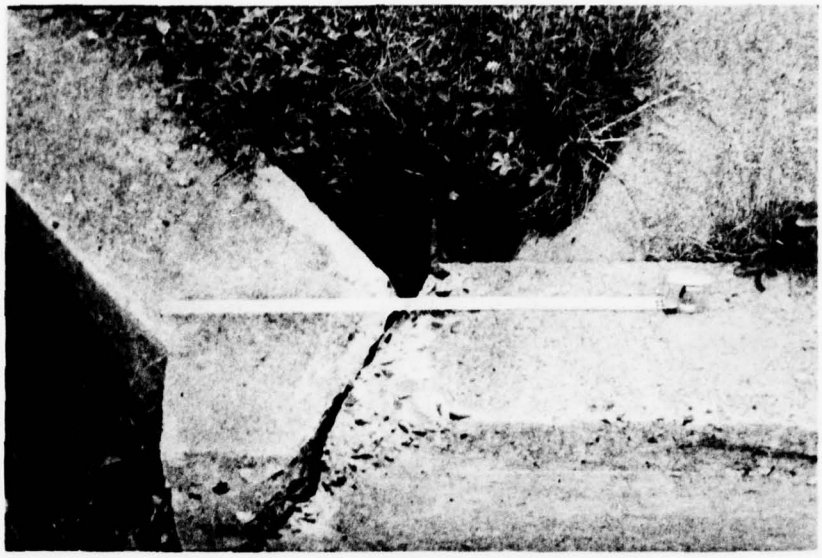
way has a lower central section for service discharges and a higher section on each side. The lower level spillway was discharging a small flow and was functioning very well. The crest of the weir is flat and extends over the full dam crest thickness. A small wooden footbridge was installed over the lower spillway notch. This bridge will probably be washed away if a large flow occurs over the upper level of the spillway. Erosion of backfill was observed behind the left wingwall of the spillway approach.

Photo 11 - Erosion and settlement of wingwall at left side of approach to masonry spillway.

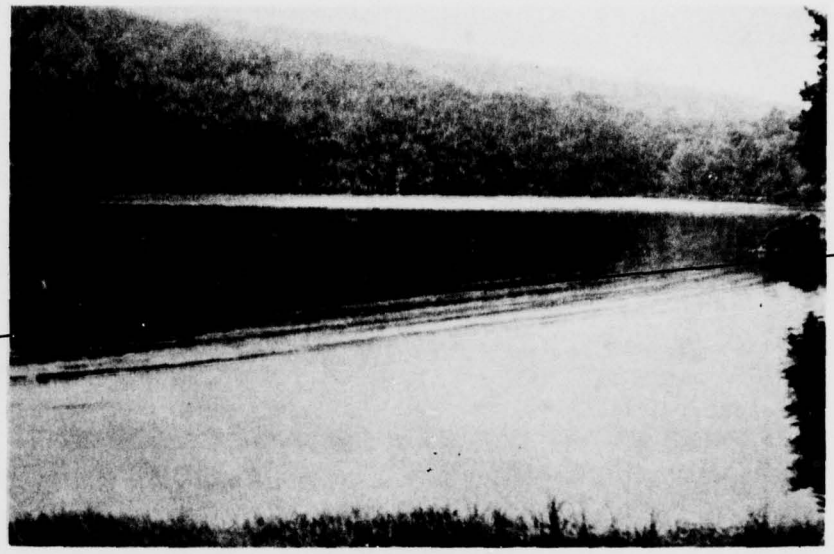
Photo 15 - View of Cold Springs Lake from near right abutment.
