COLONIAL LAKE DAM

PHASE I INSPECTION REPORT

NATIONAL DAM SAFETY PROGRAM

NJ 00261

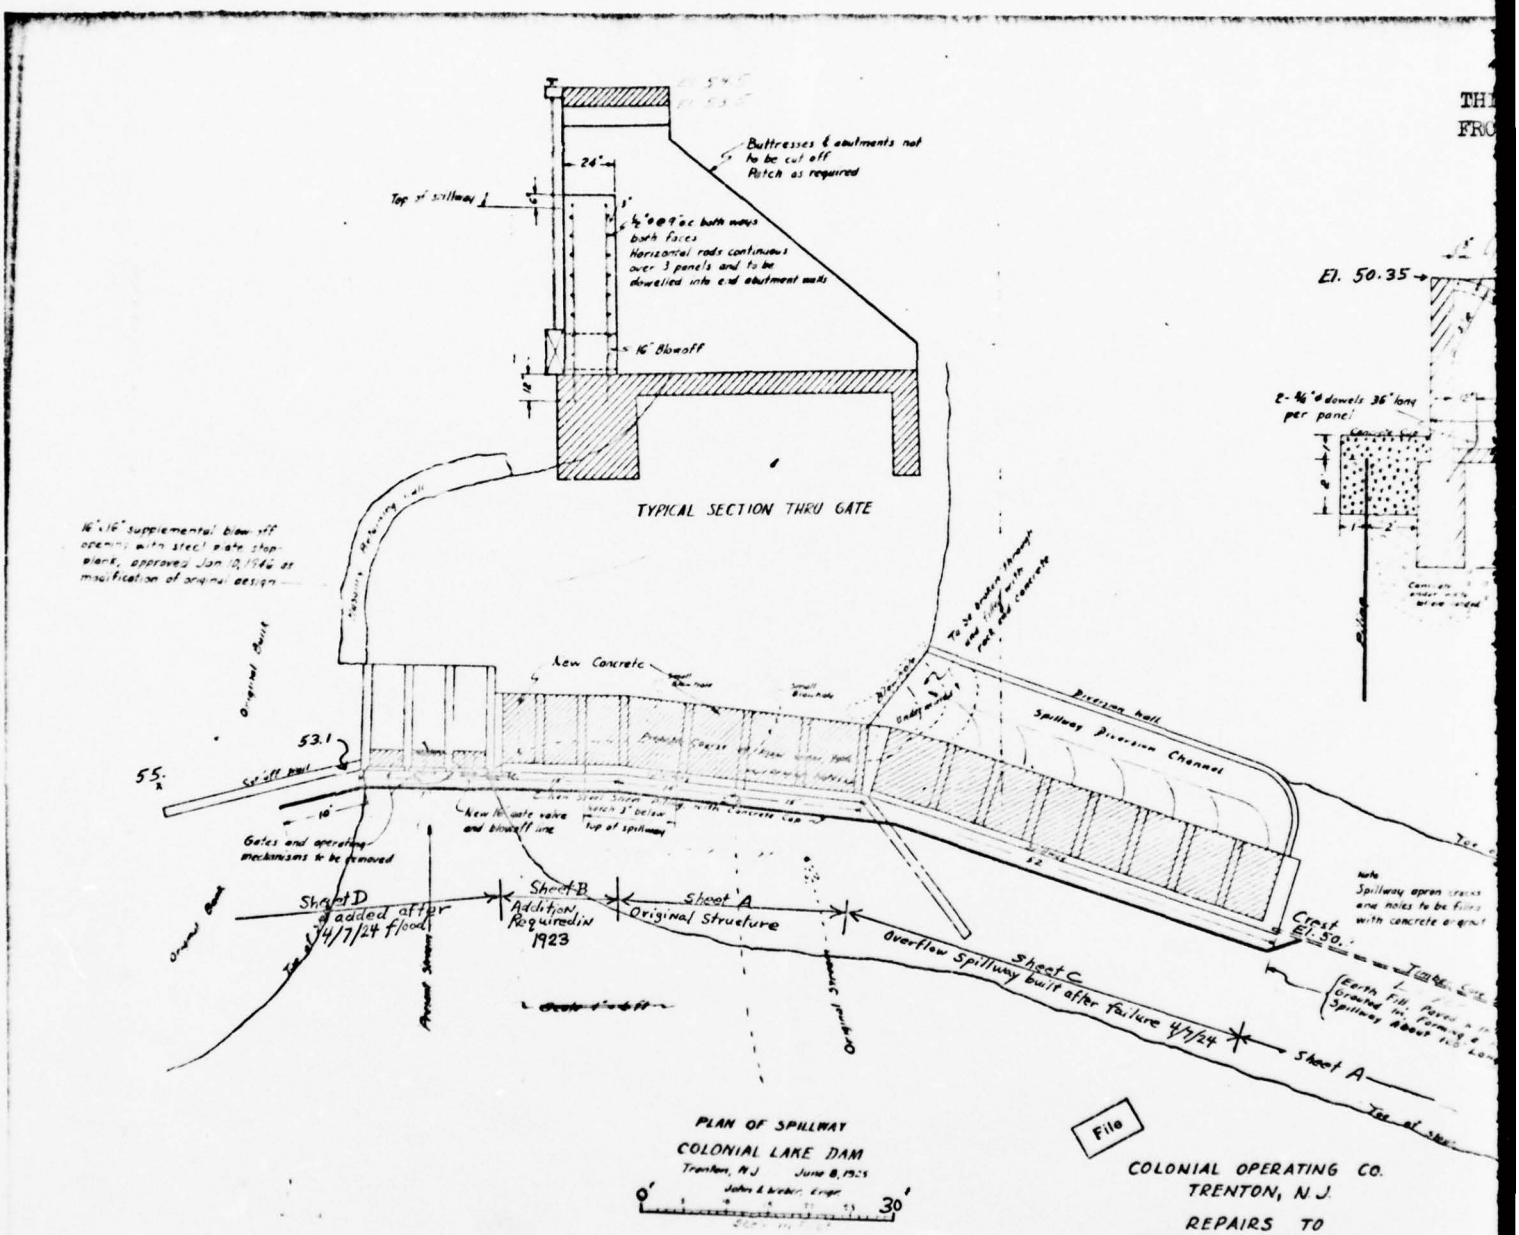
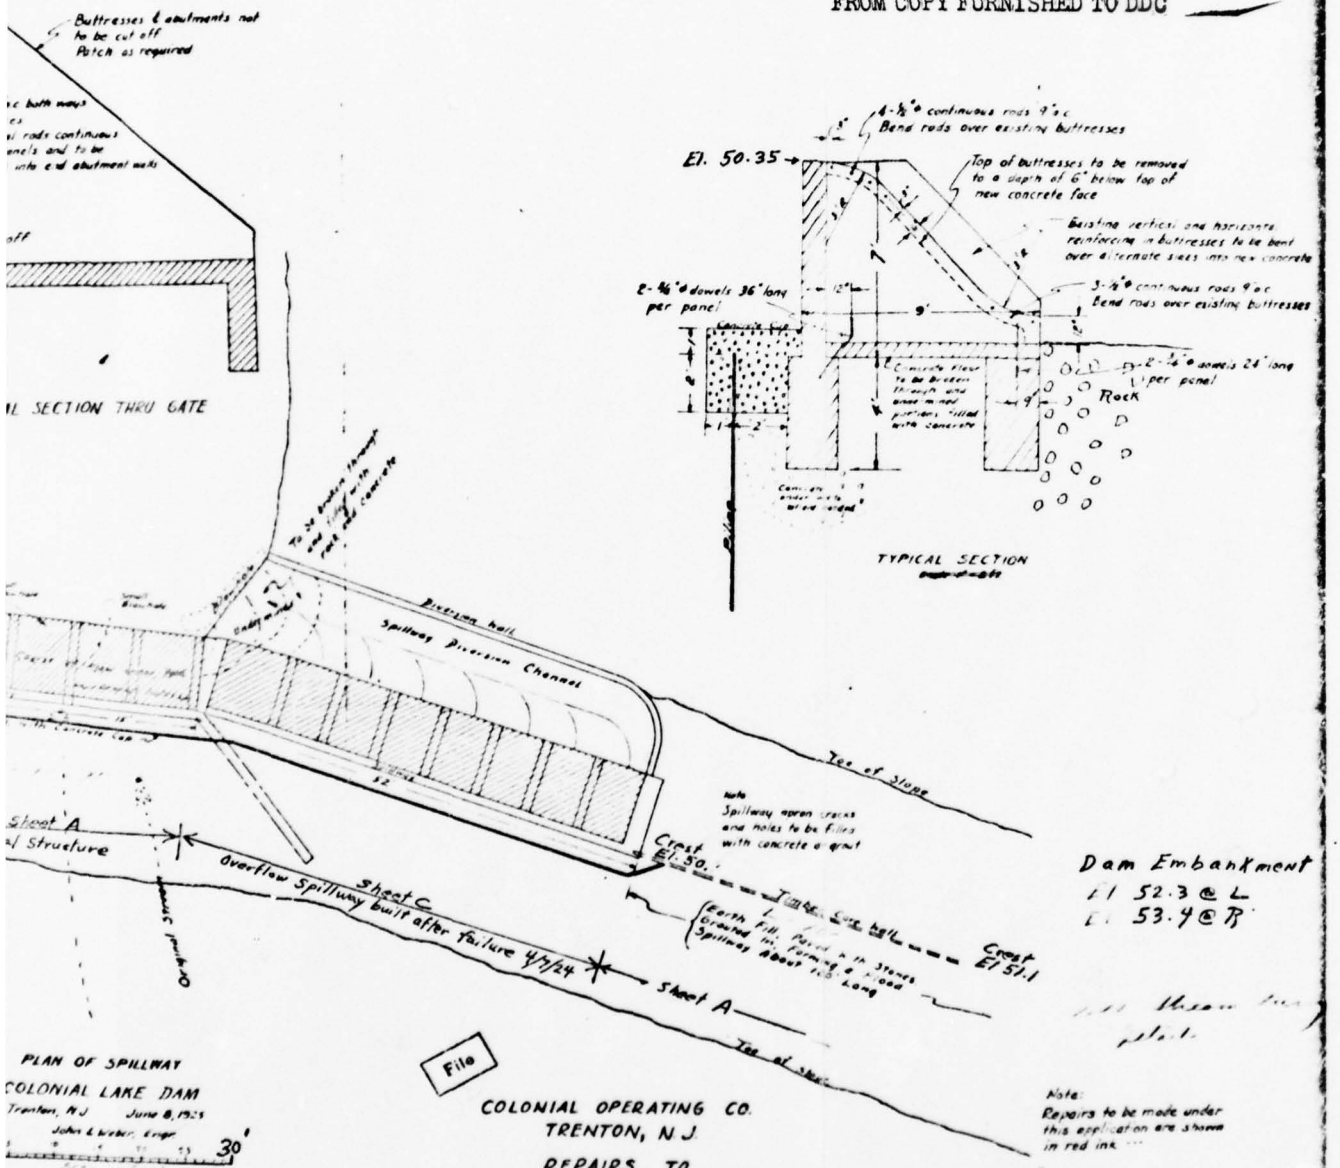
PLATE 2

REPAIRS TO
COLONIAL LAKE DAM
SHABAKUNK CREEK
LAWRENCE TWP MERCER CO.
OCTOBER 1945
