ORADELL RESERVOIR DAM

PHASE I INSPECTION REPORT

NATIONAL DAM SAFETY PROGRAM

NJ 00258

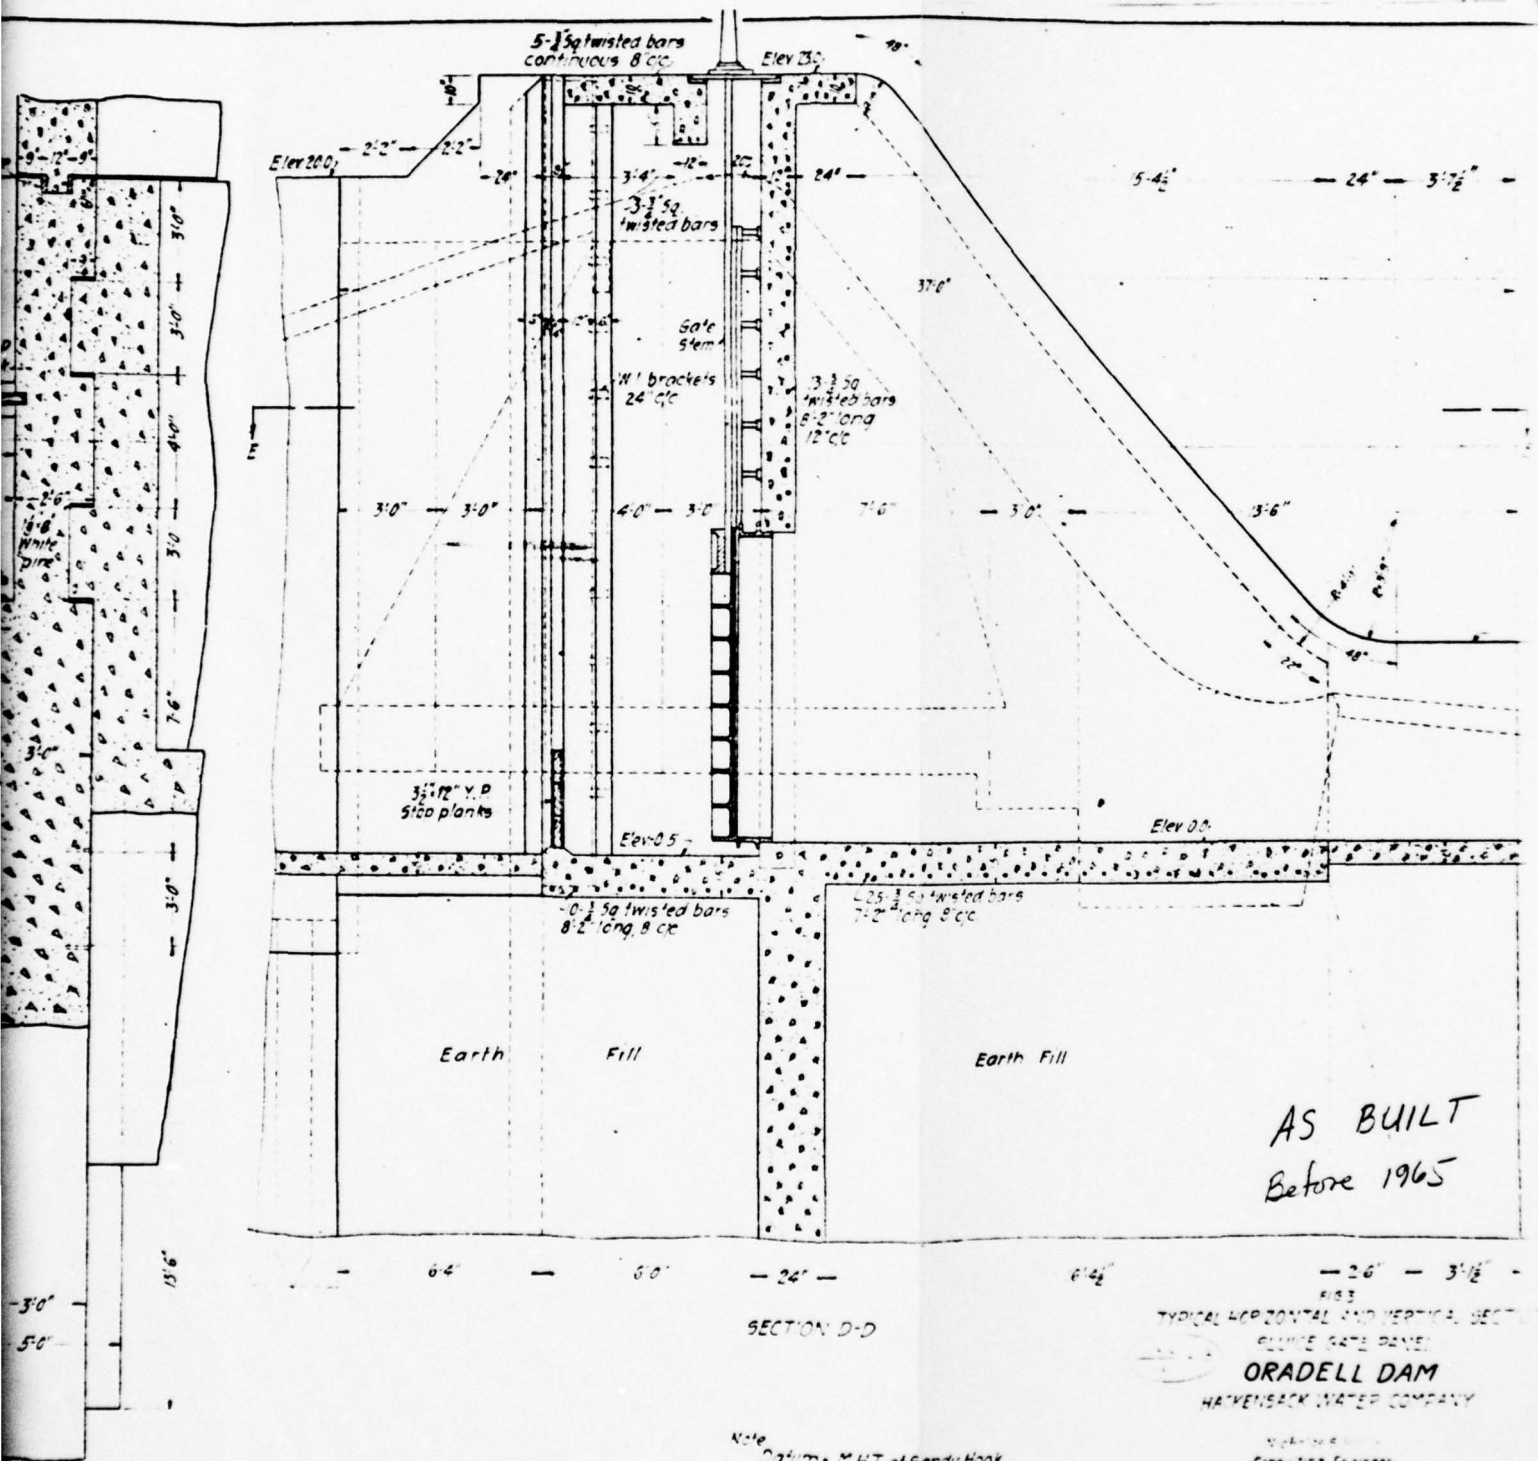
PLATE 2

FIG 3
TYPICAL HORIZONTAL AND VERTICAL SECTIONS
SLUICE GATE BENCH
ORADELL DAM
HACKENSACK WATER COMPANY

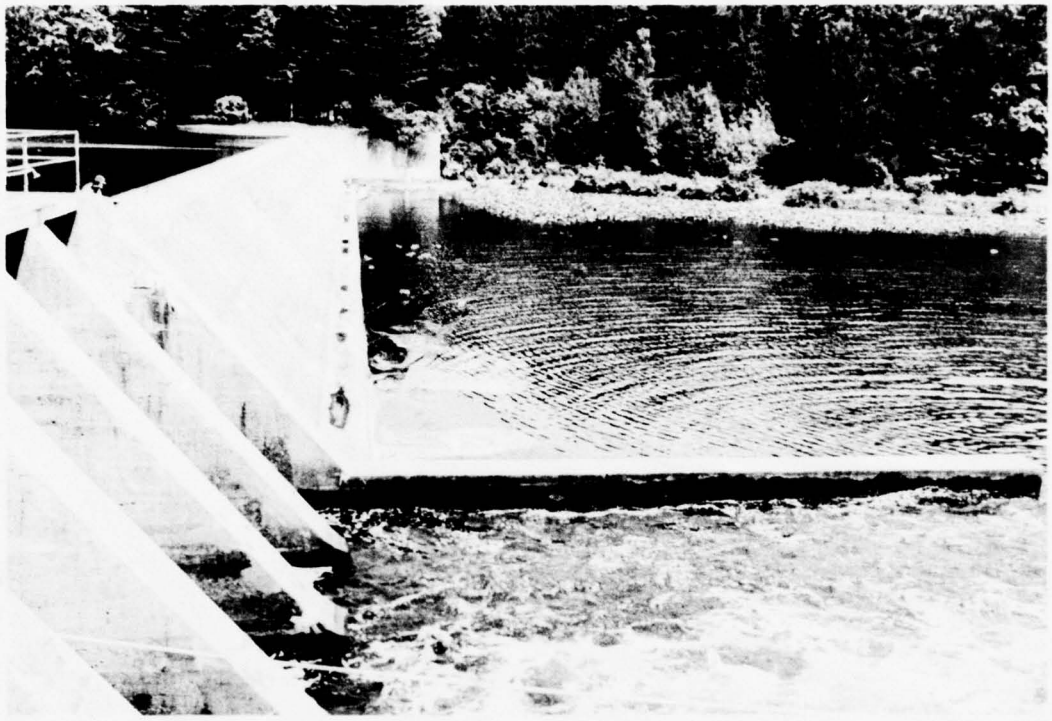
PHOTO 2

Photo 2 - View Downstream (Southeast) Over Crest of Spillway Weir From Approximately 100 Feet Upstream of Right (West) Abutment; Left (East) Abutment at Left Edge of Photo; Sluice Gates at Right Edge of Photo - 12 June 1978

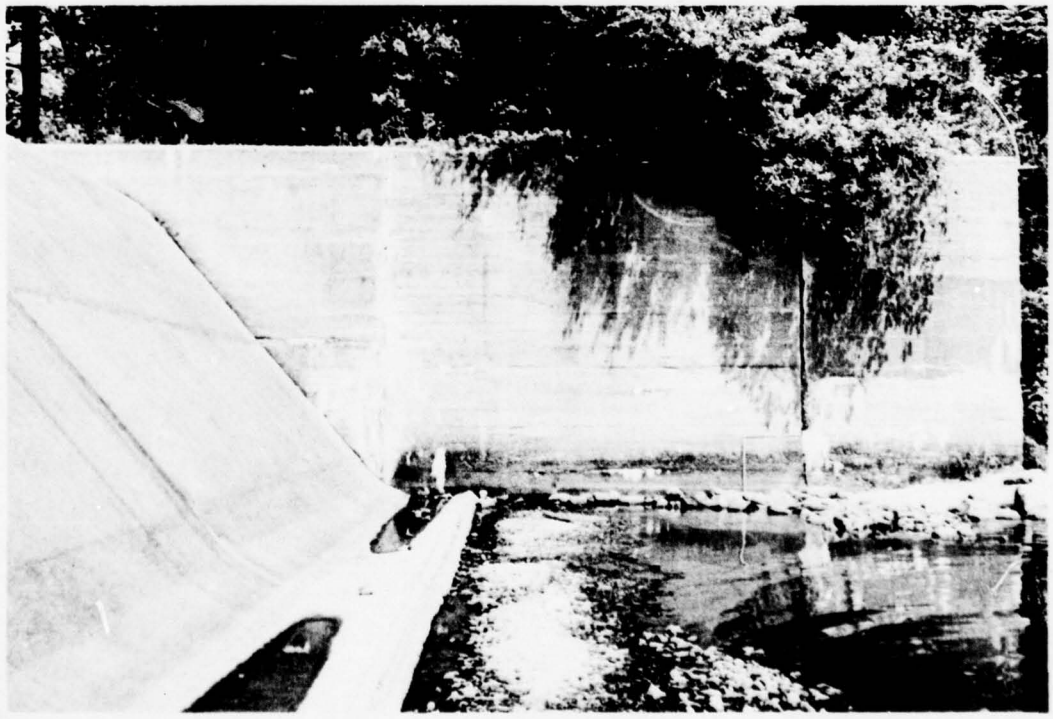
PHOTO 3

Photo 3 - View East Across Downstream Face of Dam From Right (West) Abutment; Sluice Gates at Left Side of Photo; Spillway in Left Center; Left (East) Abutment Wing Wall in Top Left Center (Close-up in Photo 4) - 12 June 1978

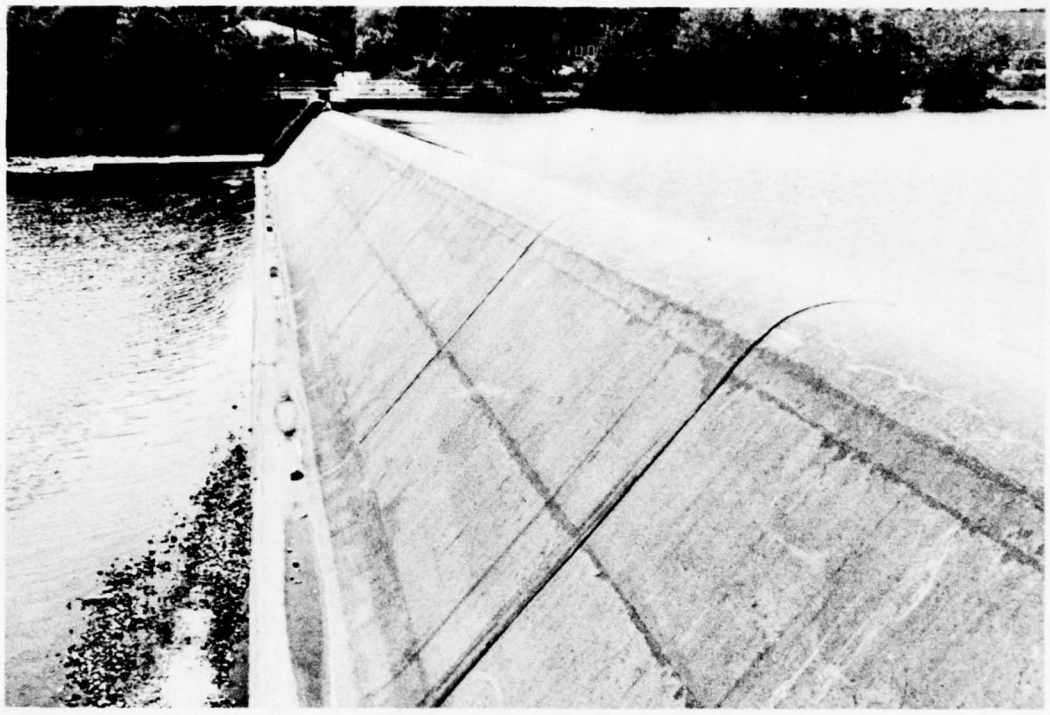
PHOTO 4

Photo 4 - Close-up of Left (East) Abutment Wing Wall (Photo 3) Showing Cracked and Spalled Concrete and Open Vertical Joint; Three Feet by Three Feet Rule for Scale - 12 June 1978

(6) All expansion joints on the left and right retaining walls should be cleaned out and repaired, and the sealant should be replaced.

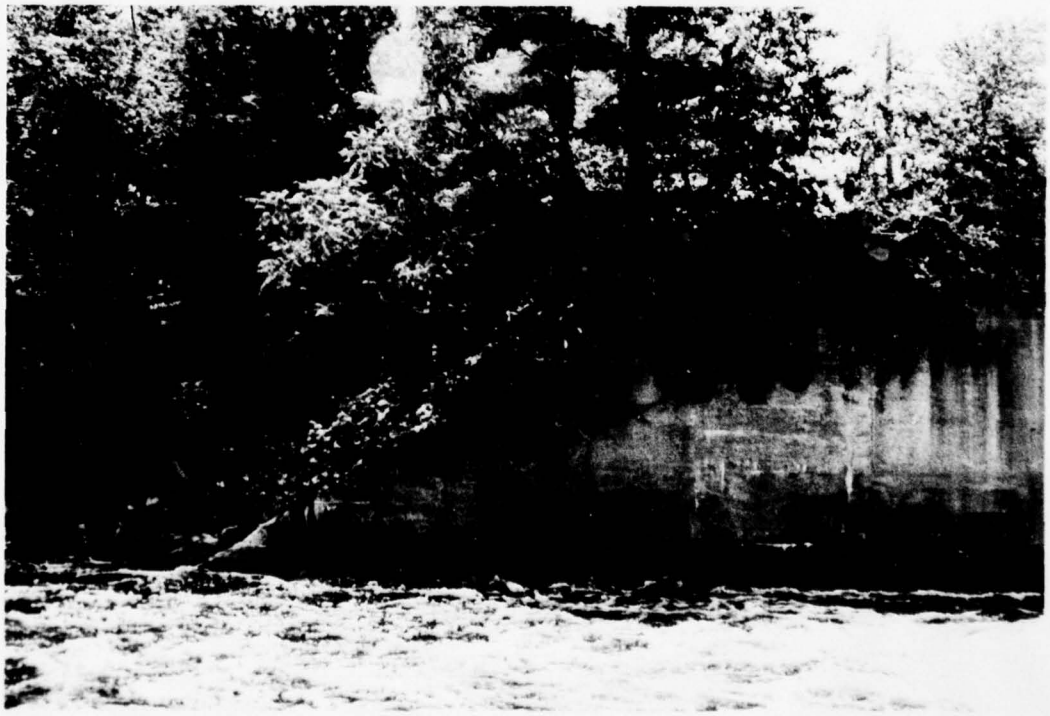
PHOTO 5

Photo 5 - View West Across Downstream Face of Dam From Left (East) Abutment; Sluice Gates and Right (West) Abutment Wing Wall (Close-up in Photo 6) in Top Left Corner of Photo - 12 June 1978
