ACCELERATED MISSION TEST OF A TF41 WITH AIRCOOLED SECOND STAGE TURBINE BLADES

TECHNICAL REPORT AFAPL-TR-78-87
Final Report for Period 10 August 1977 – 26 October 1977

AIR FORCE AERO PROPULSION LABORATORY
AIR FORCE WRIGHT AERONAUTICAL LABORATORIES
AIR FORCE SYSTEMS COMMAND
WRIGHT-PATTERSON AIR FORCE BASE, OHIO 45433

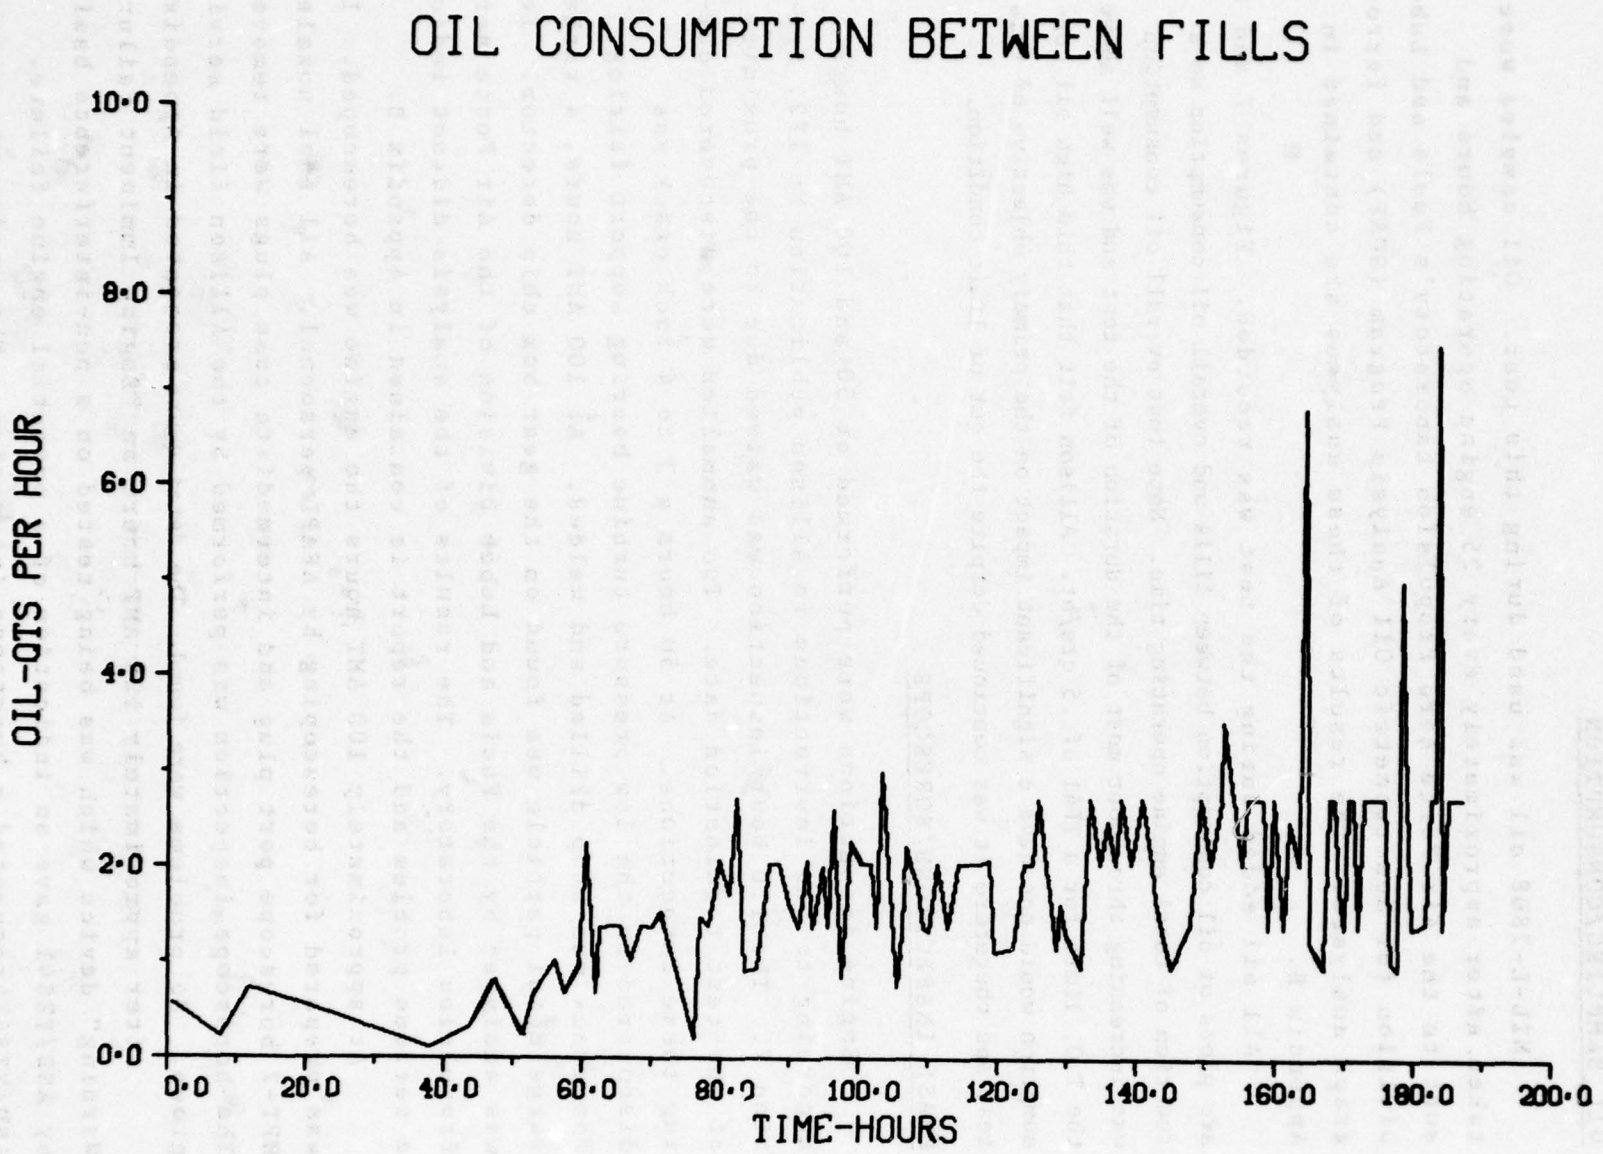
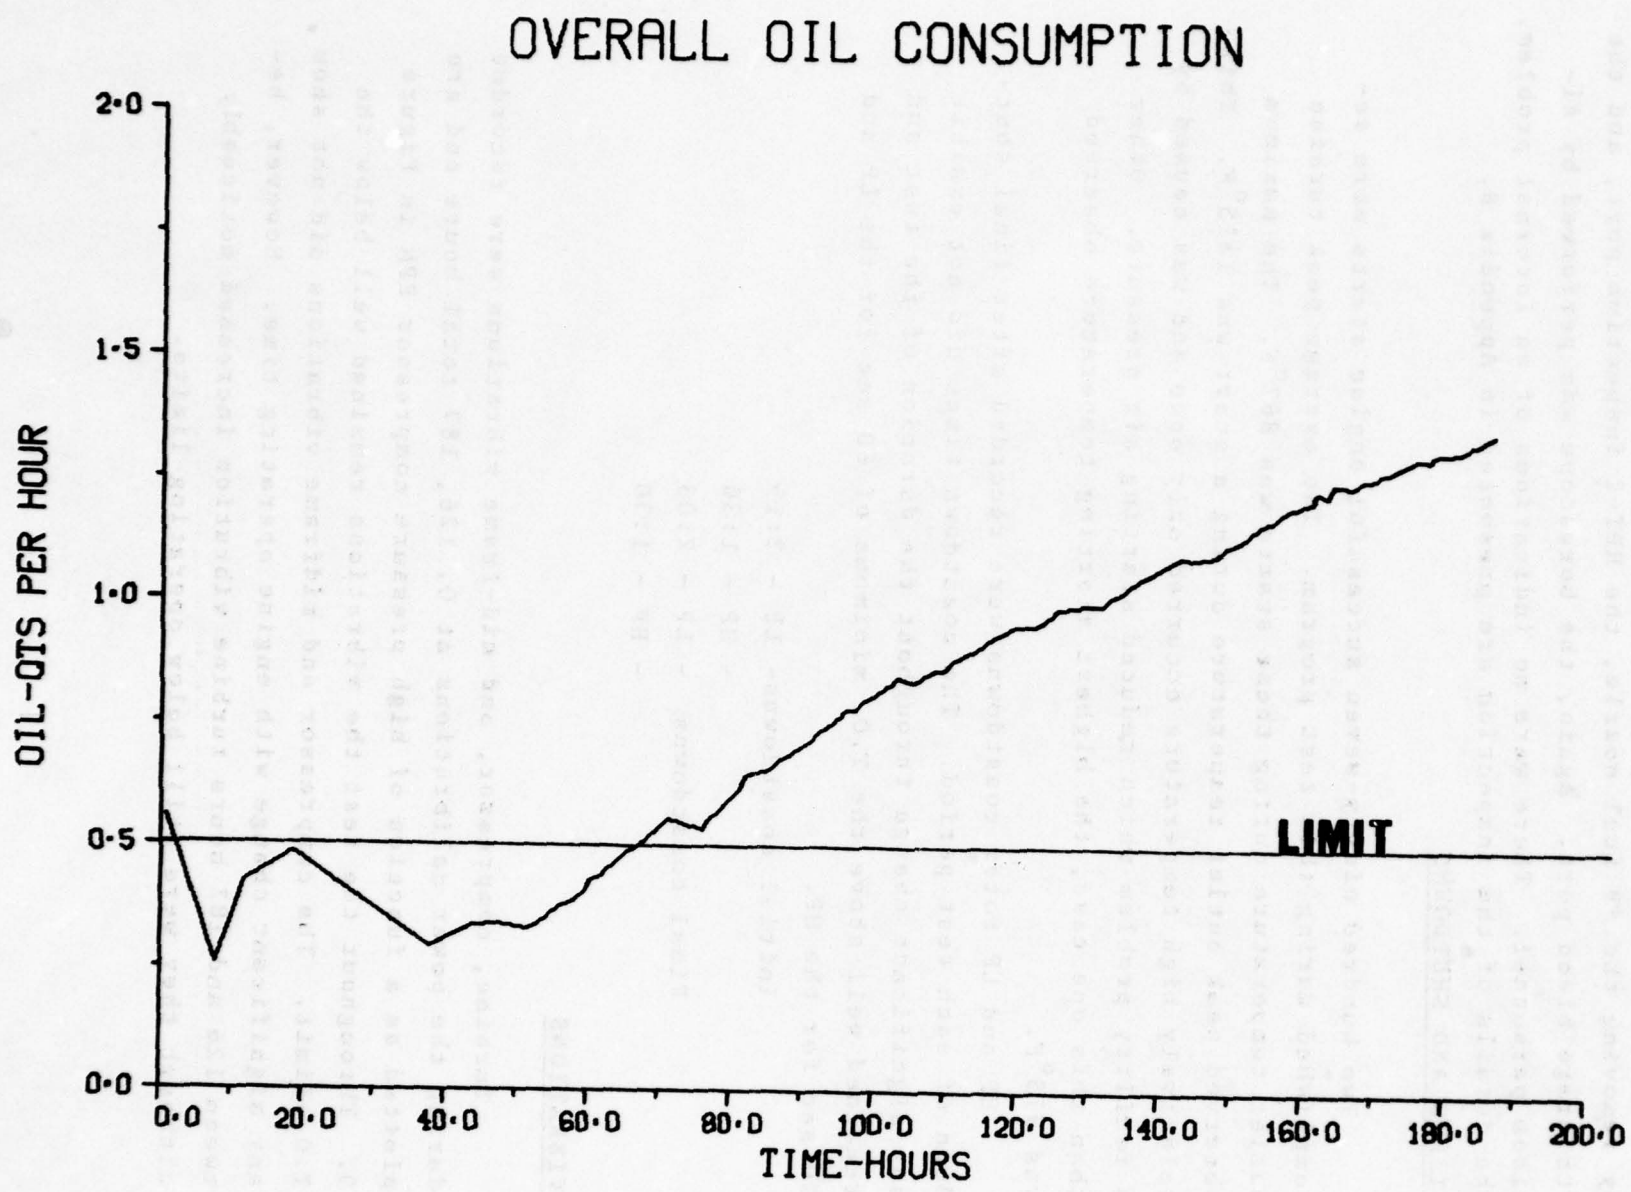
All oil added during the test was recorded. Figures 7 and 8 are plots of oil consumption between fills and overall oil consumption as a function of total engine operating time. Note that overall oil consumption was increasing throughout most of the duration of the test and was well above the T.O. limit for a TF41 of .5 qts/hr. Allison felt that this high oil consumption would not have a significant impact on the primary objective of this test and therefore it was continued despite the out of limit condition.

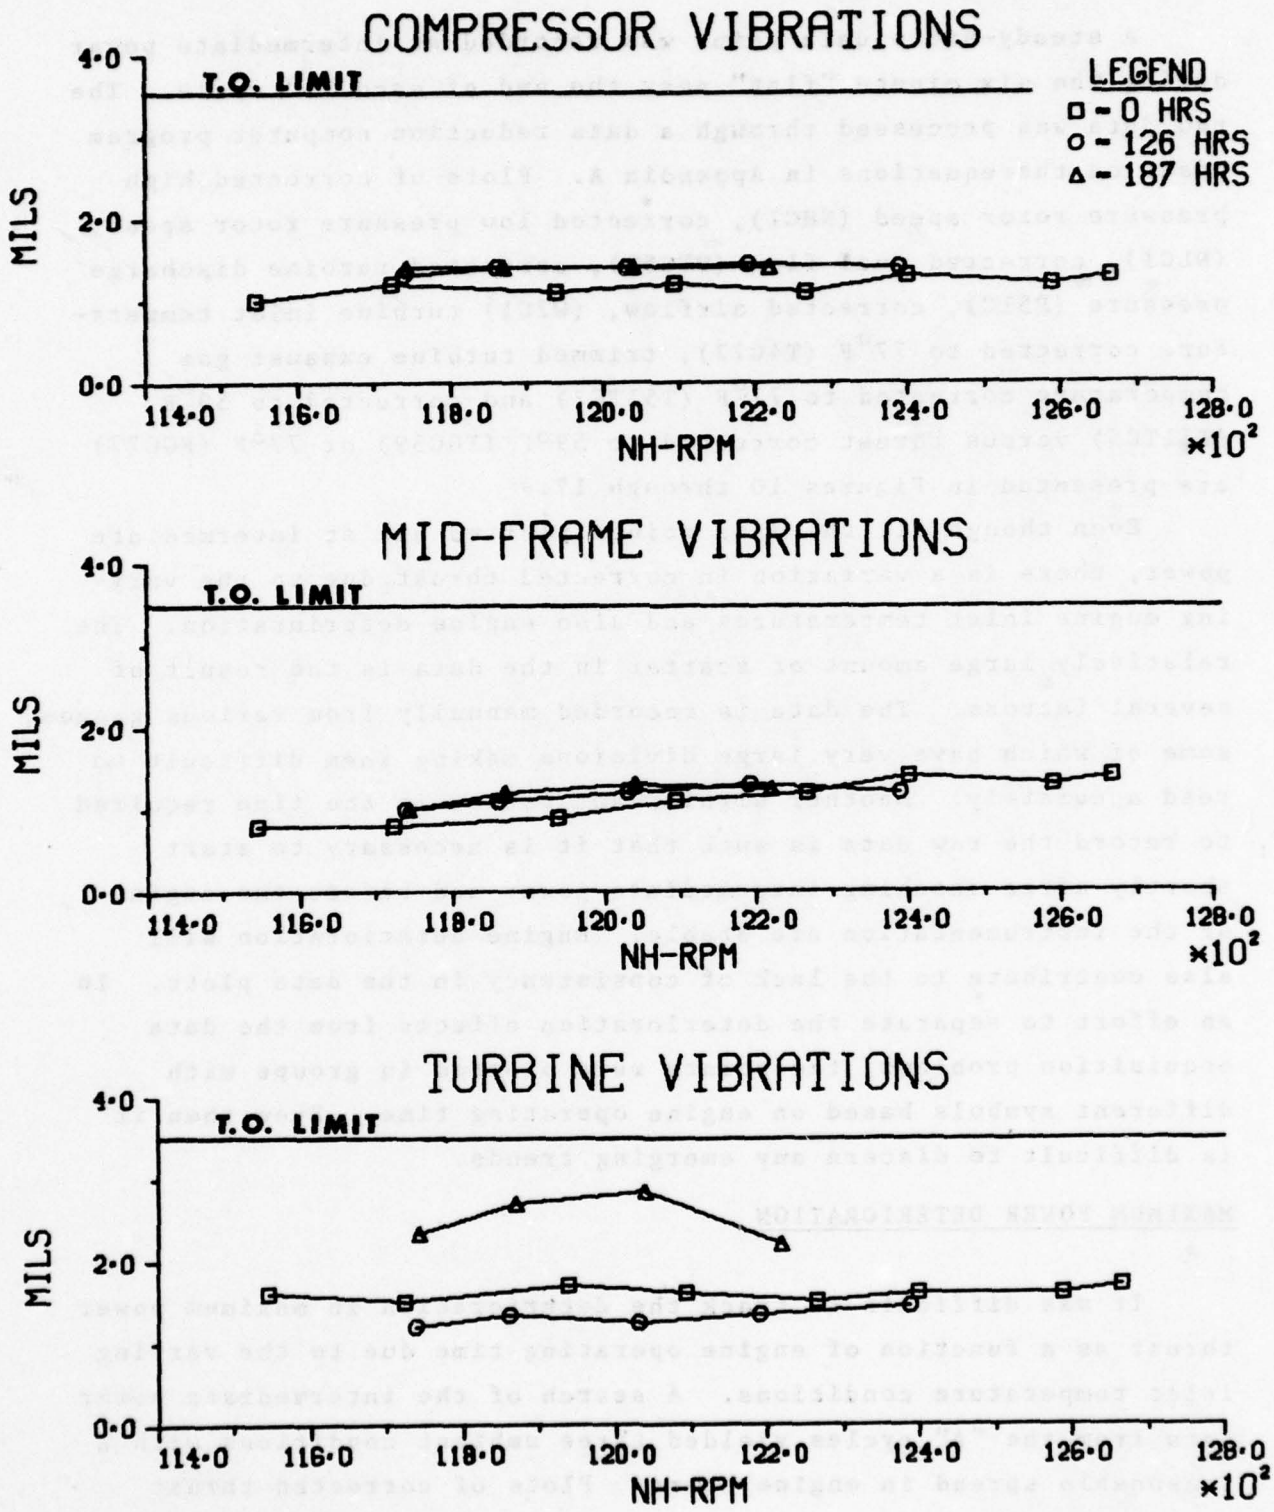
FIGURE 9 - ENGINE VIBRATION HISTORY

Turbine, compressor, and mid-frame vibrations were recorded during the power calibrations at 0, 126, 187 total hours and are plotted as a function of high pressure compressor RPM in Figure 9. Throughout the test the vibrations remained well below the T.O. limit. The compressor and midframe vibrations did not show any significant change with engine operating time. However, between 126 and 187 hours turbine vibration increased noticeably although they were still below operating limits.

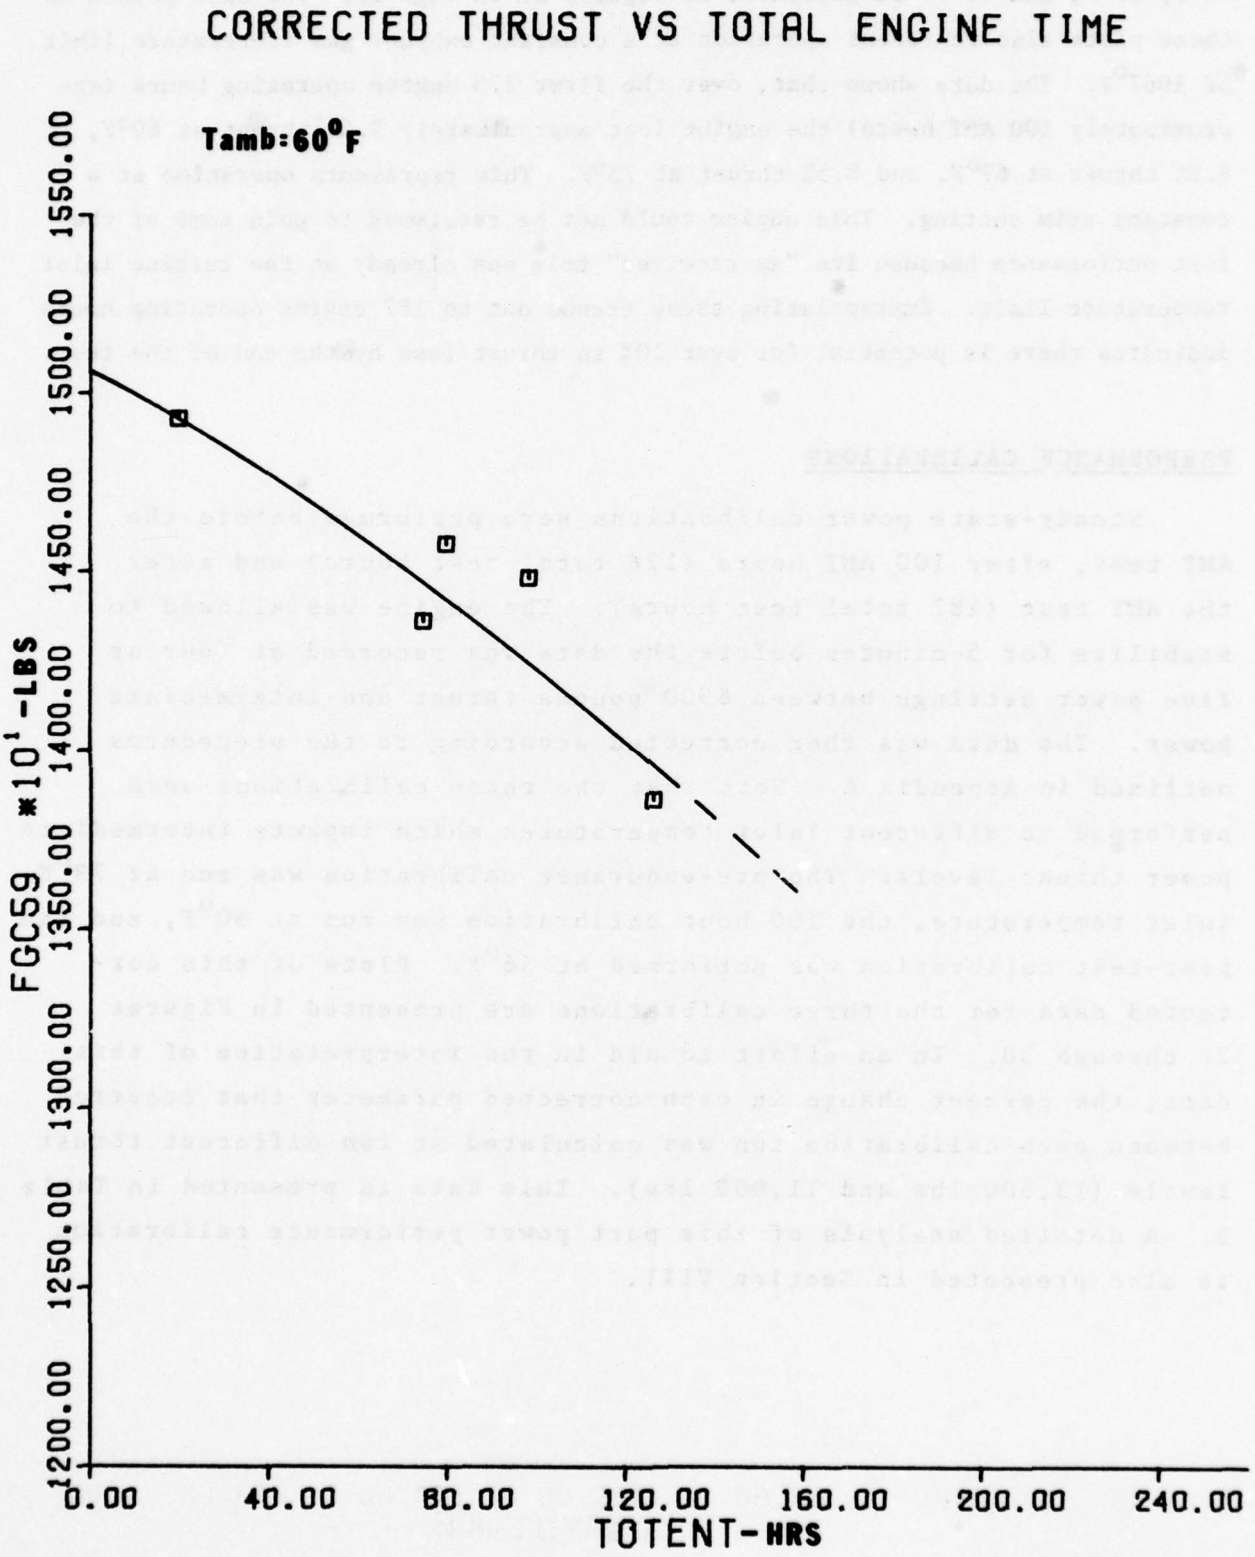
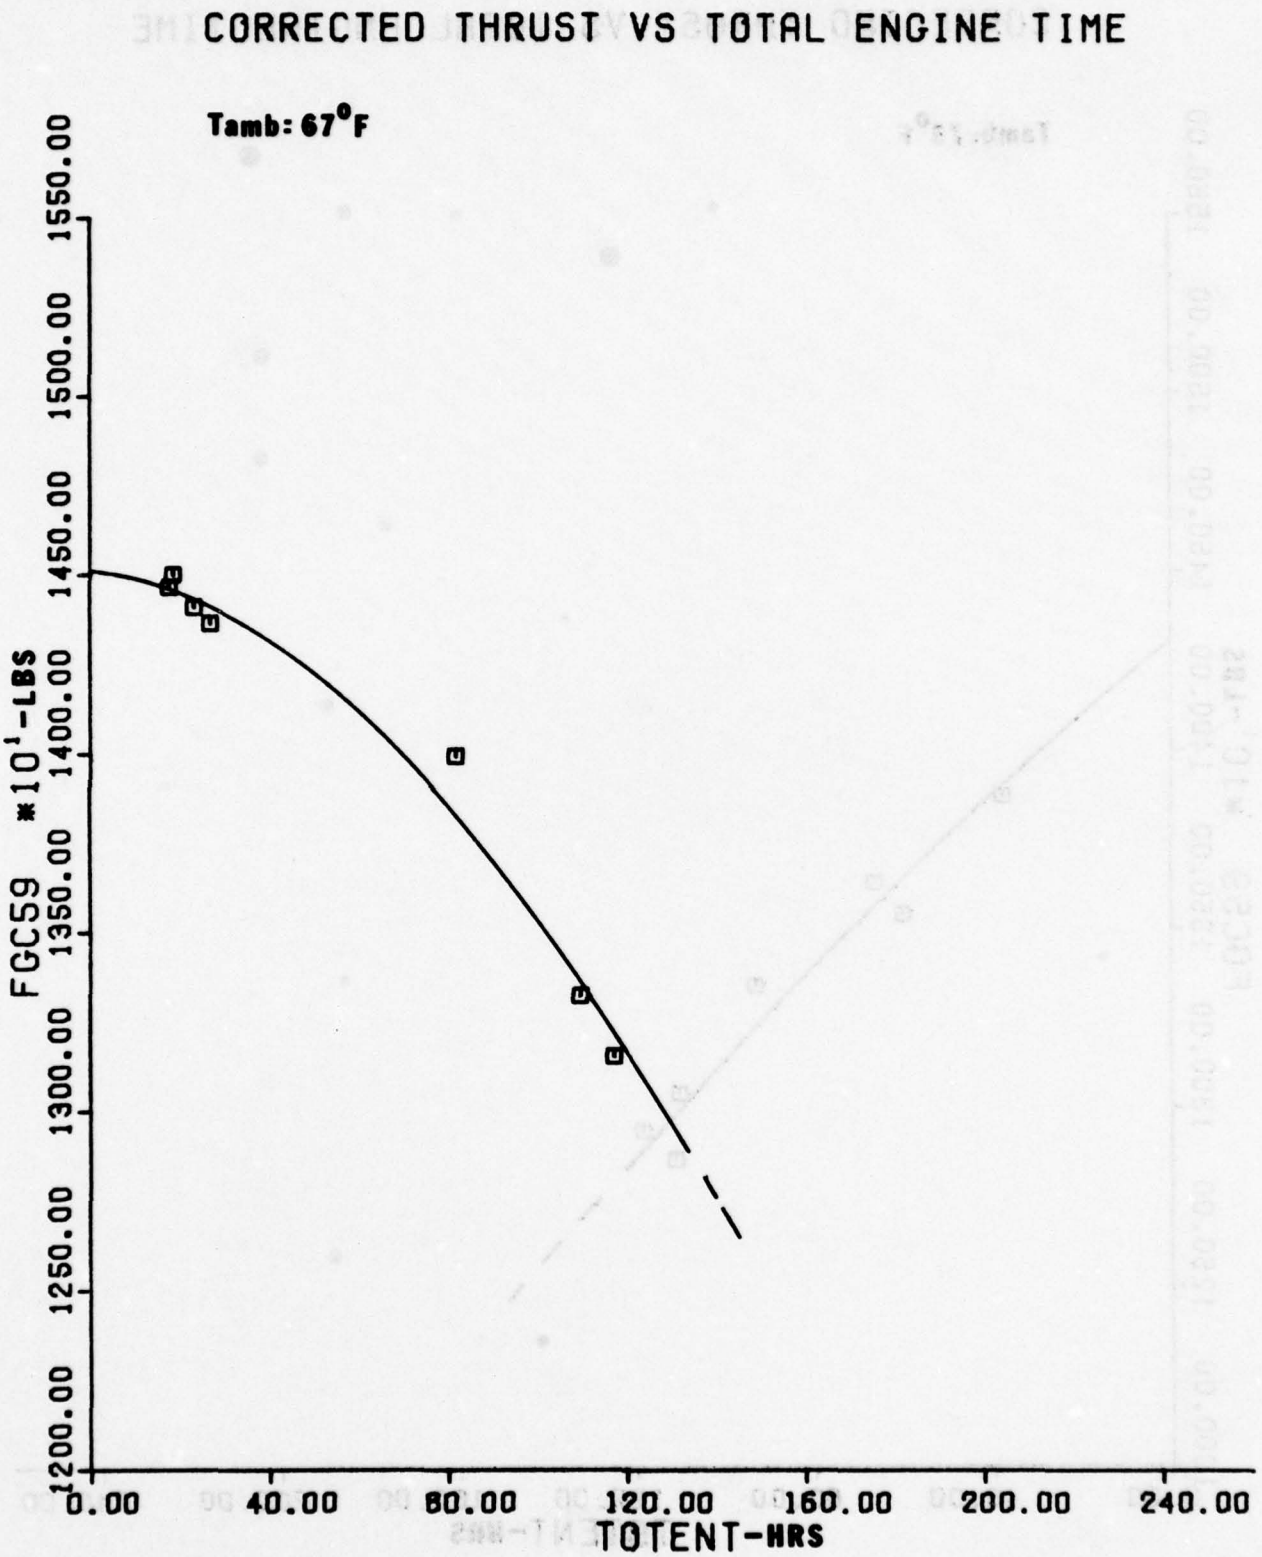
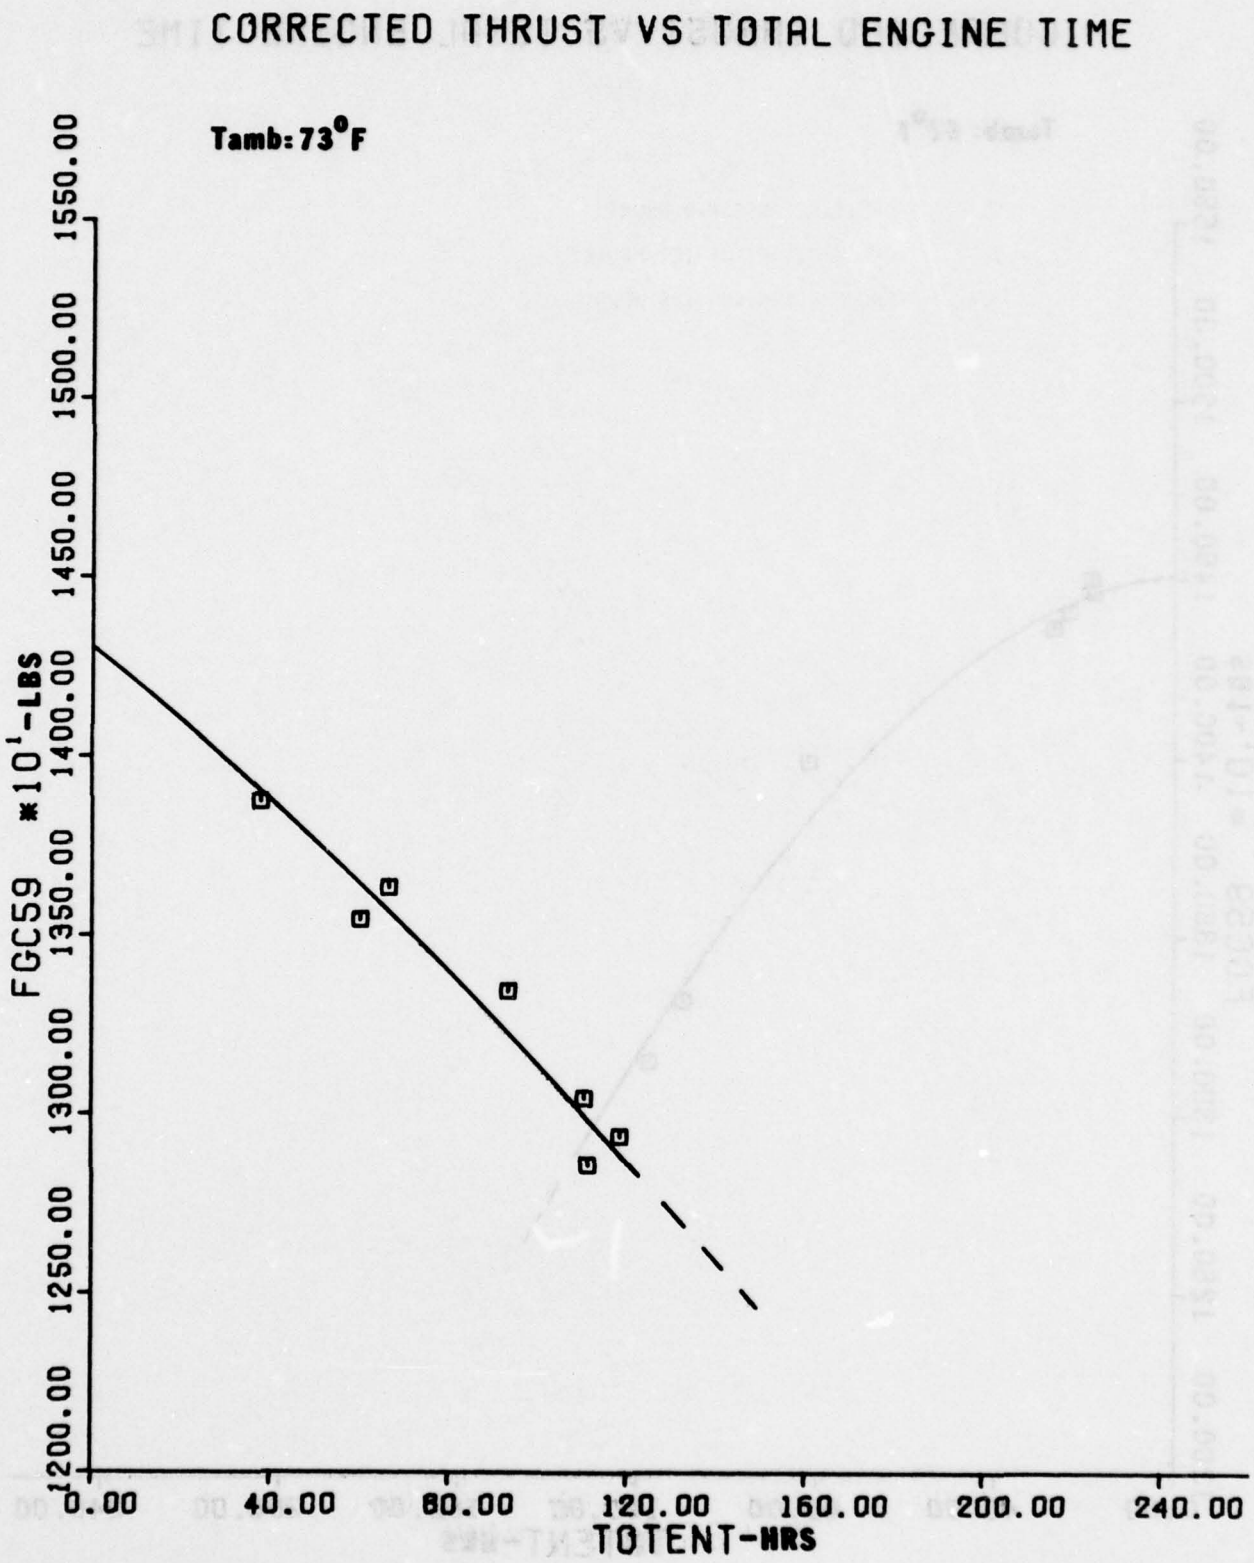
60°F, 67°F, and 73°F are presented in Figures 18 through 20. The data points on these plots also represent operation at a constant exhaust gas temperature limit of 1067°F. The data shows that, over the first 125 engine operating hours (approximately 100 AMT hours) the engine lost approximately 7.5% thrust at 60°F, 8.2% thrust at 67°F, and 8.5% thrust at 73°F. This represents operation at a constant trim setting. This engine could not be retrimmed to gain some of the lost performance because its "as received" trim was already at the turbine inlet temperature limit. Extrapolating these trends out to 187 engine operating hours indicates there is potential for over 10% in thrust loss by the end of the test.

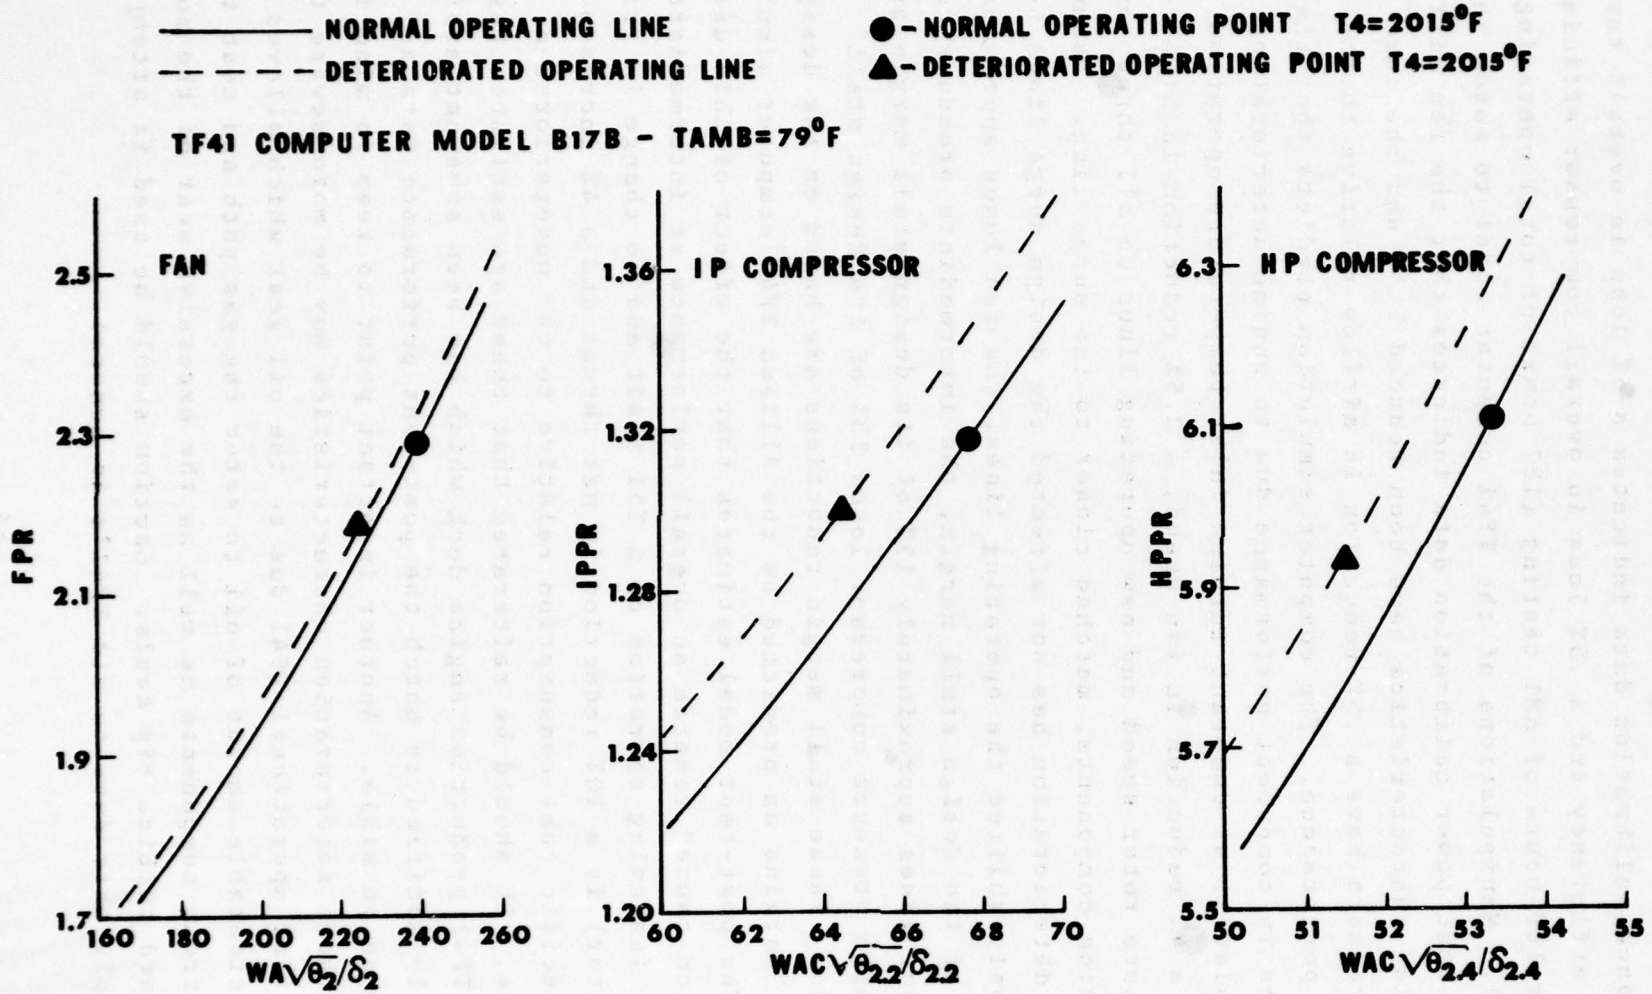
FIGURE 37 - EFFECT OF DETERIORATION ON ESTIMATED COMPRESSION SYSTEM OPERATING LINES

In summary, comparison of the pre-test and post-test performance calibration data indicates a 4% loss in overall turbine efficiency and a .5% loss in overall compressor efficiency after 160 hours of AMT testing (187 hours of total operating time). Manipulations of the TF41 computer model to match the post-test power calibration data indicates that the fan airflow pumping characteristics have been reduced 1.5% and the core compressors have a .5% reduction in airflow relative to the pre-test performance. The computer simulation predicts that these losses in component performance due to engine deterioration translates, at constant turbine inlet temperature operation, into a 4% reduction in fan speed, a 2.5% reduction in high pressure rotor speed and new operating lines on all three compression components, matched closer to the surge line. Assuming that deterioration has not affected the design surge lines but has only shifted the operating lines, the fan loses approximately 7.5% of its design stall margin, the intermediate pressure compressor loses approximately 15% of its design stall margin and the high pressure compressor loses 13% of its design stall margin. These stall margin reductions are based on the design stall margins as predicted by the Allison TF41 computer simulation.

The post-test model estimates that the effect of this deterioration caused rematch on overall performance at intermediate power (assuming operation on a T51 limit and no change in trim resistor) is a 10% reduction in net thrust and a 4% increase in specific fuel consumption relative to the undeteriorated engine. It should be reiterated that these are estimates based on a TF41 production engine deck which has been somewhat arbitrarily modified to match the post-test performance data as close as possible. Another important point to keep in mind is that these deterioration characteristics may be more severe than a typical operational TF41 due to the oil leak which allowed a considerable amount of oil to enter the gas path and coat the downstream components as well as the excessive wear of the non-standard turbine tip seals. Caution should be used in attempting to apply this data to all TF41's in general.

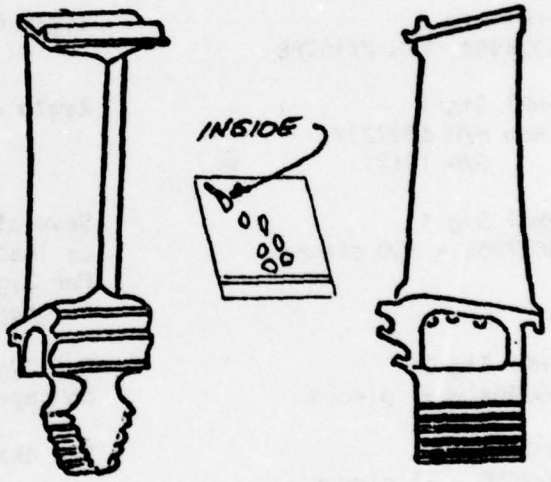
Blade P/N 6869795 has indications as shown.
