4. TITLE (and Subtitle)
Phase I Inspection Report
Batavia Kill Watershed Project Dam #3
Mohawk River Basin, Greene County, New York
Inventory No. N.Y. 608

Name of Dam:	Batavia Kill Watershed Project Dam No. 3 - I.D. No. NY-608 (#191C-3818)
State Located:	New York
County Located:	Greene
Watershed:	Mohawk River Basin
Stream:	an unnamed tributary to the Batavia Kill (a tributary to the Schoharie Creek)
Date of Inspection:	July 11, 1978

PHASE I INSPECTION REPORT
NATIONAL DAM SAFETY PROGRAM
BATAVIA KILL WATERSHED PROJECT
DAM No. 3
I.D. No. NY-608
(#191C-3818)
MOHAWK RIVER BASIN
GREENE COUNTY, NEW YORK

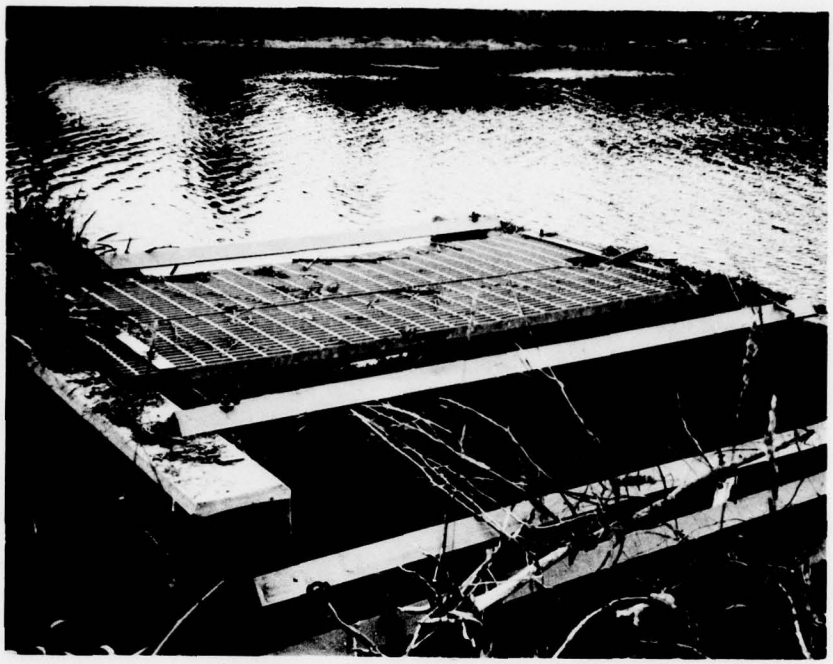
INLET of PRINCIPAL SPILLWAY
@ RISER

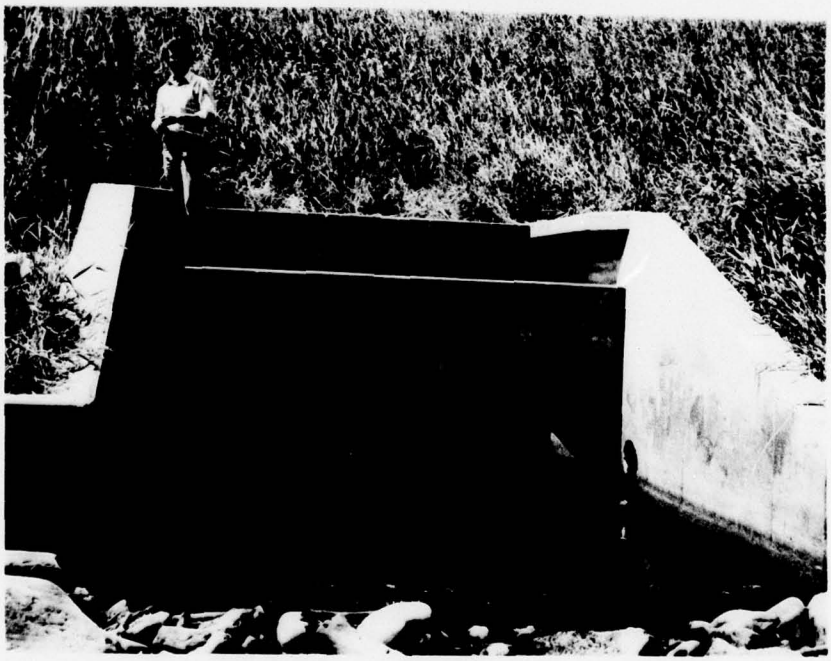
OUTLET of PRINCIPAL SPILLWAY
@ IMPACT BASIN
