AFFDL-TR-78-190

ADVANCED COMPOSITE WING COVER-TO-SUBSTRUCTURE ATTACHMENT (CTSA) DEVELOPMENT PROGRAM

Grumman Aerospace Corporation
Bethpage, New York 11714

January 1979

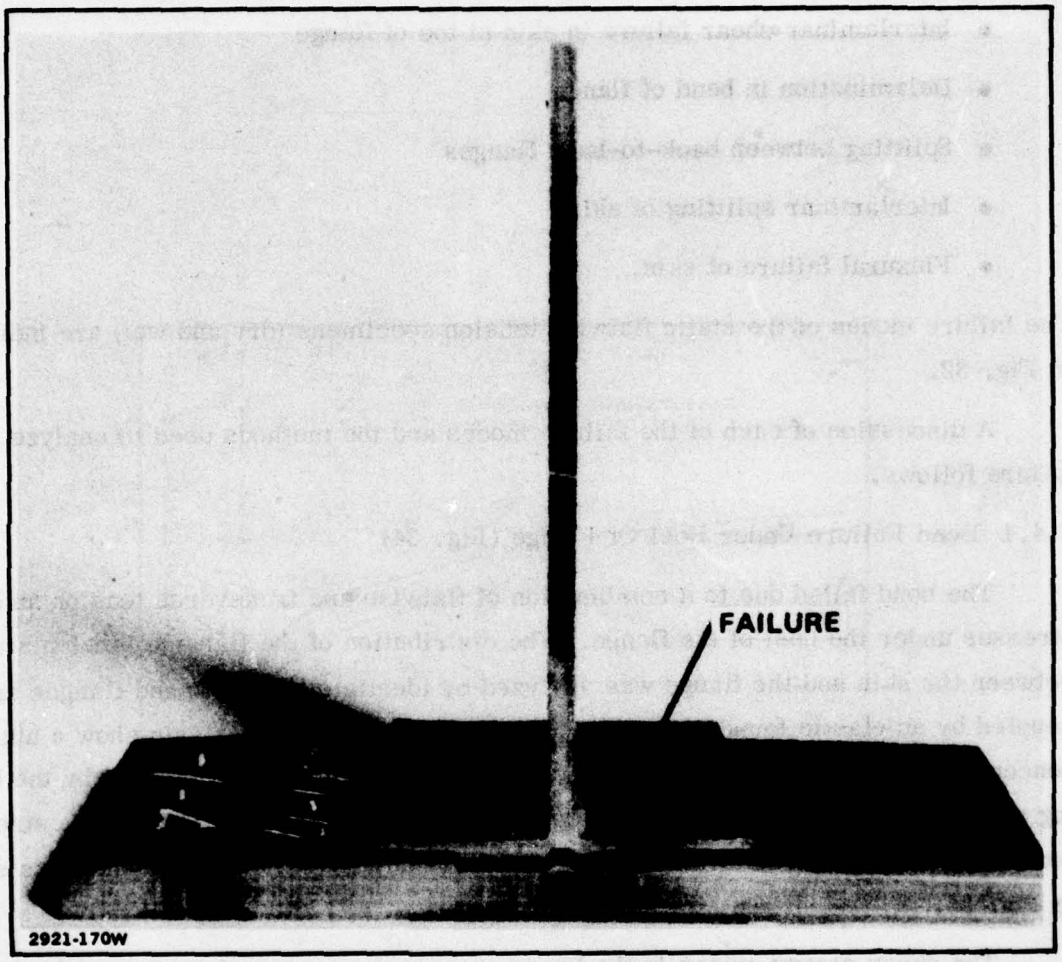
Fig. 34 Bond Failure Under Heel of Flange

3.4.1 Bond Failure Under Heel Of Flange (Fig. 34)

The bond failed due to a combination of flatwise and transverse tension and shear stresses under the heel of the flange. The distribution of the flatwise tension stress between the skin and the flange was analyzed by idealizing the skin and flanges as beams coupled by an elastic foundation (Ref. 3). The results of the analysis show a high stress concentration immediately under the heel of the flange, caused primarily by the bending of the skin so as to impose zero slope at the centerline of the joint. The stress concentration can be reduced by increasing the bending stiffness of the skin, as shown in Fig. 35.

The shear stress arises in the bond because of a mismatch in the axial strains (in the 90° direction) at the adjacent faces of the skin and flange. The skin has a tensile strain at the joint due to the bending moment imposing zero slope on the skin at the joint centerline; the flange has zero moment at the heel. The shear stress was analyzed by a simple "shear lag" model per Ref. 1. Again, the magnitude of the shear stress concentration is reduced by increasing the bending stiffness of the skin simply because the strain mismatch is reduced. Combining the flatwise tension, transverse tension due to skin bending, and the shear stresses with a modified Hill-von Mises yield criterion for the matrix enables a successful prediction of the bond

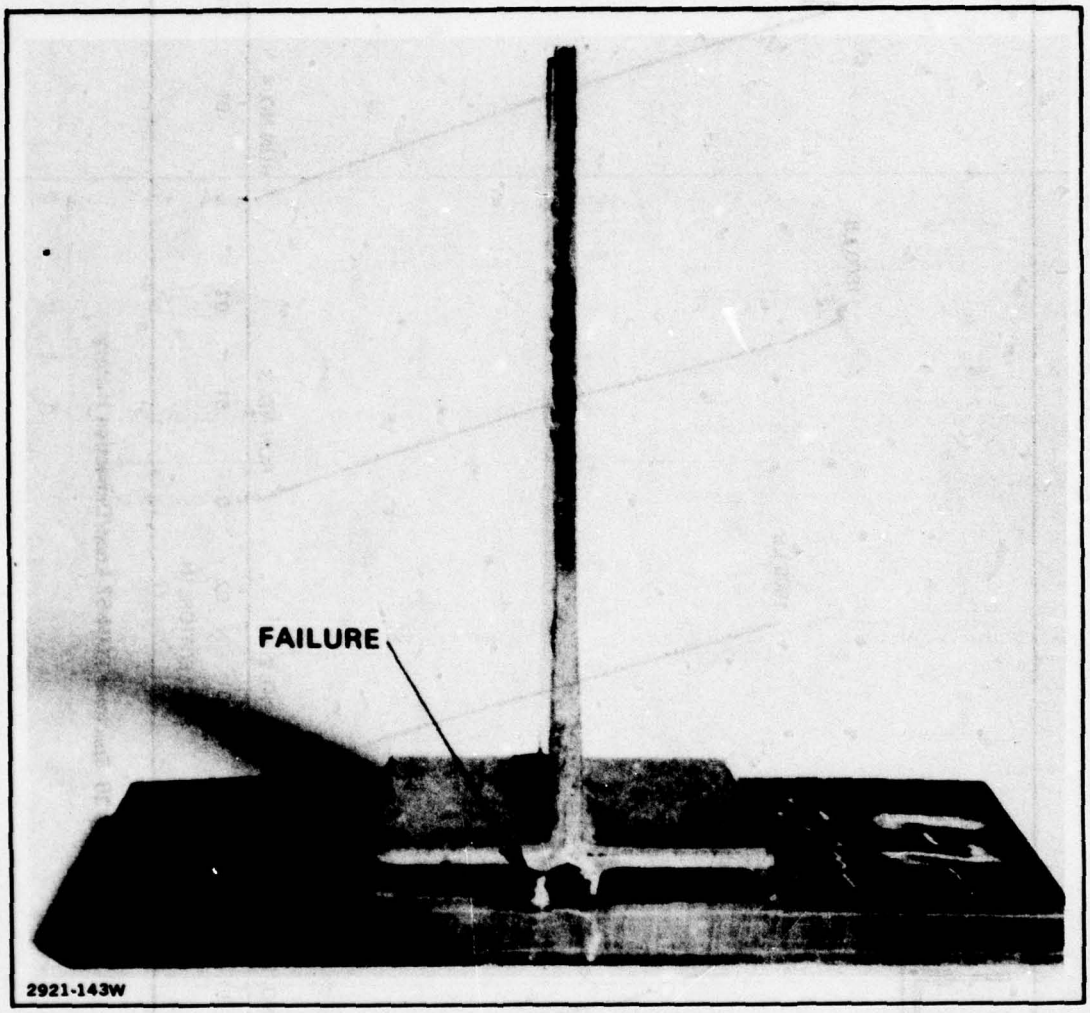
Fig. 37 Failure of Stitch

3.4.2 Failure of Stitch (Fig. 37)

The stitch failed in tension, and the failure can be predicted on the basis of a simple "heel and toe" action of the flange with tension in the stitch near the heel and bearing pressure over a small area at the toe of the flange. The matrix can be neglected in this analysis because the matrix failed before the stitch as a result of the combination of high flatwise tension and shear stress at the heel. In fact, the stitch acts as a form of crack stopper to the spread of the bond failure and the joint carries further load after the bond failure.

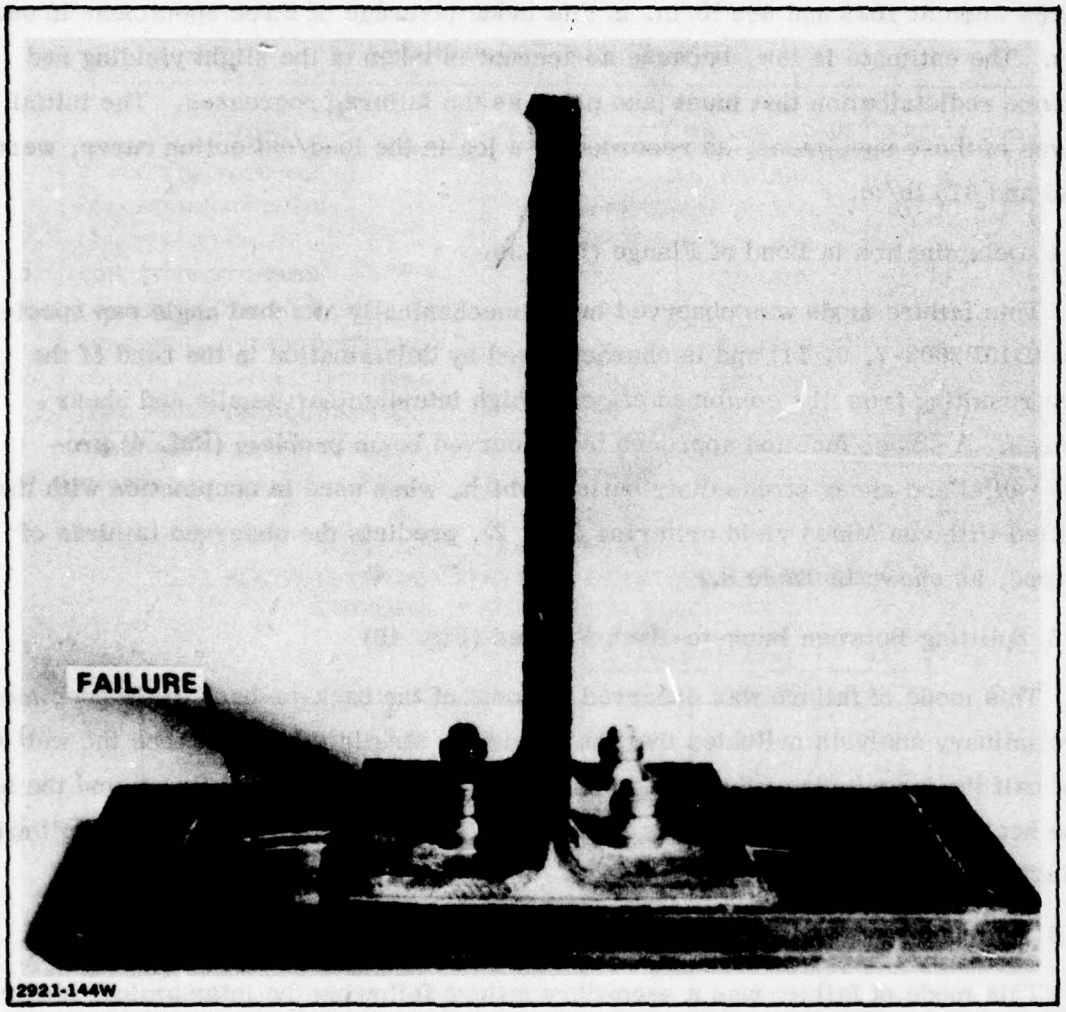
Fig. 38 Interlaminar Shear Failure in Skin at Toe of Flange

3.4.3 Interlaminar Shear Failure Of Skin (Fig. 38)

This failure was not a failure of the joint, but occurred in the skin close to the toe of the flange where the overall section changes abruptly on the test specimens. This abrupt change could be eliminated in future designs by tapering the flange from heel to toe.

Analysis of the specimens that failed in this way shows evidence of a nonuniform load introduction. Anticlastic curvature of the skin, coupled with the bending flexibility of the roller, caused the load to be concentrated at the outer edges of the specimen. A simple analysis shows the roller to be in contact with the skin surface over

Failure analysis based on the maximum interlaminar shear stresses under the peak bearing location gives an estimated failure load of 603 lb/in. for the joint. Test failures were at 1028 and 869 lb/in. in this mode (average of three specimens in each case). The estimate is low, because no account is taken of the slight yielding and pressure redistribution that must take place as the failure progresses. The initial failures of these specimens, as recorded by a jog in the load/deflection curve, were at 785 and 615 lb/in.

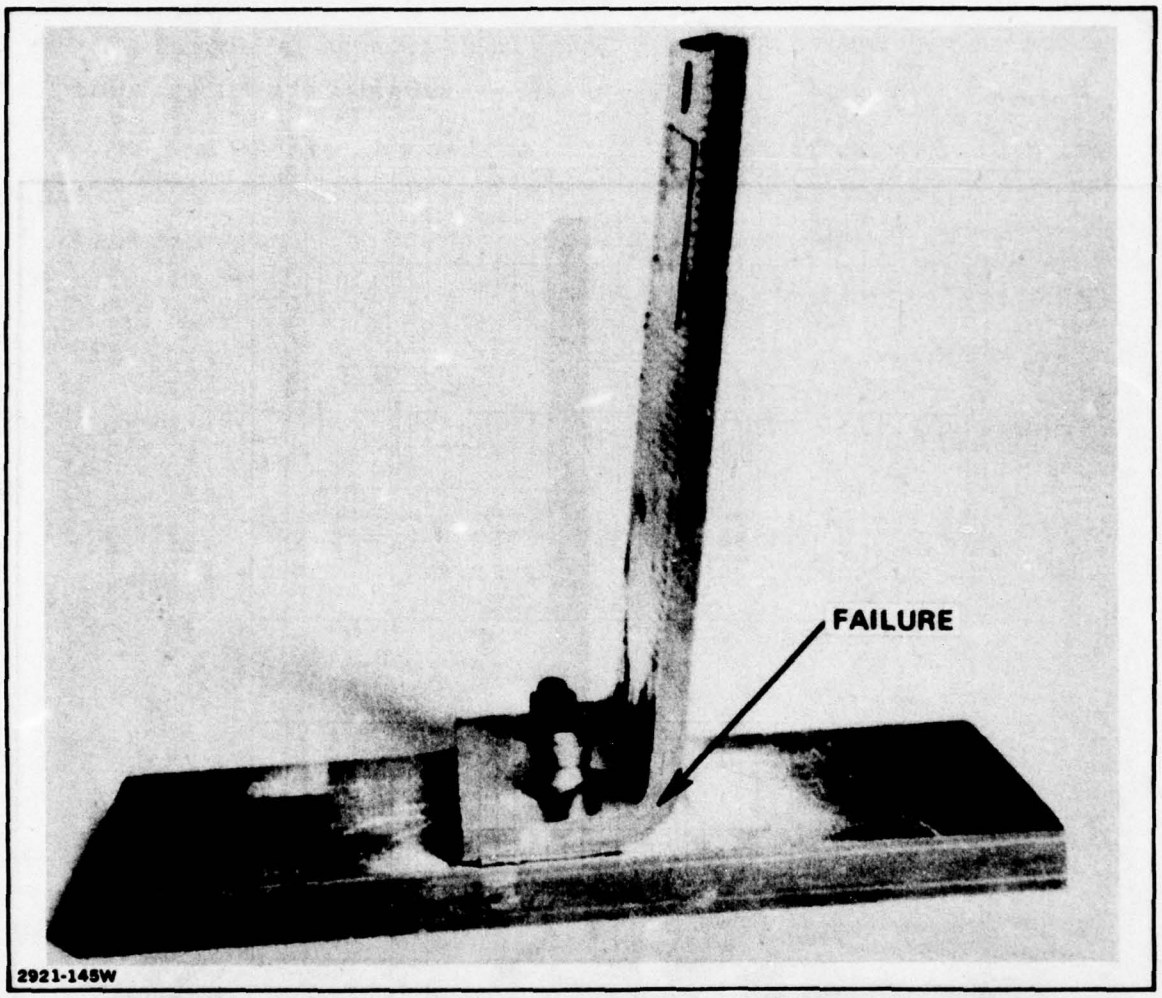
Fig. 39 Delamination in Bend of Flange

This failure mode was observed in the mechanically attached angle cap specimens (D10B2003-7, 9, 11) and is characterized by delamination in the bend of the flange resulting from the combined effect of high interlaminar tensile and shear stresses. A stress function approach to the curved beam problem (Ref. 4) produces radial and shear stress distributions which, when used in conjunction with the modified Hill-von Mises yield criterion (Ref. 2), predicts the observed failures of this type, as shown in Table 8.

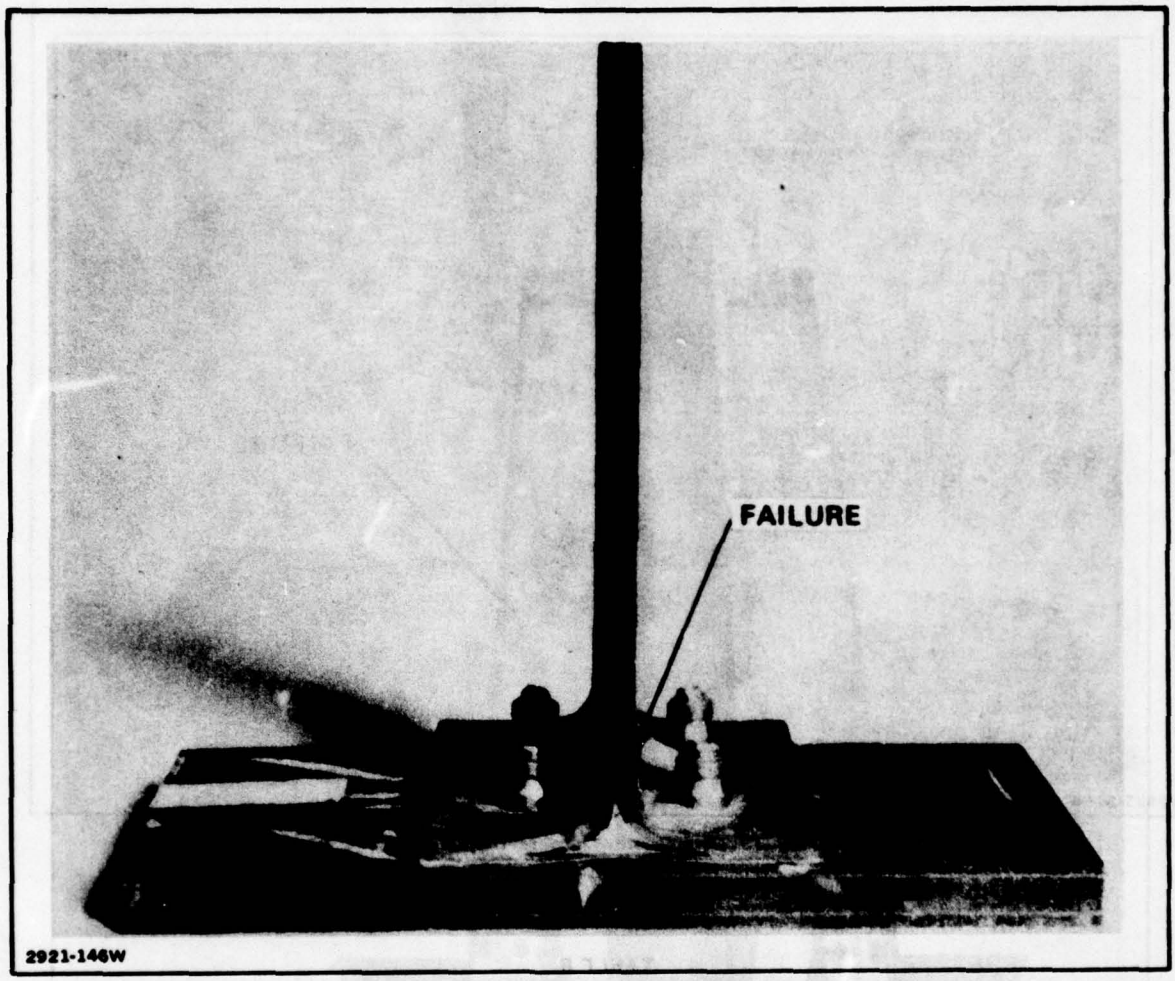
Fig. 40 Splitting Between Back-To-Back Flanges

This mode of failure was a secondary failure following the interlaminar shear failure of the skin. It appears that the interlaminar shear crack propagated diagonally through the laminate until it reached the 90° (chordwise) layers, at which point the crack propagated in the chordwise direction along the 90° layers. Analagous behavior is observed in steel reinforced concrete beams where diagonal tension cracks often result in splitting of the concrete along the tension reinforcement.

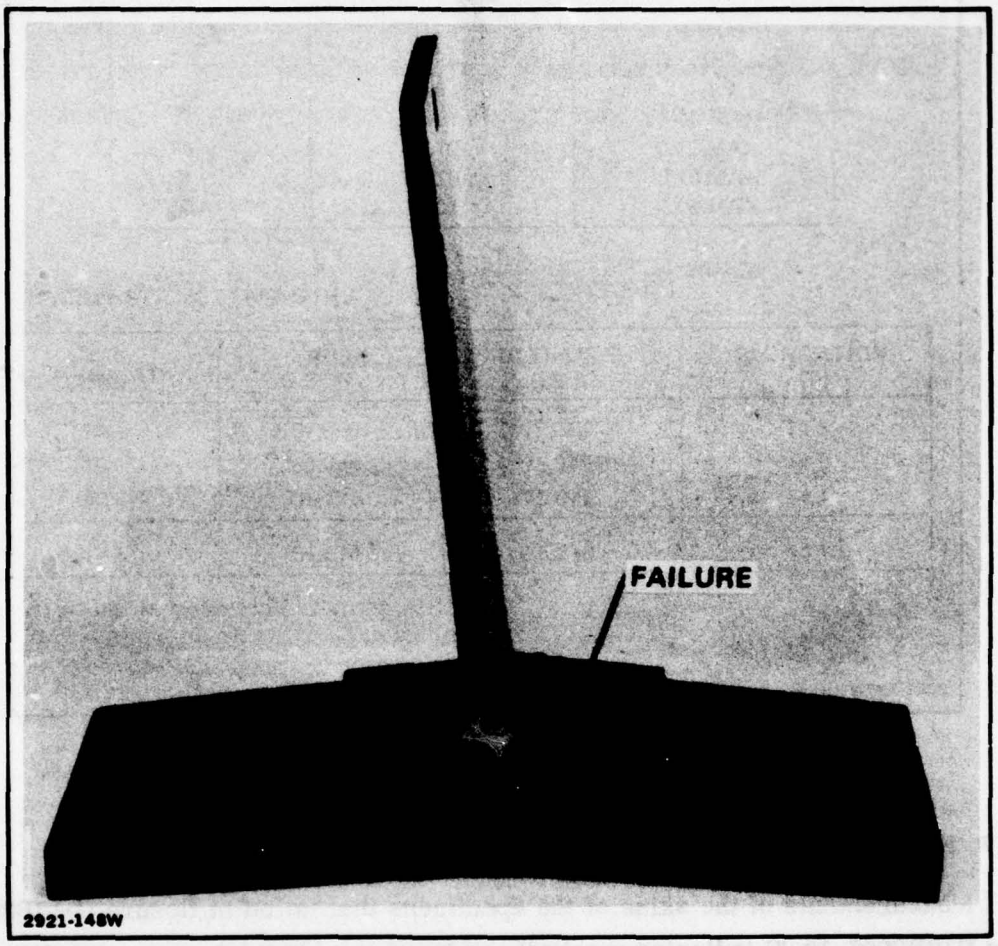
Fig. 42 Flexural Failure of Skin

3.4.7 Flexural Failure of the Skin (Fig. 42)

Measurements of the skins of the specimens that failed in flexure (D10B2005-43-3 and D10B2007-19-3) indicated markedly reduced per ply thicknesses resulting in bending stiffnesses which were significantly lower than those calculated using nominal layer thicknesses (41.7% and 16.8% reductions respectively). The results of tensile tests on stitched coupons indicate that the strength reduction caused by the stitch is equivalent to that caused by a 1/16 inch diameter open hole. This fact, used in conjunction with the actual bending stiffnesses and our notched laminate strength prediction method (Ref. 5), indicate the susceptibility of these specimens to flexural failure at -67° F as indicated in Table 9.

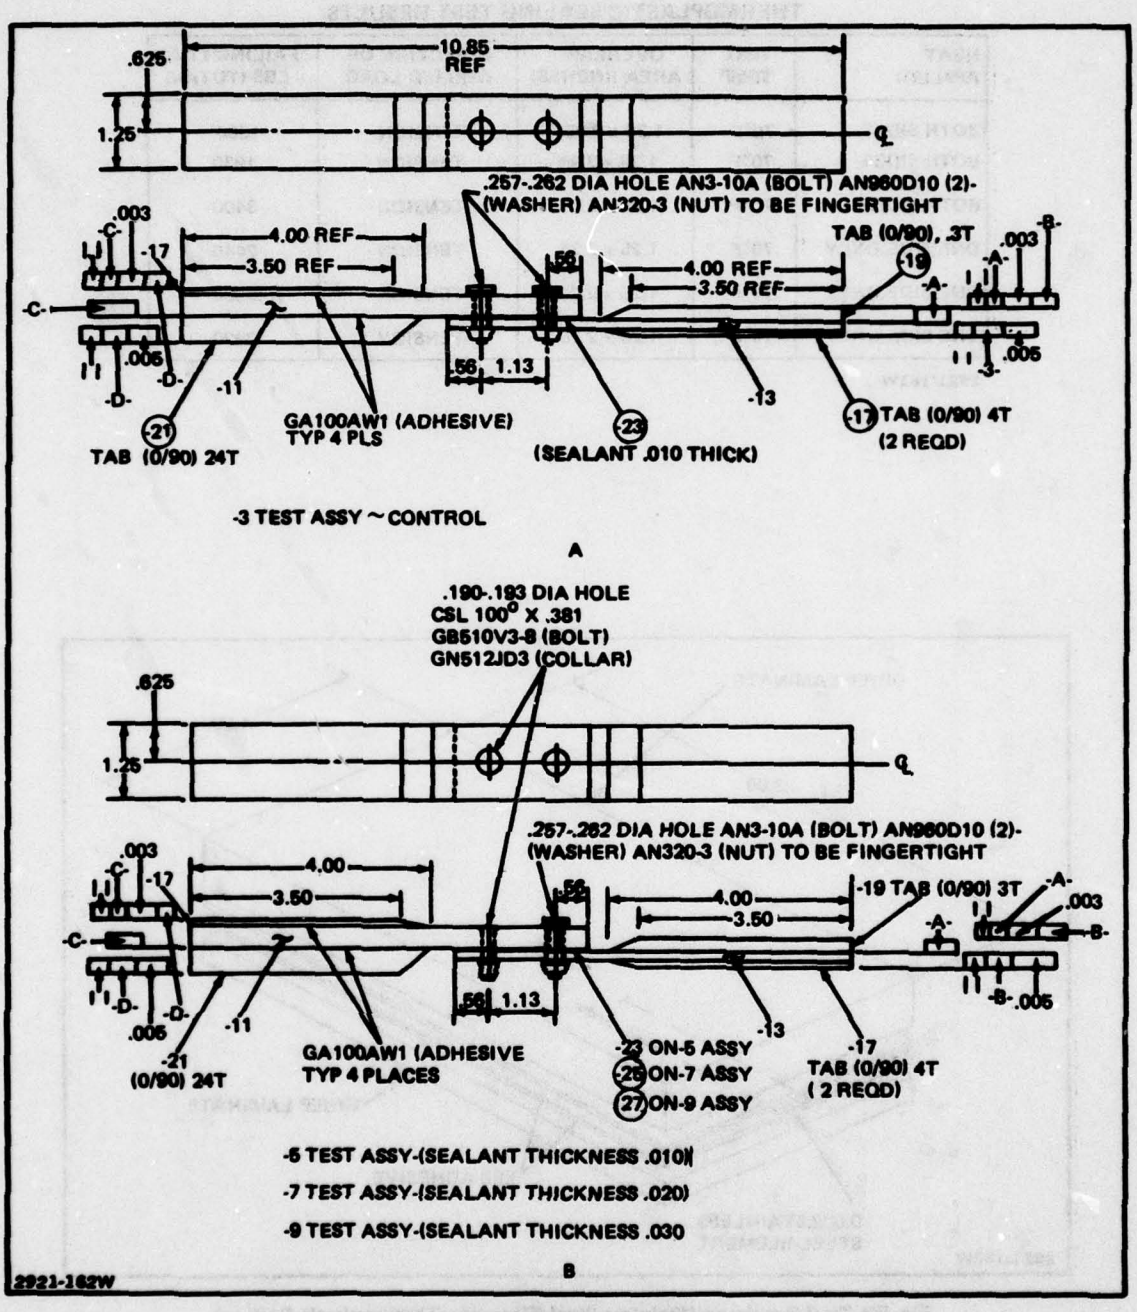
Fig. 52 Thermoplastic Sealing, Element

Six specimens (Fig. 52) were bonded by translaminate heating with the melt temperature for the polyether-sulphone (PES) adhesive in the 575-600°F range.

All failures were in the graphite/epoxy adherends; the PES adhesive bonds remained intact in all tests.

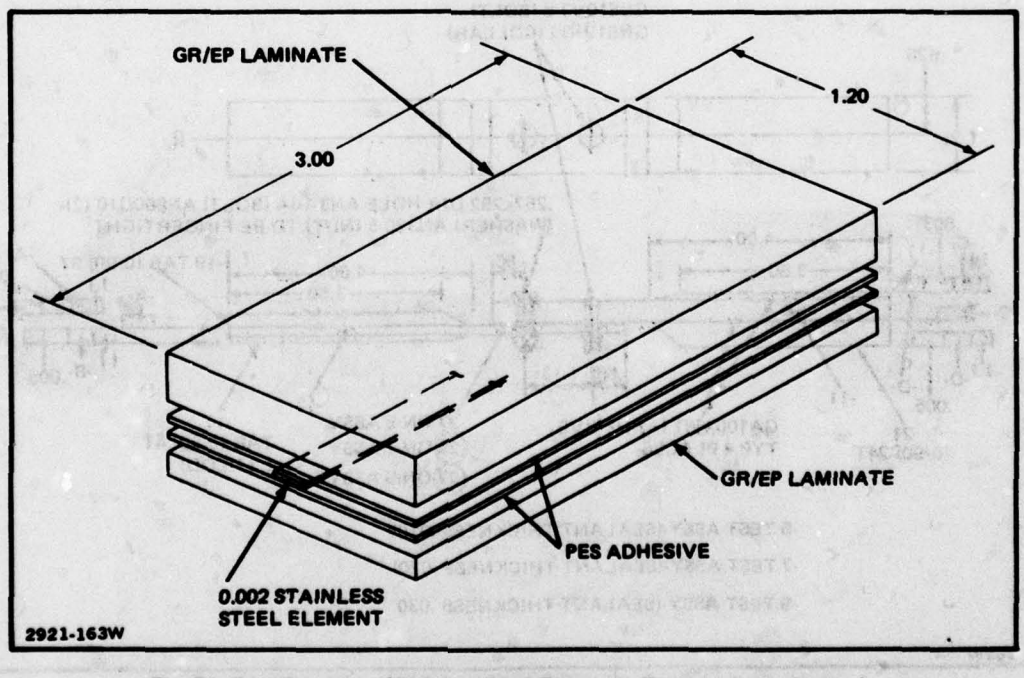
Fig. 53 Trial Specimen (Stainless-Steel Element - Thermoplastic Sealing)

Trial specimens were fabricated using a 0.25 in. wide strip of 0.002 in. thick stainless steel foil as a heating element. The specimens were 3.0 in. long and 1.20 in. wide. Three layers of 0.004 in. thick PES were placed on both sides of the stainless steel heating element as shown in Fig. 53. Electrical power was applied to the ends of the heating element to the capacity of 8.0 amps at 20.0 v. Insufficient heat was generated to completely melt the PES adhesive - only local melting in close proximity to the heating element was achieved - and it was obvious that complete melting would require a heating element with a higher resistivity and a thermoplastic adhesive with a lower melting point.

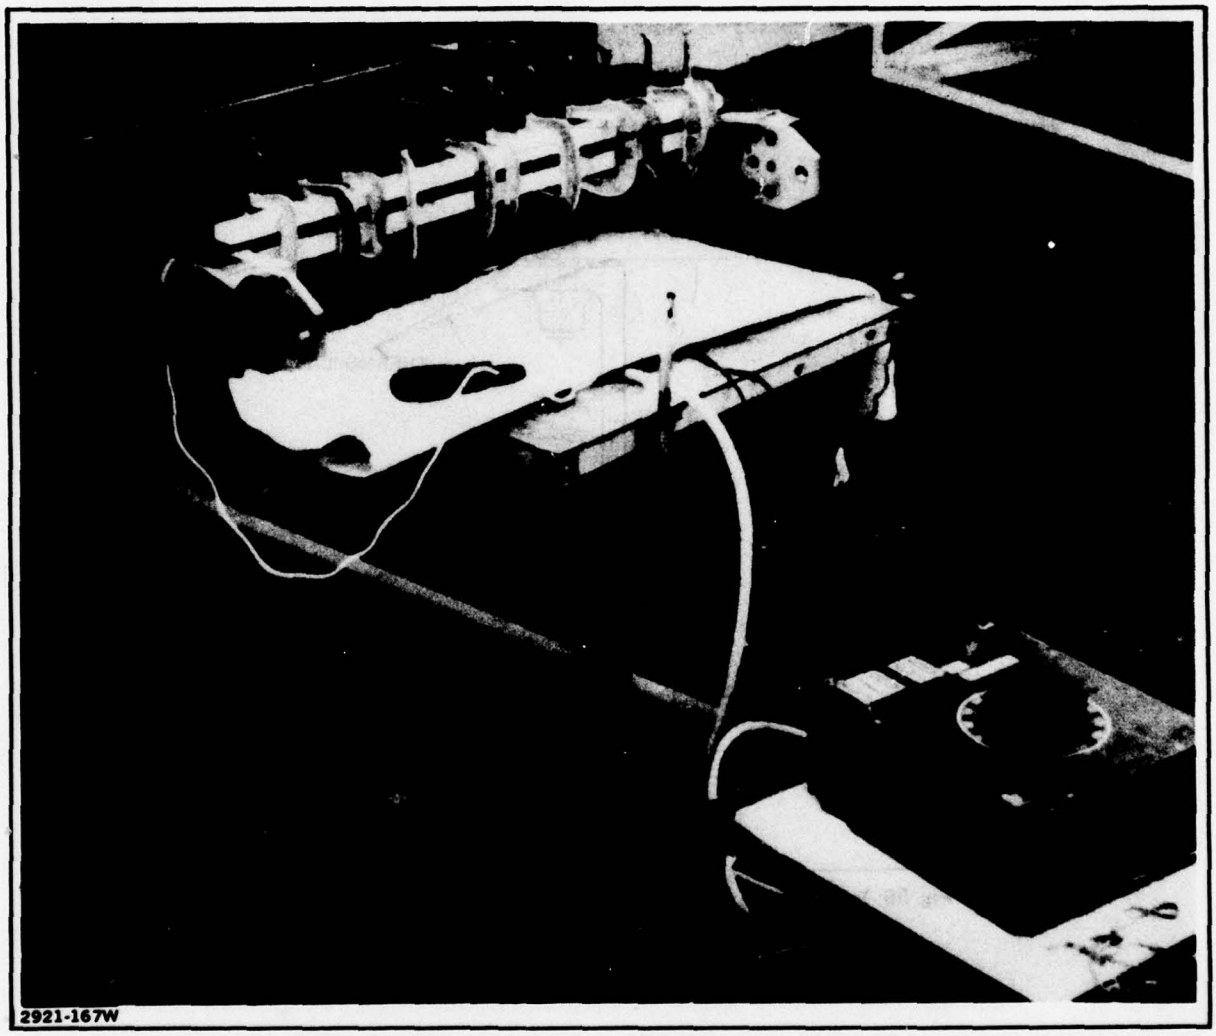
Fig. 57 Resistance Bonding of Thermoplastic Adhesive

To minimize the loss of energy due to the steel ribs, they were coated with two layers of the thermoplastic seal. The upper cover was bonded using the resistance heating method (Fig. 57). Inspection of the bond was performed using a 0.001 inch feeler gage. A one inch long disbond was discovered at all four corners of the box

(intersection of upper cover, front/rear spars and loading rib). This is only 2% of the total bond length (200 in.). Repeated tries to melt the unsealed area using the resistance heating method failed. This was due to the complexity of corner detail (i.e., steel rib - graphite/epoxy cover). It was decided to install the periphery fasteners and insert the test box assembly in the oven at 400° F for 15 minutes. This procedure was successful in sealing the four unsealed corners. Figure 58 graphically depicts the sealing sequence.

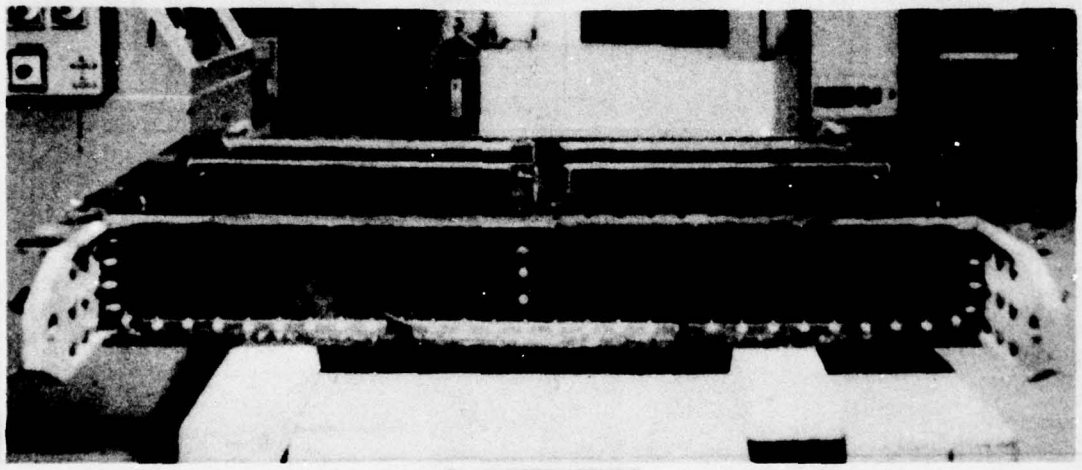
Fig. 60 Test Box Showing Upper Cover & Substructure After Removal of Thermoplastic Bond

Figure 60 shows the upper cover and substructure after removal of thermoplastic bond.

The upper cover and substructure were cleaned in a bath of Oakite before the rebonding operation. New graphite thermoplastic heating elements were made. Using the new heating elements, an attempt was made to bond the upper cover to the substructure. This was only partially successful because only the corners were bonded. The thermoplastic adhesive was melted only in the vicinity of the tabs where the temperature was in excess of 380° F. At a distance of eighteen inches from the tab, the temperature was only 180° F. Efforts to increase the 180° F temperature by increasing the amperage failed. The rises in temperature vs. current (amps) experienced are given in Table 13. These results show that the design of the graphite heating element tabs (Fig. 61) needs more development in order to solve the local overheating problem.

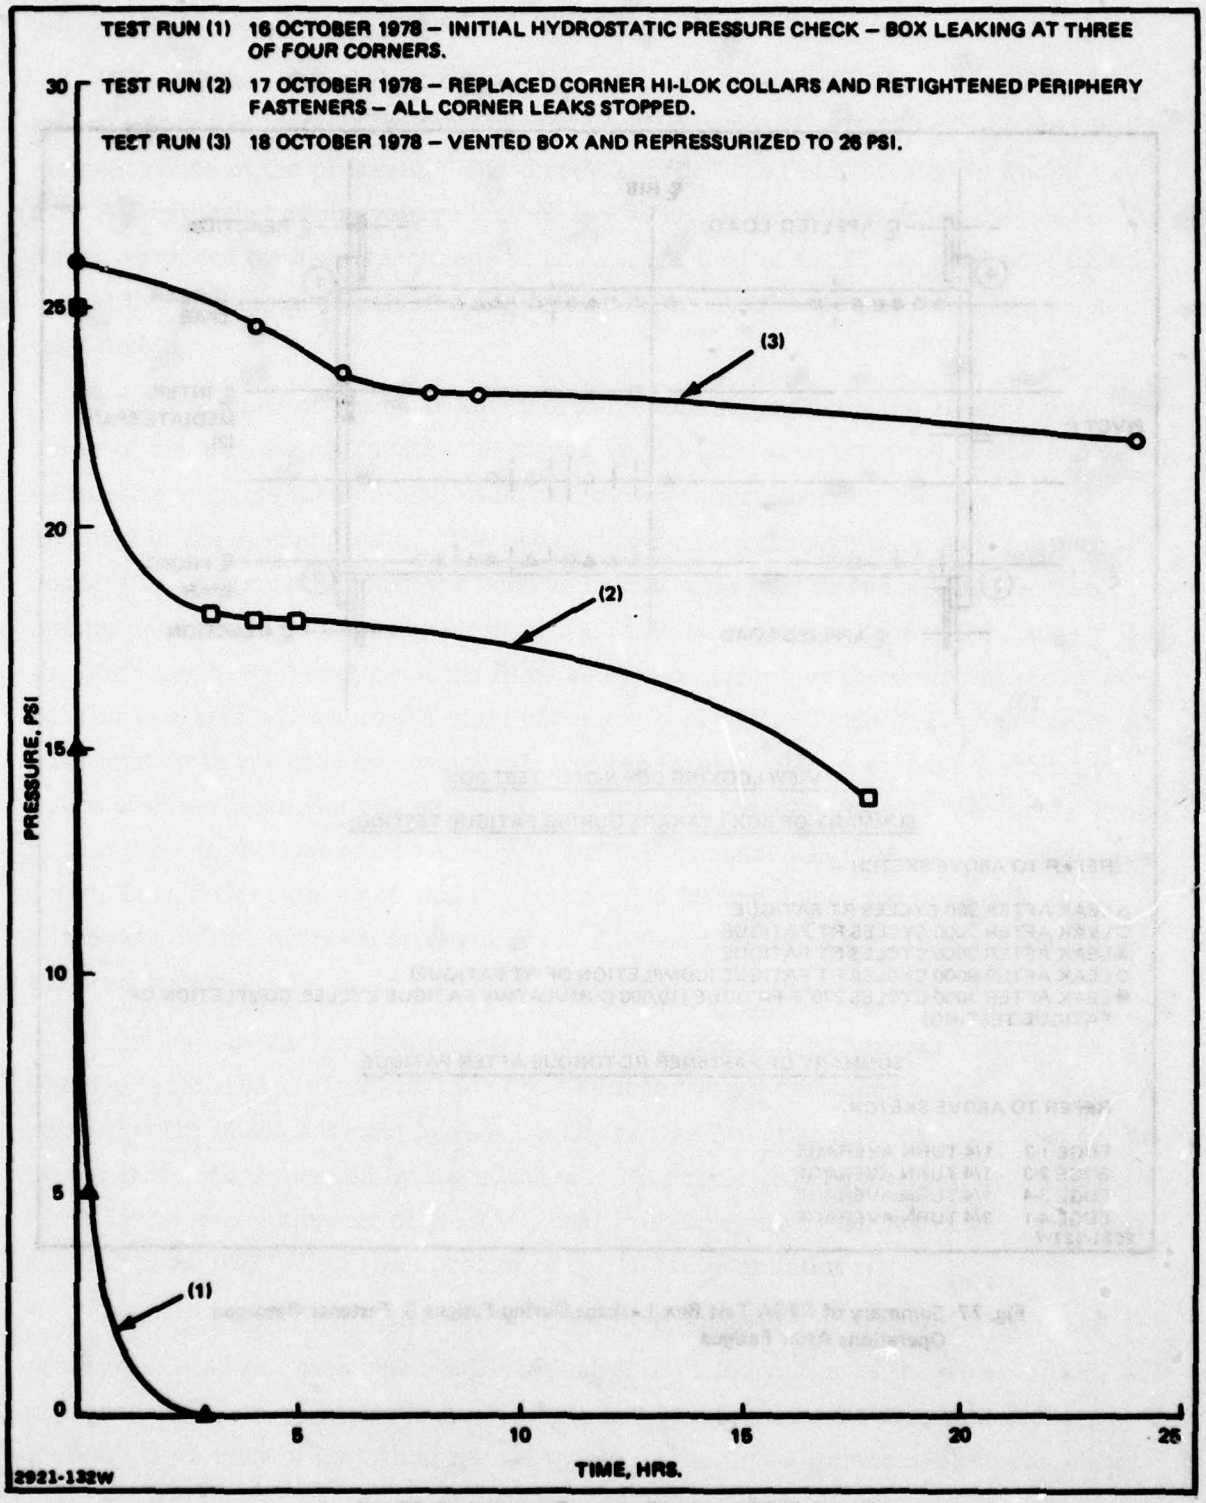
Fig. 76 Preliminary Pressure Checks of CTSA Test Box

For test number one, the specimen was filled with water and an attempt made to pressurize the box to 25 psig. After replacing the corner Hi-Lok collars and retightening the periphery fasteners, a second run was made, this time to 25 psig. This test resulted in a significant reduction of the leakage rate. A third and final run was made after the box was vented. Pressure was applied to 25 psig and held for 25 hours.

During the first test, pressure check, which consisted of three separate pressurizations, a significant reduction of specimen leakage was achieved as can be seen in Fig. 76. A discussion of this test is presented in subsection 6.5.

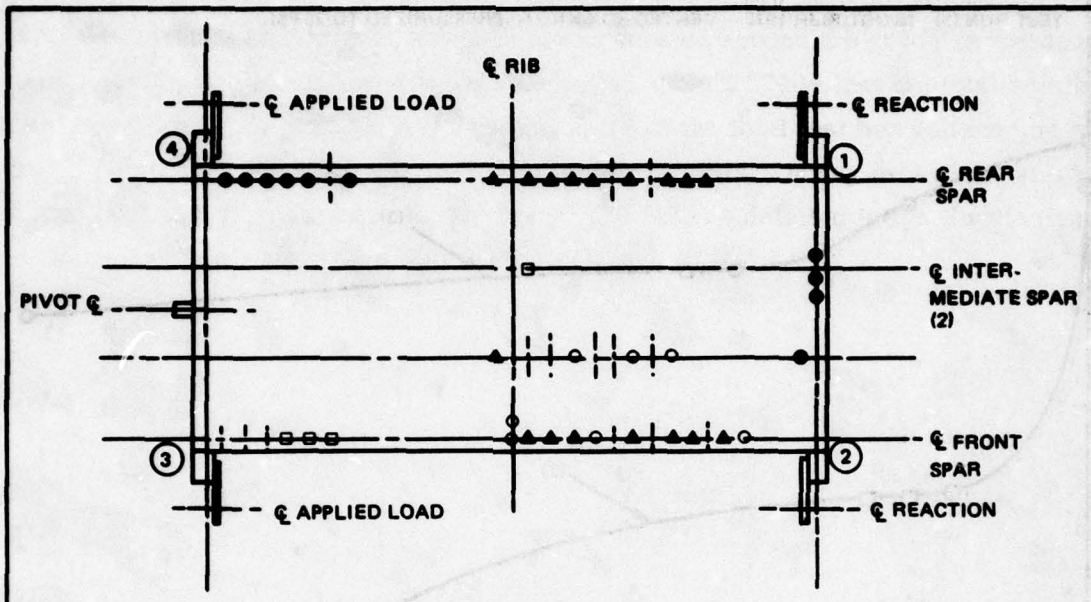
Fig. 77 Summary of CTSA Test Box Leakage During Fatigue & Fastener Retorque Operations After Fatigue

EDGE 1-2	1/4 TURN AVERAGE
EDGE 2-3	1/4 TURN AVERAGE
EDGE 3-4	1/4 TURN AVERAGE
EDGE 4-1	3/4 TURN AVERAGE

Upon completion of the fatigue test, a visual inspection of the test specimen was made to check for structural damage. None was found. However, it was noticed that a number of periphery fasteners had become loose; see Fig. 77 for a summary. All fasteners were retorqued prior to continuation of testing.

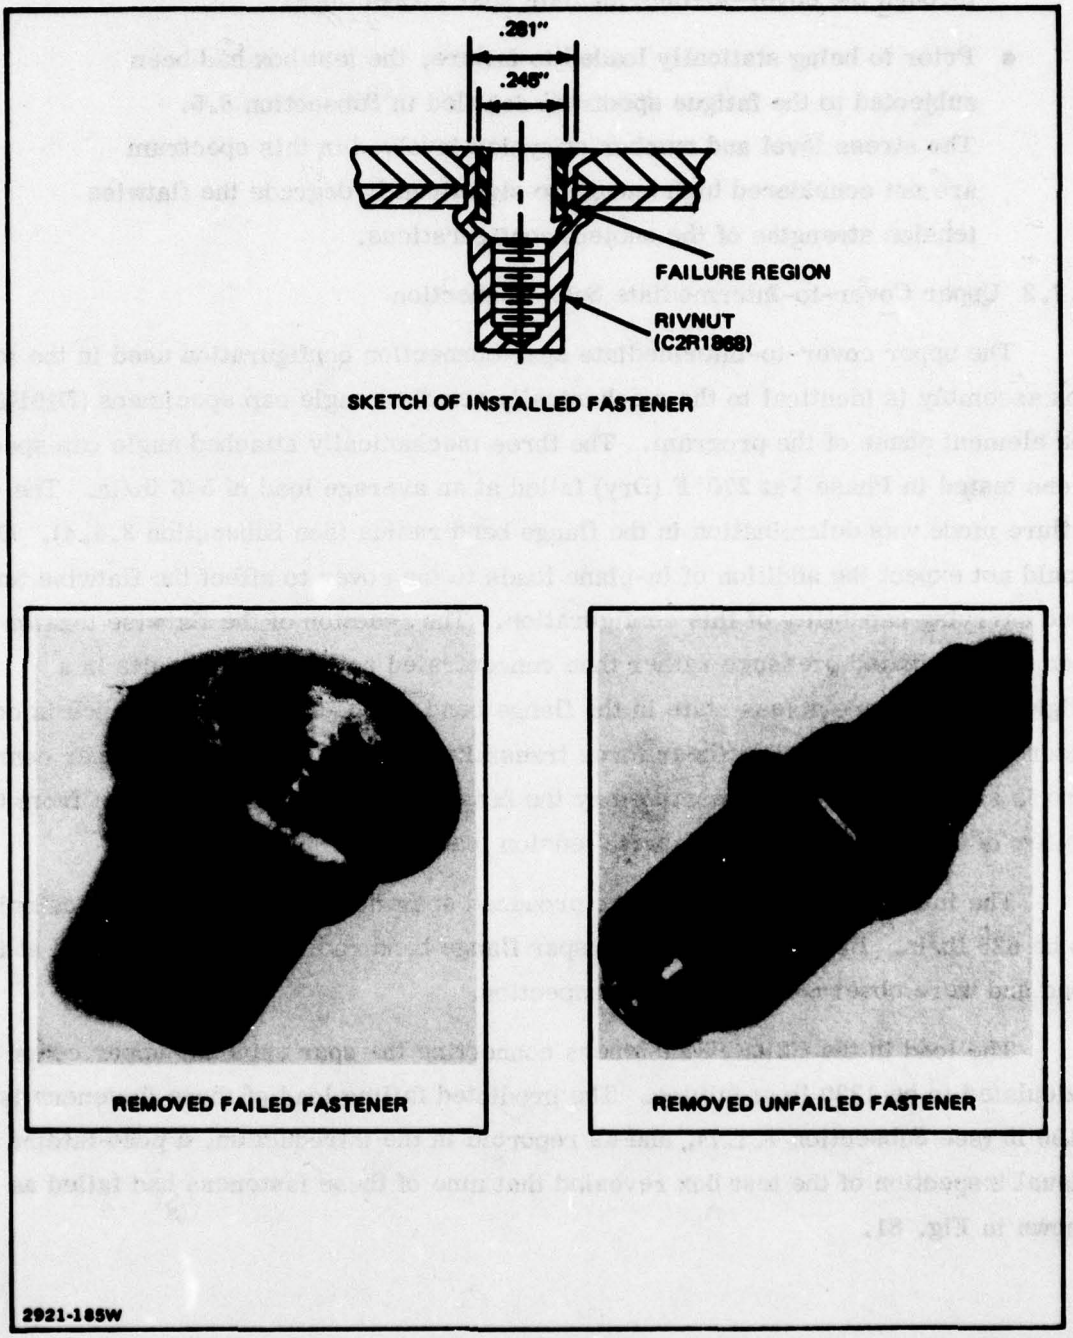
Fig. 81 Failed Fasteners

The load in the C2R1868 fasteners connecting the spar caps and upper cover was calculated to be 1330 lb at failure. The predicted failing load of these fasteners is 1190 lb (see Subsection 4.1.7), and as reported in the introduction, a post-failure visual inspection of the test box revealed that nine of these fasteners had failed as shown in Fig. 81.
