CONKLINGVILLE DAM

SARATOGA COUNTY, NEW YORK
INVENTORY NUMBER NY 146

PHASE 1 INSPECTION REPORT NATIONAL DAM SAFETY PROGRAM

L. ROBERT KIMBALL and ASSOCIATES
615 W. Highland Ave. Ebensburg, Pa.

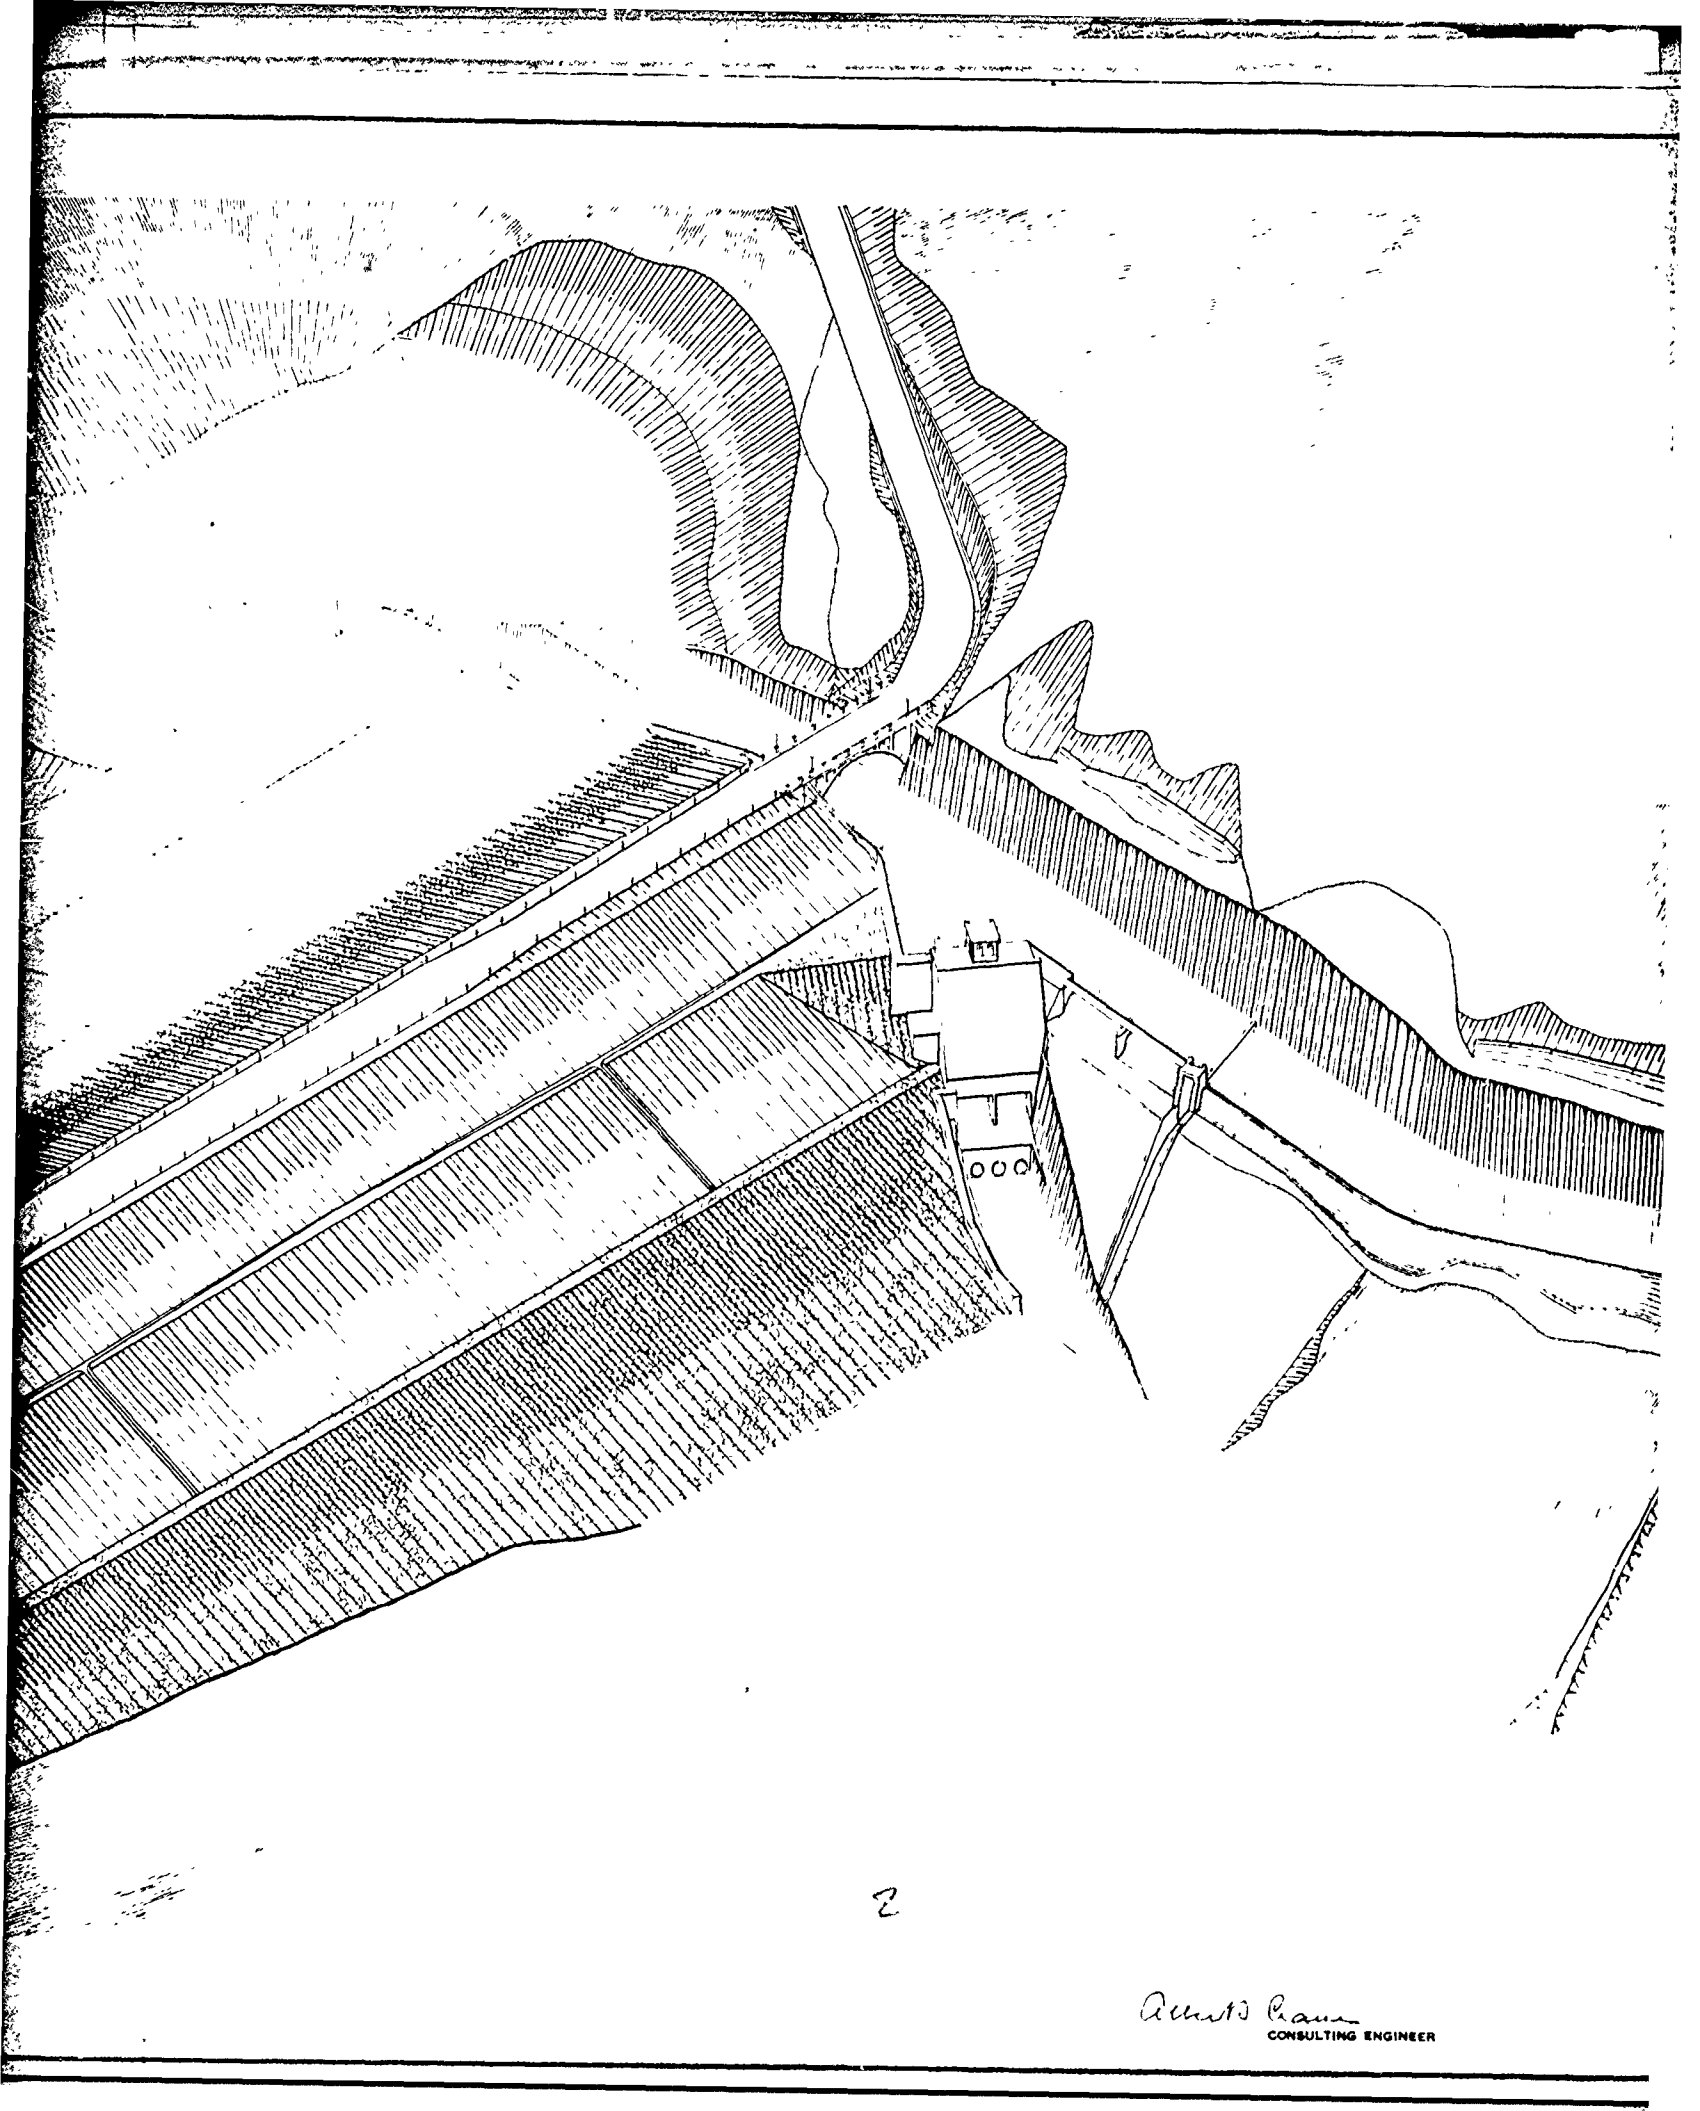
OVERVIEW OF DAM FROM
LOOKOUT ON LEFT ABUTMENT

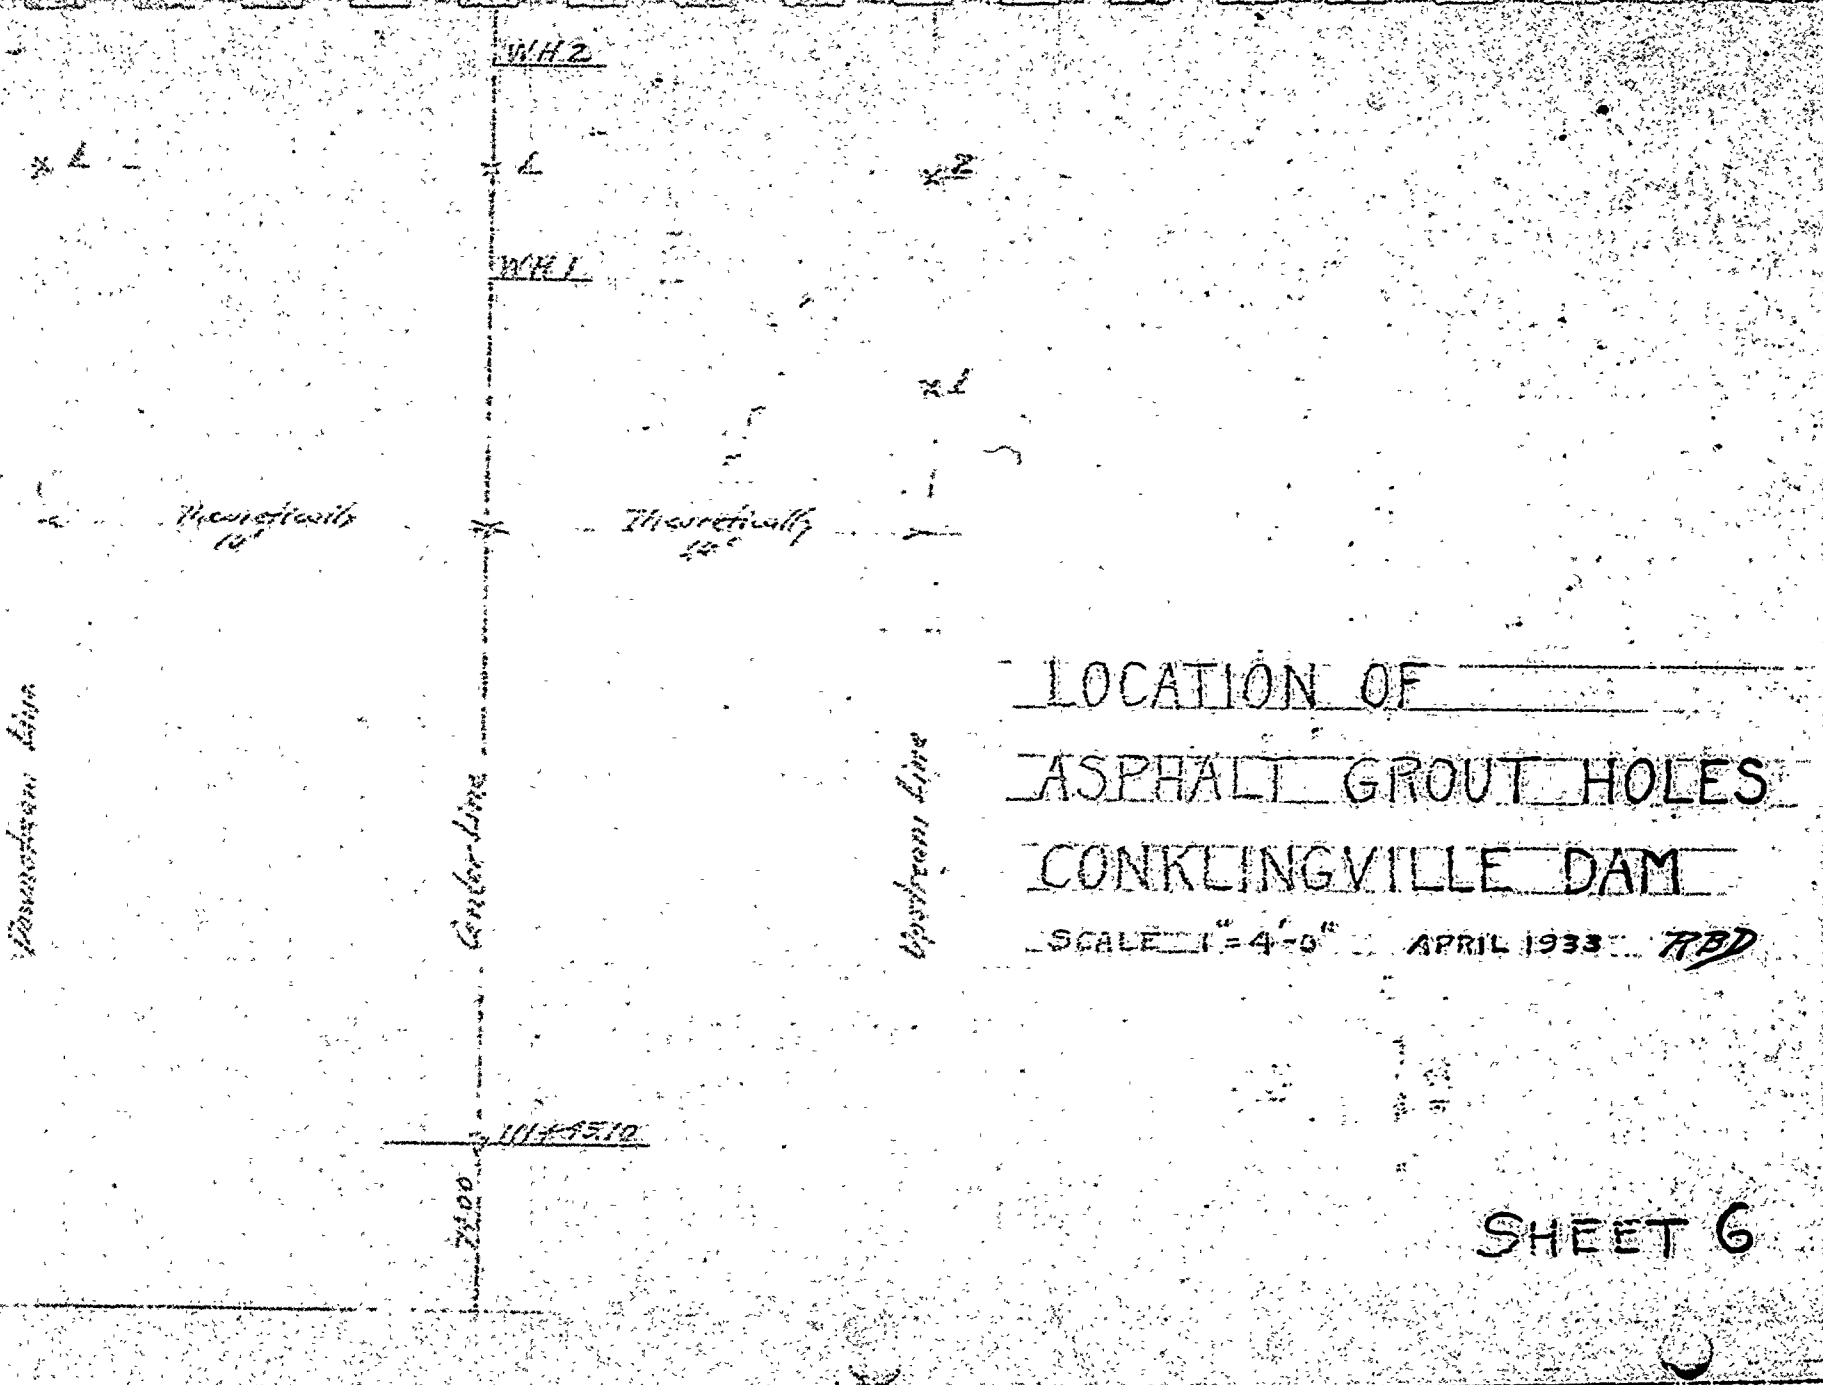
LOCATION OF ASPHALT GROUT HOLES CONKLINGVILLE DAM

Kettle placed - 12 holes drilled - 6 pipe installed as per sketch
Upstream No.4
Center line No.4 & 5
Downstream No. 3,4,5
All holes 10 feet in rock except Upstream No.4 which had broken drill steel in it.
All pipe perforated 4 feet at bottom.

All holes in each line from No. 1 to 6 inclusive grouted.
Used 9 drums of asphalt filling practically all cracks.
Used 600 lbs. pressure.
Hole No. 2 in downstream line took 3 drums of asphalt. Asphalt came out about 15 feet away from hole also filled big crack back by other holes.
Some of the holes took hardly any asphalt except enough to fill the pipe.
