LAKE CHOCTAW DAM

NDS ID NO. PA-00819
DER ID NO. 54-178

PHASE I INSPECTION REPORT

NATIONAL DAM INSPECTION PROGRAM

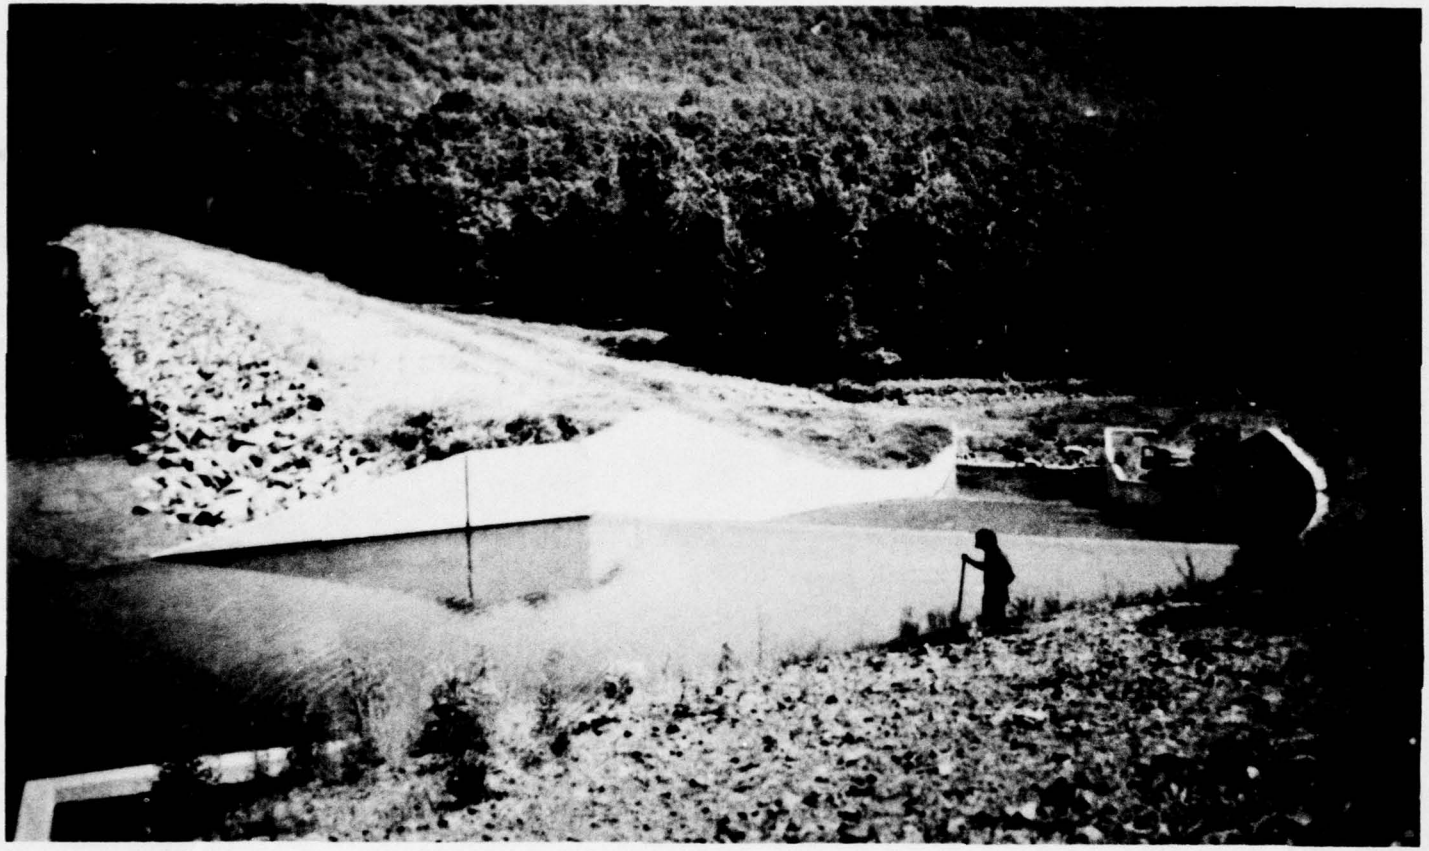
LAKE CHOCTAW DAM

Embankment and Spillway

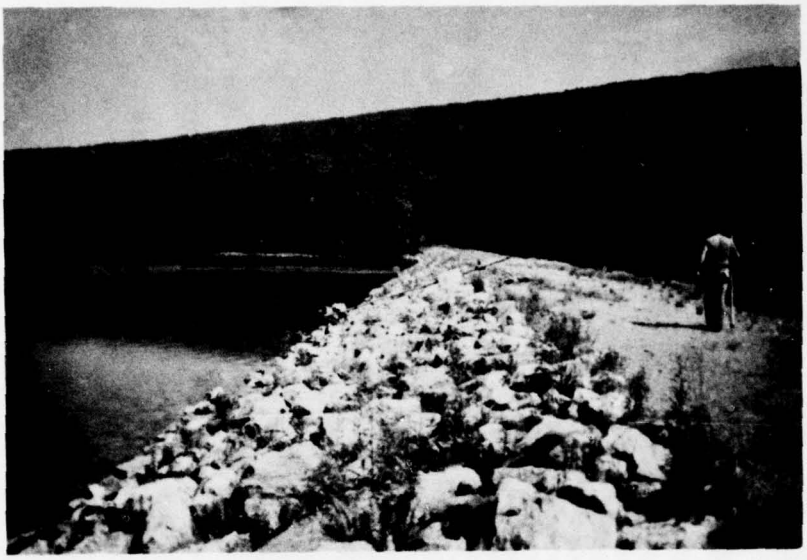
A. Upstream Slope of Embankment.

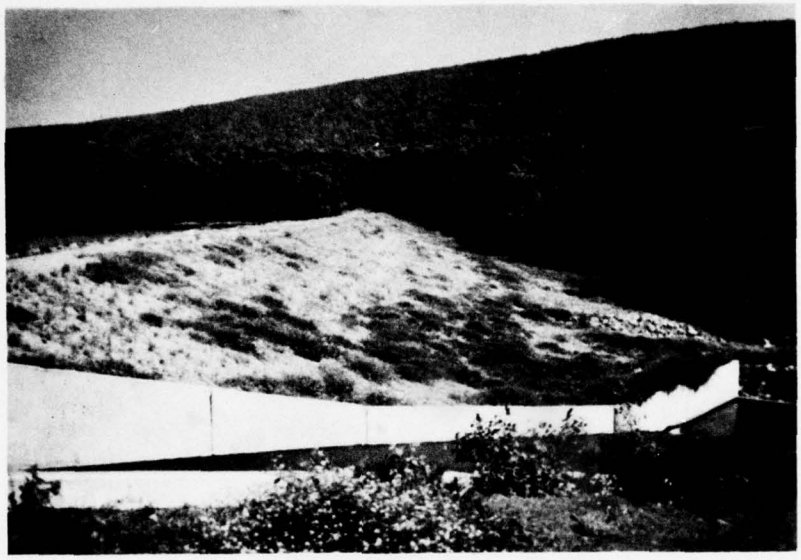
B. Low Area on Embankment Near Spillway.

(1) Repair area on upstream slope of embankment near spillway.
