SUSQUEHANNA RIVER BASIN
STAFFORD MEADOW BROOK, LACKAWANNA COUNTY
PENNSYLVANIA

LAKE SCRANTON DAM
PENNSYLVANIA GAS AND WATER COMPANY

PHASE I INSPECTION REPORT
NATIONAL DAM INSPECTION PROGRAM

MAY 1978

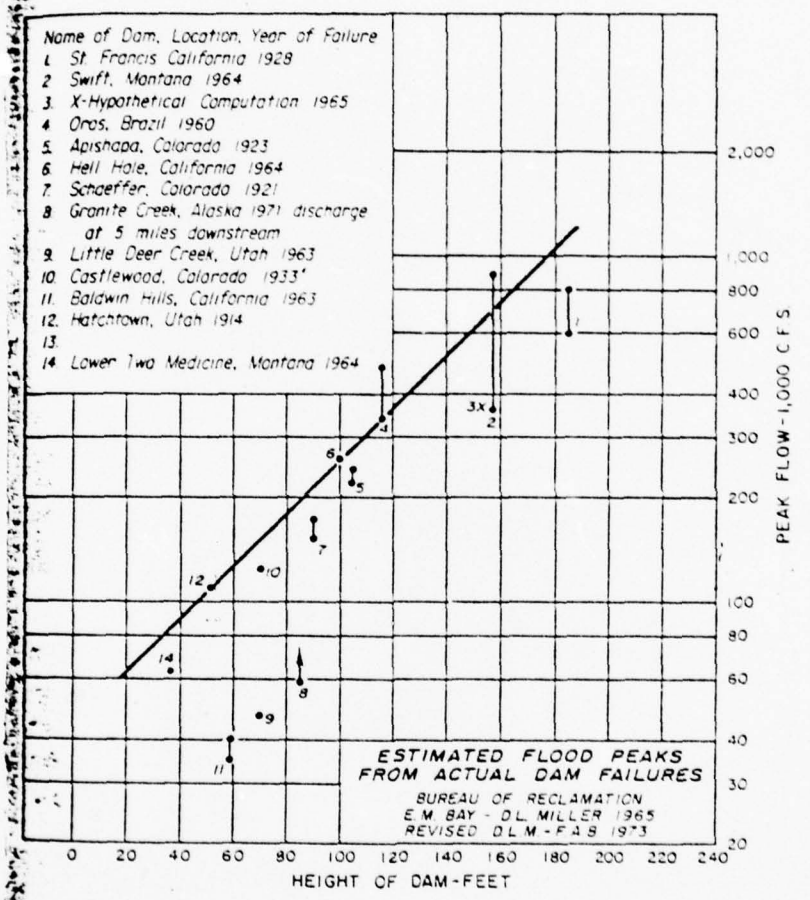
FIG. 1. -- ESTIMATED FLOOD PEAKS FROM ACTUAL DAM FAILURES

FROM FIGURE 1, p. 329, PEAK FLOW = 110,000 CFS

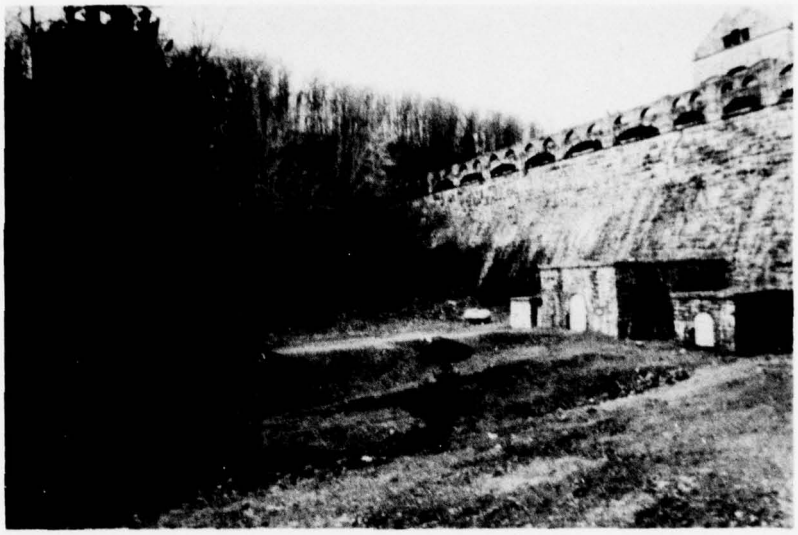
(2) Several damp areas and seepage points were observed on the downstream face of the masonry gravity section of the main dam. However, at no place was the leakage estimated to exceed about 1/4 gallon per minute, and no damage or other adverse effects have resulted from the leakage. The stone masonry and mortar joints were in excellent condition, and they had no signs of weathering, cracking, or other defects. The auxiliary spillway consists of a series of arched openings through the upper portion of the masonry gravity dam. Photographs A and B show the downstream face of the dam and the auxiliary spillway.

A. Right Abutment and Right Side of Masonry Gravity Dam

B. Left Side of Masonry Gravity Dam and Embankment Retaining Wall

(8) Visually monitor leakage quantity on downstream face of masonry gravity section of main dam and make repairs when necessary.

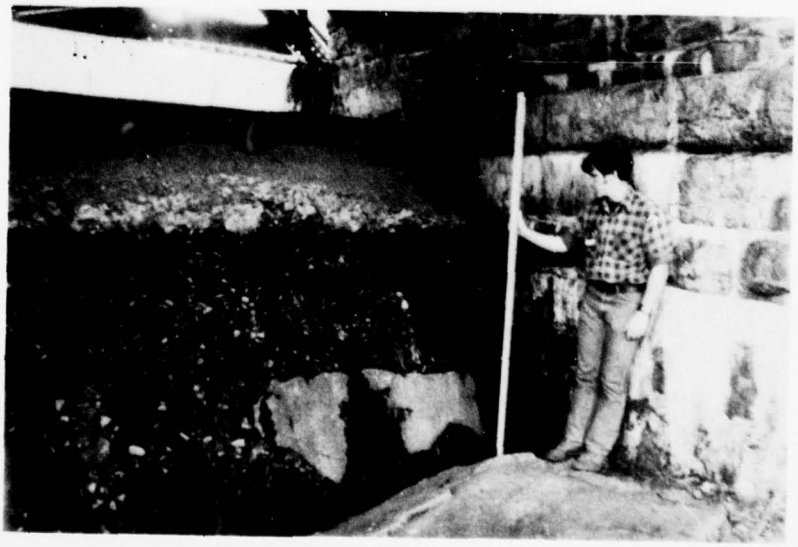
(1) The main spillway is suffering from advanced concrete deterioration (Photograph J). The concrete was placed in 1916 and was doweled to the existing masonry gravity spillway to ensure the stability of the structure. About 2/3 of the downstream face has very severe scaling to a maximum depth of about 7 inches. At the left end, 1-foot lengths of the steel reinforcement are exposed and are in early stages of corrosion. Wide horizontal cracks are present at most of the construction joints, and they are weathered and scaled to a maximum depth of 10 inches. Leakage from these joints was observed, particularly at the first joint below crest level. The most concentrated leakage point had an estimated flow of 2-3 gallons per minute (Photograph J, p.D-5). The leakage has not affected other features. Two lines of 1-1/2-inch diameter drain holes, totalling 33 holes, are on the downstream face, but discharge from them ranged from slight to nothing. A roadway bridge across the spillway crest has its low steel about 2.5 feet above the crest (Photograph I).

(1) The concrete on the main spillway, particularly on the left side, has deteriorated to the extent that its structural integrity could be affected. Examination of previous inspection records shows that the deterioration began at least as early as 1933. The location of the bridge over the main spillway is such that it might act as a hydraulic constraint when the depth of water over the crest exceeds 2.5 feet. It could also cause a buildup of debris during floods.

J. Damaged Area at Left End of
Main Spillway

(2) Perform additional studies to more accurately ascertain the spillway capacity required for Lake Scranton Dam as well as the nature and extent of mitigation measures required to make the spillways hydraulically adequate. Also include provisions to repair concrete of the main spillway.
