LOWER HUDSON RIVER BASIN

STURGEON POOL DAM

ULSTER COUNTY, NEW YORK
INVENTORY NUMBER NY 75

PHASE 1 INSPECTION REPORT NATIONAL DAM SAFETY PROGRAM

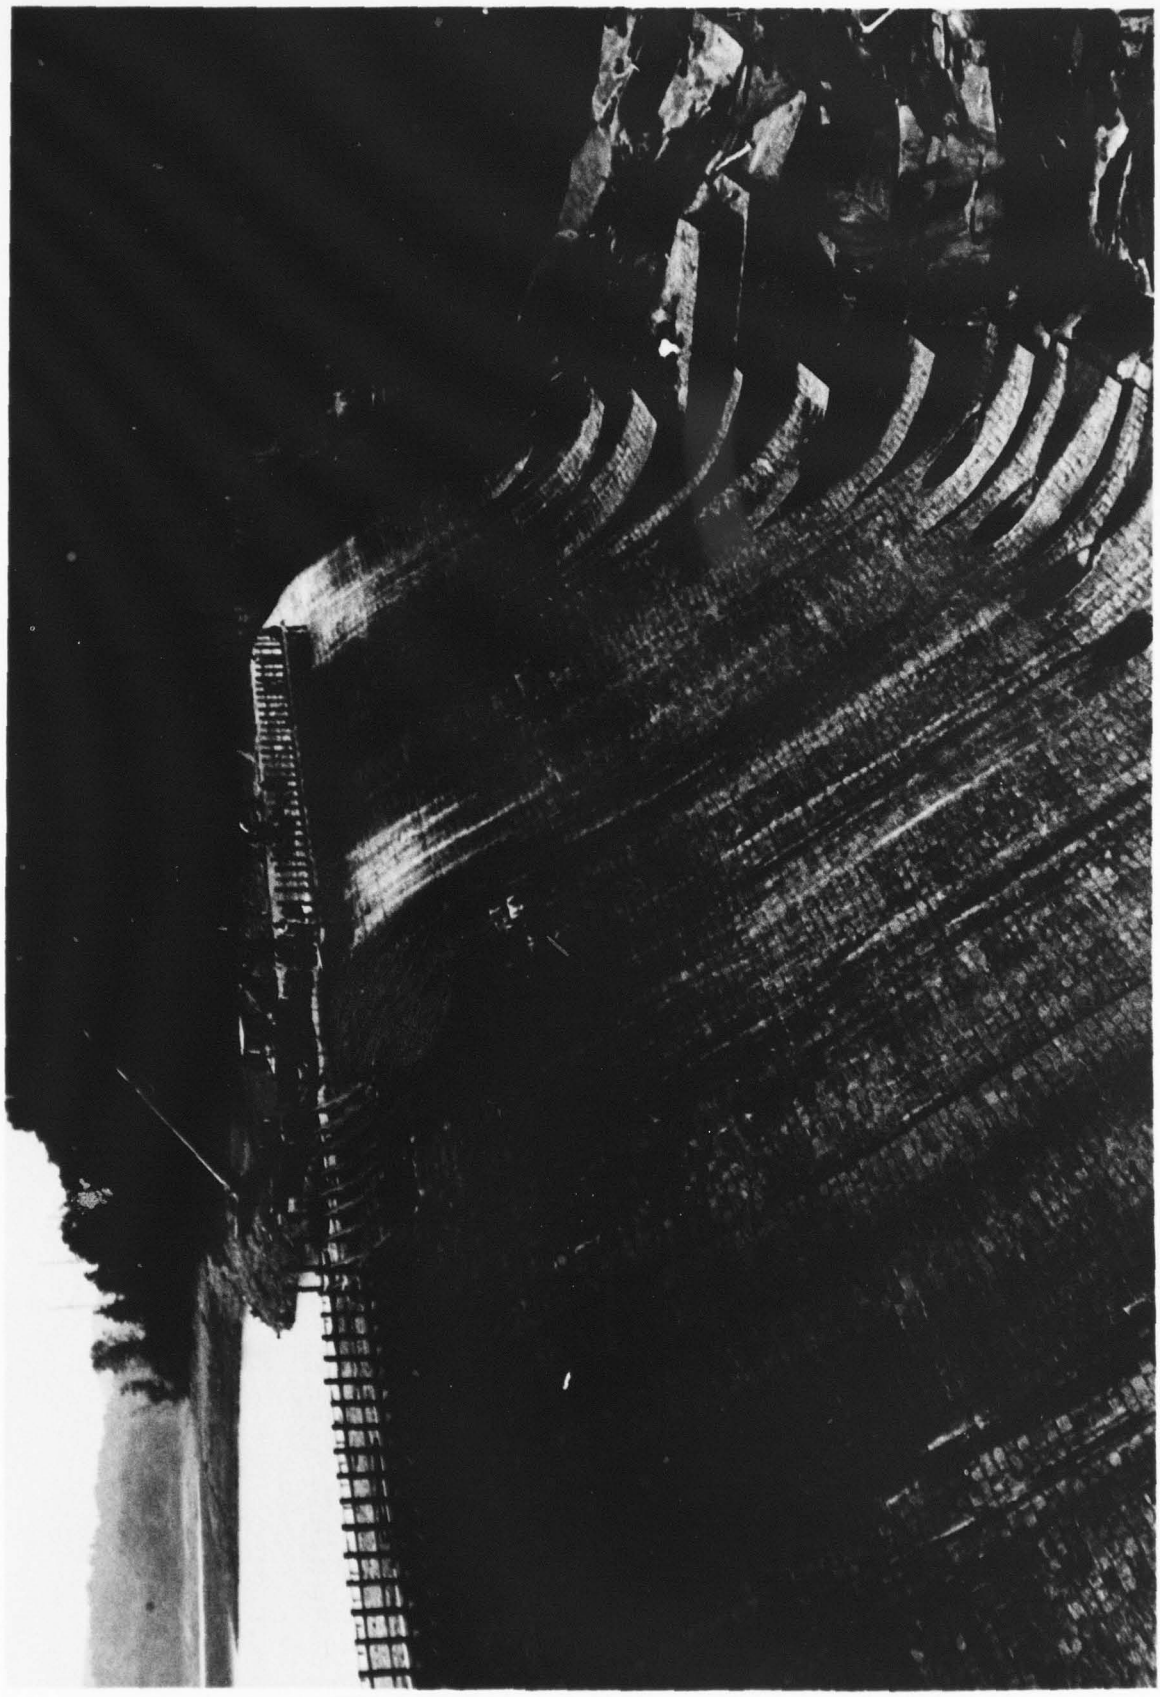
OVERVIEW OF DOWNSTREAM
FROM RIGHT ABUTMENT

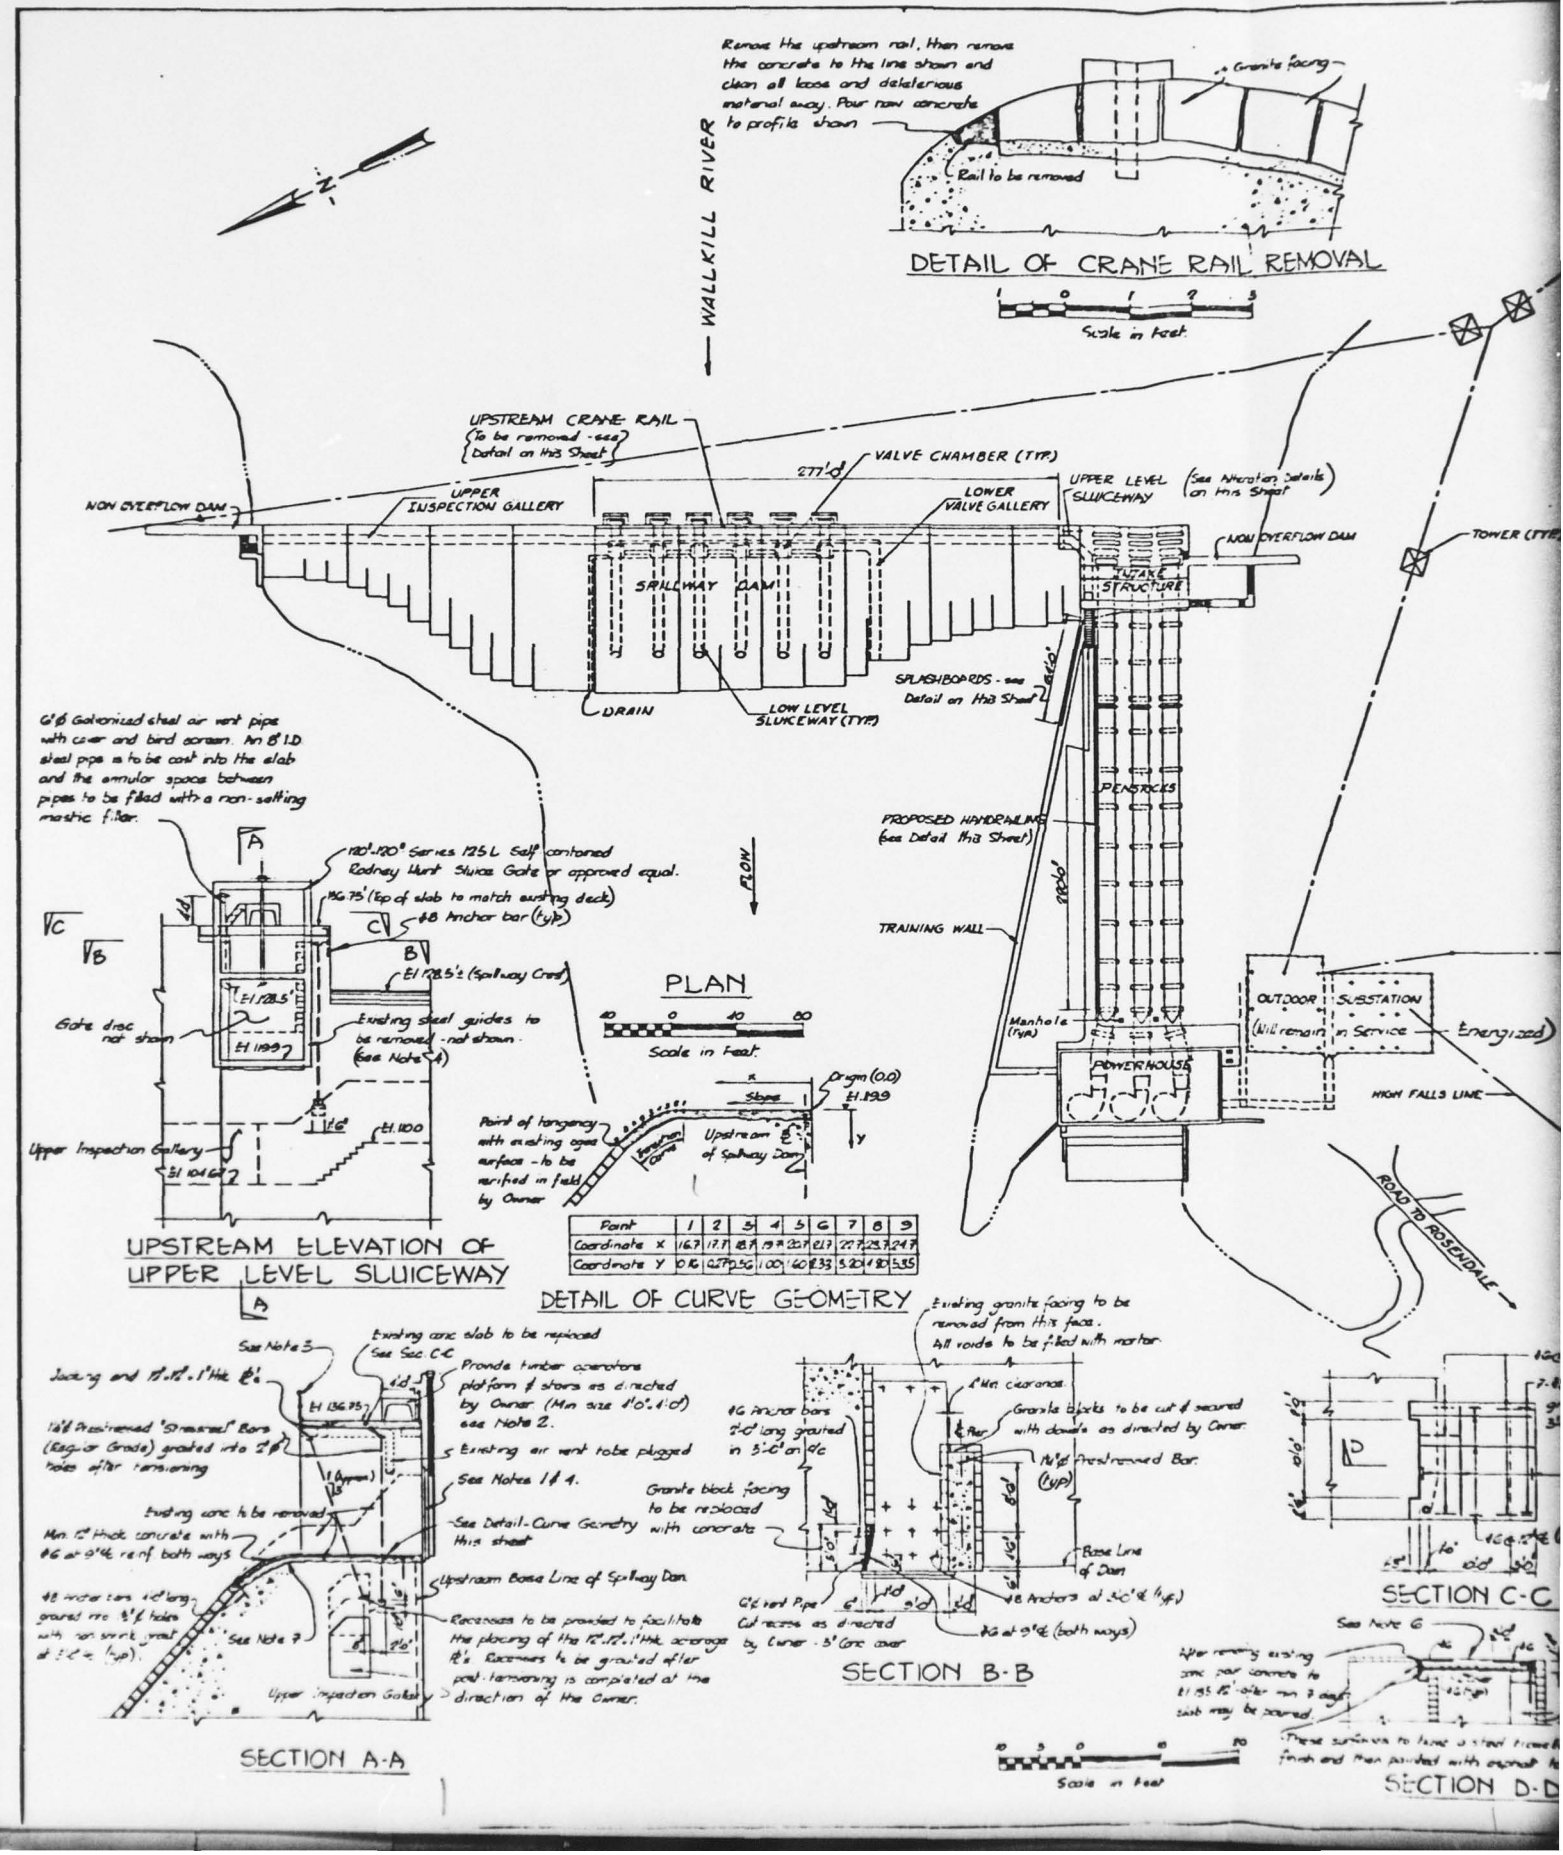
Remove the upstream rail, then remove the concrete to the line shown and clean all loose and deleterious material away. Pour new concrete to profile shown
Granite facing
Rail to be removed
DETAIL OF CRANE RAIL REMOVAL
Scale in feet
WALLKILL RIVER
UPSTREAM CRANE RAIL (To be removed - see Detail on this Sheet)
277'-0"
VALVE CHAMBER (TYP.)
UPPER LEVEL SLUICEWAY (See Alteration Details on this Sheet)
NON OVERFLOW DAM
UPPER INSPECTION GALLERY
LOWER VALVE GALLERY
SPILLWAY DAM
INTAKE STRUCTURE
NON OVERFLOW DAM
TOWER (TYP.)
DRAIN
LOW LEVEL SLUICEWAY (TYP.)
SPLASHBOARDS - see Detail on this Sheet
PENSTOCKS
PROPOSED HANDRAILING (see Detail this Sheet)
FLOW
TRAINING WALL
6"ϕ Galvanized steel air vent pipe with cover and bird screen. An 8" I.D. steel pipe is to be cast into the slab and the annular space between pipes to be filled with a non-setting mastic filler.
120'-120° Series 125 L Self contained Rodney Hunt Sluice Gate or approved equal.

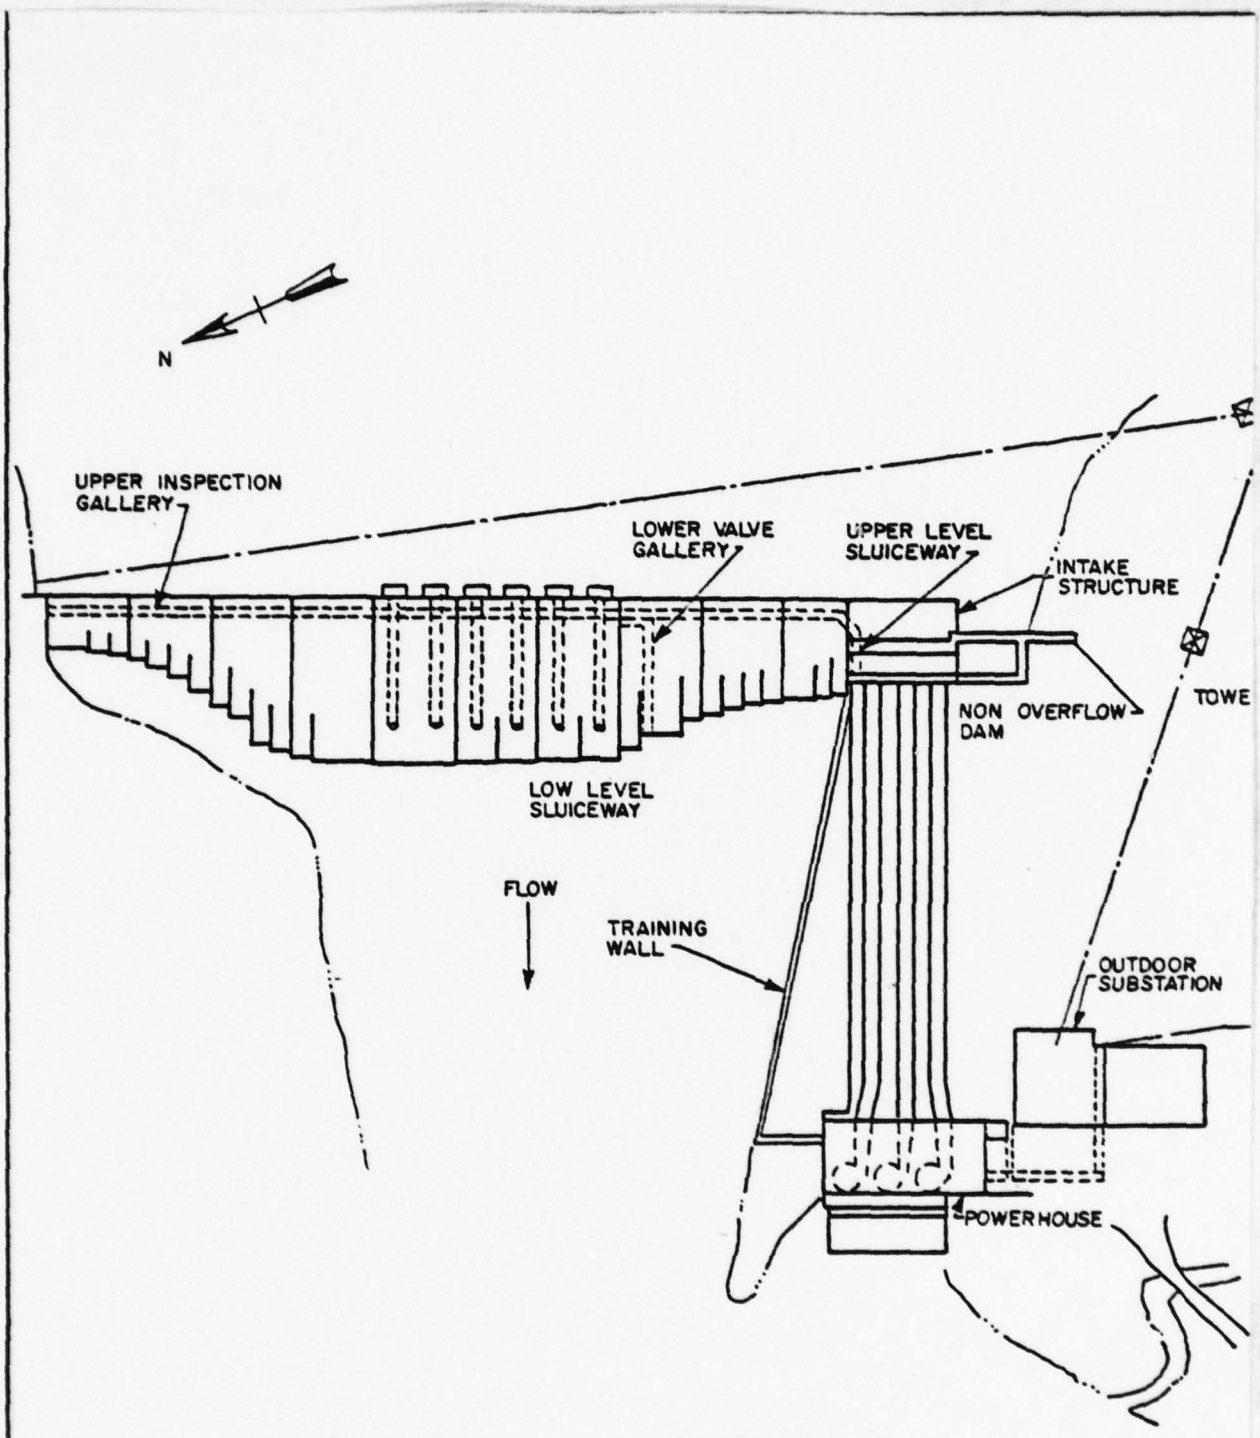
A longitudinal section (Plate 3) shows the position of the upper gallery in the dam. A visual inspection of this gallery indicates that the concrete is generally in good condition with the exception of some spalling near the contraction joints. In some cases, this may have been caused by attempts to seal the joint against seepage which resulted in a "blowing off" of both the patch and some adjacent intact concrete.

The lower gallery, which is the valve passageway in the dam, is shown on Plate 3. The concrete condition in the lower gallery is good. There are areas of precipitate build-up in some locations, but these
