CHEMUNG RIVER BASIN

BRADFORD DAM

STEUBEN COUNTY, NEW YORK
INVENTORY NUMBER NY 670

PHASE 1 INSPECTION REPORT NATIONAL DAM SAFETY PROGRAM

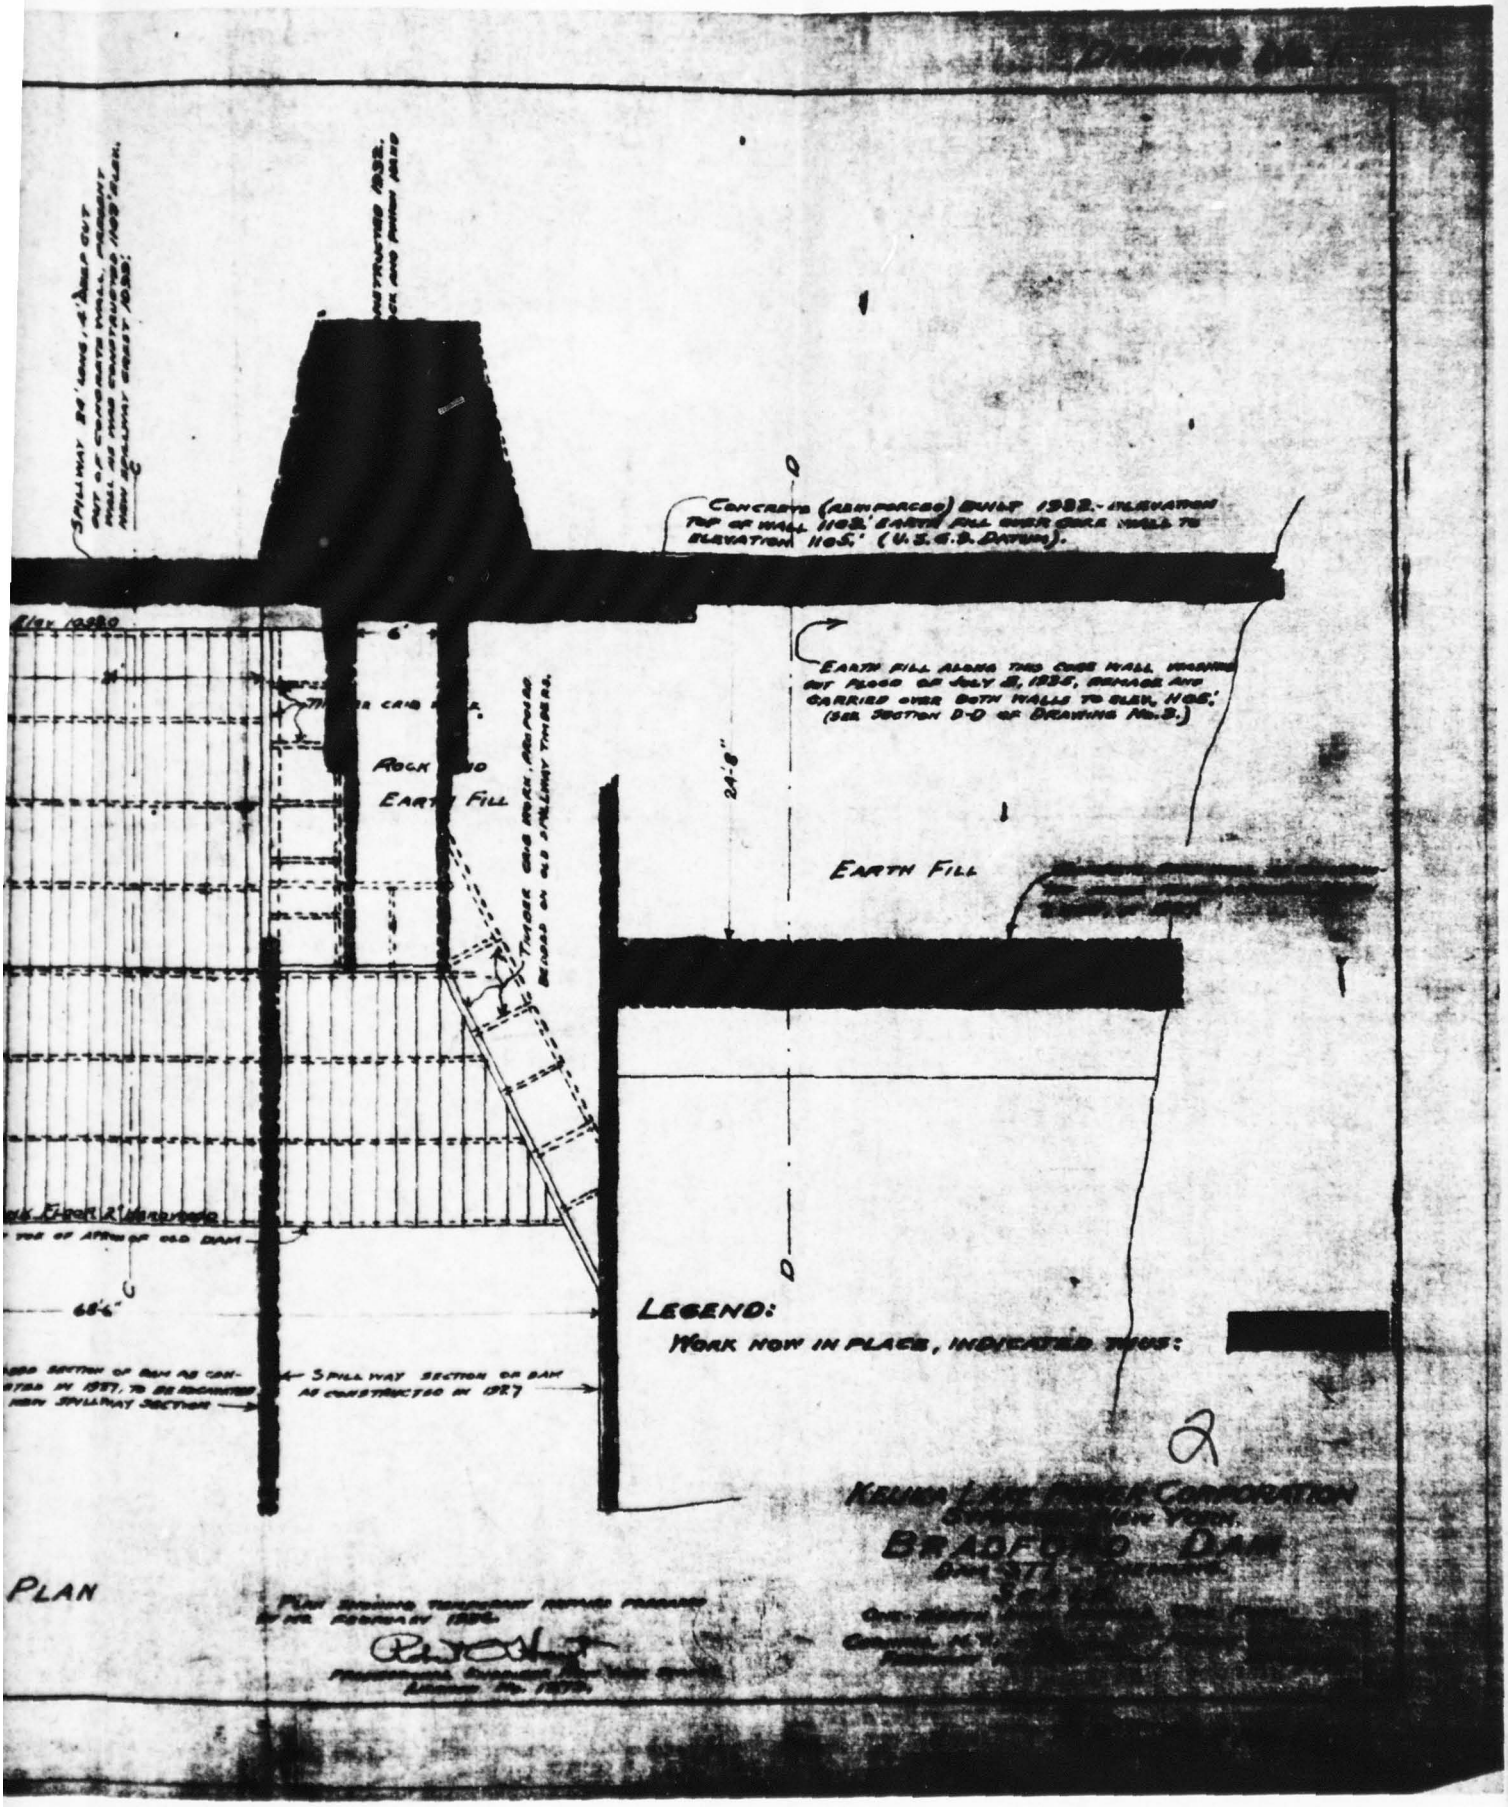
CONCRETE (REINFORCED) BUILT 1932.- ELEVATION TOP OF WALL 1102.' EARTH FILL OVER CURB WALLS TO ELEVATION 1105.' (U.S.C.&G.S. DATUM).
EARTH FILL ALONG THIS CURB WALL WASHED OUT FLOOD OF JULY 8, 1935, DAMAGE AND CARRIED OVER BOTH WALLS TO ELEV. 1105.' (SEE SECTION D-D OF DRAWING No. 3.)
EARTH FILL
ROCK AND EARTH FILL
THESE CRIB WORK FOUNDATIONS RESTED ON OLD SPILLWAY TIMBERS.
24'-8"
68'-6"
LEGEND:
WORK NOW IN PLACE, INDICATED THUS:
SPILL WAY SECTION OF DAM AS CONSTRUCTED IN 1927
PLAN
