TECHNICAL REPORT GL-79-2

TRAFFIC TESTS OF EXPEDIENT AIRFIELD CONSTRUCTION CONCEPTS FOR POSSIBLE APPLICATION IN THE NATIONAL PETROLEUM RESERVE ALASKA (NPRA)

Cecil D. Raines

March 1979
Final Report

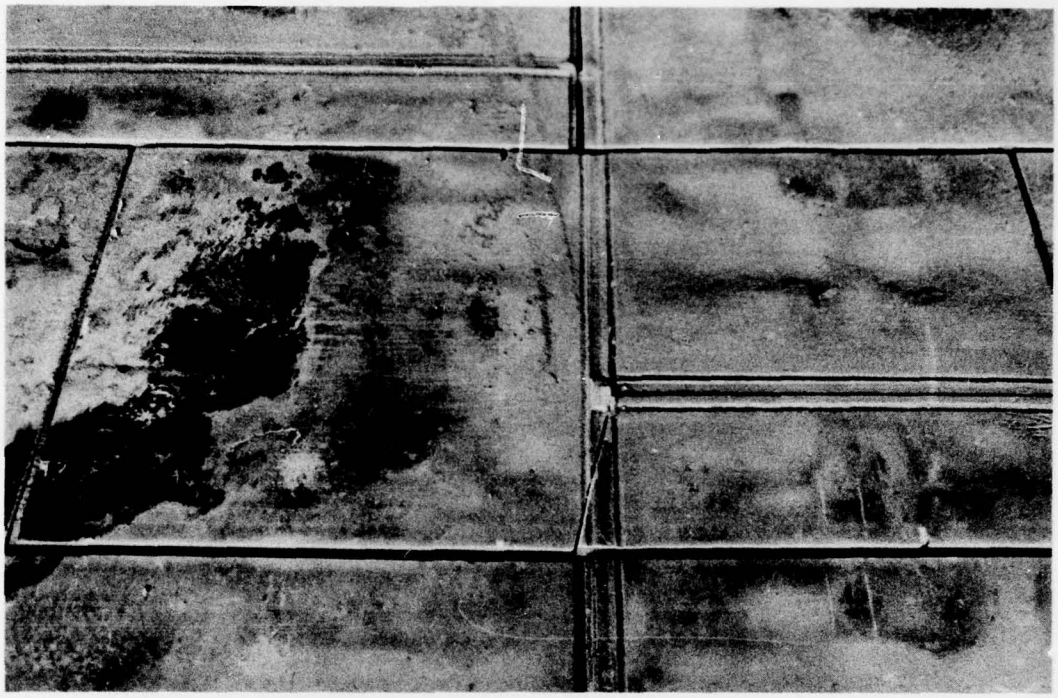
23. At the end of the traffic, the mat was removed from item 1, and an excavation trench was made in item 2 to permit examination of the Styrofoam insulation material. It was determined that the insulation panels were still in place with no damage in either item. Photo 8 shows a general view of the insulation in test item 1, after traffic and removal of mat. As indicated in Photo 9, some slight grooving and ridges were formed in the insulation material by the joints and weld seams in the XM19 mat and a few cracks in the insulation material. However, it is believed that this would have no adverse effects on the insulation properties of the Styrofoam panels.

Photo 9. Closeup view of insulation in Test Section No. 1, item 1, after traffic

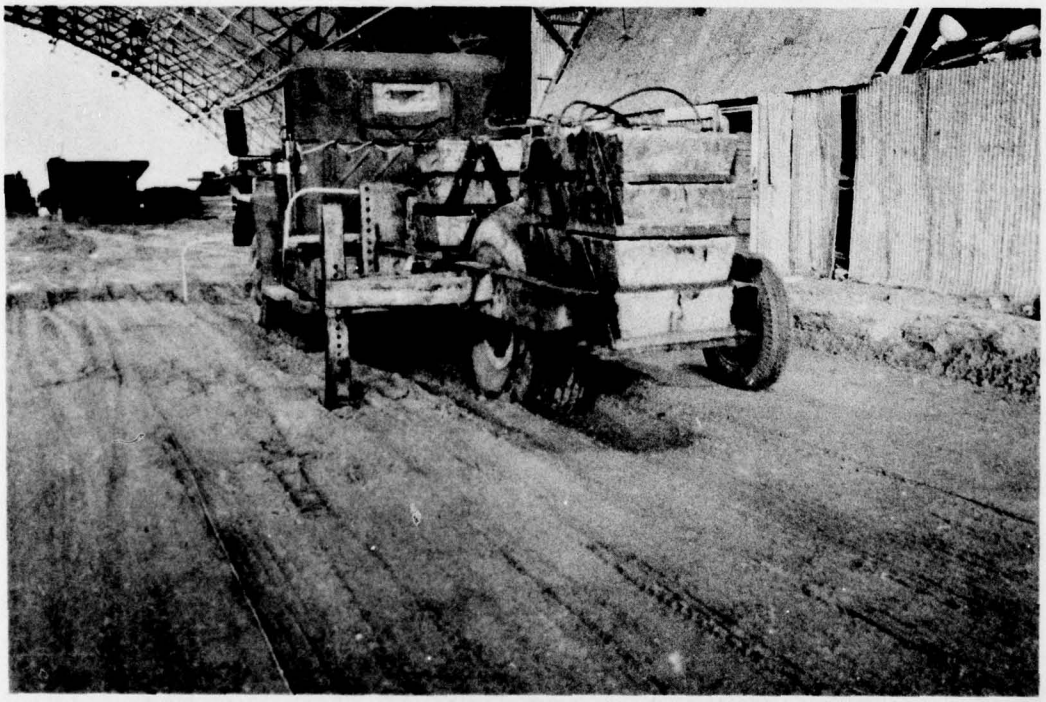
24. Since there was no damage to the insulation under the 20-in. gravel base in item 2, it was decided to remove the top 10 in. and apply additional traffic to determine if a lesser thickness of gravel would adequately protect the Styrofoam insulation. About 240 passes of the 35-kip single-wheel load were applied over item 2 after the removal of the top 10 in. of base. This resulted in considerable rutting of the base course, and at 240 passes the load cart became immobilized in about a 3-in. rut (Photo 10). An excavation trench made at this time revealed that the Styrofoam insulation panels were being compressed under the load wheel and the thickness of the Styrofoam boards had decreased from 1-1/2 to about 1-1/4 in. Therefore, it was concluded that a 10-in. gravel base was not adequate to protect the insulation, and traffic was discontinued.

Photo 10. Test Section No. 1, item 2, with 10 in. of gravel over insulation

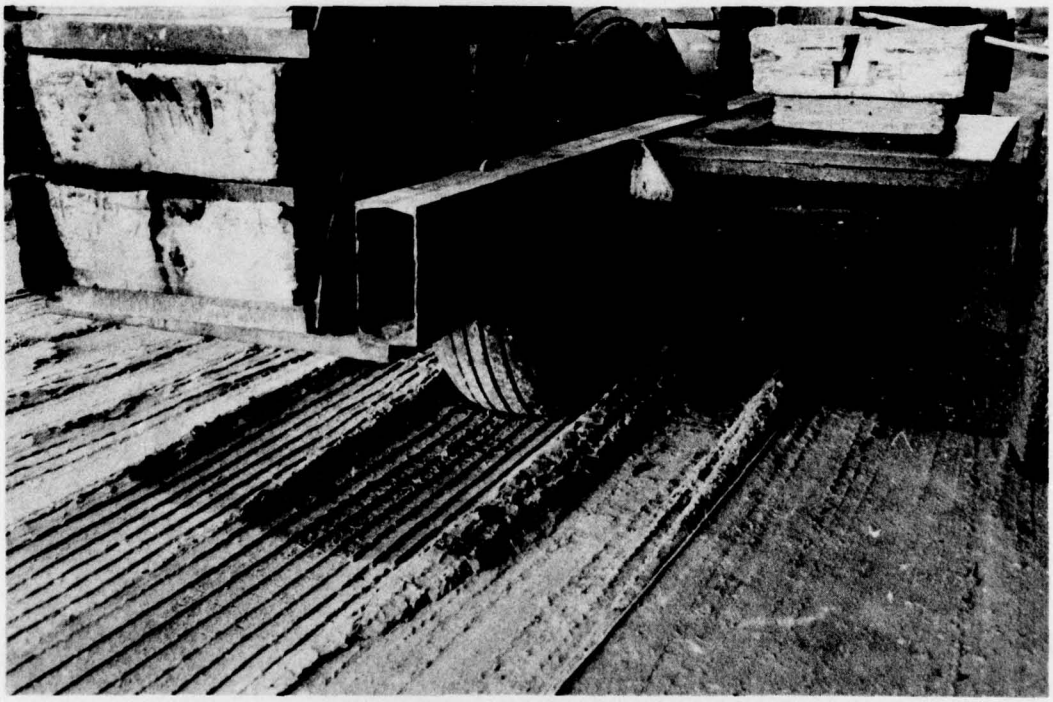
Photo 16. Test Section No. 2 with test cart immobilized after 22 passes in item 2

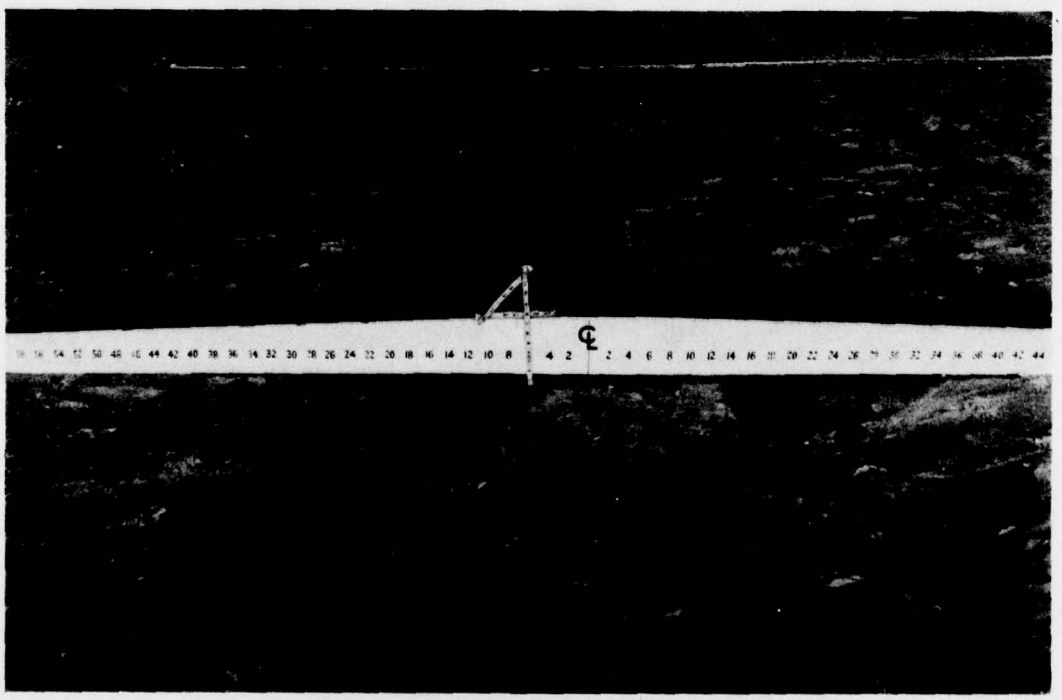
Photo 18. General view of Test Section No. 2, item 1, at end of traffic

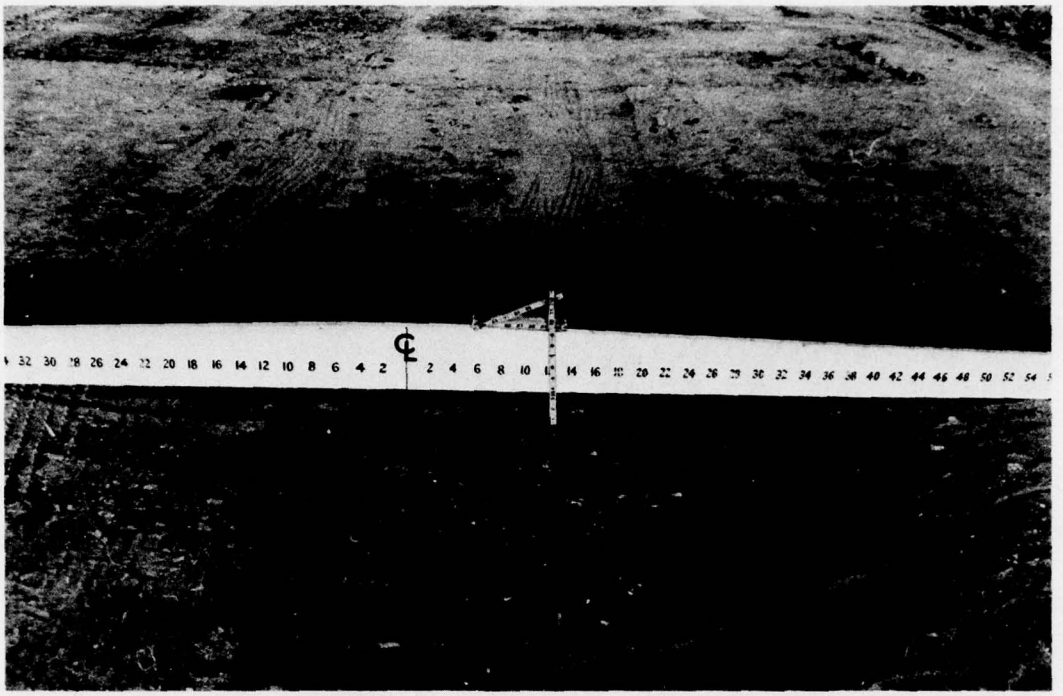
Photo 19. General view of Test Section No. 2, item 2, at end of traffic

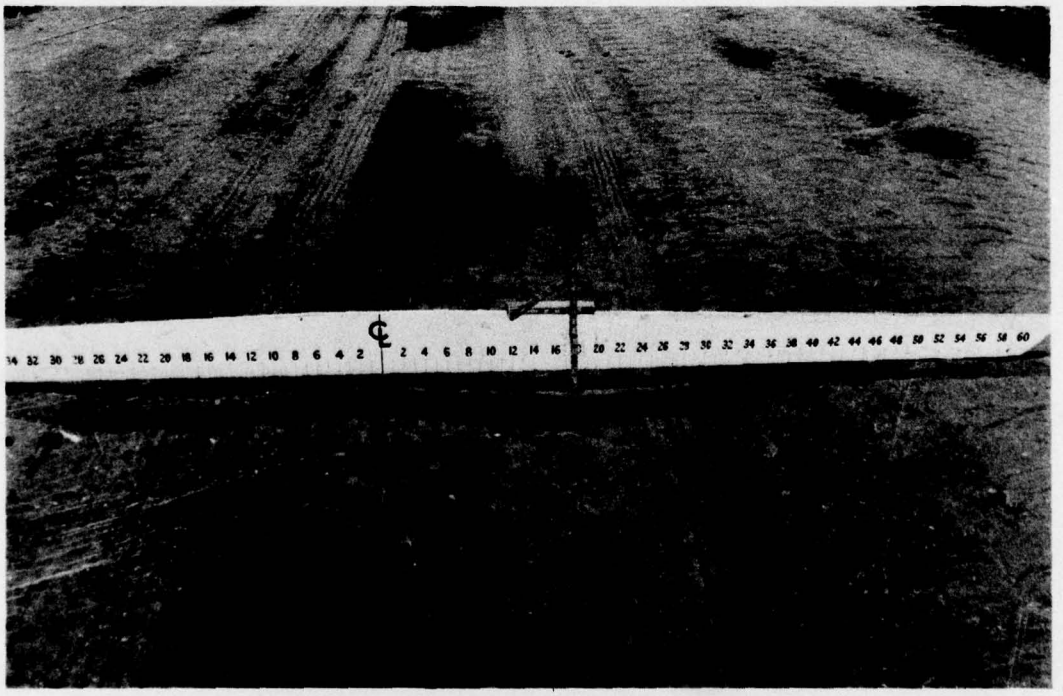
Photo 20. General view of Test Section No. 2, item 3, at end of traffic

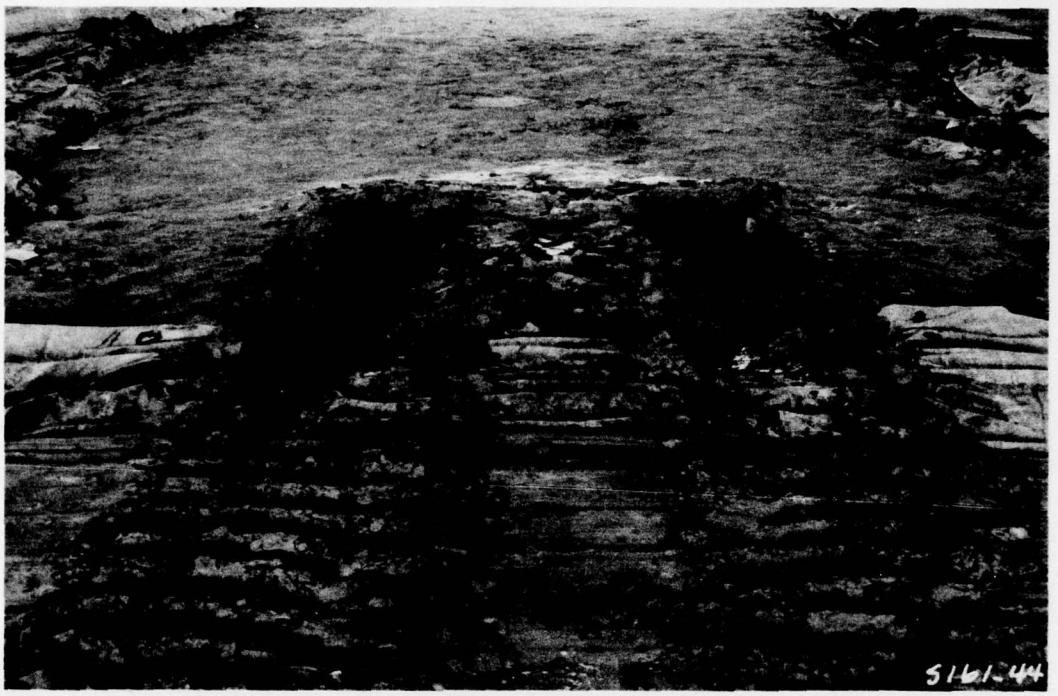
Photo 37. Closeup showing rutting and damaged grid from D-4 tractor

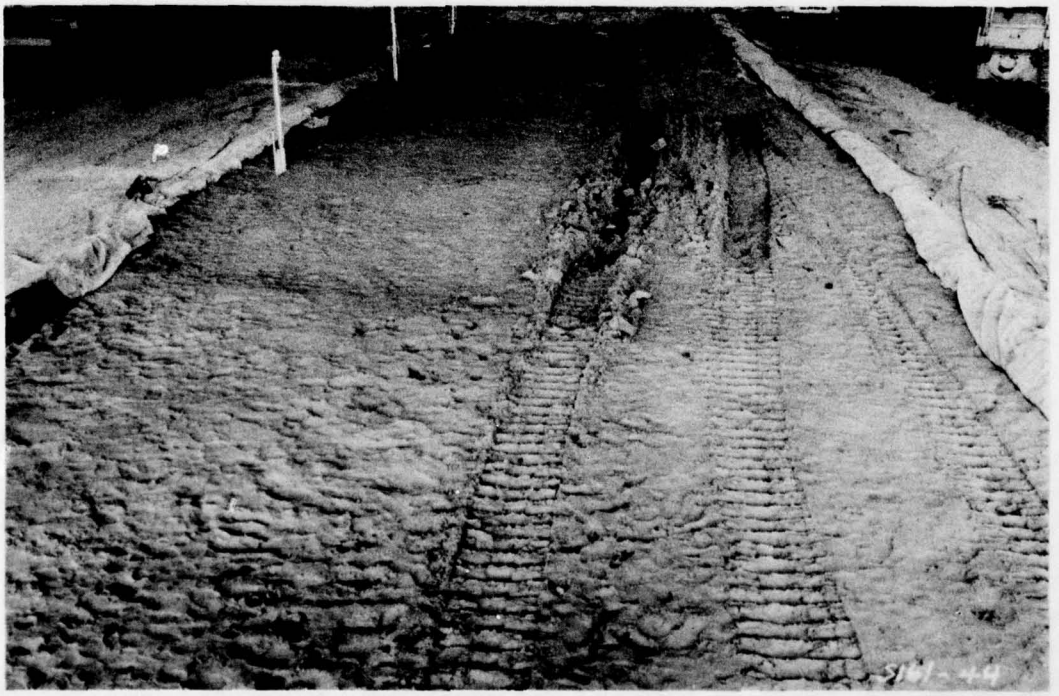
Photo 38. Two passes of D-4 tractor, Test Section No. 3, items 1 and 2, water level 23 in. below surface

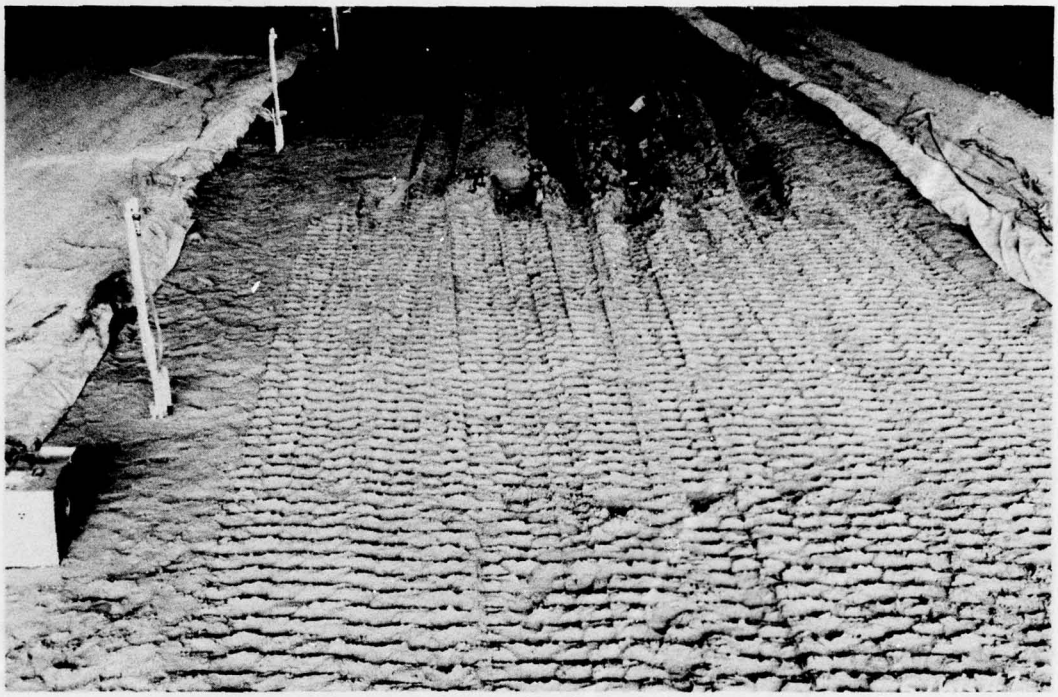
Photo 39. Two coverages of D-4 over item 1 (foreground) and two passes of D4 over item 2 (background), Test Section No. 3

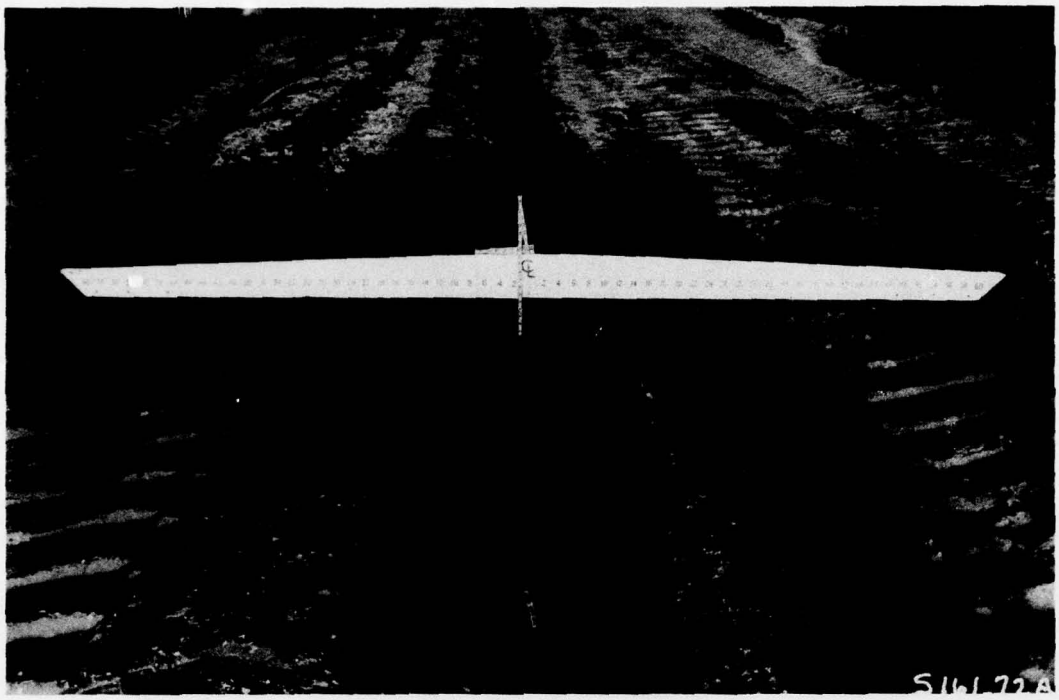
59. The first two passes of the load cart, forward and backward, in the same track left a rut varying from about 2 to 4 in. deep for the full length of the test section (Photo 43). Photos 44, 45, and 46, respectively, show a closeup view of rutting in items 1, 2, and 3 at the end of 100 coverages of traffic. As can be noted, the deformation was fairly uniform in each item, and the depth of ruts averaged about 7.5 in. in item 1, 8.5 in. in item 2, and 6 in. in item 3. The average rut depth in item 4 over the high-strength, stabilized base was about 6 in. as

Photo 43. Rutting by two passes of load wheel

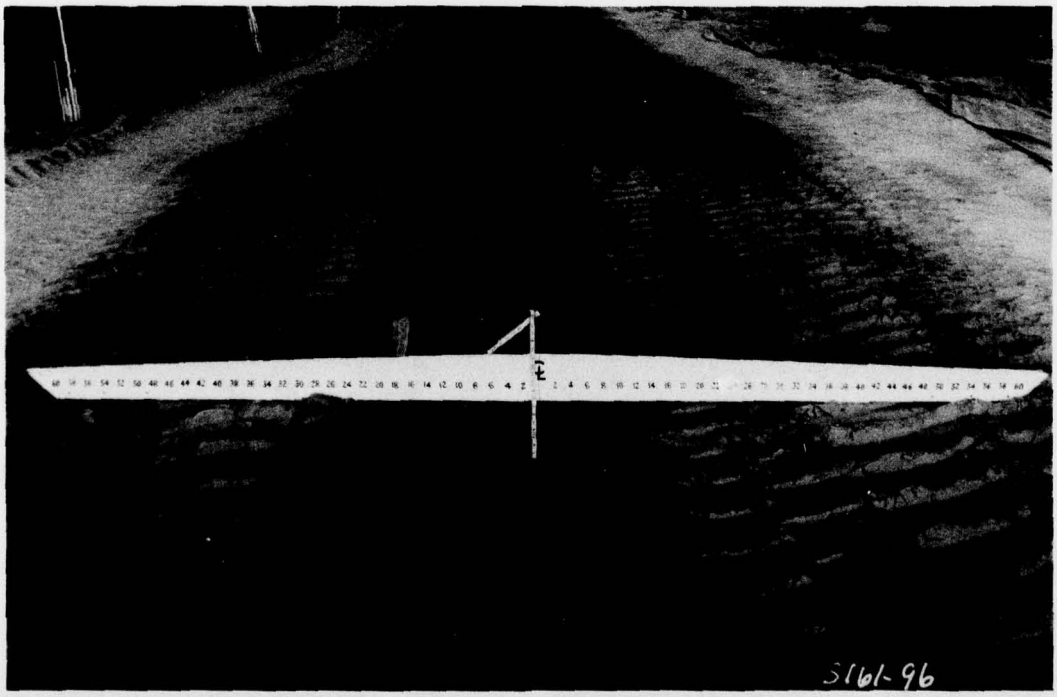
Photo 44. Test Section No. 3, item 1, after 100 coverages of C-130 loading

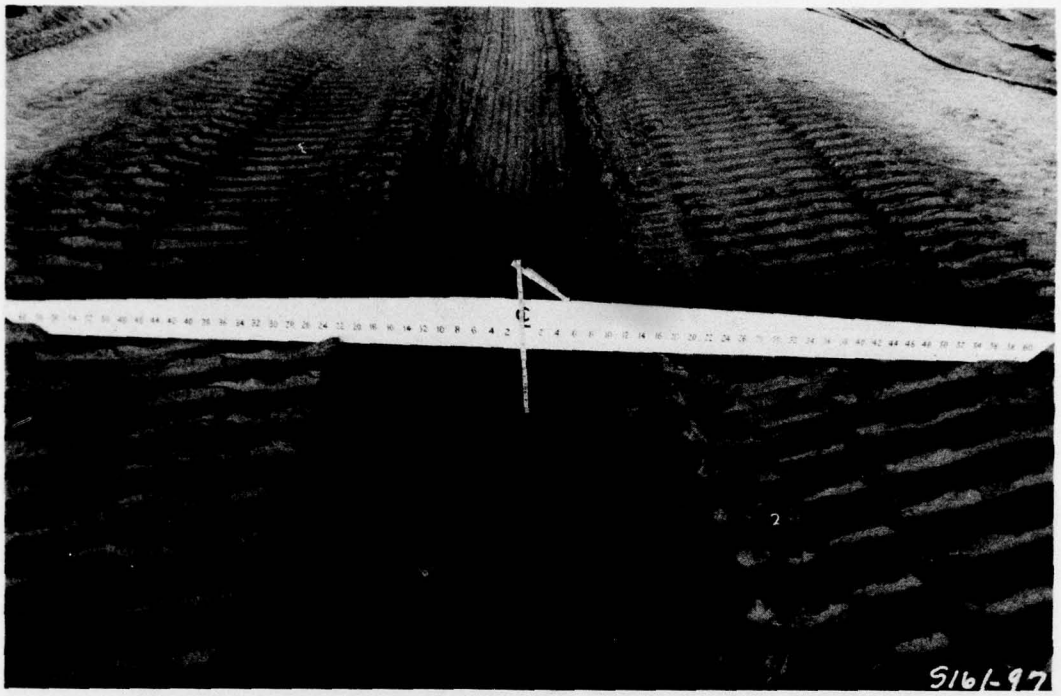
Photo 45. Test Section No. 3, item 2, after 100 coverages of C-130 loading

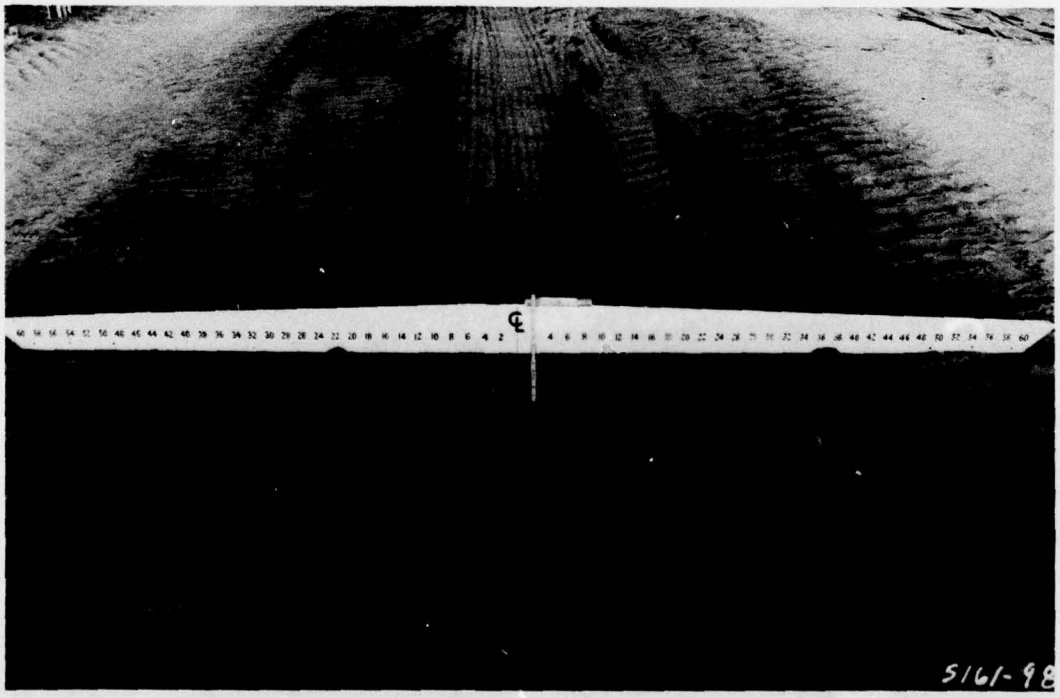
Photo 46. Test Section No. 3, item 3, after 100 coverages of C-130 loading

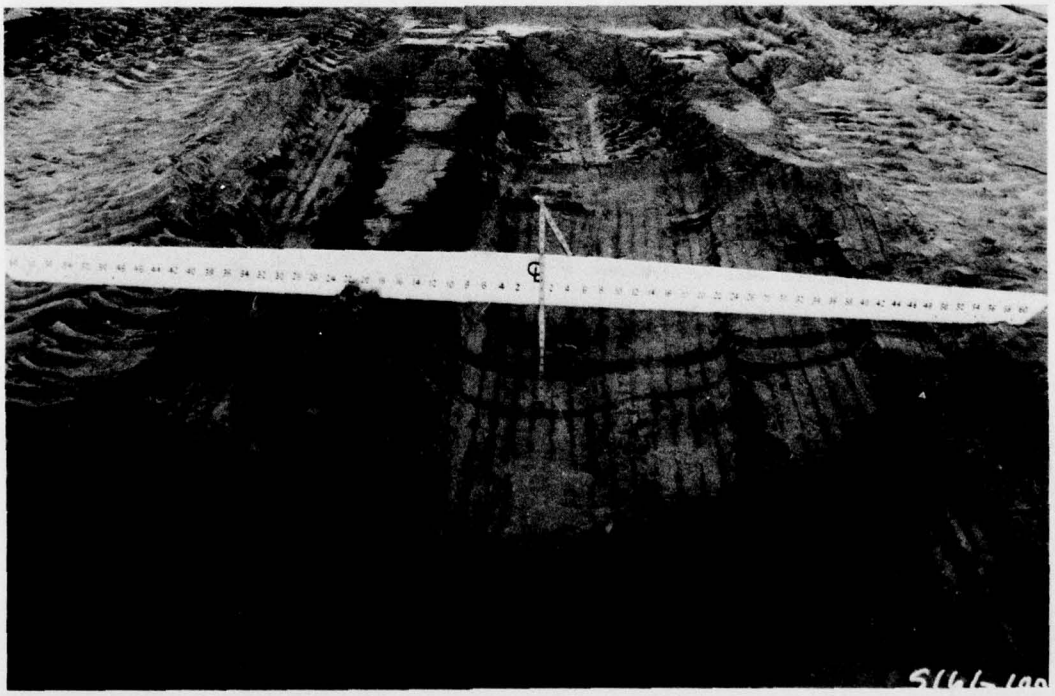
compared with about 12 in. over the loose sand foundation (Photos 47 and 48). Traffic was continued to 200 coverages, which is equivalent to about 810 aircraft operations, with very little change in rut depth or appearance of items. By this time, the sand was highly consolidated, and the stability was adequate to sustain traffic indefinitely. Therefore, traffic was discontinued.

Photo 48. Test Section No. 3, item 4, after 100 coverages of C-130 loading over loose sand

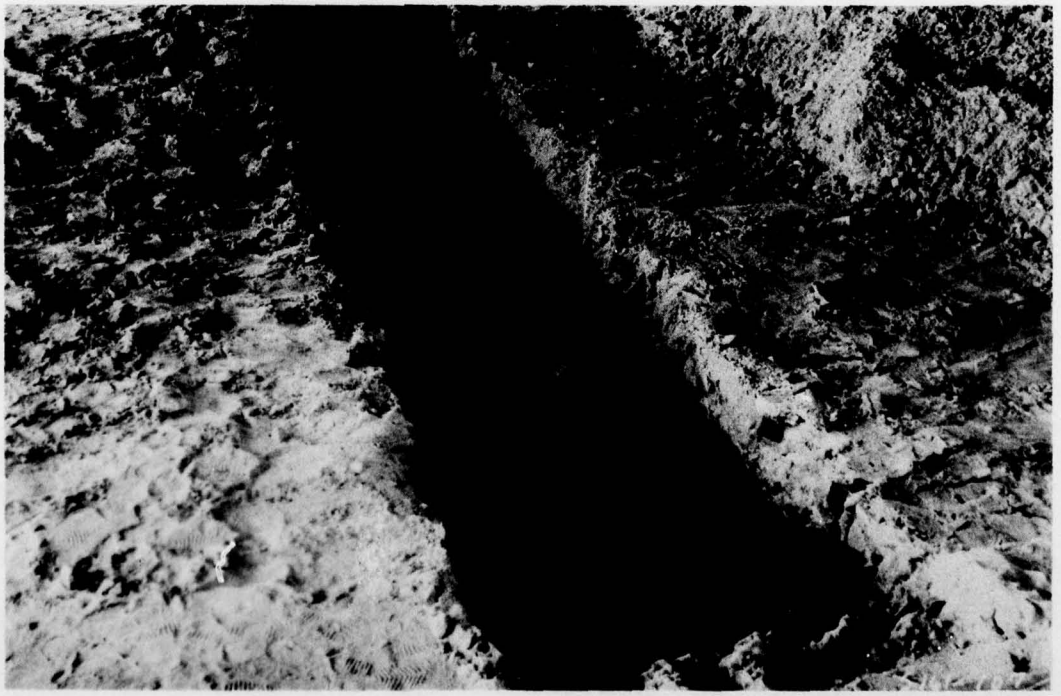
61. Following the traffic testing, test trenches were excavated across the test items in order to evaluate the condition of the paper grids. Photos 49 through 52, respectively, show views of the test trenches in items 1, 2, 3, and 4. As can be noted in the photographs, the grid remained in the vertical position as placed, and the surface contour conformed to the contour of the surface of the sand in items 1, 3, and 4. The grid was badly torn up in item 2 during the initial efforts to consolidate the sand, and the contour of the grid could not be determined in this item.

Photo 50. Test Section No. 3, item 2, trench after 200 coverages

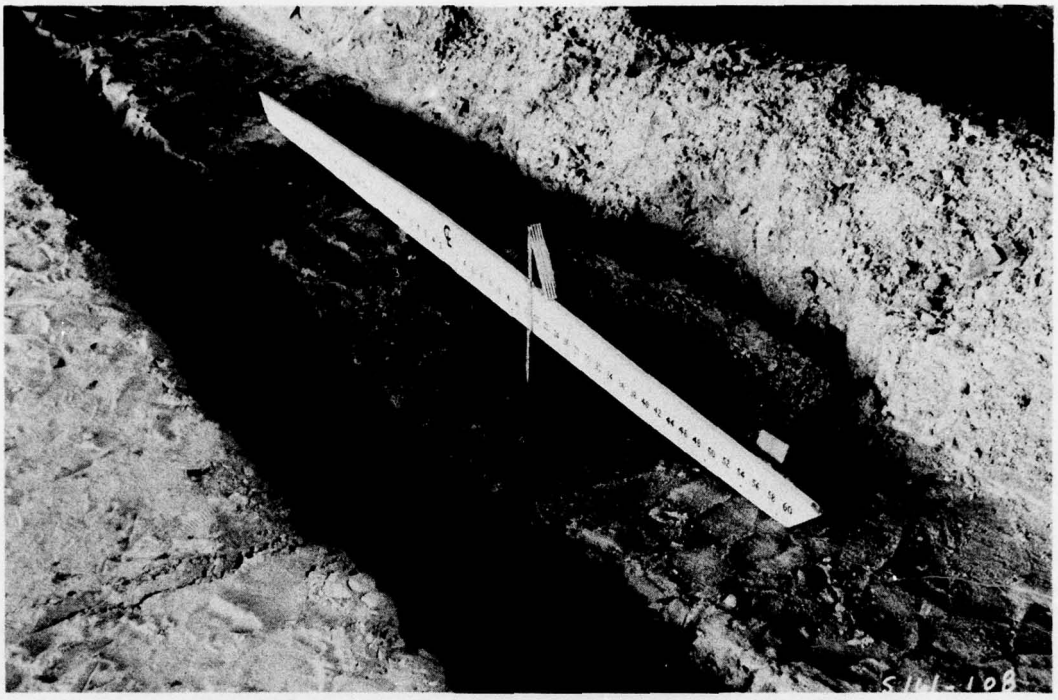
Photo 51. Test Section No. 3, item 3, trench after 200 coverages

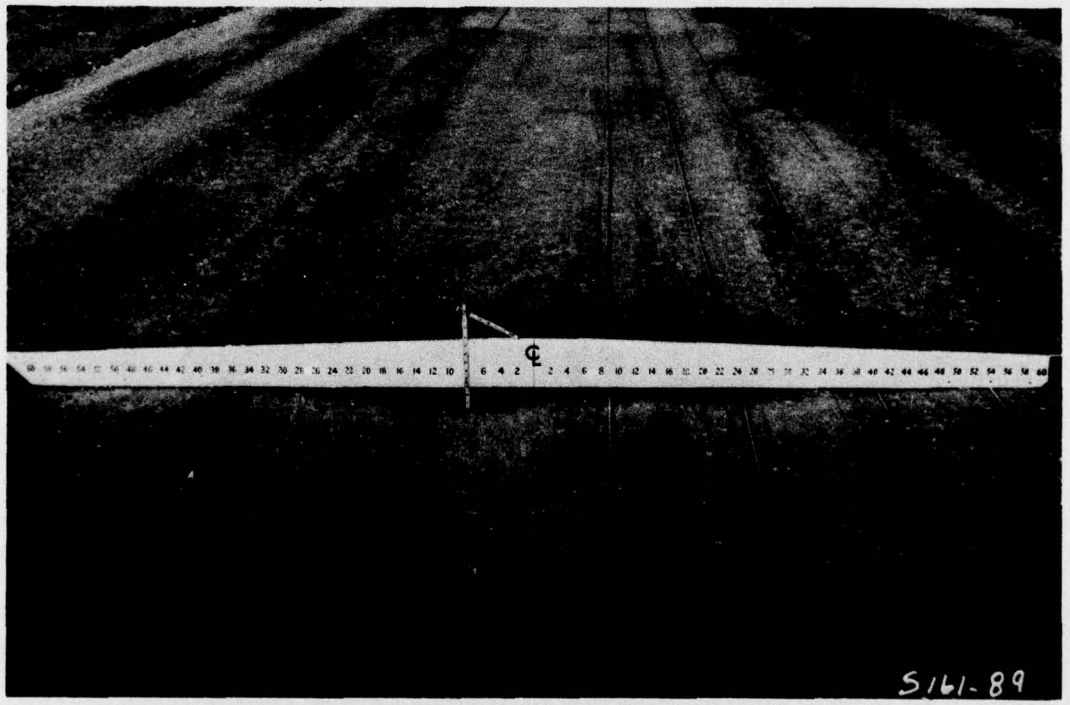
Photo 68. Test Section No. 4, item 1, after 480 passes of load wheel

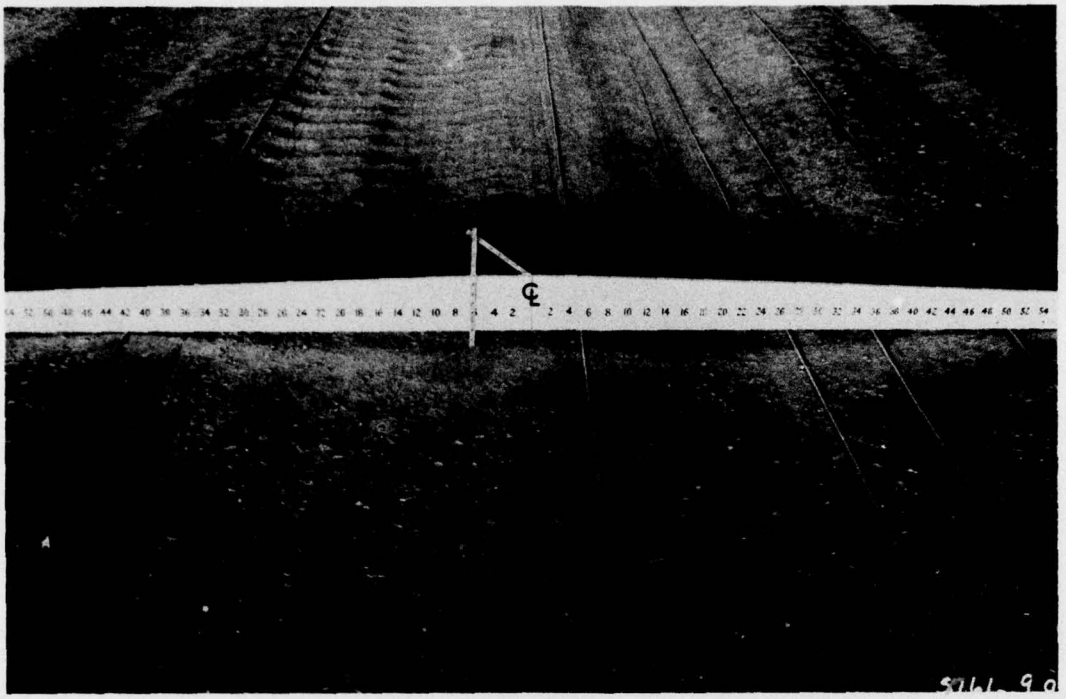
Photo 69. Test Section No. 4, item 2, after 480 passes of load wheel

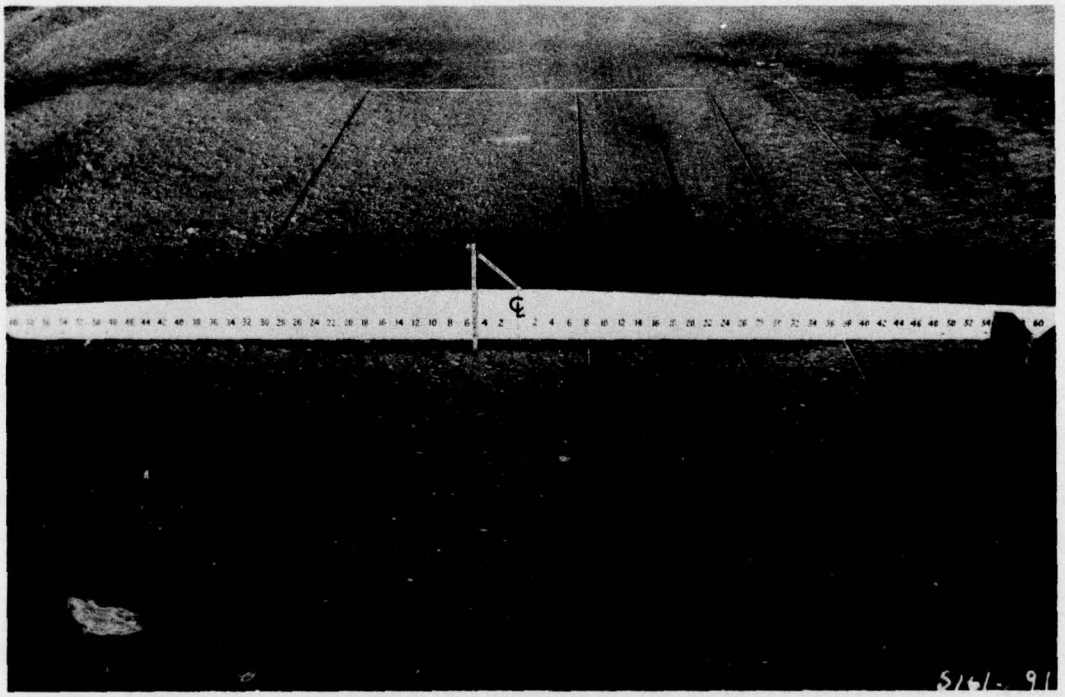
Photo 70. Test Section No. 4, item 3, after 480 passes of load wheel

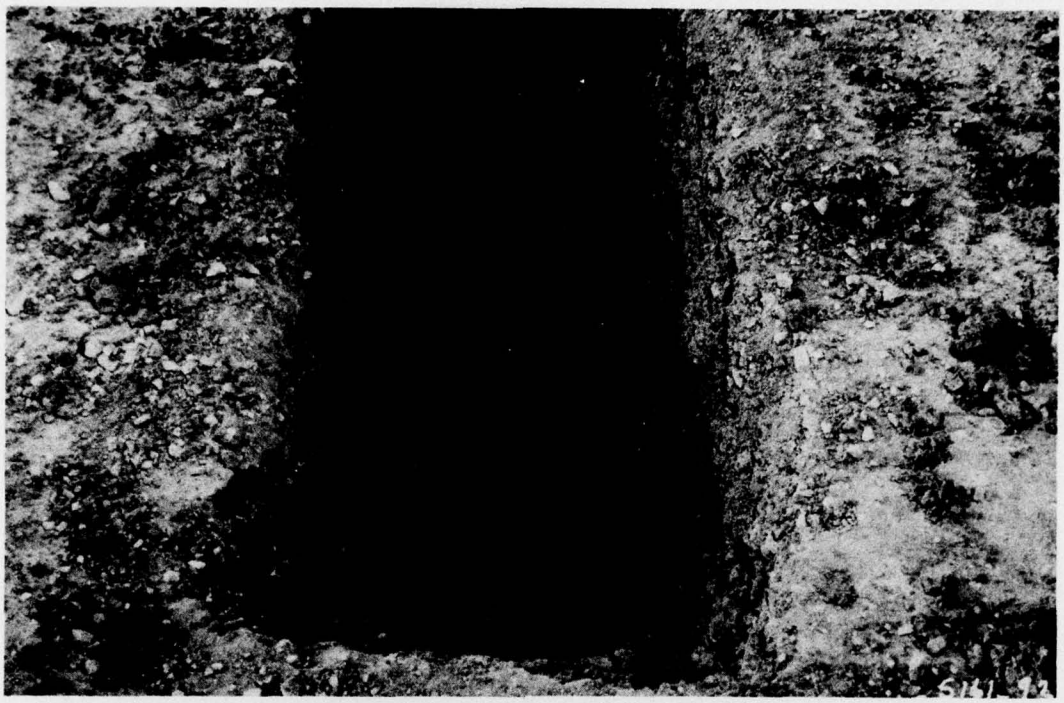
Photo 71. Trench in Test Section No. 4, item 1, showing condition of membrane after 480 passes

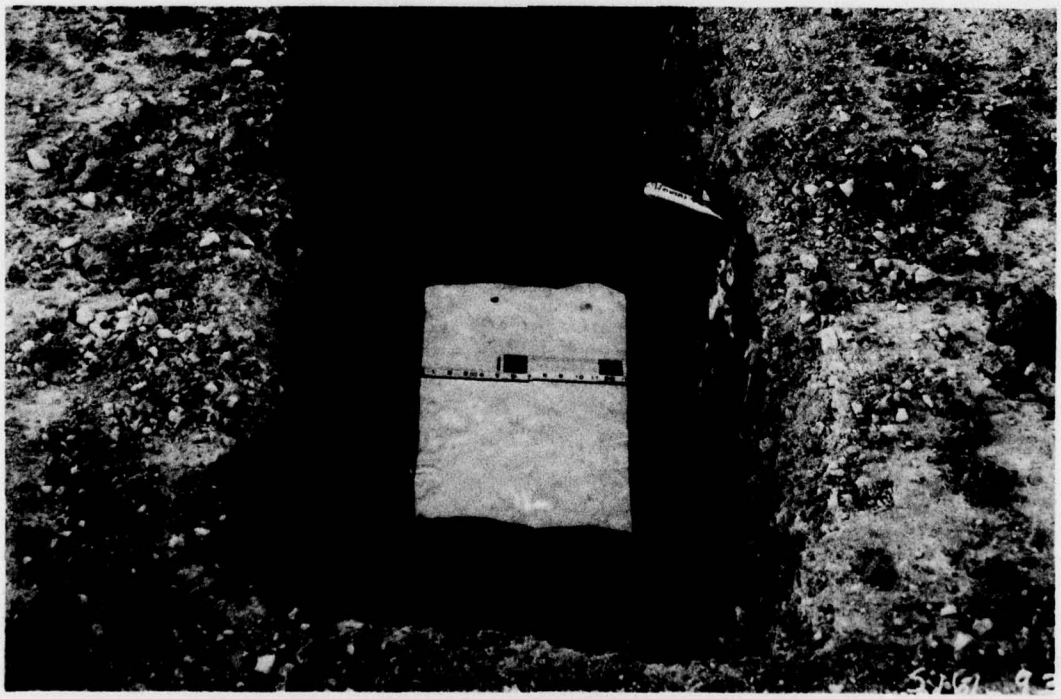
Photo 72. Surface of Styrofoam, Test Section No. 4., item 1, after 480 passes

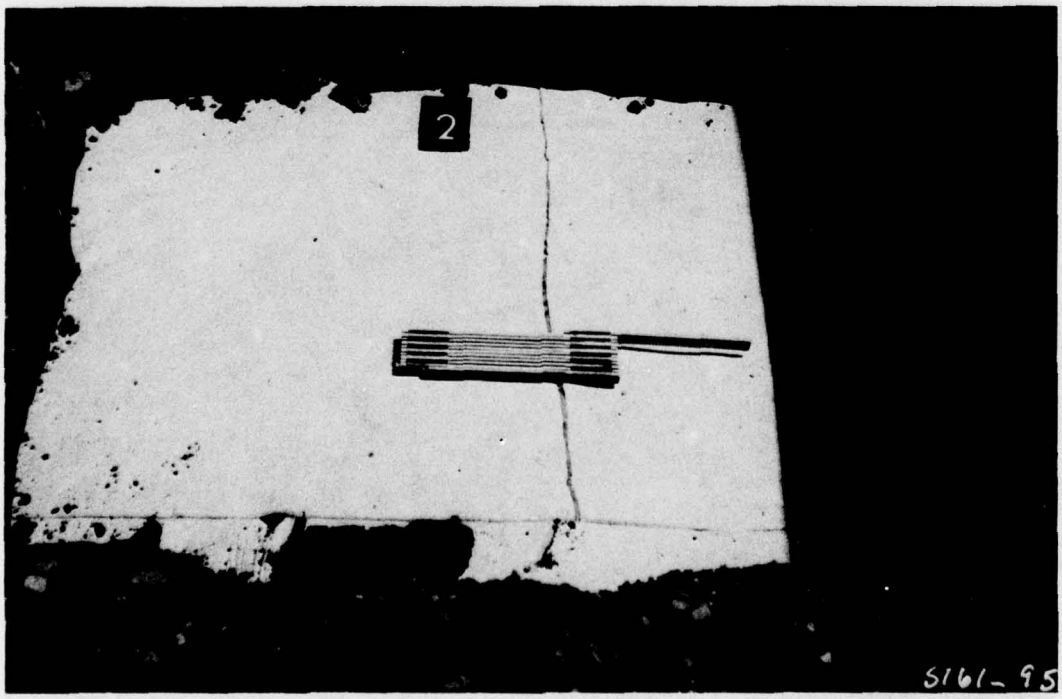
Photo 78. Break in Styrofoam in Test Section No. 4, item 2, after reduced thickness and all traffic

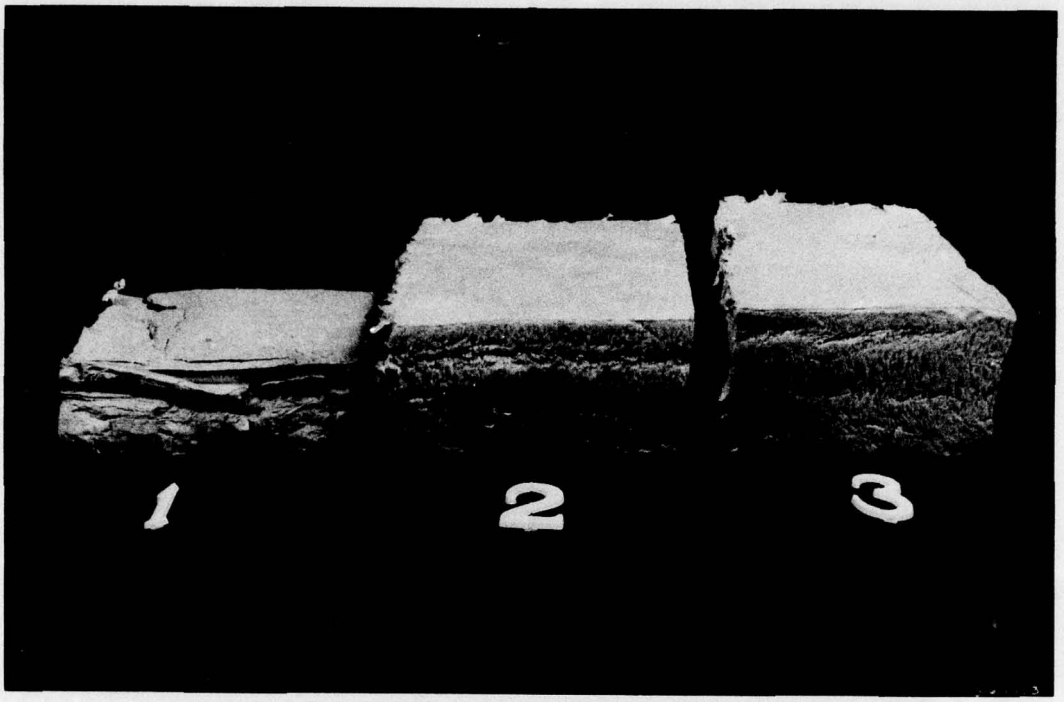
Photo 79. Comparative compression in Styrofoam cut from Test Section No. 4, items 1, 2, and 3, after reduced thickness of base and all traffic

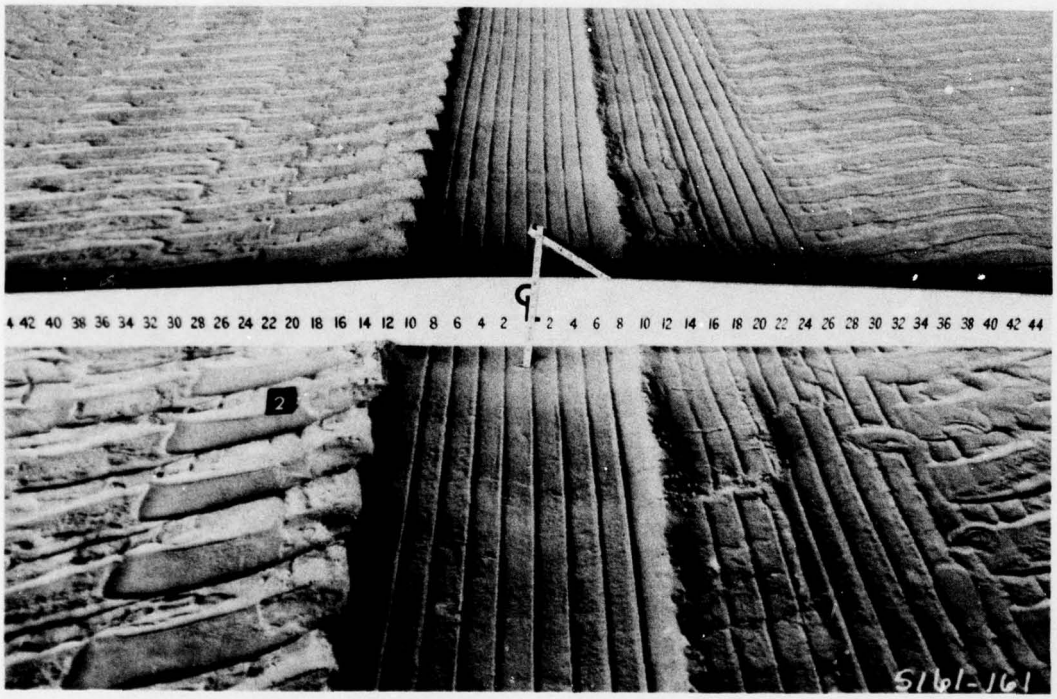
Photo 90. Two- and one-half-inch rut in Test Section No. 5, item 2, under C-130 traffic

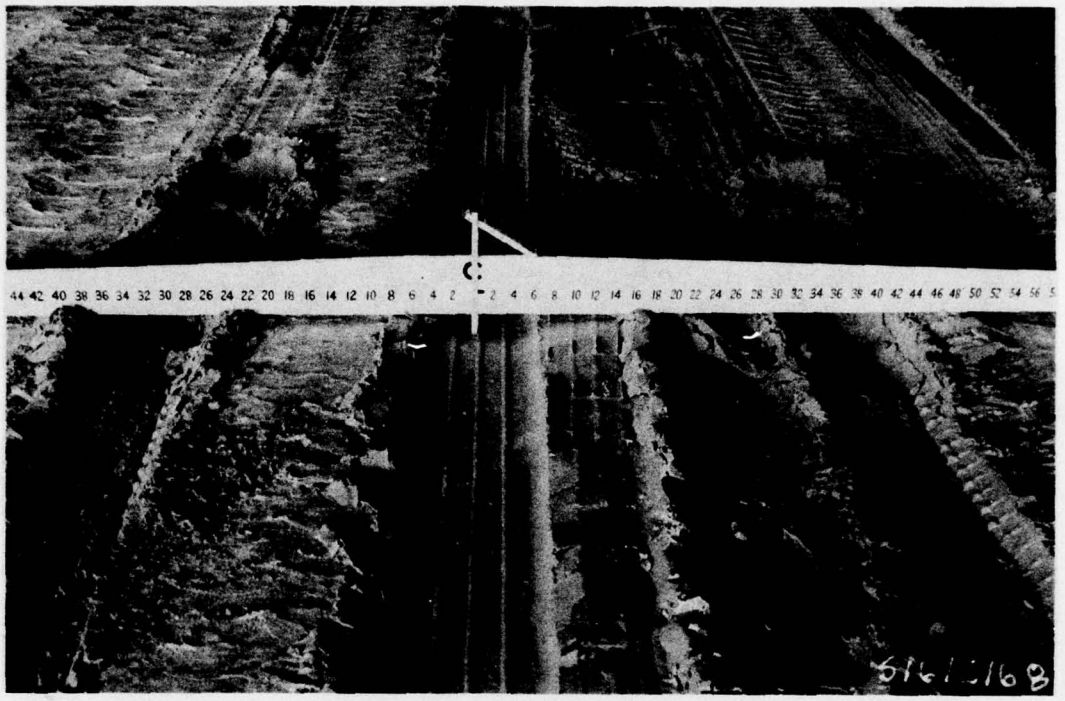
Photo 93. Rut in Test Section No. 5, item 2, after F-4C traffic
