DELAWARE RIVER BASIN
TRIBUTARY TO HAYNES CREEK
BURLINGTON COUNTY
NEW JERSEY

BREAKNECK DAM
NJ 00425

PHASE 1 INSPECTION REPORT
NATIONAL DAM SAFETY PROGRAM

May, 1979

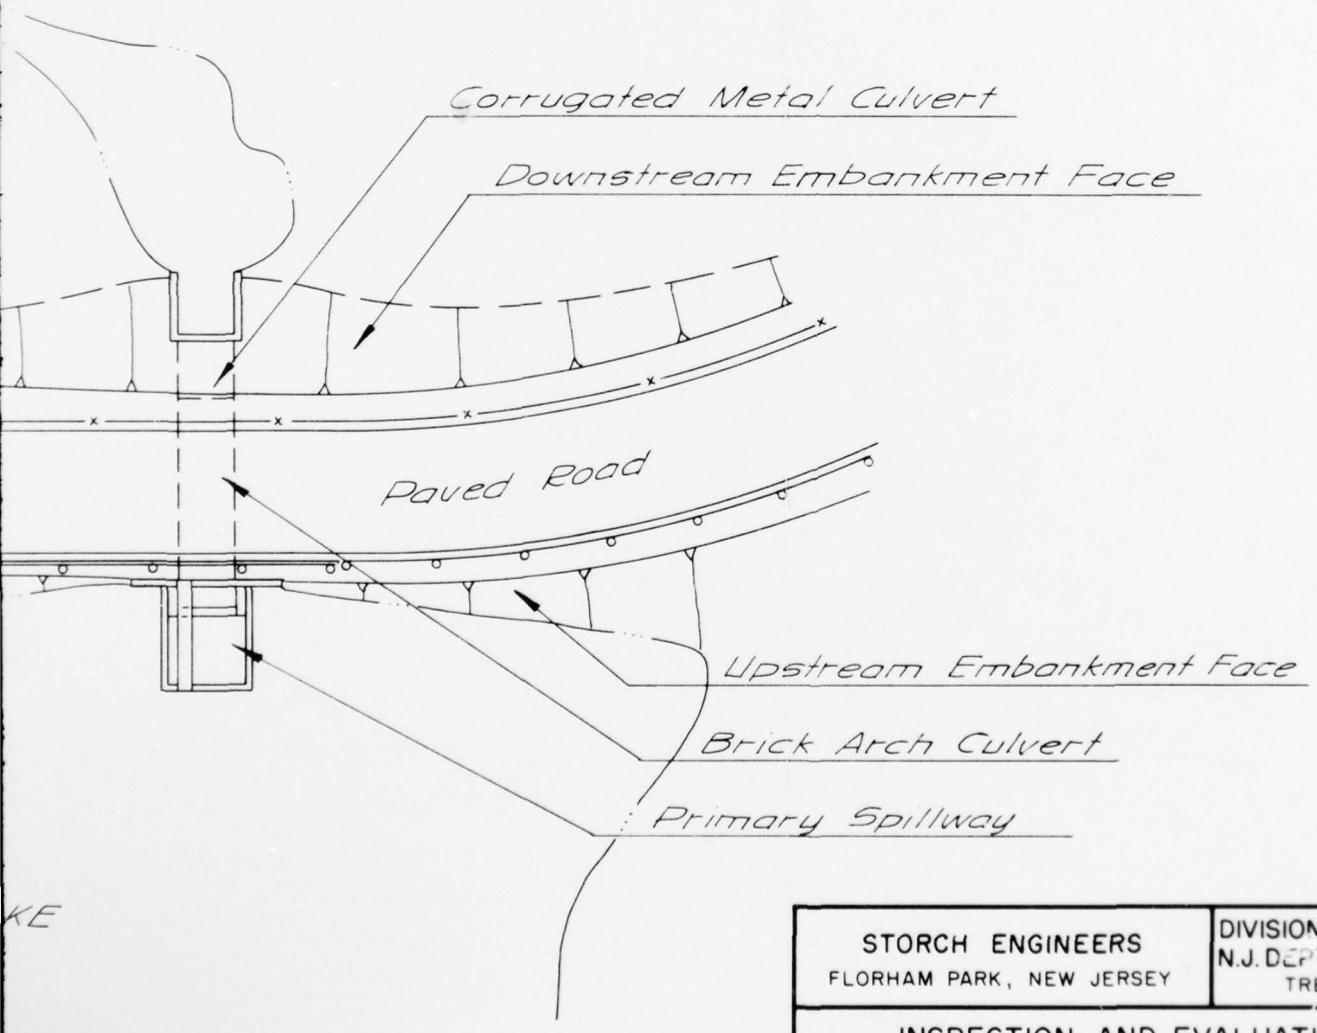
PLATE 5

A stilling basin was observed at the outfall of the secondary spillway discharge culvert. The west bank of the natural channel downstream of this outfall has been undercut and eroded. Seepage was noted exiting from the undercut area (see Plate 5 and Photo 9) discharging as a trickle with some suspended orange silt.

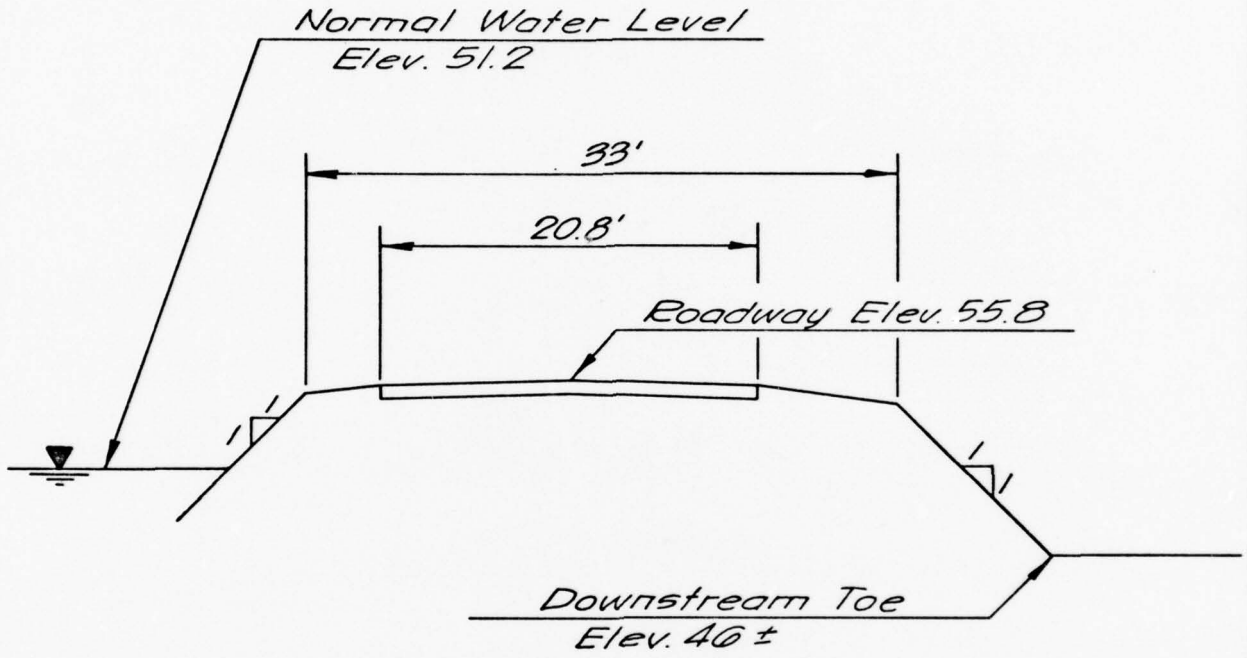
PLATE 8

The earthfill embankment is approximately 255 feet long and extends east/west. The embankment crest is 33 feet wide with an asphalt roadway at its center, about 21 feet wide (see Plate 8 and Photo 6). Based on field measurements, the upstream and downstream slopes are approximately 1:1 (see Photo 5). The embankment crest is generally level at elevation 55.8 (MSL) and the dam is about 14 feet high. Dense vegetation consisting of low level ground cover, brush and trees, covers both the upstream and downstream slopes of the embankment. The surface soil on the embankment consists mainly of sand.
