RARITAN RIVER BASIN
SOUTH BRANCH RARITAN RIVER
HUNTERDON COUNTY
NEW JERSEY

LAKE SOLITUDE DAM
NJ 00123

PHASE 1 INSPECTION REPORT
NATIONAL DAM SAFETY PROGRAM

May, 1979

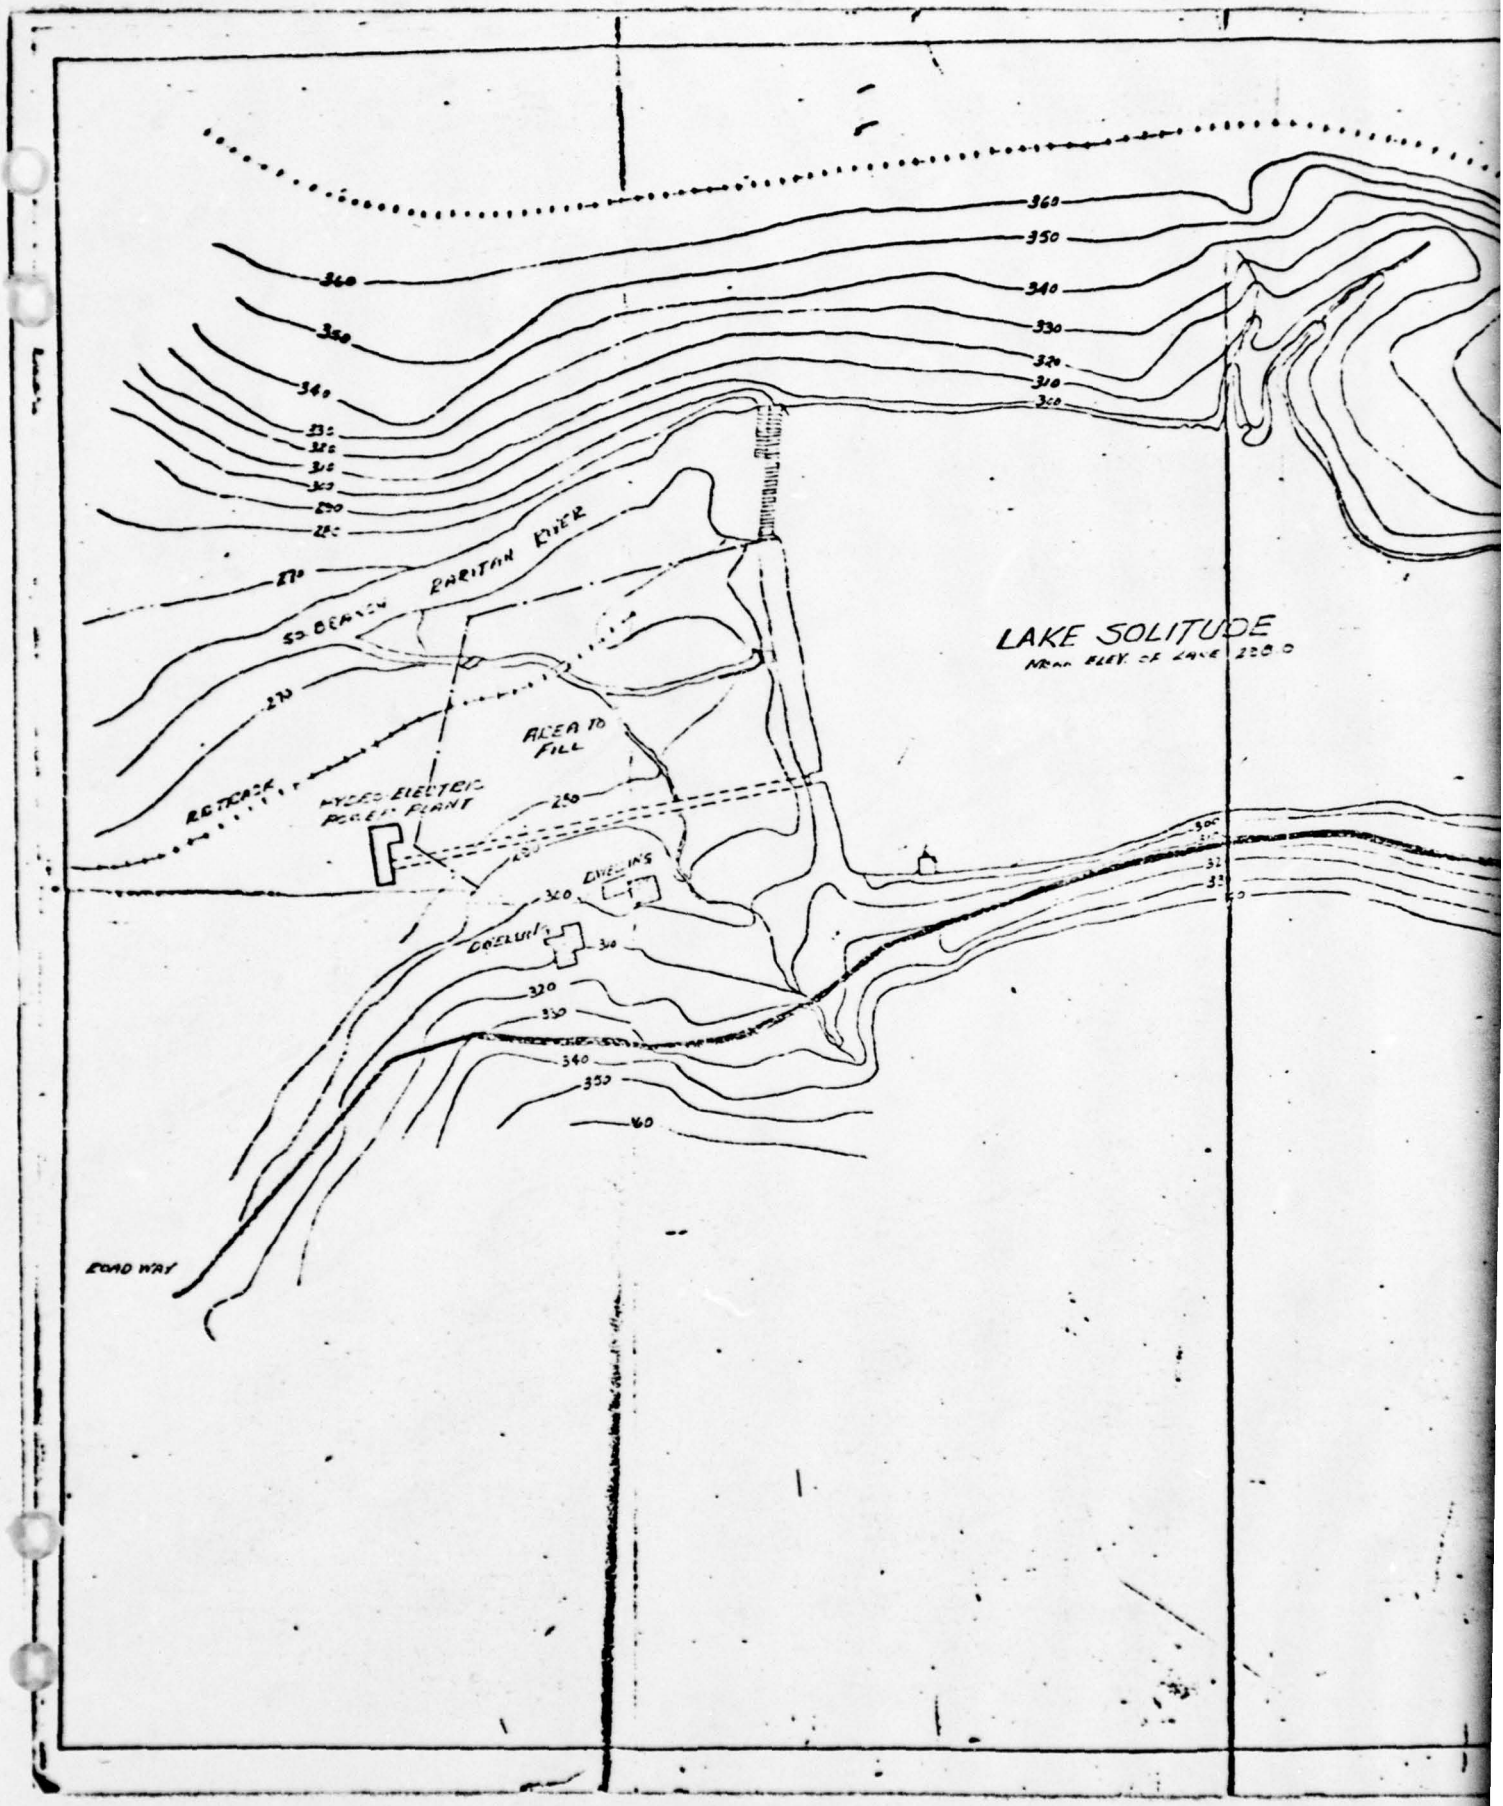
PLATE 2

A concrete lined tunnel passes through the right third of the embankment and exits into a channel with masonry walls (Photo 5). This discharge channel is approximately 3 feet high by 5 feet wide and empties into the South Branch Raritan River downstream from the dam as shown on

The third outlet was the water supply for the now abandoned hydroelectric power plant (Plate 2). The intake consists of a masonry structure located on the left third of the embankment with sliding gate and steel grate trash cover. The intake is almost completely blocked by sediment and debris (Photo 6). The masonry structure is generally in fair condition with a few dislodged stones, however, the gate which is guided by two steel channels is inoperable.

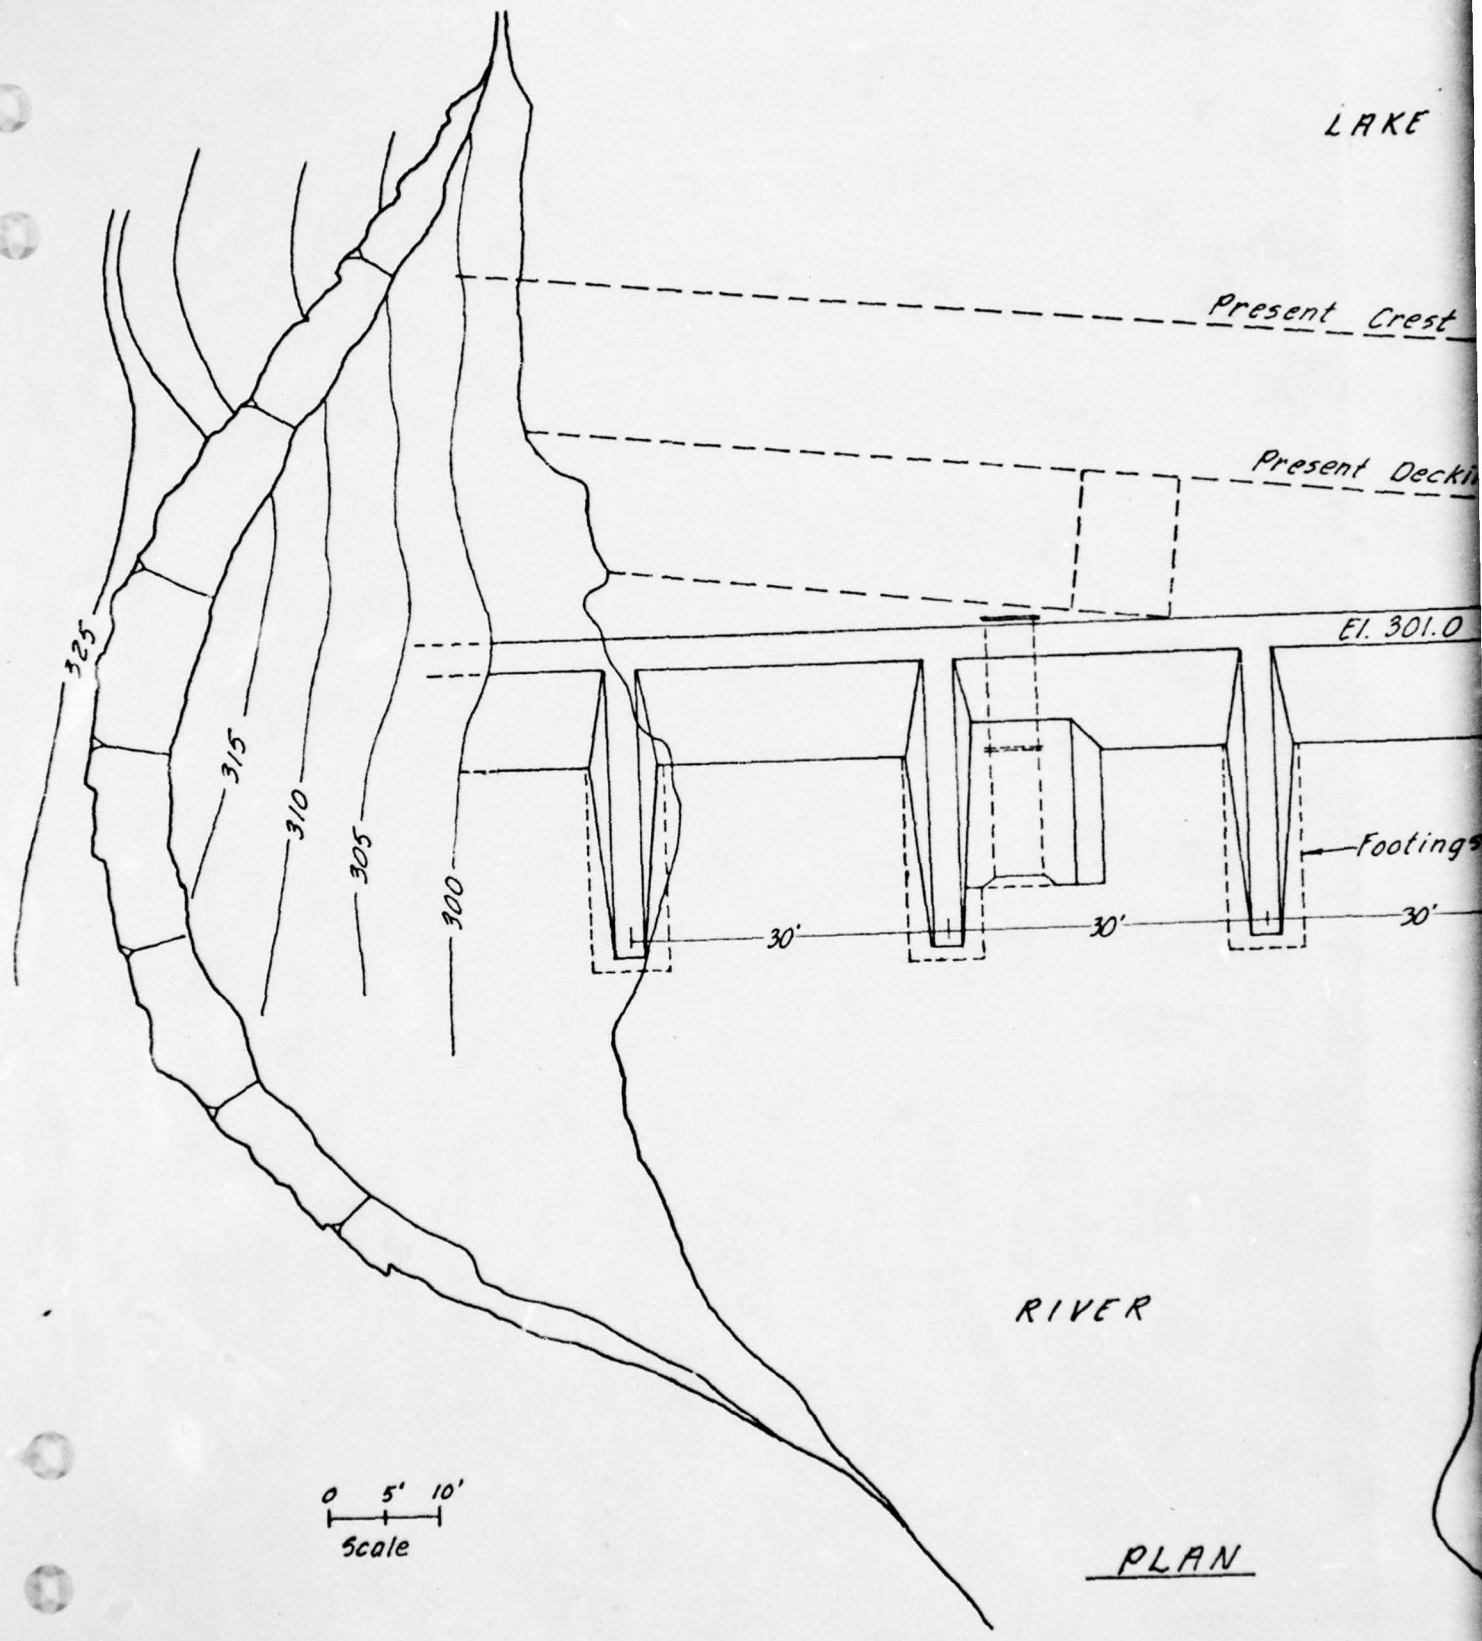
PLATE 3

The available drawings indicate that the masonry dam was designed by F. S. Tainter. The masonry dam is referred to as a steel compression dam with patent pending. The plans indicate that there were to be 6 buttresses on the downstream face of the dam (Plates 3 and 4); however, field observations revealed that there are only 4 buttresses. Thus the available plans apparently represent an earlier design. Plans indicate that the dam was designed with a skeleton of 12-inch steel I-beams set in concrete in the core of the dam (Plate 5).

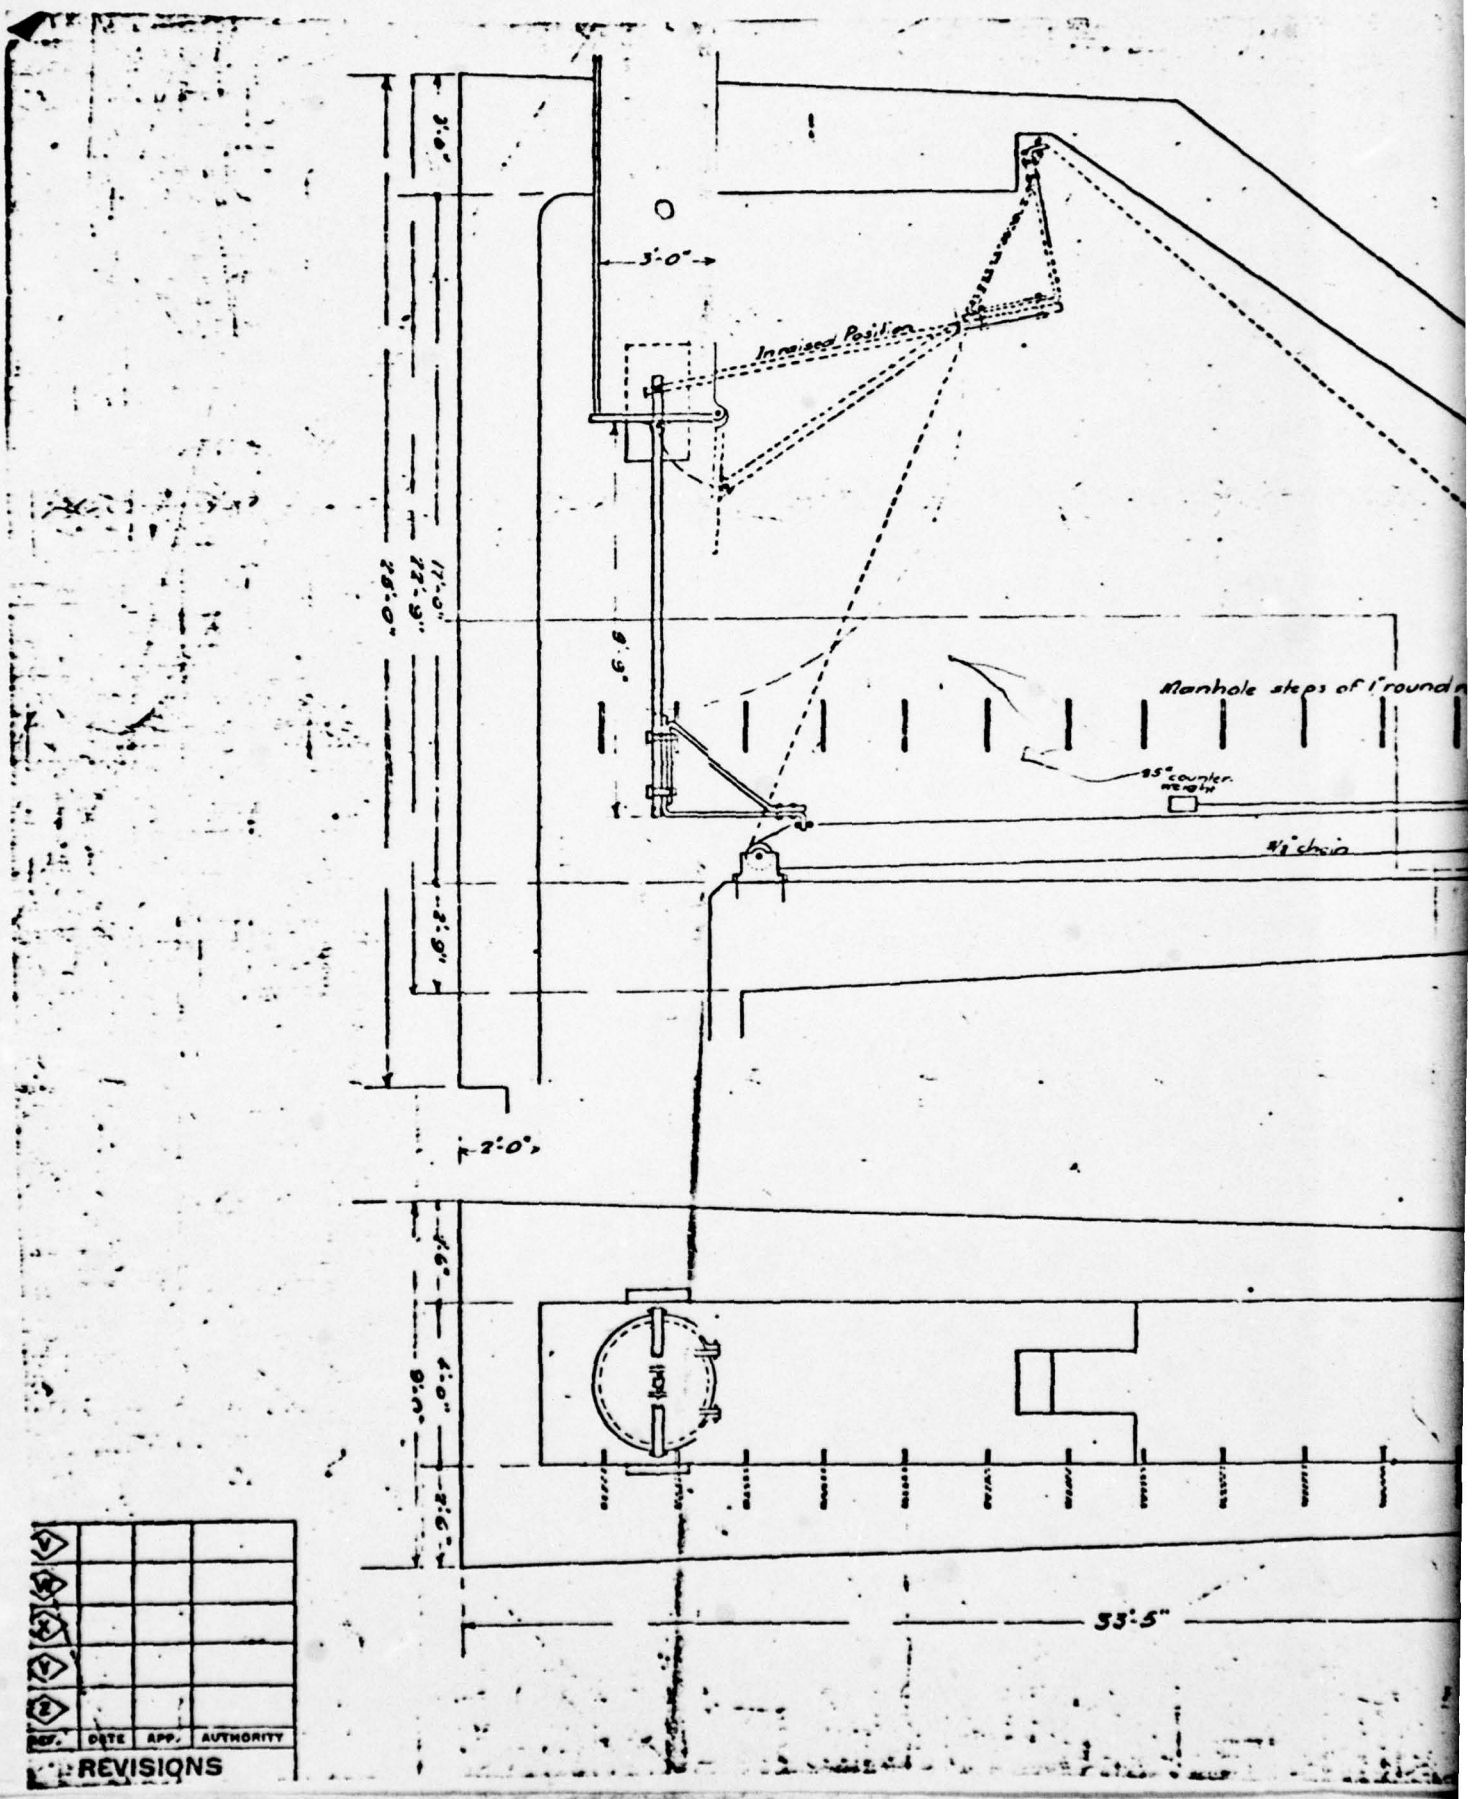
PLATE 6

The outlet through the base of the masonry dam is shown on Plate 6. The controls to this outlet are located on the crest of the dam (Photo 1). This outlet, including the gate controls, were inaccessible for inspection due to water passing over the dam. Any former access devices or structures, such as cable rigging or a bridge, have been destroyed.

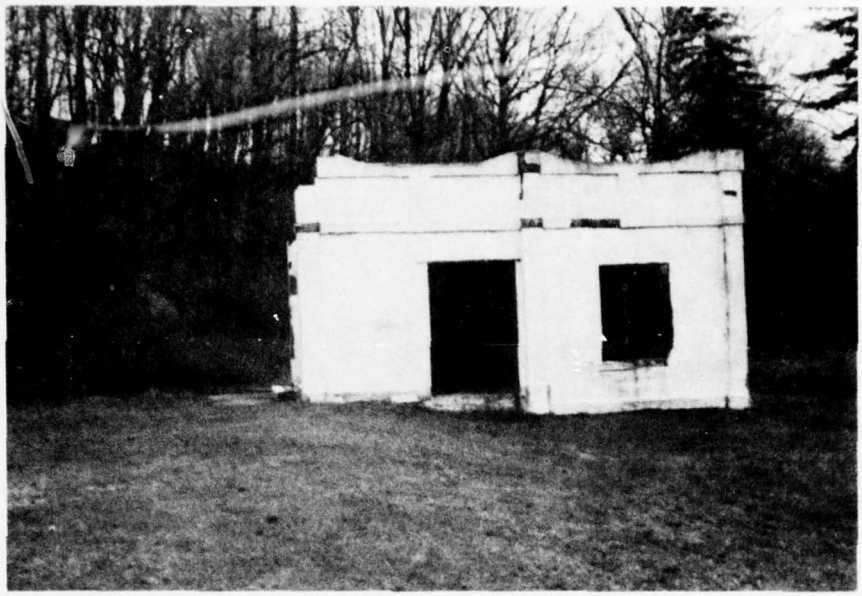
The 6-foot diameter steel penstock exits from under the embankment adjacent to the abandoned concrete power house (Photo 7). The steel is badly corroded and a jet of water was leaking from a hole rusted out at the base of the penstock where it goes underground to connect to the power house (Photo 8). A jet of water was also noted coming out of a hole in the turbine (Photo 9).

Photo 7 View of hydro-electric power plant with penstock at left

Photo 8 View of penstock showing leak (arrow)

(5) The poor condition of the penstock could result in complete failure of this structure either at its downstream end or within the embankment. Water should be prevented from passing into the penstock by thoroughly sealing its intake.

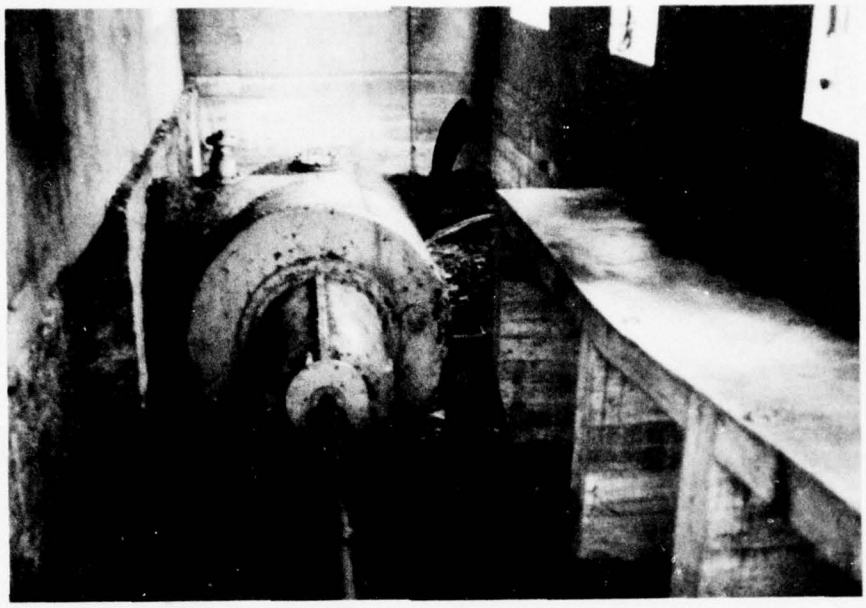
There is no program of regular inspection or maintenance of the outlet works. The intake to the penstock outlet is inoperable and the other outlets appear to be inoperable. The hydroelectric plant has been abandoned and both the penstock and the turbine are badly corroded and leaking.

Photo 9 View of turbine inside power house showing leak (arrow)

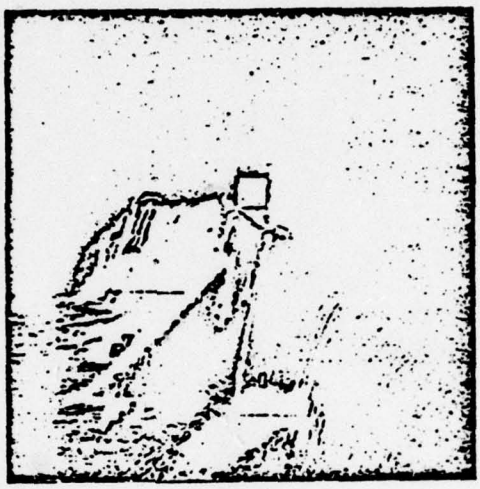
PHOTOGRAPH 2

Constructed on top of the spillway is a white shed which appeared to contain gates and valves. This could not be inspected because there was no access to it from the banks. This is shown in photograph 2.
