4. TITLE (and Subtitle)
Phase I Inspection Report
Vly Creek Dam
Lower Hudson River Basin, Albany County, NY
Inventory No. N.Y. 96

5. TYPE OF REPORT & PERIOD COVERED
Phase I Inspection Report
National Dam Safety Program

7. AUTHOR(s)
George Koch P.E.

12. REPORT DATE
28 Sept 1978

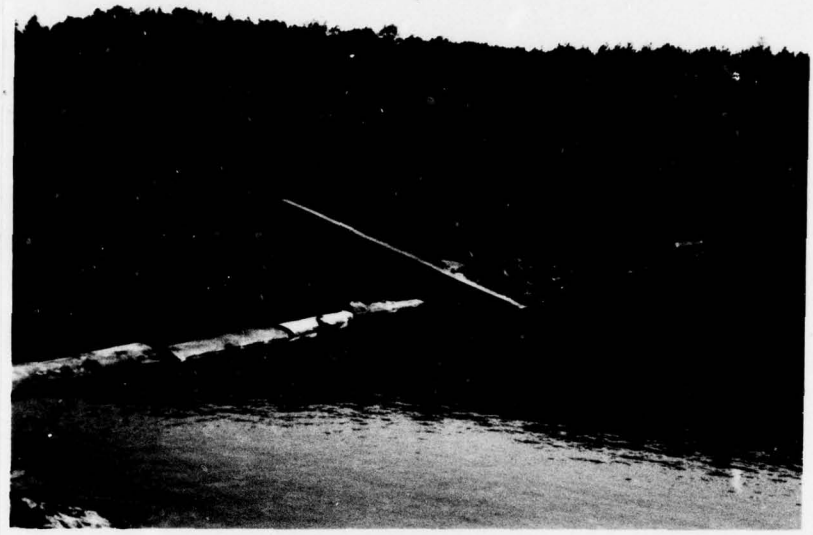
Spillway and Dam Embankment
looking west

a. General Approach channel not visible, logs to keep trash & ice away from flashboards, spillway chute walls cracked at both abutments and cracks on construction joints (minor)

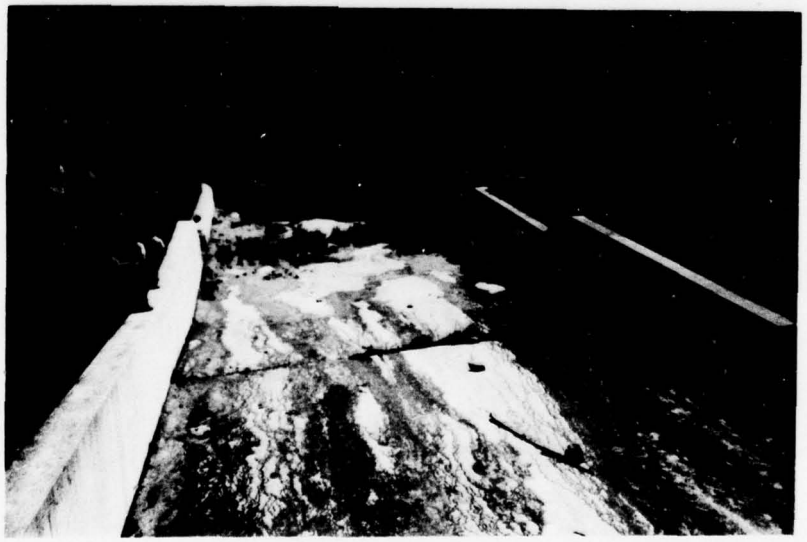
In general, the spillway is in poor condition. The spillway walls were cracked at both abutments and at the construction joints.

Considerable debris was found in the tailrace channel and at the end of the spillway chute. Vegetation was growing through the expansion joints of the spillway slabs. No energy dissipation was provided at the end of the spillway.

Spillway Chute and Downstream Channel
looking south

b. All debris in the spillway chute and the tailrace channel must be removed. All vegetative growth in the channel must be removed and periodically maintained in that manner. Vegetation below the toe of the embankments should also be regularly trimmed back to permit unimpeded inspection of this area. Additional growth observed in the riprap should be removed.

d. All joints in the spillway must be cleaned and recaulked. All concrete cracks must be cleaned and repaired, with particular attention paid to sealing of horizontal cracks and joints.

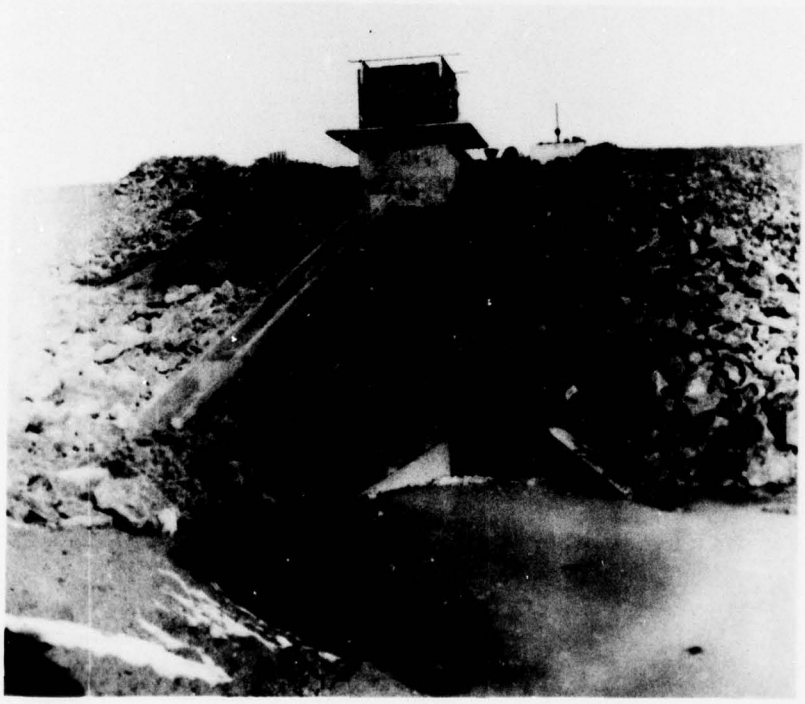
Dike Construction: Gate House, Intake Structure, and Low Level Outlet

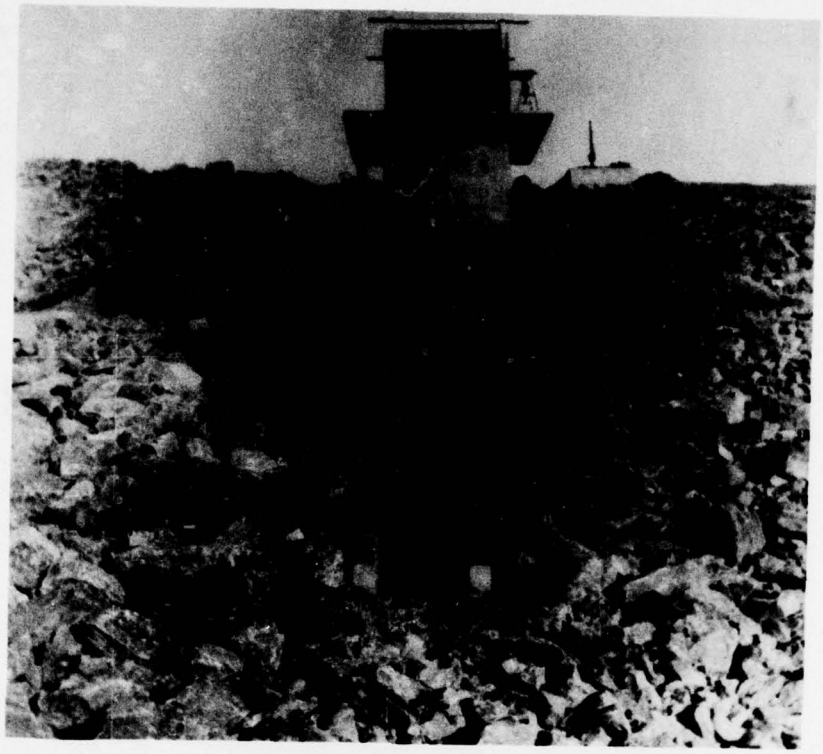
Dike Construction: Intake Structure and Gate House
looking north
