AMMRC TR 79-39

TEST AND EVALUATION OF GRAPHITE/EPOXY COMPOSITE STRUCTURE

Martin Marietta Corporation
Orlando Division
P.O. Box 5837
Orlando, Florida 32855

Final Report

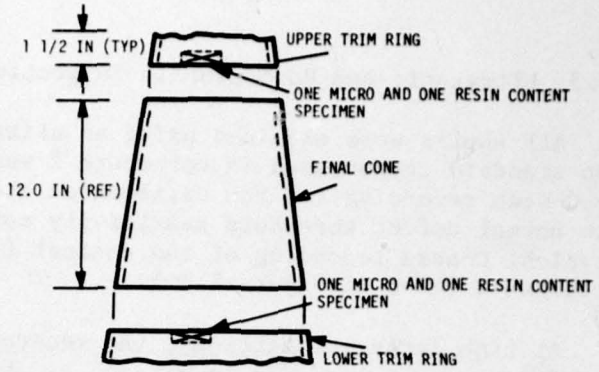
Microexamination of sections cut from trimoff rings, Figures 2.3-1 and 2.3-2, showed that uniform microcracking occurred along exterior 0 degree oriented plies and, with lesser frequency, along the interior 0 degree plies. These microcracks, which do not extend beyond the 0 degree oriented plies, are shown in Figure 2.3-3. Microcracks are characteristic of ultra-high modulus fibers in 350°F curing resin systems. The frequency of micro-cracks in the 0 degree plies of the conical frusta ranged from 11 to 33 per inch of circumference.

Figure 2.3-2. Locations of Inspection Sample Specimens

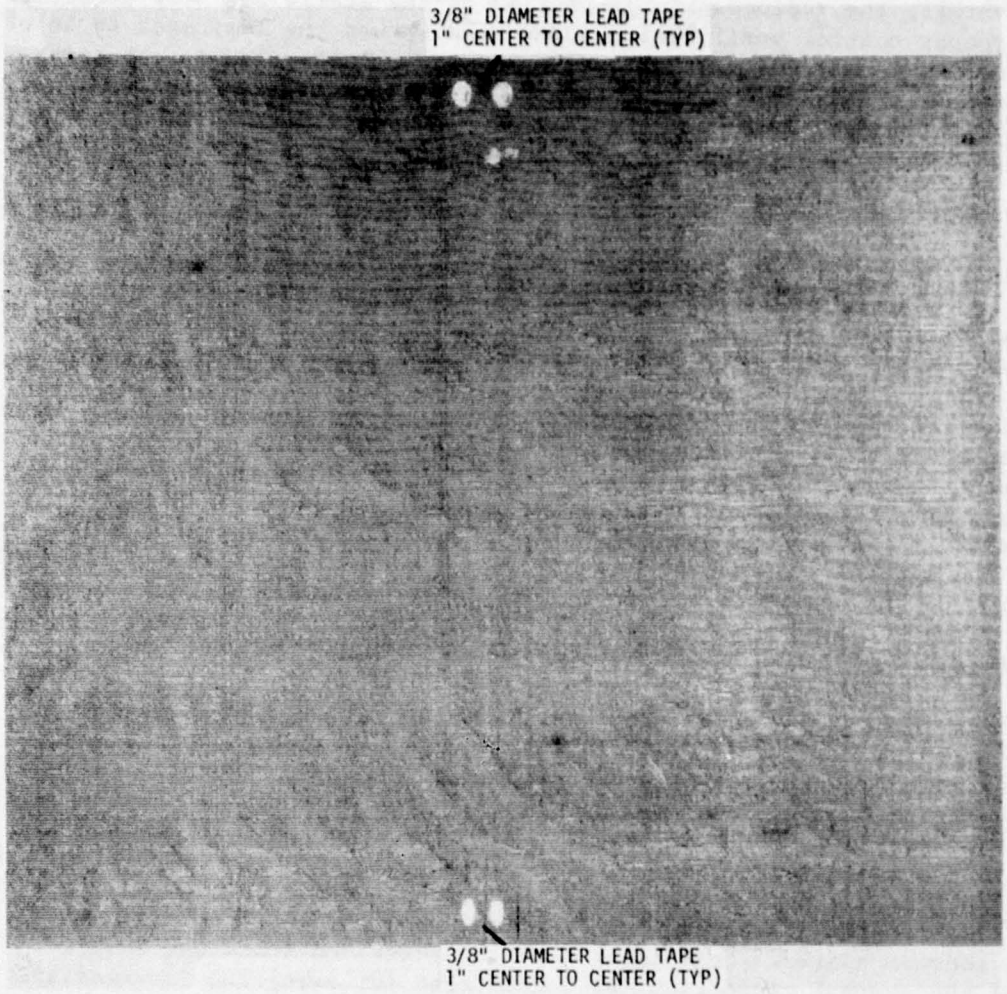
At the high intensity settings, a number of signal discontinuities were recorded, most of which were traceable to internal wall indentations and local waviness. Local density changes in the upper 1-1/2 inch end trimoff ring regions of cones 3 and 5 were detected at high intensity settings. Three out of the four delaminations of the inner two plies of cone 3, which occurred during cool-down after end ring baking, coincided with discontinuities in the high intensity C-scan recording near the upper rim.

Figure 2.3-5. Ultrasonic C-Scan of Graphite/Epoxy Cone

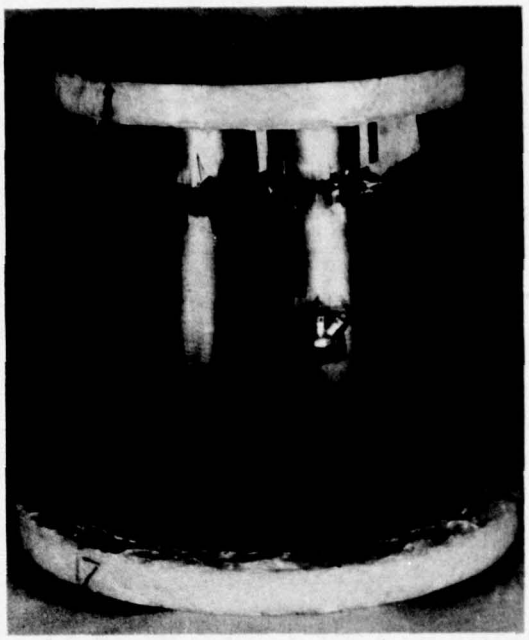
Cones 3 and 5 failed in compression while holding the load for data recording. Cone 3 emitted cracking noises prior to failure at 105,000 pounds. Cone 5 emitted only one noise earlier in the test and failed suddenly at 110,000 pounds.

Figure 3.1-2(a). Conical Shell 3 After Axial Compression Test to 105,000 lb

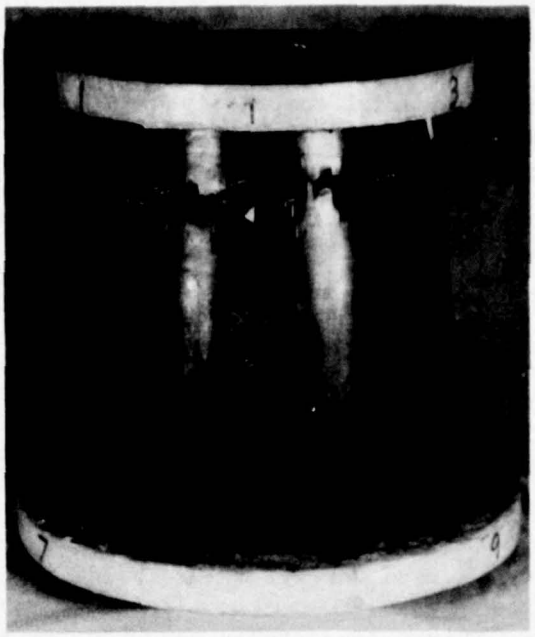
Figure 3.1-2(b). Conical Shell 5 After Axial Compression Test to 110,000 lb

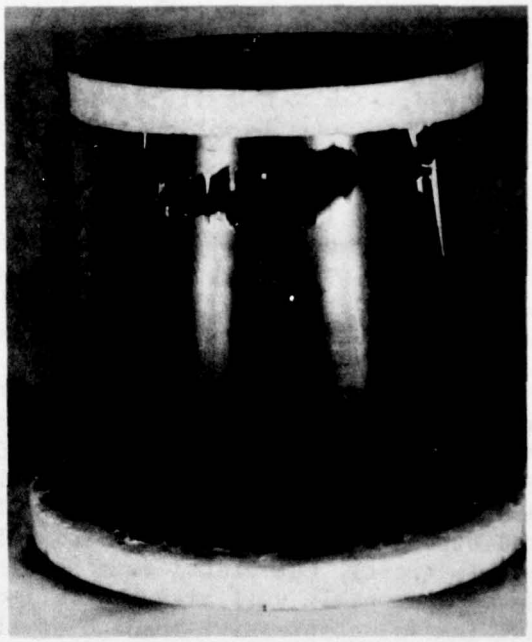
Cone 6, instrumented with only nine axial type strain gages, failed suddenly at 103,000 pounds while increasing the load from 100,000 to 105,000 pounds. All failure modes were of the same appearance as shown in Figure 3.1-2. The fracture lines are circumferential, closed path fractures which travel around the cones 1 to 2 inches from the upper (small) ends. General fragmentation of the test sections was prevented by using the test machine in stroke control mode for cones 3 and 5, and adjusting the machine ram to within 3/16 inch of its bottomed-out stroke limit for cone 6, which was tested in load control mode.

Figure 3.1-2(c). Conical Shell 6 After Axial Compression Test to 103,000 lb

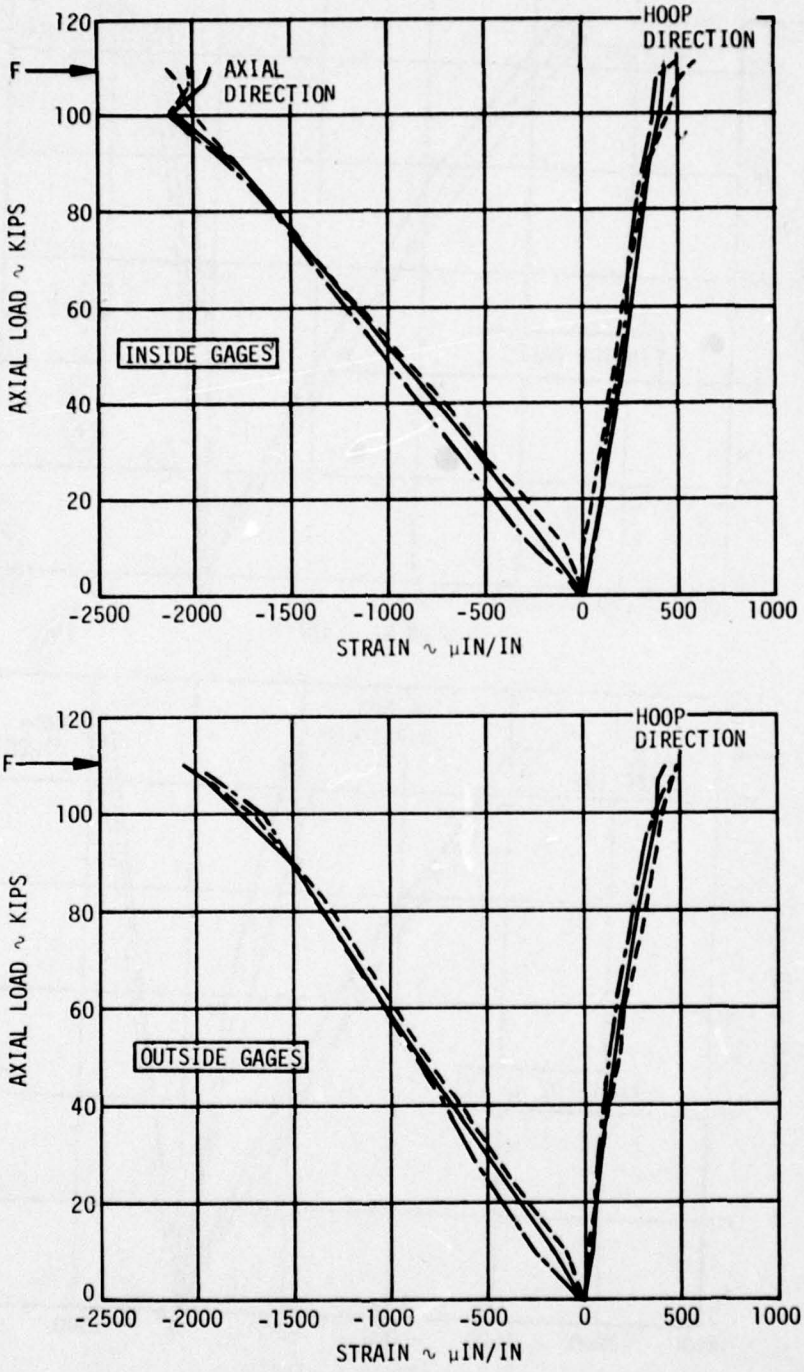
The strain gage data on cone 5 indicate that an initial local failure occurred at a 100,000 pound load at the inner plies near the small end. This is evidenced by a sudden drop of strain on two of the three axial strain gages (Figure 3.1-10). Examination of the outside strains at this location indicates that part of the load was transferred to the outer plies as shown by a sudden increase in strain at the same load level.

Figure 3.1-10. Cone 5 Axial Load Test - Section C-C
Strains versus Test Load

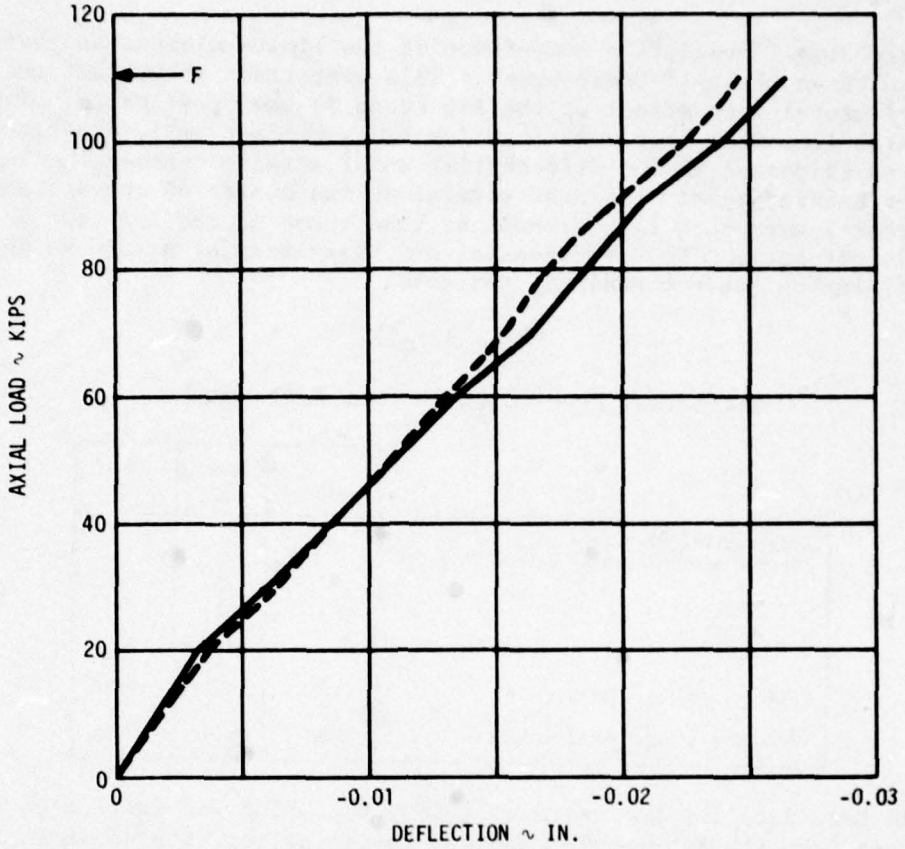
Figure 3.1-11. Cone 5 Axial Load Test - Axial Deflection versus Load

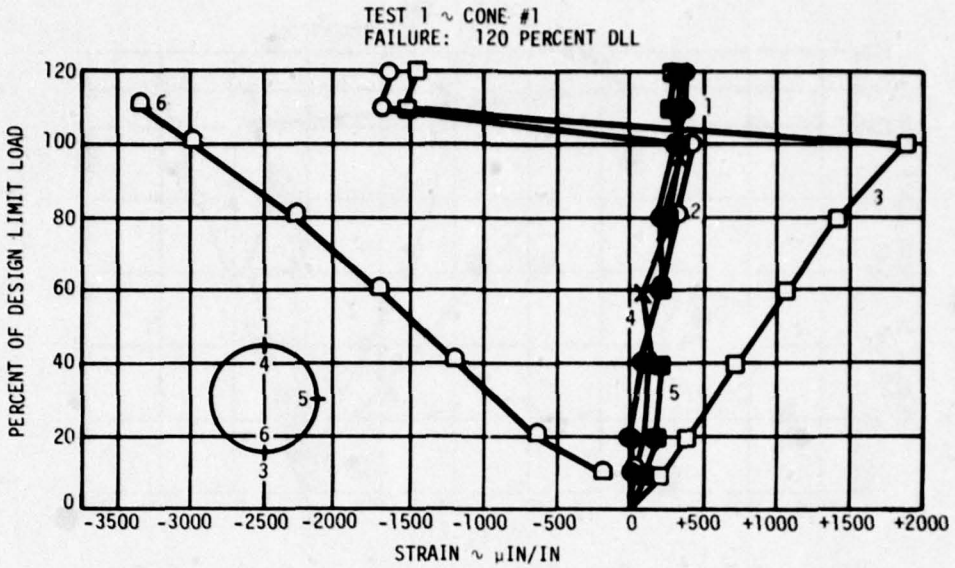
Figure 3.2-13. Cone 1 Hoop Strains at Station 6.0

At station 6.0, a maximum longitudinal compressive strain of -2300 μin/in and a maximum hoop strain of -4800 μin/in were observed. In test 1, hoop gages at locations 2 and 3 show a large change of strains at 100 percent of DLL (Figure 3.2-13), signifying local failures. The large hoop strains were caused by the strap loads which imposed high bending strains at bottom of the shell as demonstrated by gages 3 and 6.

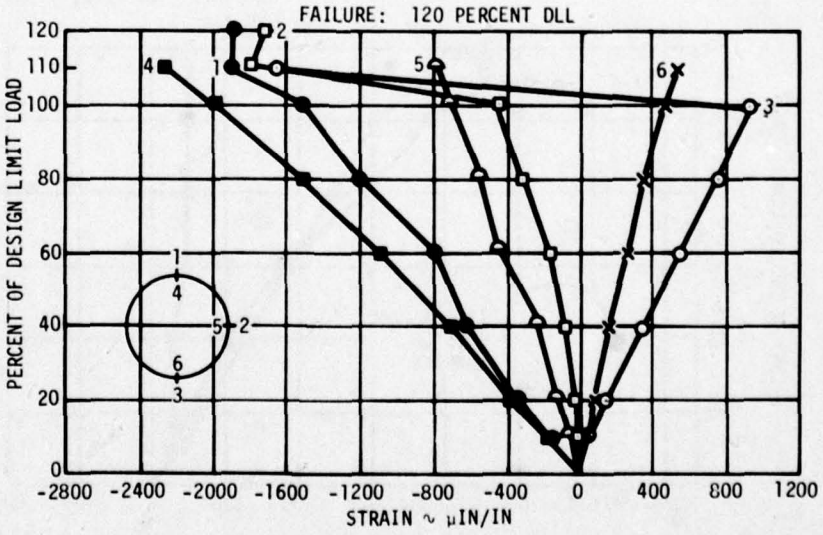
Figure 3.2-14. Cone 1 Longitudinal Strains at Station 9.60

At station 9.6, where the maximum longitudinal strains occurred and fracture took place, cone 1 (test 1) exhibited discontinuous longitudinal and hoop strains at 100 percent of DLL, and failed at a lower load than cones 2 and 4. No abrupt changes in strains were found in cones 2 and 4. The maximum longitudinal and hoop strains are -2300 μin/in and -1800 μin/in respectively. Higher strains in the internal plies were predicted by analysis but could not be measured.

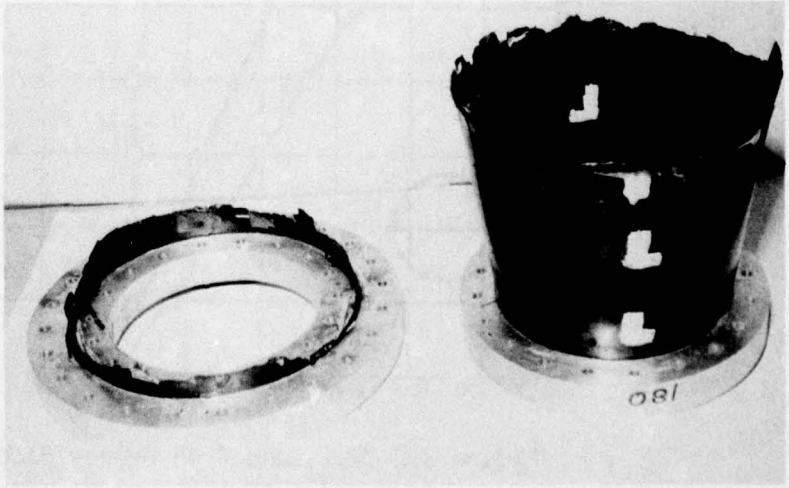
Figure 3.2-34. Failure of Cone 2 Under Combined Loads
