TECOM PROJECT NO.7-CO-RD5-TT1-016

USATTC REPORT NO. 790102

METHODOLOGY INVESTIGATION

EXPOSURE/PERFORMANCE TESTS

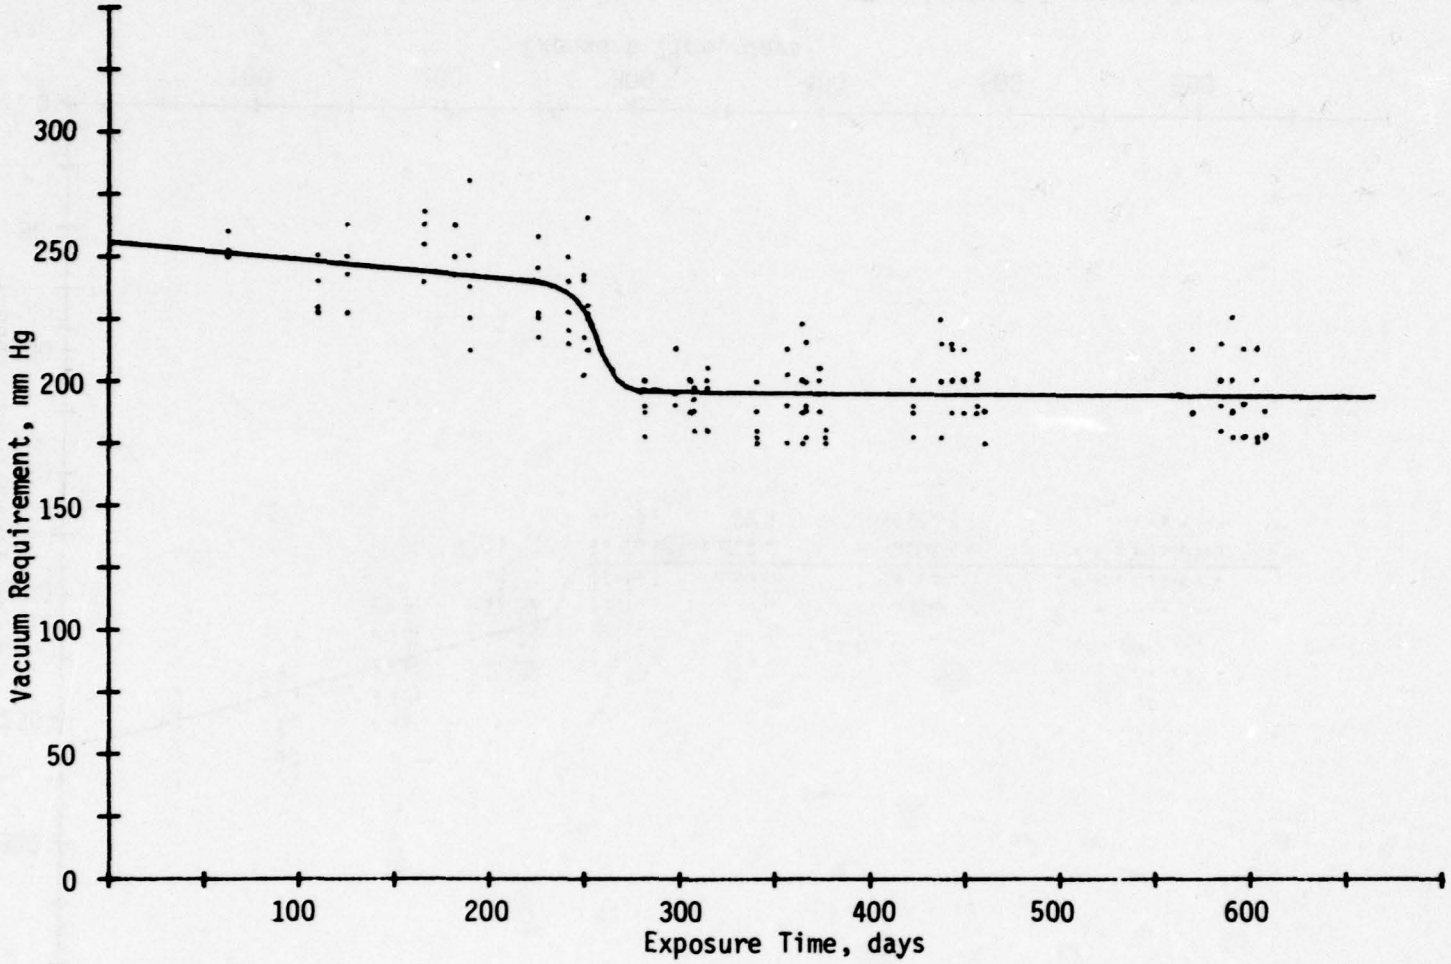
Figure 10. Wiper Motor Minimum Vacuum Requirement as a Function of Exposure Time at the Laboratory Control Site.

Statistical analysis was conducted on the performance data collected after 280 days of exposure. The method of least-squares was used to determine equations of the best-fit straight lines for the data from each site. The slopes of the lines obtained for each field exposure site were compared to that obtained for the control site using an F-ratio test (alpha = 0.05). No statistically significant degradation in motor performance was occurring because of humid tropic exposure.

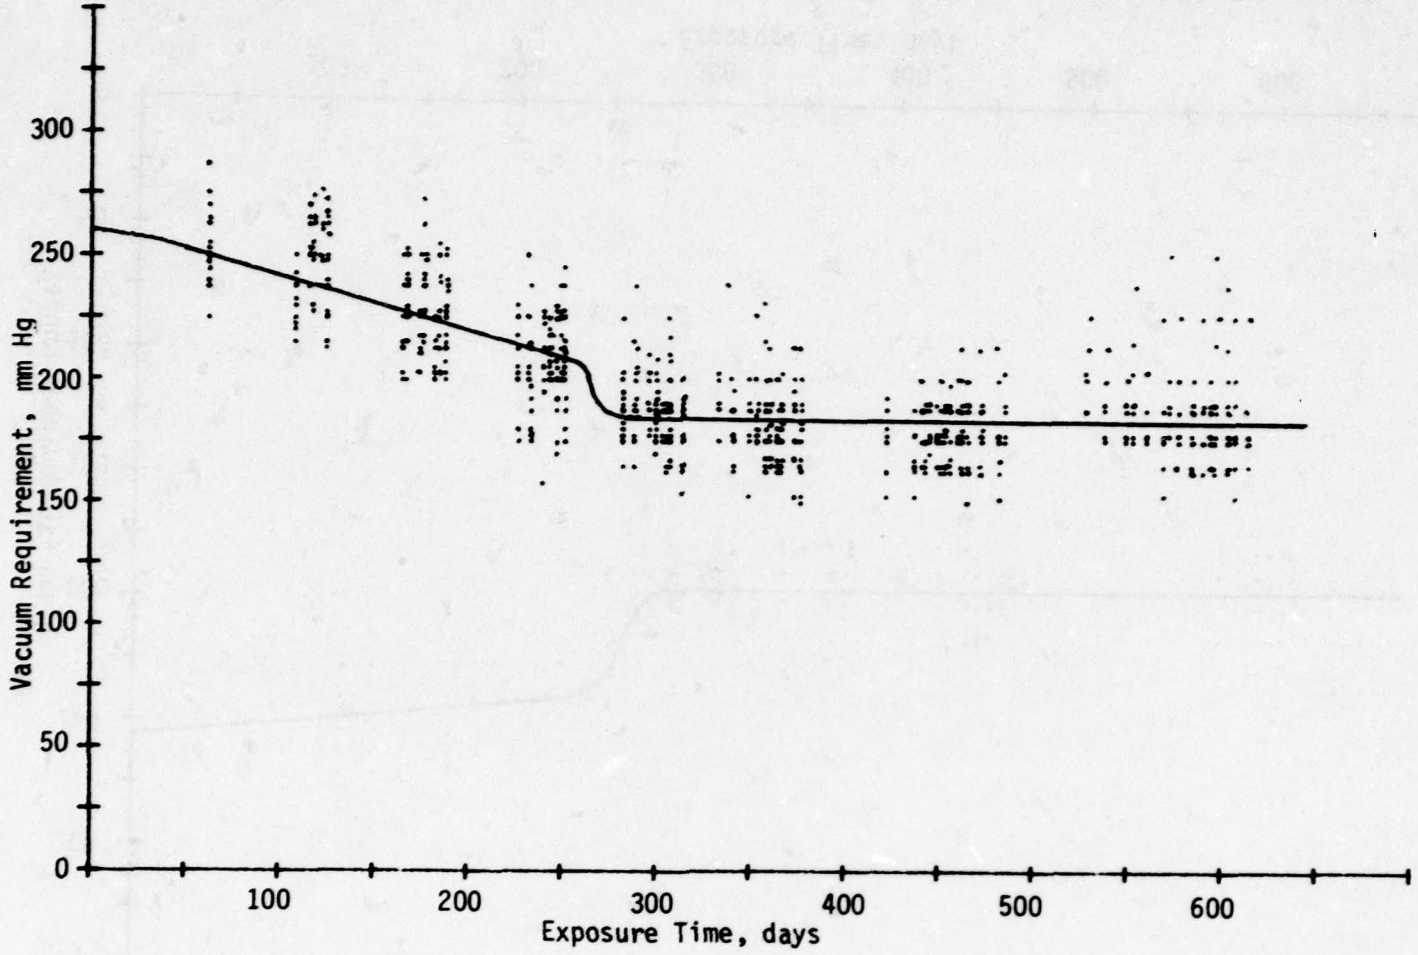
Figure 11. Wiper Motor Minimum Vacuum Requirement as a Function of Exposure Time at Humid Tropic Field Sites.

Corrosion of the shaft bushing (connection point of the wiper arm) was found to be present on significant quantities of motors only at the Coco Solo Mangrove site, after 6 months of exposure. However, it never caused the failure of any motor even after an additional 1 year of exposure.

The motors at both pallet and tarpaulin-forest sites exhibited severe blistering and peeling of paint. Blistering of paint was observed on all motors after 2 months exposure at the Coco Solo Mangrove site, while 90 percent of the motors at the Gamboa Forest "B" site exhibited blistering after 4 months of exposure. Minor blistering was also observed at the shed-forest and pallet and tarpaulin-open sites after 10 months of exposure and at the shed-open sites after 16 months of exposure.

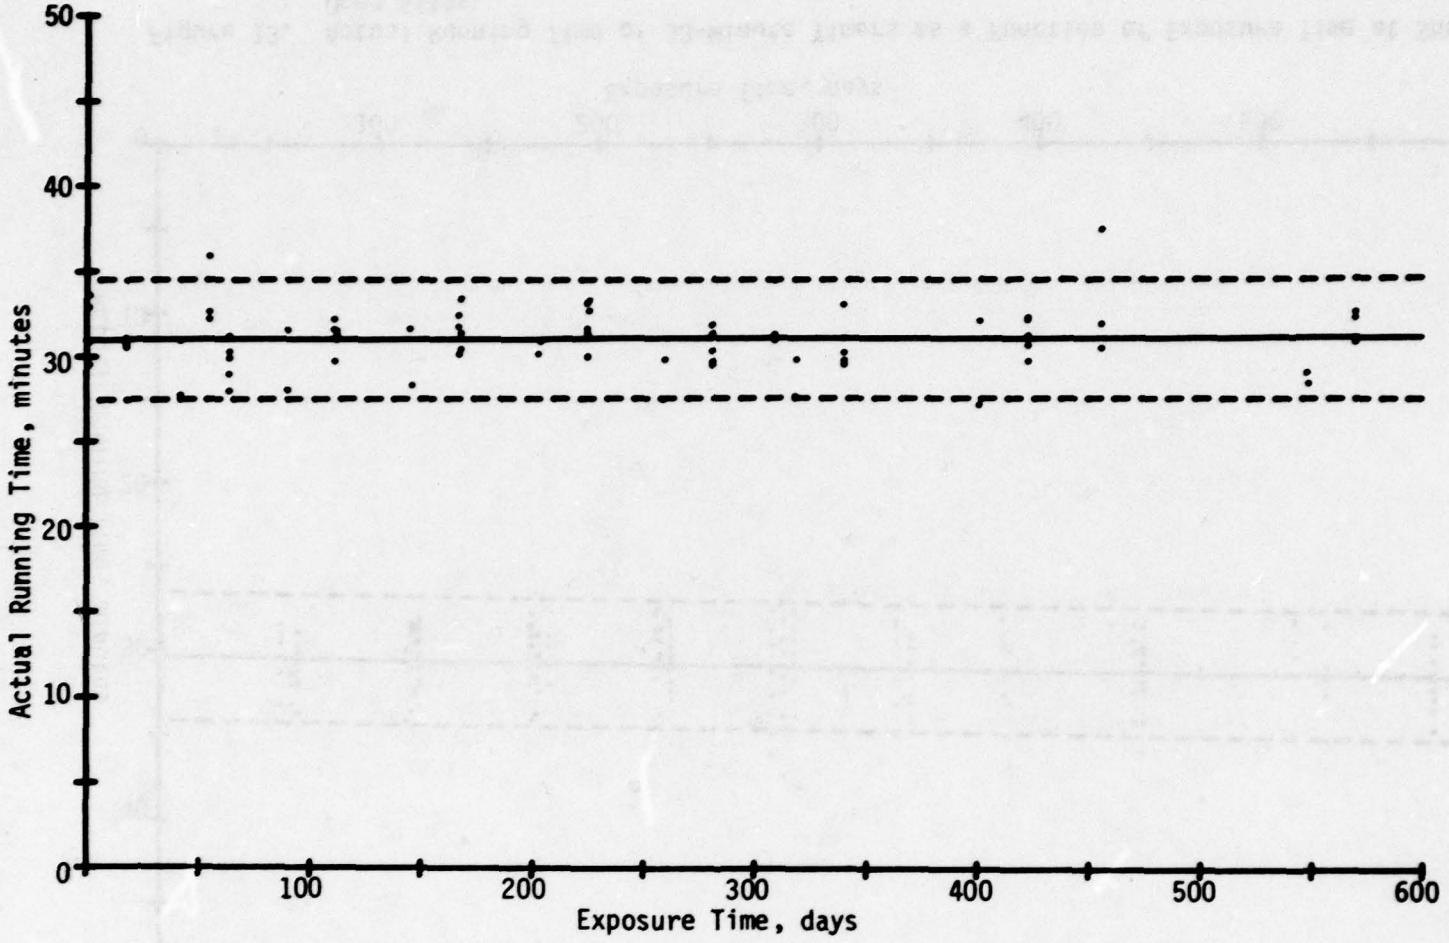
Figure 12. Actual Running Time of 30-Minute Timers as a Function of Exposure Time at the Laboratory Control Site.

The timers were tested for actual running time for a 30-minute setting. The method of least-squares was used to determine equations of the best-fit straight lines for the performance data from each site. F-ratio tests (alpha = 0.05) of the slopes of these lines showed that the running times of the timers exposed at the field sites were increasing significantly as a function of exposure time. Analysis also showed that the slopes of the lines obtained for sites with the same exposure mode, e.g., Shed-Forest, were not significantly different. Therefore, the sites were grouped by exposure mode and a common slope or degradation rate was computed for each exposure mode. The degradation rates are listed in table 16 and plots of the performance parameter as a function of exposure time are presented in figures 12 through 16. The 95-percent prediction intervals about the regression line are represented by dashed curves.

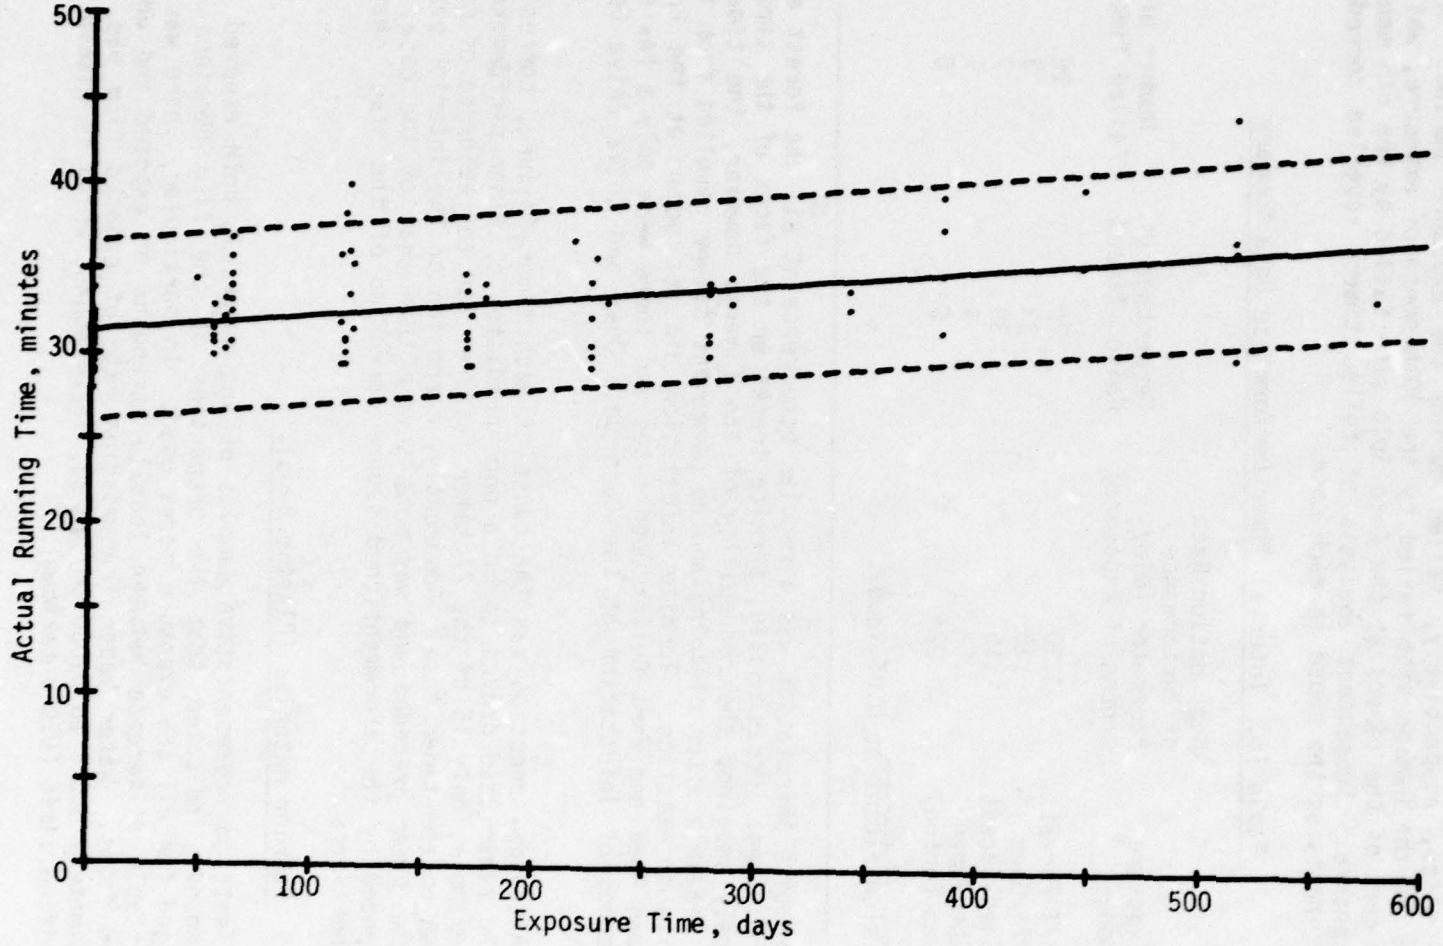
Figure 16. Actual Running Time of 30-Minute Timers as a Function of Exposure Time at Pallet and Tarpaulin - Forest Sites.

The most severe mode was the pallet and tarpaulin-forest exposure mode. The actual running time of the timers exposed in this mode was increasing at the rate of 0.30 minute per month. This result tracked well with the occurrences of timer failure. One hundred percent and

58 percent of the timers at the Gamboa Forest "B" and Coco Solo Mangrove sites, respectively, failed during the exposure period. All timers at the Gamboa site failed by the 10th month of exposure, while 42 percent of the timers at the Coco Solo site failed by the 6th month of exposure. Subsequent analysis of failed timers revealed corroded steel shafts as the cause in each case.
