4. TITLE (and Subtitle)
Phase I Inspection Report
Brant Lake Upper Dam
Upper Hudson River Basin, Warren County, New York
Inventory No. N.Y. 158

BRANT LAKE UPPER DAM

WARREN COUNTY, NEW YORK
INVENTORY No. NY 158

PHASE I INSPECTION REPORT
NATIONAL DAM SAFETY PROGRAM

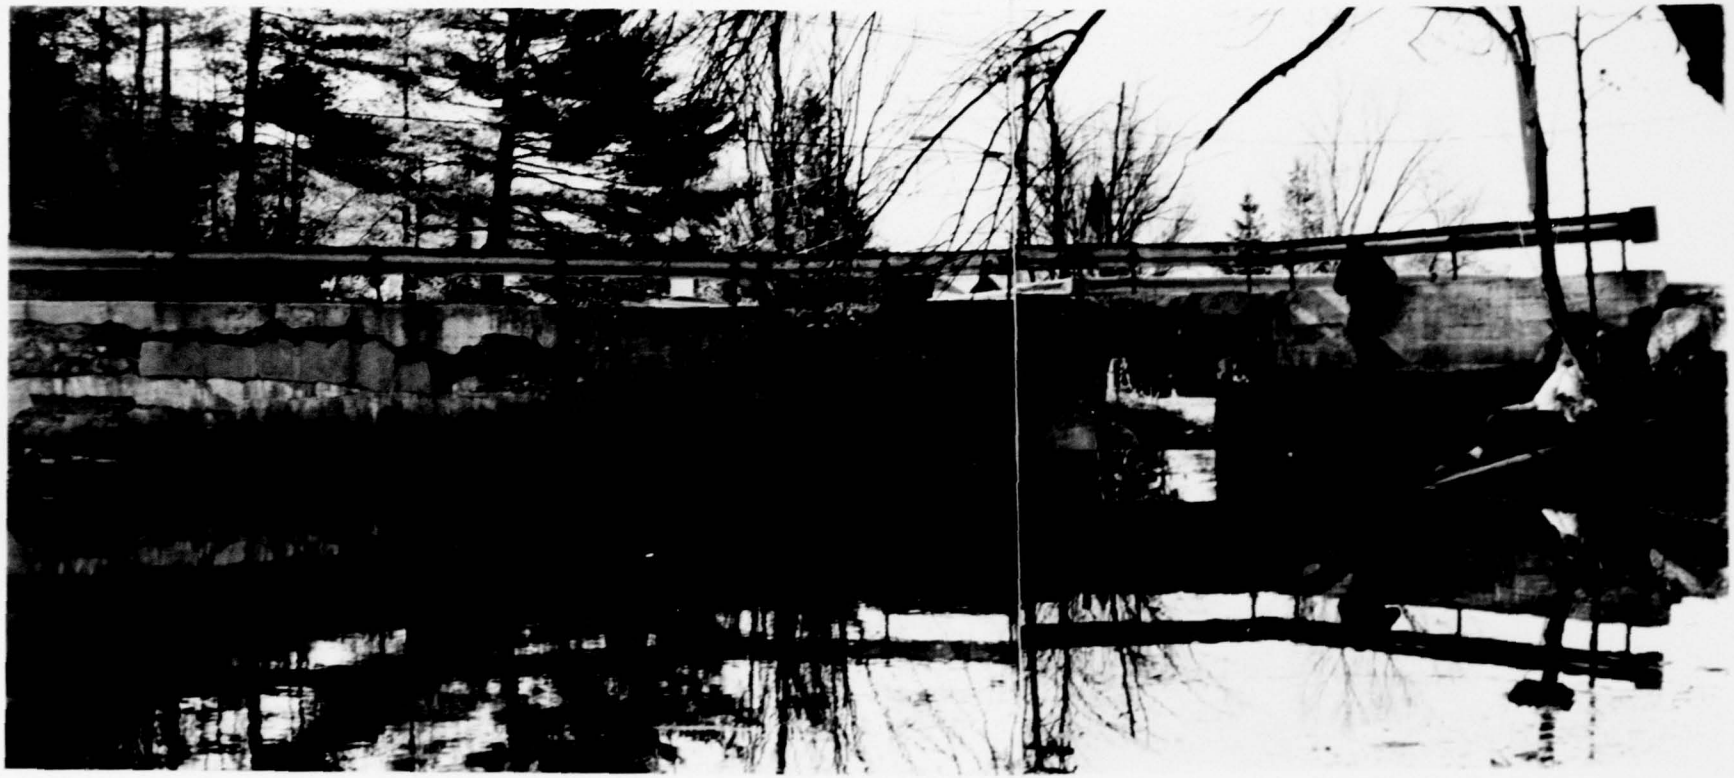
OVERVIEW - LOOKING DOWNSTREAM

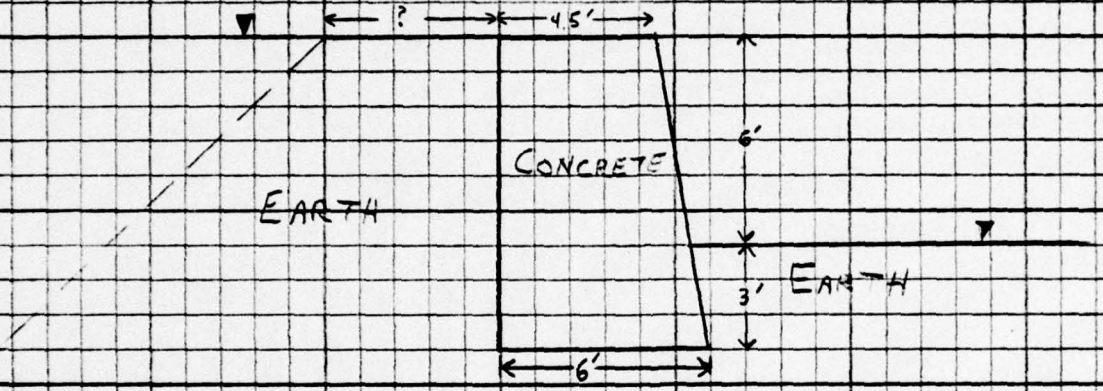
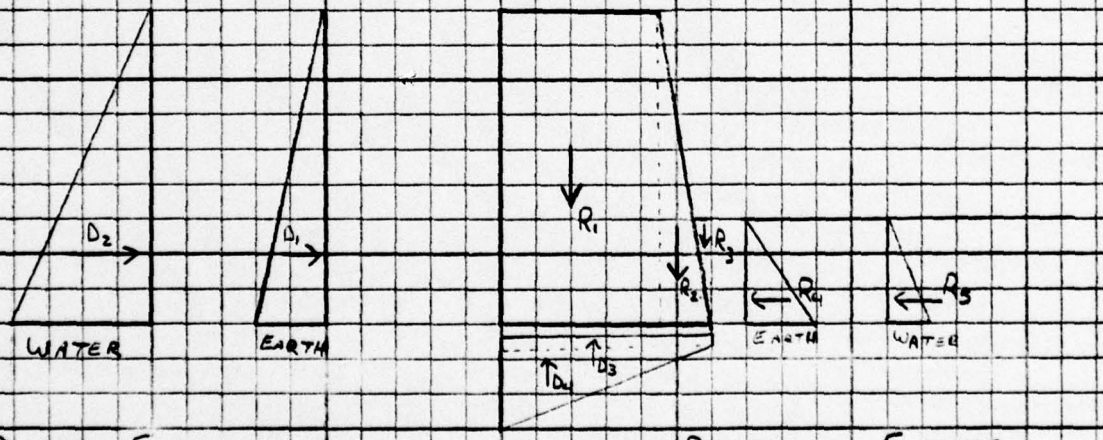
CASE I NORMAL CONDITIONS

Stability analyses for this structure indicate that the factors of safety for all conditions analyzed are unsatisfactory. Further studies are required to better assess the structural integrity of the dam. An investigation of the concrete spillway section should be made to determine the exact limits and dimensions of the concrete and using this information, the structural stability should be reanalyzed. This study should be commenced within six months of the date of final approval of this report.
