PASSAIC RIVER BASIN
ROCKAWAY RIVER, MORRIS COUNTY
NEW JERSEY

LONGWOOD LAKE DAM
NJ 00333

PHASE 1 INSPECTION REPORT
NATIONAL DAM SAFETY PROGRAM

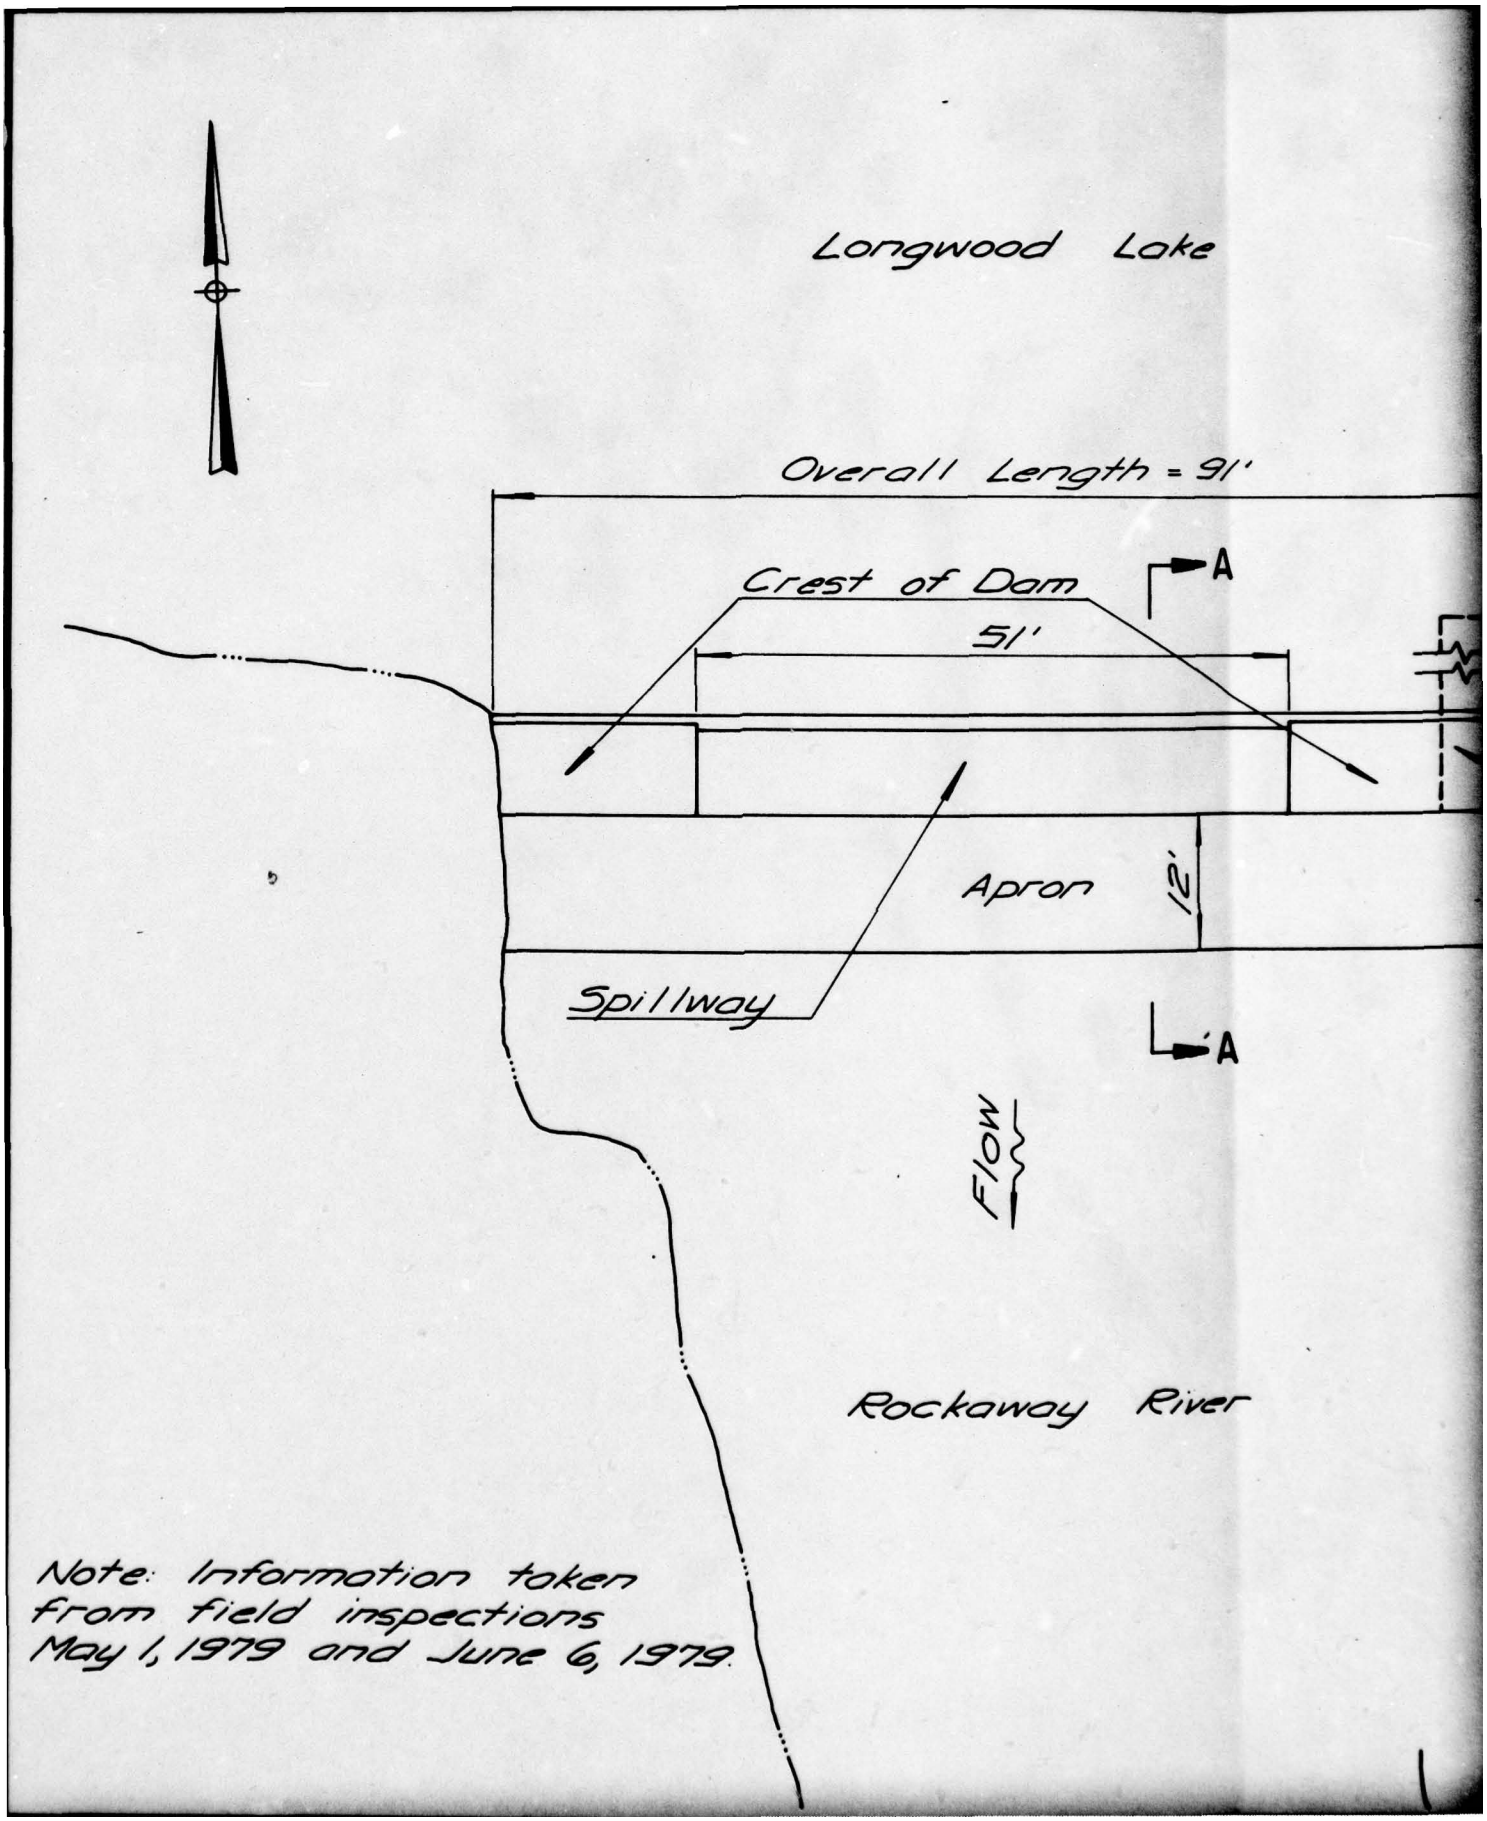
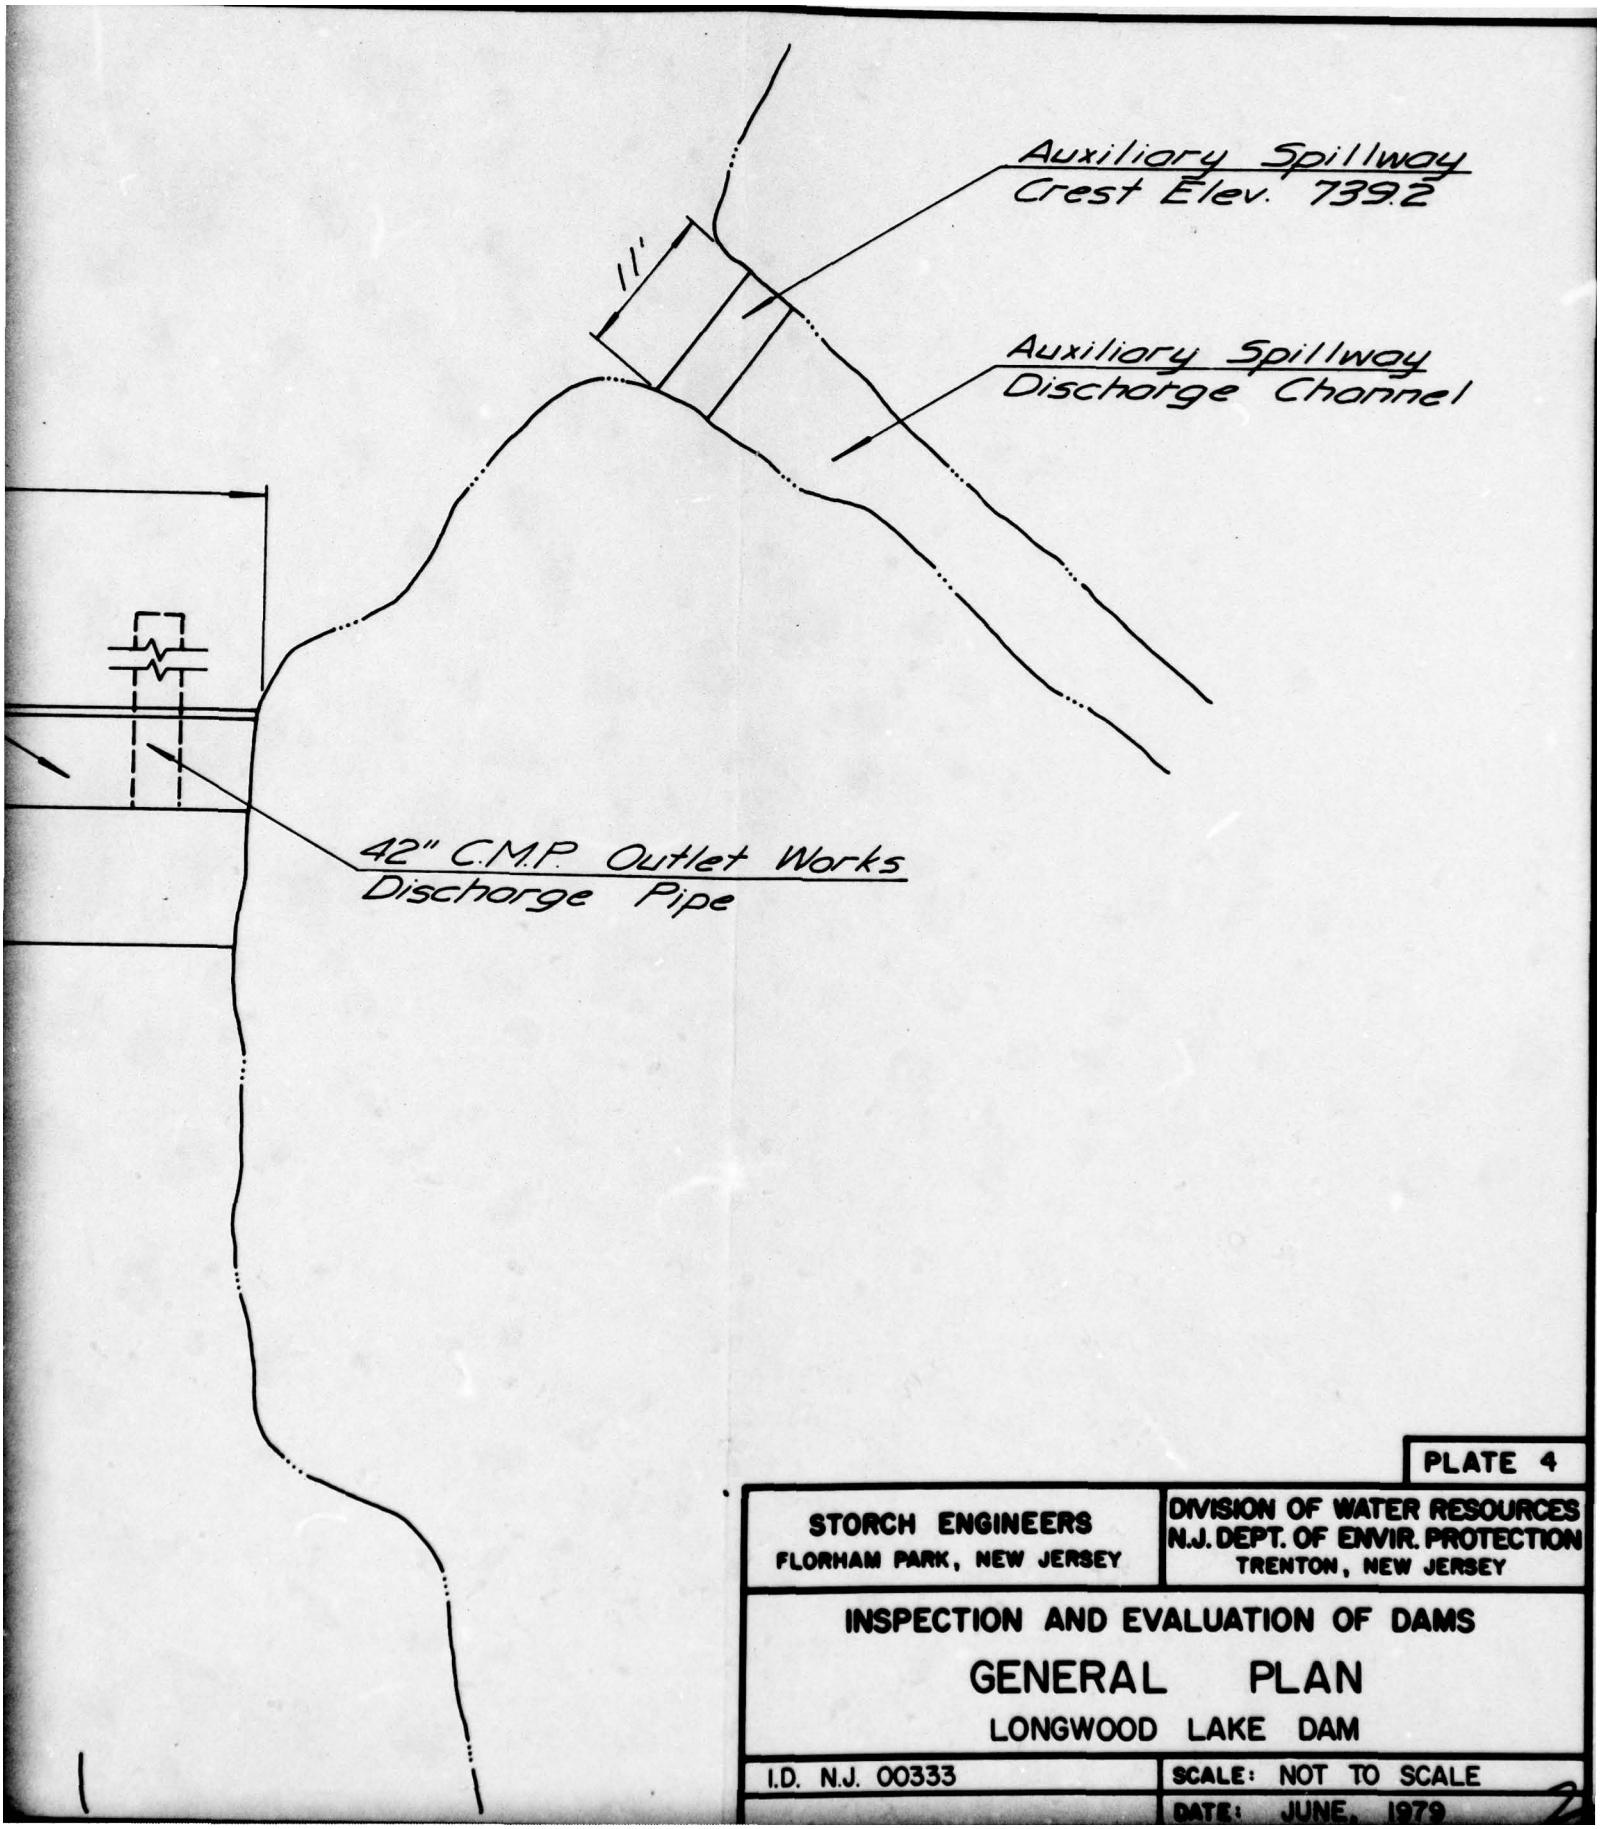
PLATE 4

Longwood Lake
Overall Length = 91'
Crest of Dam
A
51'
Apron
12'
Spillway
A
Flow
Rockaway River
Note: Information taken from field inspections May 1, 1979 and June 6, 1979.

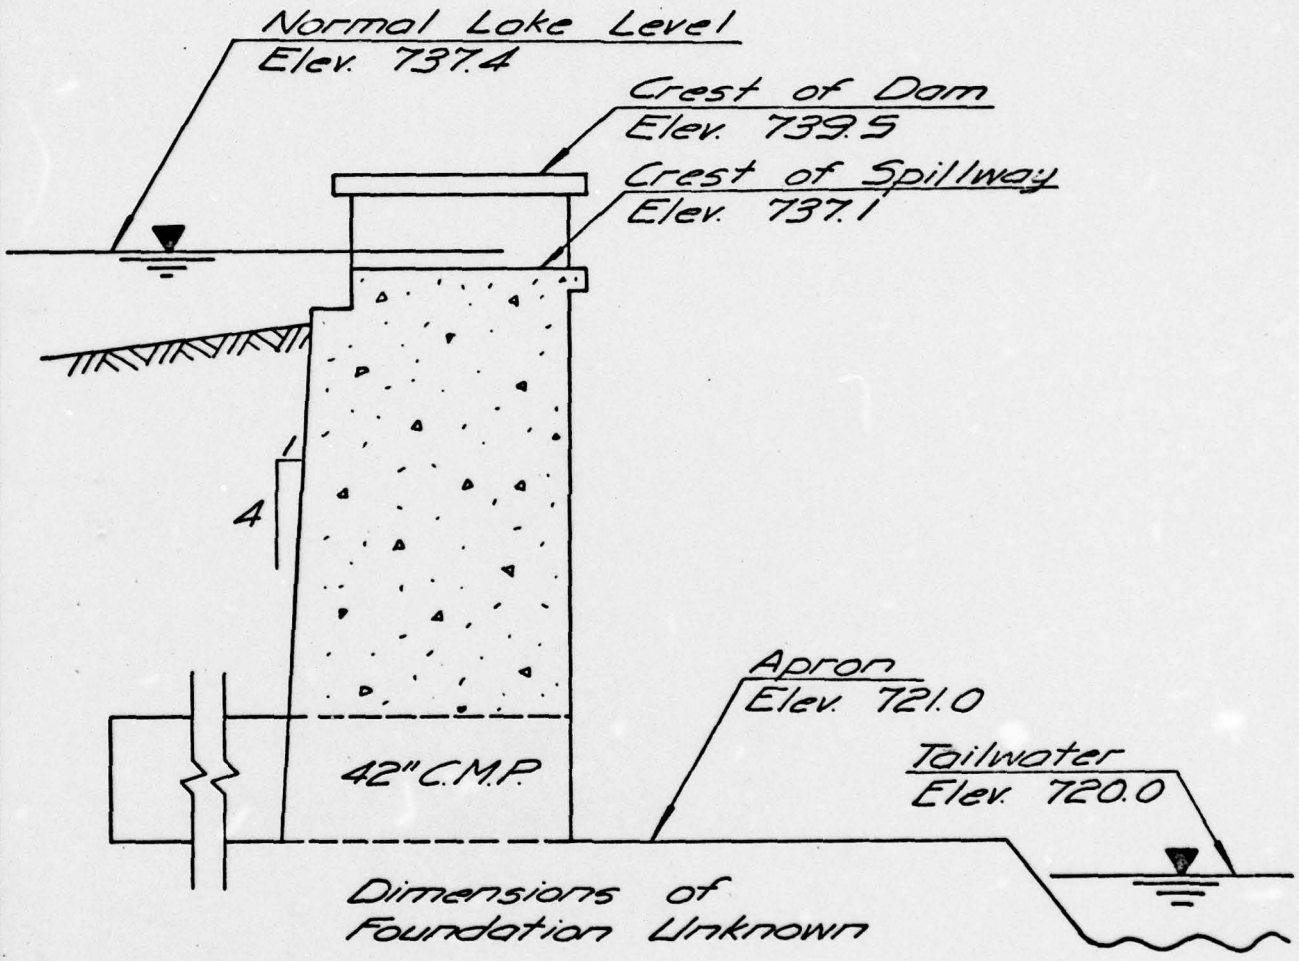
PLATE 5

Note: Information taken from field inspections May 1, 1979 and June 6, 1979.

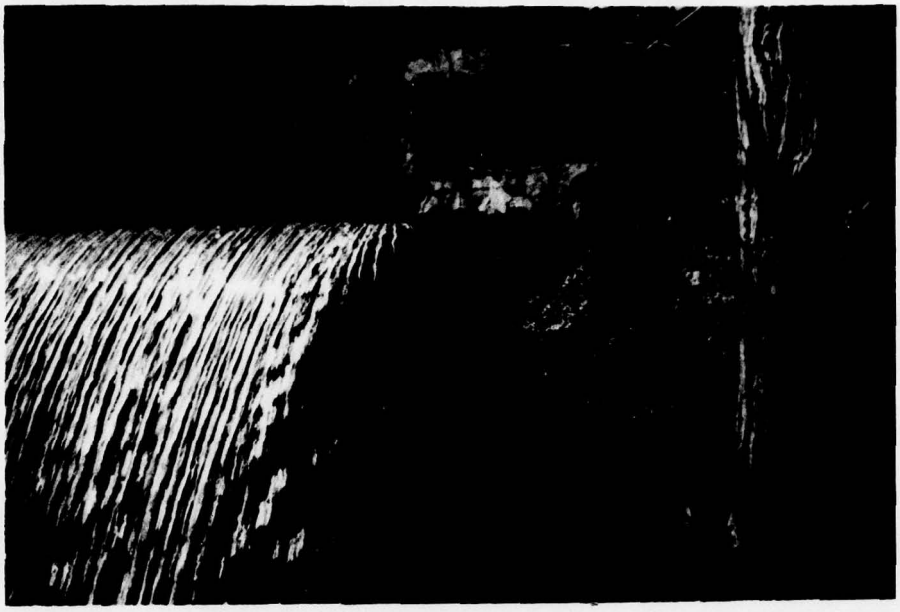
PHOTO 3

The vertical alignment of the dam crest is level and the horizontal alignment is straight. The dam appeared to be outwardly structurally stable, although some spalling about 3 inches deep was observed on the downstream face near each end. Junctions between the dam and bedrock appeared to be in generally satisfactory condition with evidence of some seepage. The discharge rate of the seepage was not measurable. A horizontal crack was observed along the downstream face of dam approximately 1 foot below the crest. It could not be determined whether the crack is on the surface or structural in nature. Evidence of leakage was observed at some seams in exposed bedrock near the east junction.

SPALL ON DOWNSTREAM FACE - EAST END OF DAM

2. Both faces of the dam should be thoroughly inspected and then renovated as determined by that inspection.

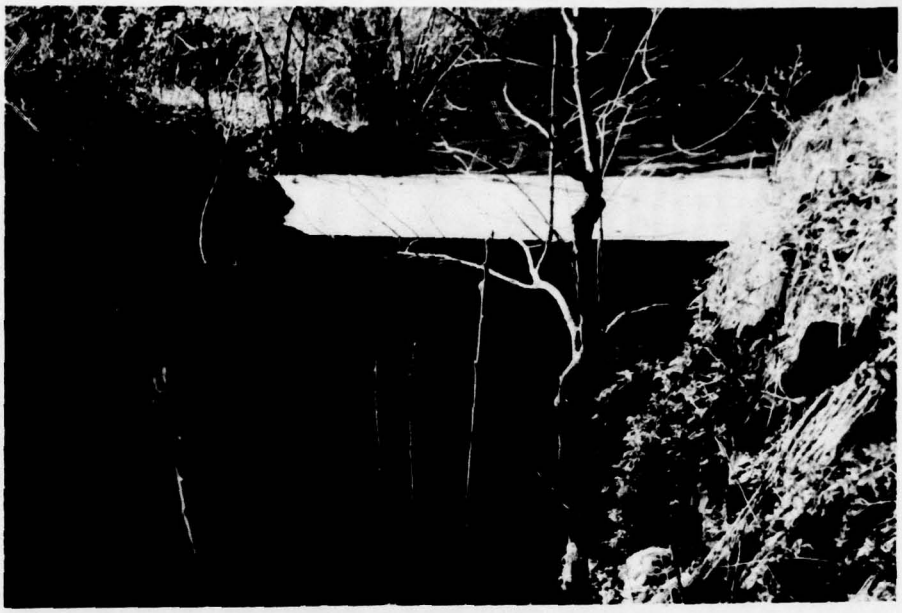
PHOTO 9

The auxiliary spillway is located 40 feet from the dam and consists of a straight concrete broad crested weir. Flow over this spillway discharges into a narrow well defined channel with steep sides composed of exposed bedrock. Both the upstream and downstream faces of the auxiliary spillway are vertical. The crest is in generally satisfactory condition.

AUXILIARY SPILLWAY EAST OF DAM
