Name Of Dam: UPPER BLACKWATER NO. 4
Location: FRANKLIN COUNTY, VIRGINIA
Inventory Number: 06702

PHASE I INSPECTION REPORT
NATIONAL DAM SAFETY PROGRAM

PREPARED BY
NORFOLK DISTRICT CORPS OF ENGINEERS
803 FRONT STREET
NORFOLK, VIRGINIA 23510

AUGUST 1979

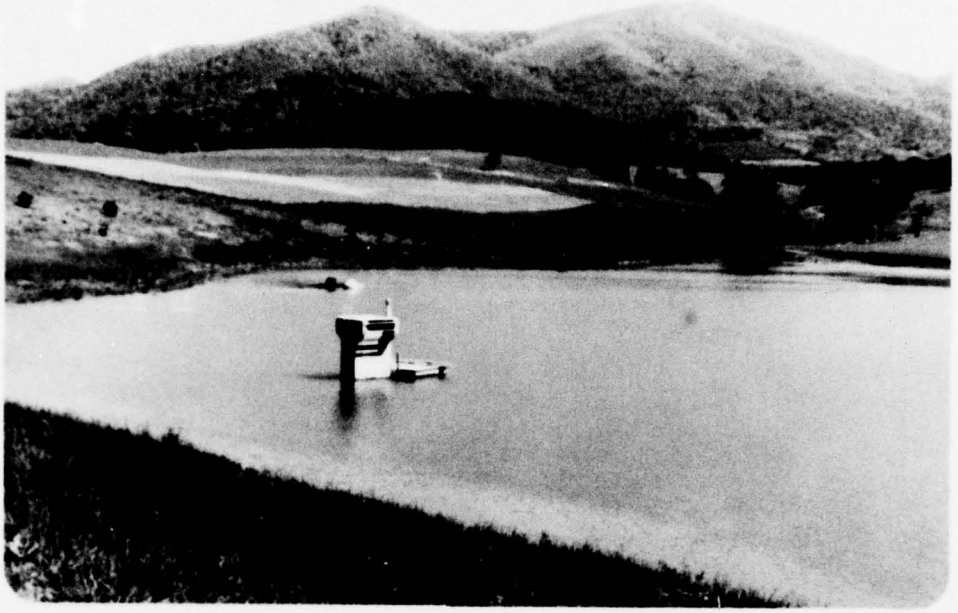
3.1.4 Appurtenant Structures: The intake structure was not inspected because the structure is only accessible by boat. Observing from a distance, the concrete structure appeared to be in excellent condition. Water was discharging through the 24-inch-diameter outlet pipe about 1/6 full. The outlet pipe and its concrete saddle were in excellent condition. The handle for the emergency gate located at the intake structure was not in place; it is stored at the landowner's premises.

PHOTO #1 INTAKE STRUCTURE

PHOTO #2 OUTLET STRUCTURE
