Name Of Dam: LAKE COHOON DAM
Location: CITY OF SUFFOLK
Inventory Number: VA. 12301

PHASE I INSPECTION REPORT
NATIONAL DAM SAFETY PROGRAM

DEWARD M. MARTIN & ASSOCIATES
WILLIAMSBURG, VIRGINIA
AUGUST 1979

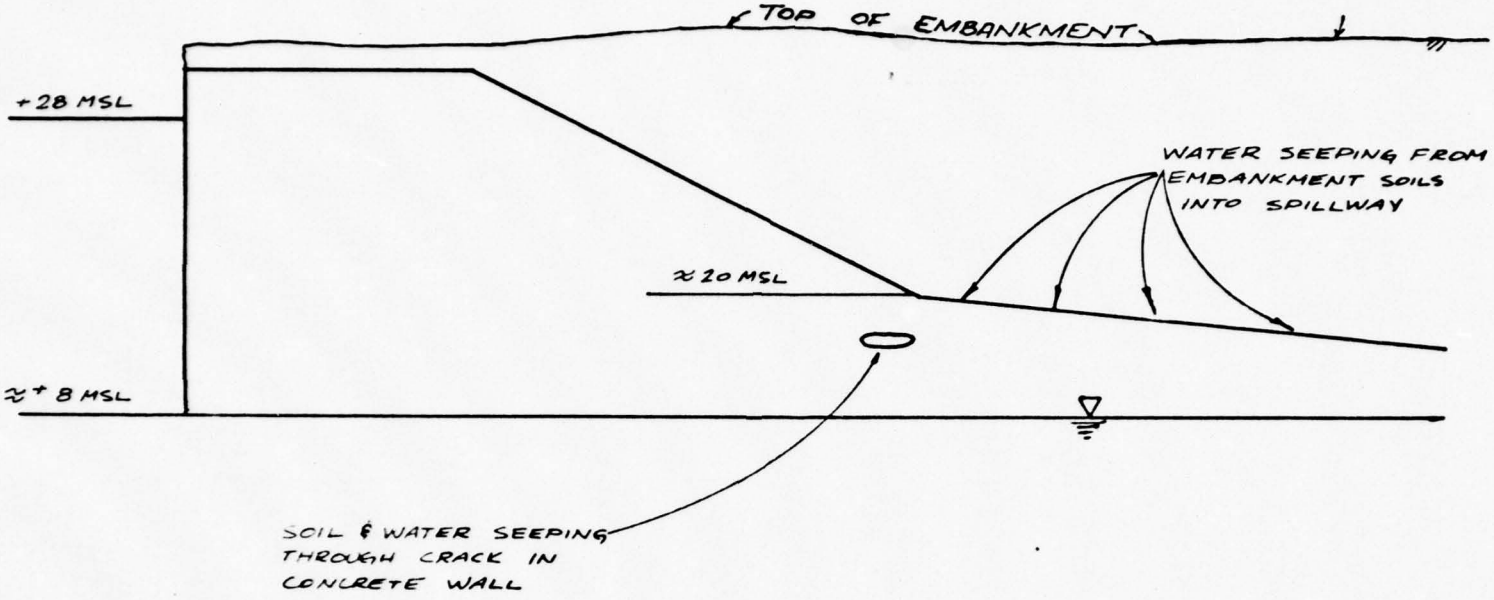
SCHEMATIC OF NORTH SIDE OF SPILLWAY

3.1.4 Abutments: The abutment walls show white stains, spalling, and actual seepage. At the left abutment wall, about 4 feet downstream from the end of the slope wall, there is a joint showing seepage of less than 1 GPM accumulation of mud and small roots. The abutment walls showed signs of spalling and reinforcing bars were visible in some locations.

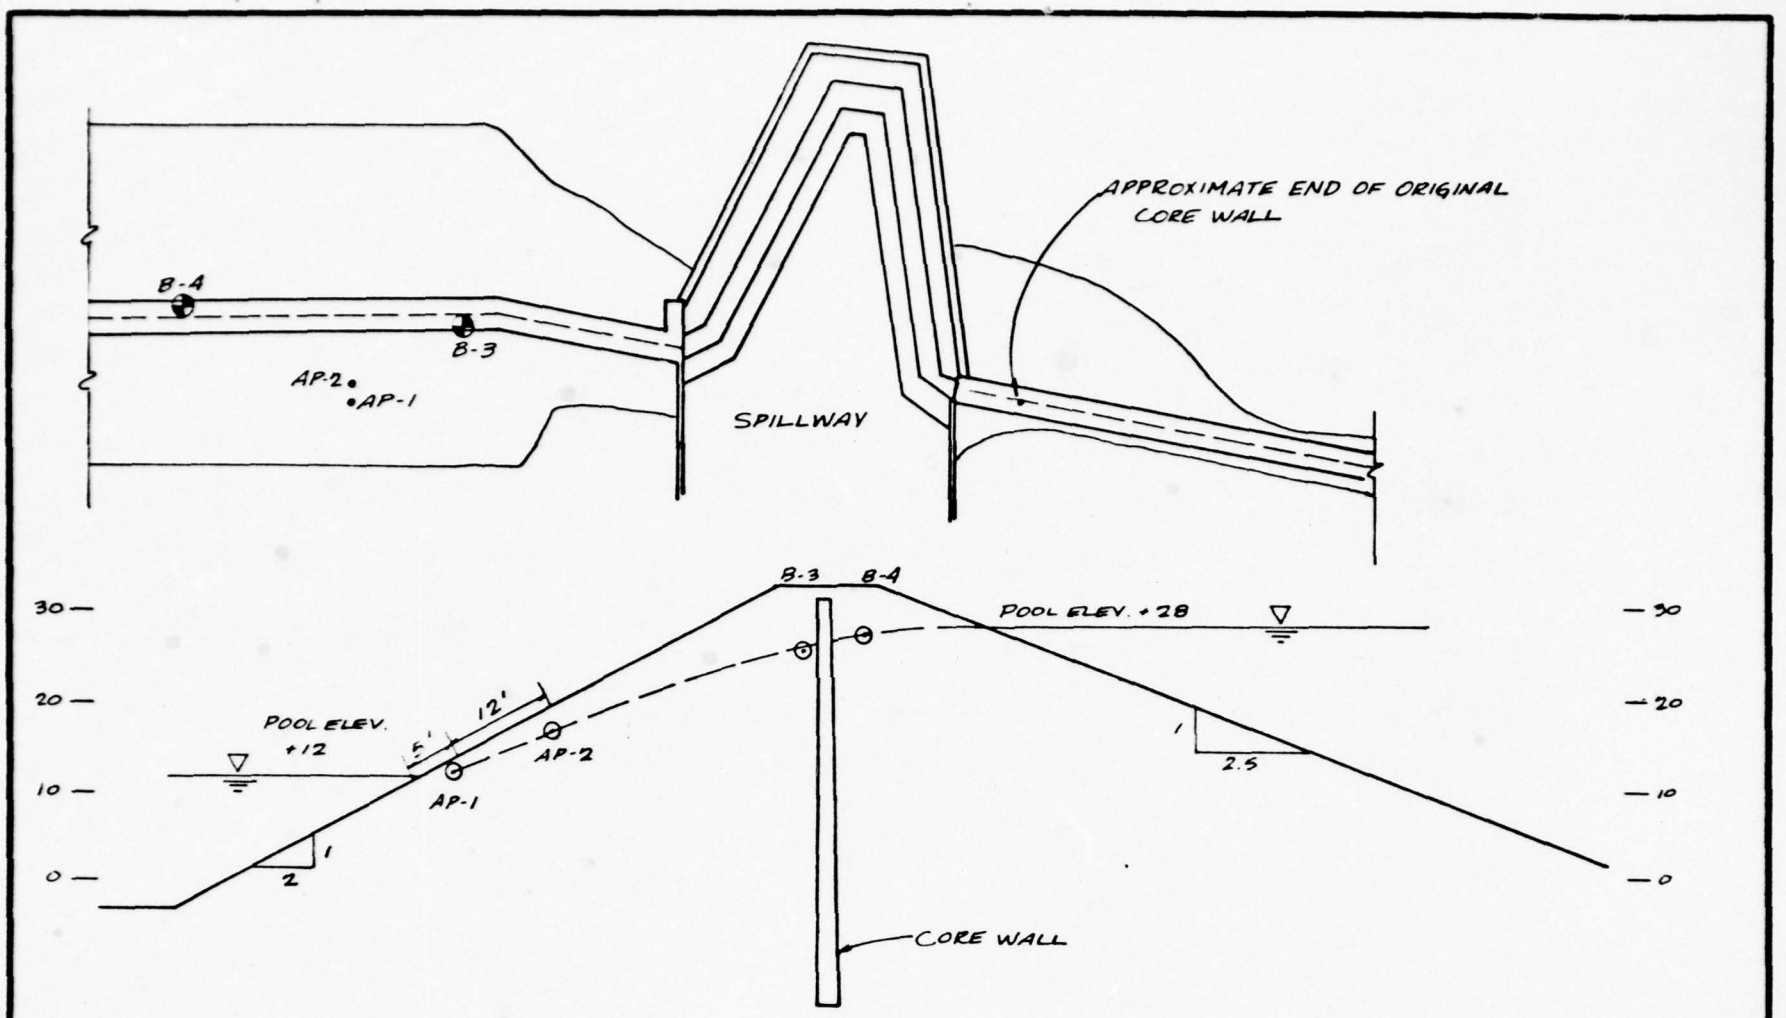
3.1.2 Dam: There is no obvious horizontal or vertical misalignment in the dam. Minor undulations were observed in the downstream slope, however, no cracking, settlement or bulging was observed. A path was worn into the downstream slope approximately five feet up from the pool. Minor erosion of the surface soils has resulted along the path. The placed stones on the upstream slope needs to be relaid where some small depressions have occured. There is no obvious sloughing on the visible slopes. There was no cracking or erosion noticeable at the abutments. Approximately 10 tree stumps were observed on the downstream slope of the embankment to the left of the spillway. The trees appeared to have been cut recently. Water level readings were taken in two observation wells located on the crest of the dam. According to the geotechnical report enclosed in Appendix IV these wells are located on either side of the concrete core wall. In addition, two hand auger probes were made along the downstream slope of the dam. Approximate water levels were obtained from these probes. The water level readings obtained from the wells and probes indicated the core wall was not functioning. A typical cross section of the dam with an approximate line of seepage based on the water level readings taken is shown on Plate 7 in Appendix 1.

*7.1 General Condition: From a geotechnical standpoint, the dam appears to be functioning well, with the exception of the observed seepage along the left abutment and the cloudy nature of the water downstream of observation well B-3 as discussed in Section 3. In addition, water level readings obtained during the inspection indicate the core wall is apparently not functioning properly.

7.2 Recommended Remedial Measures: It is recommended that the owner, over the next 6 months, monitor, on a regular basis, the water elevations on either side of the core wall. If the water level on the downstream side of the wall remains at or near the height shown in Plate 7, Appendix I , the owner should secure the services of a registered professional engineer to perform a detailed inspection and stability analysis on the dam. He should also evaluate the potential that the tree stumps located along the dam have for creating high seepage gradients and subsidence upon decay. The owner should immediately take action to prevent further deterioration of the concrete surfaces and reinforcing steel. A regular maintenance and inspection program should be initiated to help detect and control problems that may occur and a warning system should be established for the dam.

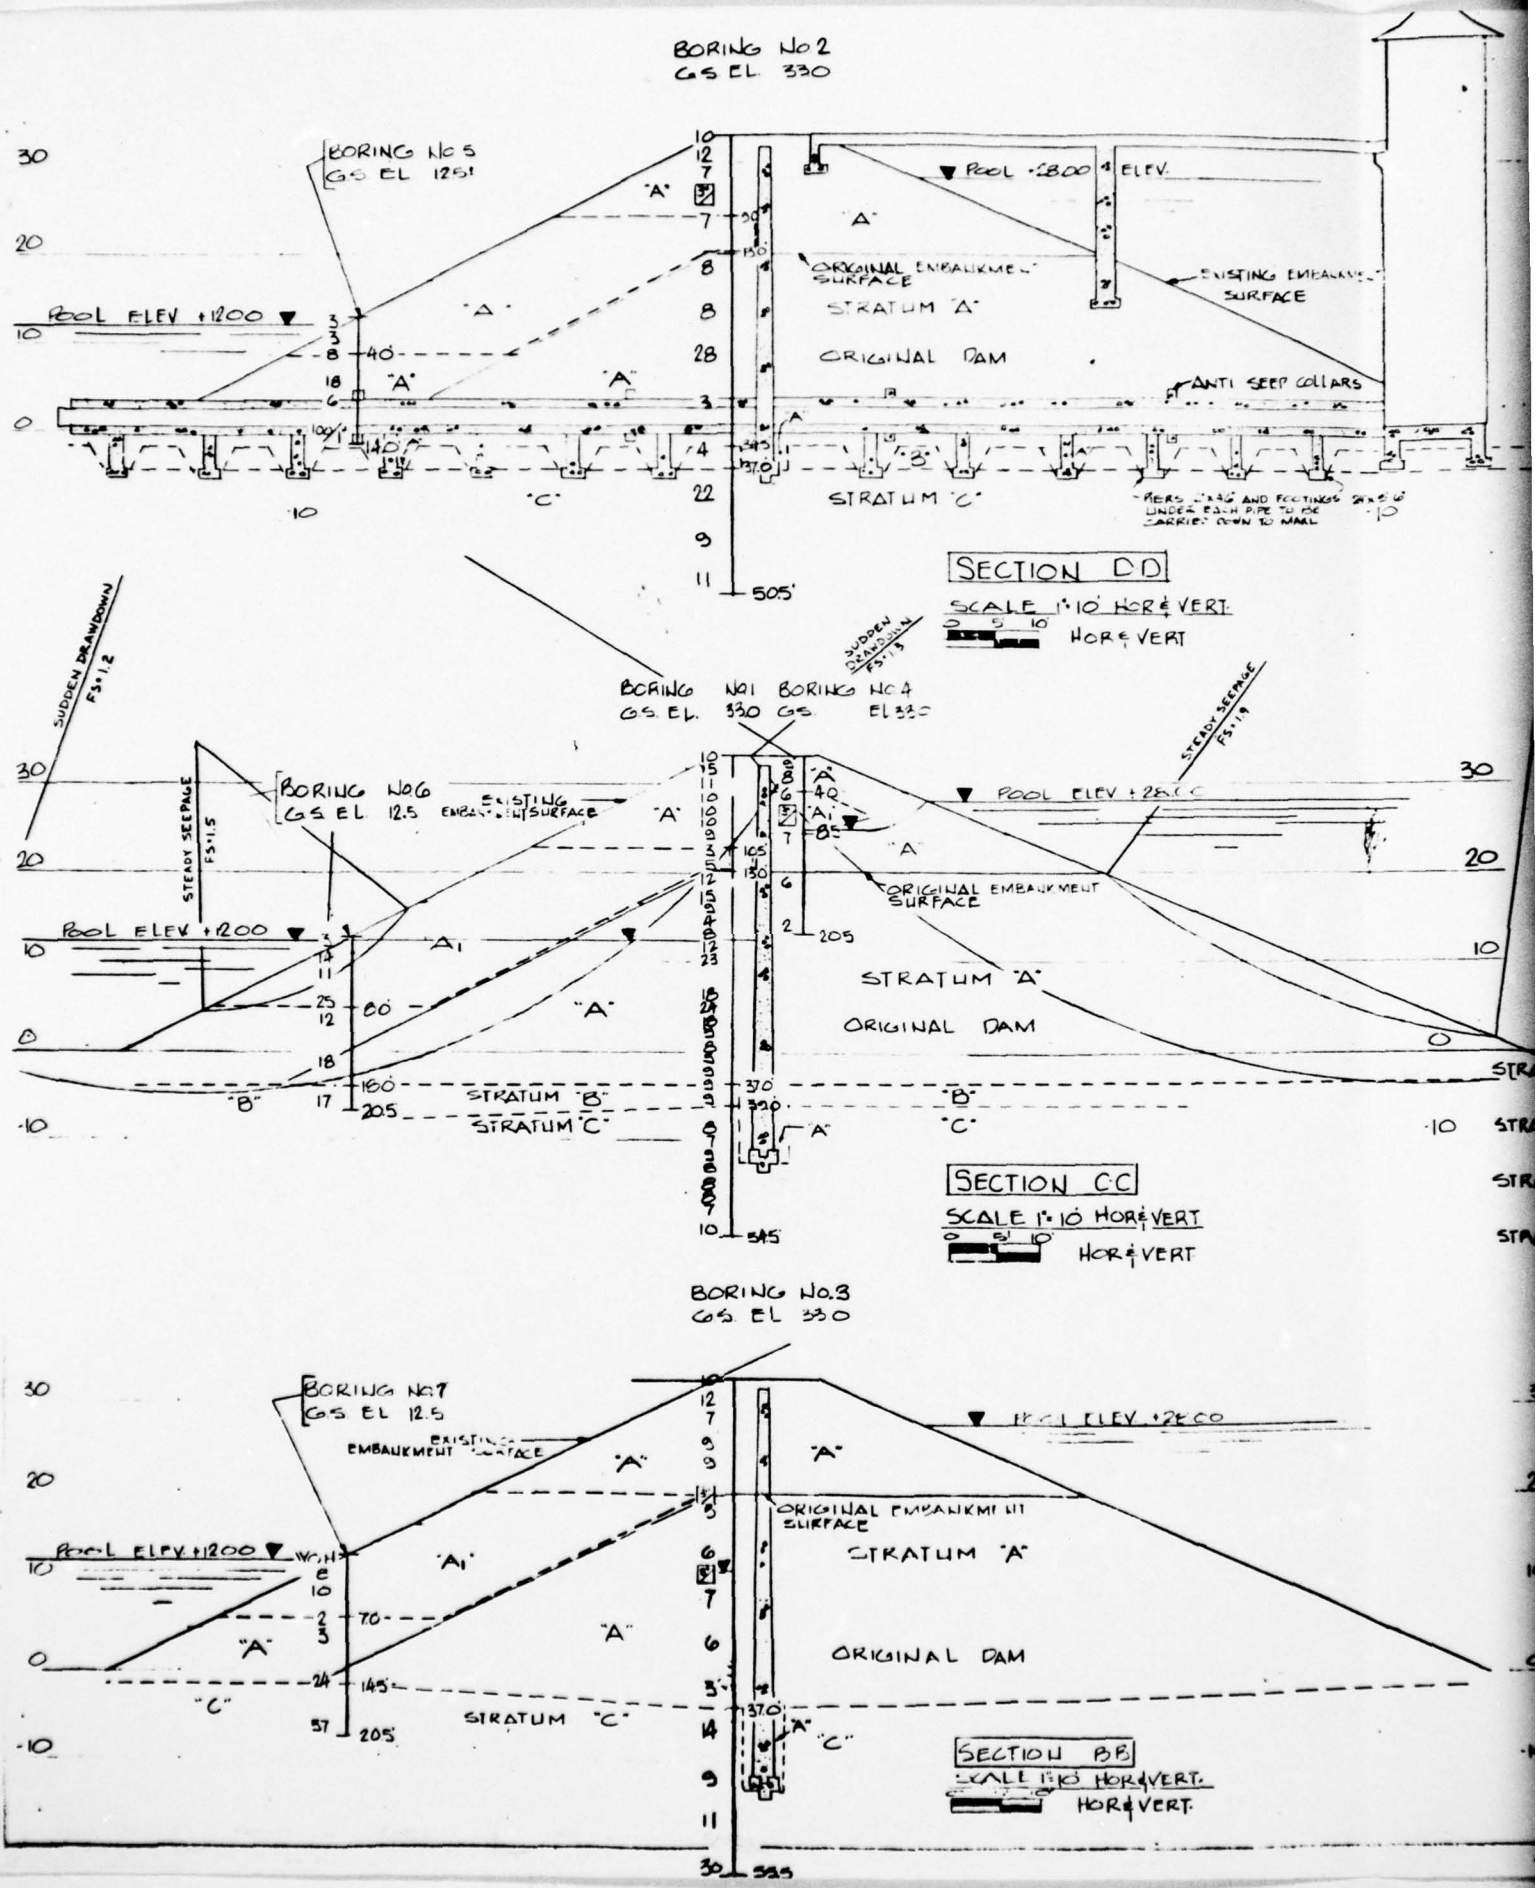
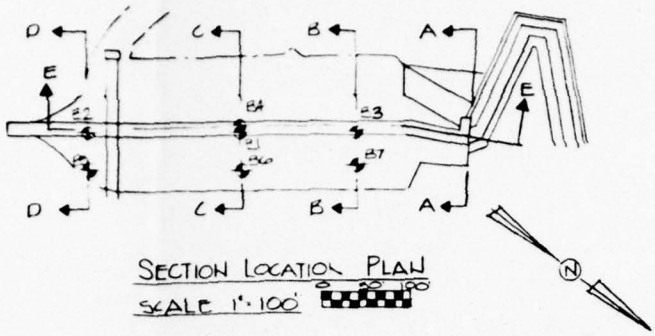
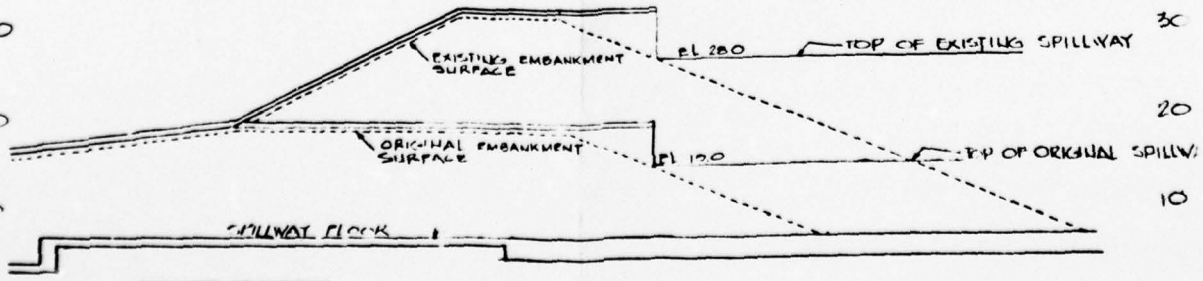
PLATE 2

*2.2.3 Dam Foundation: The dam is founded on a layer of alluvial soils consisting of silty and clayey sands. This is designated as "Stratum B" in the 1978 Report by J. K. Timmons and Associates and Schnabel Engineering (see Plates 2, 3 and 4 of Appendix IV.) No strength tests were performed on these soils, however, total and effective friction angles of 35° and total and effective cohesions of 0 were assigned to the stratum. These alluvial soils are underlain by clayey sands, clayey silts and silty clays of the Yorktown Formation (Stratum C.) No strength tests were performed in this stratum.

Stability analyses were conducted by Schnabel Engineering Associates in conjunction with the subsurface investigation performed in 1978. The loading conditions of both steady state seepage and sudden drawdown of the reservoir were considered for both the upstream and downstream embankment slopes. The seepage line for steady state seepage conditions was developed from readings taken at the observation wells along the crest of the dam. The phreatic surface used for the section used by Schnabel in their analysis is shown on Plate 2, Appendix IV.
