Name Of Dam: SWIFT CREEK RESERVOIR DAM
Location: CHESTERFIELD COUNTY
Inventory Number: VA. 04112

PHASE I INSPECTION REPORT
NATIONAL DAM SAFETY PROGRAM

DEWARD M. MARTIN & ASSOCIATES
WILLIAMSBURG, VIRGINIA

AUGUST, 1979

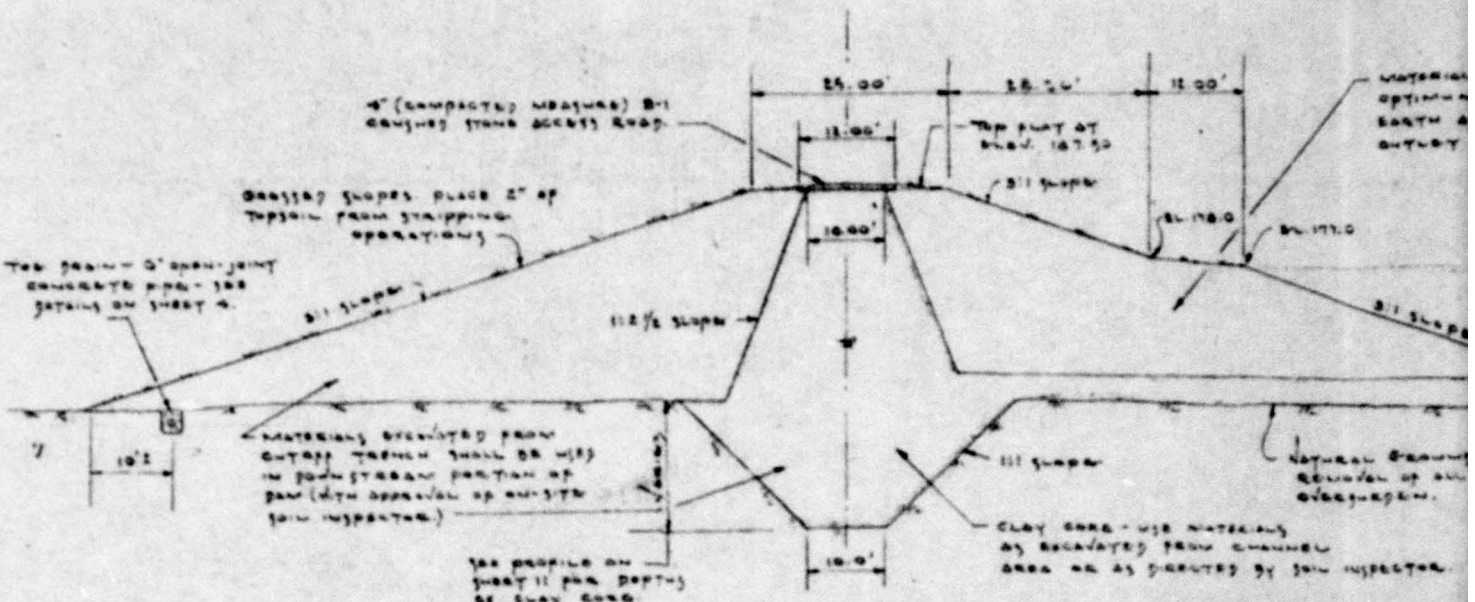
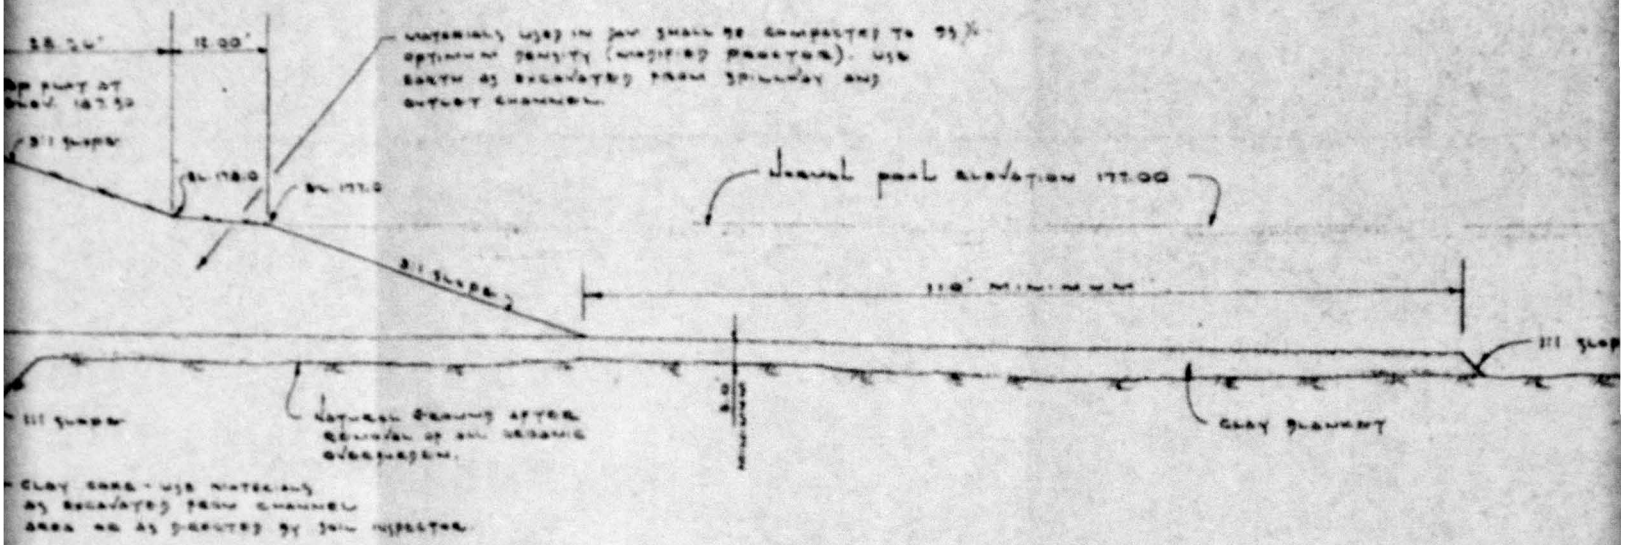
DAM - TYPICAL SECTION

During the present site inspection, water level readings were taken in two observation wells, B-2 located at the crest of the dam and just downstream of the core, and B-3 located just downstream of B-2, at the toe of the dam. The water level readings taken on June 25, 1979 (Plate 1, Appendix III) indicated either the core wall is not functioning or the pool elevation is above the core and water is following a line of seepage above it.

Water level readings taken in 1978 indicated the core was functioning properly. Plate 1 in Appendix III is a typical cross-section of the dam taken at the observation well locations, and shows the two approximate lines of seepage.

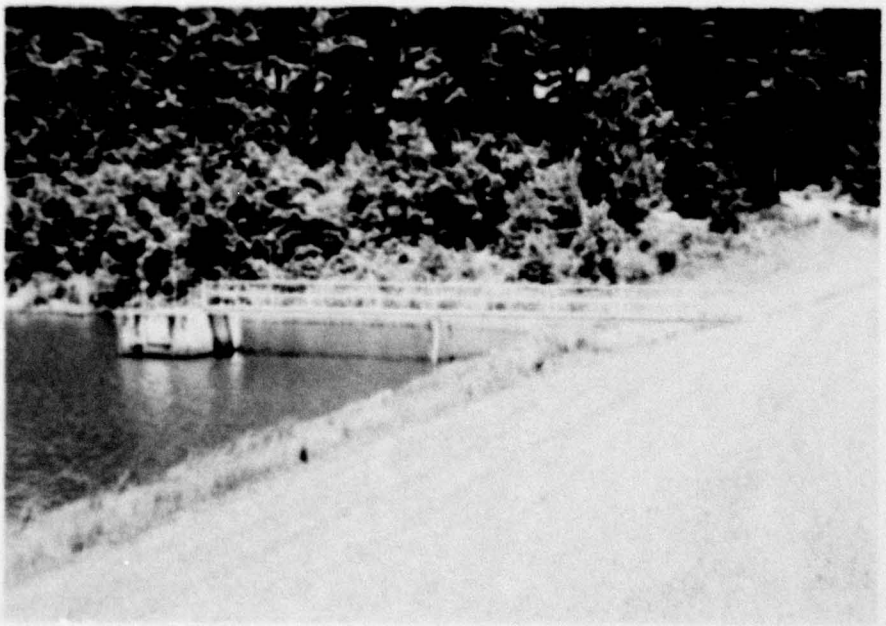
PHOTOGRAPH NO. 1
Upstream Face

An area of seepage was observed at the toe of the downstream slope just west of the 60 inch diameter drain as noted previously and illustrated on Photographs 1 & 2. This was the only observed seepage on the downstream face. This seepage apparently has been occuring for several years due to the presence of marsh grass and cattails in the area. We believe this seepage is related to the backfill soils along and above the 60 inch diameter drain pipe since the only source observed is located about 6 to 8 ft west of the pipe centerline. It is difficult to completely eliminate this type of seepage since the pipe is a discontinuity in the dam section. The seepage collars provided are for the purpose of increasing the length of the flow path along the pipe. Even with these seepage collars, however, some seepage is likely. Since this dam does not have a downstream drainage blanket extending back from the toe drain to allow interception of this seepage, it is draining from the area at the toe of the slope. The seepage flow is estimated at less than 1/4 gpm.

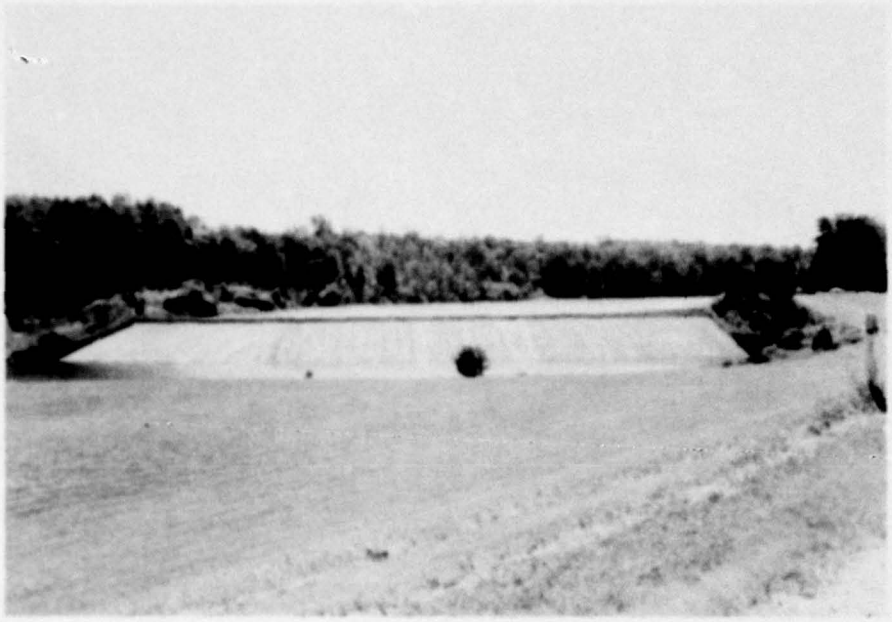
PHOTOGRAPH NO. 3
Concrete Spillway

3.1.4 Spillway: The general condition of the concrete spillway surface was good although some small cracks were noted. The inspection also revealed some seepage in the concrete slab joints.

Seepage was observed adjacent to the 60-inch diameter outlet pipe and in the joints on the concrete spillway. The sealer in these joints has deteriorated to a large degree allowing moisture to seep through in several locations. Erosion was also detected in two areas on the downstream side of the embenkment. These need remecial action.

3.2 Evaluation: The dam, in general, appears to be in good condition. It is recommended, however, that remedial action be taken to repair the sealer in the slab joints on the spillway. The areas of the embankment where erosion has occured should be repaired and reseeded. The causes of the high phreatic surface as indicated by the reading of the observation wells should be investigated.

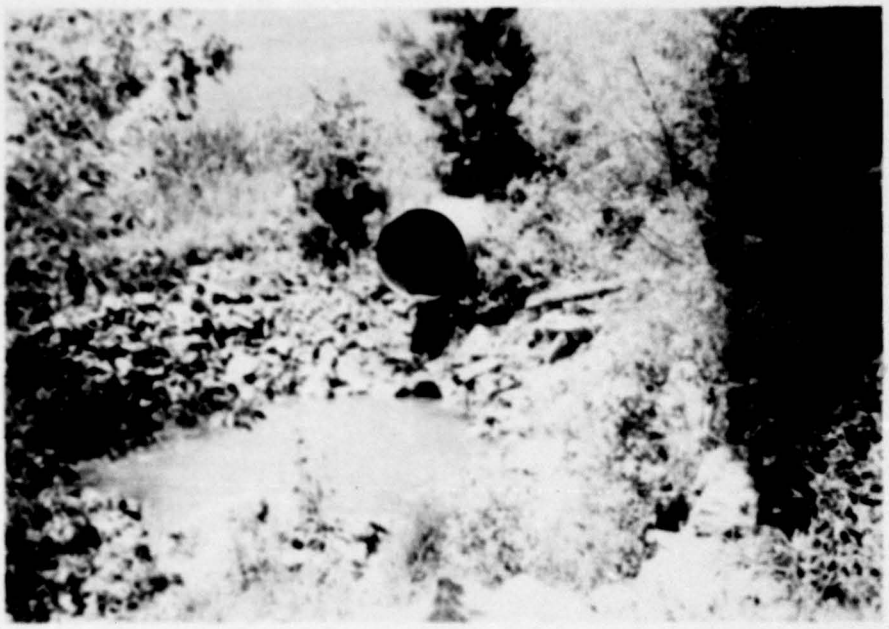
PHOTOGRAPH NO. 5
60-inch Diameter Drain Outlet

*Evidence of seepage, approximately 1 gpm, was observed adjacent to a 60-inch diameter drain located at the downstream toe of the dam. Marsh grass, cattails and saturated soils were observed adjacent to the pipe.

*7.2 Recommended and Remedial Measures: Action should be taken to determine whether the core is functioning and to determine the present stability of the dam. The evidence of seepage adjacent to the 60-inch diameter drain and around the left side of the spillway should be investigated so that remedial measures can be implemented. The sealer in the joints on the concrete spillway should be repaired as soon as possible and the areas of the embankment where erosion has occured should be repaired and reseeded.

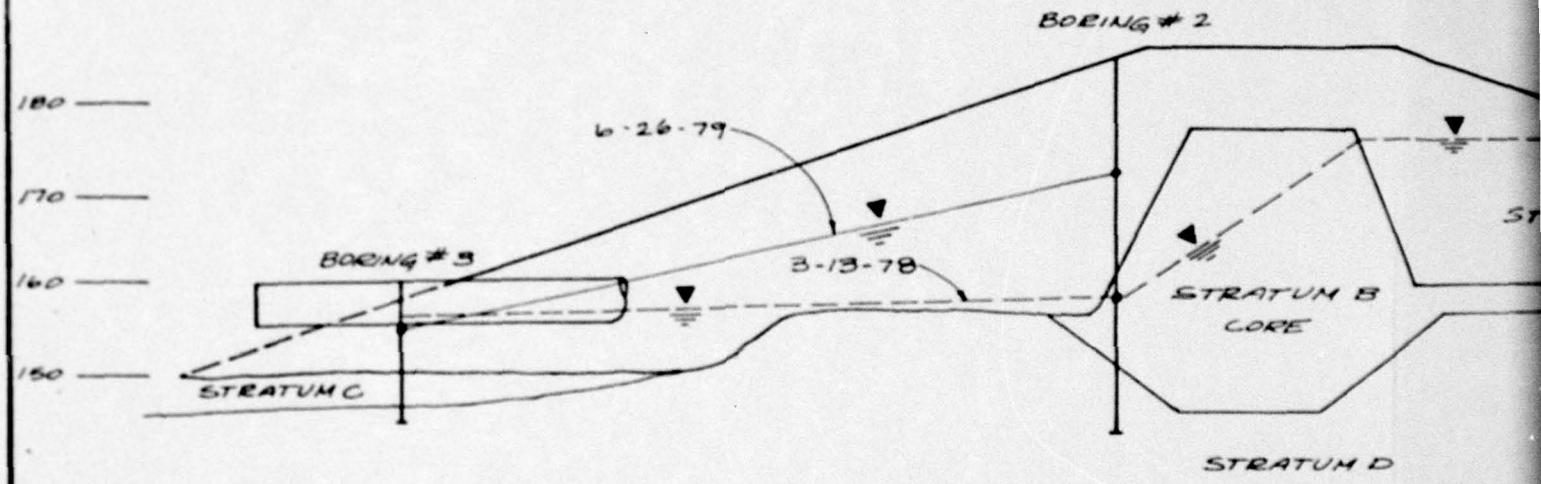
WATER LEVEL READINGS	
	3-13-78	6-26-79
BORING # 2	25' 10"	12' 0"
BORING # 3	2'-9"	4' 6"

*7.1.2 From a geotechnical standpoint, the dam appears to be functioning well, with the exception of seepage conditions as noted in Section 3. In addition, the water level readings obtained on June 26, 1979 at two observation wells at the crest and downstream toe indicate either the core is not functioning properly or the pool had risen and seepage was occurring above the core. The higher line of seepage created by this condition makes the stability of the dam questionable.

The available geotechnical engineering data and assumptions made for the strength properties of the embankments and foundations are generally acceptable. The possibility of a higher phreatic surface as observed at the time of inspection was not considered in previous stability analyses. Assuming that the core was constructed properly, it is not unreasonable to expect the phreatic surface level in the embankment to fluctuate due to changes in precipitation and pool level. Therefore, the factor of safety for the downstream slope which was determined by using a phreatic surface much lower than observed on June 26, 1979 is not considered acceptible.

*7.2.1 It is recommended that the owner, at his own expense, secure the services of a professional engineer to monitor the seepage and phreatic levels to determine whether any further studies are necessary. The engineer should also make recommendations to corrective measures suggested in 7.2.

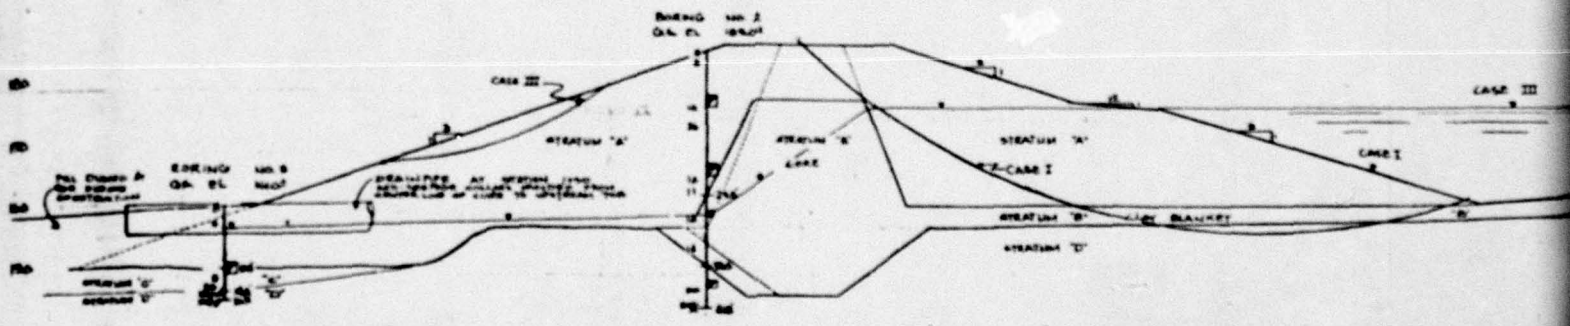
SECTION 2+00

It should be noted in Drawing 3 that the critical failure circle for Case I loading conditions goes through Stratum D. There was no laboratory data presented for Stratum D and it is highly unlikely a critical failure would occur in this very dense material weathered rock rather than in the Stratum B soils (clay blanket) above it.

STABILITY	ANALYSIS
CASE NO	FACTOR OF SAFETY
I	2.0
III	1.5

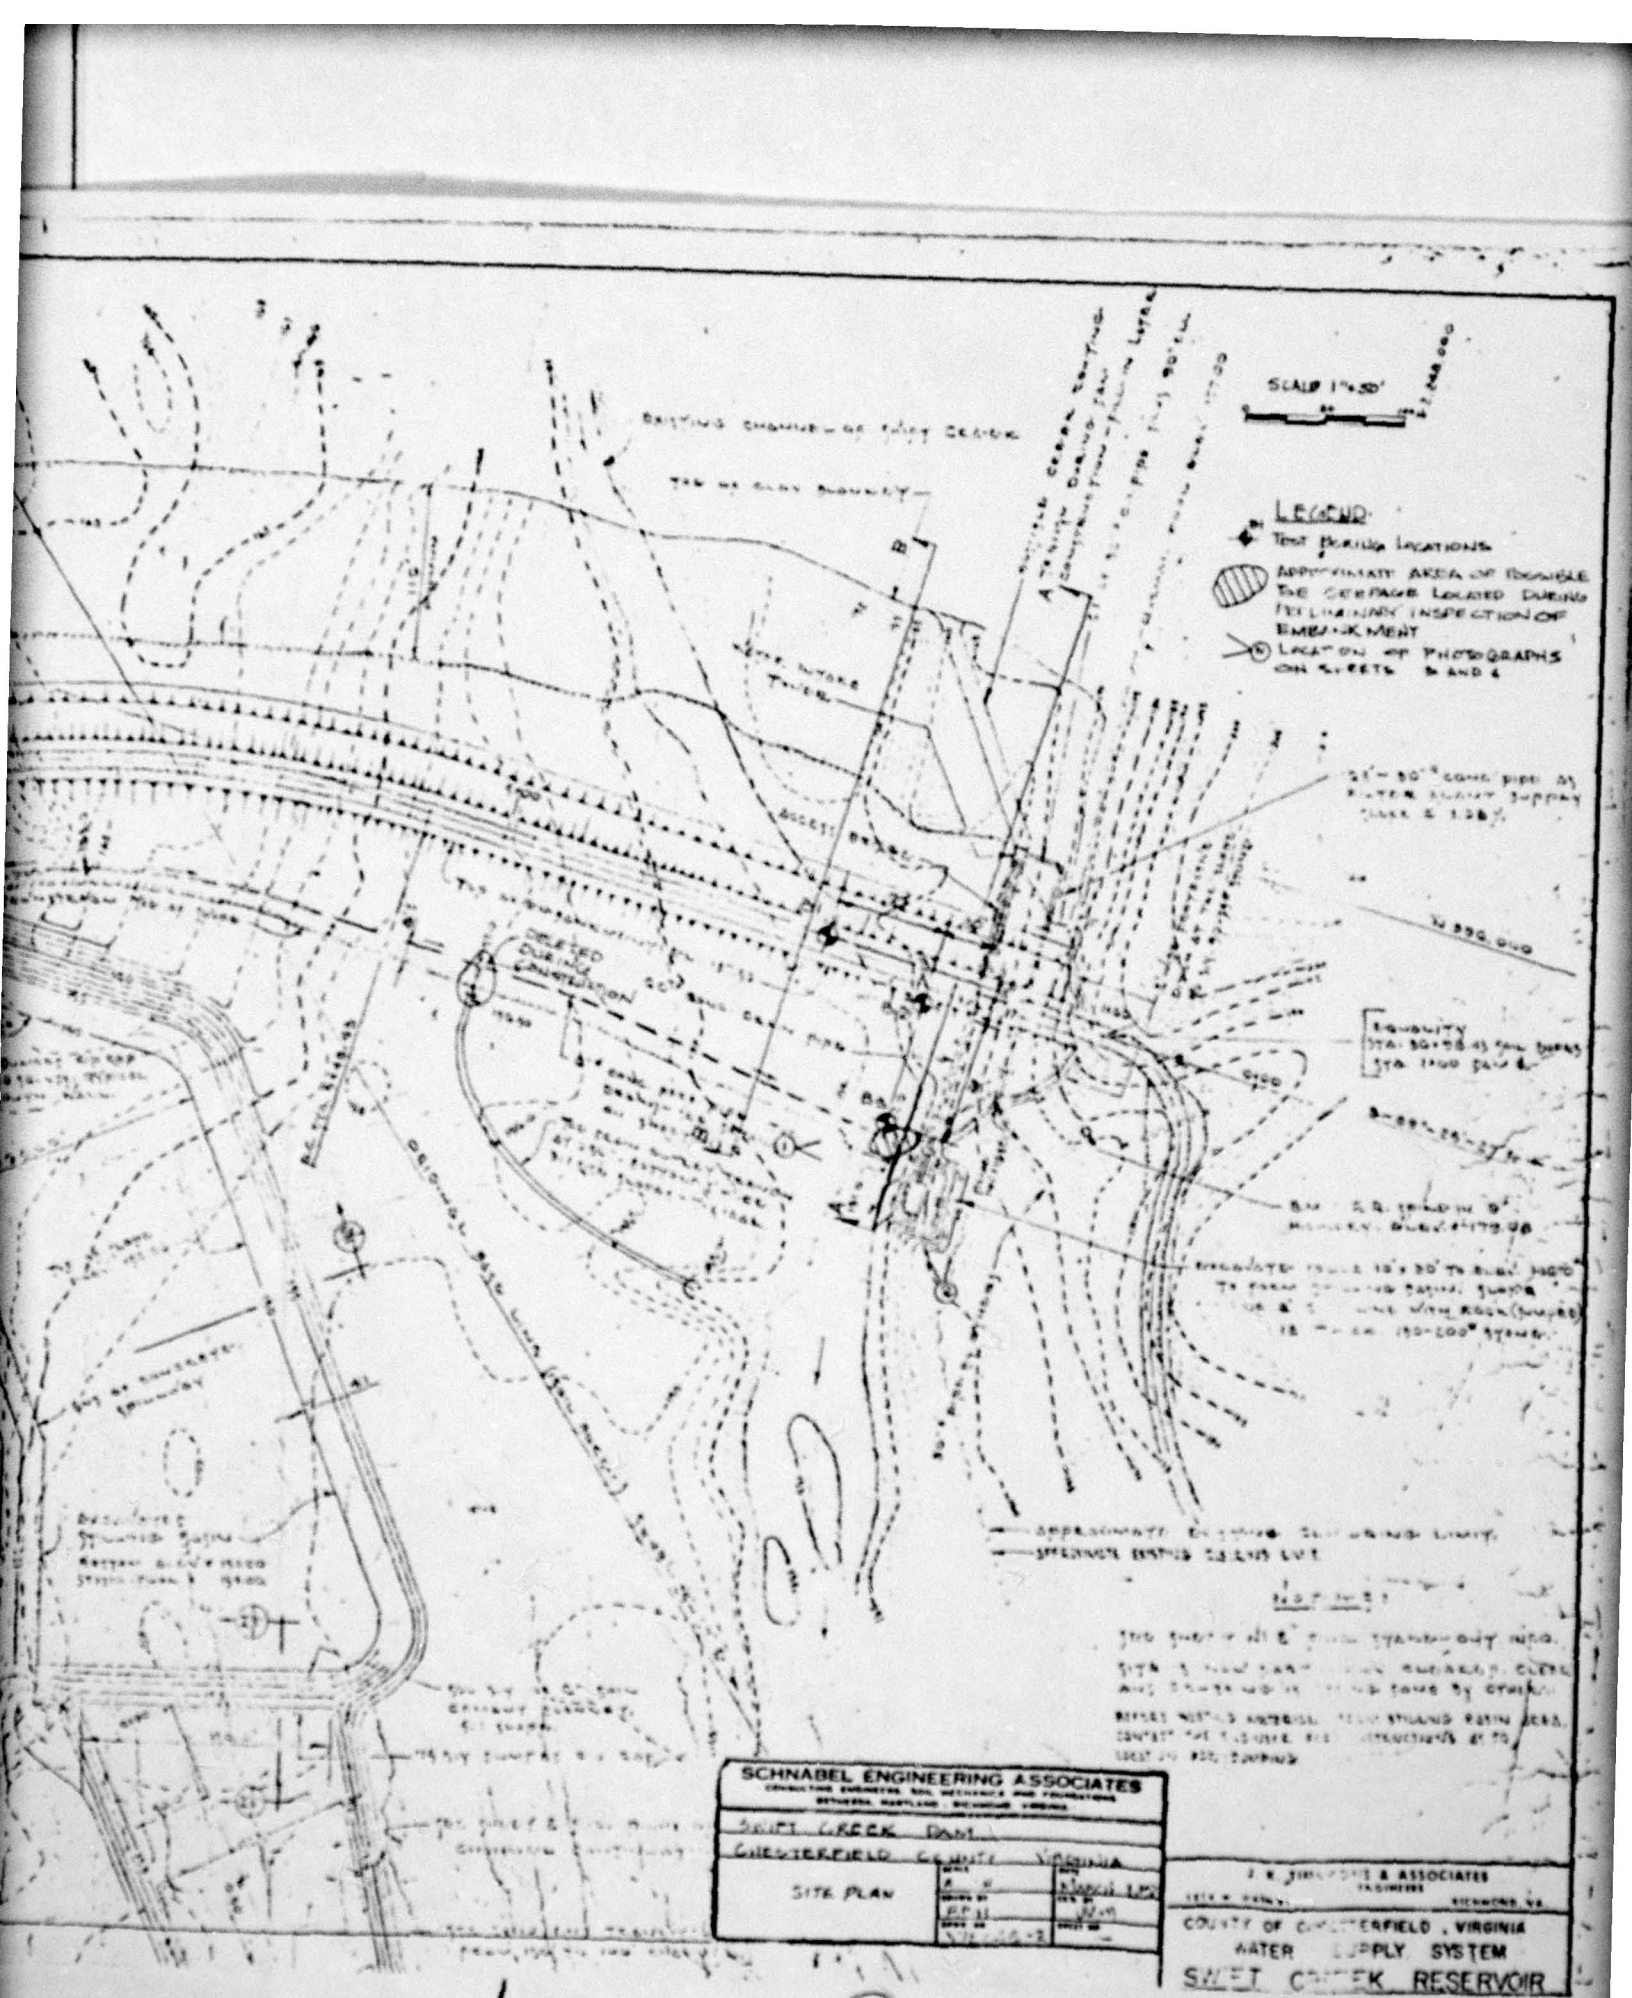
SCALE 1"=50'
LEGEND
Test Boring Locations
Approximate Areas of Possible Tie Seepage Located During Preliminary Inspection of Embankment
Location of Photographs on Sheets 5 and 6
EXISTING CHANNEL OF SWIFT CREEK
TOP OF CLAY BLANKET
ACCESS BRIDGE
DELETED DURING CONSTRUCTION
ORIGINAL BASE LINE (DAM AXIS)
EQUALITY
SCHNABEL ENGINEERING ASSOCIATES
SWIFT CREEK DAM
CHESTERFIELD COUNTY VIRGINIA
SITE PLAN
J. R. JOHNSON & ASSOCIATES
ENGINEERS
RICHMOND, VA.
COUNTY OF CHESTERFIELD, VIRGINIA
WATER SUPPLY SYSTEM
SWIFT CREEK RESERVOIR
