TECHNICAL REPORT GL-79-12

# USE OF LIME IN LEVEE RESTORATION

Frank C. Townsend

Geotechnical Laboratory
U. S. Army Engineer Waterways Experiment Station
P. O. Box 631, Vicksburg, Miss. 39180

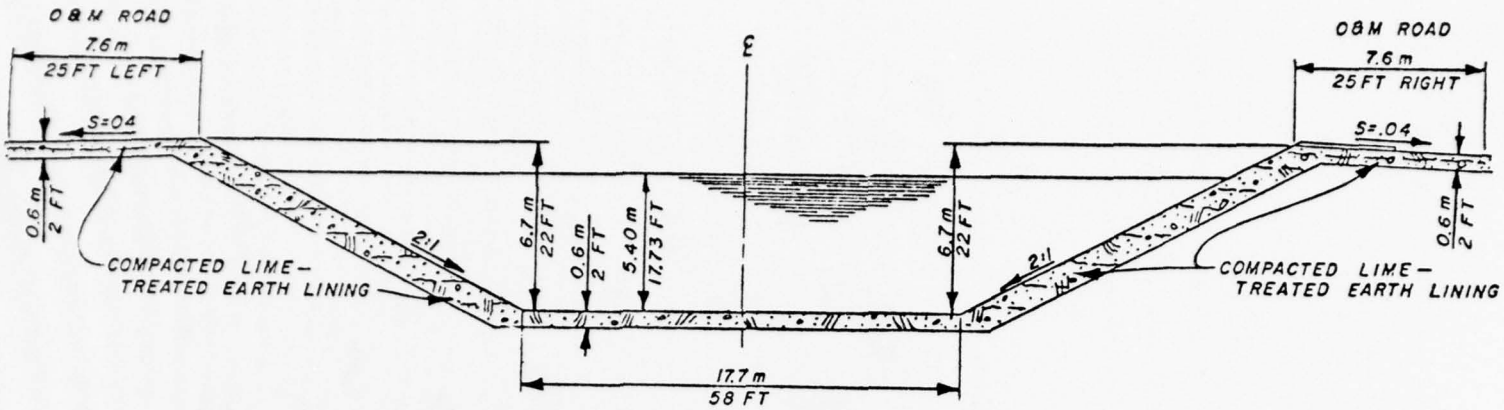
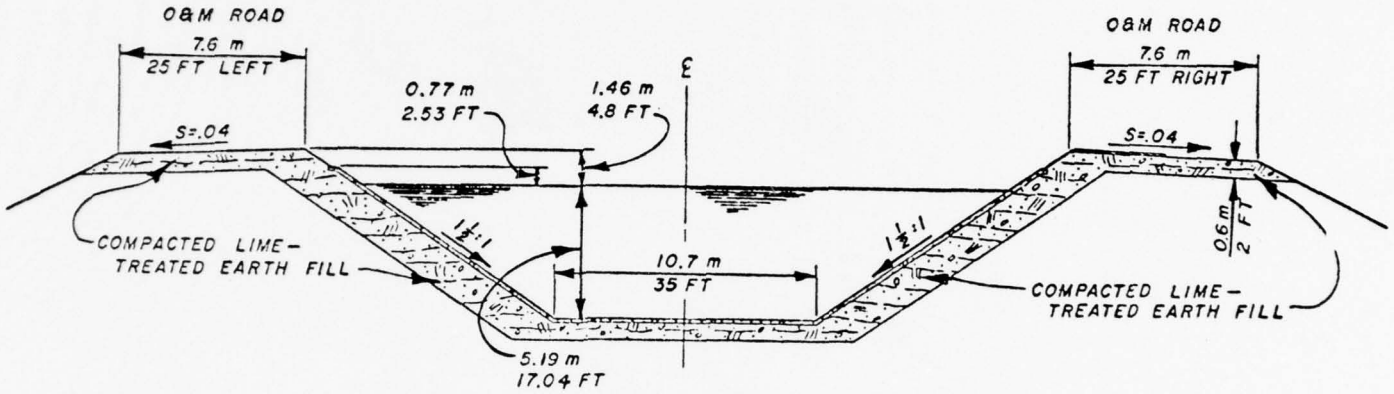
Figure 4. Rehabilitated canal sections (from Reference 19)

18. Since construction in the late 1940's the Friant-Kern Canal in California has experienced cracking, sliding, and sloughing on the side slopes in areas of expansive clays and in both the concrete-lined and earth-lined portions. Failure was generally attributed to the highly expansive fat clay (CH) soils, forming deep surface cracks by shrinkage that result in a loss in shear strength, or swelling and softening as they become saturated that also result in lower shear strengths. In the early 1970's, after having unsuccessfully converted failed concrete linings to earth sections with flatter slopes or trying electrochemical treatment, the Bureau of Reclamation decided to remove portions of the canal lining, flatten the slopes, and reline the canal using a compacted soil-lime mixture. Rehabilitation shown in the upper diagram of Figure 4 for the earth-lined sections consisted of flattening the slopes from 1.5:1 to 2:1. The compacted soil-lime earth lining was to be 2 ft thick for access roads on the tops of both banks and for the canal bottom, while the side slopes were 3.6 ft thick normal to the slope. In the case of the sections beneath a concrete lining, the side slopes were left at 1.5:1, resulting in a thickness of 4.4 ft normal to the slope, with the bottom and access road sections being 2 ft thick.

20. Even though construction took place during December and January of 1972-1973 and 1973-1974 when the canal was dry, excellent results were obtained. In fact, the earth-lined sections performed so well during watering that concrete linings were deemed superfluous and were discontinued. Current (1976) conditions indicate a slight fluff (1 to 2 in.) has formed on treated surfaces due to wetting and drying, but underlying material is quite hard and resistant.*

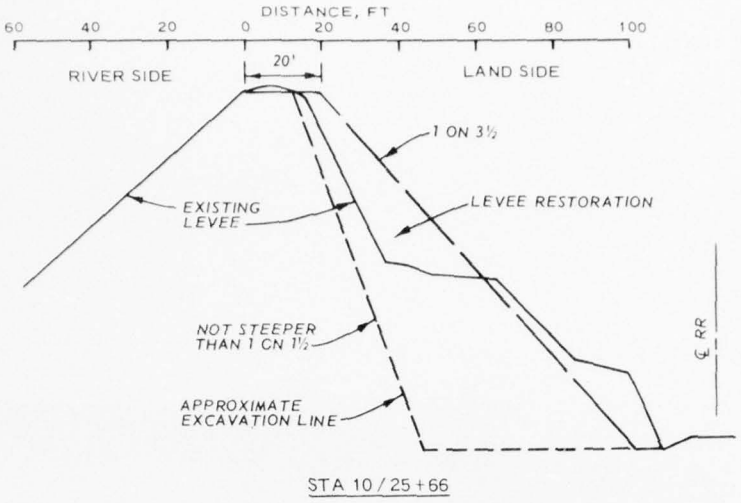
Figure 6. Profile of slide conditions, Little River Levee System, Memphis District

Nash, Missouri, and Figure 6 presents a schematic of the conditions. The levee is approximately 25 ft high in this section, with adjacent unfailed slopes of 1:3.5-4.0. The slide extends approximately from sta 24+94 to 26+83 or 190 ft. The close proximity of the railroad at the slide toe precludes repair by flattening the slope or placement of stabilizing berms, unless the railroad is relocated. In this case, either a retaining wall or improvement of the soil strength by admixtures, which would

permit repair to prefailure slopes or steeper, would be a viable restoration method. The material sampled was from the base of scarp, which is thought to represent material from or near the failure plane.

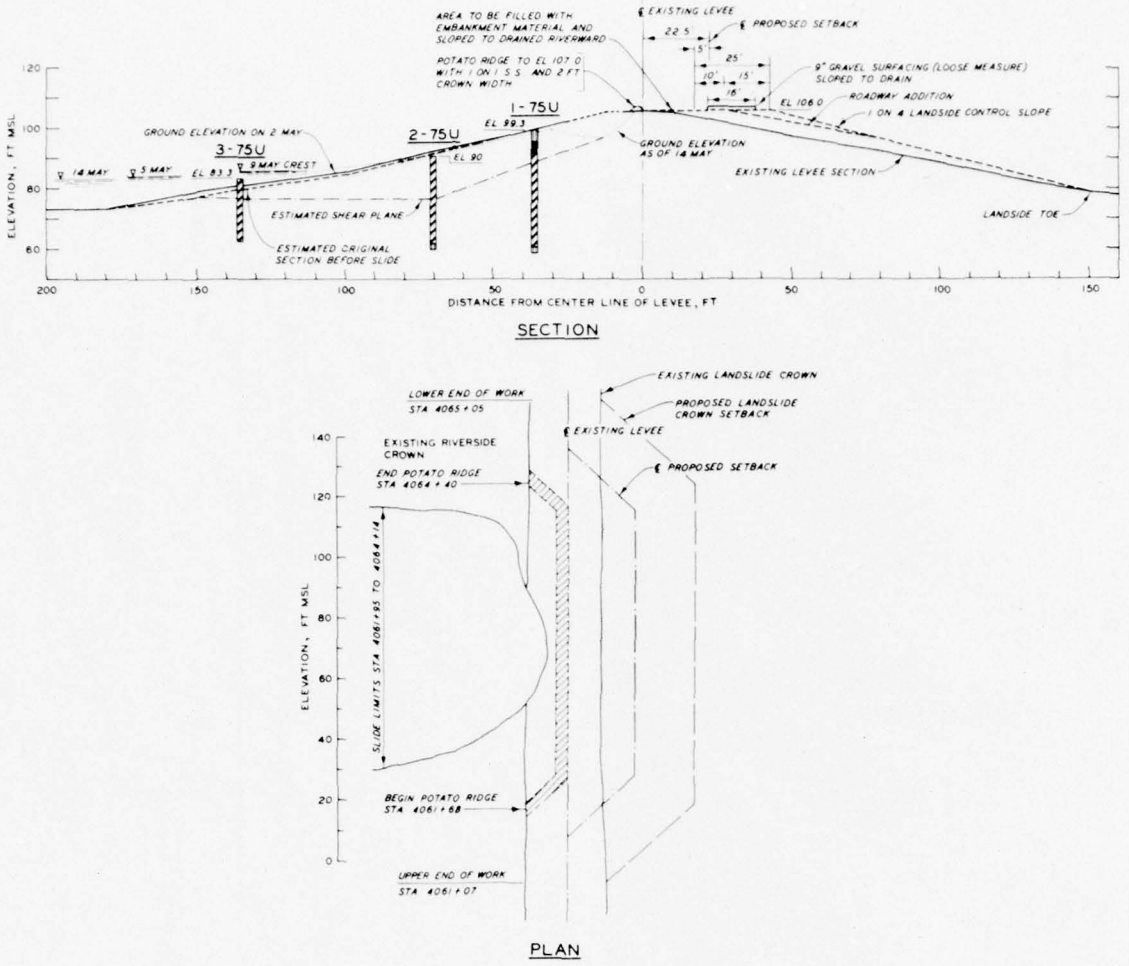
Figure 8. A schematic of slide conditions, Roundaway Bayou Levee, Vicksburg District

c. Roundaway Bayou Levee, Vicksburg District. Figure 7 presents a river-side slide on the Roundaway Bayou Levee near Vicksburg, Mississippi, while Figure 8 presents the geometry of the conditions. The levee is approximately 25 ft high in this section, with prefailure slopes of 1:3.5-4.0. The slide extends approximately from sta 4161+95 to 4164+14 or 219 ft. The material sampled was from the base of the scarp.

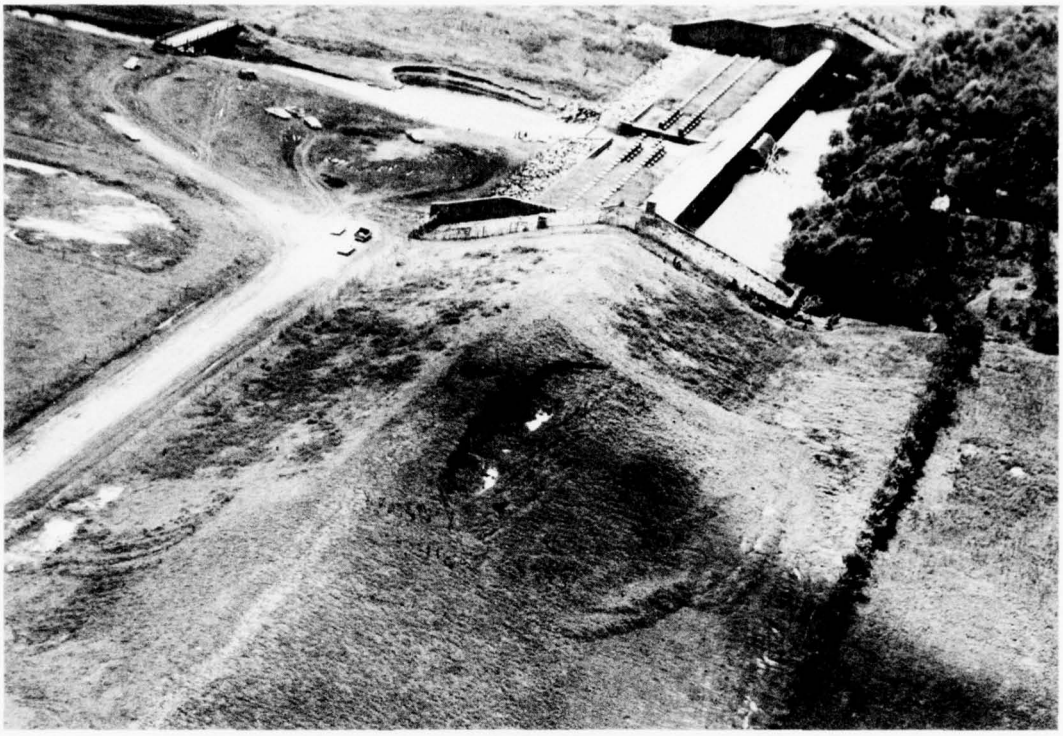
Figure 9. Slide on Wallace Lake Dam, New Orleans District

d. Wallace Lake Dam, New Orleans District. Figure 9 shows a slide on the upstream face of Wallace Lake Dam. This slide occurred in an area that had failed when the slopes were 1:3 and had been improperly restored 3 months earlier to 1:4 slopes, prior to the second slide that was due to improper reconstruction as shown in the figure. Figure 10 is a schematic of the geometry of the slide. The levee section is approximately 20 ft high in this section. The slide is approximately 250 ft long. The material used in the testing program was a composite of undisturbed samples from four borings taken from the slide area.

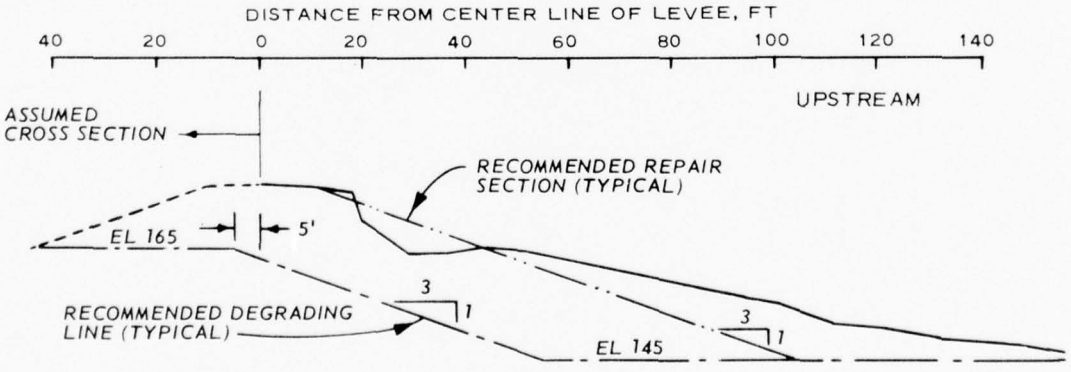
Figure 10. A schematic of slide conditions, Wallace Lake Dam, New Orleans District, at sta 38+50

Slopes were 1:3 and 1:4, and material was always a CH soil at a high water content. Typically, the slides were small (100-300 ft in length), varying in depth from 2 to 15 ft. Failure was attributed to continued seasonal wetting and drying, which created numerous cracks and fissures and resulted in a blocky structure. Movement of water into these fissures softens the material along these planes causing a decrease in strength and failure.*
