U.S. ARMY MISSILE RESEARCH AND DEVELOPMENT COMMAND

TECHNICAL REPORT T-79-42

FINAL EVALUATION OF RAIN EROSION SLED TEST RESULTS AT MACH 3.7 TO 5.0 FOR SLIP-CAST FUSED SILICA RADOME STRUCTURES

6 March 1979

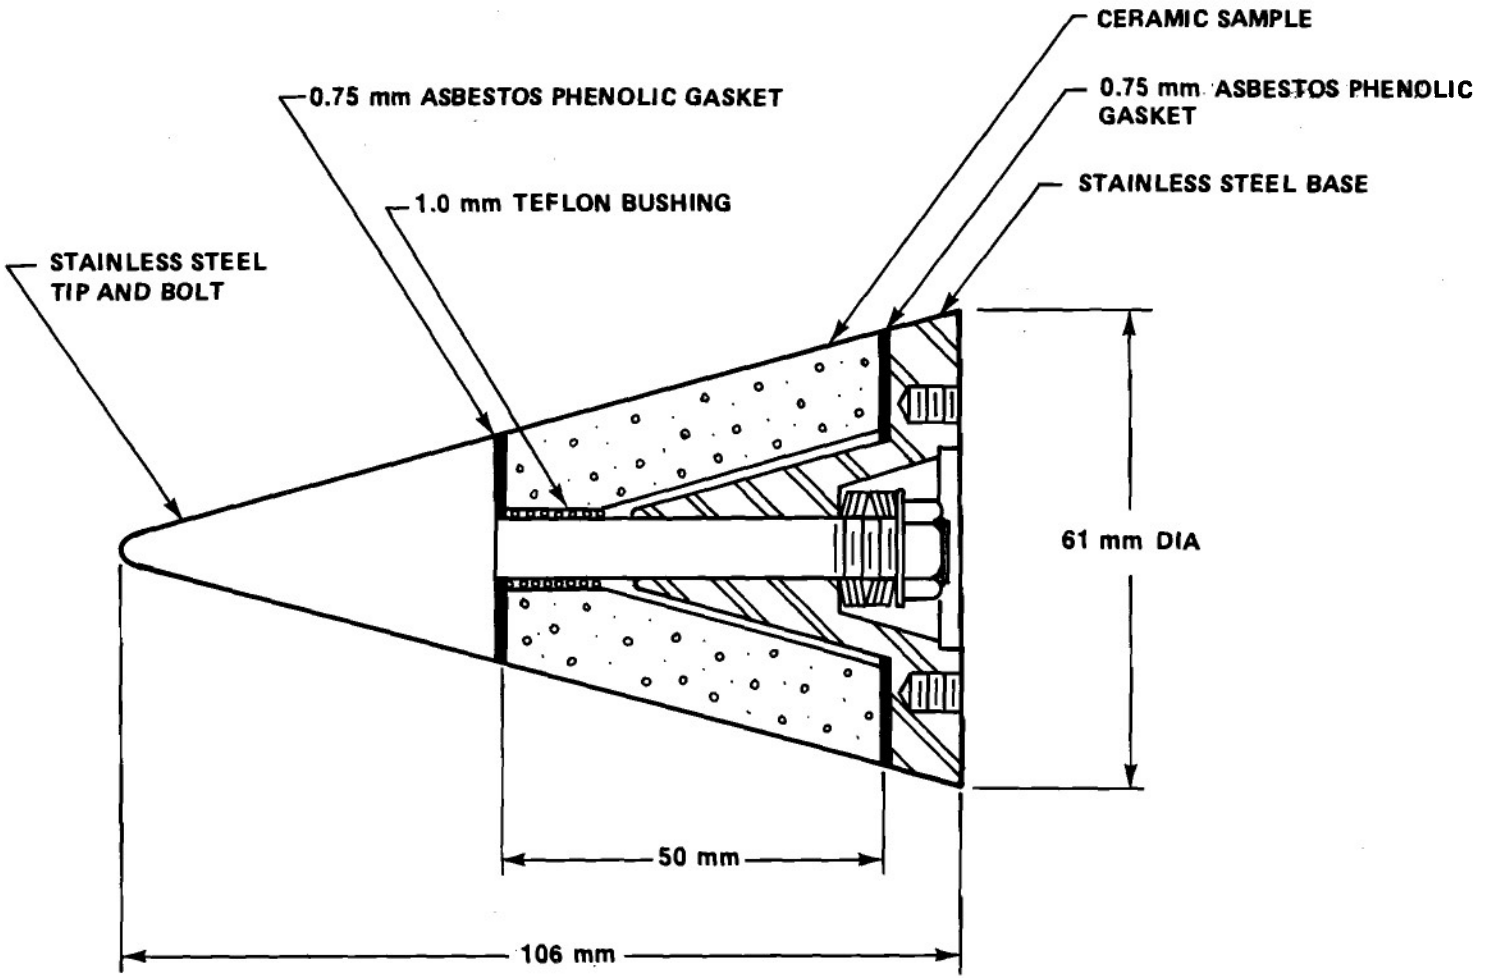
Figure 2. Sample subassembly for initial test.

Figure 3 through *13* are pre- and post-test photographs of the test specimen and hardware for the first five tests. The SCFS samples in *Figure 4* show the detrimental effects of sharp edges at the base for the sample design of *Figure 2*. All samples with a semivertex angle of 15 deg survived the 610 m rainfield at Mach 5 with negligible erosion because the normal component of velocity (V sin θ) was less than that at which significant erosion begins on SCFS.

In the first test, gaskets of asbestos phenolic were used at each end of the samples to distribute loads uniformly (*Figure 2*).

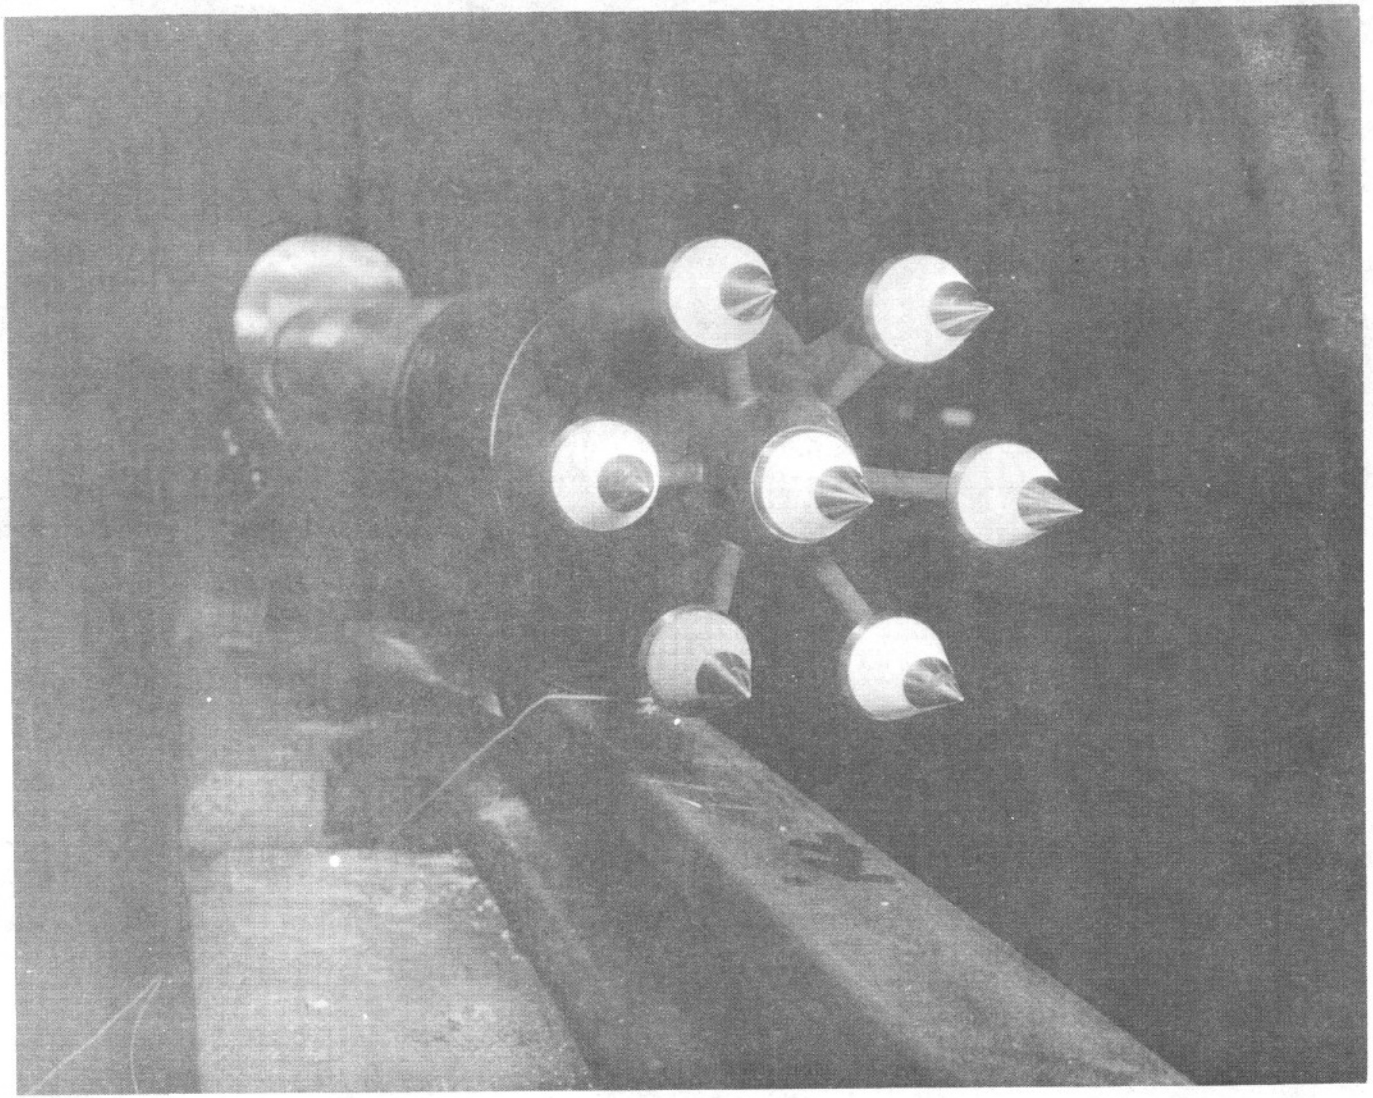
Figure 3. Samples assembled for test 1.

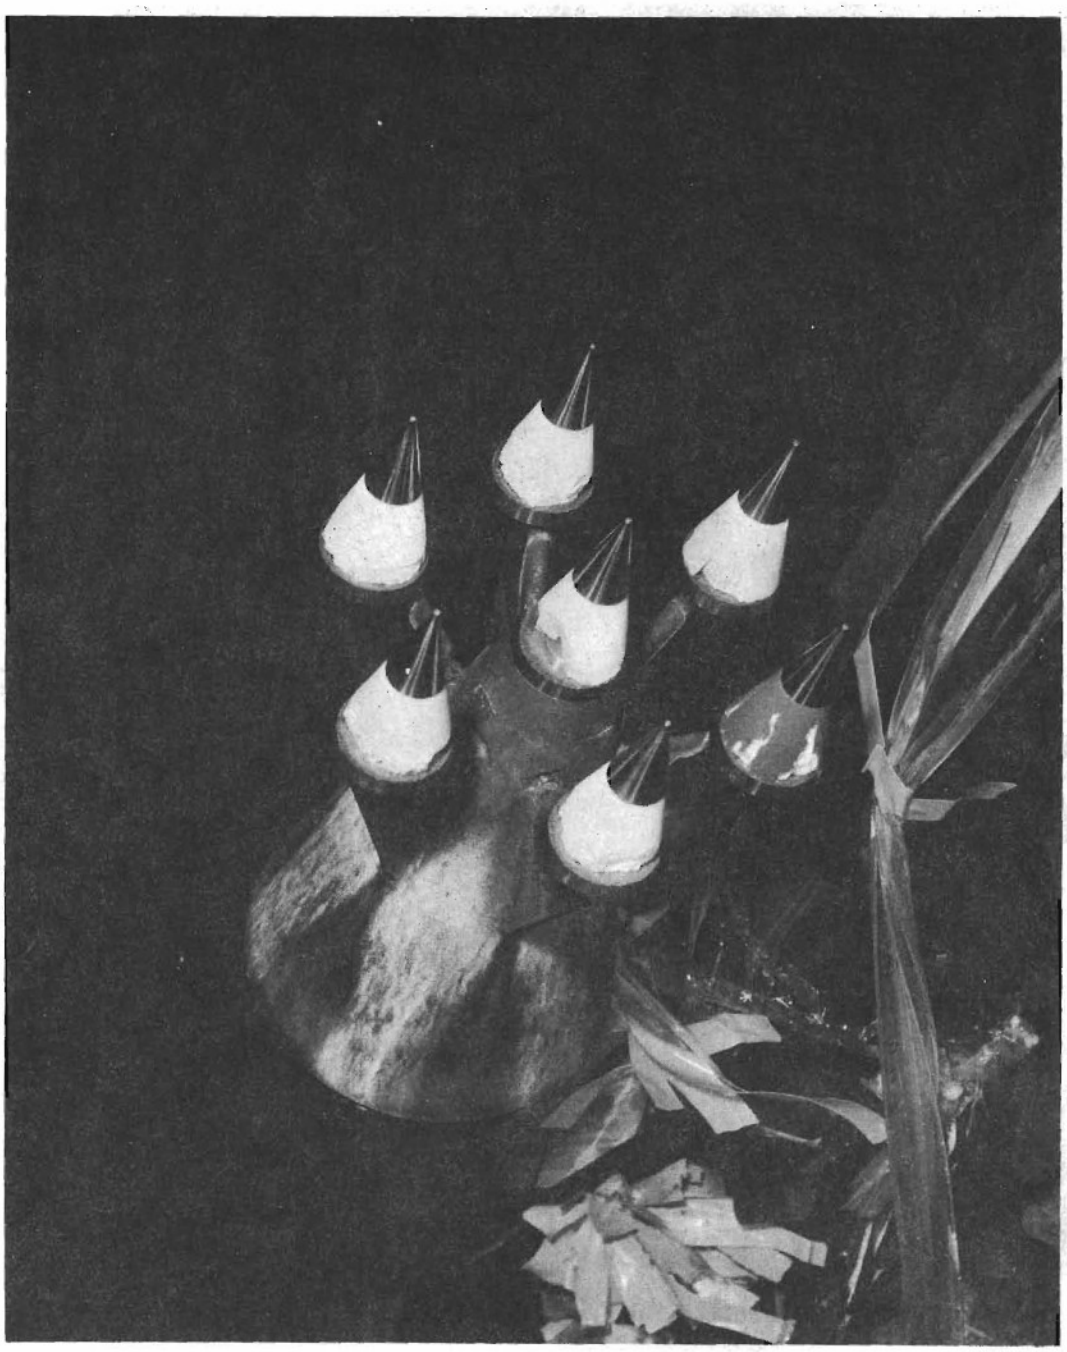
Figure 4. Post-test view of test vehicle and samples of test 1.

Edge effects in the form of chipping at the base in test 1 were eliminated in test 2 and subsequent tests by redesigning the external configuration of the ceramic sample as shown in *Figure 14*. All samples were SCFS in test 2 except sample 5, which was Avcoat

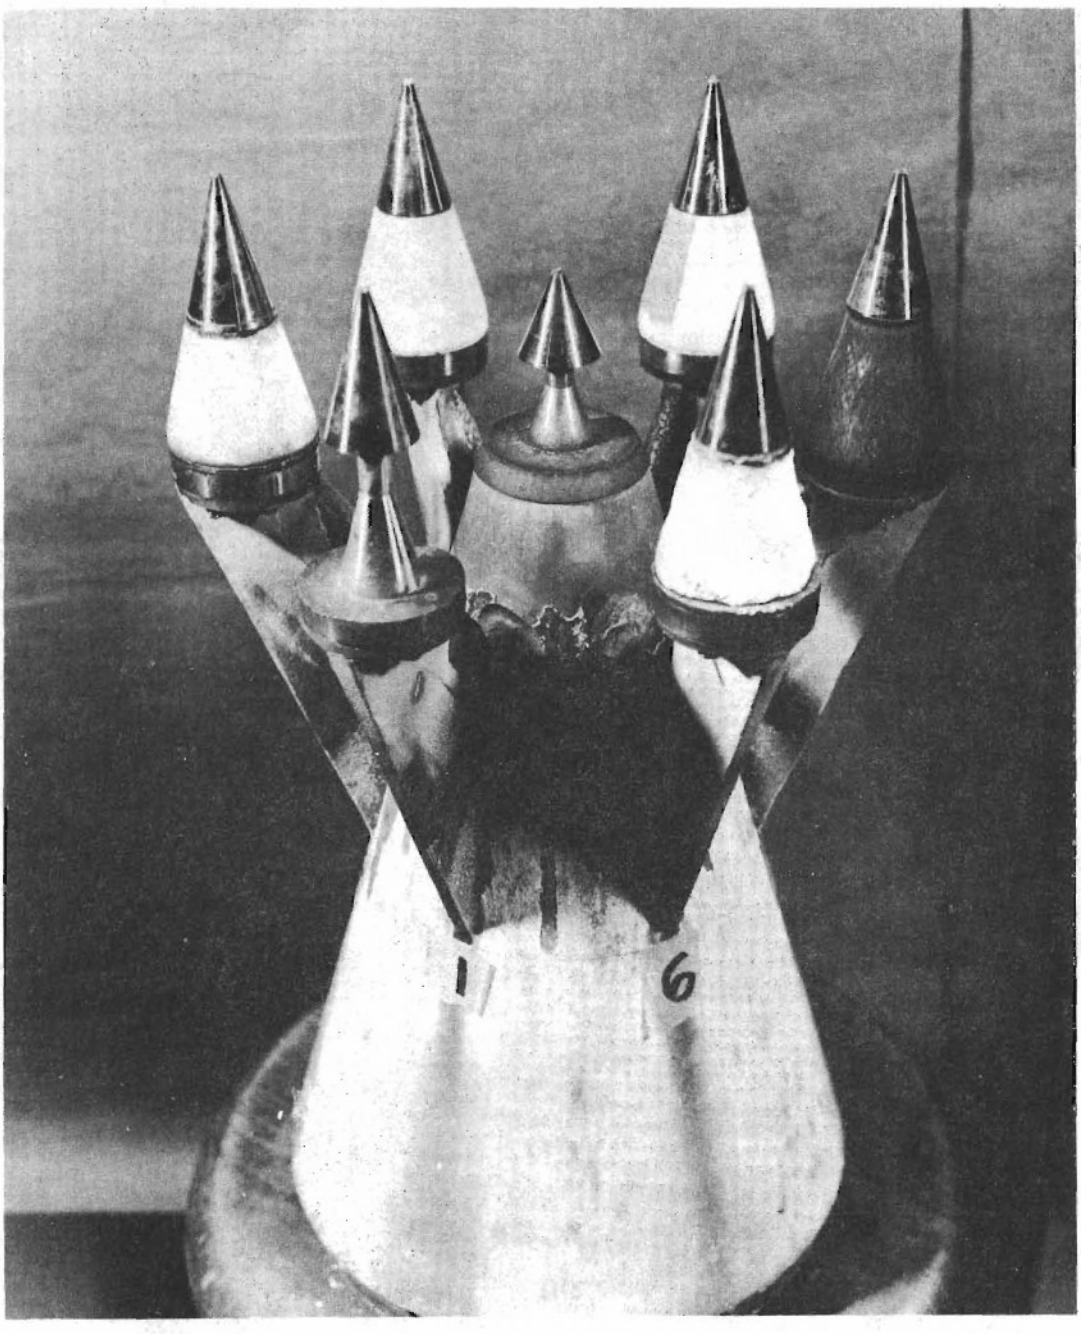
Figure 7. Test vehicle and samples after test 2.

8027, an epoxy. Only the 22.5 deg center sample and the 15 deg sample coated with chromium oxide (sample 1) were lost in the 1100 m rainfield. Erosion of high-purity SCFC (samples 2, 3, and 4) was very minor, whereas the erosion of low-density SCFS (sample 6) was great.

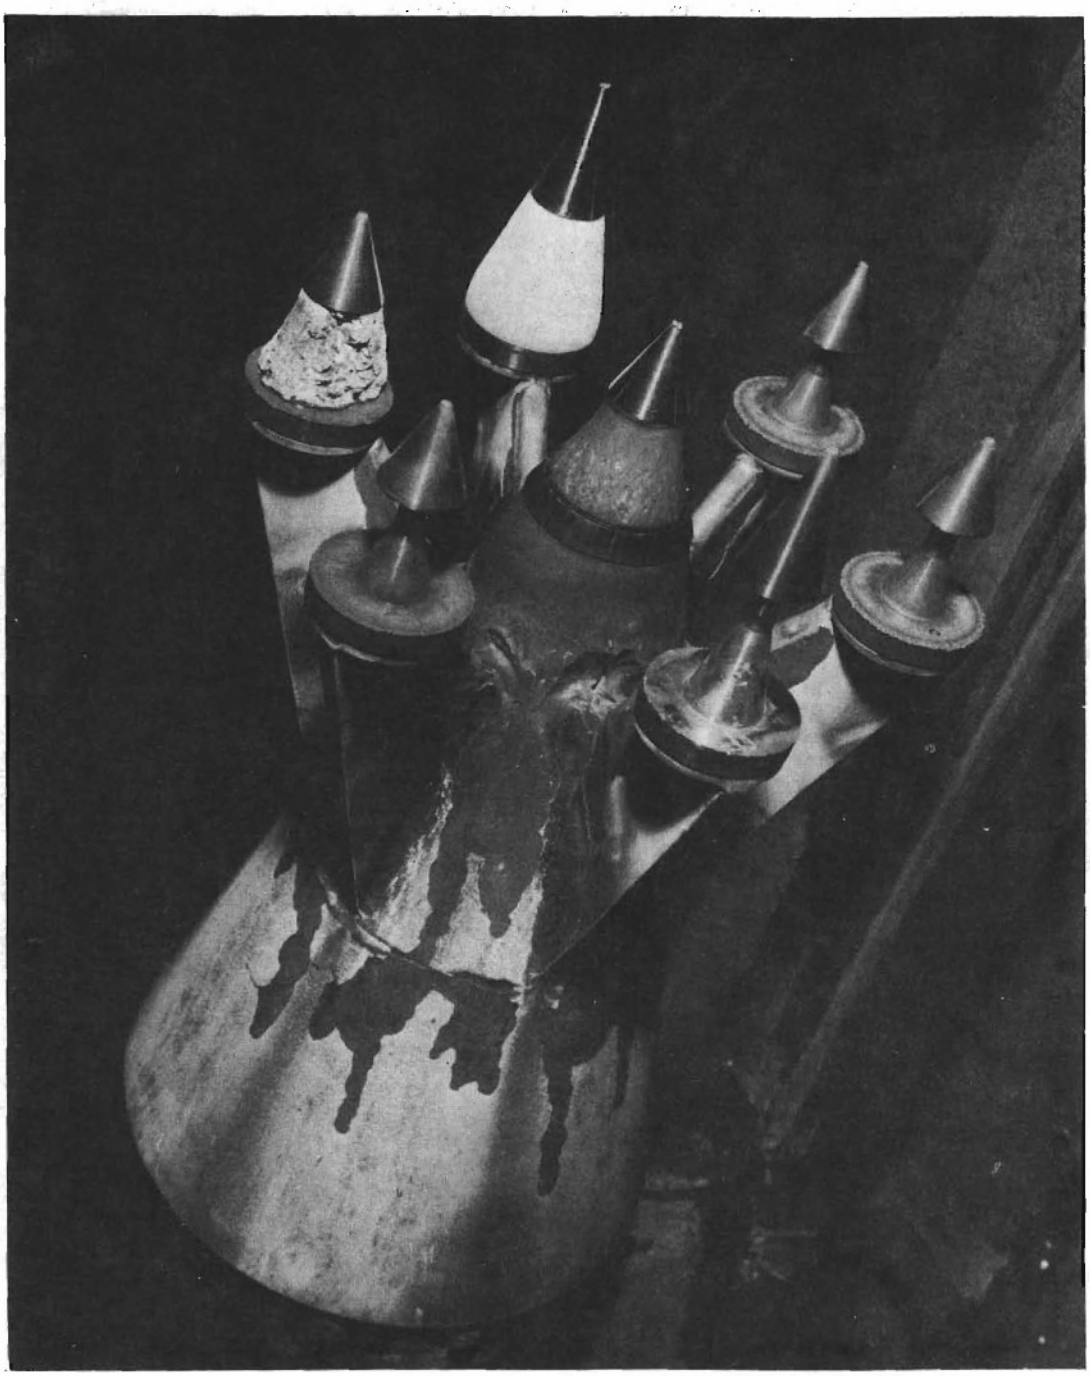
Figure 9. Test vehicle and samples after test 3.

In test 3 only one SCFS model (15 deg in *Figure 9*) survived at Mach 5 through 853 m of artificial rain. The other 15 deg sample was lost after exit from the rainfield. All 22.5 deg models were lost. A ruptured water line, which possibly sprayed water across the track, may have contributed to sample failures in this test. The center sample was Avcoat 8027.

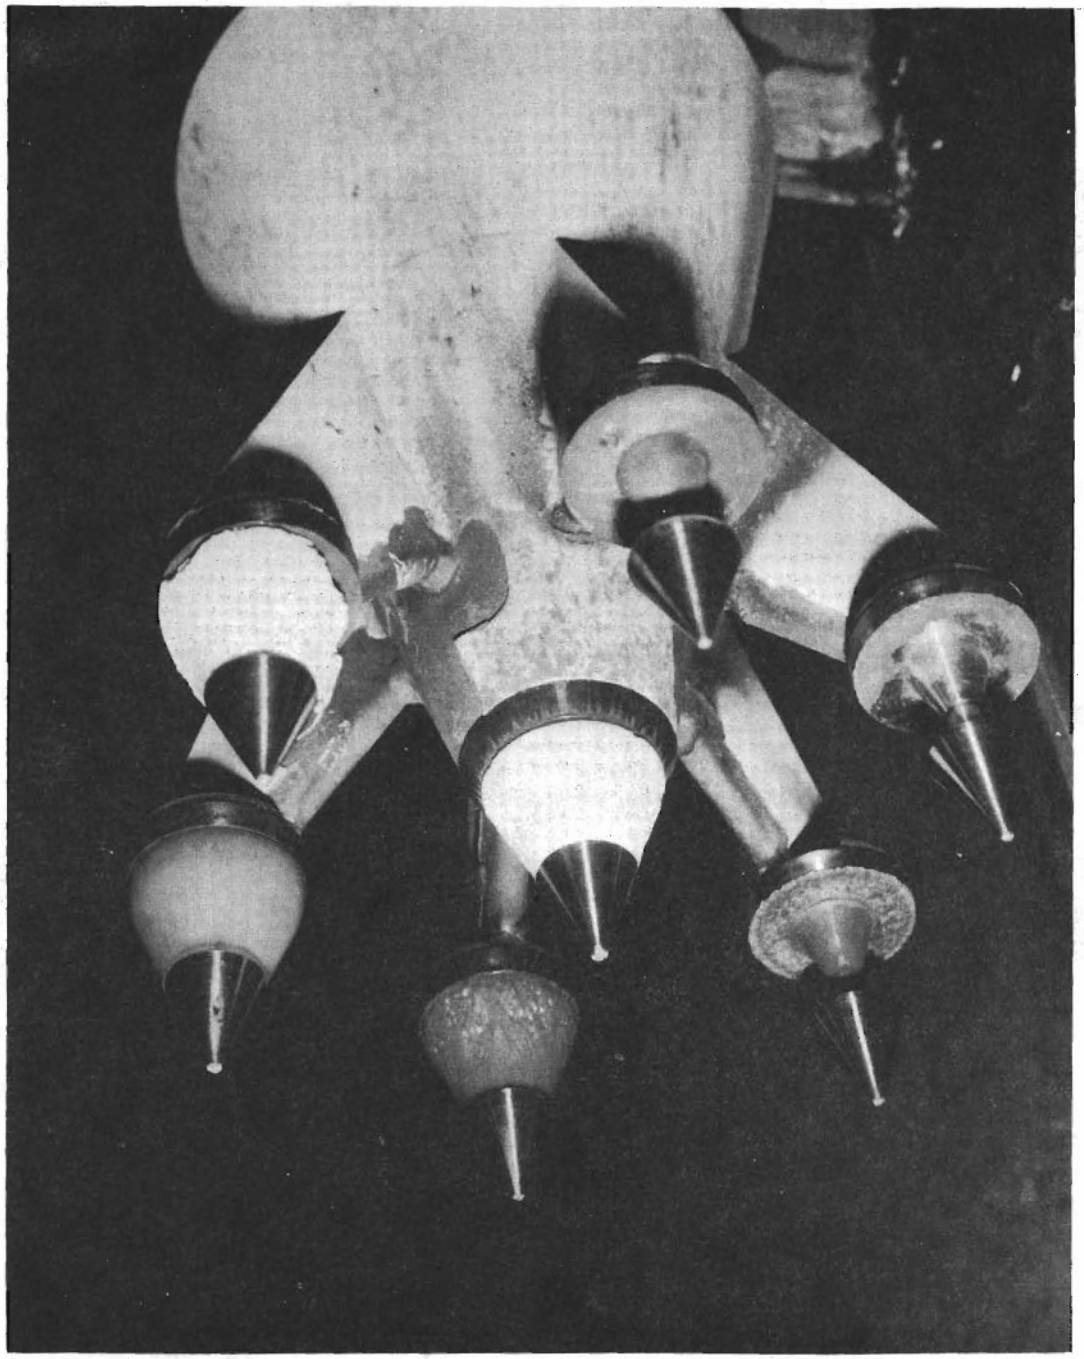
Figure 11. Test vehicle and samples after test 4.

Teflon, Avcoat 8027, and hot-pressed silicon nitride survived in test 4. One SCFS sample was lost early in the rainfield (evidenced by the severity of rain damage on sample mounting hardware), two samples were damaged in rain, and the remaining material was lost after leaving the rainfield. One SCFS sample (4-1, *Figure 11*) survived in a severely damaged condition. Additional shock mounting procedures (Appendix B) were implemented for SCFS samples with semivertex angles of 22.5 deg and greater to prevent sample loss after severe erosion.

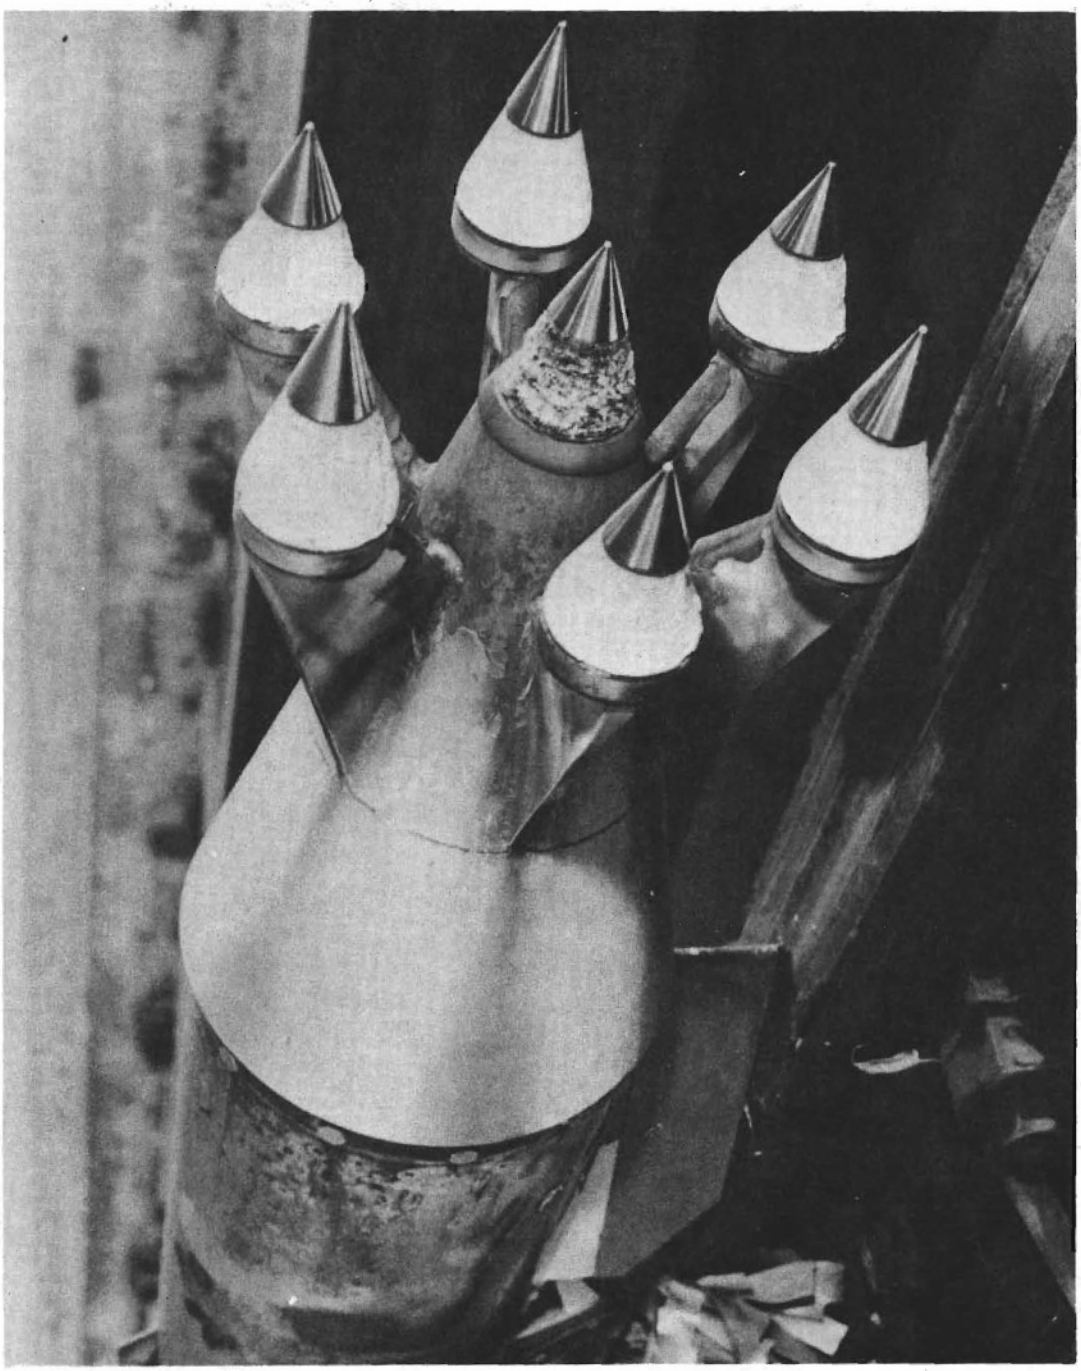
Figure 13. Test vehicle and samples after test 5.

Beginning with test 5, the techniques used to eliminate damage by track vibrations and stress risers were successful so that all subsequent samples of SCFS were recovered in a condition which allowed correlations to be made between erosion, velocity, and angle of impingement. Six SCFS specimens were successfully tested on test 5 (*Figure 13*). The center sample was made of quartz-polyimide.

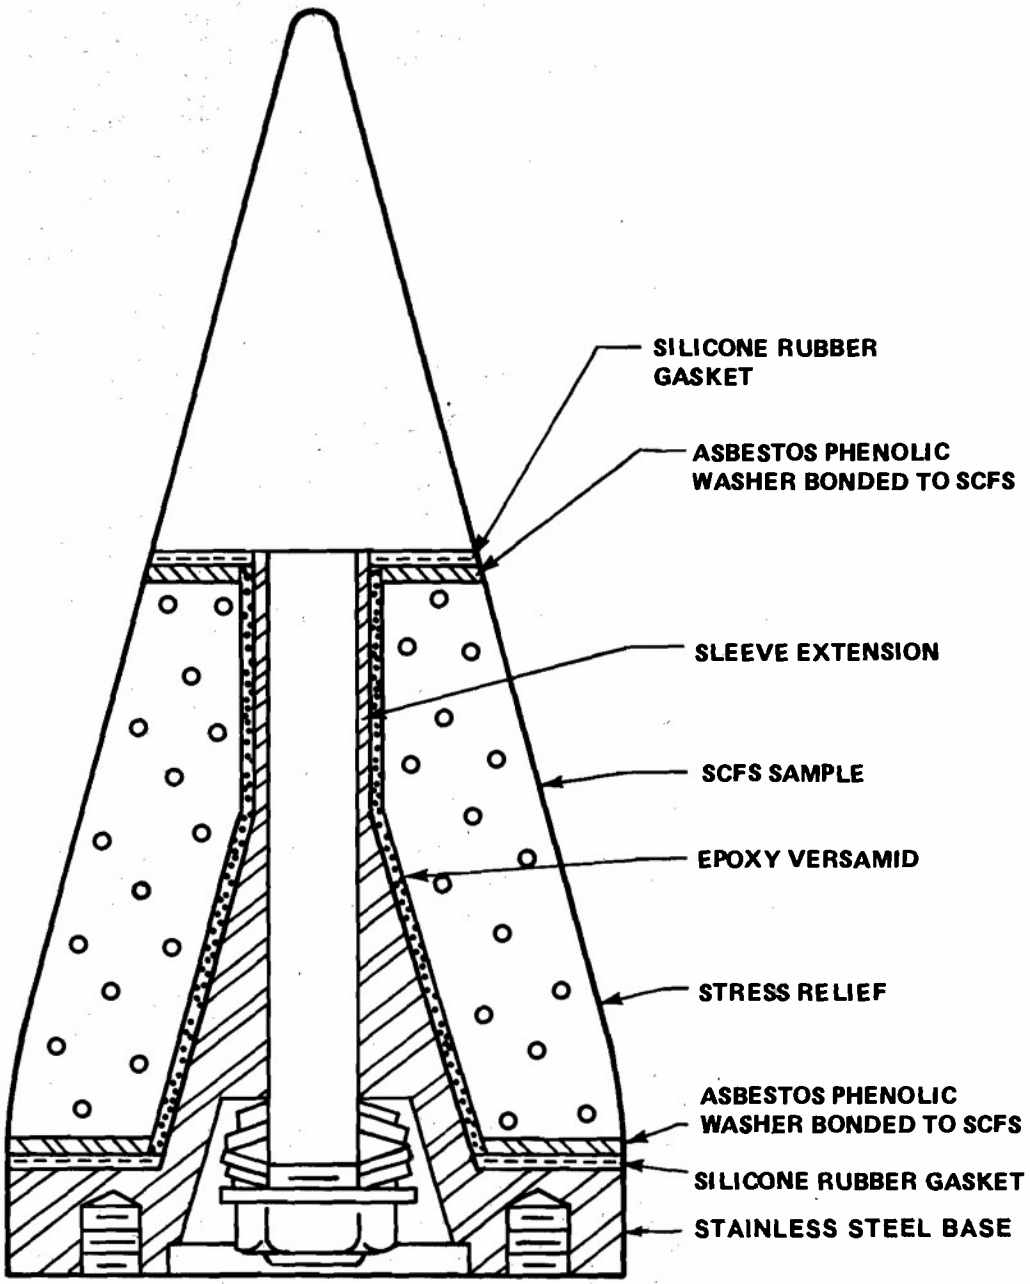
Figure 14. Modifications to sample subassembly for test 5 and subsequent tests.

asbestos phenolic was substituted for invar because of lower cost. As an additional aid in reducing the effects of sled vibration, epoxy versamid was used between the sample and sleeve. These modifications were successful and led to the final design and mounting arrangement shown in *Figure 14* which has been completely successful in eliminating failures due to spurious causes.

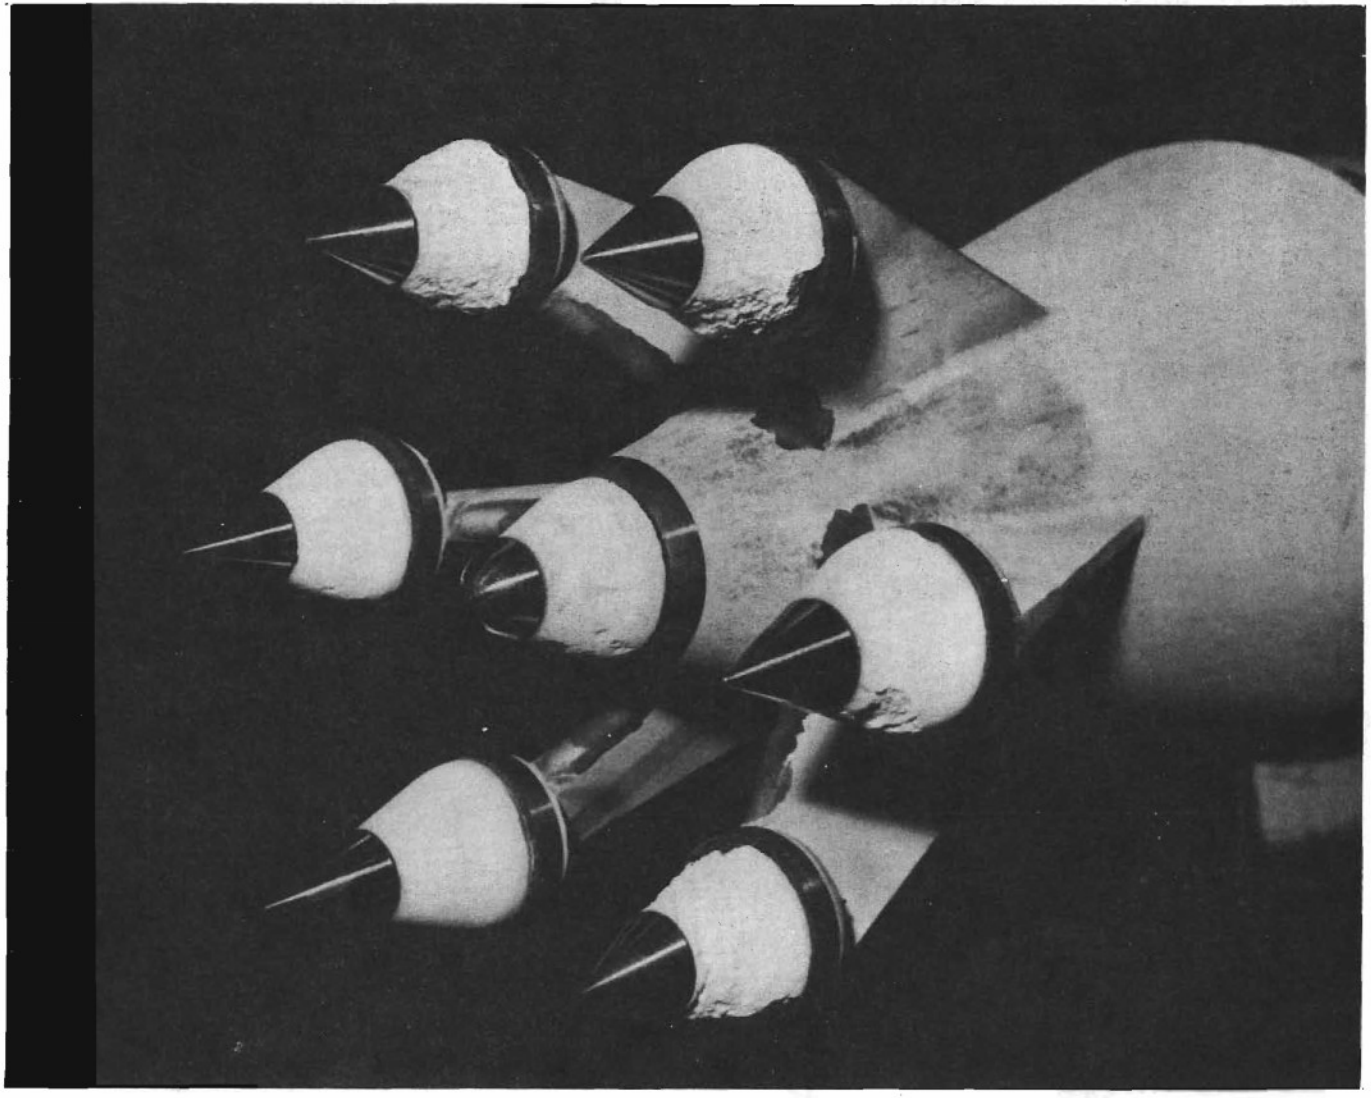
Figure 16. Test vehicle and samples after test 8.

Table 1 gives characterization and performance data for each sample in test 8. The cone semivertex angles were 19, 22.5 and 25 deg and the average velocity in the rainfield (*Table 2*) was 1524 m/sec (5000 ft/sec). A pretest view of the test vehicle and samples is shown in *Figure 15* and the post-test view is found in *Figure 16*. The surface condition and weight loss of sample 8-4 indicate that a rain damage/erosion threshold occurs at a normal component of velocity near 500 m/sec; i.e., while most of the surface was covered with very small pits, a few large craters were found.

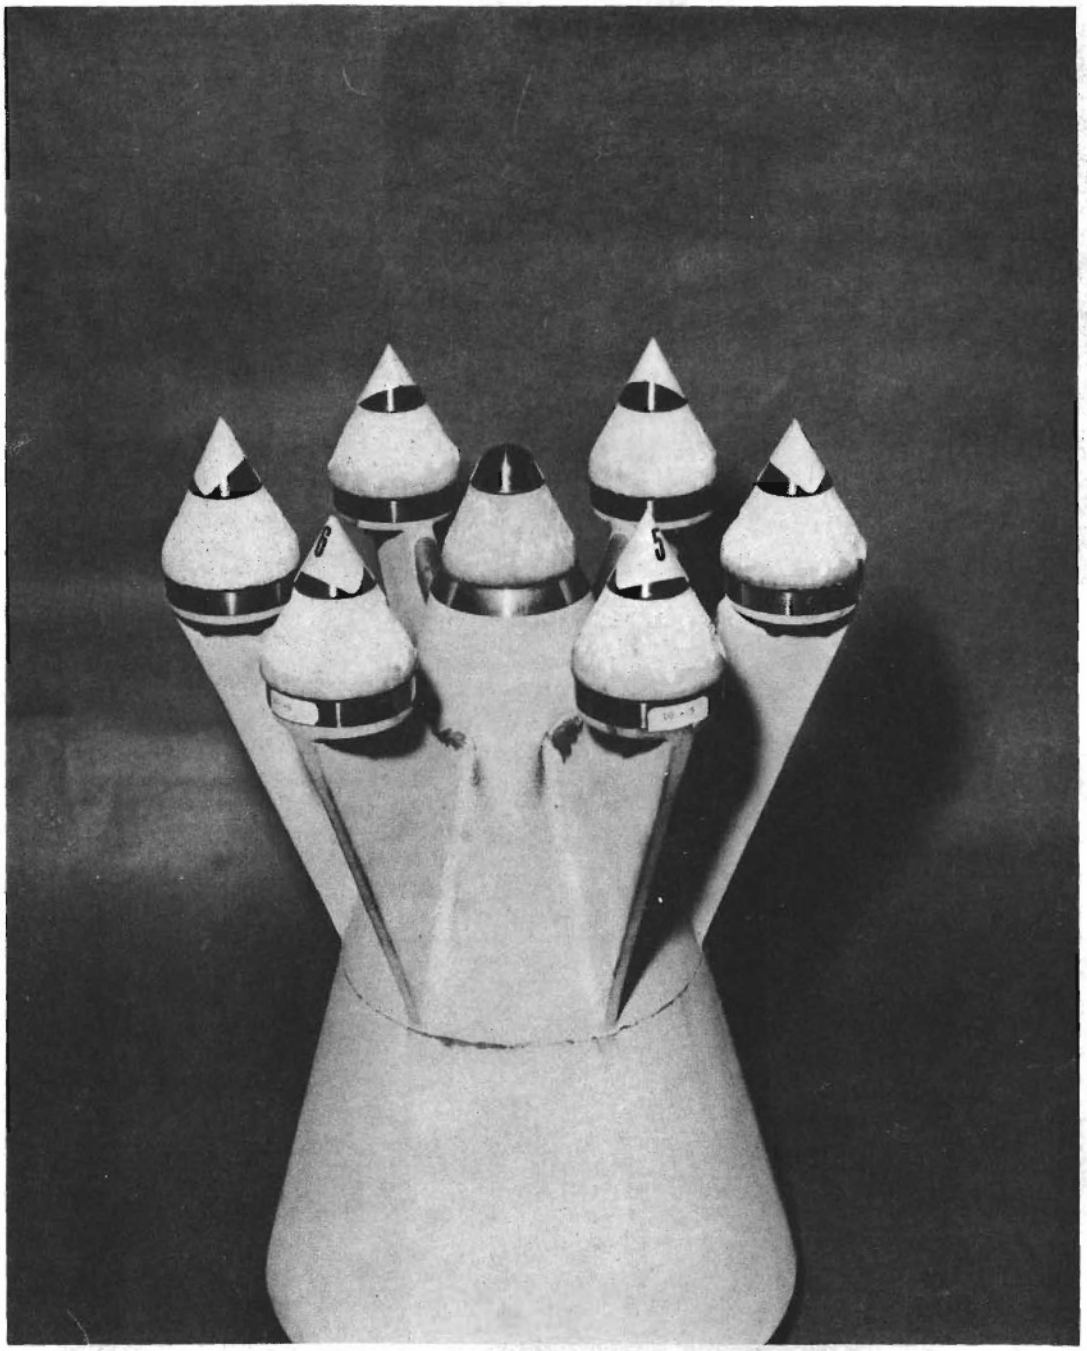
Figure 18. Test vehicle and samples after test 10.

Pre- and post-test views of the test vehicle and samples are shown in *Figures 17* and *18*. The center sample (10-7) had a 25 deg semivertex angle which caused its normal component of velocity to be slightly above the damage threshold region as indicated by visual inspection and the measured mass loss of 1.175 g (*Table 1*). Erosion data from all seven samples correlated well with previous results.

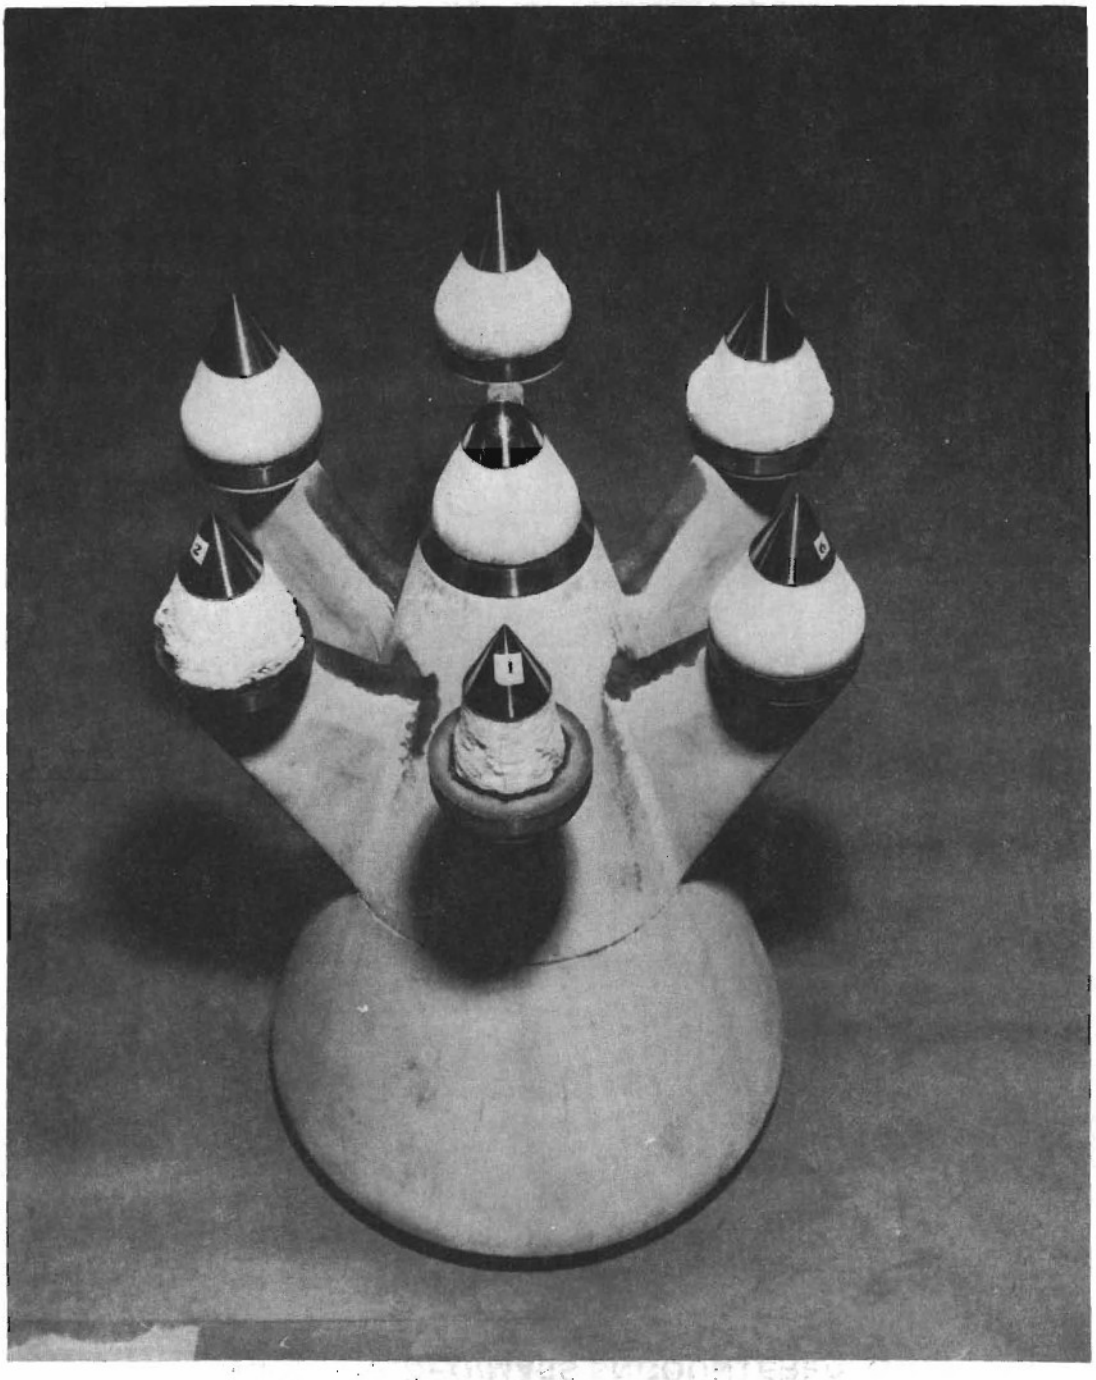
Figure 20. Test vehicle and samples after test 11.

The normal component of velocity (548 m/sec) of the 22.5 deg SCFS sample was near the damage threshold value (500 m/sec) as indicated by earlier results in this test series, and the performance of this sample was consistent with the previous results. The rain erosion data from all SCFS samples in this test correlate well with data from the previous tests. Post-test views of the samples are found in *Figure 20*.

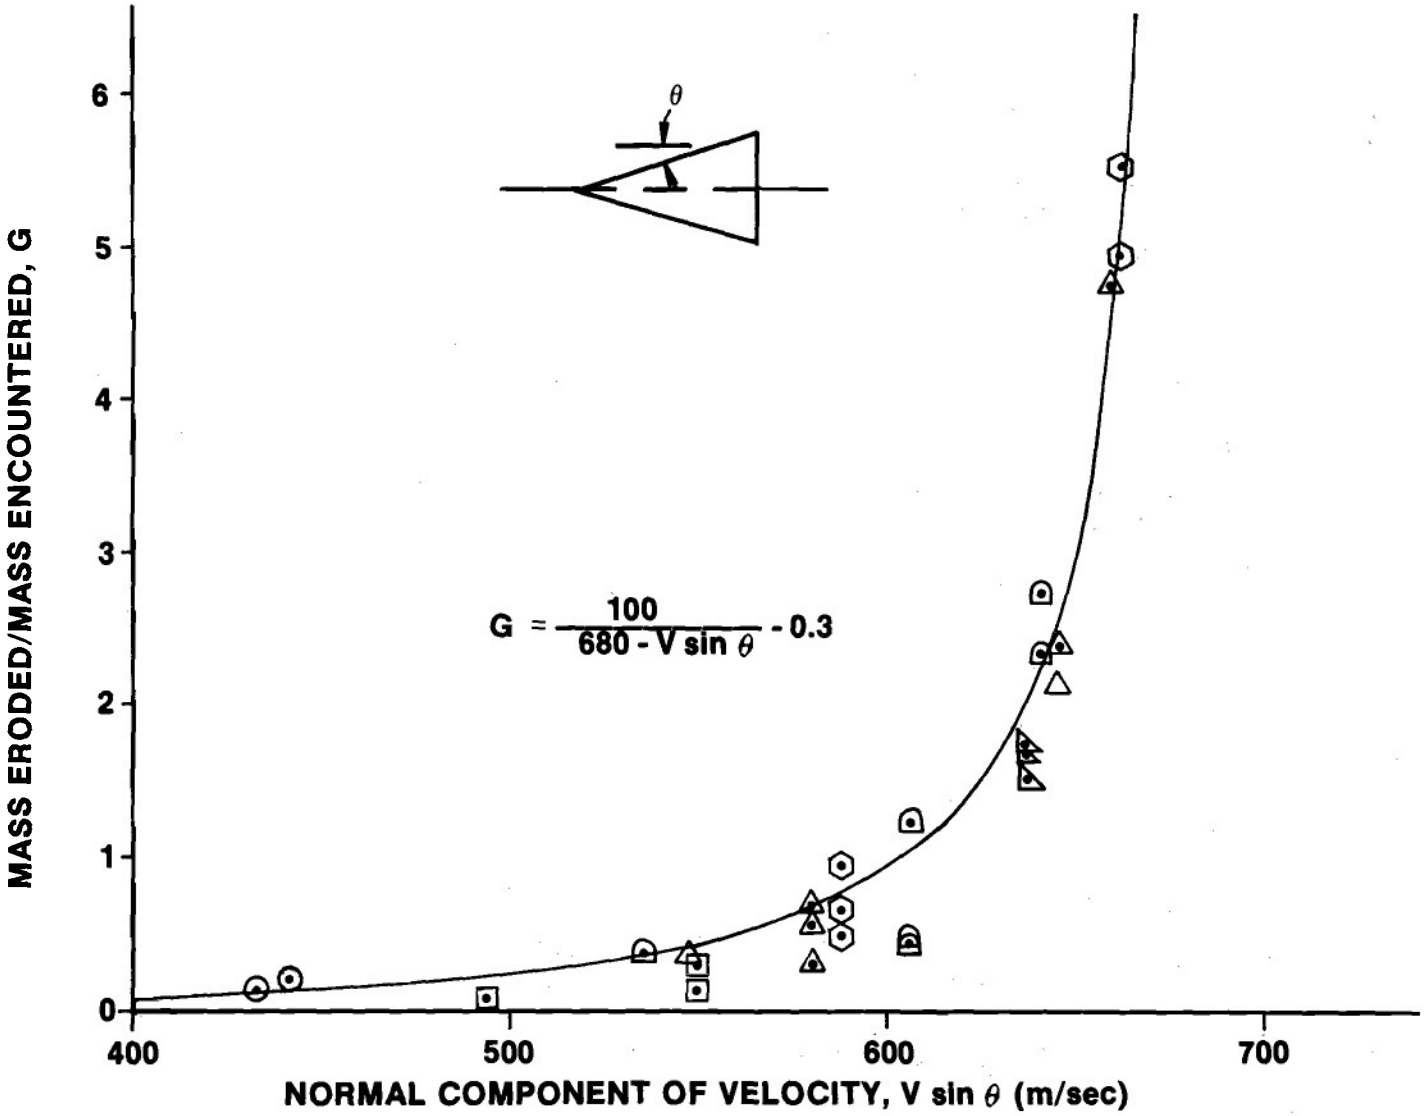
Figure 21. Rain erosion results for bare SCFS on supersonic sleds.

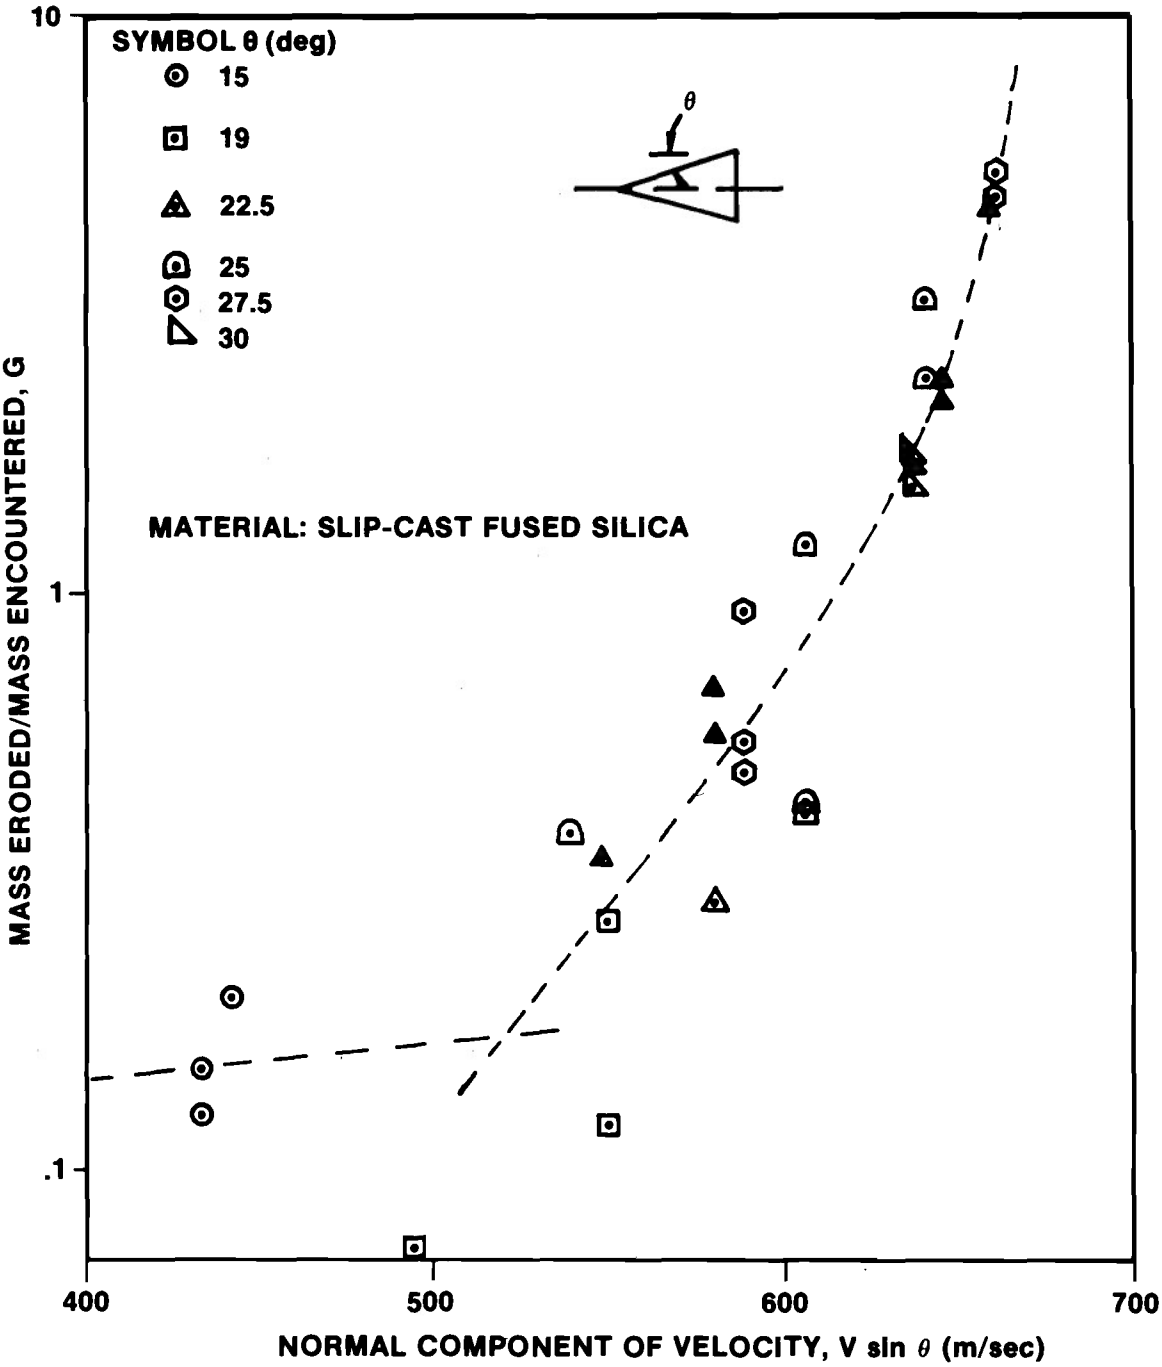
Figure 22. Rain erosion results for bare SCFS on supersonic sleds.

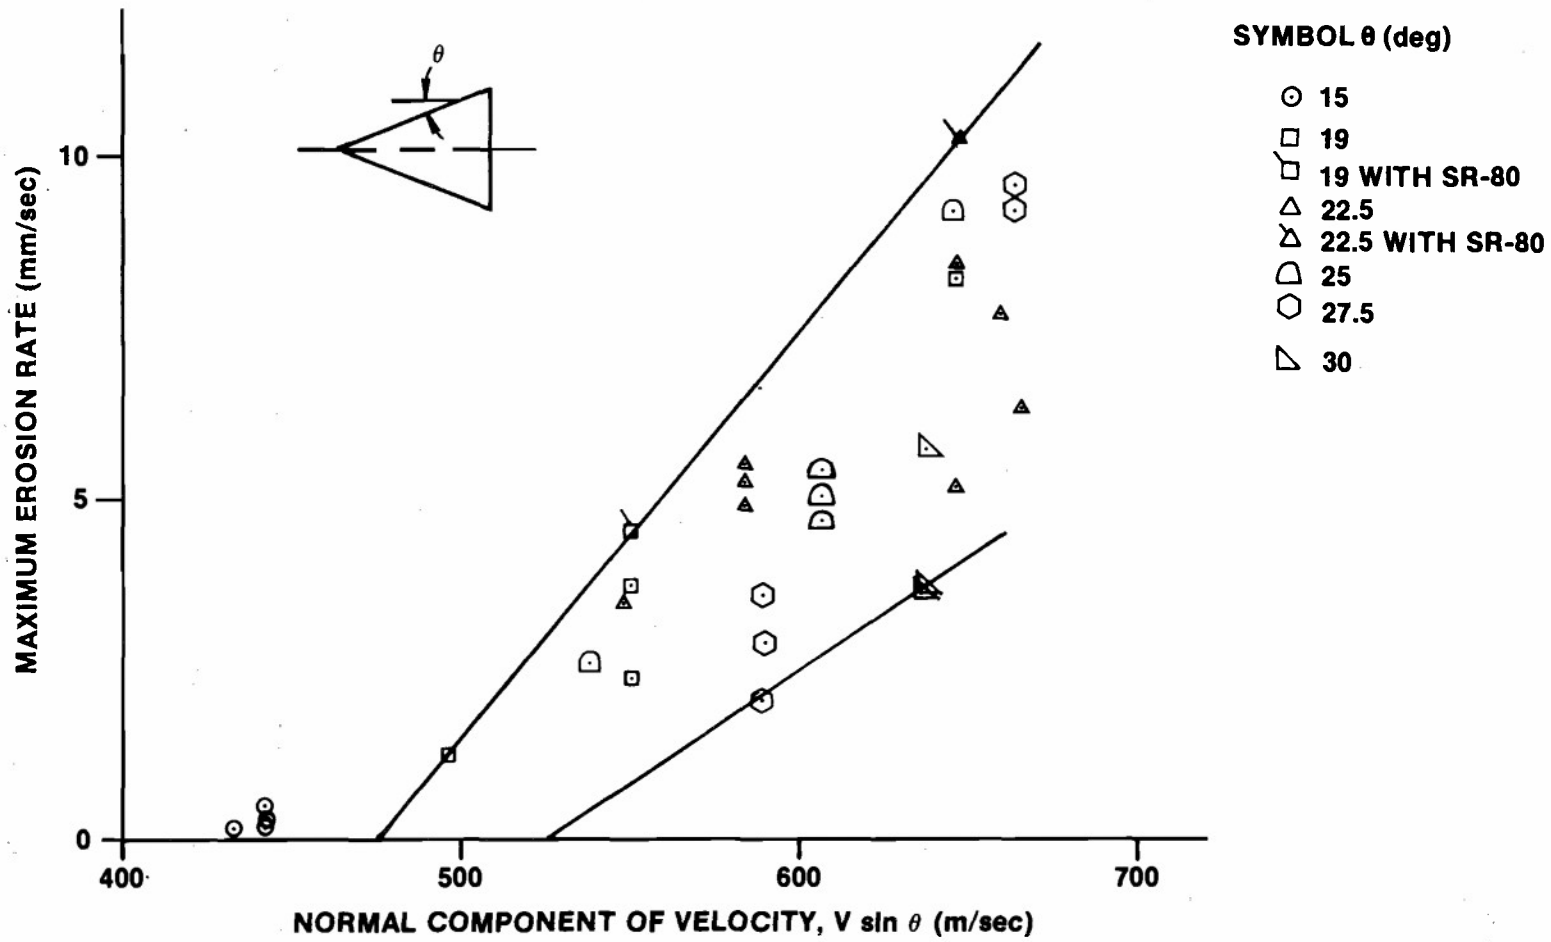
Figure 23. Measured maximum erosion rate of SCFS.
