U.S. ARMY MISSILE RESEARCH AND DEVELOPMENT COMMAND

TECHNICAL REPORT T-79-42

FINAL EVALUATION OF RAIN EROSION SLED TEST RESULTS AT MACH 3.7 TO 5.0 FOR SLIP-CAST FUSED SILICA RADOME STRUCTURES

6 March 1979

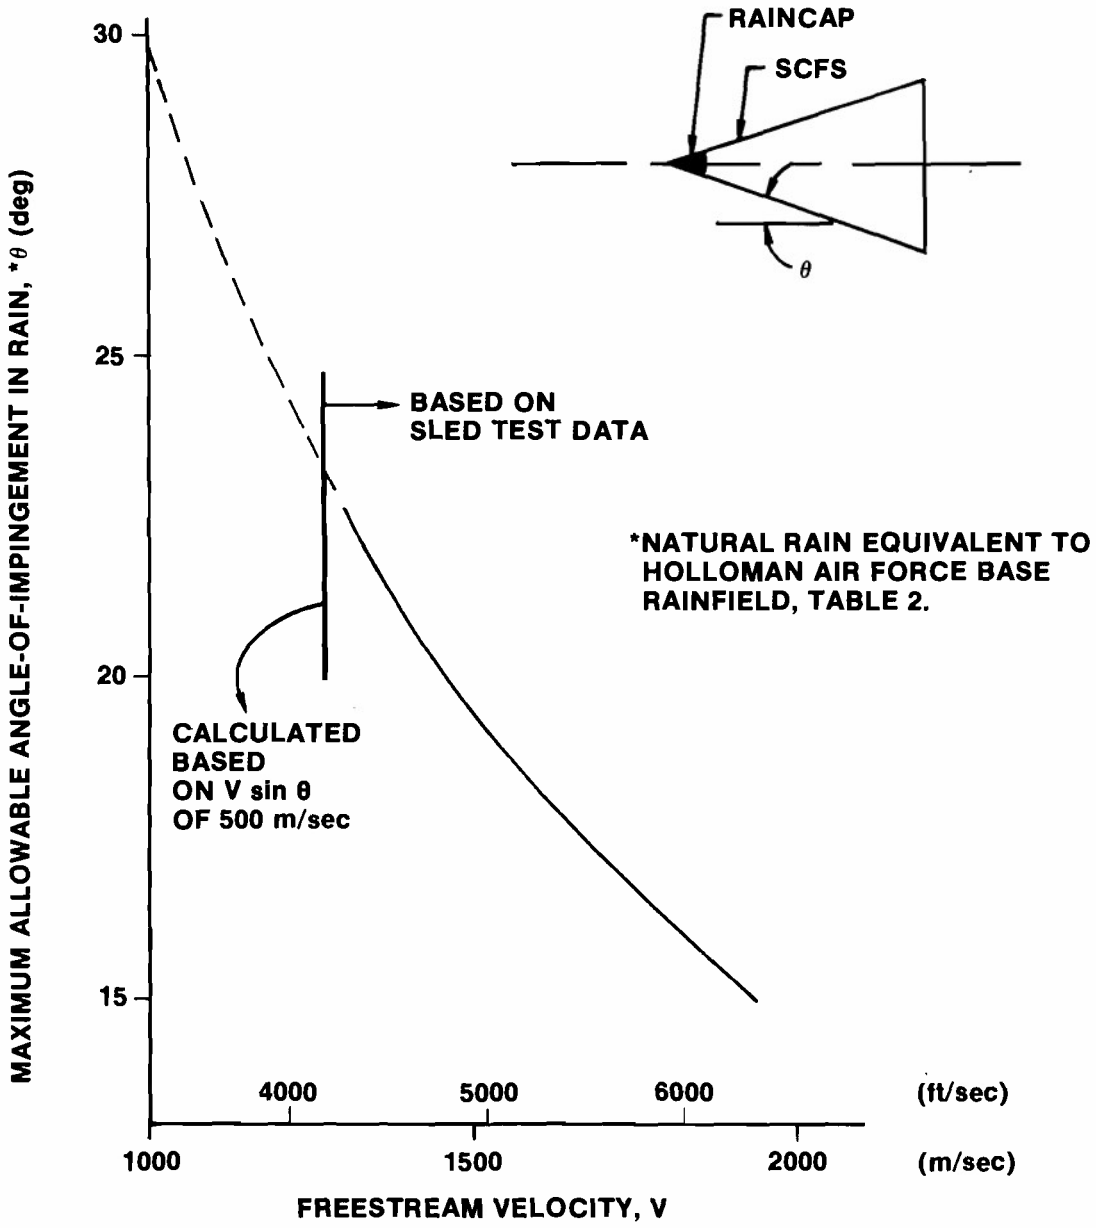
3. At a normal component of velocity above the threshold region, the risk of catastrophic failure of an SCFS radome is unacceptably high. Therefore, flight limitations in terms of velocity and impingement angles can be established for a specific rainfield.

Figure 24. Allowable angle-of-impingement for SCFS

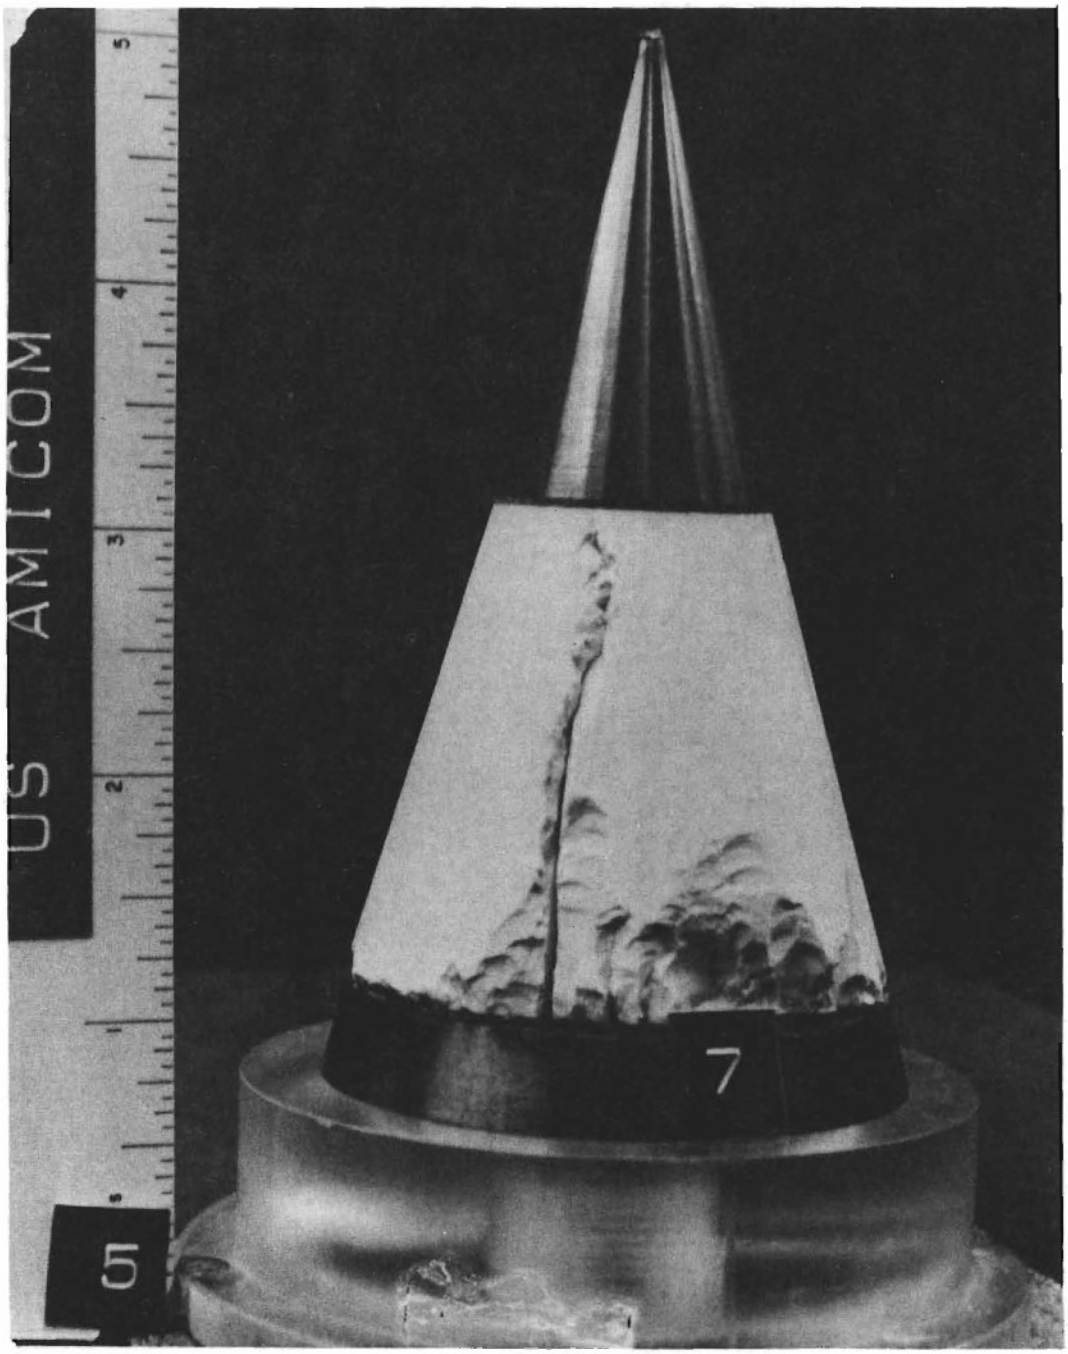
Figure B-1. Typical result from first test.

A maximum preload on each sample of approximately 6900 kPa (1000 lb/sq in.) was applied to prevent loss of a sample if cracking occurred. The vibration loads expected to be induced by the track were applied to the vehicle and sample subassemblies, without damage, in a laboratory simulation prior to the first sled test. However, during the first sled test severe chipping of the region near the sample base and longitudinal cracking occurred on most of the samples. There was evidence also, on the steel tip stud, that tip deflections had been severe. A typical result is shown in *Figure B-1.* These effects are attributed to a combination of sled vibration, rain impact and structural preload. To avoid these problems, modifications to the samples and to the mounting procedure were made. To eliminate chipping of the base edge of the samples a stress relief was provided to prevent raindrop impact on the base corner. To prevent longitudinal cracking of the samples the sample preload was reduced to one-half its value in the first test. The steel sleeve through which the tip stud passes was extended completely through the center of the sample to prevent tip vibration from imparting loads to the sample. Also, to reduce vibration and to distribute loads more uniformly to the samples, gaskets of silicone rubber were used instead of gaskets of asbestos phenolic at each end of each sample. Some of the samples provided by the High Temperature Materials Division of the Georgia Institute of Technology had invar washers bonded to each end of the samples.This concept was incorporated, but

asbestos phenolic was substituted for invar because of lower cost. As an additional aid in reducing the effects of sled vibration, epoxy versamid was used between the sample and sleeve. These modifications were successful and led to the final design and mounting arrangement shown in *Figure 14* which has been completely successful in eliminating failures due to spurious causes.
