BRADFORD CITY No. 5 DAM

(TUNA CREEK DAM)

NDI No. PA 00026

PHASE I INSPECTION REPORT

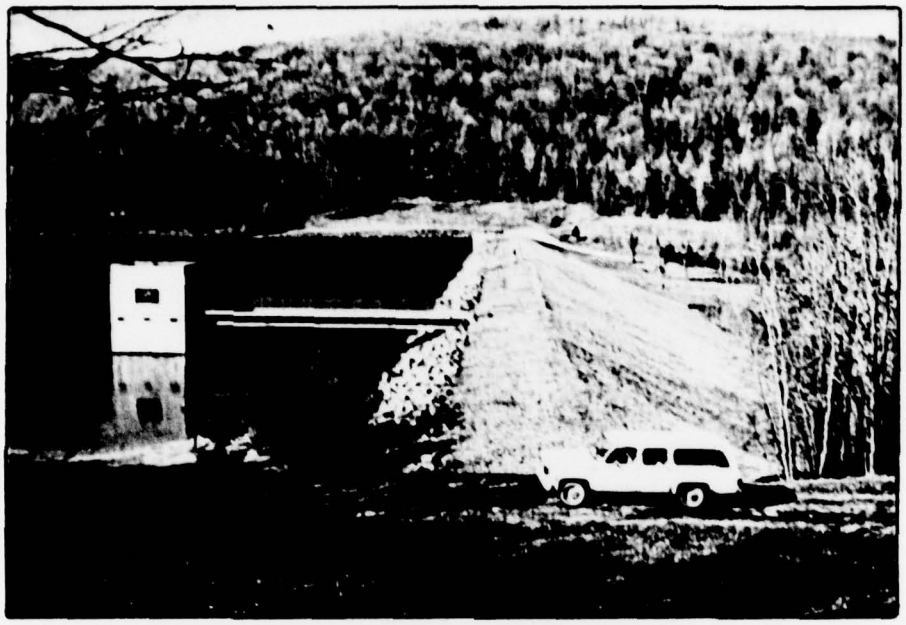
Overall View of Dam from Right Abutment
(Intake Tower and Walkway in Left of Photo)

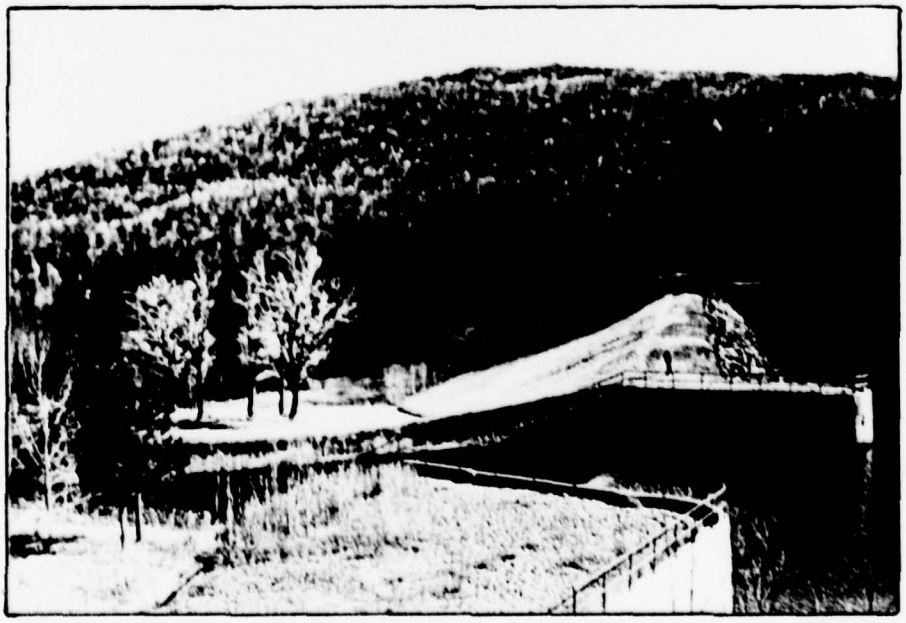
Overall View of Dam from Left Abutment
(Entrance to Ogee Spillway at Right-Bottom of Photo)

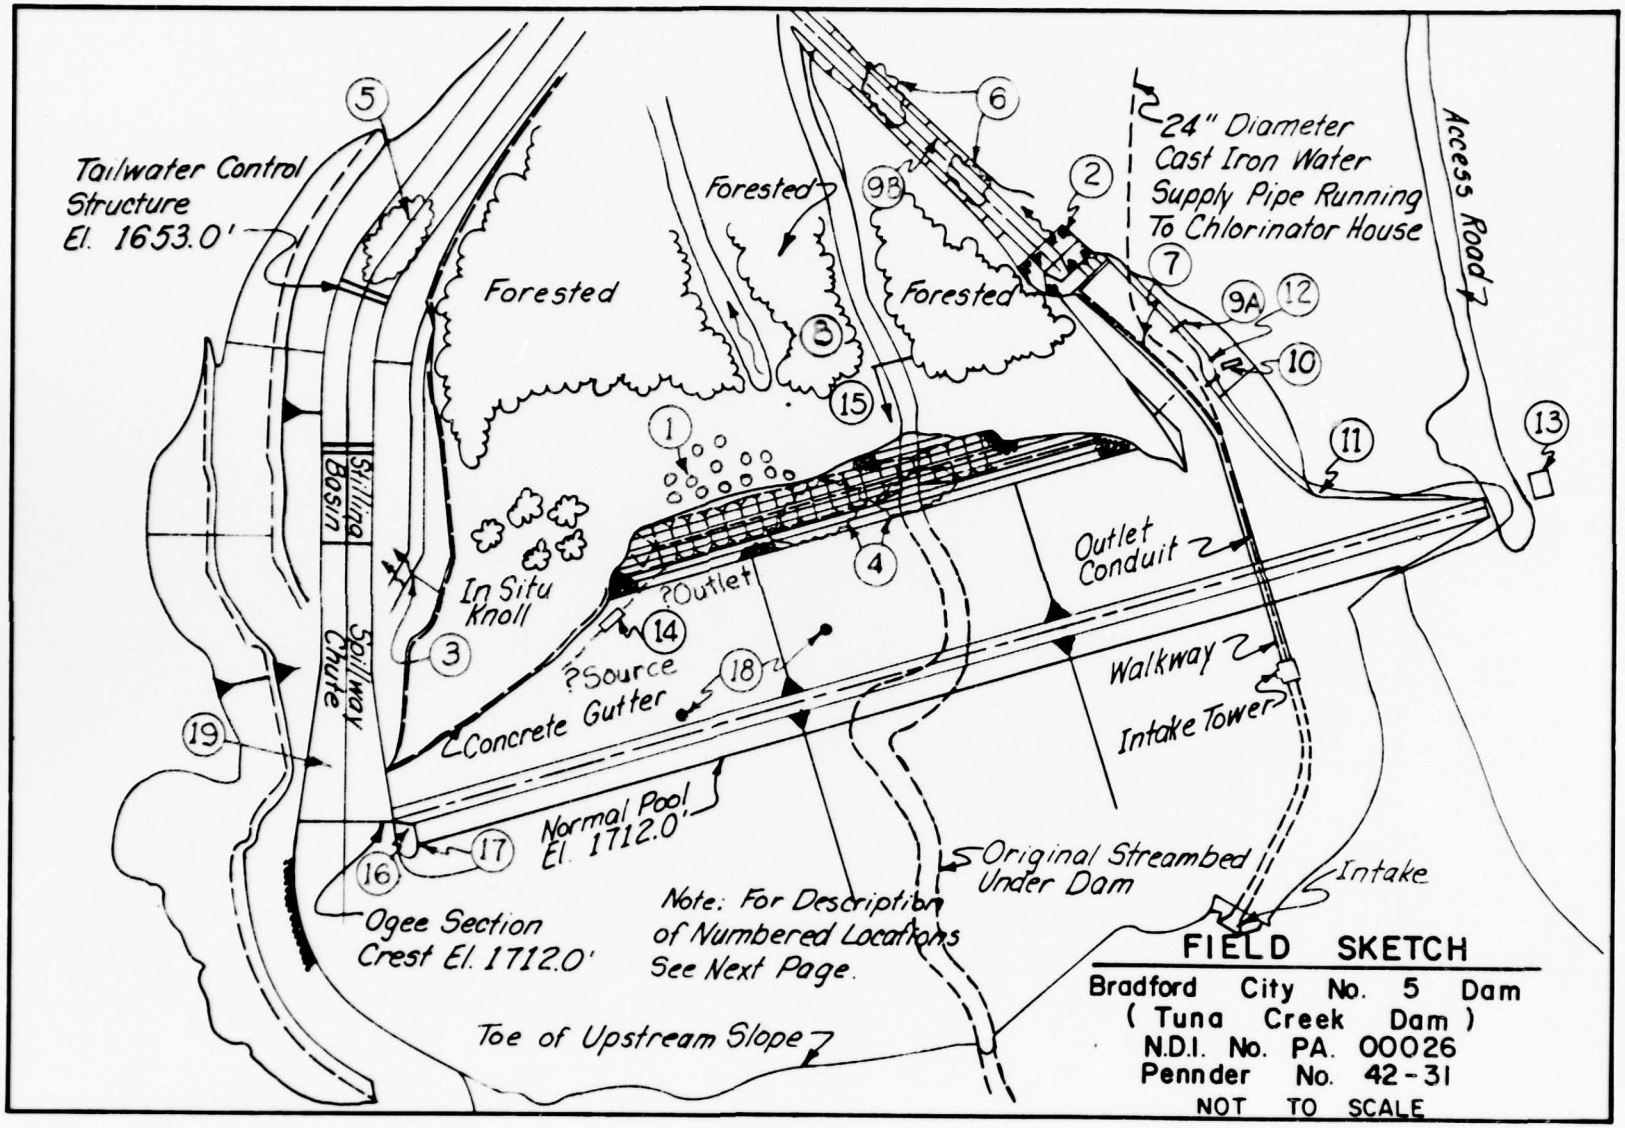
BRADFORD CITY No. 5 DAM (TUNA CREEK DAM)
NDI No. PA 00026, PennDER No. 42-31

Trees and shrubs were observed growing in the rock toe drain and the downstream area near the center of the dam. Also, several rodent holes were observed in the downstream embankment. The approximate locations of the trees and rodent holes are shown on the field sketch.

7. The soffit of the outlet conduit is spalled in several locations.

7) Repair the animal burrows in the embankment and establish a rodent control program.

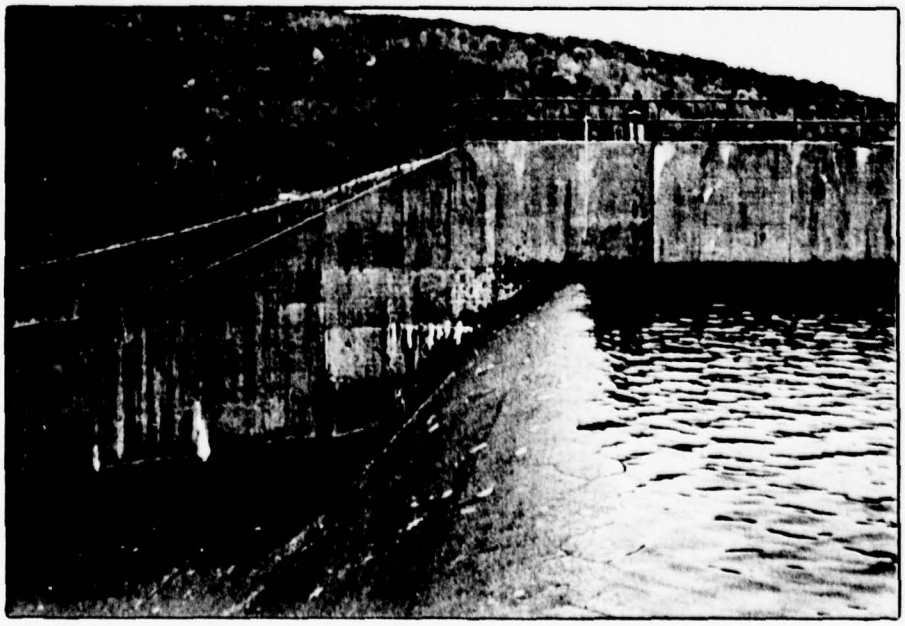
PHOTO 2. Detail View of Ogee Section at Spillway and Right Spillway Training Wall

8) Where necessary, replace the joint filler in the spillway and other appurtenant structures.

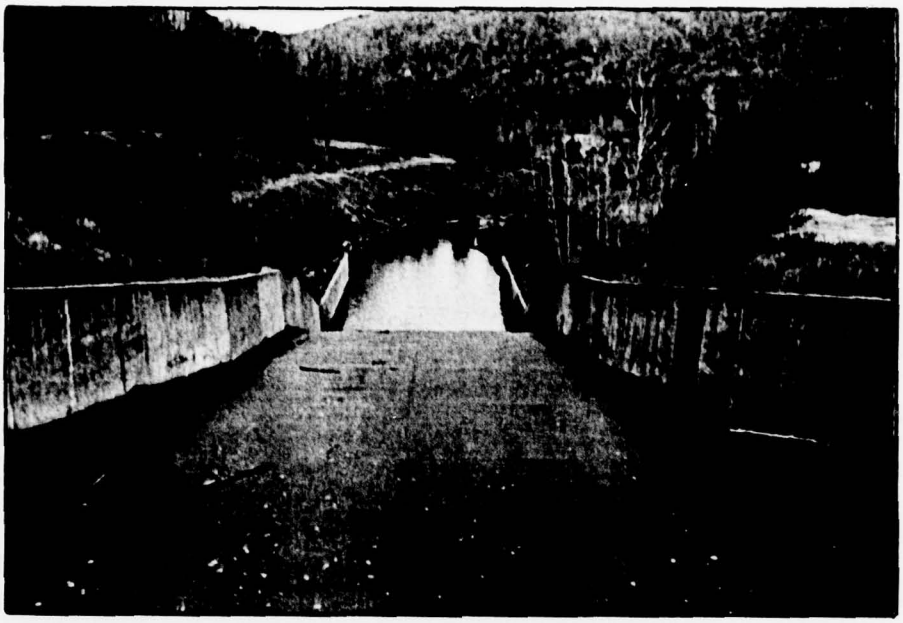
PHOTO 3. View Looking Downstream at Stilling Basin and Discharge Channel

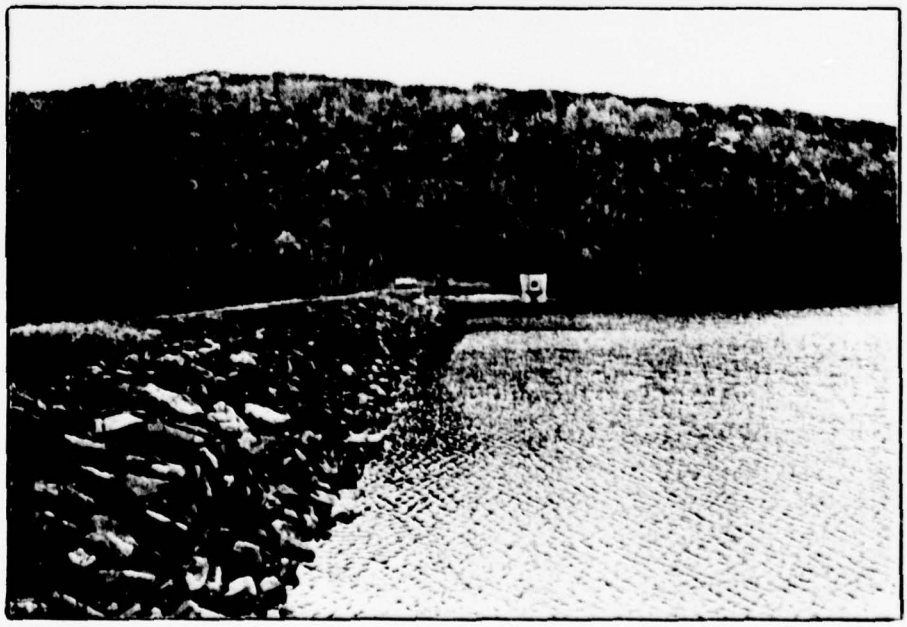
PHOTO 4. View of Upstream Slope and Riprap Protection

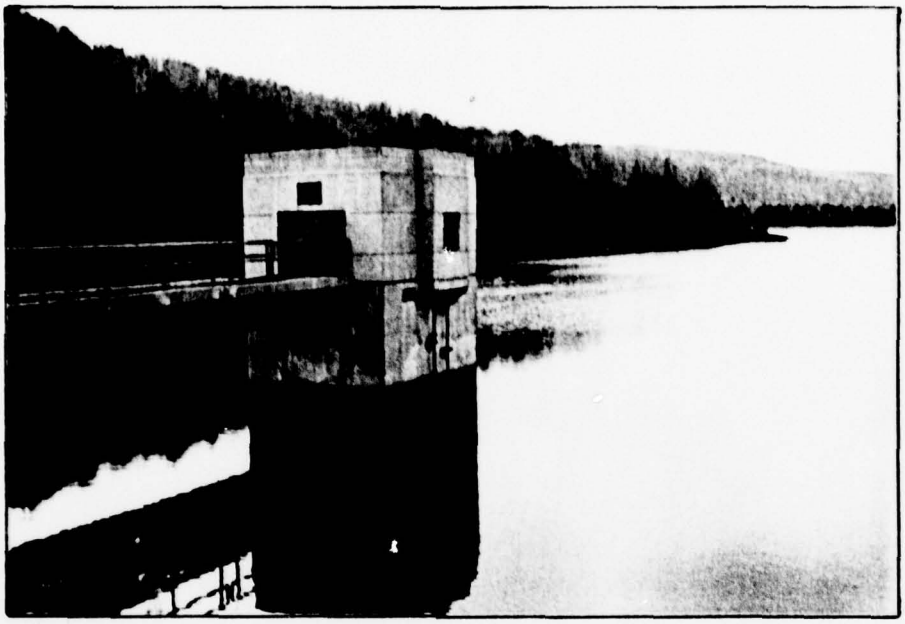
PHOTO 5. View of Intake Tower and Walkway

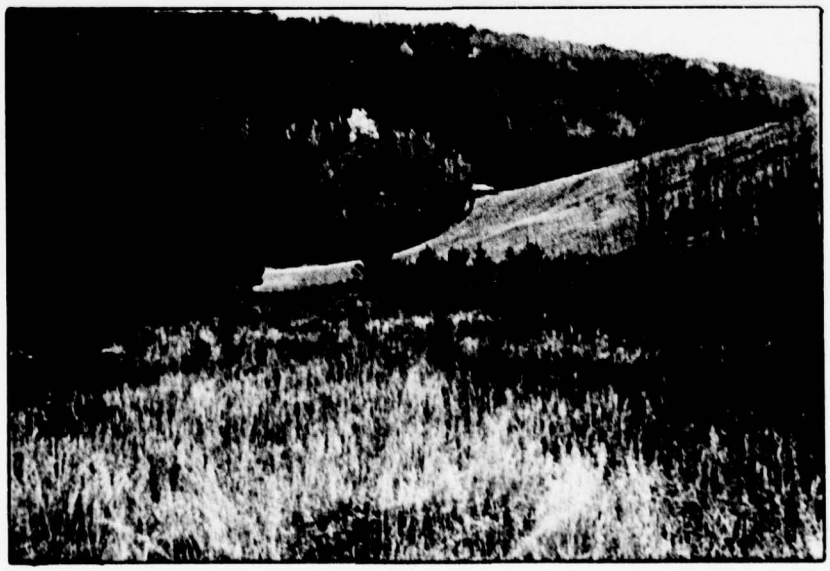
PHOTO 8. View of Rock Drain at Toe of Downstream Slope

location of the drain outlet noted in the correspondence could not be found.
