GALLO DAM

NDS I.D. No. PA - 00233

PHASE I INSPECTION REPORT
NATIONAL DAM INSPECTION PROGRAM

SEPTEMBER 1979

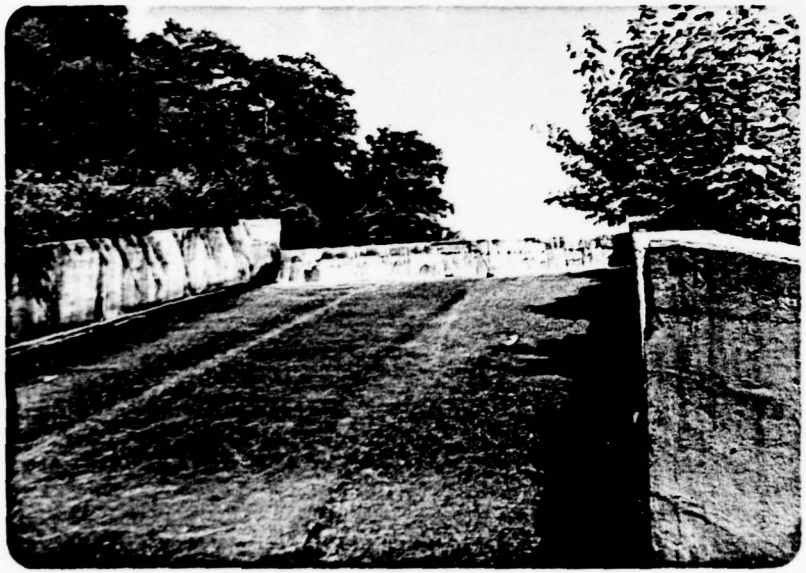
1. Spillway. The visual inspection indicated that the spillway is in fair condition. Much of the concrete surfaces exhibit scaling, and the wingwalls contain hairline cracks and efflorescence (See Photos 1 and 3).

A portion of the lower end of the spillway was dislodged in the past, necessitating some remedial work (See Photograph 4). Also, the weir crest was re-shaped and raised in 1969 by approximately 2 feet, while approximately 6 inches of concrete was added to the spillway weir sidewalls (See Photograph 3). The modification has resulted in the reduction of spillway capacity. The spillway crest addition is cracked and somewhat rotated (See Photograph 3), possibly from ice pressure.

1. Spillway. The spillway was modified in 1969 when two feet of concrete was added to the weir crest in order to provide additional reservoir depth and surface area for recreational use. This spillway cap has since cracked and rotated somewhat (see Photograph 3). Since the cap only represents the upper two feet of the weir crest, the situation is not considered critical; however, it should be noted that the weir was also reshaped and the spillway sidewalls were not raised accordingly when the crest was raised, both of which have led to a reduction in the actual capacity of the spillway.

PHOTOGRAPH 3 — View of the spillway from near the plunge pool. Note concrete caps that were added to the weir crest and left sidewall (also to the right sidewall). Also note the cracking of the weir, and the apparent rotation of the weir cap.

PHOTOGRAPH 4 — View of the downstream area as seen from the spillway crest. Note that a portion of the downstream terminus of the spillway has spalled off. Some minor cracking and efflorescence is visible on the spillway sidewalls.

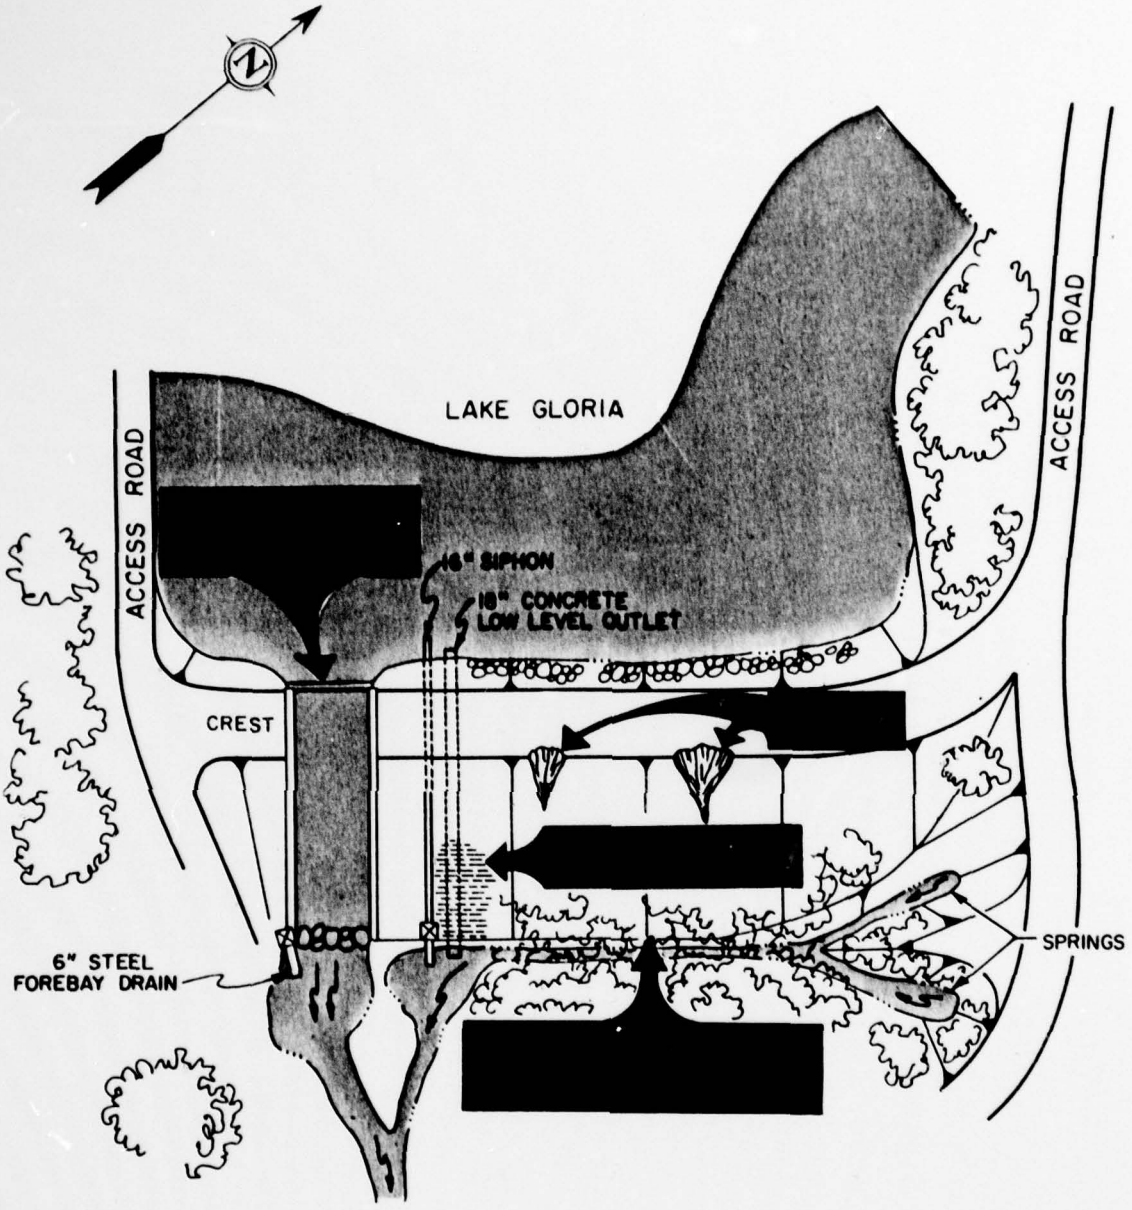
FIGURE 1 - GALLO DAM

b. Embankment. Observations made during the visual inspection indicate the embankment to be in fair condition. Deficiencies include a heavily overgrown and brush-strewn downstream face, an uneven downstream slope with erosion ditches at several locations (See Figure 1), and swamp-like conditions immediately downstream of the embankment toe.

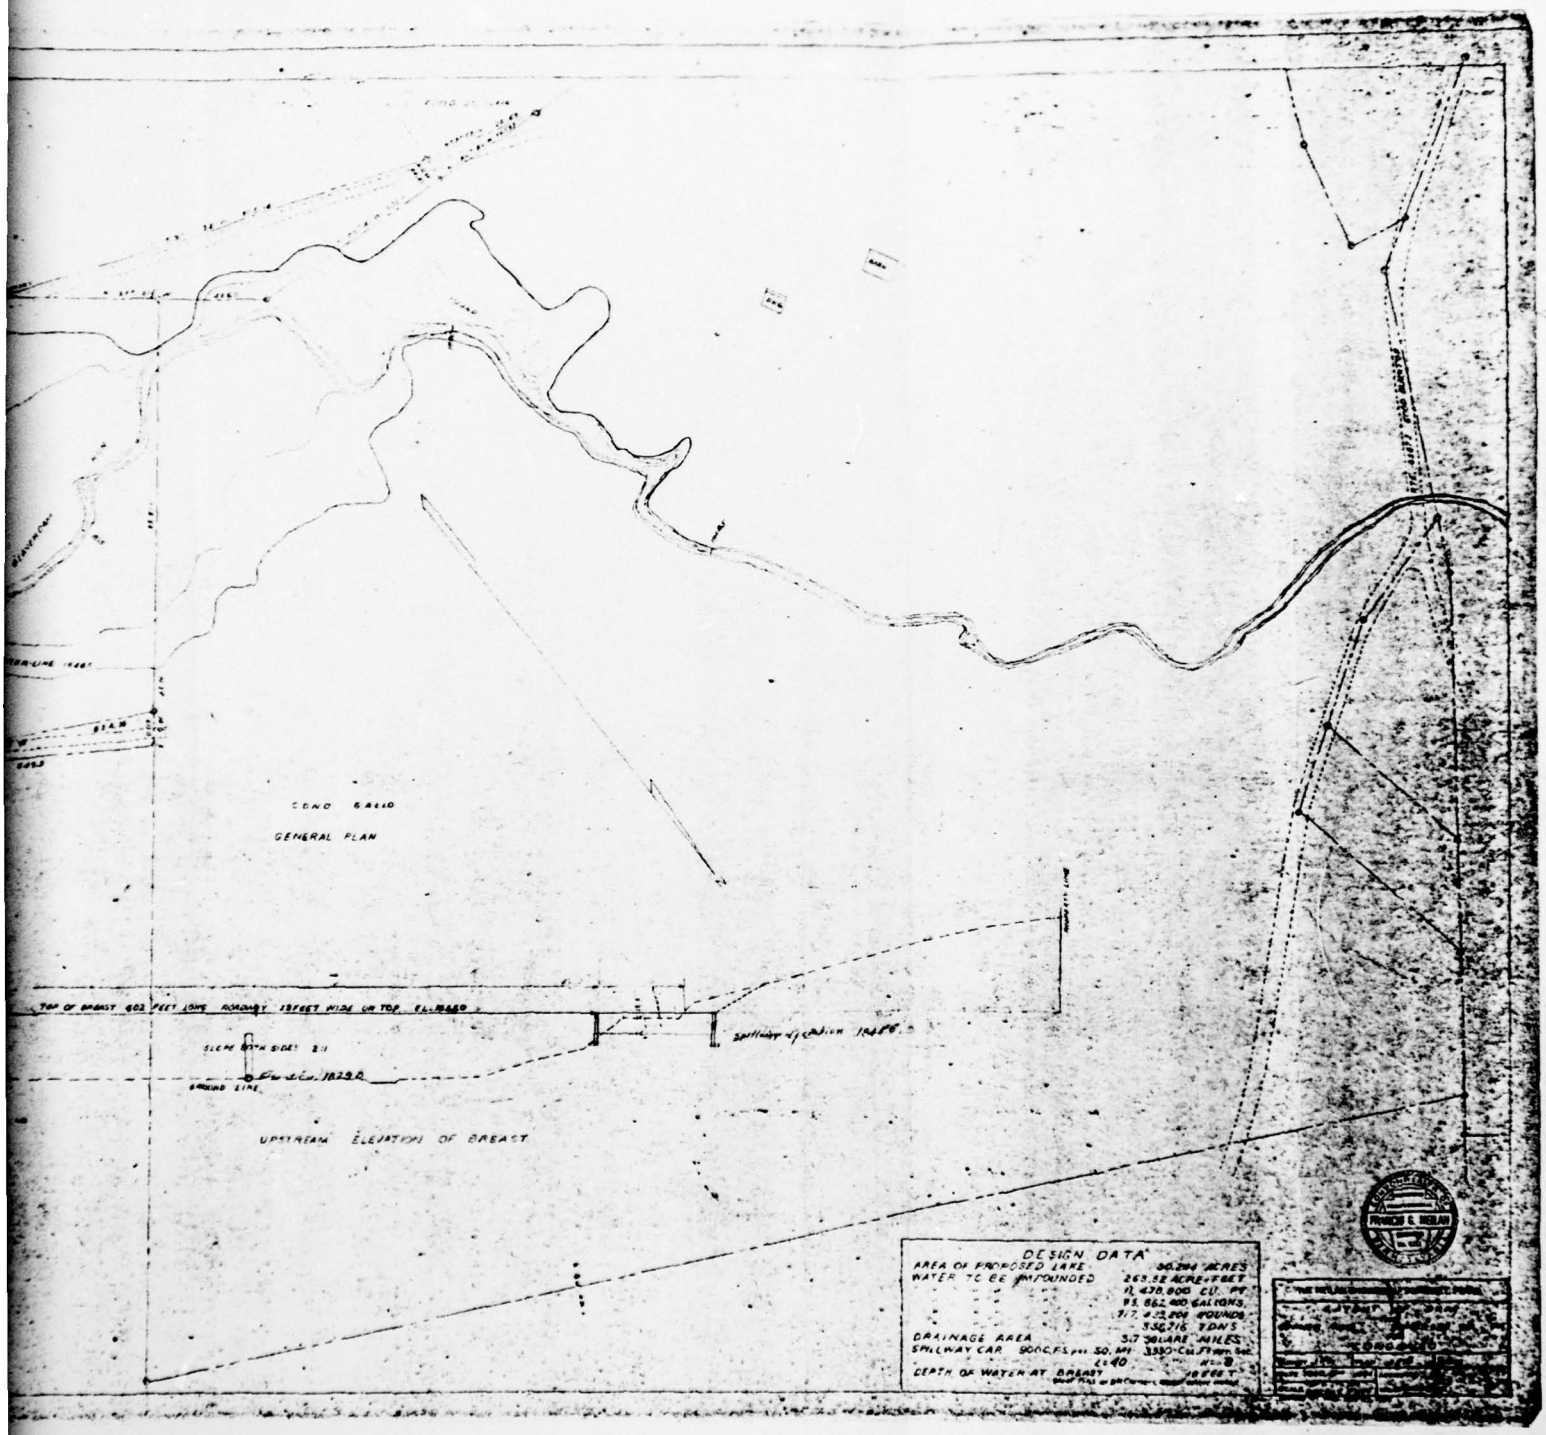
FIGURE 2

1. Change in the inclination of the spillway with respect to the dam axis as shown on design drawing (Figure 2).
