SUSQUEHANNA RIVER BASIN

MARSHWOOD DAM

NDI ID No. PA-00365
DER ID No. 35-88

(6) PHASE I INSPECTION REPORT

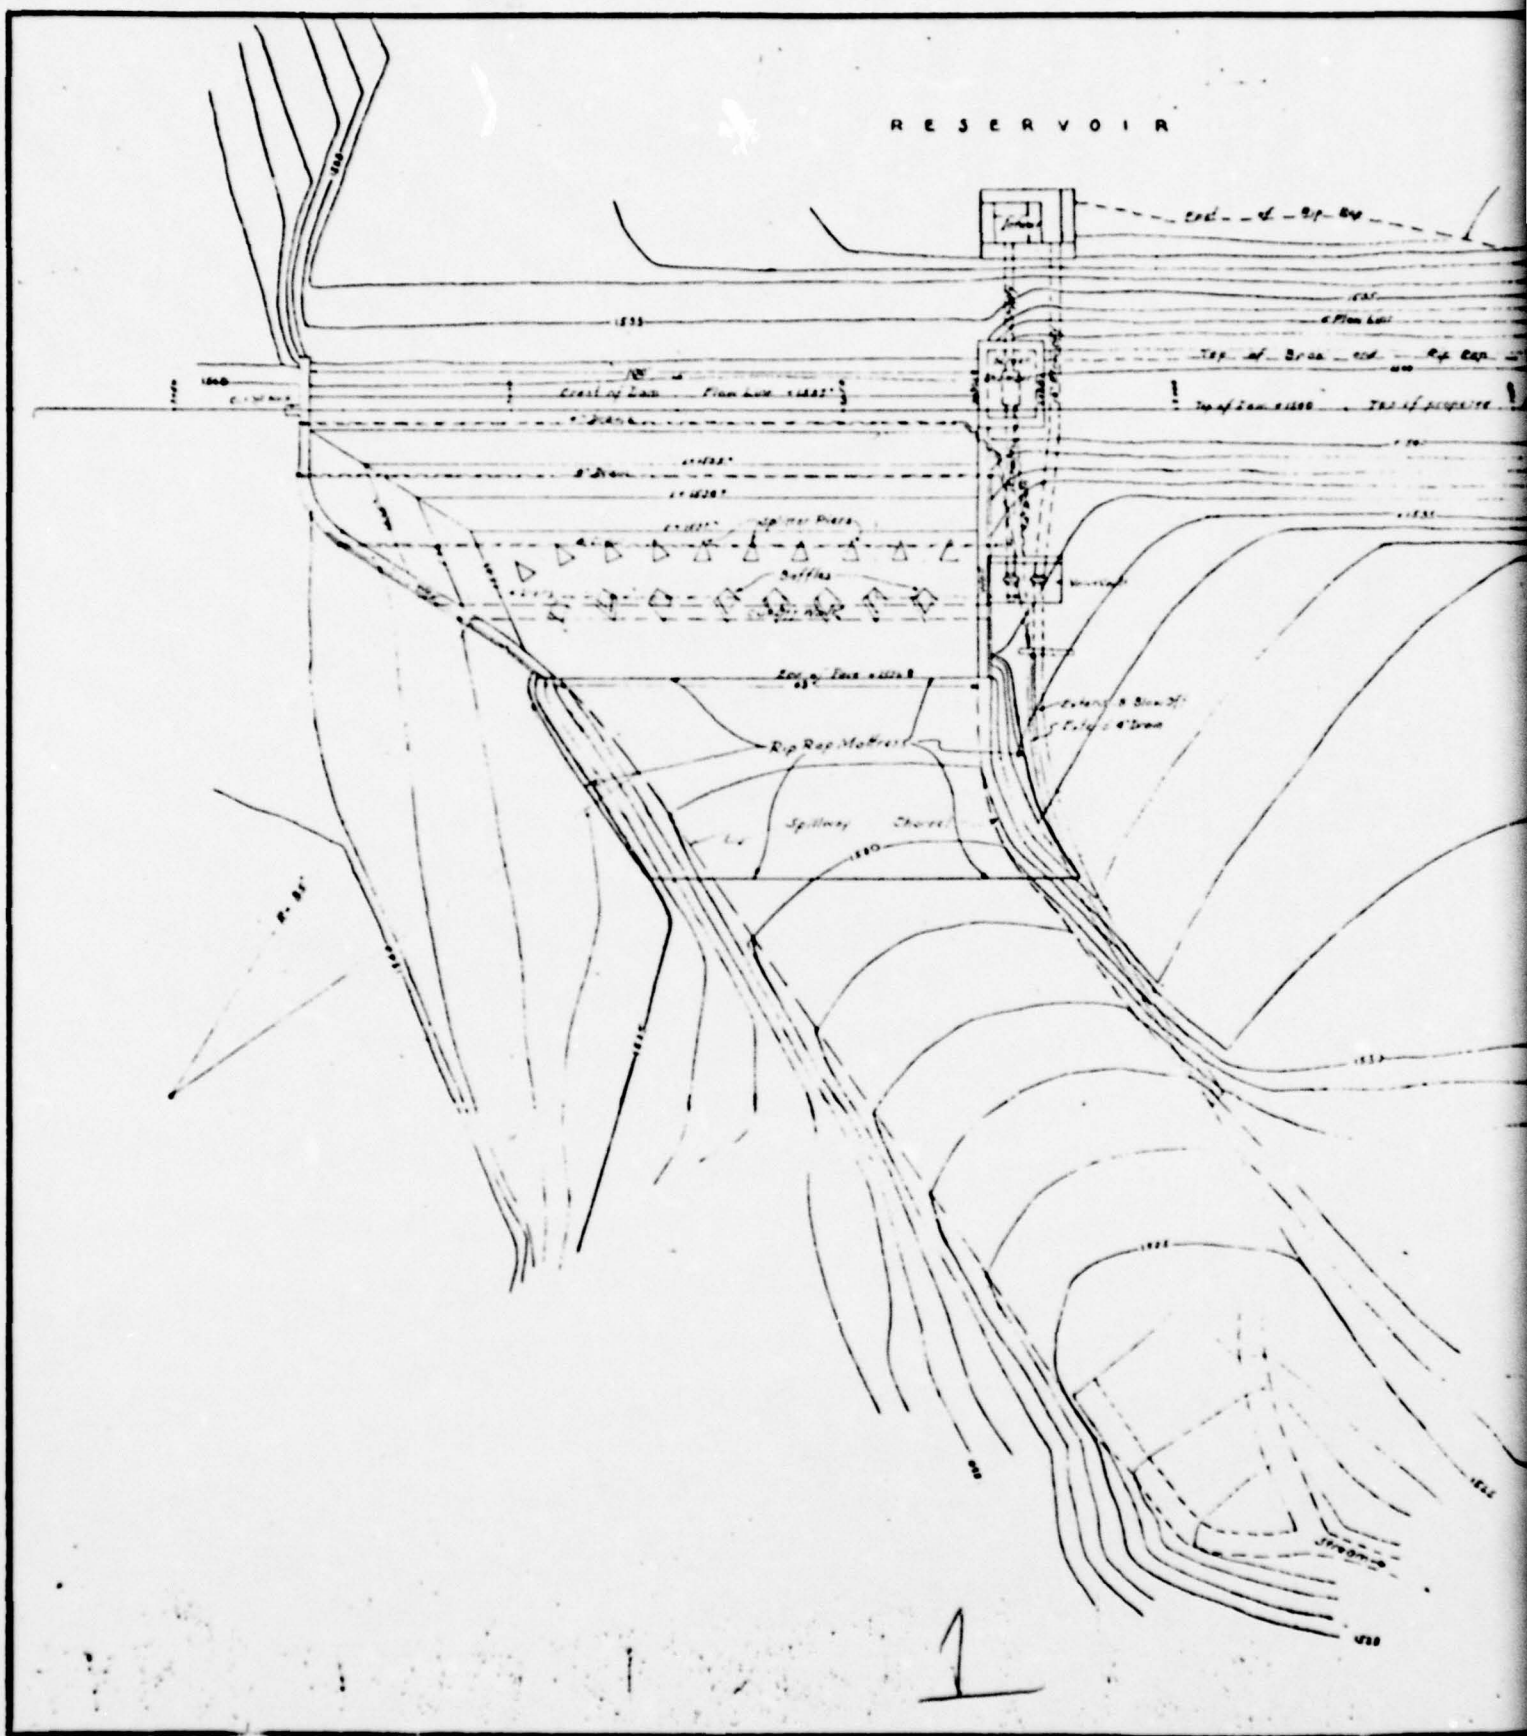
FEBUARY 1979 PLATE 2

SOUTH EMBANKMENT
AND SPILLWAY

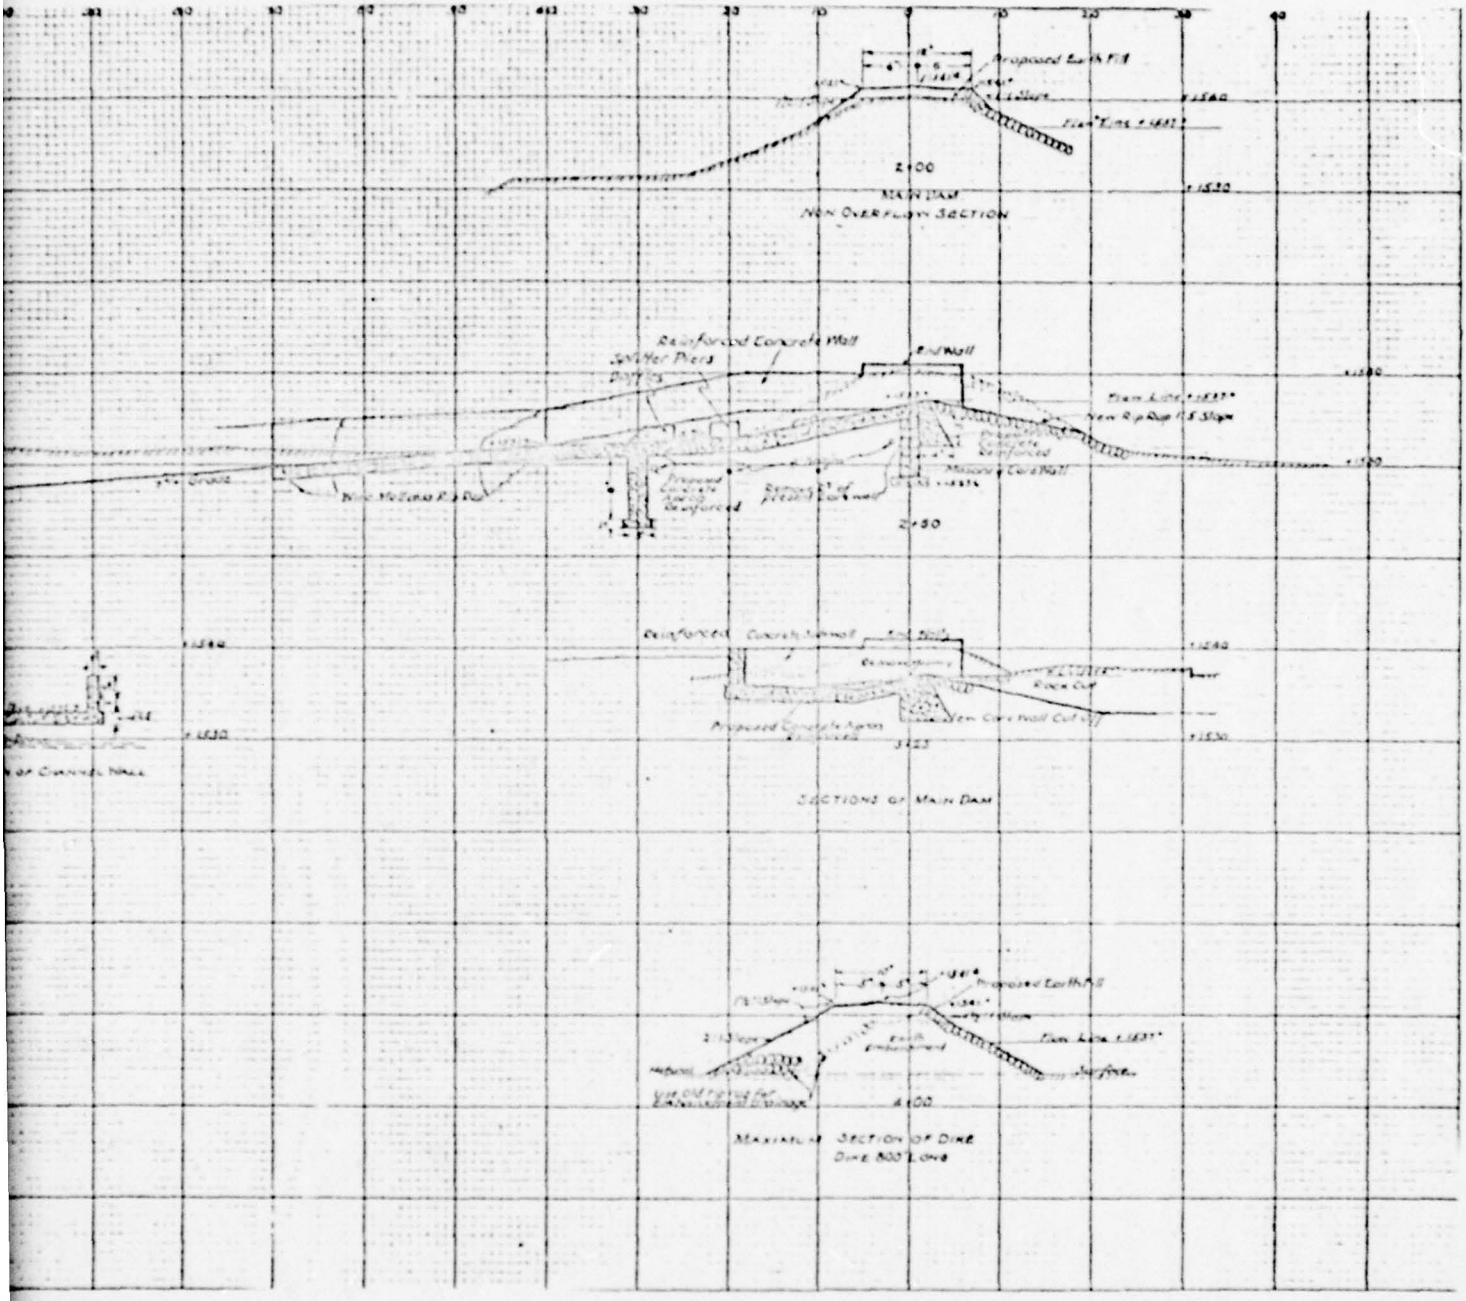
PLATE 3

Plate 3 was prepared for the 1946 modification to the dam. Although no core-wall is shown on the typical embankment sections, it was probably omitted from the drawings.

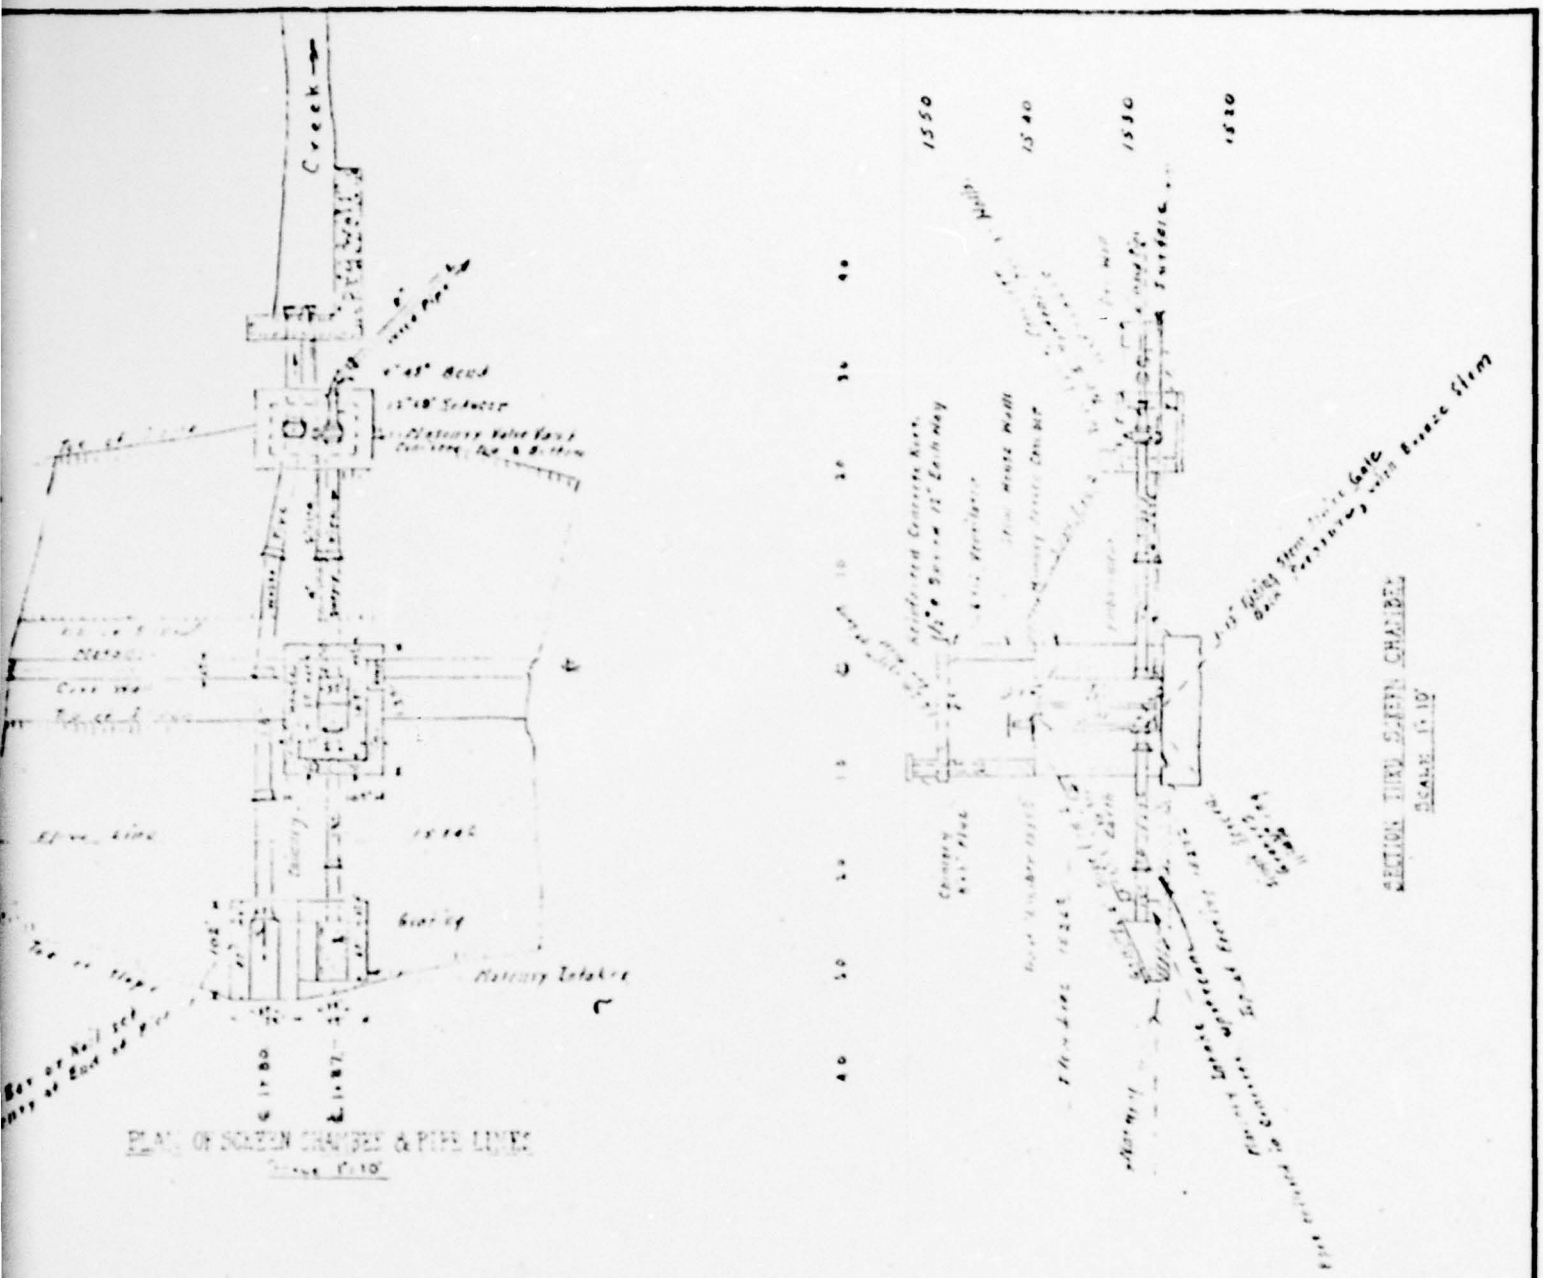
FEBUARY 1979 PLATE 4

The outlet works is shown on Plate 4. This plate was prepared before the outlet works pipe was extended in 1946, as shown on Plate 2.

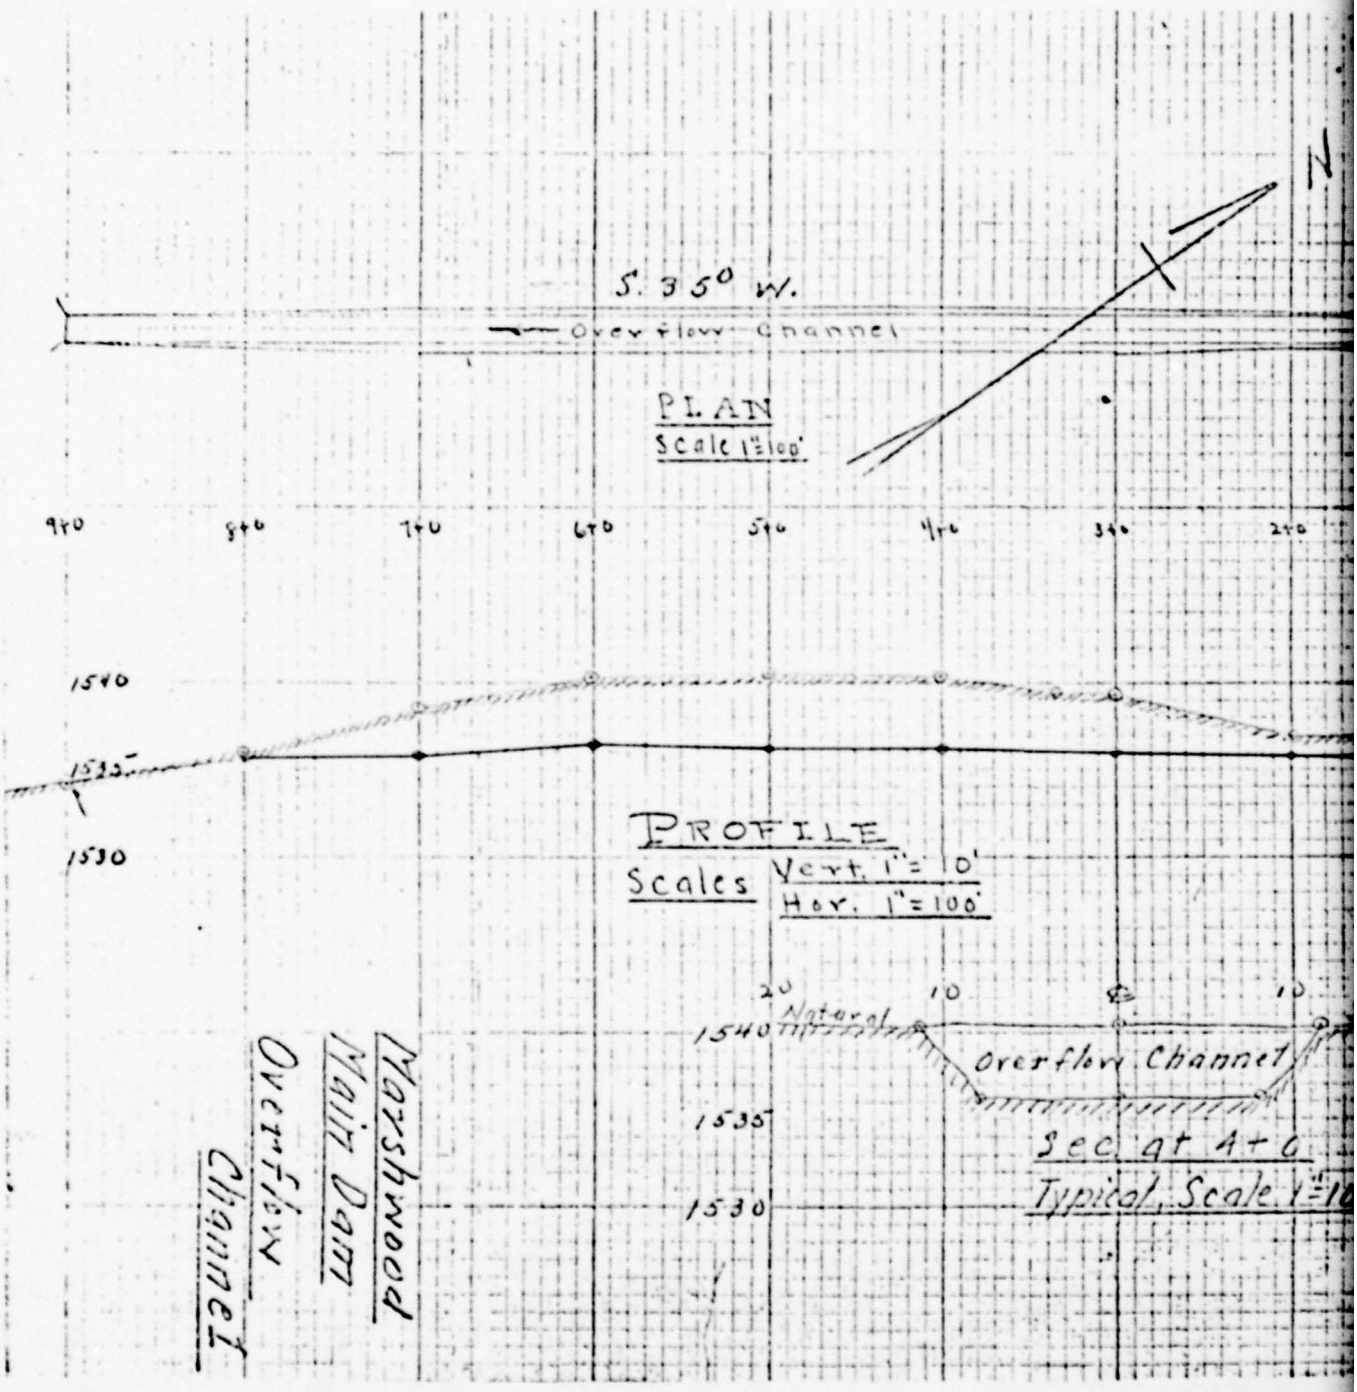
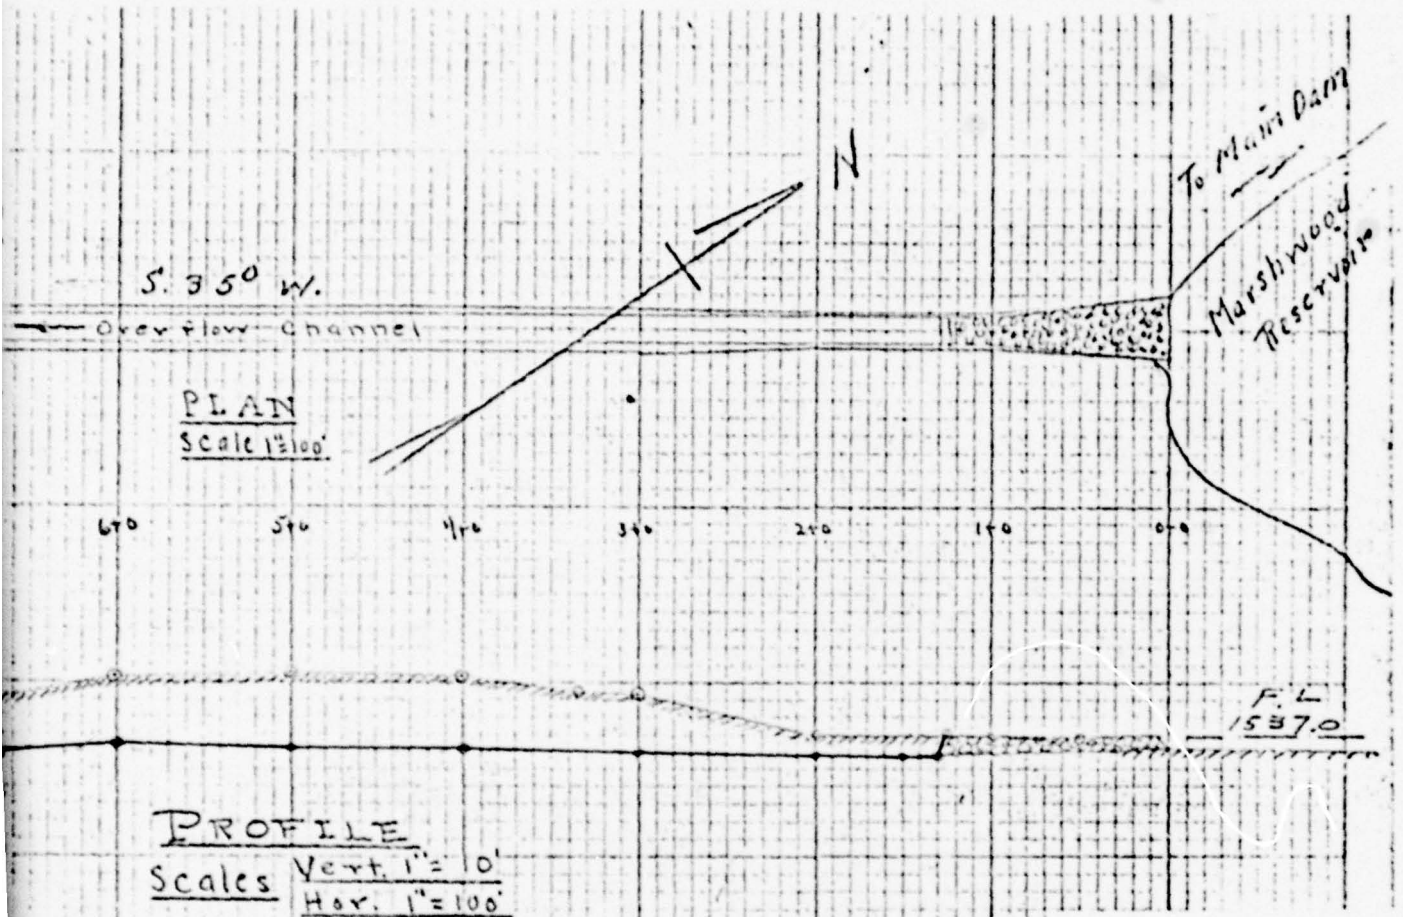
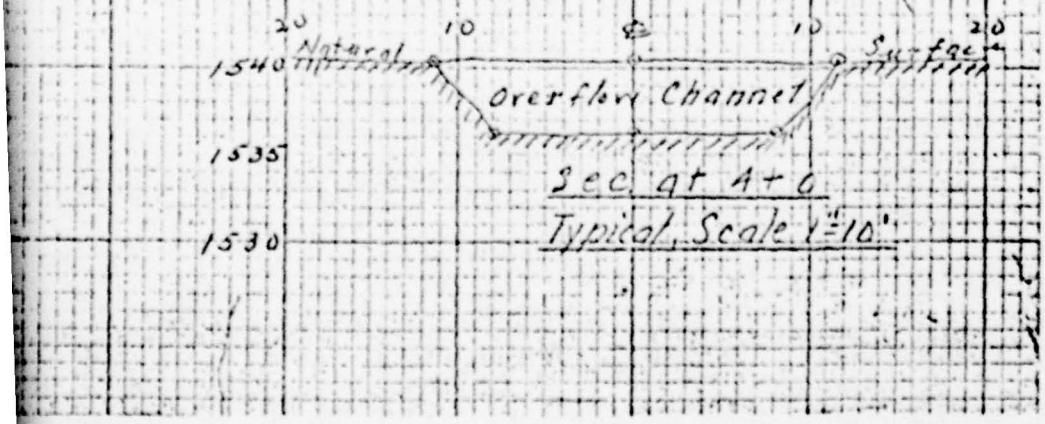
PHASE I INSPECTION REPORT
NATIONAL DAM INSPECTION PROGRAM
MARSHWOOD DAM
PENNSYLVANIA GAS AND WATER COMPANY
AUXILIARY SPILLWAY
FEBUARY 1979 PLATE 6

The main spillway is shown on Plates 2 and 3 and on Photographs A, B, C, and D. The auxiliary spillway is shown on Plate 6 and on Photograph F. There is conflicting data concerning this spillway, as discussed in Section 5.

The conditions at the auxiliary spillway are of concern. The approach area and the banks of the canal are overgrown to an extent that would significantly decrease the discharge capacity. Although the banks of the canal are earthen, the low velocities in this type of spillway should not be an erosion hazard. The design information available for review and measurements obtained for this inspection indicate that the bottom width of the auxiliary spillway is 25 feet. Plate 6 indicates that the bottom width is 16 feet. Although the capacity must remain as uncertain, it has been computed using a 25-foot bottom width. The Owner stated that an in-house diving capability and various size plugs are available to provide upstream closure for the outlet works. This is deemed adequate, if the proper size plug is readily available.
