VALLEY—HI EAGLE LAKE DAM

NDS I.D. No. PA - 00186

PHASE I INSPECTION REPORT
NATIONAL DAM INSPECTION PROGRAM

SEPTEMBER 1979

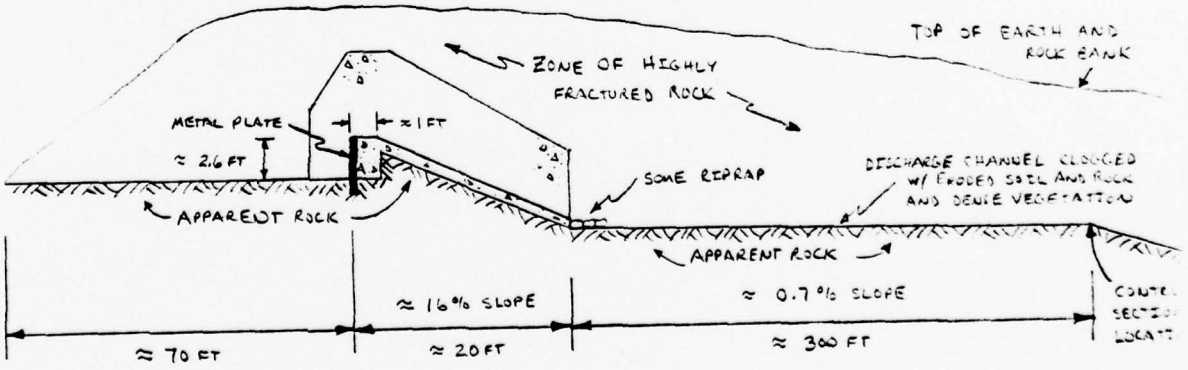
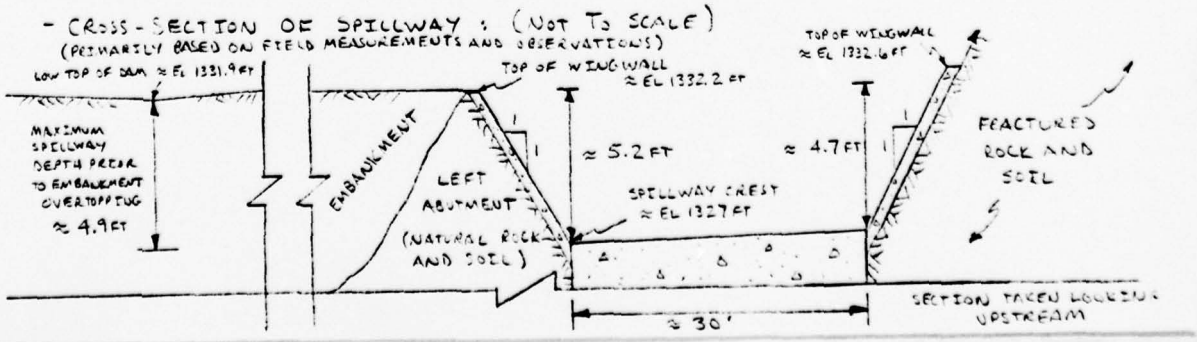
- PROFILE OF SPILLWAY : (NOT TO SCALE)
(PRIMARILY BASED ON FIELD MEASUREMENTS AND OBSERVATIONS)

- CROSS-SECTION OF SPILLWAY : (NOT TO SCALE)
(PRIMARILY BASED ON FIELD MEASUREMENTS AND OBSERVATIONS)

- SPILLWAY IS A FREE OVERFALL, CONCRETE, TRAPEZOIDAL-SHAPED WEIR STRUCTURE WHICH DISCHARGES INTO A RELATIVELY FLAT OPEN CHANNEL. THE DISCHARGE CHANNEL IS PRESENTLY CLOGGED WITH FALLEN ROCK AND SOIL FROM THE UNPROTECTED SIDEWALLS, AND BY DENSE VEGETATION GROWING WITHIN THE CHANNEL. THUS, THE CHANNEL HAS LESS OF A CONVEYANCE CAPACITY, WHICH WHEN COUPLED WITH THE RELATIVELY FLAT CHANNEL SLOPE CAN LEAD TO ADVERSE TAILWATER CONDITIONS ON THE WEIR OUTFLOWS. WEIR DISCHARGES CAN BE DEFINED BY THE RELATIONSHIP:

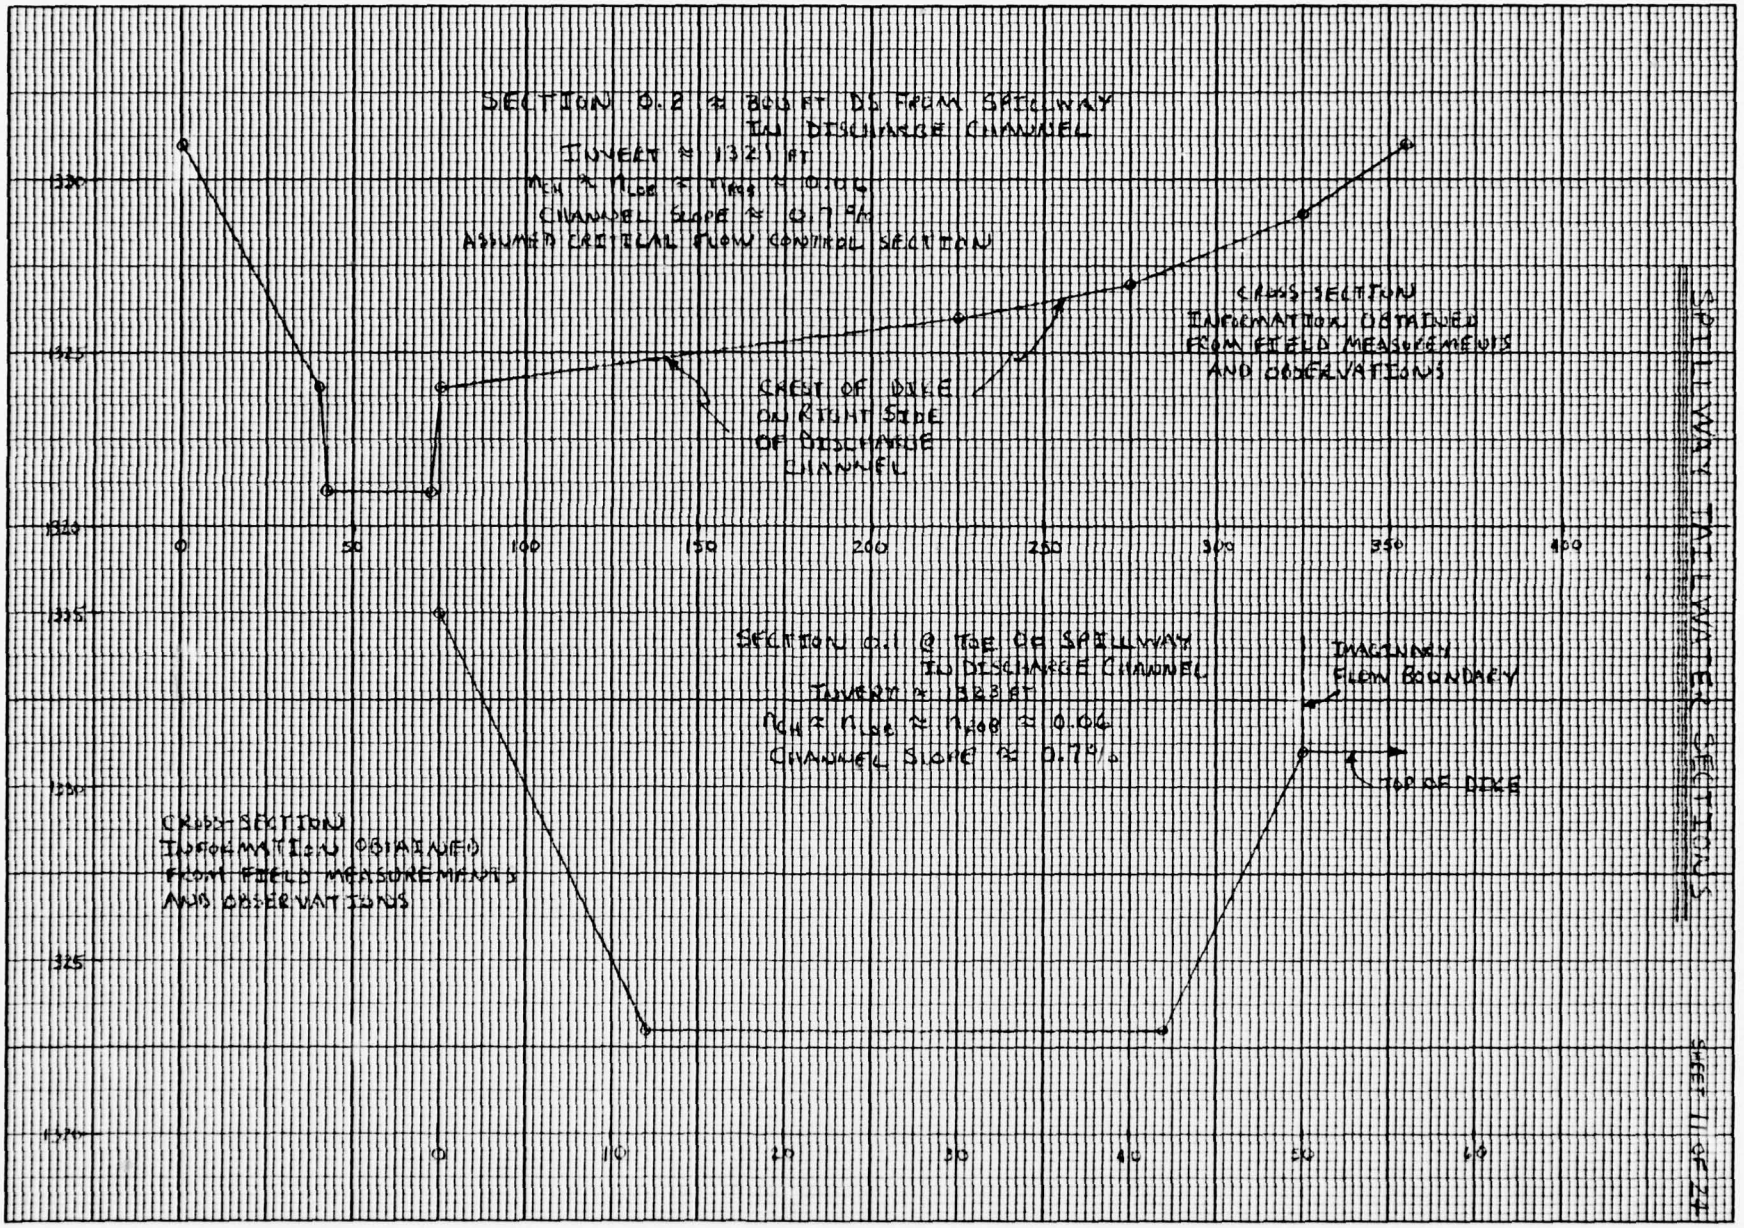
DUE TO THE HEIGHT OF THE SPILLWAY CREST ABOVE THE DISCHARGE CHANNEL (ONLY ≈ 4 FT), AND TO THE VERY FLAT GRADIENT OF THE DISCHARGE CHANNEL (≈ 0.7%), A BACKWATER CURVE WAS COMPUTED TO ASCERTAIN THE EFFECTS OF TAILWATER ON SPILLWAY DISCHARGES. THE BACKWATER CURVE WAS CALCULATED VIA THE HEC-2 WATER SURFACE PROFILE COMPUTER PROGRAM*. HEC-2 COMPUTES BACKWATER BY THE STANDARD STEP METHOD (REF 7, PG 274-280), BASED ON CHANNEL CROSS-SECTION INFORMATION. THE SPECIFIC CROSS-SECTION DATA USED IS GIVEN ON SHEET 11. THE COMPUTATIONS WERE INITIATED AT AN APPARENT CONTROL SECTION, LOCATED ABOUT 300 FT DOWNSTREAM FROM THE SPILLWAY, BY THE ASSUMPTION OF CRITICAL DEPTH. (THE CONTROL SECTION INCLUDED THE PROFILE ALONG THE SPILLWAY DIKE; SEE FIGURE 1, APPENDIX F.) CALCULATIONS PROCEEDED UPSTREAM TO THE TOE OF THE SPILLWAY IN ONE STEP. THE RATING TABLE BELOW CORRESPONDS TO THE HEC-2 OUTPUT FOR SECTION 0.1 @ THE TOE OF THE SPILLWA

SECTION 0.2 @ TOE AT DS FROM SPILLWAY
TO DISCHARGE CHANNEL
INVERT ≈ 1321 FT
NCH ≈ NLOB ≈ NROB ≈ 0.06
CHANNEL SLOPE ≈ 0.7 %
ASSUMED CRITICAL FLOW CONTROL SECTION
CROSS SECTION INFORMATION OBTAINED FROM FIELD MEASUREMENTS AND OBSERVATIONS
CREST OF DIKE ON RIGHT SIDE OF DISCHARGE CHANNEL
SECTION 0.1 @ TOE OF SPILLWAY
TO DISCHARGE CHANNEL
INVERT ≈ 1323 FT
NCH ≈ NLOB ≈ NROB ≈ 0.06
CHANNEL SLOPE ≈ 0.7 %
IMAGINARY FLOW BOUNDARY
TOP OF DIKE
CROSS SECTION INFORMATION OBTAINED FROM FIELD MEASUREMENTS AND OBSERVATIONS
SPILLWAY CROSS SECTIONS
SHEET 11 OF 27

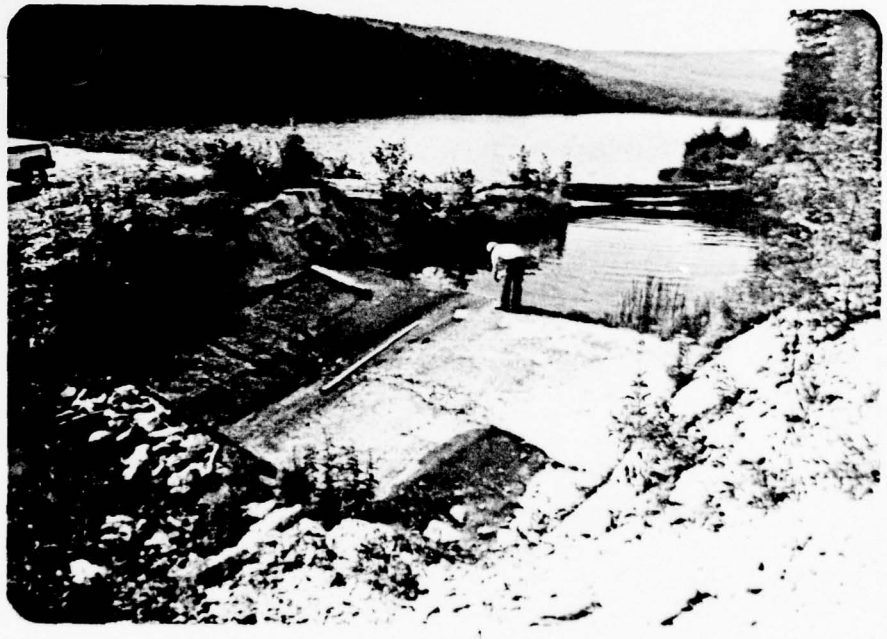
1. Spillway. The spillway, as observed during the visual inspection, appears to be in fair condition. A log bridge has been placed across the approach channel (see Photograph 4) and serves as a potential obstruction to unimpeded spillway discharge as does heavy overgrowth and boulders observed within the discharge channel (see Photograph 6). The concrete overflow weir and sidewalls show signs of cracking, scaling, and overall minor deterioration (see Photograph 4). Water was observed seeping through a crack located near the middle of the left side of the overflow weir (see Photograph 5).

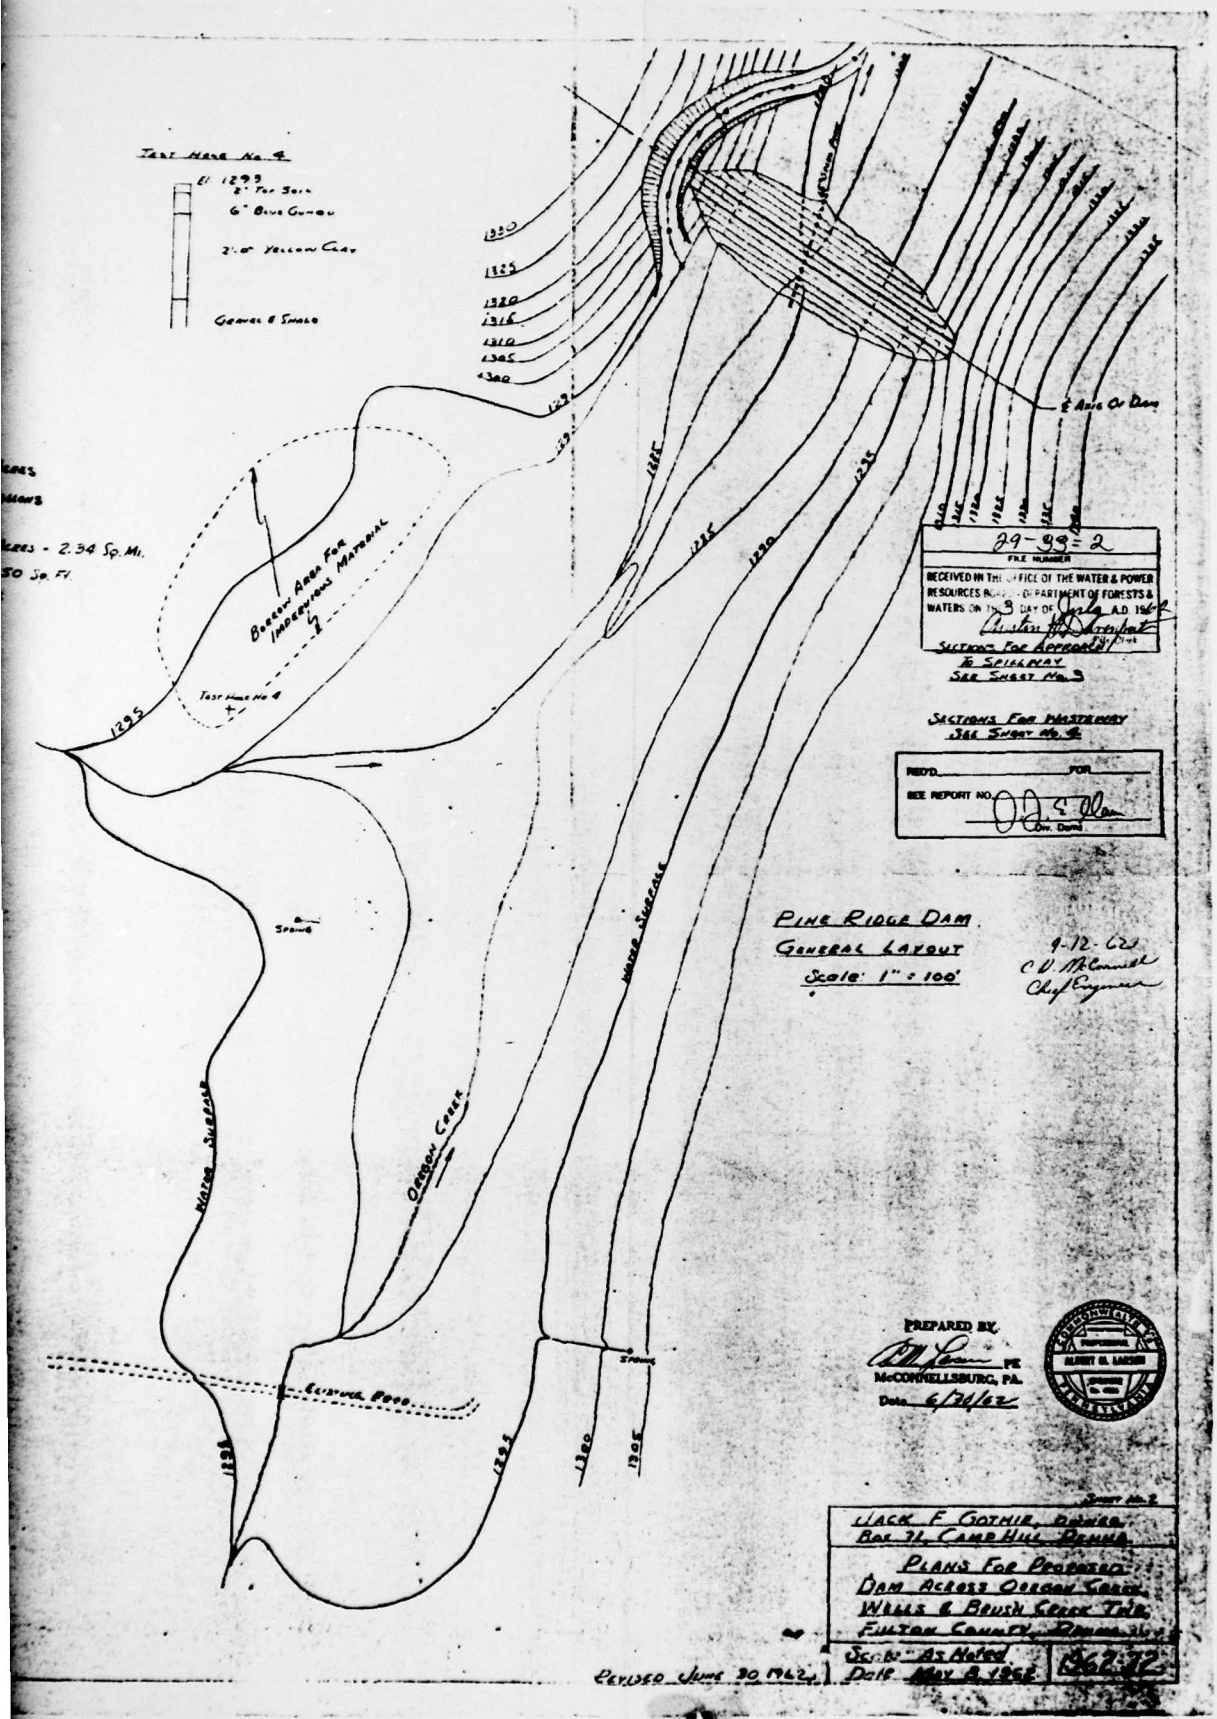
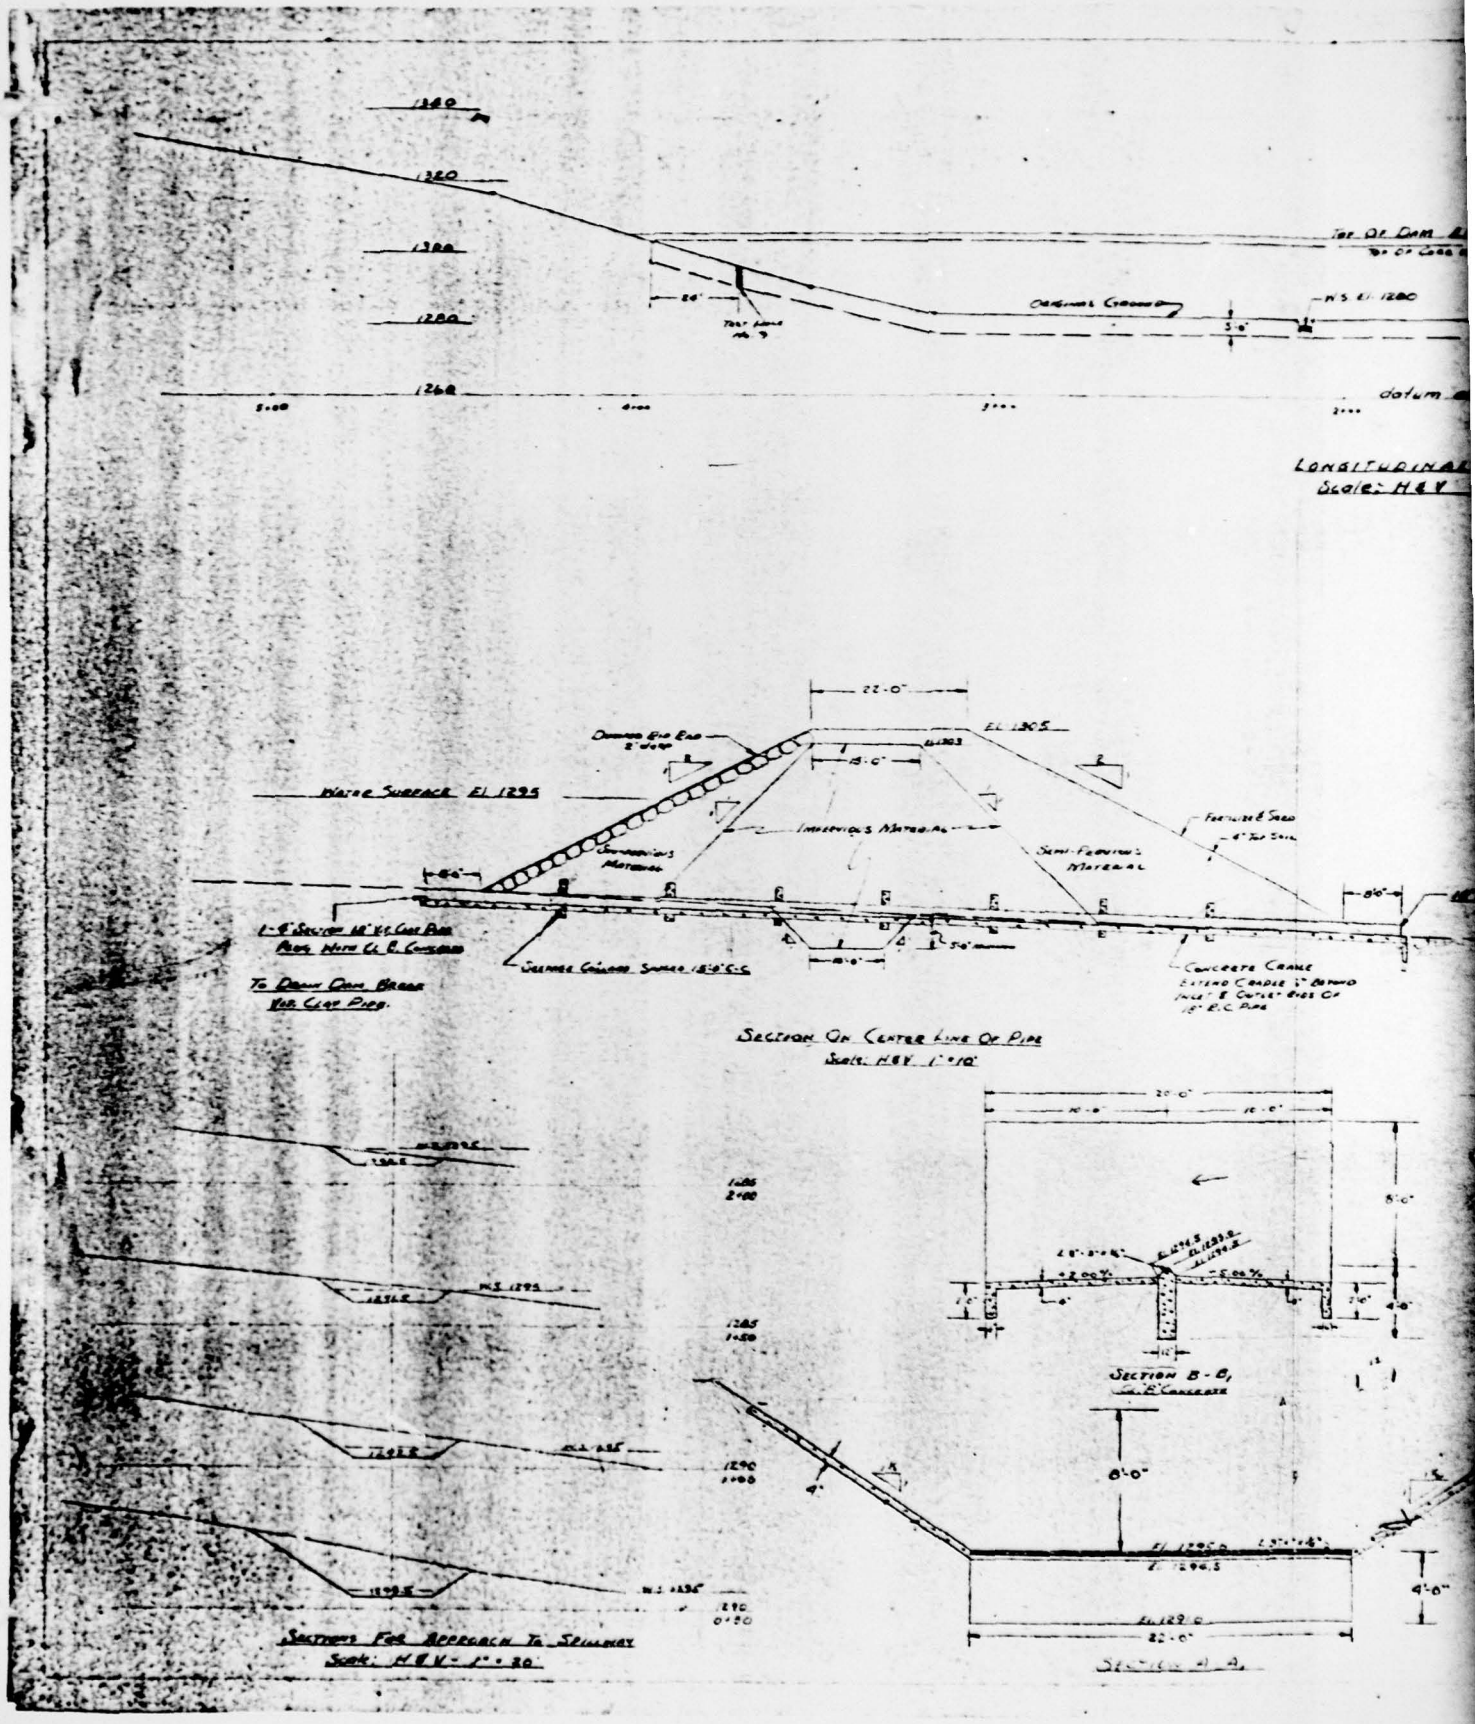
FIGURE 2

Available design drawings indicate that a 10-foot wide cutoff is provided along the embankment centerline (see Figure 2). Contract specifications state that all fill was to be placed in 8-inch loose layers and compacted with a sheep's foot roller to a density of 95 percent of maximum dry weight.

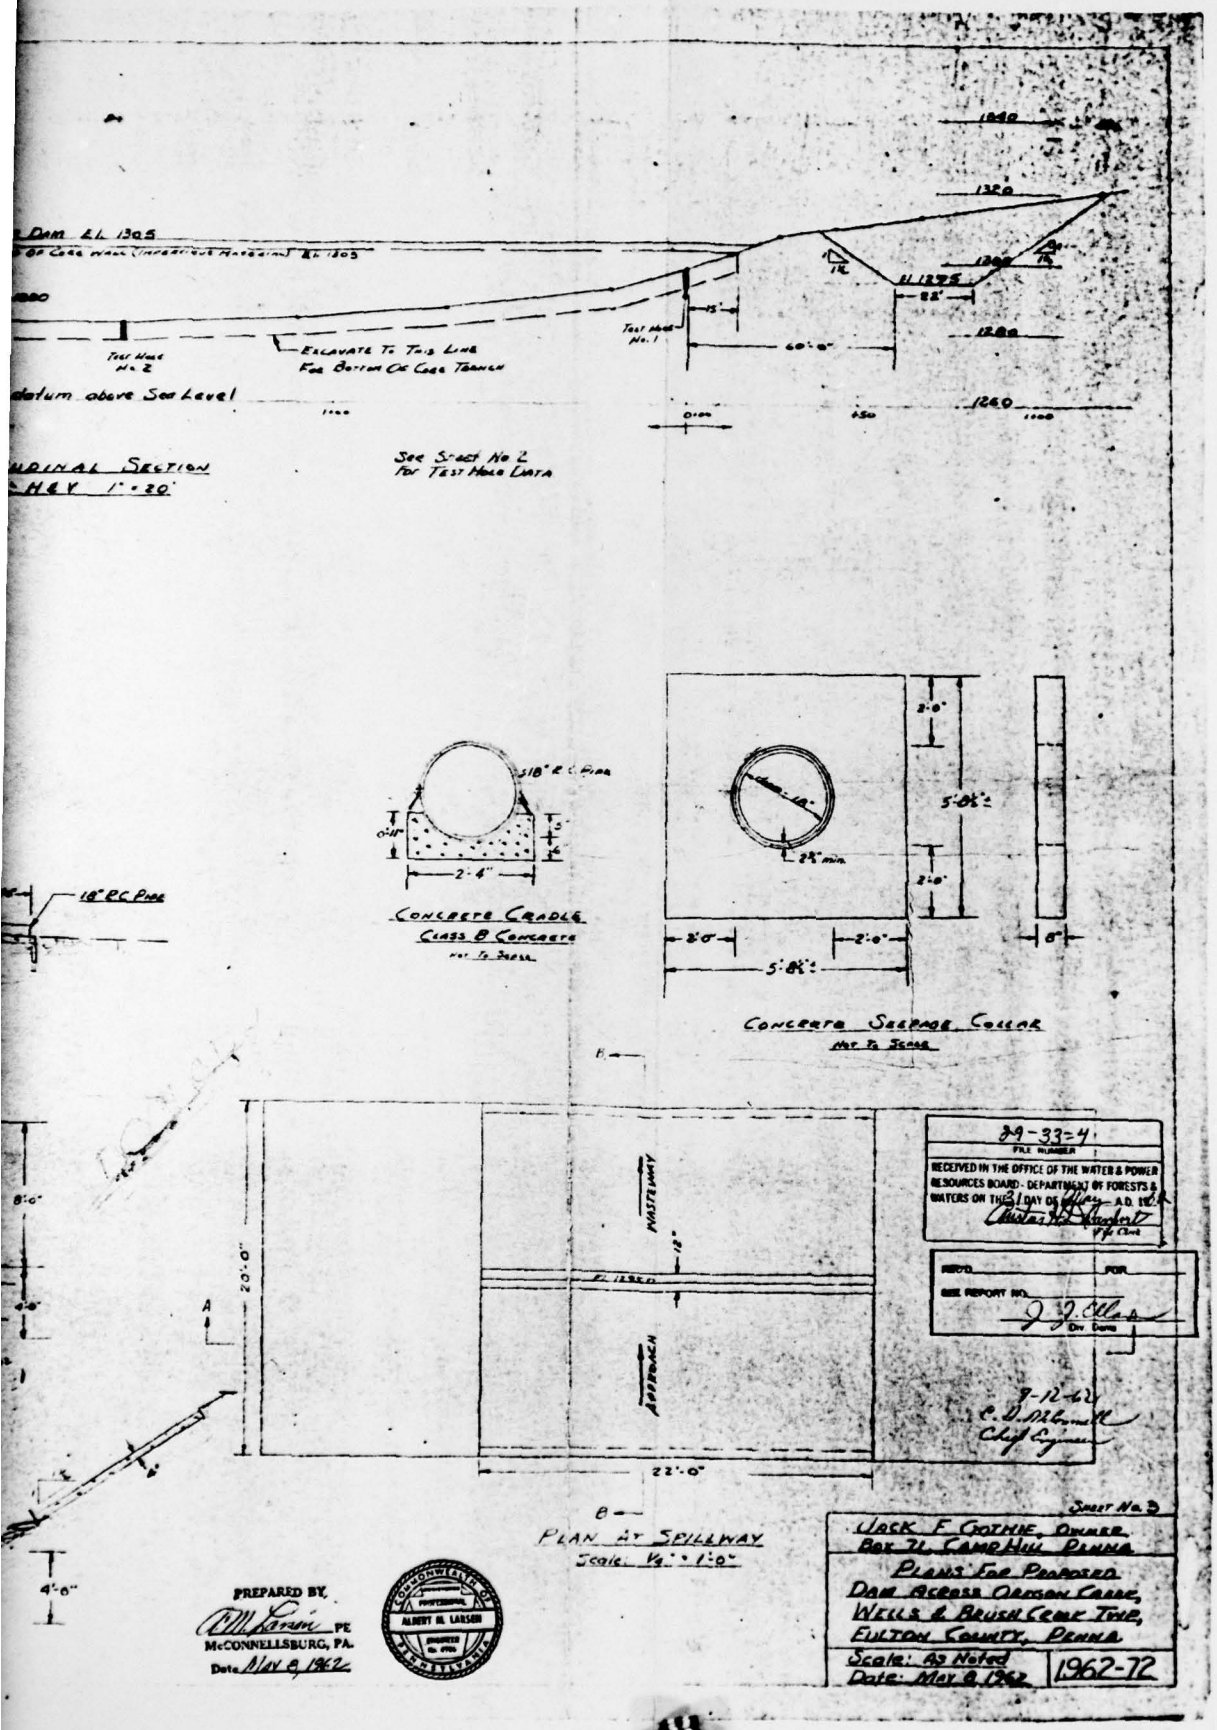
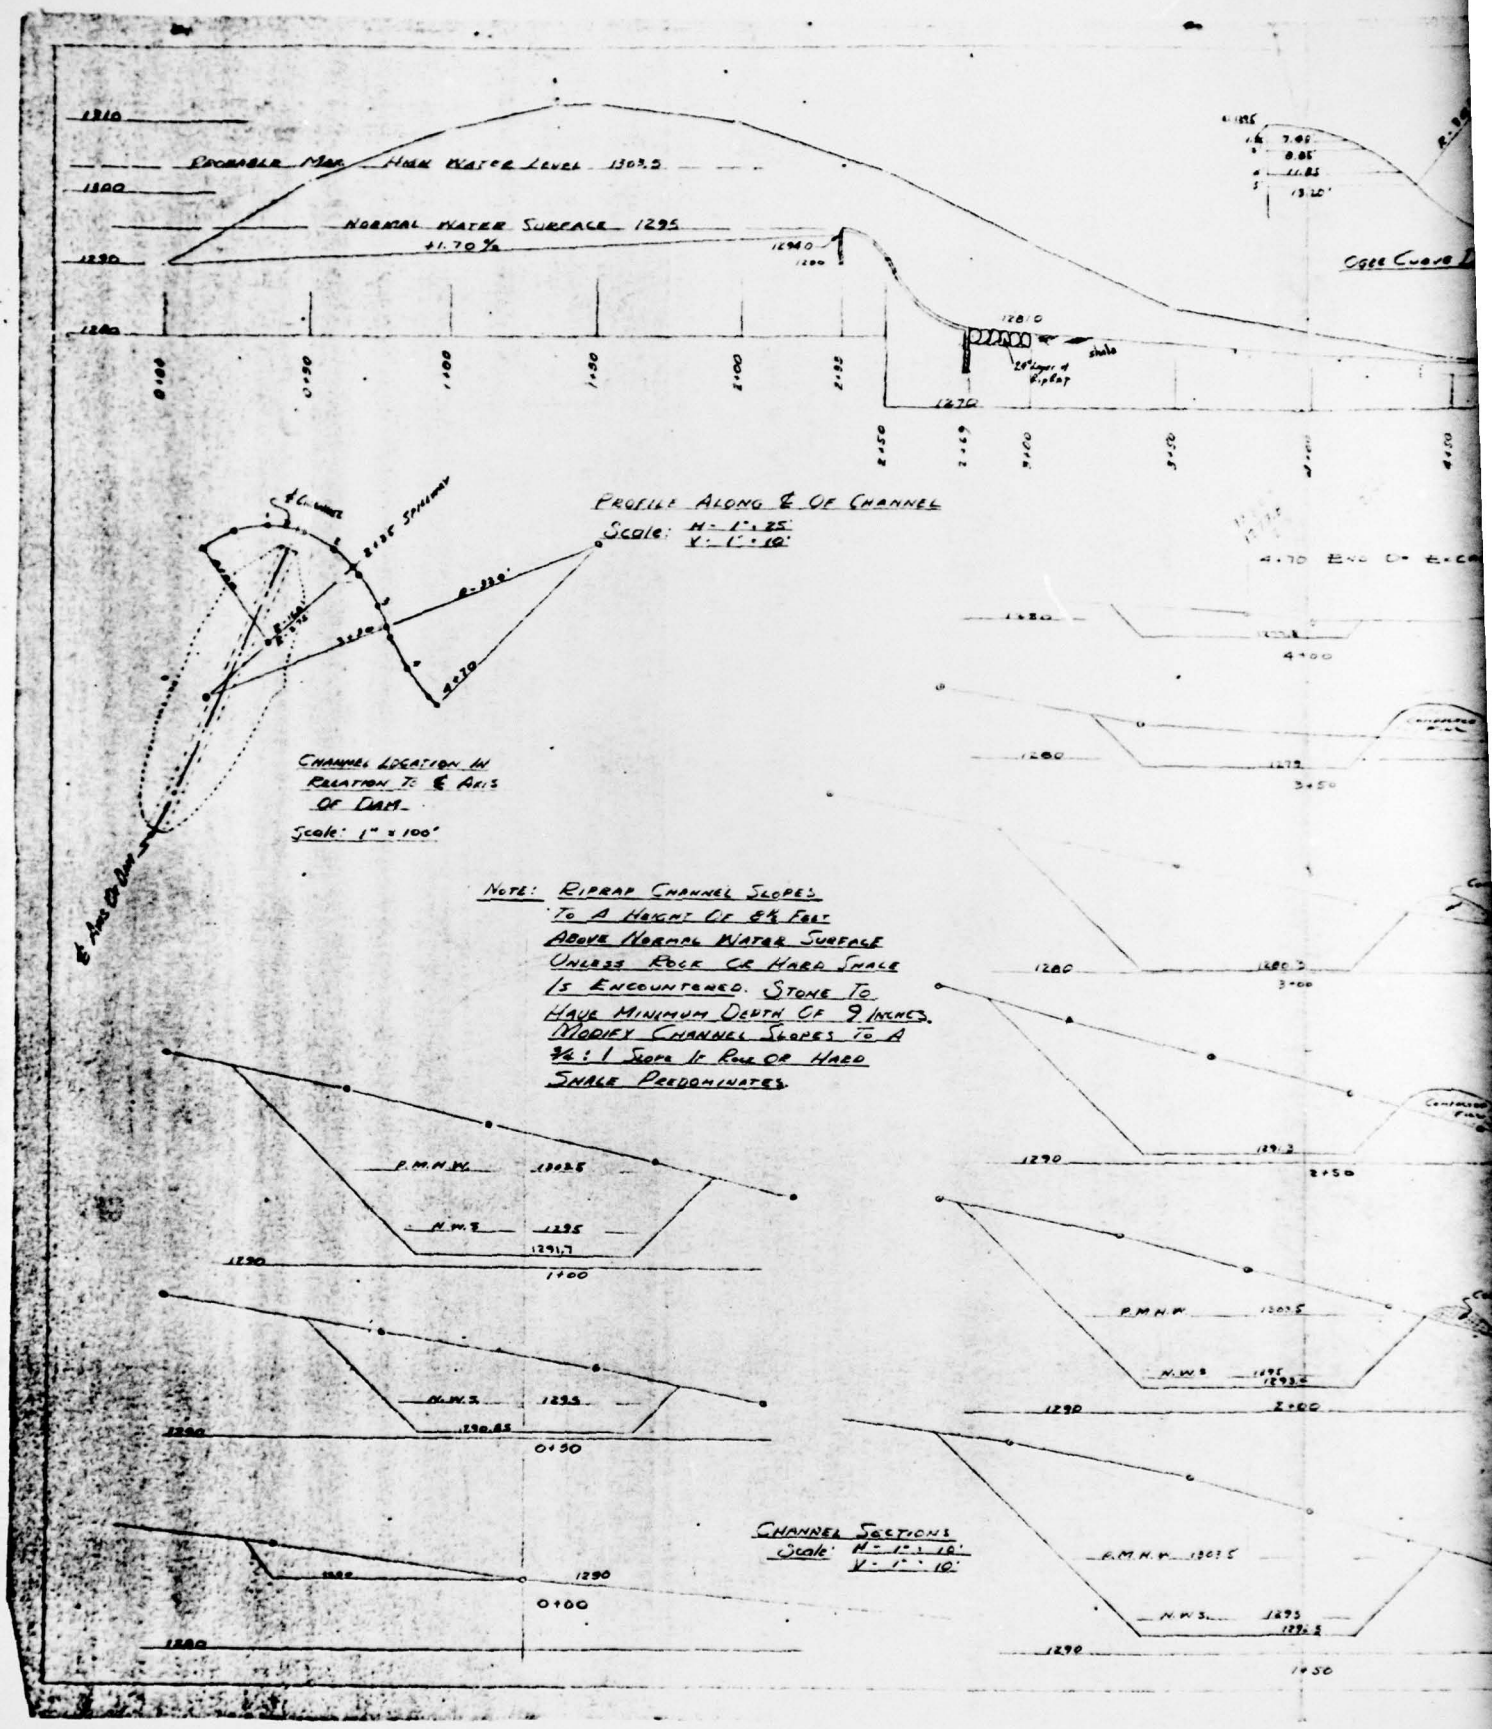
FIGURE 3

prised of a mixture of clay and shale (see Figure 3).
	Impervious Core	See "Zoning" above.
	Cutoff	Core trench 10 feet wide at the base with 1H:1V side slopes is reportedly provided along the embankment centerline (see Figure 3).
	Grout Curtain	None indicated.
h.	Diversion Canal and Regulating Tunnels.	None.
i.	Spillway.	
	Type	Trapezoidal-shaped channel cut in rock at the left abutment and equipped with a concrete trapezoidal-shaped overflow weir (See Appendix C, Sheet 5).
	Crest Elevation	1327 feet
	Crest Length	30 feet
j.	Outlet Conduit.	
	Type	15-inch diameter steel pipe placed on a concrete cradle.
	Conduit Length	130 feet (inlet to outlet).
	Closure and/or Regulating Facilities	Flow through the conduit is reportedly controlled via a 15-inch diameter gate valve located at the inlet end.
	Access	Under normal pool conditions, the gate

ITEM	REMARKS NDI# PA - 186
SPILLWAY: PLAN SECTION DETAILS	See Appendix F, Figure 3 and 4. (Figures 3 and 4 do not accurately represent as-built conditions).
OPERATING EQUIPMENT PLANS AND DETAILS	None available.
DESIGN REPORTS	None available.
GEOLOGY REPORTS	None available.
DESIGN COMPUTATIONS: HYDROLOGY AND HYDRAULICS STABILITY ANALYSES SEEPAGE ANALYSES	None available.
MATERIAL INVESTIGATIONS: BORING RECORDS LABORATORY TESTING FIELD TESTING	See Appendix F, Figure 2.
