AD-A079 475 NAVAL WEAPONS HANDLING CENTER COLTS NECK NJ F/G 15/5
DEVELOPMENT, TESTING AND EVALUATION OF AN INTERNAL RESTRAINT SY--ETC(U)
OCT 78 F G CICCOLELLA
UNCLASSIFIED NWHC-7801 NL

DEVELOPMENT, TESTING AND EVALU
OF AN
INTERNAL RESTRAINT SYSTEM
FOR
TRANSPORTING ORDNANCE I
COMMERCIAL INTERMODAL CONTA

REPORT DOCUMENTATION PAGE	READ INSTRUCTIONS BEFORE COMPLETING FORM
(14) 1. REPORT NUMBER: NWHC-7801 ✓	2. GOVT ACCESSION NO. / 3. RECIPIENT'S CATALOG NUMBER

(6) 4. TITLE (and Subtitle): Development, Testing and Evaluation of an Internal Restraint System for Transporting Ordnance in Commercial Intermodal Containers	(9) 5. TYPE OF REPORT & PERIOD COVERED: Final Rept.

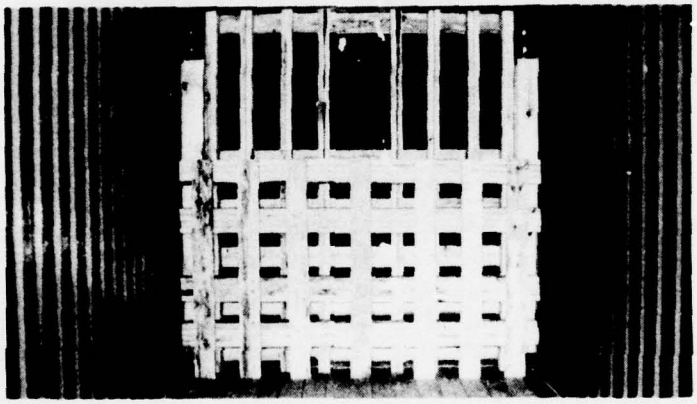
Figure 26 - Adapter Installed Between Front Bulkhead and Front Wall Panel In All-Steel Container

The All-Steel Container, CTI 041689, packed with MK 82 Bombs, remained tight and secure during and after the tests. However, the container forward wall panel and corner posts bowed out approximately 1 inch due to contact with, and deflection of the transverse beams of the forward bulkhead assembly. There was no other damage to the container or inert lading.

The noted damage occurred during the impact toward the "B" (closed) end at 8.8 MPH. It should be noted that the restraint system has no load carrying capability in the direction of the closed end due to usage of wire rope cables. Therefore the closed end structure must be capable of withstanding the forces of impact in that direction. However, the forces imparted to the closed end during a rail impact test were in excess of the applicable design requirements for a container end wall.

A duplicate test configuration, (with a redesigned forward-bulkhead section) was subsequently tested with no discernible damage to the closed end wall and corner posts. The forward bulkhead was retained, but an adapter was fabricated. This adapter was placed between the bulkhead and the container front wall and corner posts (Figure 26). The adapter was designed to conform to the container front wall contours and to distribute the force of impact over the maximum front wall panel and corner post area. The combined bulkhead assembly and adapter has approximately three times the bearing area of the original bulkhead.

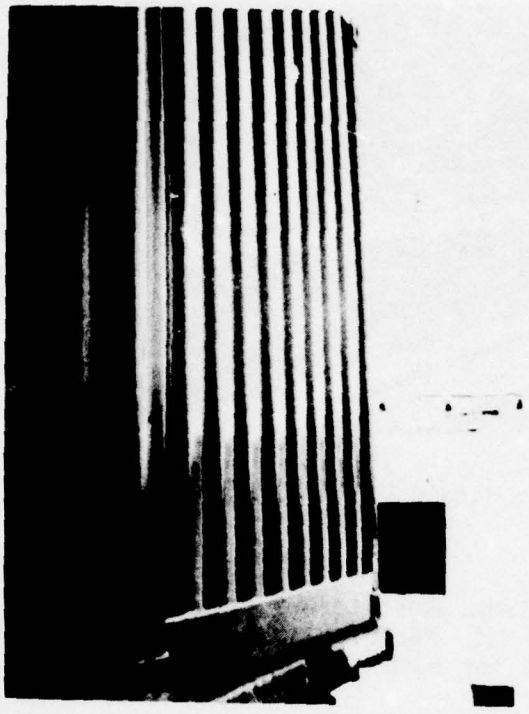
Figure 28 - Front Wall of Steel Container After Additional Impact Toward "A" End

The impacts against the "A" end (4, 6 and 8 MPH) were performed without discernible damage. The impact toward the "B" end in excess of 8 MPH produced the same type of bowing in the front wall panel as occurred in the corresponding COFC test. The maximum deflection was approximately 1/2 inch in the area corresponding to the second tier of bombs. In order to determine whether this was permanent deformation, an additional impact was made against the "A" end. The velocity was not measured but was sufficient to remove the slack in the cables and shift the load off of the front wall. The deformation which remained in the wall panel after this impact was considerably less than 1/2 inch, indicating that a major part of the initial deflection was temporary. Figure 28 was taken after this additional impact and is included for reference although little is apparent due to the dimensions involved.

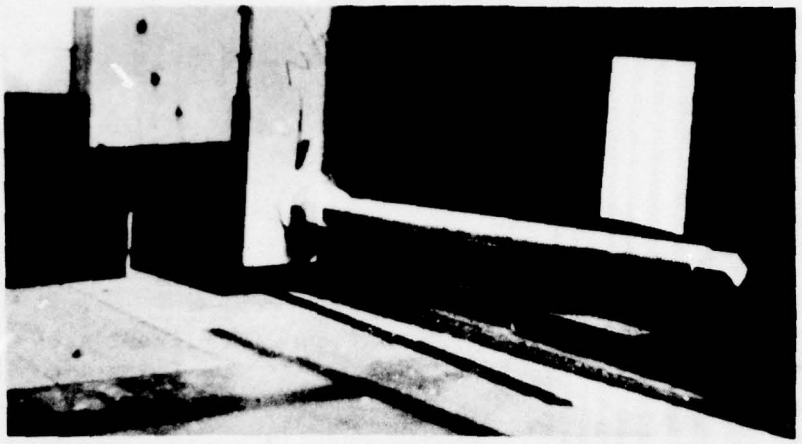
Figure 29 - Structural Angle (Right) Lifted During Hazard Course Test

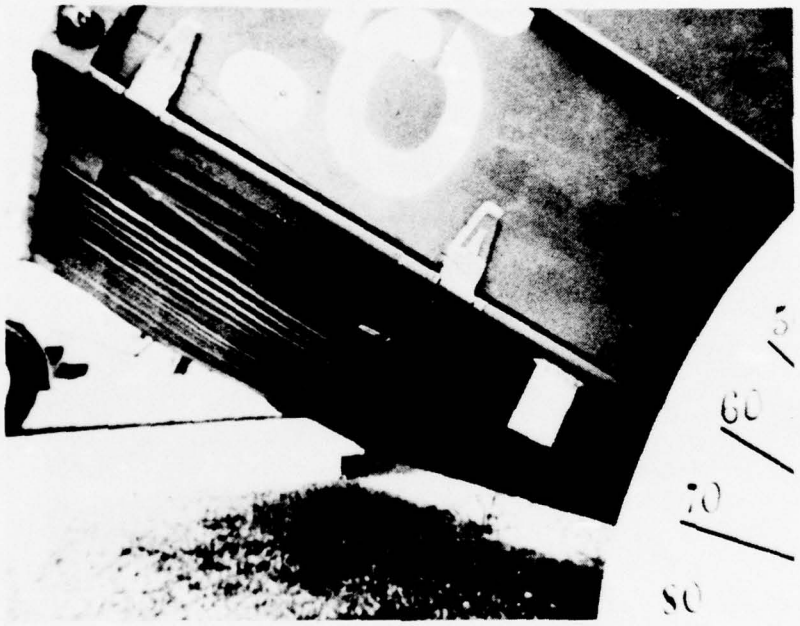
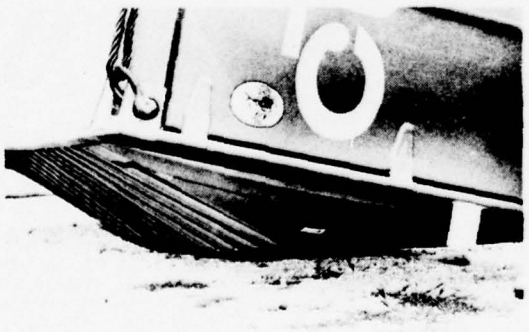
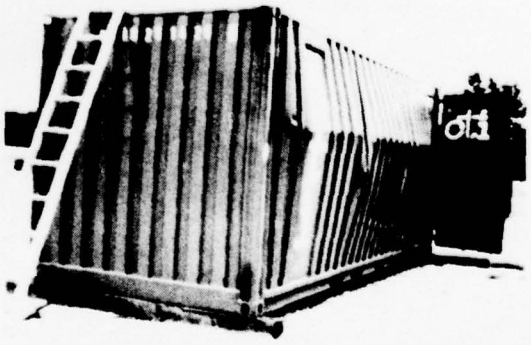
All Steel Container with MK 82 Bombs. This configuration had been designated for testing without any side bracing as explained in Section II, Paragraph B. As the tilt angle was increasing from 0°, deflection was apparent from the beginning and increased to 30°. At 40°, creasing of the sidewall began due to contact with the horizontal corners of the top tier unit loads. The tilt was continued slowly to 80°, no deflection measurements were taken. The creasing and overall deformation was pronounced (Figures 31 and 32). Shortly before achieving 80°, the center dunnage spacers collapsed permitting the right side unit loads to drop onto the left. The container was returned to the upright position and no further damage such as broken welds or wall punctures was noted (Figure 33). It was agreed that the container wall had failed, not the restraint system.

Figure 31 - Steel Container At 60° Angle During Tilt Test

Figure 32 - Steel Container At 80° Angle During Tilt Test

Figure 33 - Steel Container Upright After Tilt Test

The MK 82 Bomb load subsequently received U.S. Coast Guard approval for containership shipments in conformance with drawings depicting suitable sidewall bracing. However, 80° tilt testing of the revised configuration was not required.

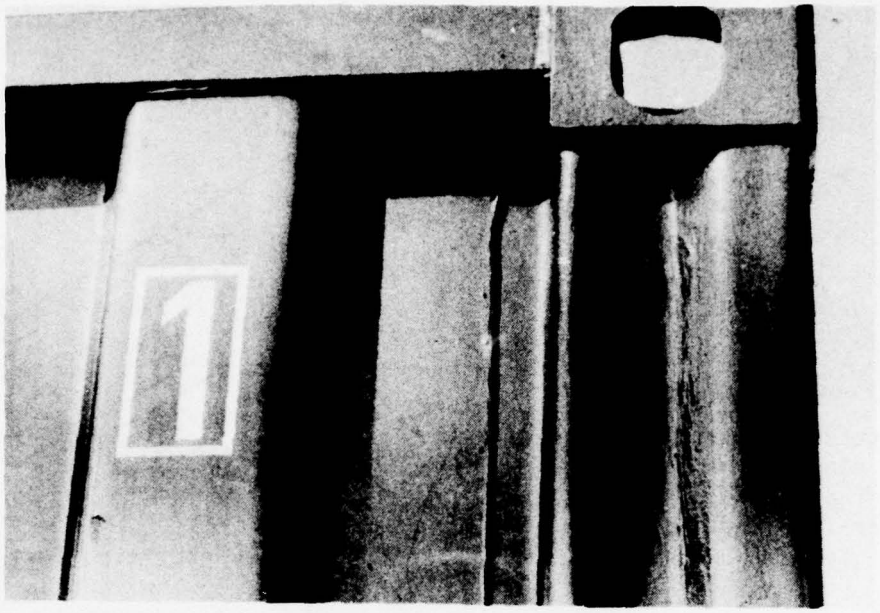
Additionally, the data suggests further investigation into the necessity or method of restoration of the front corner posts after removal of the IRSKIT attachments. Reduction of these restoration costs has a significant bearing on the life cycle cost of IRSKIT. Heretofore, charges for complete replacement of the drilled corner posts have been incurred by NWHC upon return of the containers to the leasors. It now appears that replacement corner posts offer little or no structural advantage over either the as-modified or the plug welded posts.

Figure 48 - Exterior: Right Corner Post-Plug Welded and Contoured

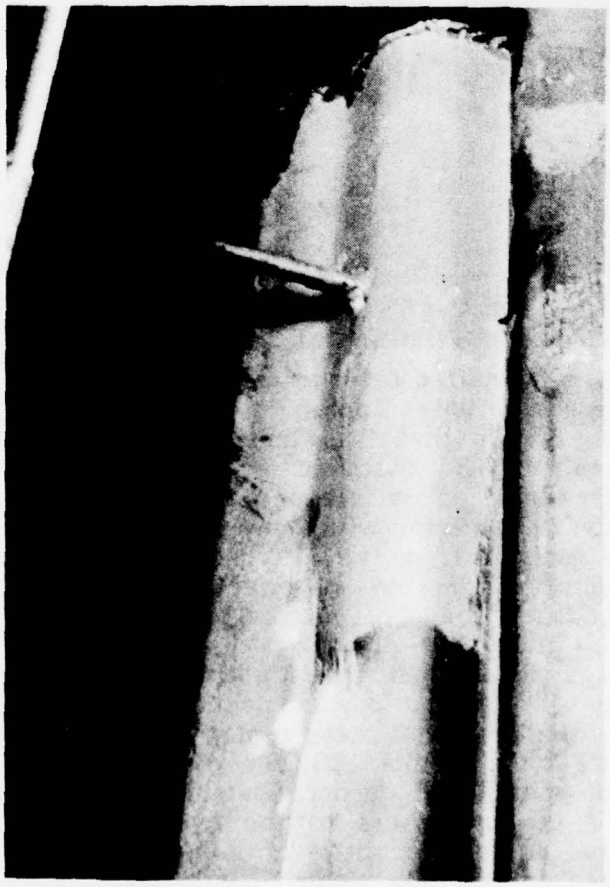
Figure 49 - Interior: Right Corner Post-Plug Welded and Contoured
