USAAVRADCOM TR 79-45

MM&T FIBER-REINFORCED PLASTIC HELICOPTER TAIL ROTOR ASSEMBLY (PULTRUDED SPAR)

Maron J. Bonassar and John J. Lucas
Sikorsky Aircraft Division
United Technologies Corporation
Stratford, Conn. 06602

Final Report for Period August 1975 - October 1978

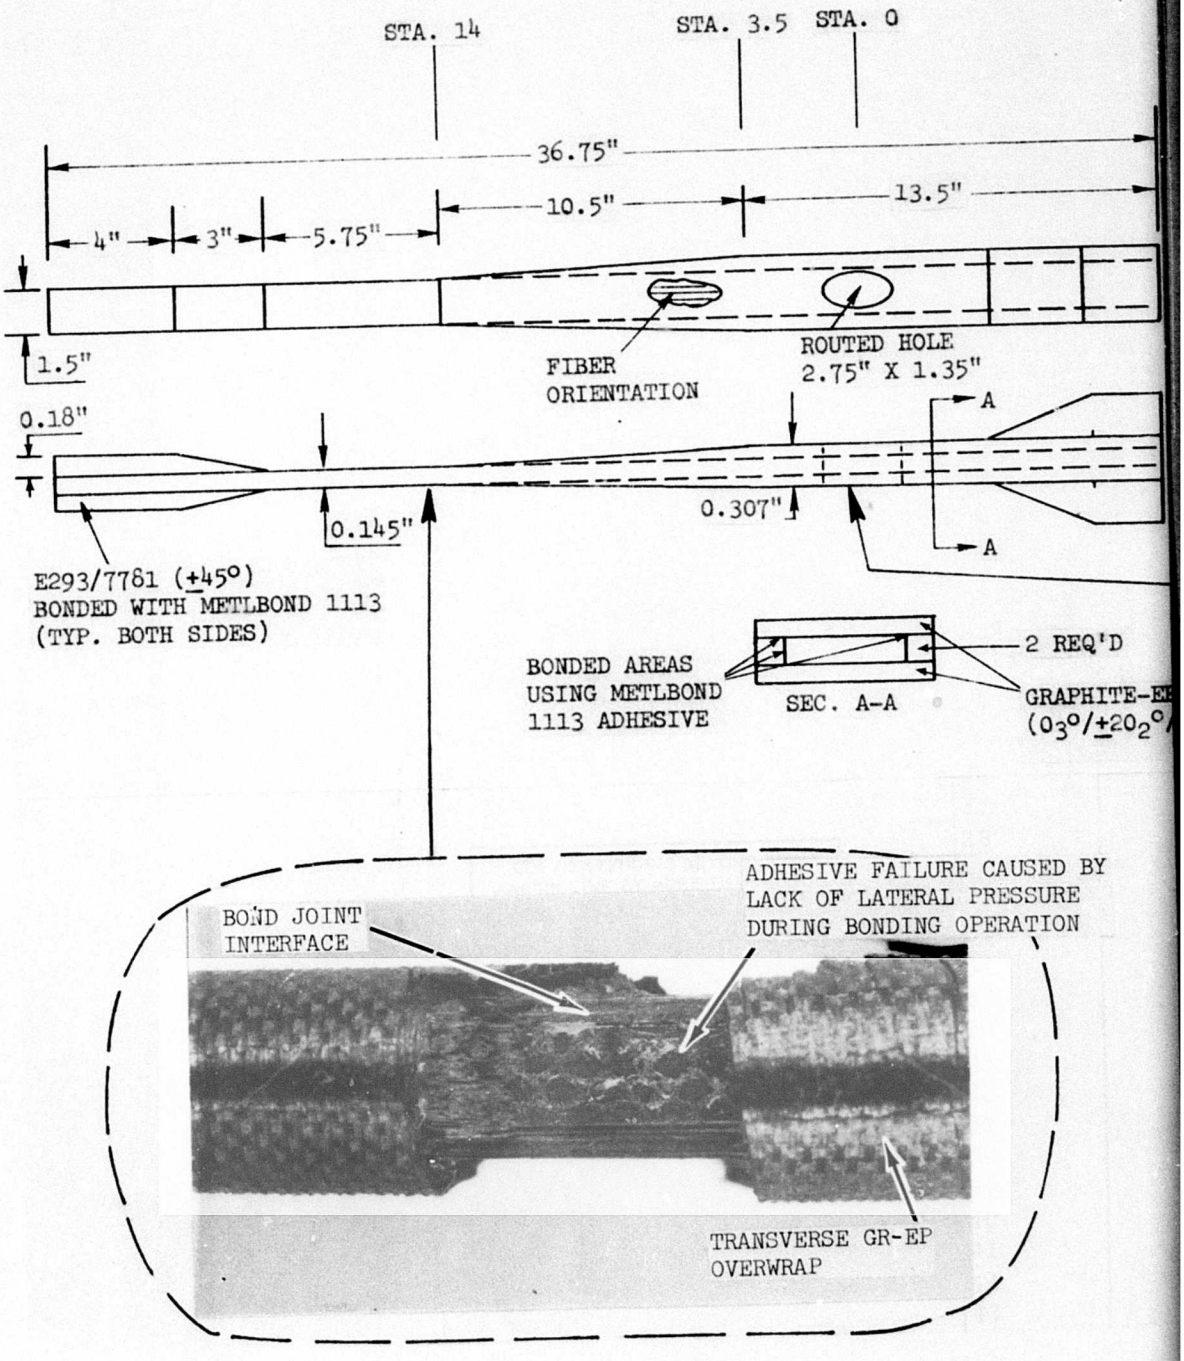
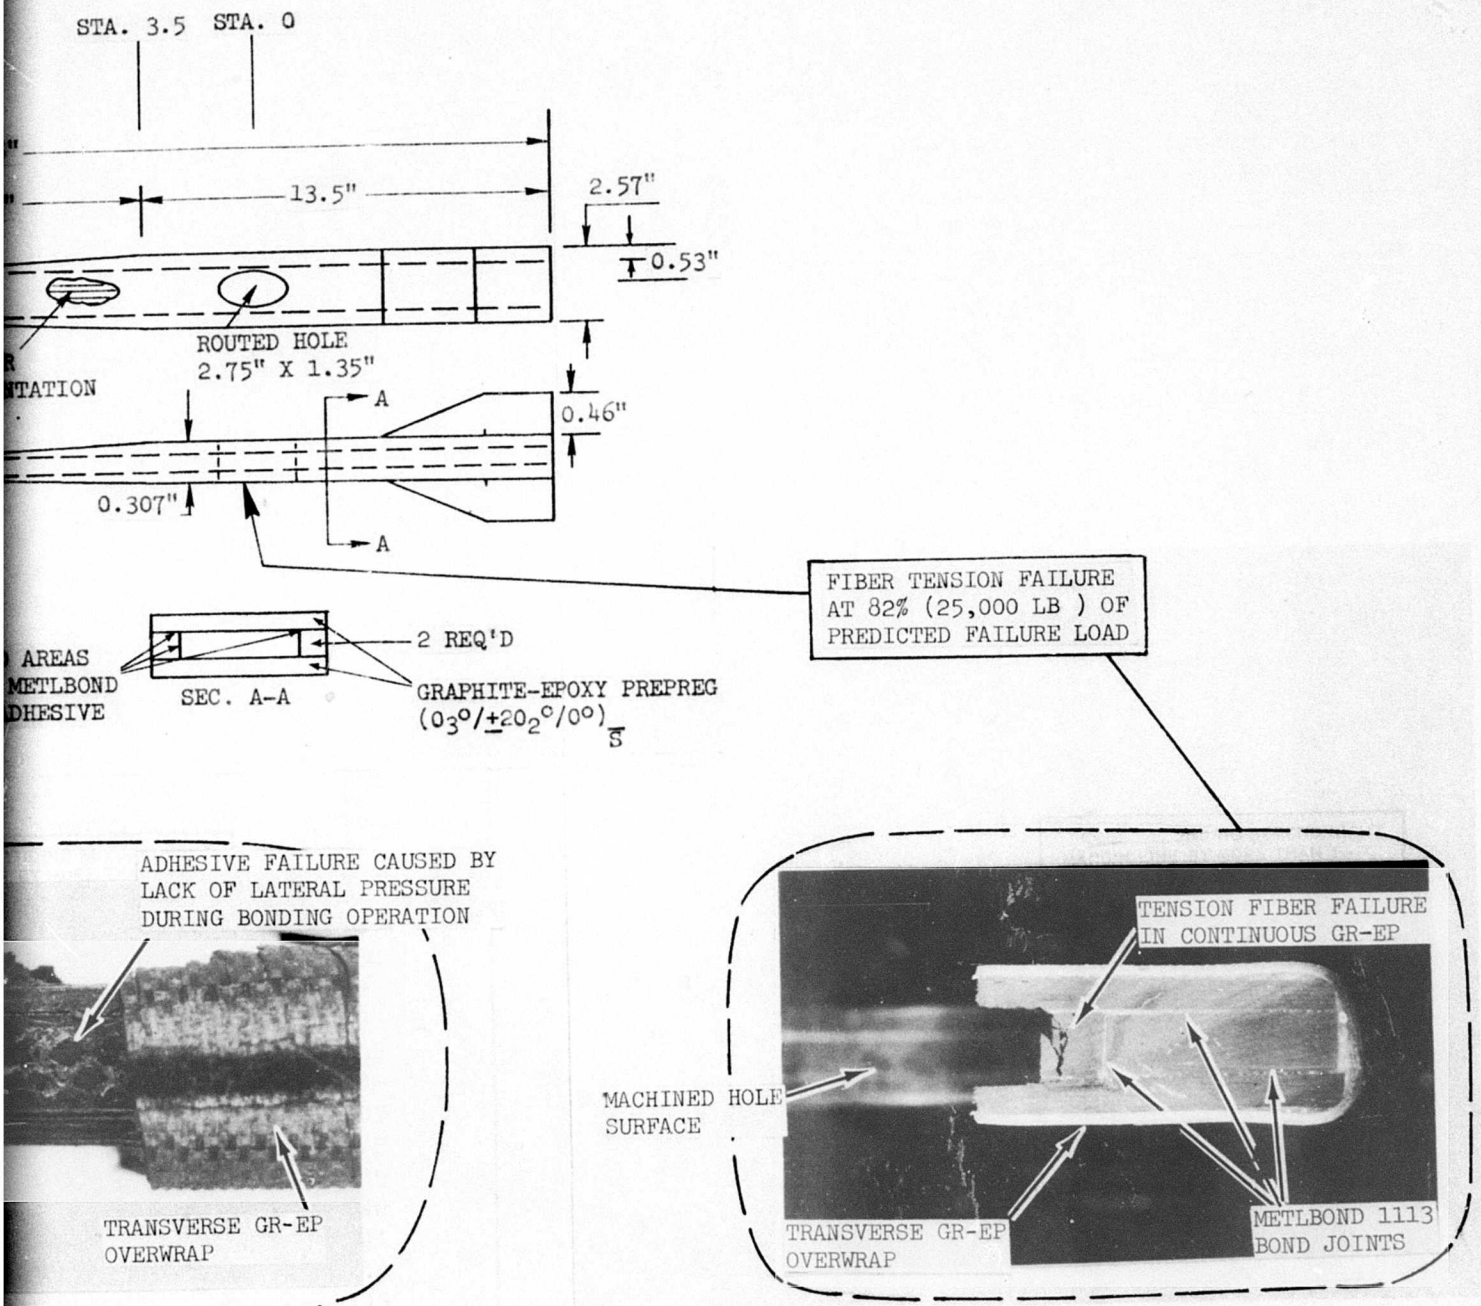
Figure 9. Concept I - Subscale Static Specimen Detail Failures.

The Concept I subscale specimen was tested axially in tension at room temperature and fractured at 25,500 pounds which, when normalized for fiber content, is 82 percent of the predicted design ultimate load. Examination of the specimen revealed that fracturing of the fibers in the hub attachment hole at Station 1.0 was followed by separation of the vertical bond interface of the center strip and side strip at Station 10.5. Figure 9 depicts the locations and closeup views of each of the separated details. The vertical bond fracture at Station 1.0 revealed a poor quality bond joint, which was associated with insufficient lateral pressure during bonding of the right and left side strips to the constant cross section center strip. The capability of the thick bondline to transfer shear loads may have been reduced sufficiently to cause premature fiber failure. The predicted area of failure was outboard of the bonded tapers at Station 10.5. The subscale Concept I test results indicated that the design was marginal, but no manufacturing risks were anticipated. These test results and conclusions confirmed the original previously expressed statements that Concept I is a high design risk and a low manufacturing risk.

In order that the structural risk of the Concept I design be lessened, additional off-angle (one each $\pm$ 20°) graphite prepreg plies were added to the internal interfaces of the external segments and to both interfaces on the internal strips for the Phase I, Concept I full-scale specimen. The addition of off-angle plies at the interface locations was to facilitate the transfer of shear loads around the hole at the root area. To supplement the autoclave pressure when bonding the vertical joint of the internal side strips for the full-scale specimen, mechanical force was applied to insure sufficient lateral pressure to produce a structural bondline of 0.005 - 0.008 inches.

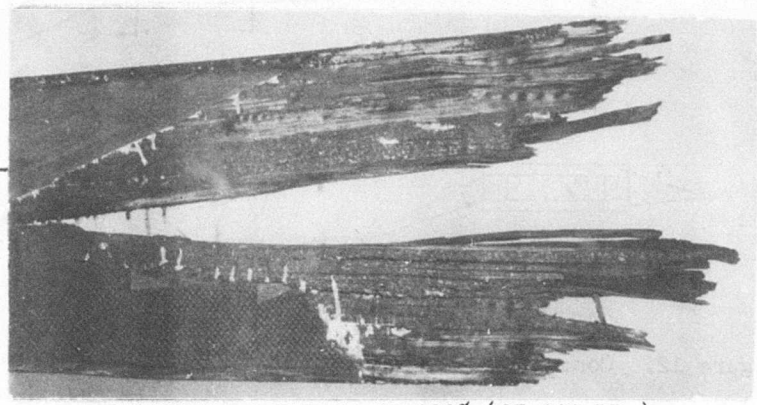
SPECIMEN 1 FAILED AT 122% (37,900 LB) OF PREDICTED FAILURE LOAD.

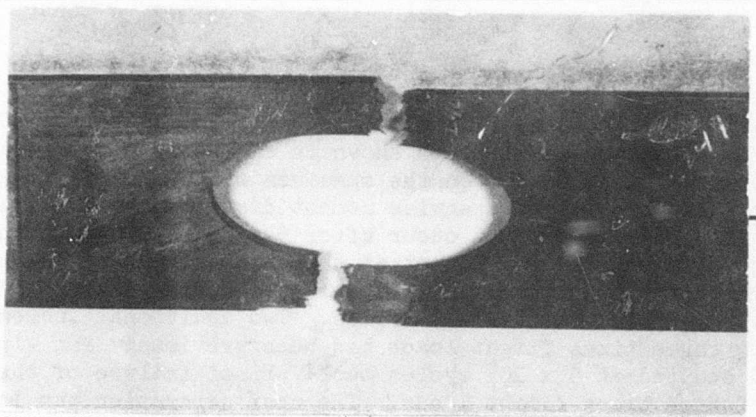
Figure 13. Concept II - Subscale Static Specimen Detail Failures.

SPECIMEN 2 FAILED AT 97% (30,200 LB) OF PREDICTED FAILURE LOAD. FABRICATED PREPREG THROUGHOUT SPECIMEN.

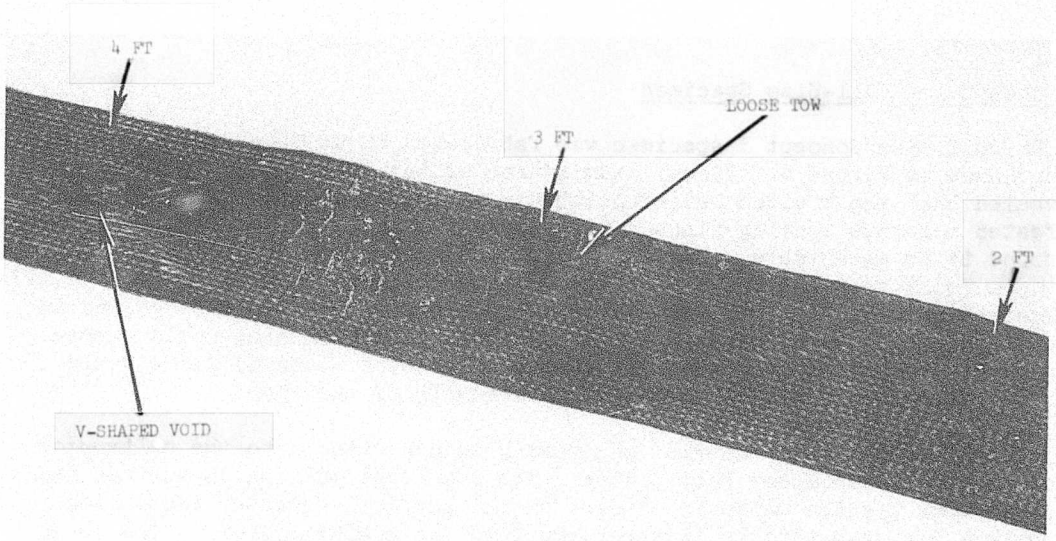
Figure 16. Typical Weaving Flaws of $\pm 20^{\circ}/0^{\circ}$ Braided Graphite.

The full-size Concept I specimen was fabricated in accordance with the lay-up shown in Figure 4. Visual examination of the fabricated specimens revealed that the braided material (T300 graphite braided at $\pm 20^{\circ}/0^{\circ}$) manifested numerous weaving flaws not observed in the 8-foot sample previously found to be acceptable. Typical variations in the braid ranged from loose (open void) to tight weave with the 0° tows stitched-in (Figures 16 and 17). The braided material was used in order that experience would be gained in pultruding off-angle materials. Since subsequent machining would remove many of the braiding defects, it appeared that the observed flaws would have little or no effect on the axial strength of the spar.

The braided graphite material was easily incorporated into the pultrusion of the upper and lower root plates. The resultant pultrusion surface was rough with braided material exposed on the surface. Greater tensioning control was needed to be incorporated into the graphite braid. The loose graphite tows were the apparent cause of many of the surface imperfections and the strength variation observed in previous pultrusions.

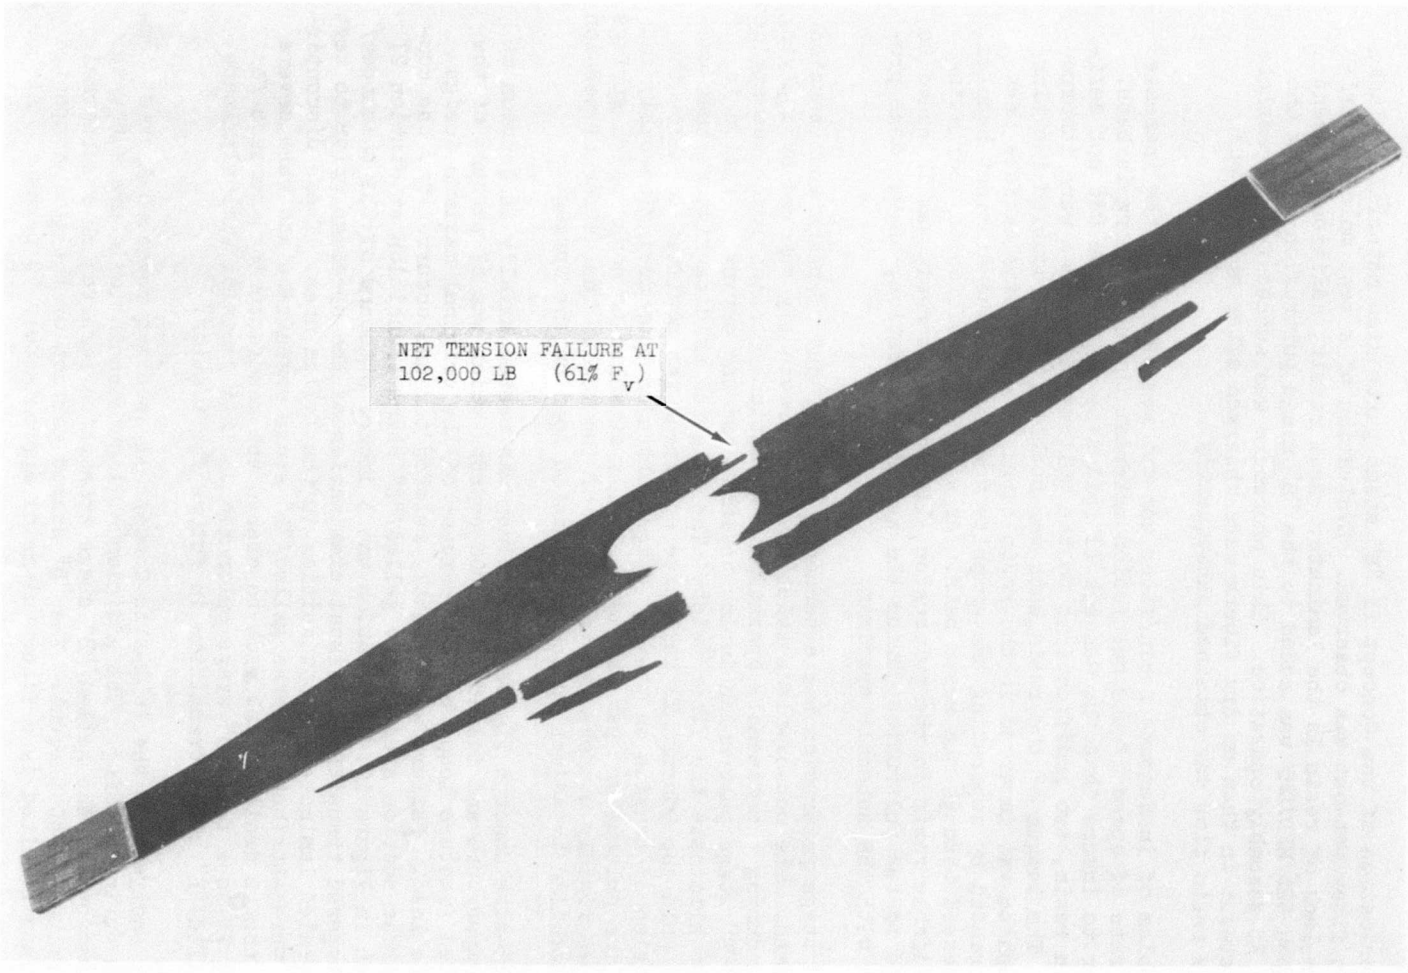
Figure 18. Concept I - Full-Size Static Specimen Showing Location of Fracture Through Hub Attachment Hole.

Static testing of the full-size Concept I specimen was performed in axial tension at room temperature. Failure occurred at 102,000 pounds, 80 percent of the predicted failure load. Separation was through the hub attachment hole at the root end region of the spar. Analysis disclosed the fiber volume to be 61 percent. Figure 18 shows the fractured specimen.

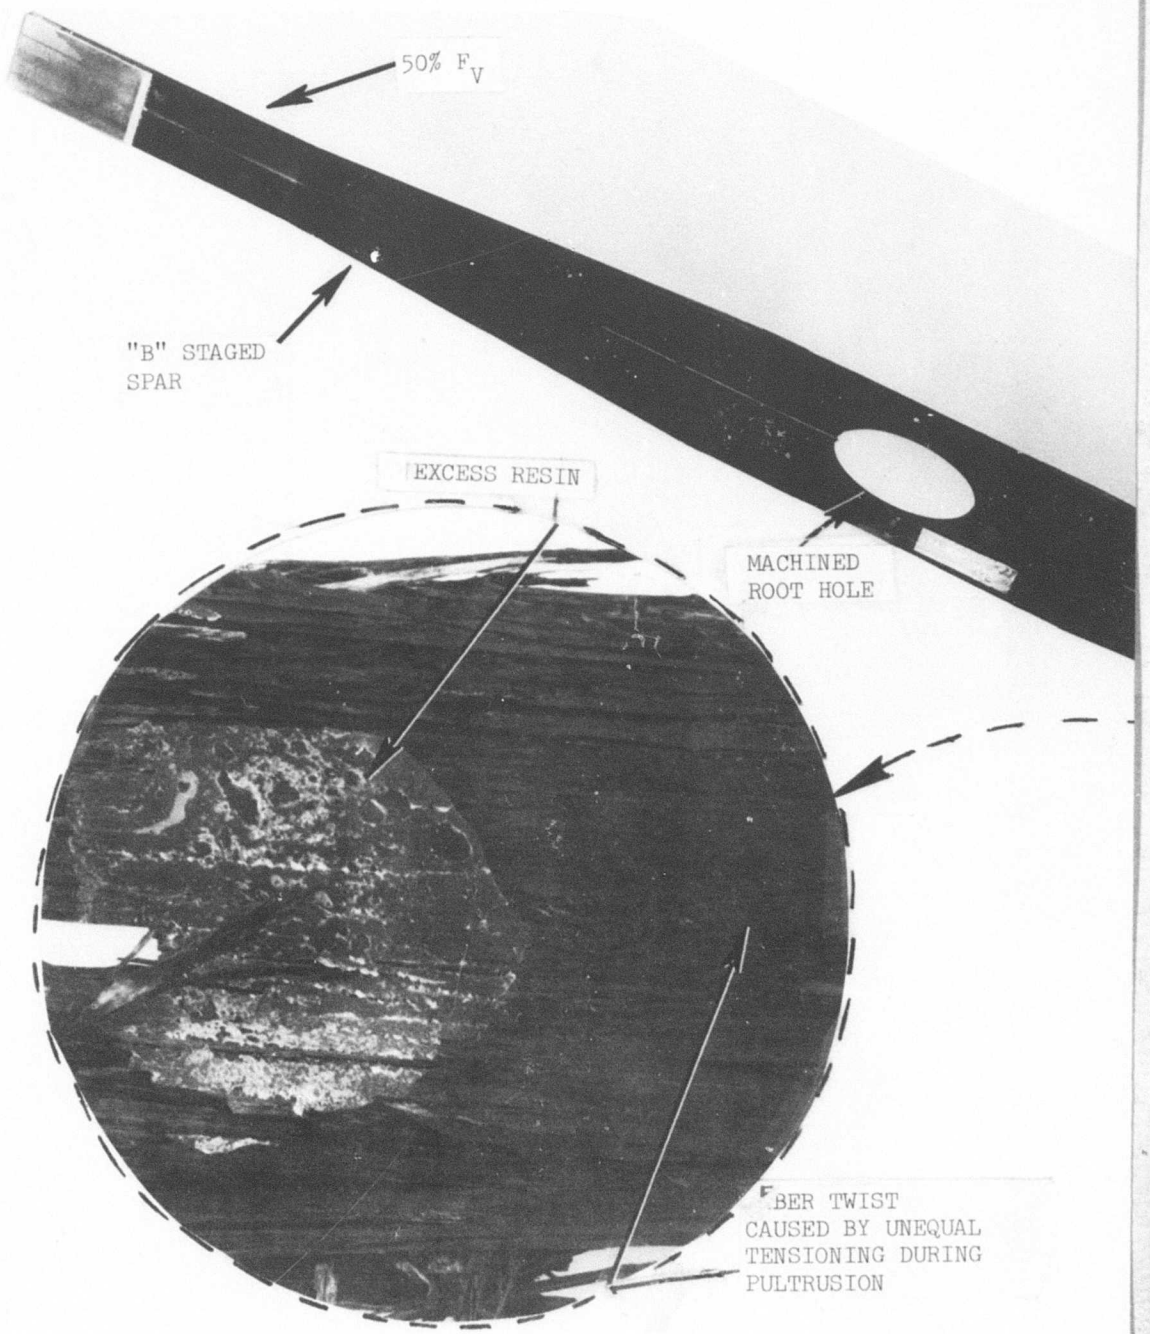
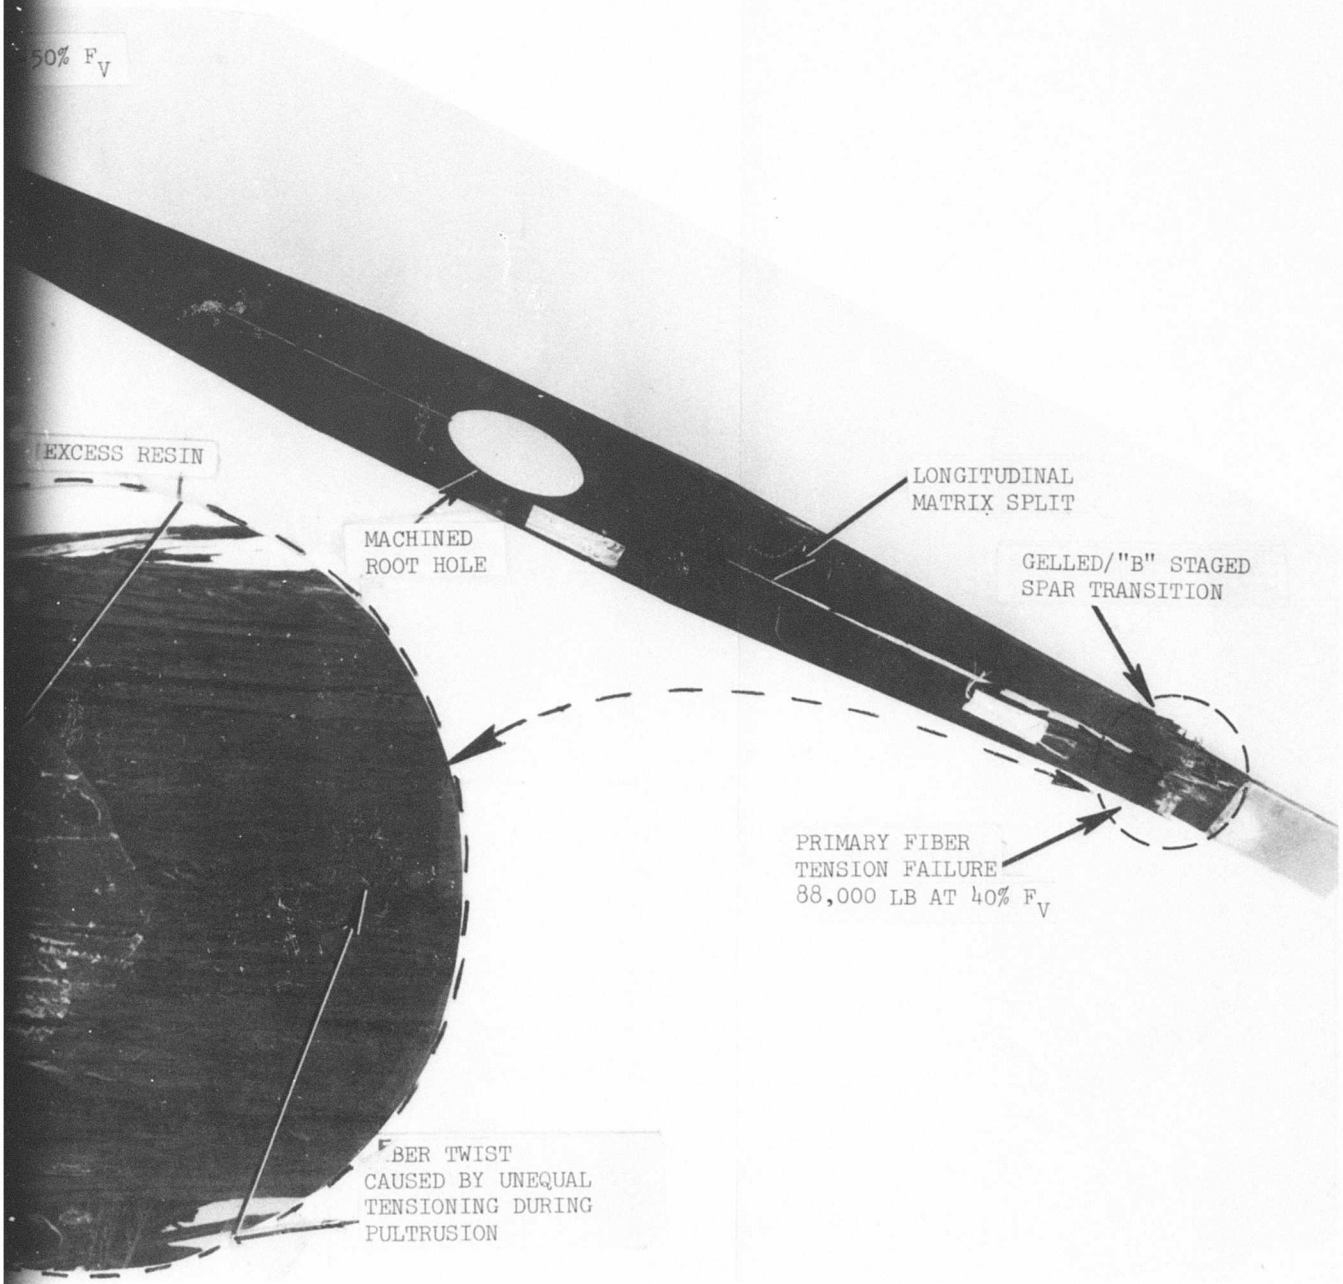
Figure 19. Concept II - Full-Size Static Specimen Showing Location of Fracture in Constant Cross-Section Area at the Gelled/"B" Staged Transition at Station 27.

The full-size Concept II static specimen was tested axially in tension at room temperature and failed at 88,000 pounds, which was 67 percent of the predicted fracture load, but 188 percent of the original maximum design ultimate load. Failure was directly related to, and occurred in, the constant cross-section area at the gelled/"B" stage transition at Station 27 as shown in Figure 19. Separation was 3 inches outboard of the thickness/width tapered transition. Visual examination of the specimen prior to test had revealed laminate discontinuities in the failed area. These discontinuities were attributed to the gelled/"B" stage transition and were severe enough that a decision was made to change the manufacturing approach for Concept II to a full "B" stage pultrusion. This decision will eliminate the gelled/"B" stage transition in future fabrication.

Failure analysis of the full-size Concept II specimen revealed lack of compaction during molding. The addition of liquid resin to insure adequate fiber wet-out in the gelled/"B" stage transition resulted in a subnormal fiber volume of 40 percent. The "B" staged portion of the spar compacted better and resulted in a fiber volume of approximately 50 percent. Although

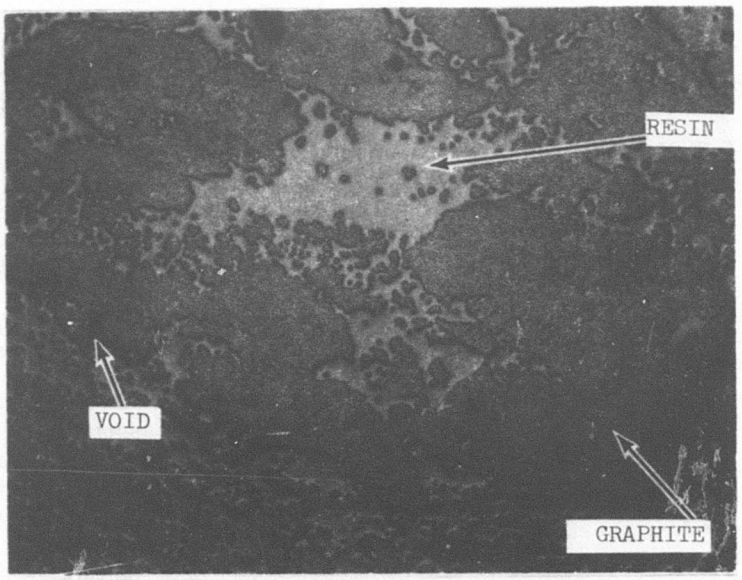
After autoclave cure, the completed spar was visually examined for defects. The gelled/"B" staged transition displayed poor fiber collimation and lack of fiber compaction. Thickness of the gelled/"B" staged transition ranged from 0.287 inches to 0.330 inches. Overall, the spar tooling mold did not close by approximately 0.040 inches, which resulted in a thicker spar. The inability to close the tooling mold also caused a lack of lateral compaction in the root hub region. The observed surface resin was excess parent resin Epon 826/MPD/DMF added during the spar assembly operation. The "B" stage transition area resulted in improved fiber collimation and compaction. A resin notch was formed in the pultrusion spar resulting from the bleeder cloth being pressed into the layup by autoclave pressure. This condition was eliminated in future spars by the use of a thin-gauge metal caul plate to fill in the gap.

GELLED/"B" STAGE SPAR TRANSITION WITH 40% FIBER VOLUME

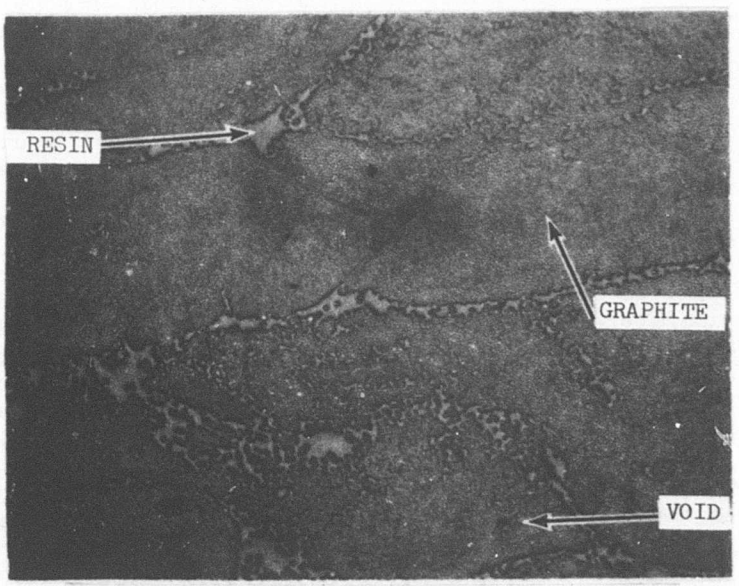
Figure 20. Cross-Sectional Views of Concept II Full-Size Spar. (50X)

compaction of the spar was poor, the void contents were low, as shown in Figure 20. These results confirm the decision to modify the Concept II manufacturing approach to eliminate the gelled/"B" staged transition.

B STAGE SPAR AREA WITH OVER 50% FIBER VOLUME

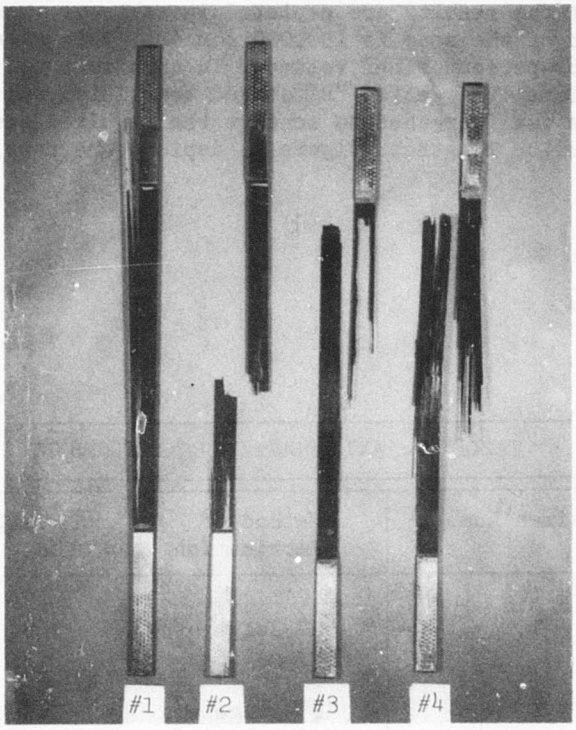
Figure 25. Axial Subscale Test Specimen After Testing.

Specimen Number	Method of Fabrication	Failure Load (psi)
1	"B" stage w/o transition	168,000
2	"B" stage w/o transition	148,000
3	"B" stage/gell transition	112,000
4	"B" stage/gell transition	128,000

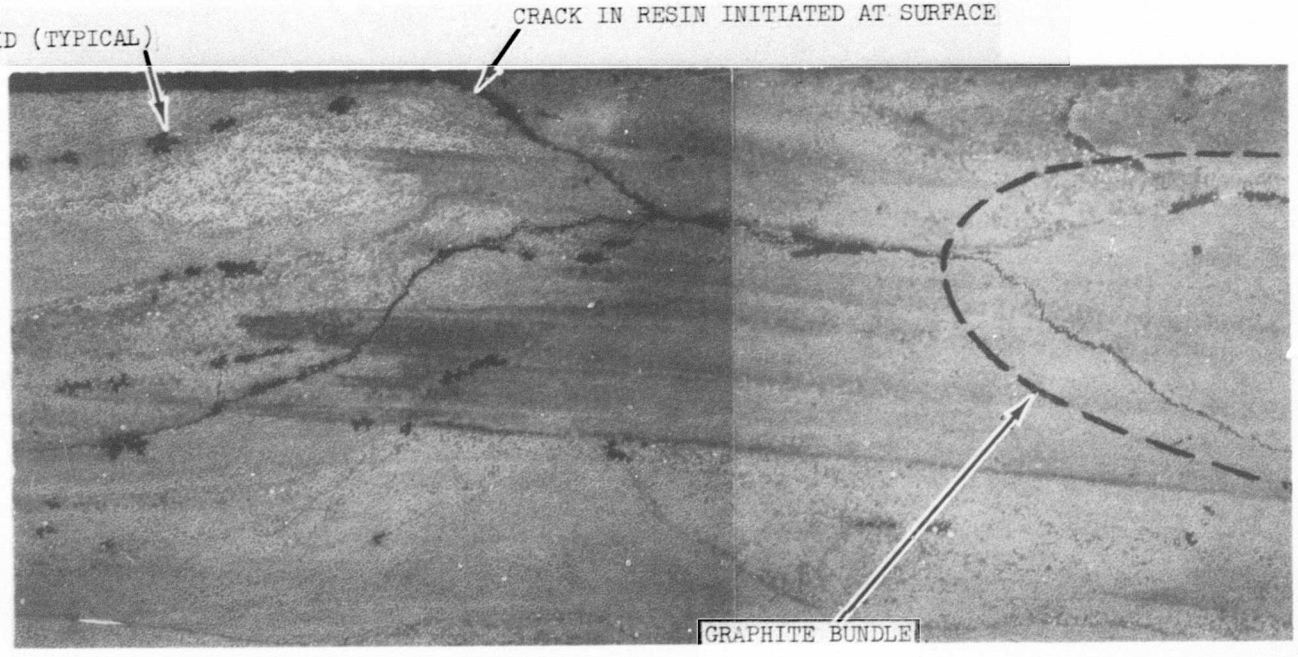
Figure 34. Typical Fatigue Damage Induced by Torsion. (Specimen 2) (50X)

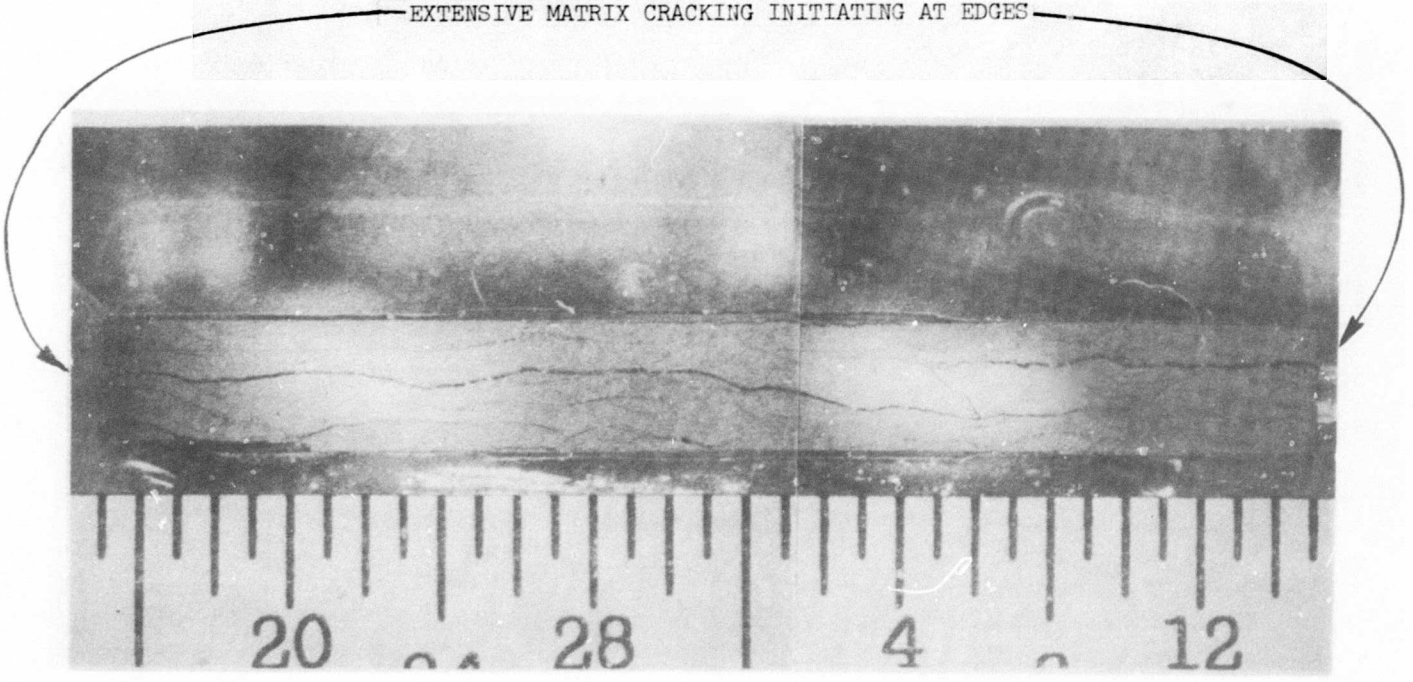
Figure 35. Typical Fatigue Damage Induced by Bending. (Specimen 6) (4X)

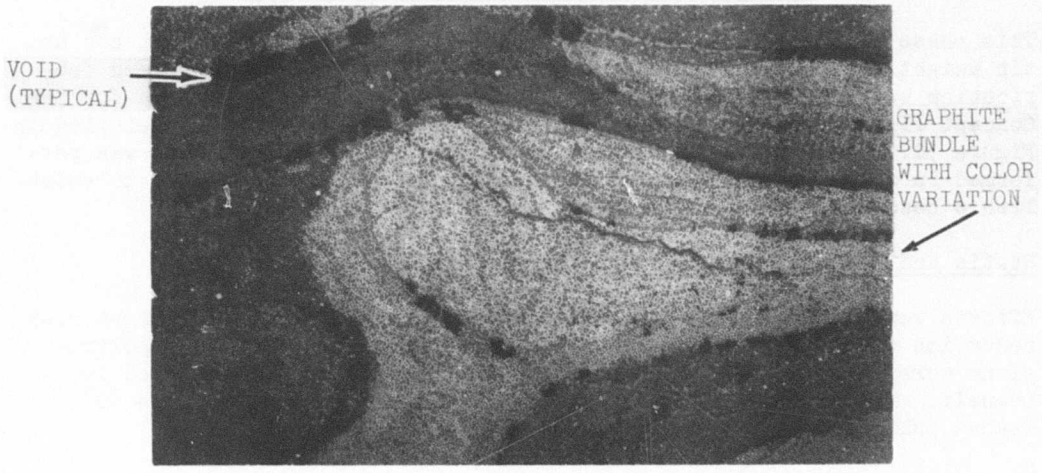
Figure 36. Torsion Fatigue Specimen Without Damage and Variation in Color. (Specimen 1) (50X)

The variation in color within the individual graphite bundle as noted in Figure 36 has been observed in many of the photomicrographs without any apparent detrimental effect on the strength of the graphite pultrusion. The color variations may be due to differences in the graphite fiber finishing and the manner in which it wet-out the matrix.

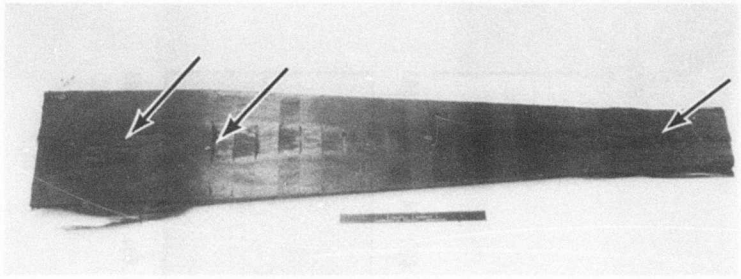
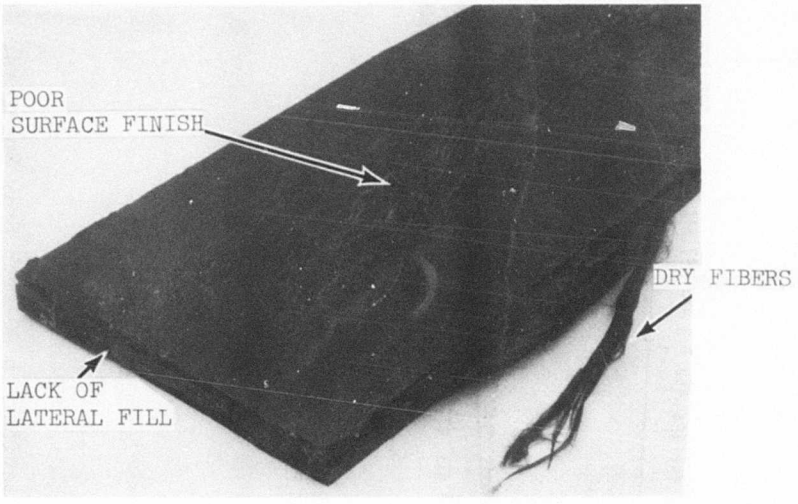
Specimens 1 and 2, 30 inches in length, representing the tail rotor spar from Station 0 to Station 30, were molded from the second shipment of pultrusion material. Attempts to fabricate specimens from this material resulted in components with extensive voids, lack of compaction, fiber tows not coated with resin, fiber twisting, and lack of resin flow during the autoclave molding operation. Figures 38 and 39 illustrate the defects and dimensional variations observed in the specimens. These defects were caused by resin advancement during transit, pultrusion pulling rate and die temperature, and the technique used in stringing the graphite tows.

NOTE:

PULTRUSION QUALITY WAS POOR THROUGHOUT, OVERADVANCED AND NOT ADEQUATELY WET-OUT.

The autoclave pressure used to mold the spar and prepreg plates was increased to 165 psi (including 15 psi of vacuum) in order to assist in obtaining closure of the molding tool.

Specimens 3 through 7 were fabricated incorporating the described corrective actions with progressive successes.

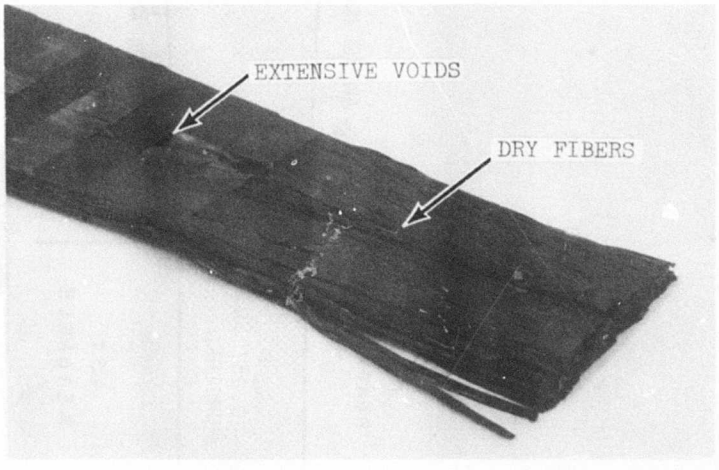
Figure 38. Appearance of 30-inch Spar Specimen, S/N 2.
(Defects depicted by arrows)

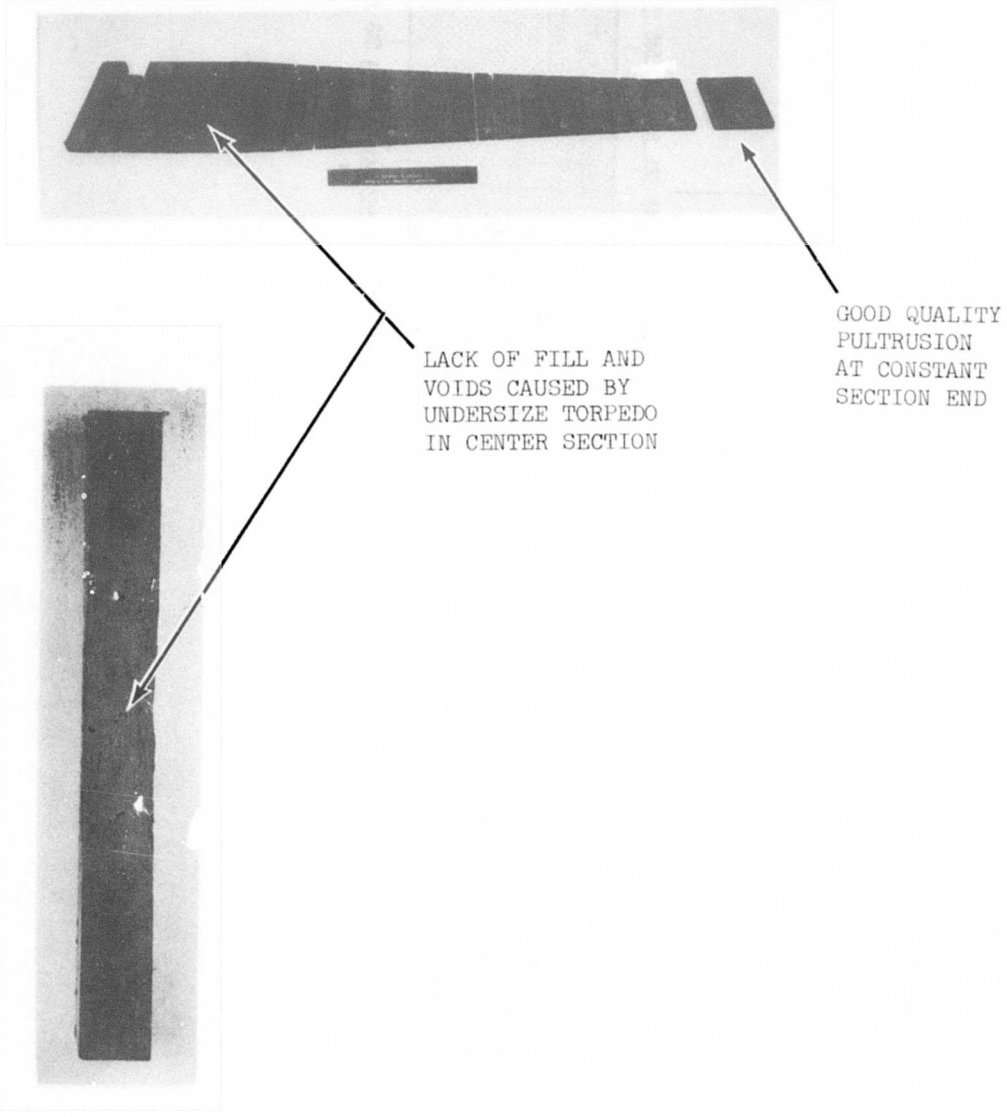
Figure 40. Appearance of 30-inch Spar Specimen, S/N 3.

Specimen 3, 30 inches in length, representing the spar from Station 0 to Station 30, was fabricated. The specimen exhibited good quality in the constant thickness pultrusion area; however, voids were evident in the prepreg root end buildup regions. These voids were attributed to the undersize fit of the prepreg torpedo. Figures 40 and 41 show the lack of fill and voids caused by the undersize torpedo in the center section, and the dimensional variations in the spar.

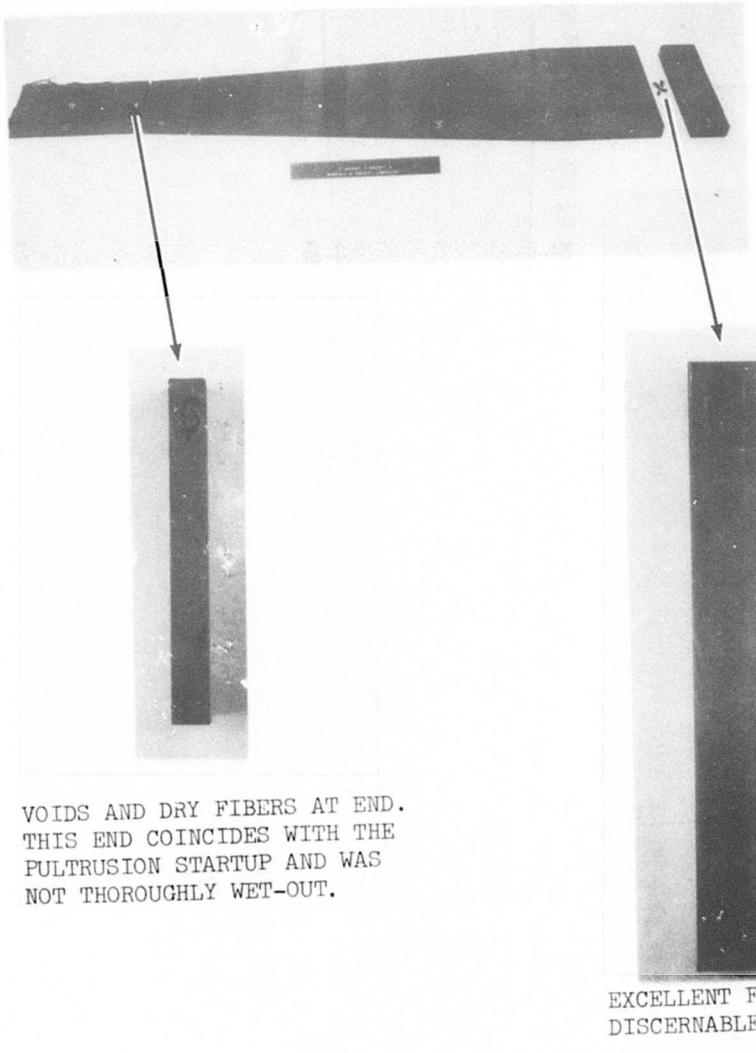
Figure 42. Appearance of 30-inch Spar Specimen, S/N 4.

Specimen 4, 30 inches in length, representing the spar from Station 0 to Station 30, was fabricated using an improved prepreg torpedo layup and pultrusion material of poor quality. The section of pultrusion used was from the start of the pultrusion run and was intermittently coated with resin. The quality of the cured specimen was excellent, but the root end region of the specimen was approximately 0.020 inch oversize. Figures 42 and 43 depict the voids and dry fibers at the end of the specimen, and the dimensional variations in the spar.

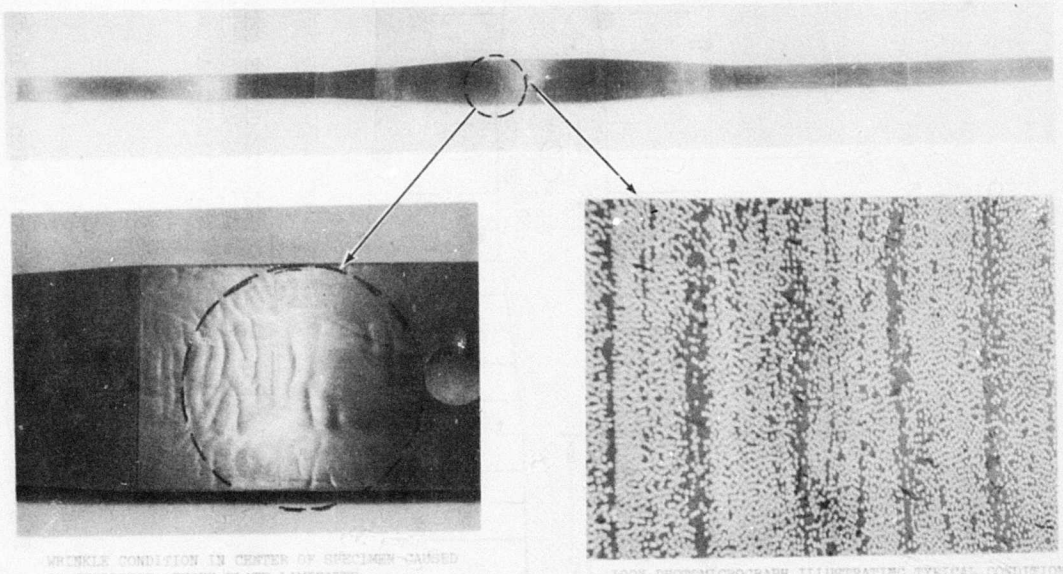
Figure 44. Appearance of Full-Size 10-foot Spar, S/N 5.

WRINKLE CONDITION IN CENTER OF SPECIMEN CAUSED BY INCORRECT LENGTH PLATE LAMINATES.

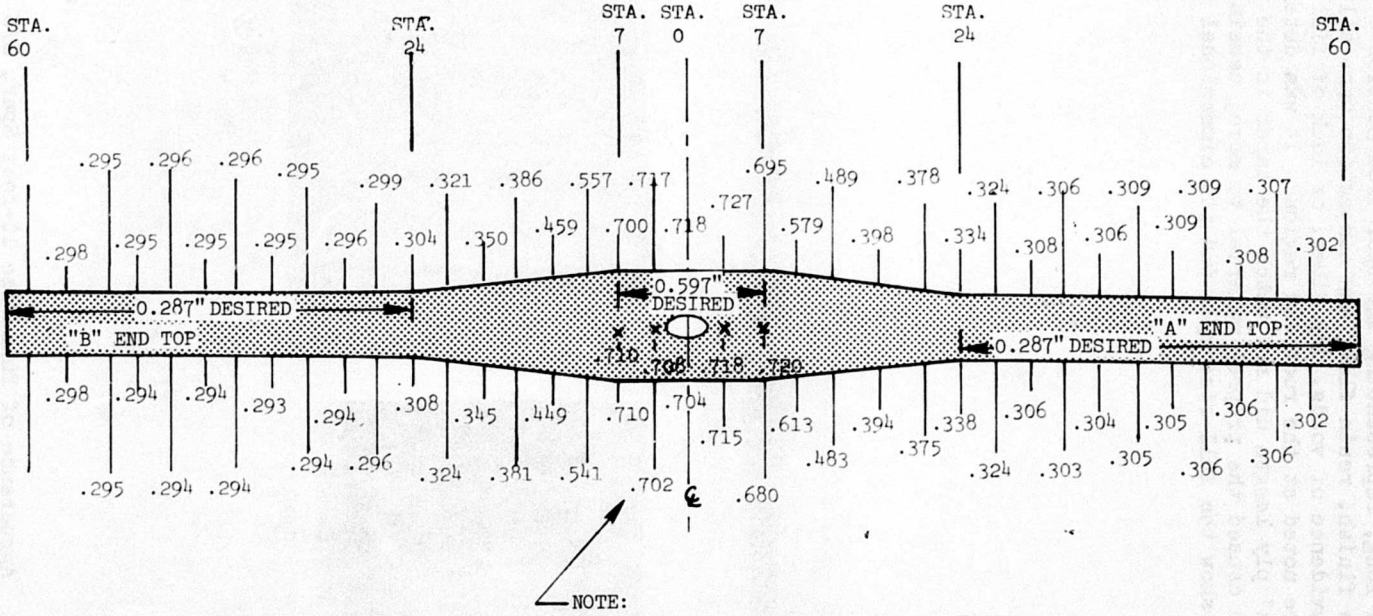
Figure 45. Thickness Variation in 10-foot Spar, S/N 5.

Specimen 5 produced a full-size specimen of excellent quality. The specimen was 120 inches long, representing the spar from Station + 60 to Station - 60. The surface finish, resin flow, and compaction were all of the highest caliber. No evidence of voids, dry fiber, or lack of fill was detected. Wrinkles were noted at the root end region. It was determined that the prepreg plates' ply length did not match the taper in the tool. This mismatch condition caused the prepreg material to move, causing wrinkles. Figures 44 and 45 show the full-size spar and its dimensional variation.

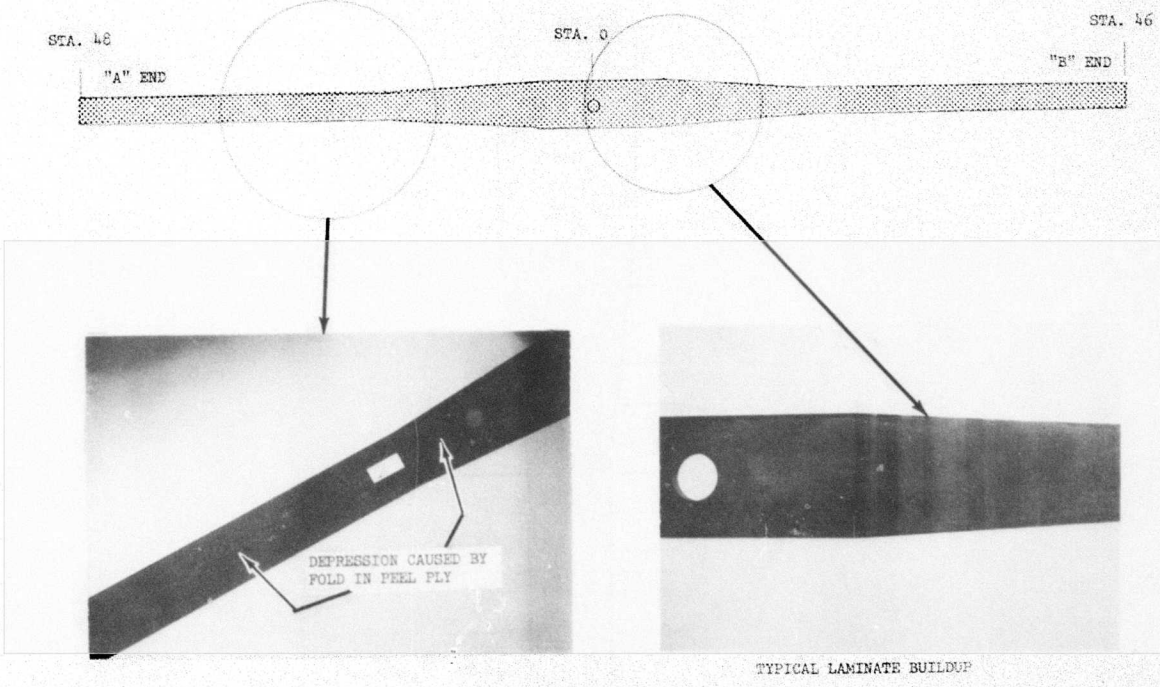
Figure 46. Appearance of Full-Size 10-foot Spar, S/N 6.

Specimen 6 incorporated prepreg plate plies that were modified to account for the nonlinear spar taper. The full-size spar specimen, 120 inches long, representing the spar from Stations + 60 to - 60, was fabricated without wrinkles and was of excellent visual quality as shown in Figure 46. A nylon peel ply was used when molding this spar. Minor folding of the material caused by movement of the pultrusion during molding and associated with the nylon peel ply resulted in several lengthwise depressions in the constant section of the pultrusion (see Figure 46). The thickness of the constant dimension pultrusion area was within the desired spar thickness but the root end region of the spar was 0.020 to 0.030 inch oversize. Because of the fiberglass buildup area in the spar root end region, the assembly can tolerate up to a 0.050-inch oversize condition. Figure 47 shows the dimensional variation in the spar. Photomicrographs of the pultrusion indicate an absence of voids and dry fibers. Figure 48 depicts typical cross sections at 50 and 250 magnifications. The fiber volume of the spar was measured to be 60 percent. This specimen was selected for use as a full-size root end static specimen.

Specimen 7 was laid up using the same general procedure and technique employed for the previous successful specimens. The primary modification was the use of 0.005-inch steel shim stock material in place of the nylon separator film and peel ply that caused linear depressions in the previous S/N 6 specimen. The full-size spar specimen, 100 inches long, representing the spar from Station + 50 to Station - 50, was fabricated with excellent visual quality. No surface anomalies were observed. The thickness of the constant-dimension pultrusion area was 0.005 to 0.010 inch below the desired spar requirement, but was still within acceptable design limits. The root end region of the spar (Station - 7 to + 7) was 0.005 inch undersize to 0.017 inch oversize (see Figure 49). Because of the fiberglass buildup area in the spar root end region, the assembly can tolerate these slight dimensional variances. Photomicrographic examination of cross sections of the spar specimen depicts some voids as shown in Figure 50. None of these voids was considered detrimental to the testing. The fiber volume of the specimen was 65 percent. This specimen was selected for use as the full-size spar root end fatigue test specimen.
