USAAVRADCOM TR 79-45

MM&T FIBER-REINFORCED PLASTIC HELICOPTER TAIL ROTOR ASSEMBLY (PULTRUDED SPAR)

Maron J. Bonassar and John J. Lucas
Sikorsky Aircraft Division
United Technologies Corporation
Stratford, Conn. 06602

Final Report for Period August 1975 - October 1978

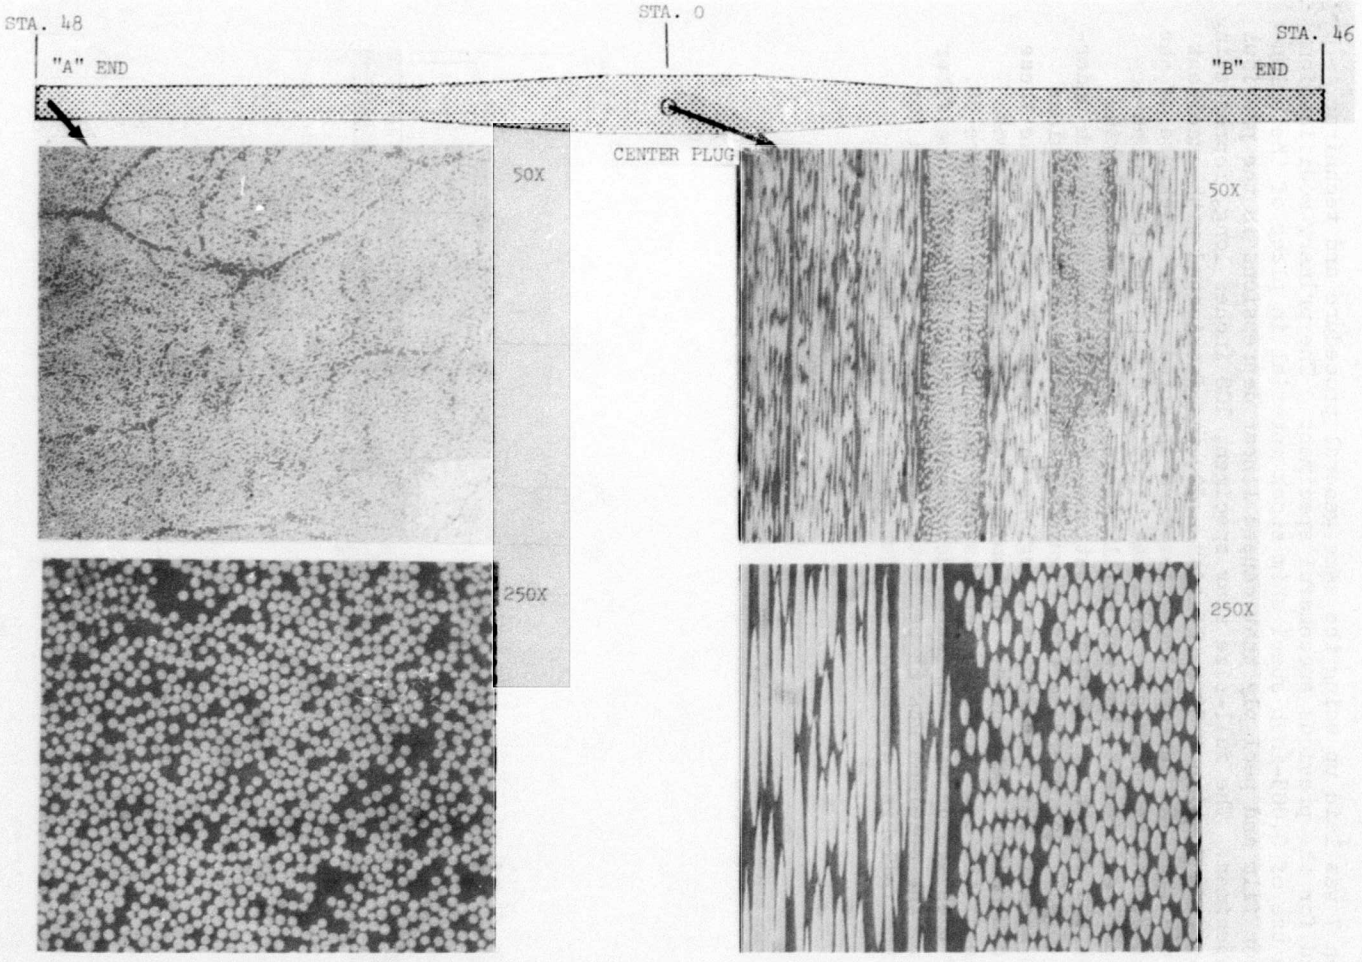
Figure 48. Photomicrographs of Cross Sections of Full-Size Spar, S/N 6.
(Depicting good compaction and absence of voids)

Specimen 6 incorporated prepreg plate plies that were modified to account for the nonlinear spar taper. The full-size spar specimen, 120 inches long, representing the spar from Stations + 60 to - 60, was fabricated without wrinkles and was of excellent visual quality as shown in Figure 46. A nylon peel ply was used when molding this spar. Minor folding of the material caused by movement of the pultrusion during molding and associated with the nylon peel ply resulted in several lengthwise depressions in the constant section of the pultrusion (see Figure 46). The thickness of the constant dimension pultrusion area was within the desired spar thickness but the root end region of the spar was 0.020 to 0.030 inch oversize. Because of the fiberglass buildup area in the spar root end region, the assembly can tolerate up to a 0.050-inch oversize condition. Figure 47 shows the dimensional variation in the spar. Photomicrographs of the pultrusion indicate an absence of voids and dry fibers. Figure 48 depicts typical cross sections at 50 and 250 magnifications. The fiber volume of the spar was measured to be 60 percent. This specimen was selected for use as a full-size root end static specimen.

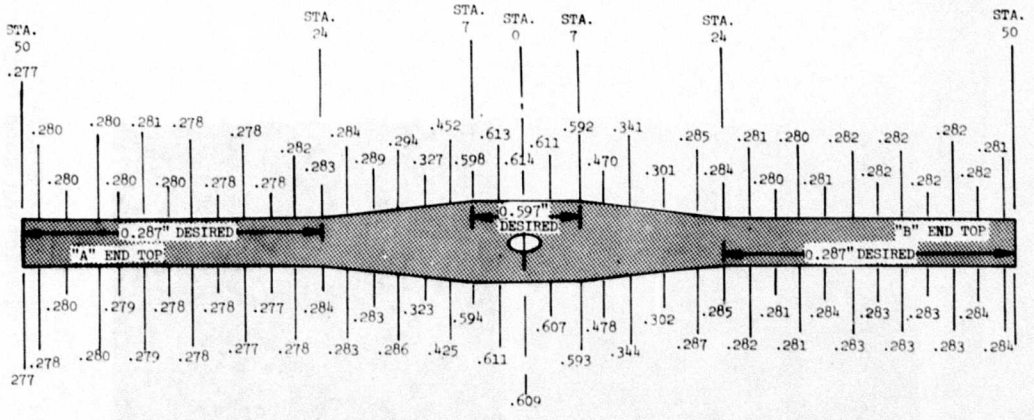
Figure 49. Thickness Variation in 100-inch Spar, S/N 7.

7	Full-Size Spar	25 April 1977	3 May 1977	152 lb of dry ice in package when received 72 hr after fabrication at GEI. Overall quality of pultrusion was good.		S/N 7 fabricated in accordance with procedure established for S/N 6. S/N 7 exhibited good visual quality. Spar to be used for fatigue test specimen. (See Figures 49 and 50). Constant Section Pultrusion (Sta. 24 to 50) Fiber volume 65% within desired thicknesses, no significant voids, good surface finish. Tapered Section (Pultrusion/Prepreg Sta. 0 to 24) Fiber volume 54%, visual quality good, 0.003-inch undersize to 0.017-inch oversize condition.

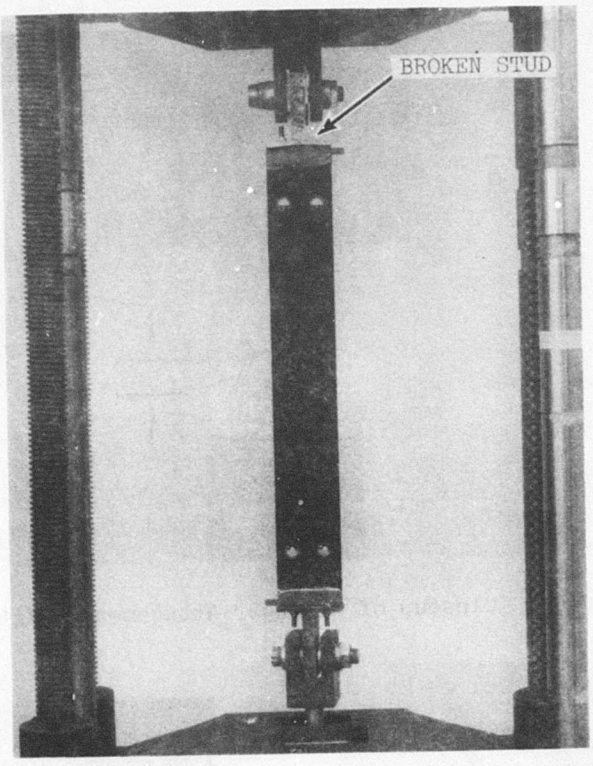
Figure 59. Tip Attachment Specimen, Static Test.

Static testing of the tip attachment specimen was accomplished in axial tension loading at room temperature. Failure of the specimen occurred after 9,250 pounds axial load was attained. This value is well above the design load of 8,150 pounds. Failure of the tip attachment specimen occurred through the threaded area of one of the -109 studs, as shown in Figures 59 and 60. During testing, one of the T-fittings that attach the specimen to the testing machine was observed to have bent as shown in

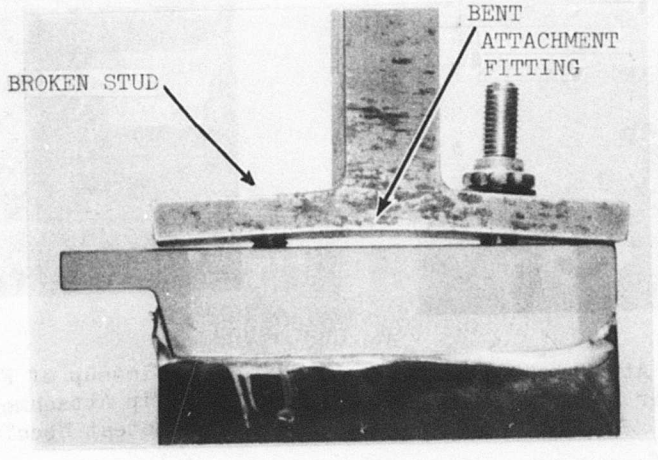
Figure 60. Closeup of Failed Area, Tip Attachment Specimen.
(Note bent test attachment fitting)

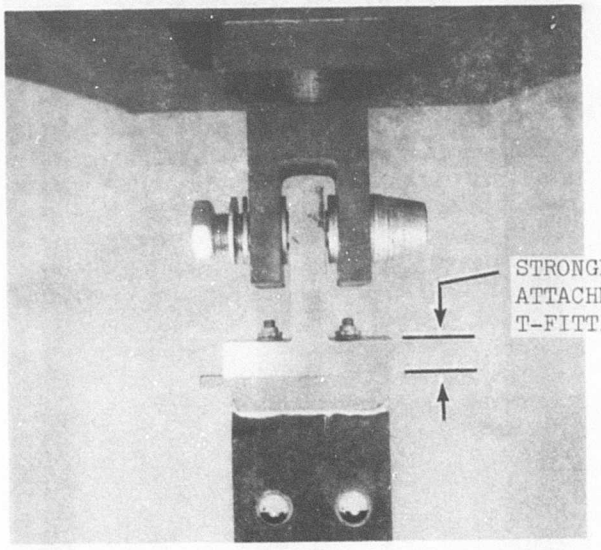
Figure 61. Closeup of Stronger Attachment T-Fitting.

Figure 60. Bending of the T-fitting also introduced bending as well as axial loads on the studs and directly influenced failure of the studs. A stronger attachment fitting was fabricated and the tip attachment specimen was retested. Only the end of the specimen, which previously did not fail, was retested. The end that originally failed was secured in the test facility by wedge-type grips. A value of 11,600 pounds axial load was attained before failure of the tip attachment specimen occurred. This value is well above the tensile allowable of 8,150 pounds and the previous value of 9,250 pounds for the other end of the test specimen. Failure of the tip attachment specimen retest occurred by stripping the threads of one of the SS5086C04S nuts. This failure mode differs from the original failure mode through the threaded area of one of the -109 studs. Figure 61 shows the tip attachment static setup at the retest end before testing, while Figures 62 and 63 depict the tip attachment specimen after testing.

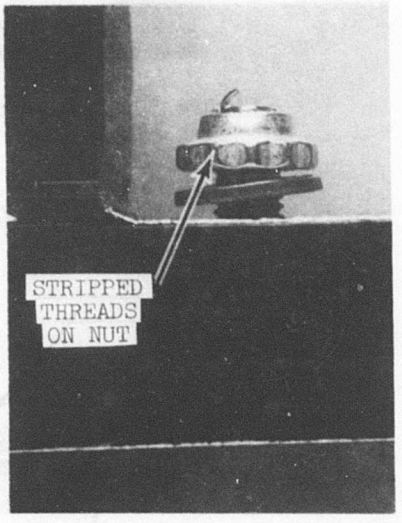
Figure 63. Closeup of Failed Area, Tip Attachment Static Retest Specimen. (2X)

(Note that failure mode is different than original)

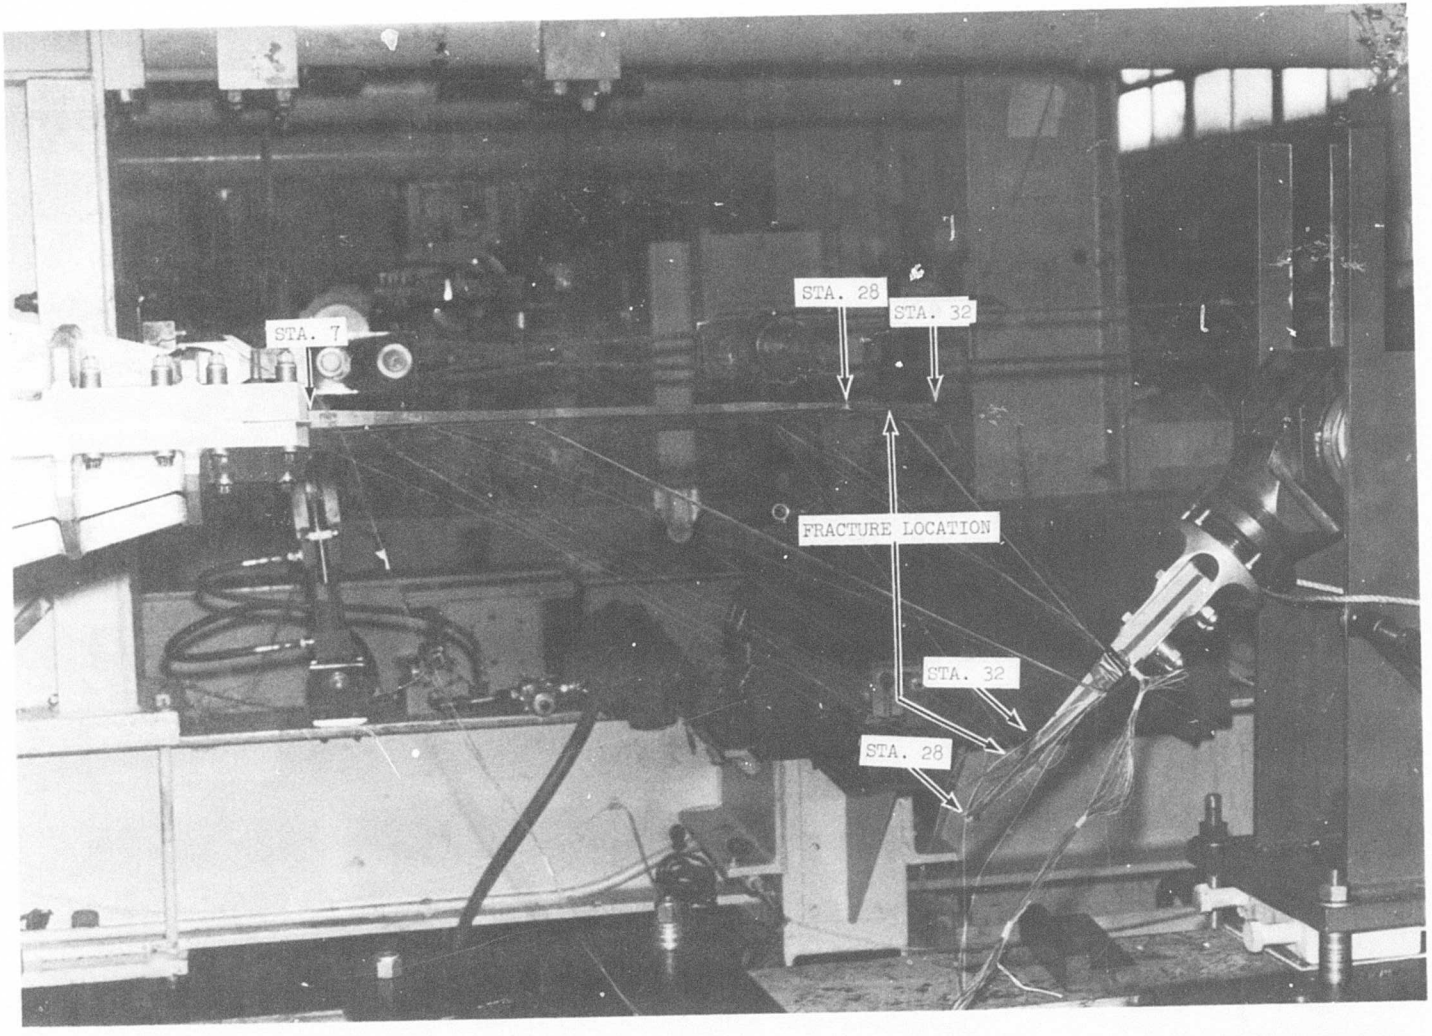
Figure 67. Root End Static Test Specimen, Fractured.

Static Root End Evaluation. In an effort to determine more definitively the cause of fracture at Stations 28 to 32, analyses of the test data, test conditions, and material were performed. Results of the analysis of the test data and test conditions revealed no abnormal factors that contributed to the premature fracturing of the spar specimen at the Station 28 to 32 location; i.e., the critical section is analytically predicted to be at Station 7.75. Macro- and micro-examination of cross sections confirmed that the ultrasonic indications were local dry, unwetted fiber areas as depicted in Figure 70. Short beam interlaminar shear test specimens were sectioned from several locations in the pultrusion material portion of the spar specimen and subsequently tested. The shear specimens were taken from areas in and adjacent to the dry fiber areas observed in

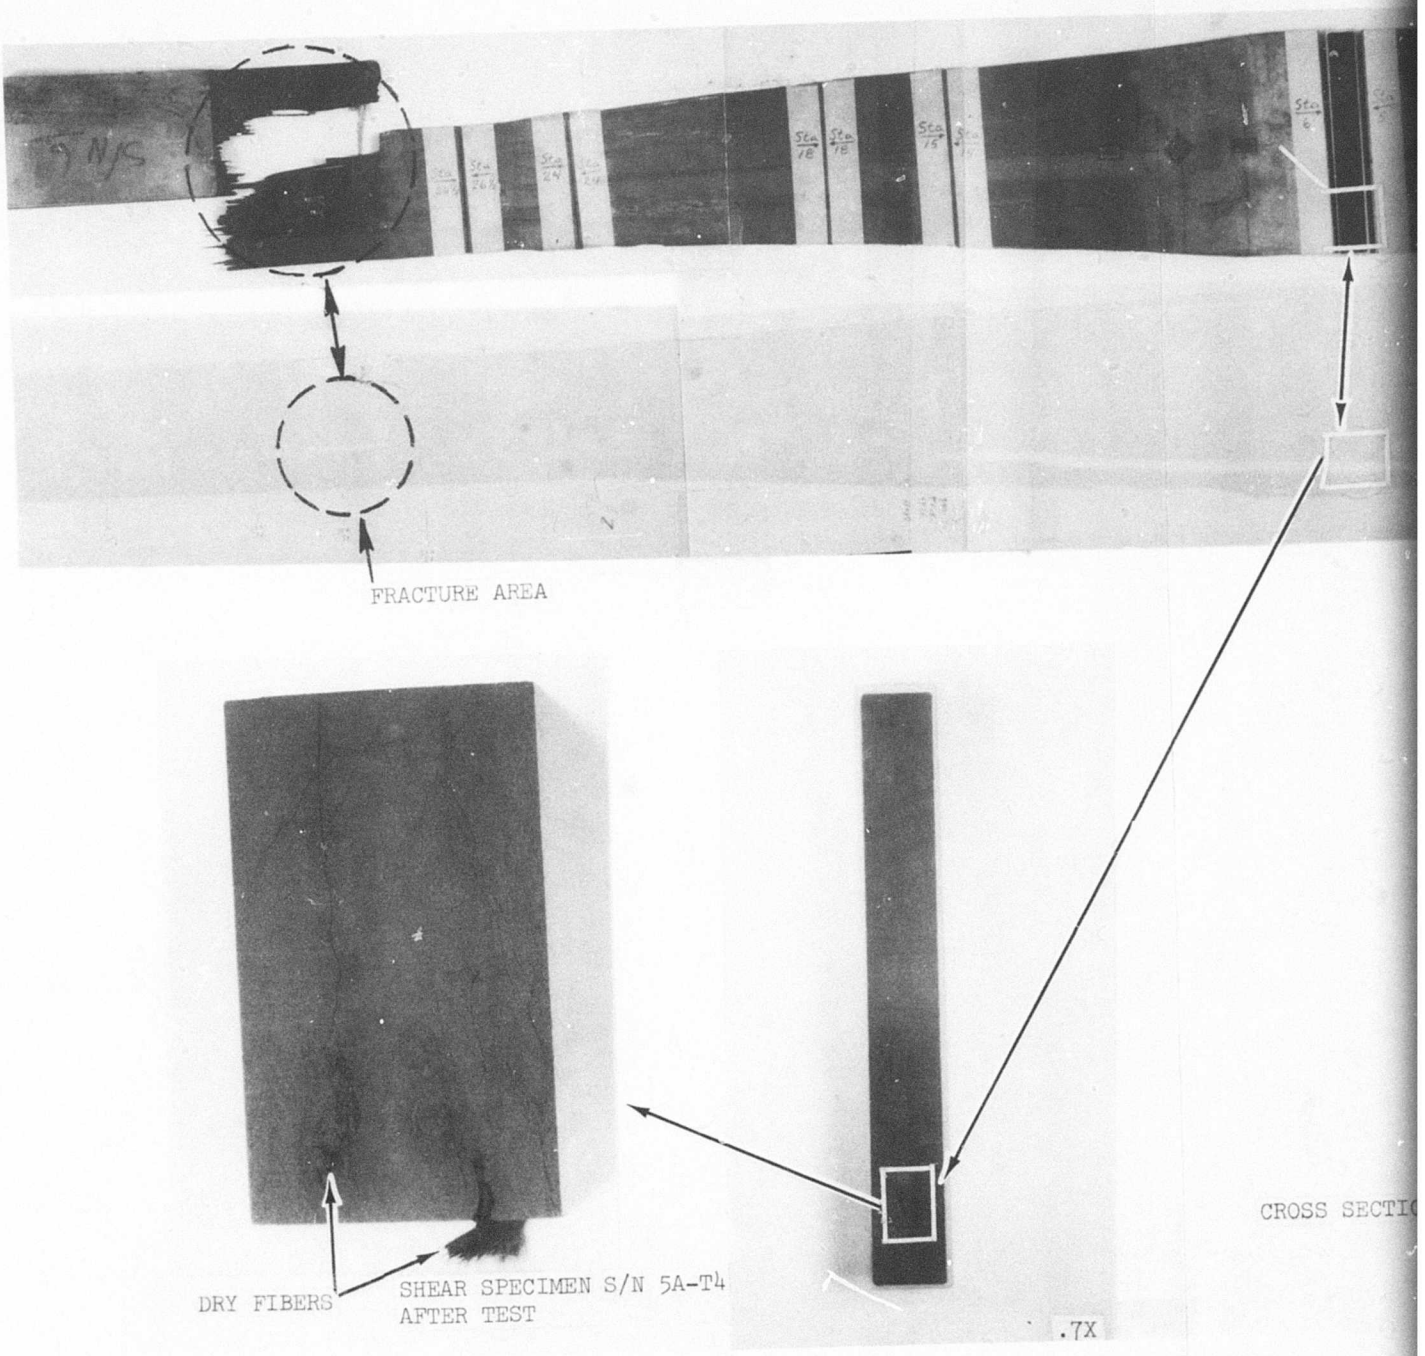
Figure 70. Static Test Specimen With Ultrasonic C-scan Recording and Cross Sections Depicting Indications of Dry Fibers in Pultrusion Material.

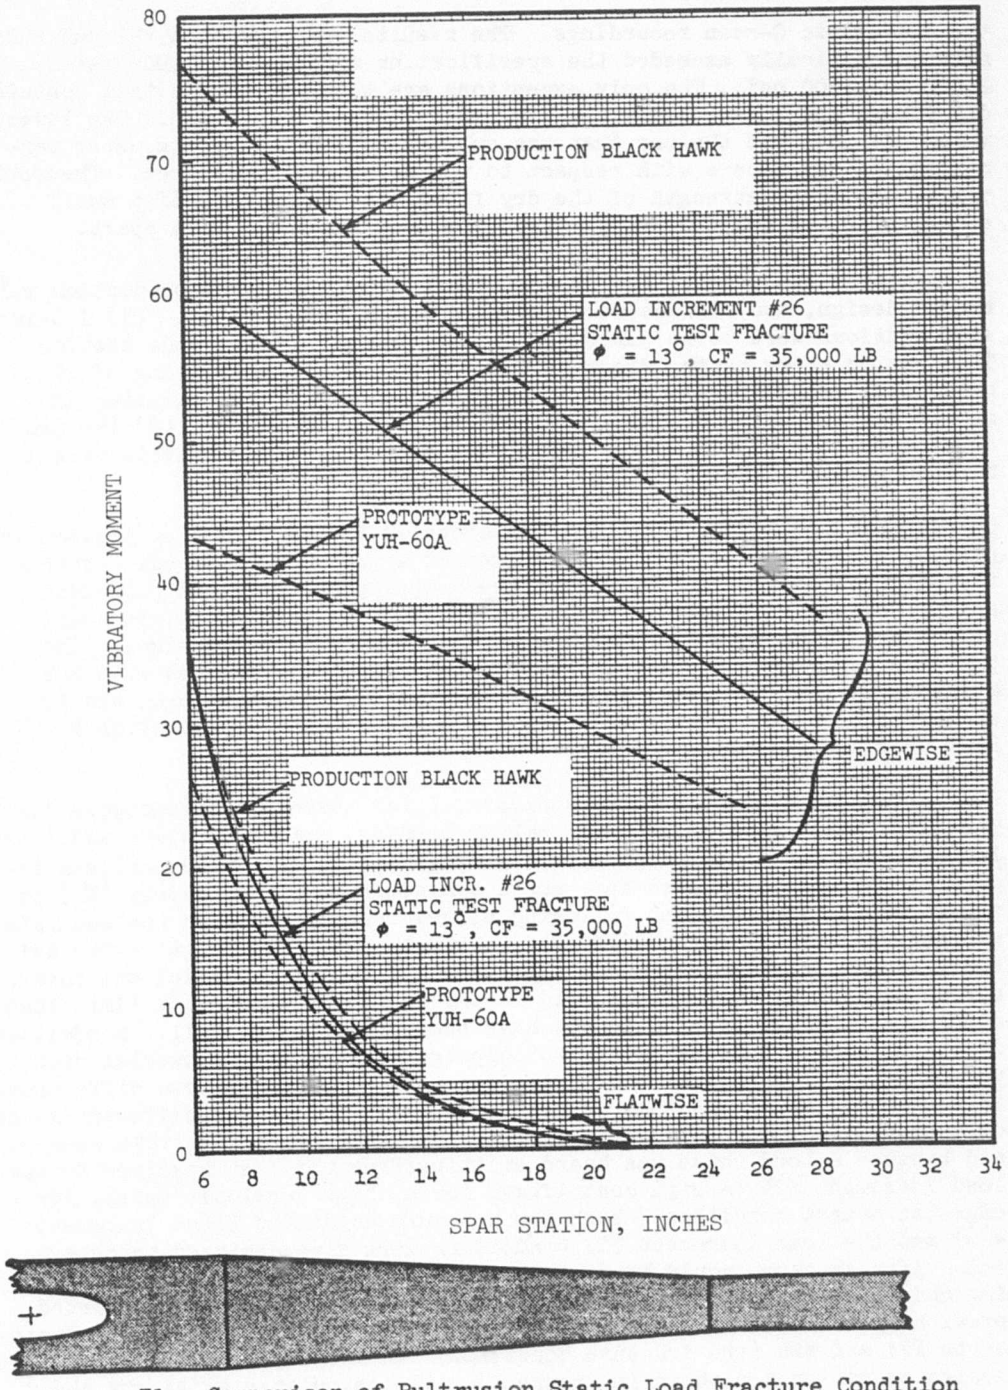
Figure 71. Comparison of Pultrusion Static Load Fracture Condition With Prototype and Production Requirements.

Static Root End Stress Analysis. As shown in Figure 71 and as previously discussed, the static fracture occurred at a test condition that exceeded the original design conditions for the prototype (UTTAS) and pultruded spar. However, the load level was lower than the new 1.5X limit load design condition used for the production BLACK HAWK spar designs. The pultruded spar stress analysis had predicted positive margins with the original design load condition. The initial effort, therefore, was to analyze the current pultruded spar design using the new production BLACK HAWK spar loads.

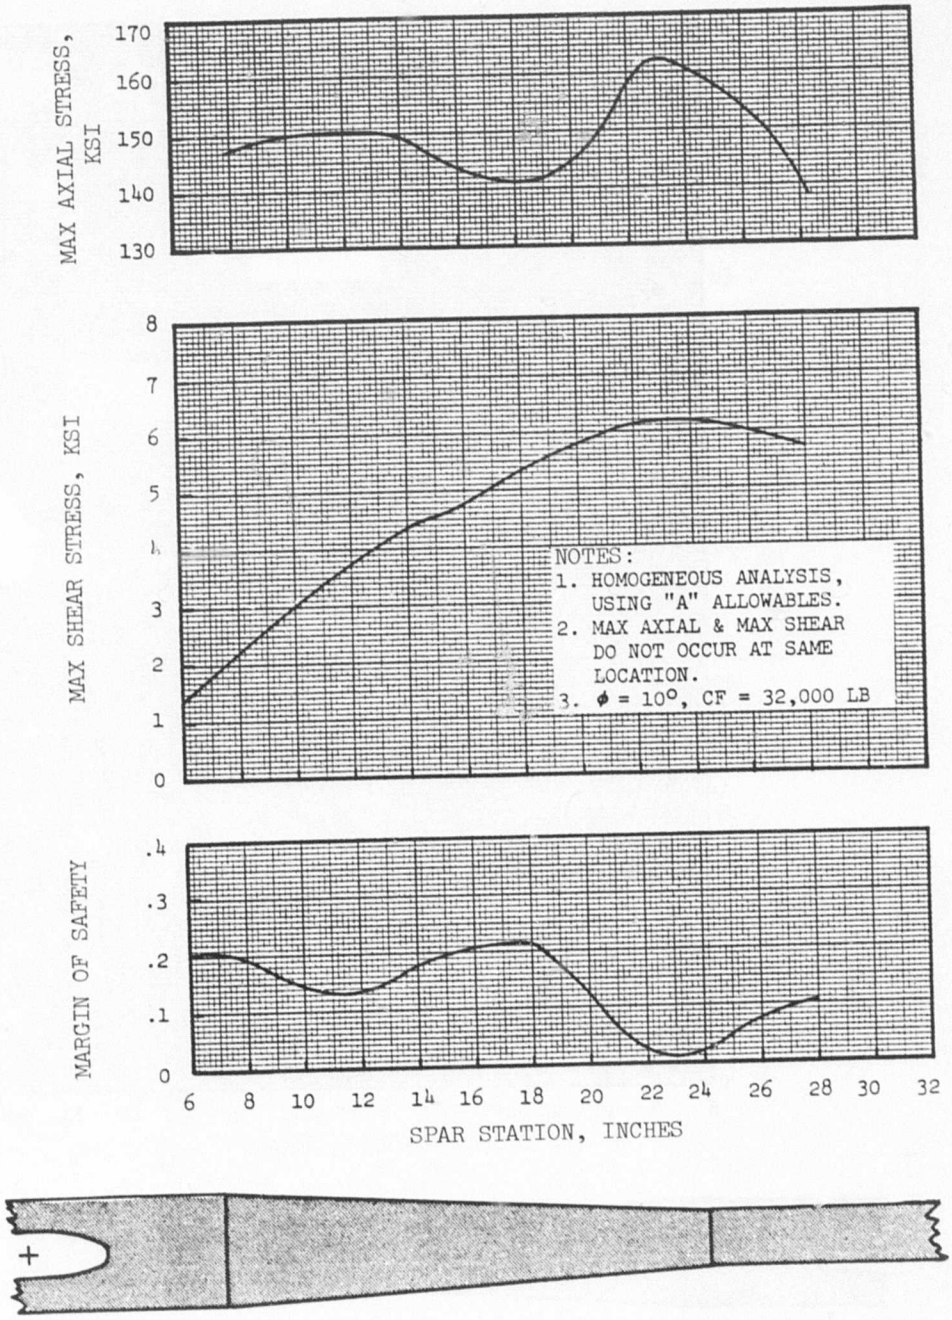
Figure 72. Maximum Axial Shear Stress and Calculated Margin of Safety for Pultruded Spar Design.

Figure 72 summarizes the basic analysis, which assumes a homogeneous spar. The "Hill Criterion" was used to combine bending, axial, in-plane and interlaminar shear stresses to predict the margin of safety. The analysis indicates that the pultruded spar shows a minimum margin of safety (MS) of + 0.01 at Station 23. The following allowables were used in the analysis: ultimate flexure strength - 180 ksi, ultimate tensile strength - 160 ksi, and ultimate interlaminar shear - 10 ksi. If the flight axial and shear stress distribution are duplicated in the lab for the new 1.5X limit load condition, the specimen would not have been predicted to fail. Nonfailure of the specimen would have been anticipated because the allowables used were reduced from typical small specimen mean strengths. Some differences in the actual axial and shear stresses do exist due to the different method of introducing loads between in-flight and static test. For this reason, and because a loud noise was heard emitting from the test specimen during load increment #21 (a high centrifugal force, high torsional twist, low edgewise moment condition), both the fracture condition (load increment #26) and the load increment #21 conditions were also analyzed to determine if a fracture could have been predicted. Details of the loading and unloading sequences and reasons for the sequences were reported previously in Table 14. The actual load distributions attained for increments #21 and #26 (the fracture condition) and for the new 1.5X limit load design condition are shown in Figure 73. The calculated axial and shear stresses and margins of safety versus span are shown in Figure 74 along

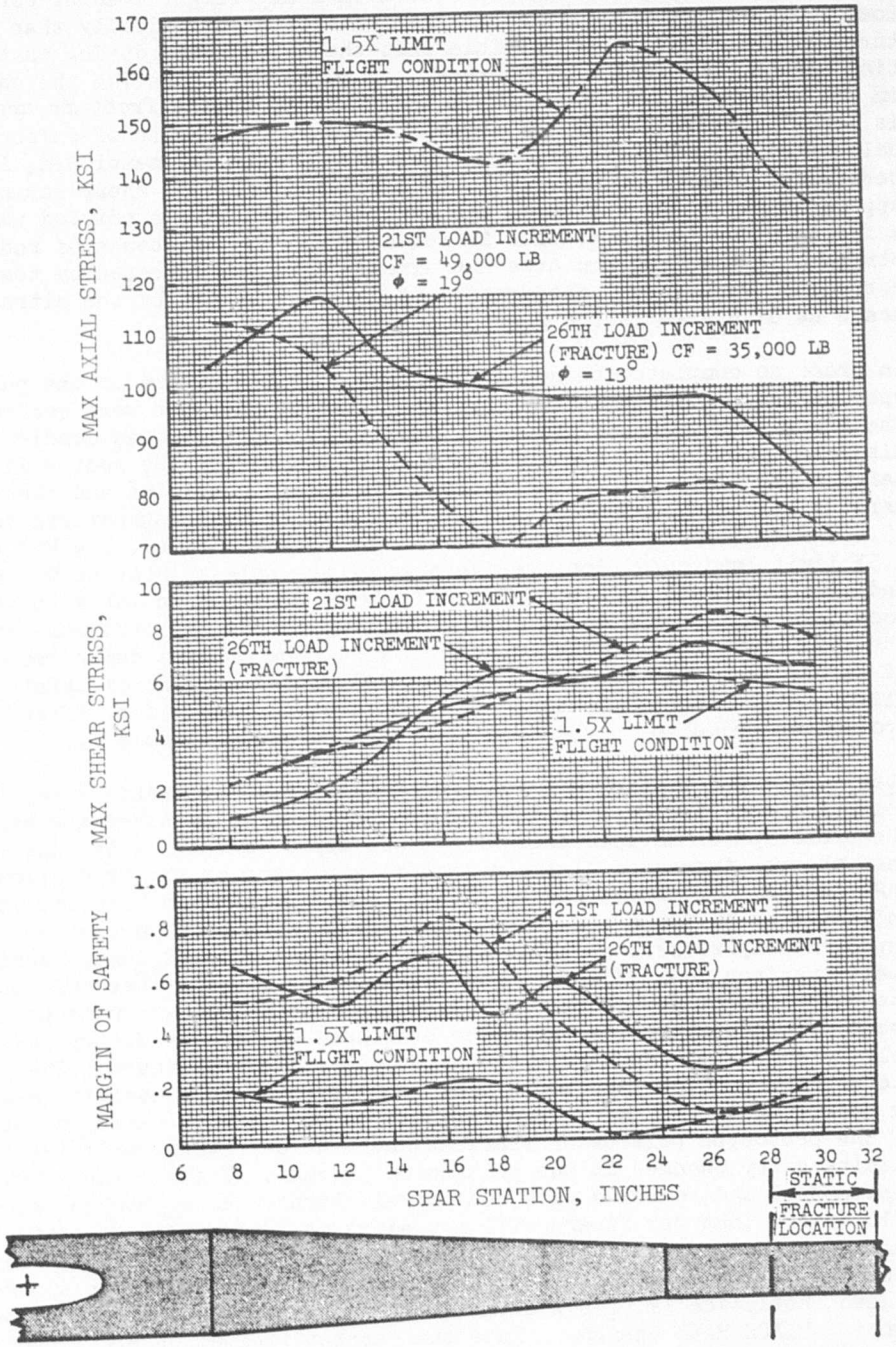
Figure 74. Comparison of Maximum Axial and Shear Stress, and Calculated Margins of Safety for 1.5X Limit Load.

with the previous prediction for the 1.5X limit flight loading condition. Load increment #21 is a more critical condition analytically than the fracture condition and it is possible that the noise heard during that condition was the initiation of a crack. As shown in Figure 74, the calculated MS for increment #21 is + 0.08 in the vicinity of the fracture area and is largely controlled by the shear stresses. The margin of safety was calculated assuming the allowable stresses previously mentioned, i.e., interlaminar shear = 10 ksi, etc. If a reduced value of shear stress of approximately 9 ksi was used, the analysis would have predicted MS = 0 or a fracture for test condition increment #21. The existence of reduced shear strength in the fracture area has already been demonstrated by test and correlated with visual observation of dry fibers, and by the ultrasonic C-scans as discussed in the previous section.

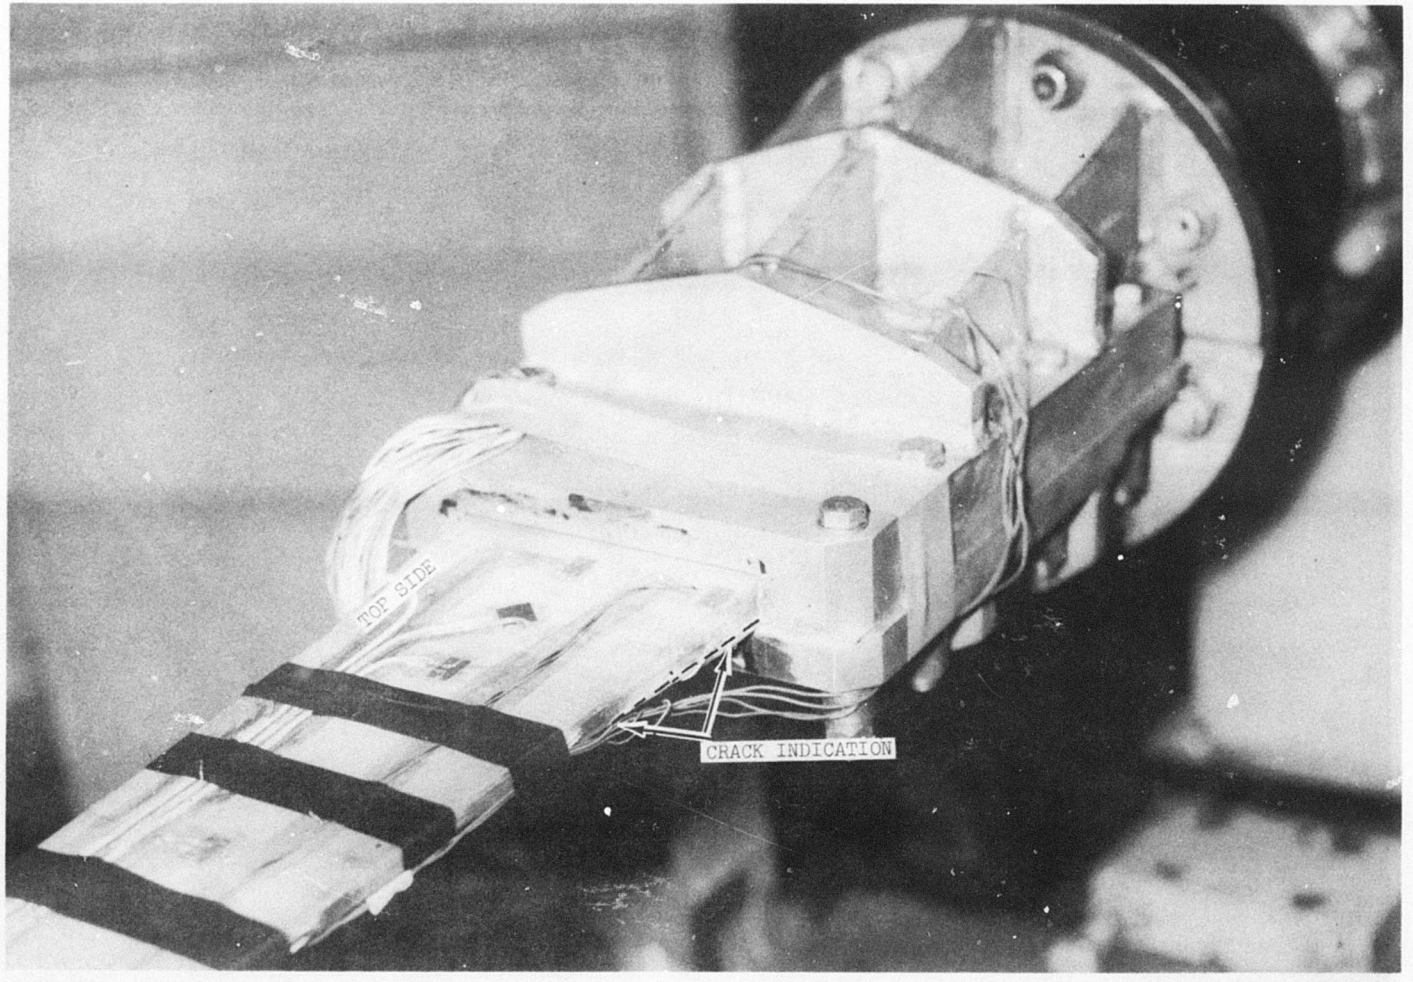
Figure 76. Fatigue Test Specimen Depicting Crack Indication.

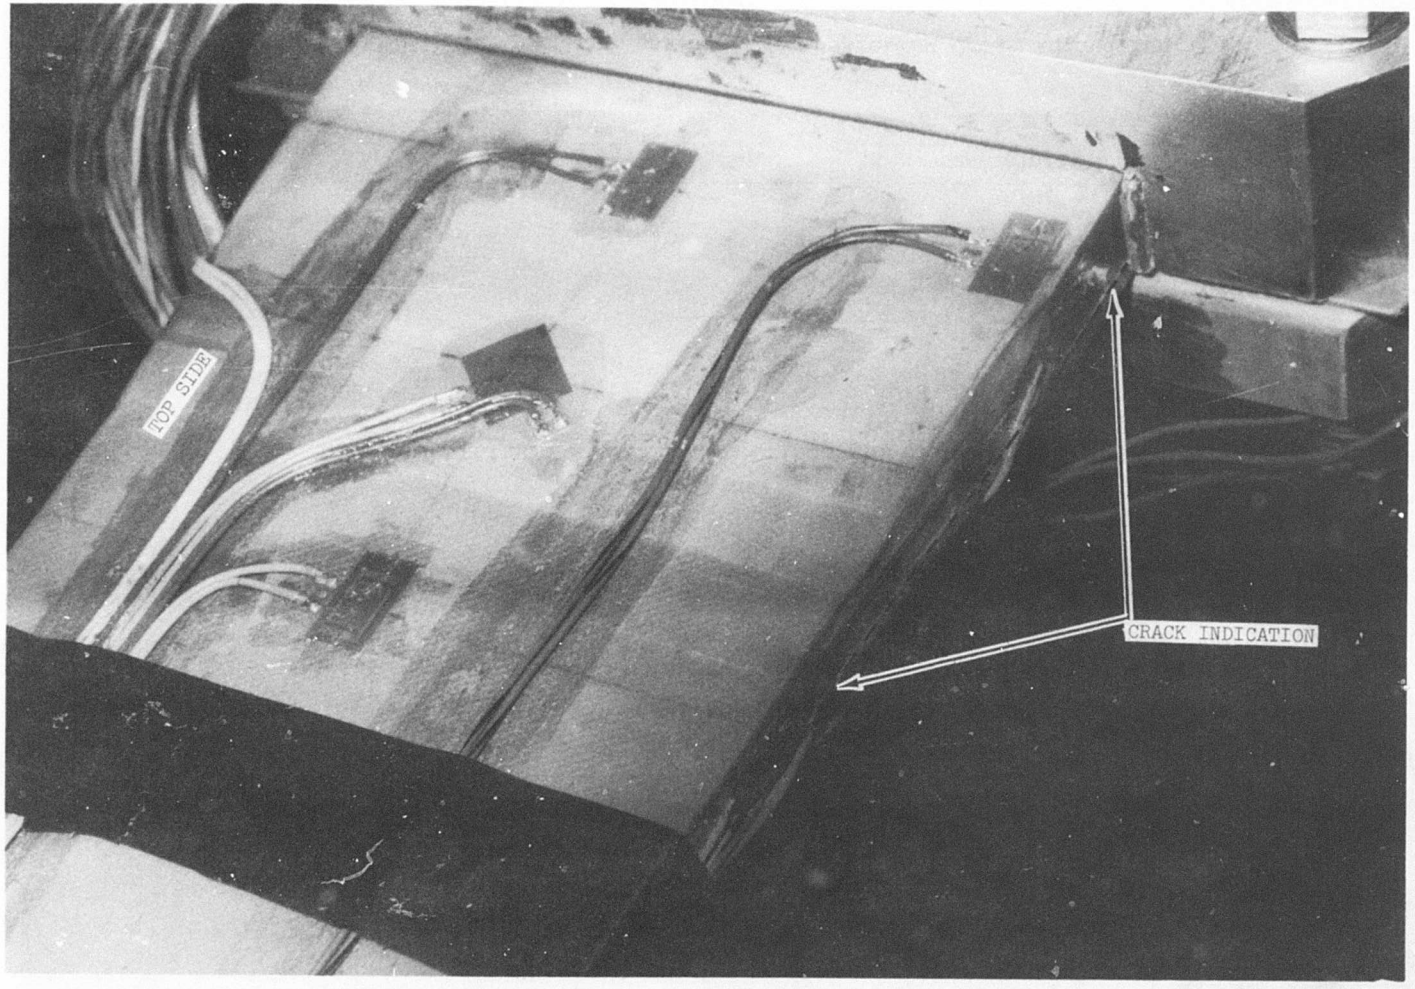
Figure 77. Closeup of Fatigue Test Specimen Depicting Crack Indication.

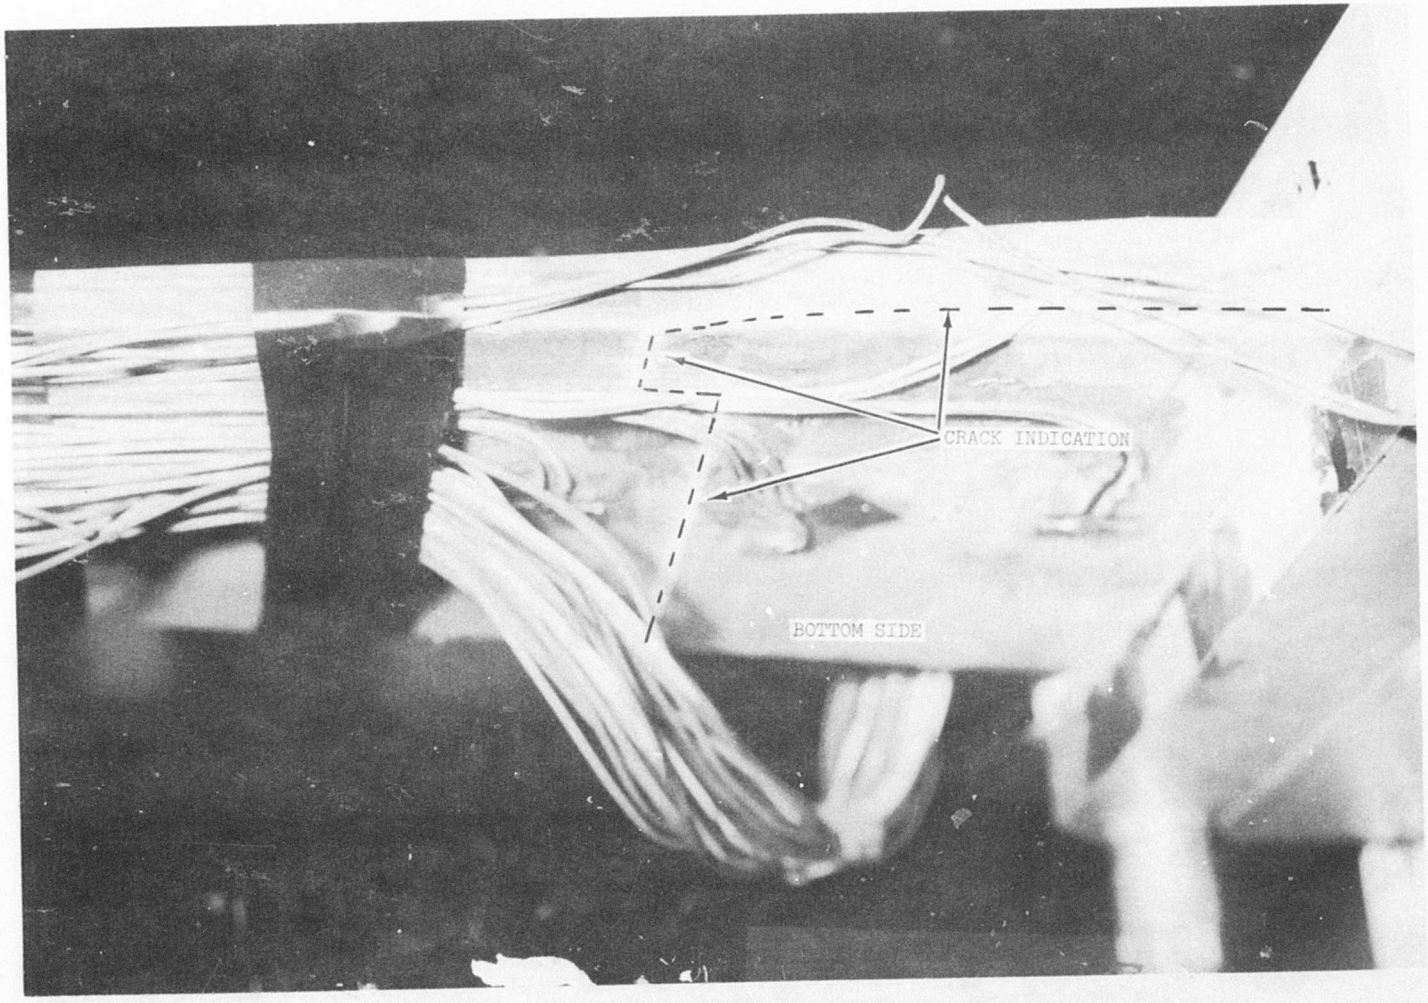
Figure 78. Fatigue Test Specimen Depicting Crack Indication Extending Onto Bottom Side.

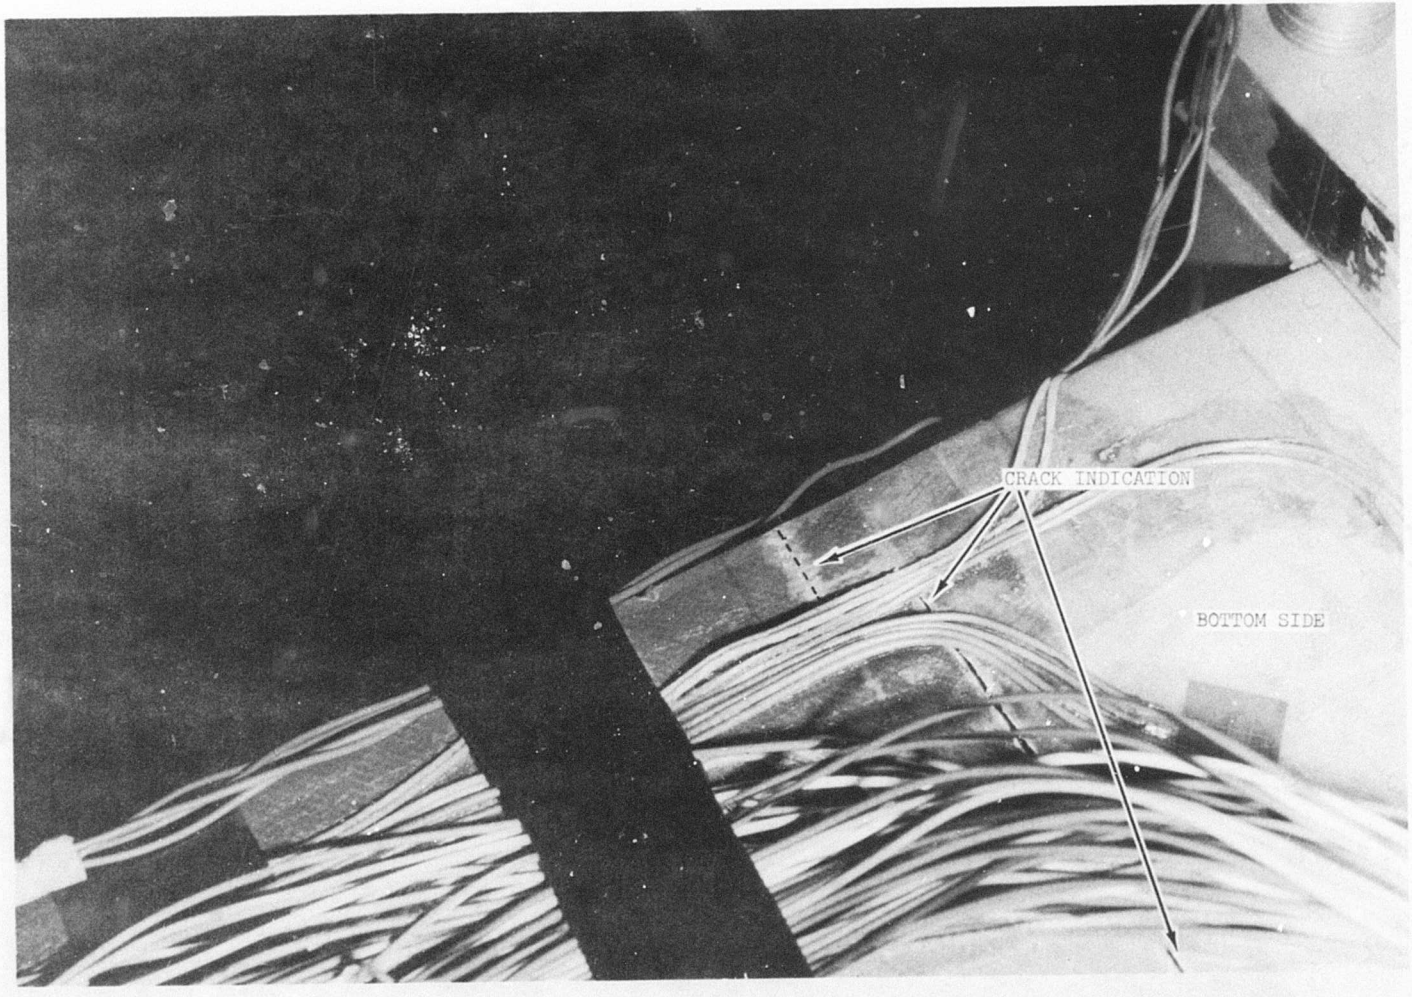
Figure 79. Closeup of Fatigue Test Specimen Depicting Crack Indication on Bottom Side.

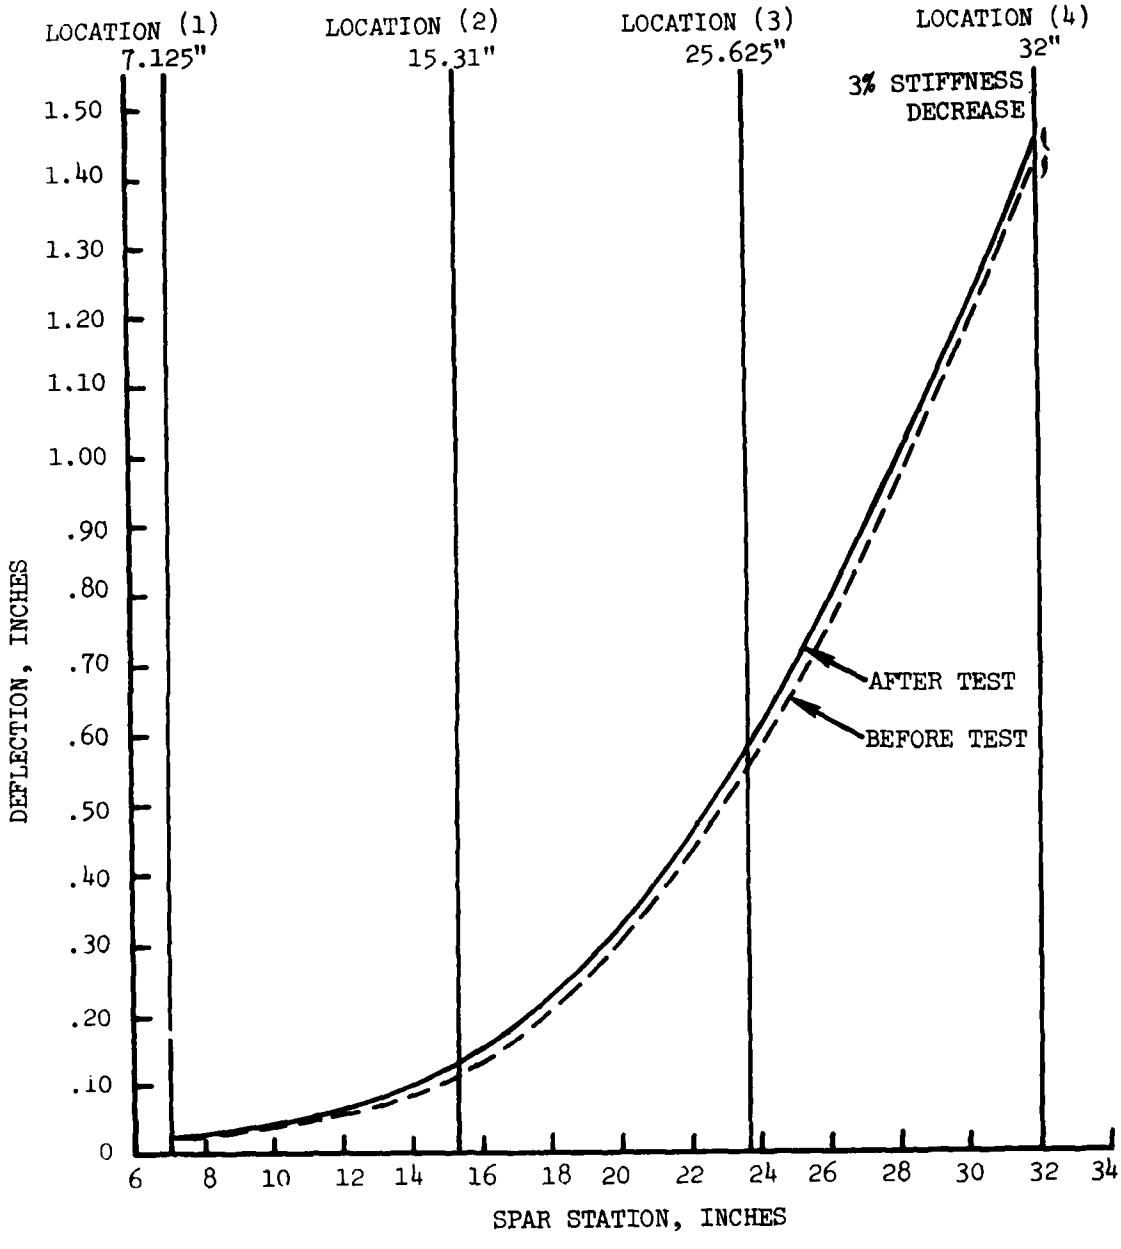
Figure 81. Flatwise Stiffness Curves of Fatigue Root End Test Specimen Before and After Testing.

Stiffness measurements of the fatigue specimen after crack detection were performed for comparison to values before the test. No significant difference in stiffness was detected. The change observed in the before and after measurements, e.g., the 3 percent in the flatwise direction, is generally within the normal scatter of measuring and is not considered a significant change. Figure 80 depicts the stiffness measurement setup. Figures 81, 82, and 83 are plots of each load direction at the maximum load used in the stiffness measurement. These plots depict the high load deflection obtained at each spar station during the calibration. These deflection conditions illustrate that there is no significant change in the before and after measurements.

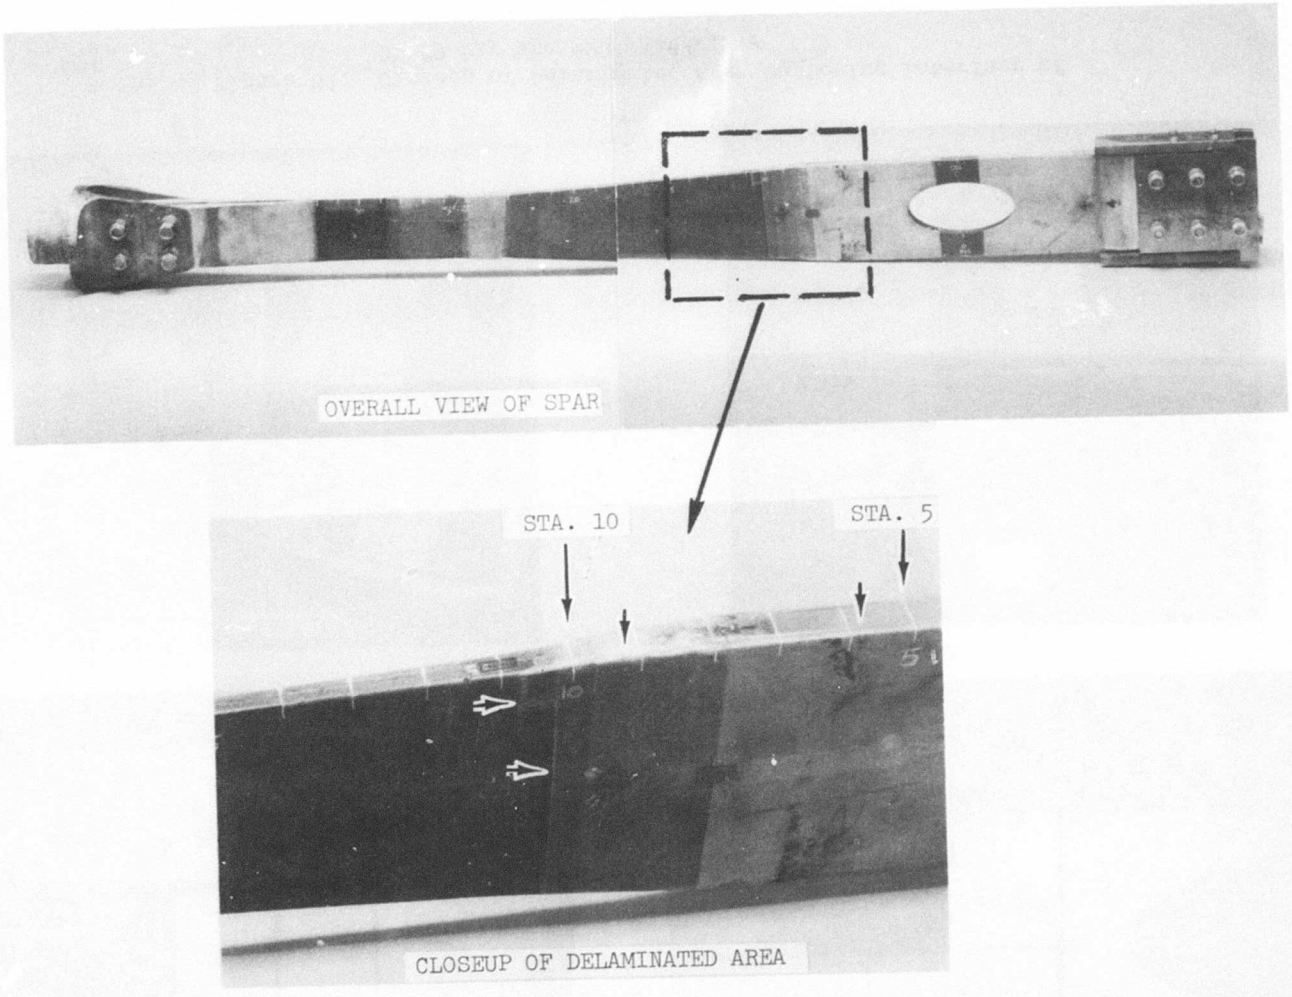
Figure 84. Fatigue Crack Indication in Root End Fatigue Test Specimen, S/N 7.

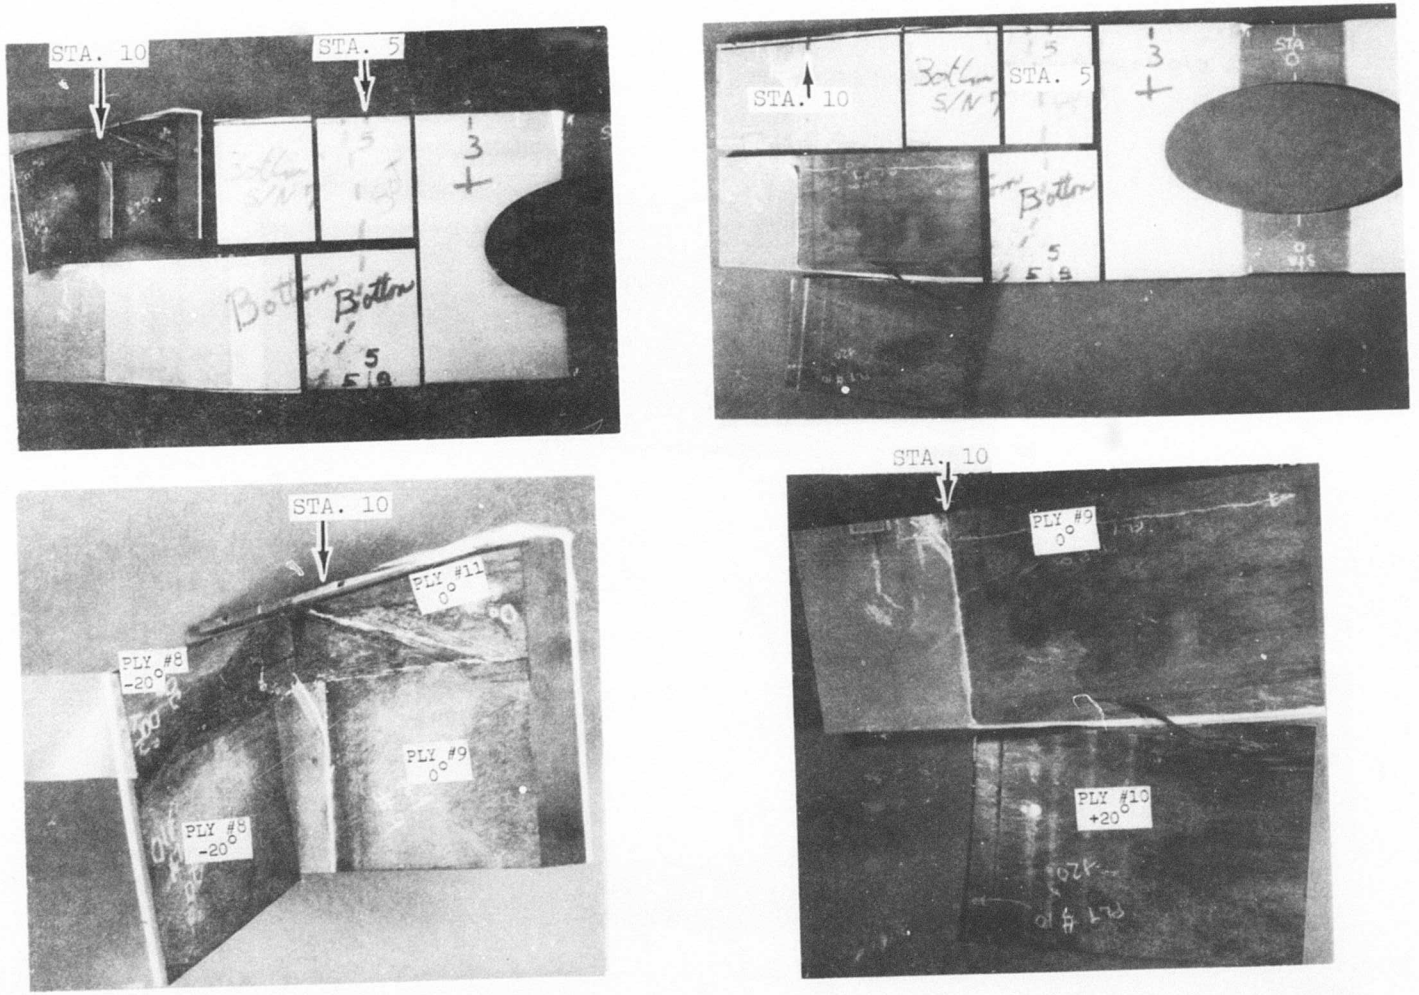
Figure 85. Closeup of Delaminated Area Depicting Interface of 0° #9 Ply and +20° #10 Ply.
