Low-Cost Shore Protection

Final Report on the Shoreline Erosion Control Demonstration Program (Section 54)

1981

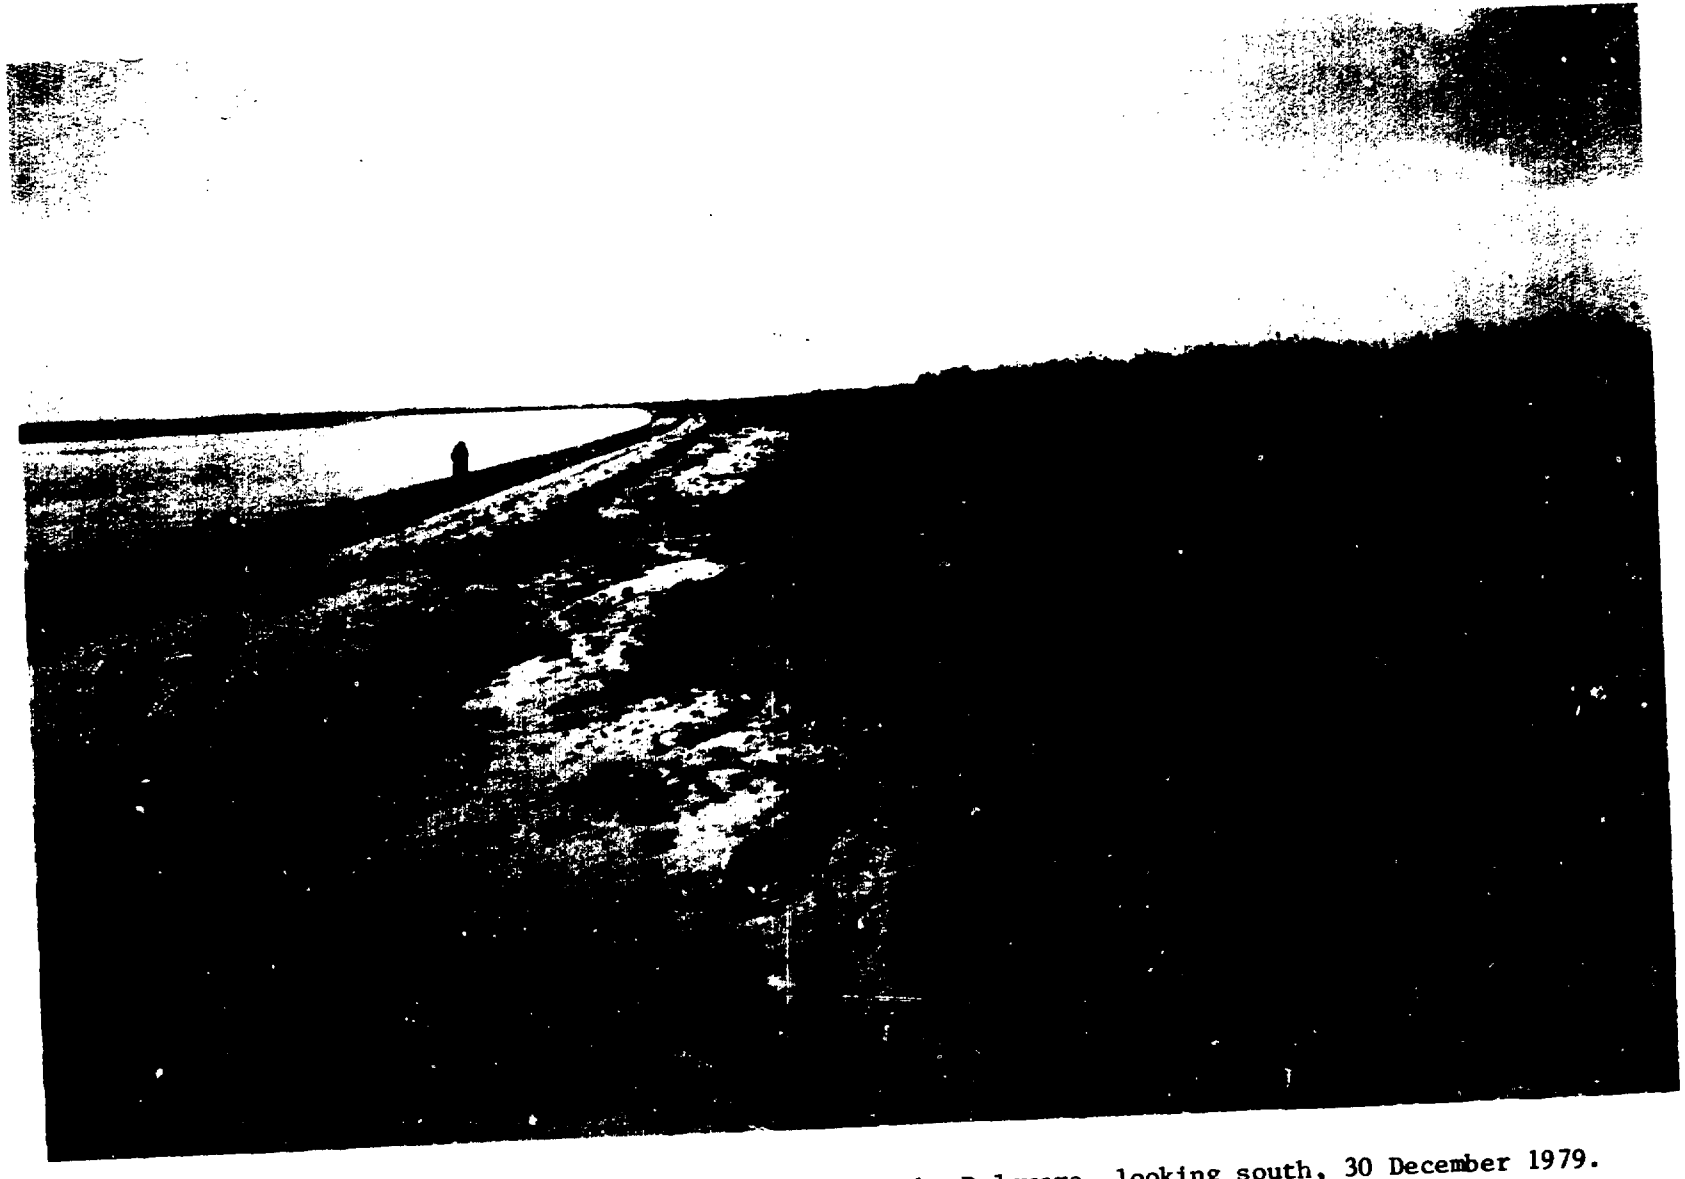
Beachgrass also did very poorly at this site. Midseason survival was about 40 percent, but the end-of-season count showed only 7 percent of the original plantings remaining. In May 1980, only the uppermost row of beachgrass remained. Figures 2-23 and 2-24 show the vegetation plantings in December 1979.

Figure 2-23. Vegetation plantings at Kitts Hummock, Delaware, looking south, 30 December 1979.

Figure 2-24. Vegetation plantings at Kitts Hummock, Delaware, looking north, 30 December 1979.

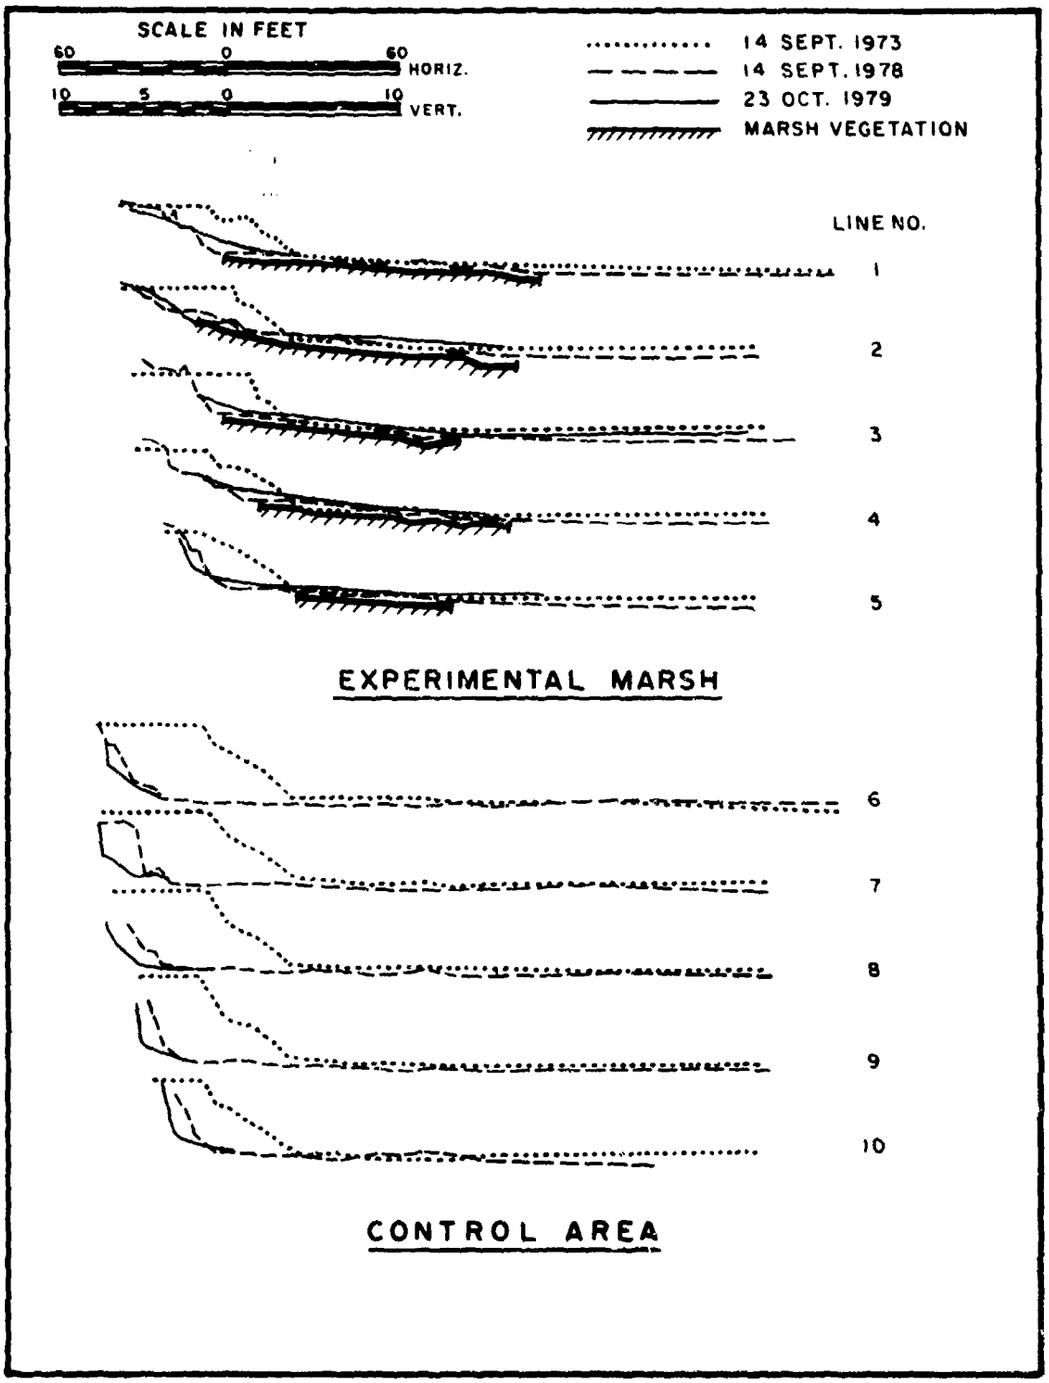
The effect of the experimental marsh in slowing the rate of bank erosion is indicated by the profiles in Fig. 2-74. While the control area shoreline continued to erode at an average rate of 8.8 feet per year, the rate of shoreline recession behind the marsh decreased progressively as the growth of vegetation provided more and more protection. The profiles taken in October 1939 show that bluff erosion behind the marsh has now ceased, while erosion in the control area is continuing unabated. Volume calculations based on the profile data show that some accretion occurred in the marsh area between the May and October surveys in 1979 (Table 2-21).

Figure 2-74. Comparative profiles, Duck, North Carolina.

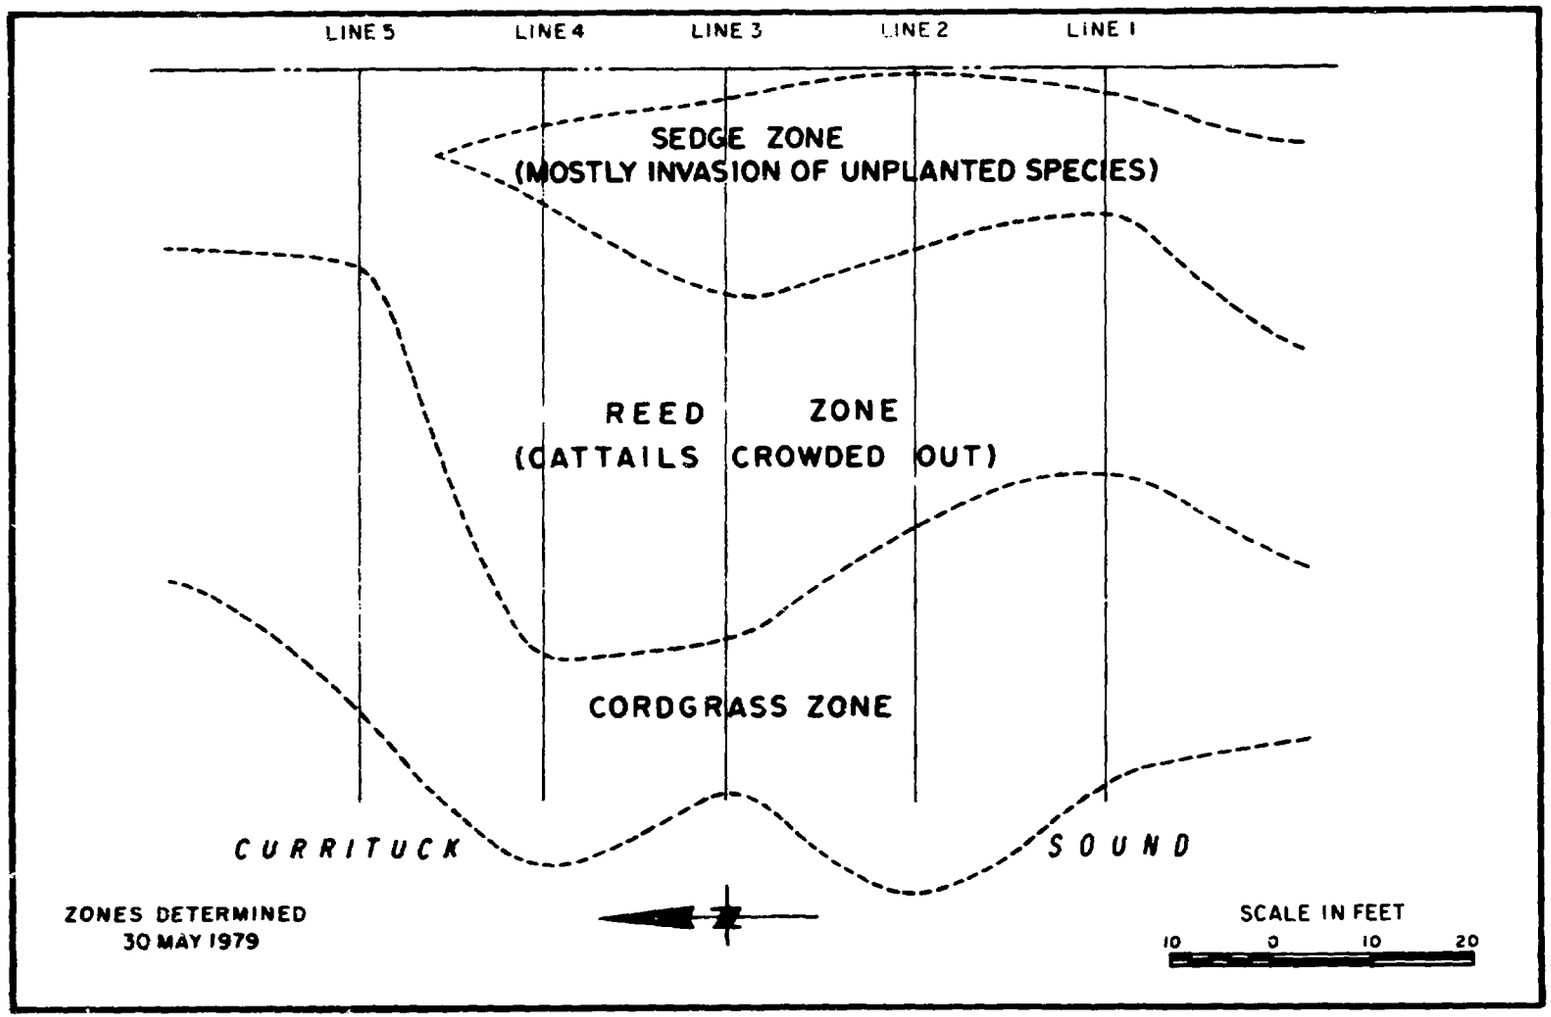
Figure 2-75. Zones of predominant marsh plants, Duck, North Carolina.

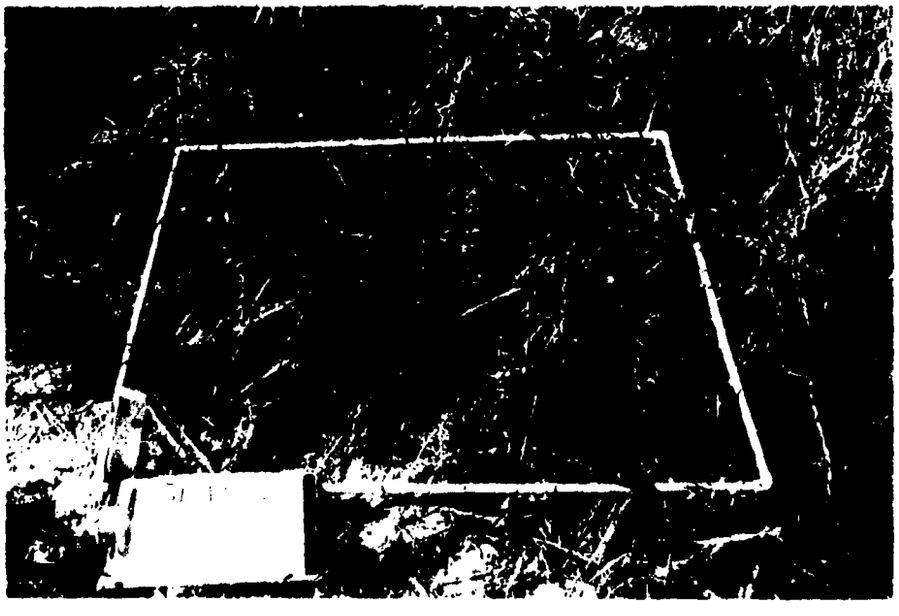
Figure 2-79. Sedge zone, Duck, North Carolina, 24 October 1979.

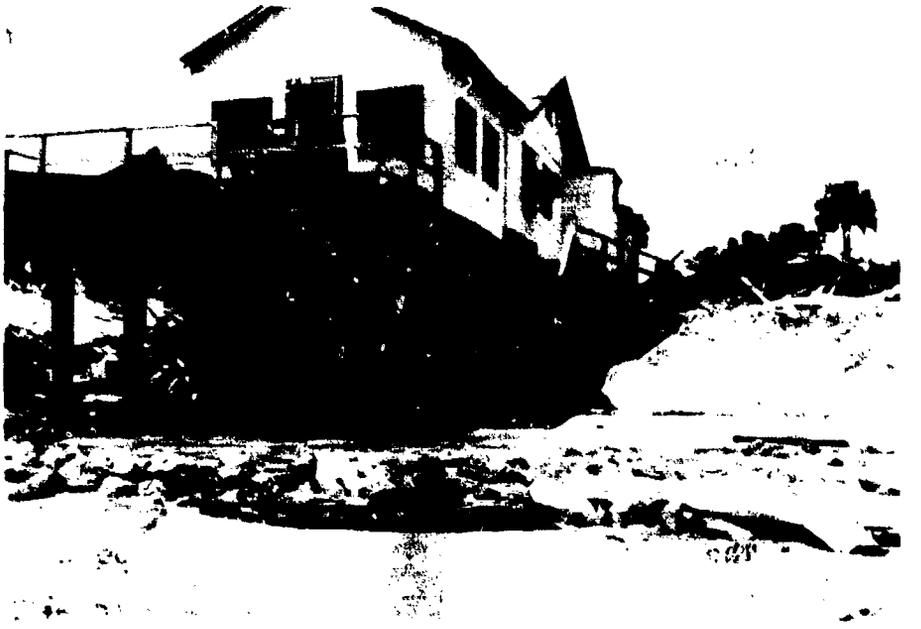
In December 1979 the rock revetments (devices 3 and 5) were rebuilt to higher levels in front of houses 306 and 308. In January 1980 sandfill was added on top of and behind device 3 (Fig. 2-113), and the rocks on device 5 were displaced by waves, exposing the filter cloth (Fig. 2-114). By March 1980 major structural damage had occurred to house 306 behind device 3. It is not known whether wave action damaged the house; however, adjacent houses were not damaged. By May 1980, device 3 was completely destroyed (Fig. 2-115) and more riprap was placed on device 5. As of May 1980

Figure 2-115. Device 3 revetment was completely destroyed, Folly Beach, South Carolina, 29 May 1980.

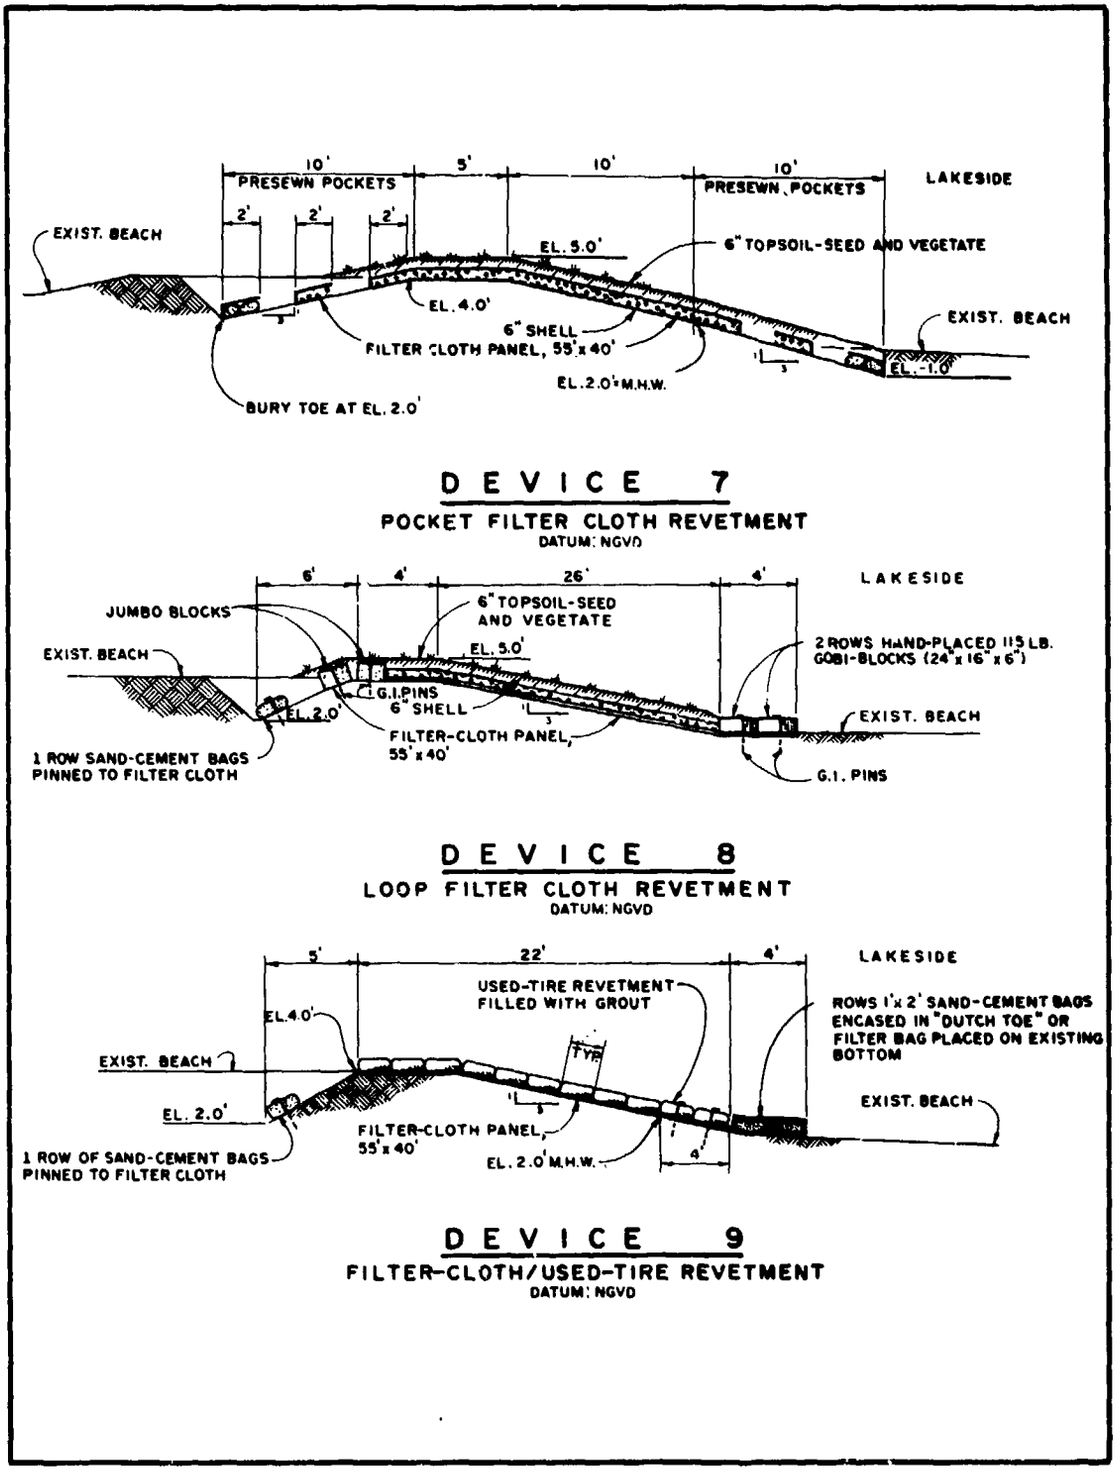
Figure 2-167. Devices 7, 8, and 9 at Fontainebleau site.

(i) Device 9 (Used-Tire/Filter-Cloth Revetment). Immediately adjacent to device 8 is a filter-cloth revetment constructed of grout-filled used tires placed on top of a 55- by 40-foot filter-cloth (Nicolon 66424) panel (Fig. 2-167).

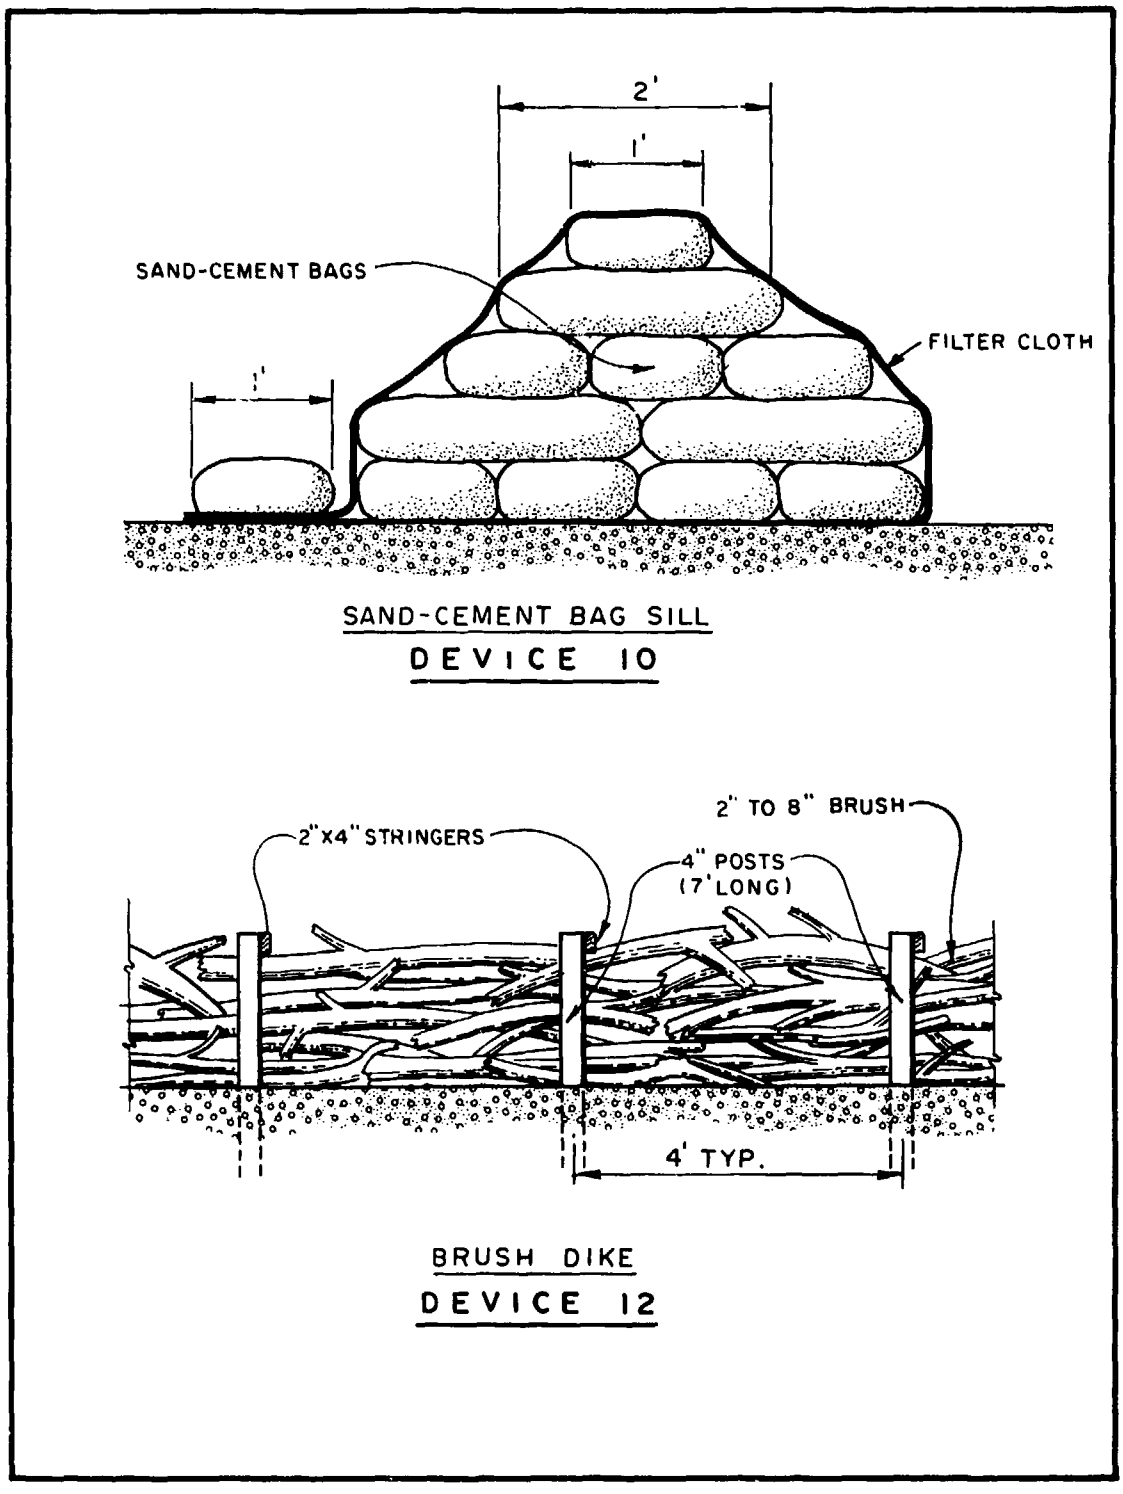
Figure 2-168. Devices 10 and 12 at Fontainebleau site.

(l) Device 12 (Brush Dike). The structure fronting vegetation segments 9 and 10 is a brush dike (Fig. 2-168).

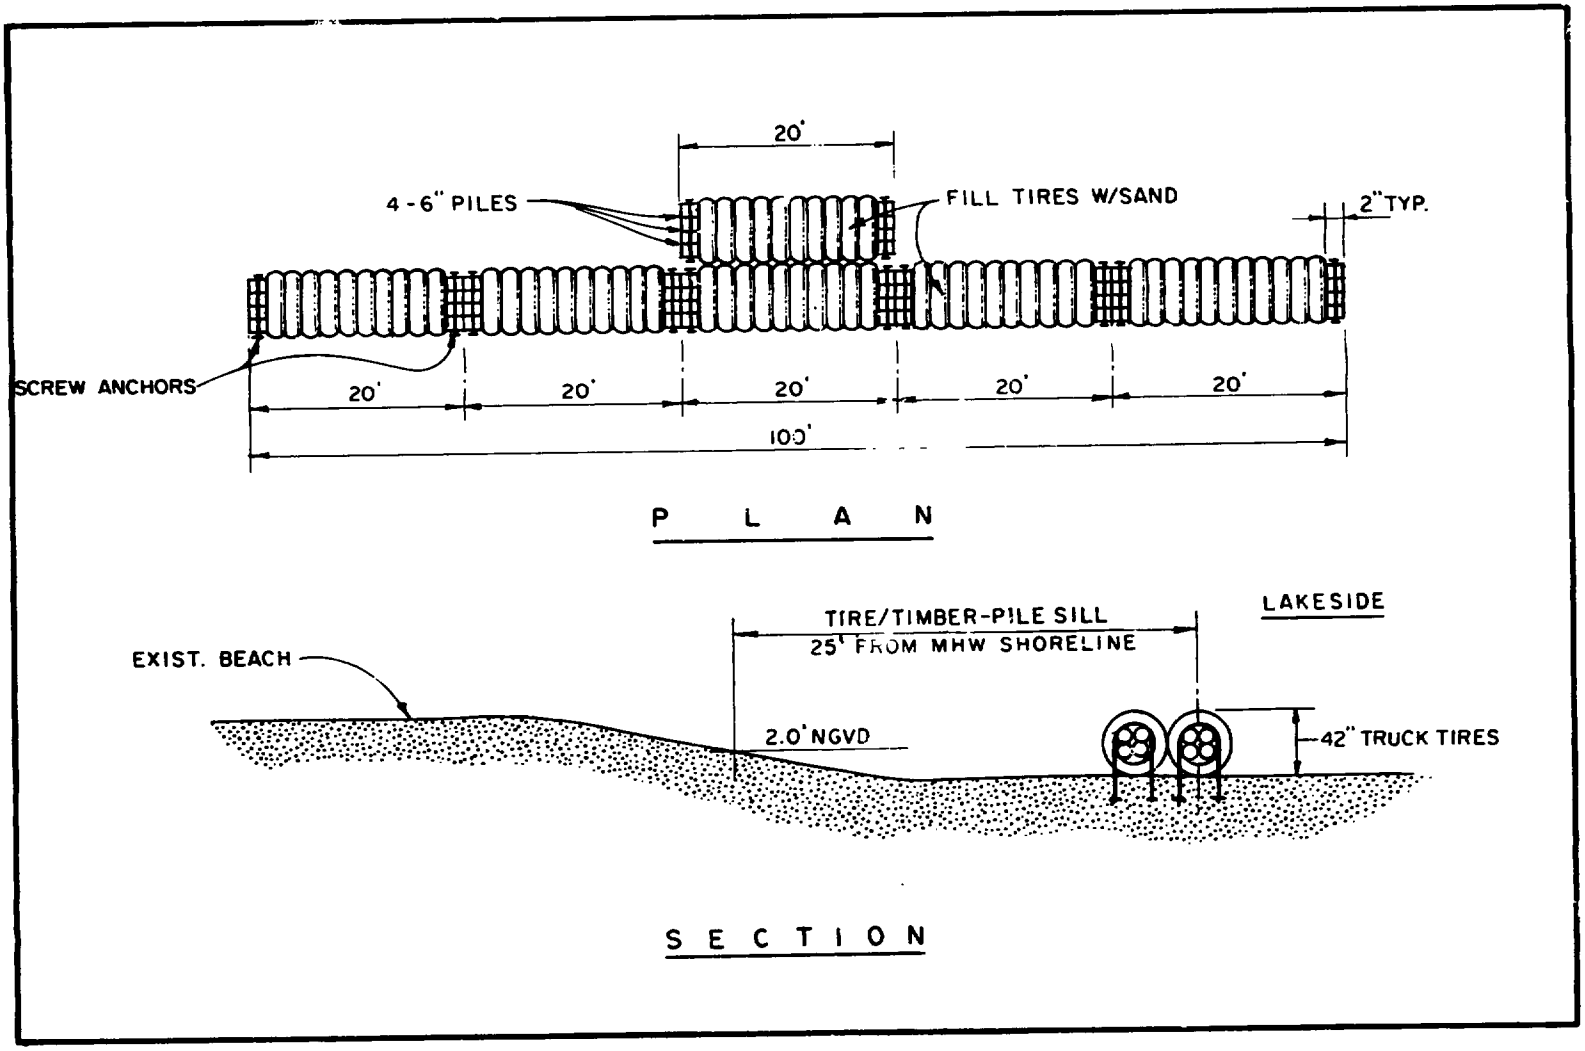
Figure 2-169. Device 11 at Fontainebleau site.

(k) Device 11 (Rolling Tire Breakwater). A rolling tire/timber-pile breakwater was constructed in front of vegetation segment 3. In contrast to device 6, the piles of device 11 are oriented horizontally and anchored to the bottom by screw anchors and only truck tires are used (Fig. 2-169).

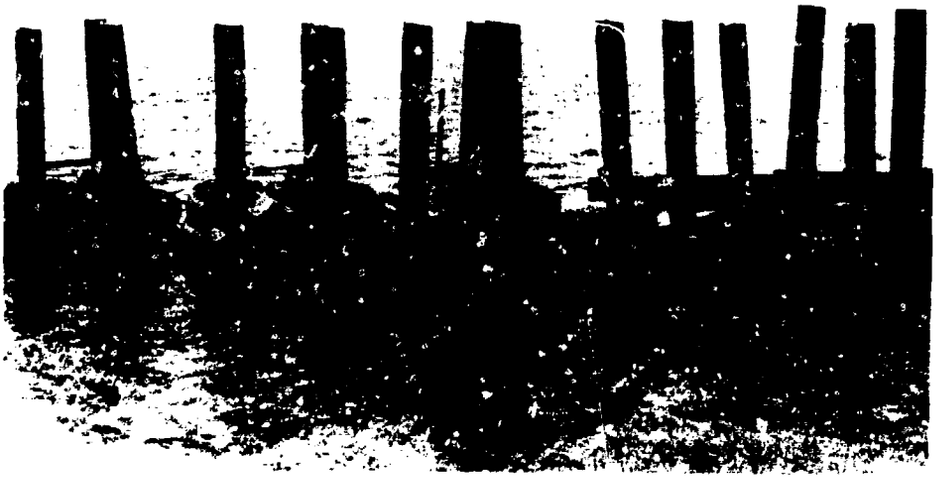
However, the prebanding operation was suspended because of the difficulty of handling the heavy stacks. Tires were then placed singly from a platform built on a crawler tractor. Timber wales and cables, used to fasten the piles together (Fig. 2-178), were installed with the aid of a small aluminum boat. Construction was completed on 2 November 1979. Cost data are given in Table 2-34.

Figure 2-178. Piles fastened together with cables and timber wales, device 6, Fontainebleau State Park, Louisiana, 15 February 1980.

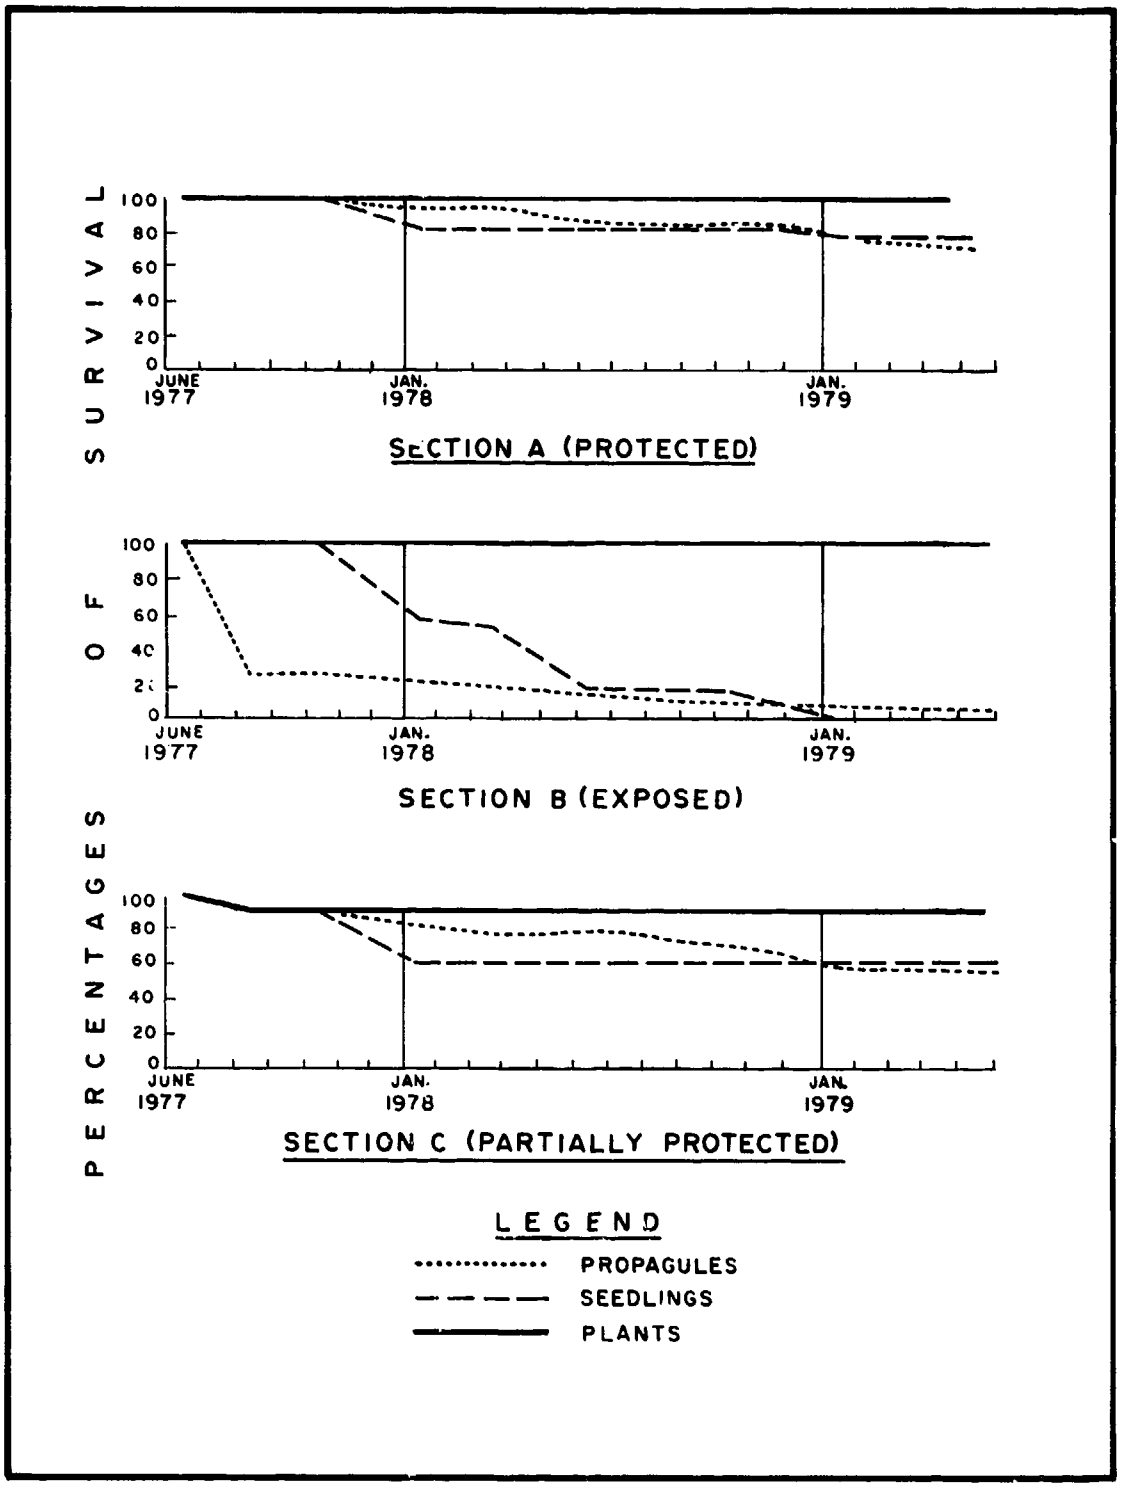
(5) Performance. Survival of red mangroves at the college area varied with the degree of protection and the size of the plant at the planting time. A count of surviving individuals from the initial plantings was made in late May 1979. Figure 2-199 traces the survival of the plants to that date.

Figure 2-199. Survival of transplanted red mangroves at Florida Keys Community College, Key West, Florida, June 1977 to May 1979.

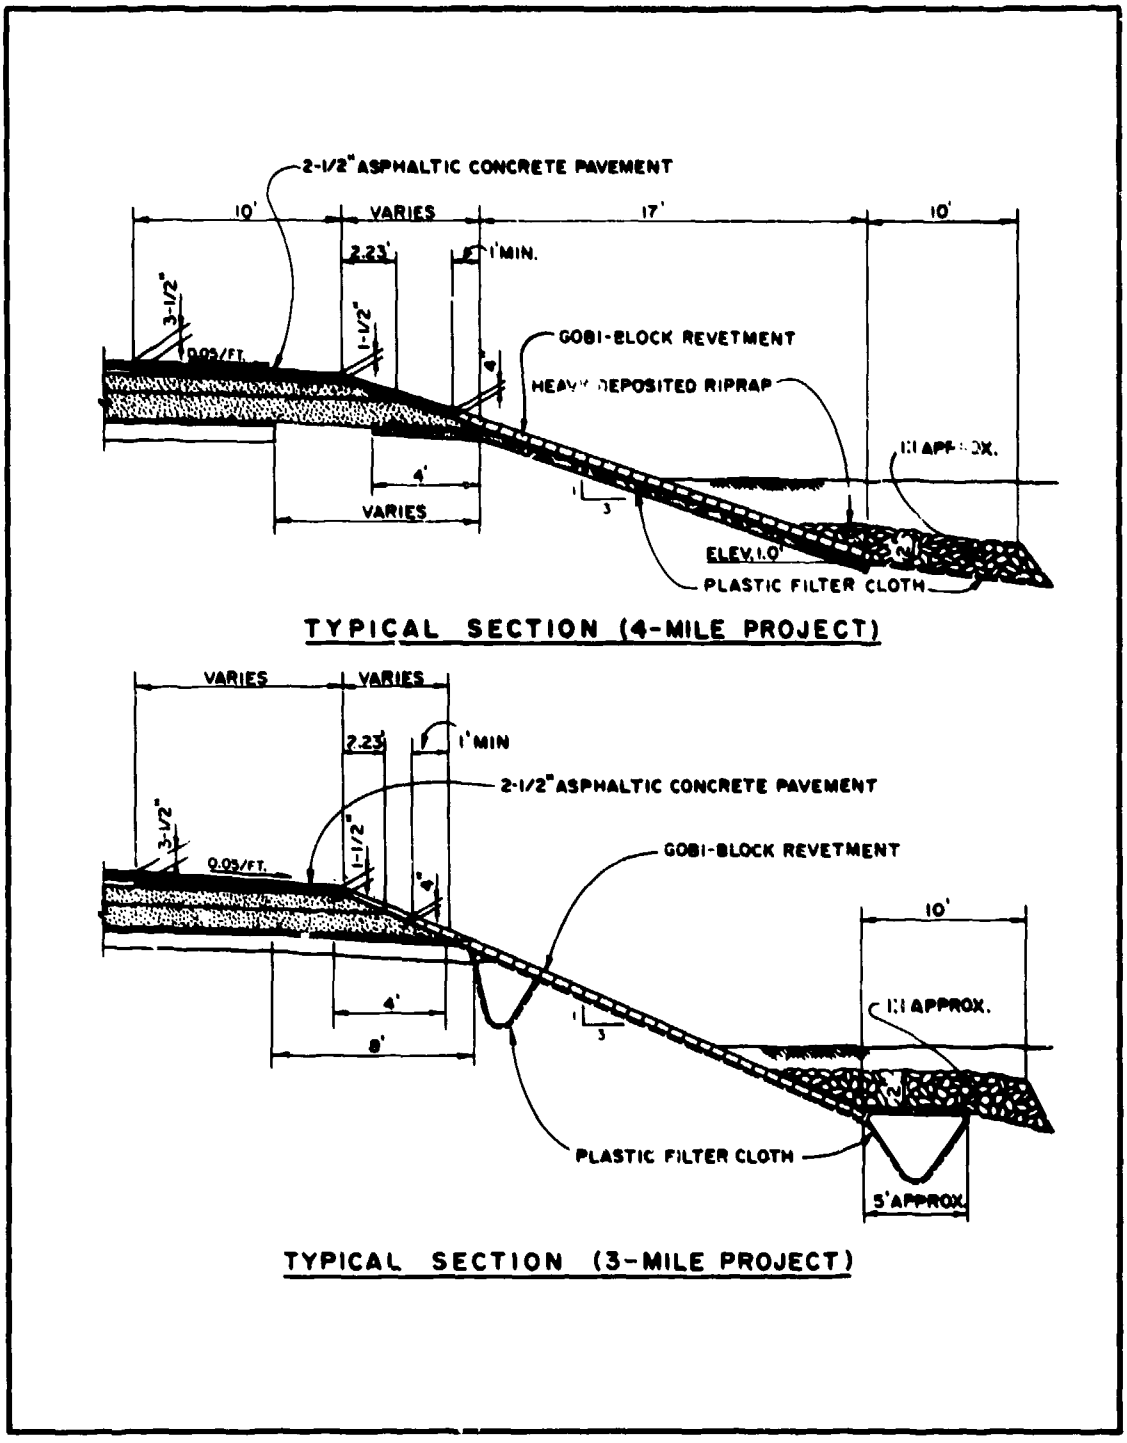
Figure 2-220. Rebuilt 3-mile and 4-mile projects at Holly Beach site.

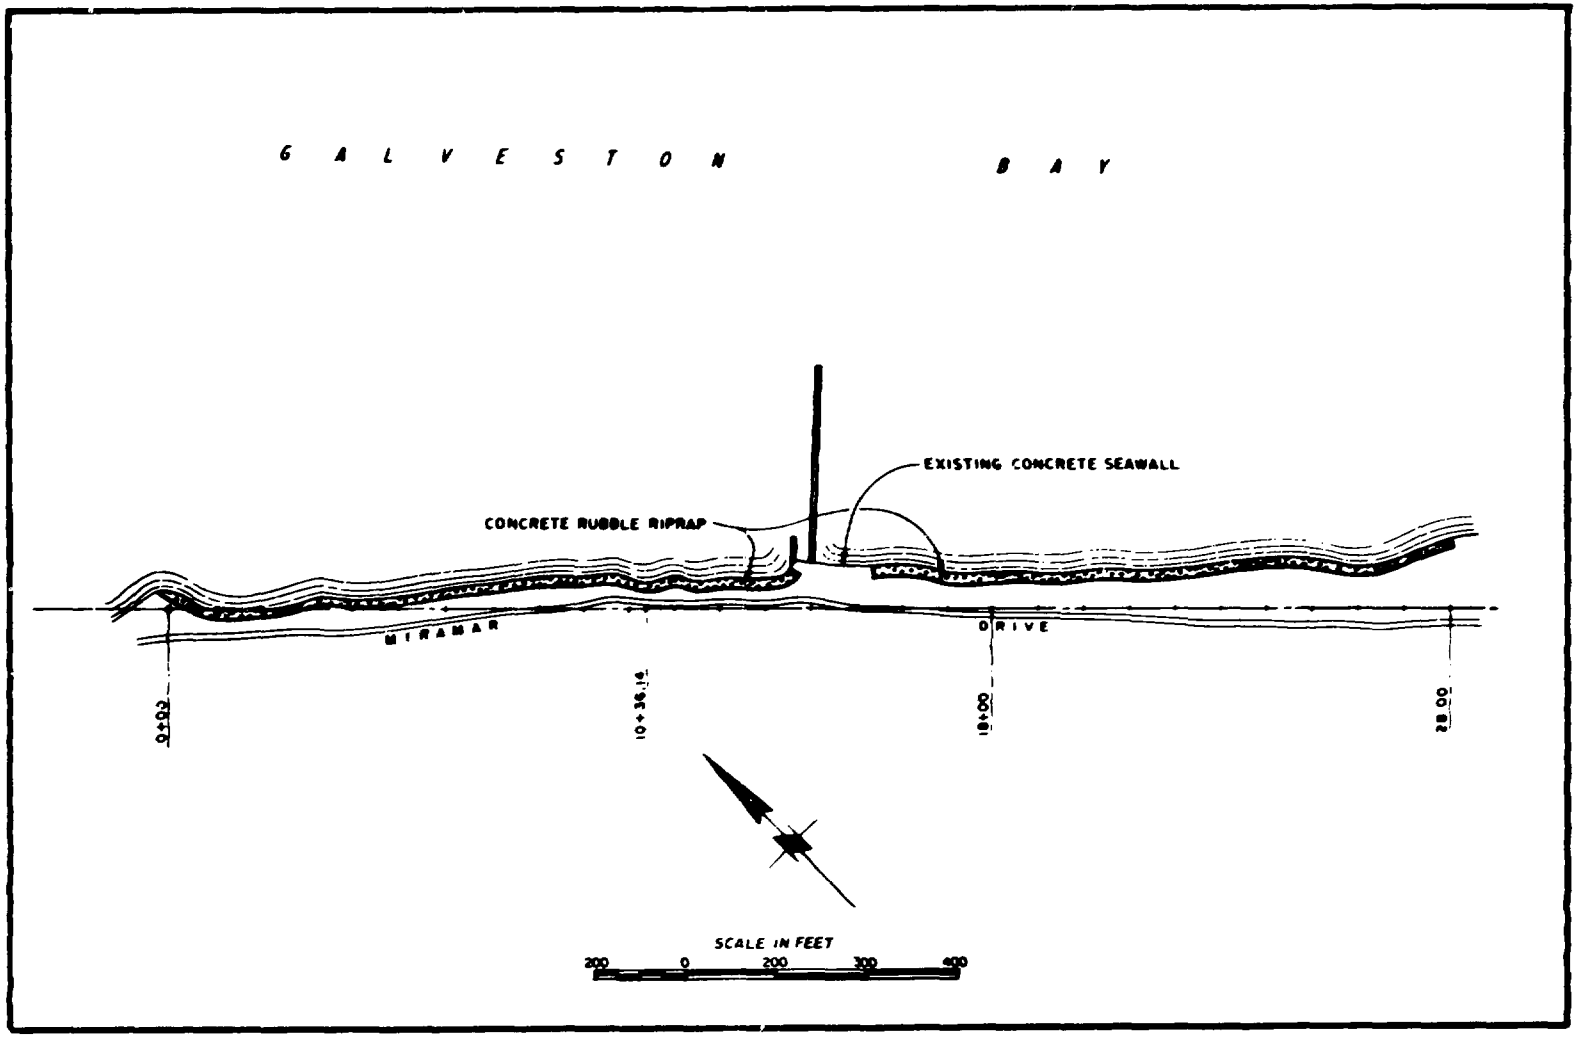
Figure 2-243. General plan of Shoreacres, Texas, monitoring site.

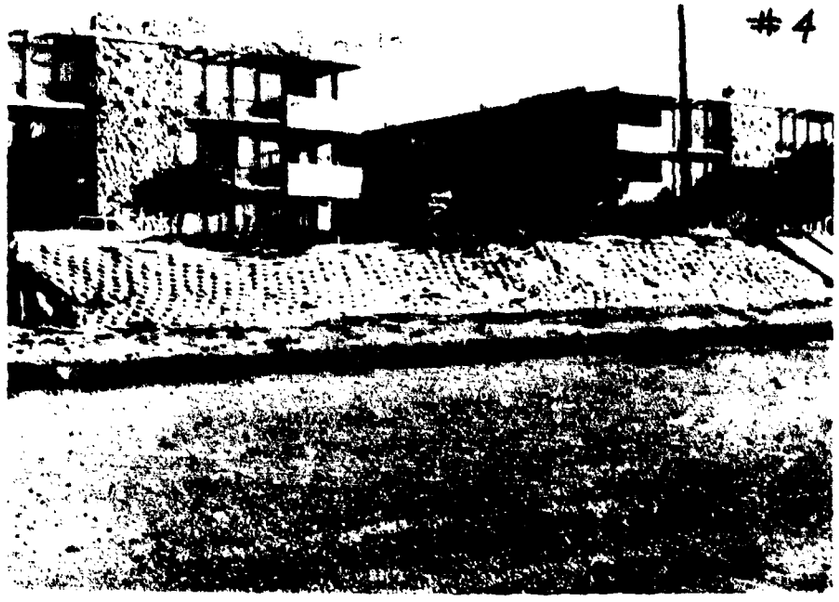
Figure 2-261. Nylon-mat revetment, device 4, Alameda, California, 27 November 1978.

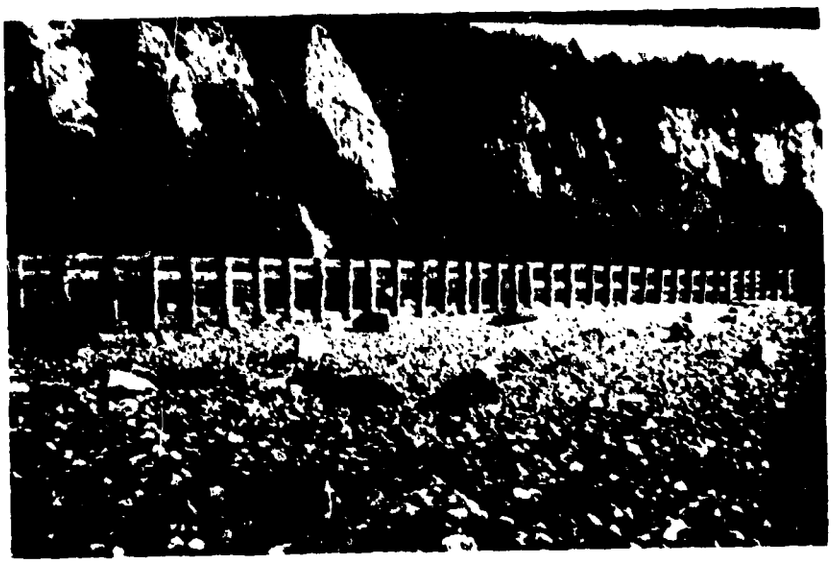
Device 4 (timber bulkhead) was damaged extensively; device 4a (horizontal logs) was essentially destroyed. All backfill material was washed out, and a number of the horizontal logs were removed (Figs. 2-348 and 2-349). The western part of device 4a had no filter, and the fine (silty sand) backfill material was easily washed through the logs. Apparently the gravel filter material in the eastern part of device 4a was undersized and was washed through voids between the logs. Once a breach in the filter had been established, the backfill material (pit-run gravel) escaped. A small void under the separation bulkhead between 4aW and 4bE allowed about 20 cubic yards of material to escape from behind 4bE (treated plank bulkhead with cloth filter) (Fig. 2-350). In device 4bW (treated planks without filter material), all of the silty sand backfill (about 110 cubic yards) was eroded (Fig. 2-351). Much of the toe protection was displaced along device 4b, exposing a gap of 1 to 2 inches below the bottom plank, which allowed the backfill to escape. The destruction of devices 4aW and 4bW exposed the separation bulkheads on each end of 4bE.

Figure 2-348. Extensive damage to device 4a, Oak Harbor, 14 February 1978.

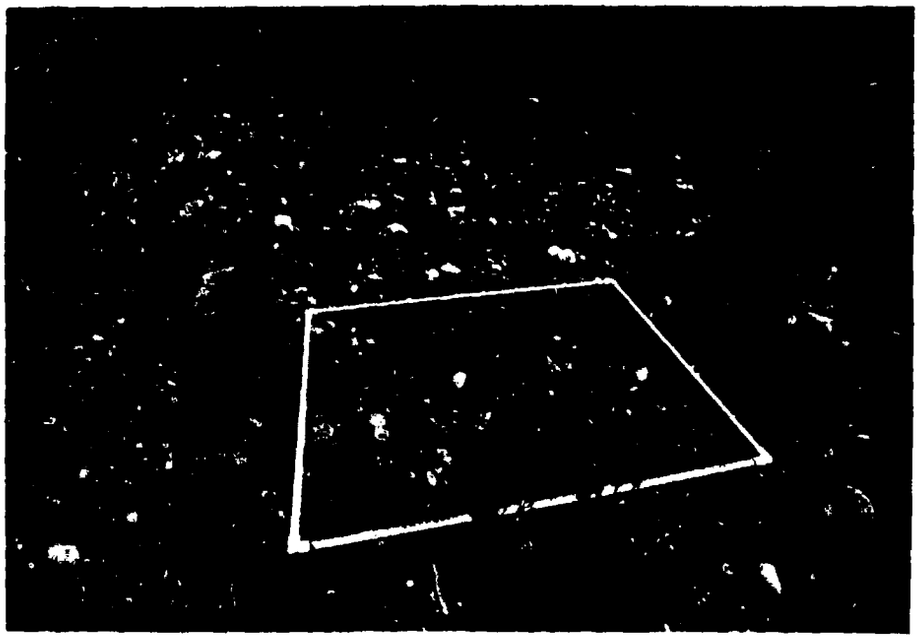
(d) Vegetation Plantings. Success of plantings at this site was low due to extreme weather and the damage to the structures below the plantings (Figs. 2-352 and 2-353). The severe storm in February 1979 removed the backfilled material in areas behind devices 3b, 4a, and 4b, and these could not be sampled. The area behind device 2a was also not sampled as repair to the structure deposited a layer of gravel cobble over the plantings. It was seeded with large variety tall wheatgrass in September 1979, but sampling was not performed until 1980.

Figure 2-352. Destroyed vegetation area behind the gabion revetment, Oak Harbor.

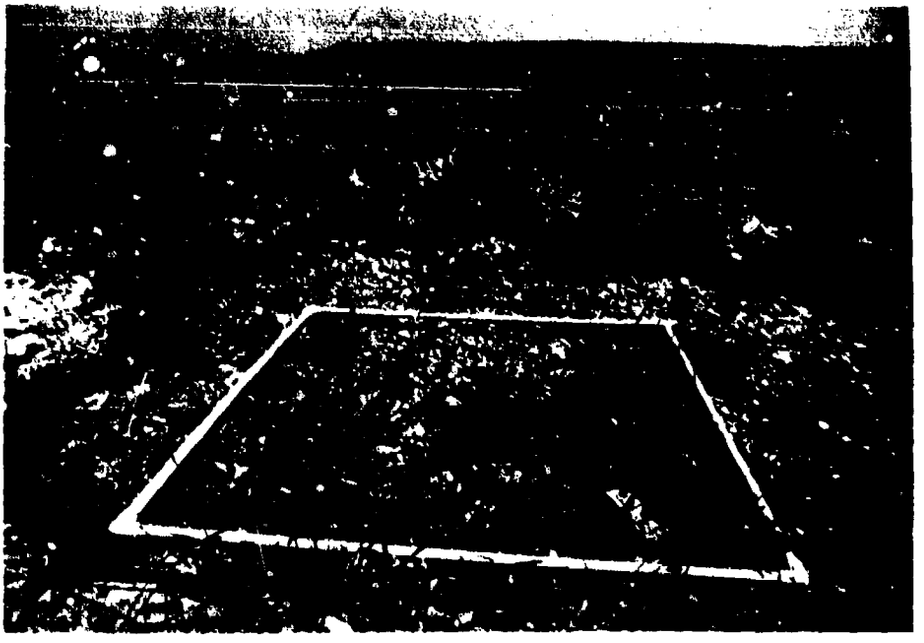
Figure 2-353. Vegetation plantings behind the used-tire bulkhead, Oak Harbor.

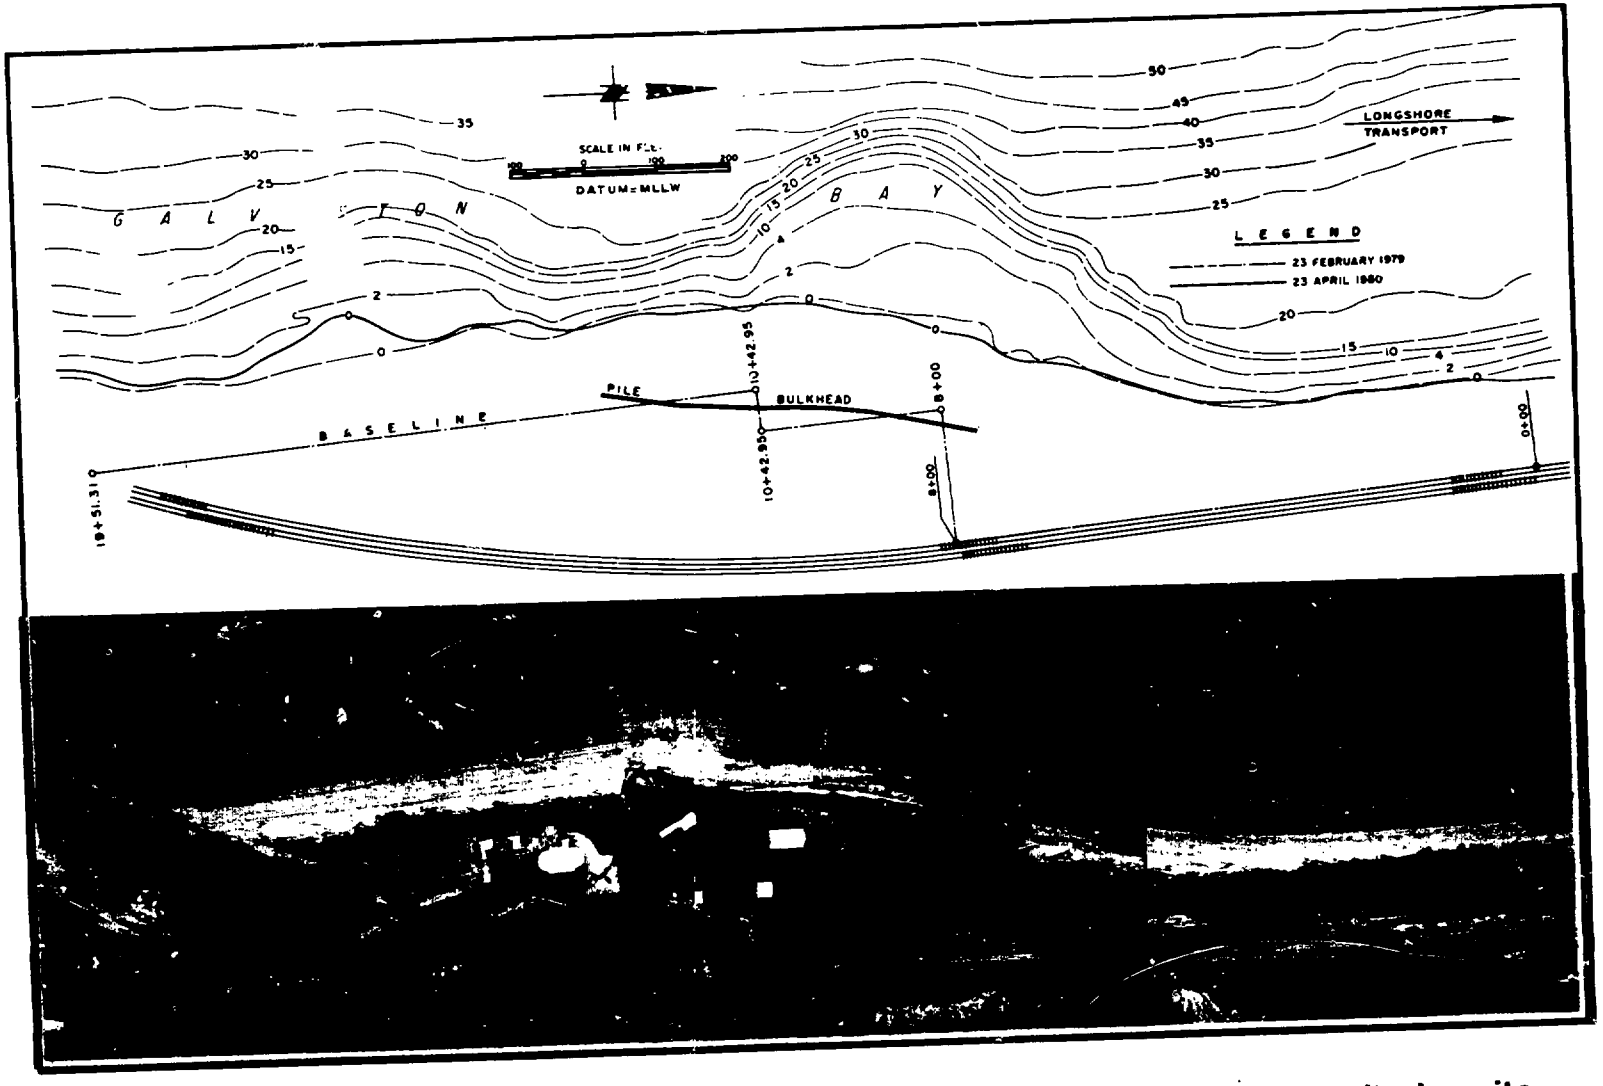
Figure 2-363. General plan and photo of Sunnyside Beach, Washington, monitoring site.
