Low-Cost Shore Protection

Final Report on the Shoreline Erosion Control Demonstration Program (Section 54)

1981

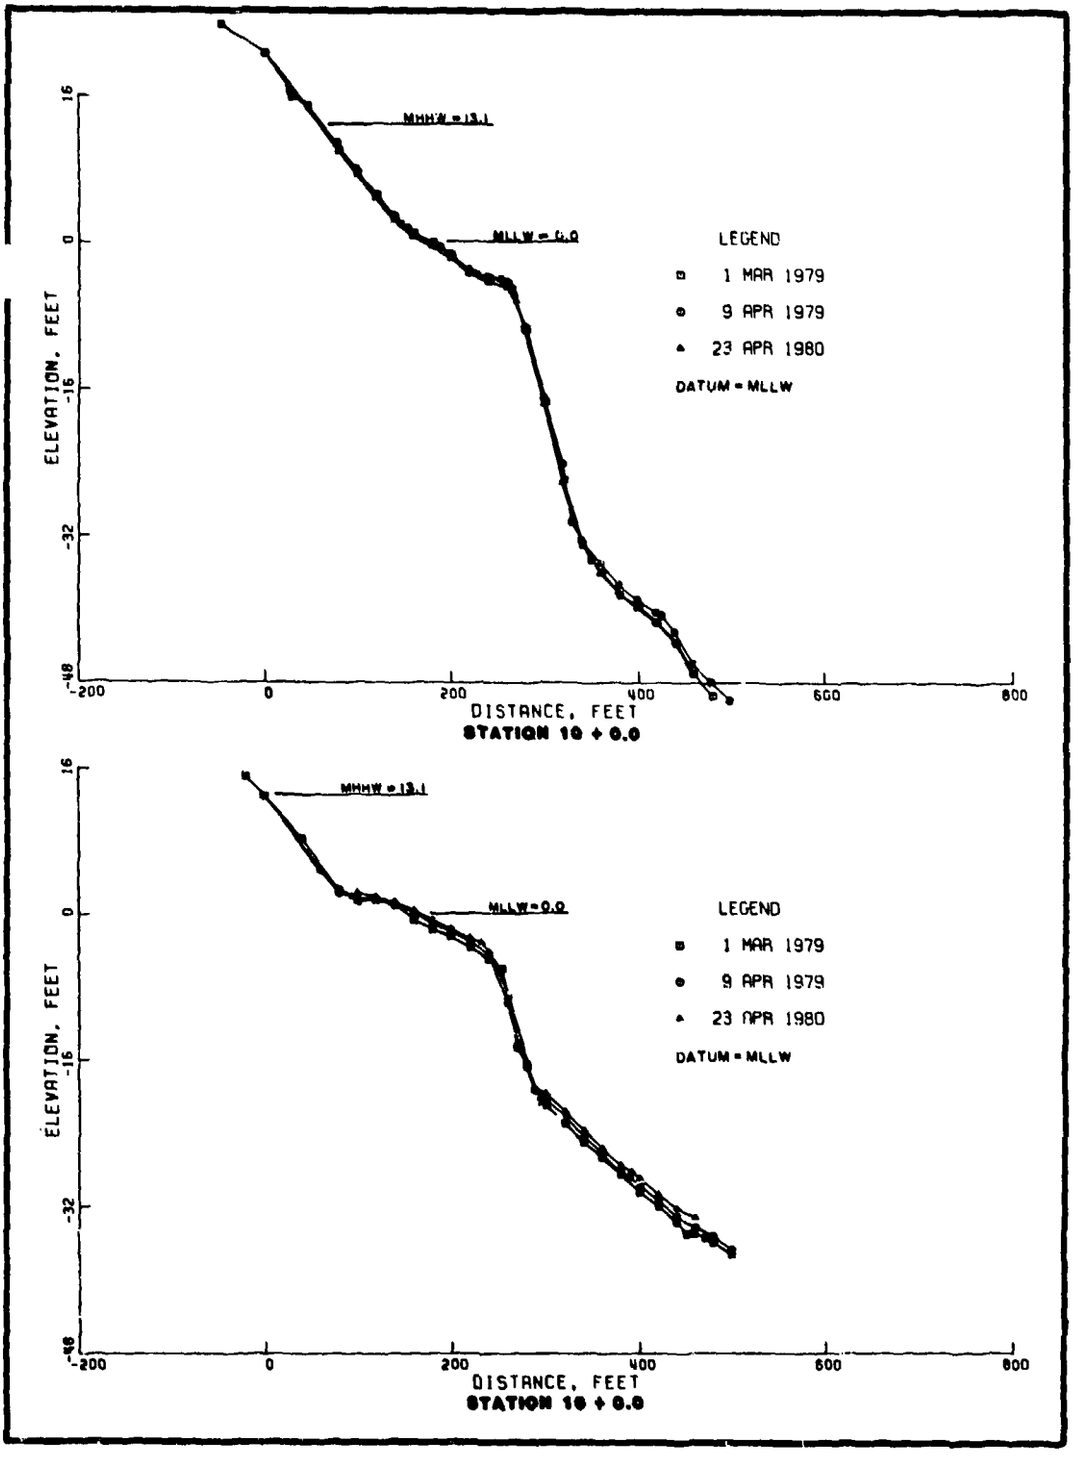
amount of accretion between March and April 1979, but then an overall erosion up to April 1980. The profiles at station 16+00 show continual accretion (Fig. 2-366), and station 4+00 shows a fluctuation between accretion and erosion (Fig. 2-367).

Figure 2-366. Typical profiles, Sunnyside Beach.

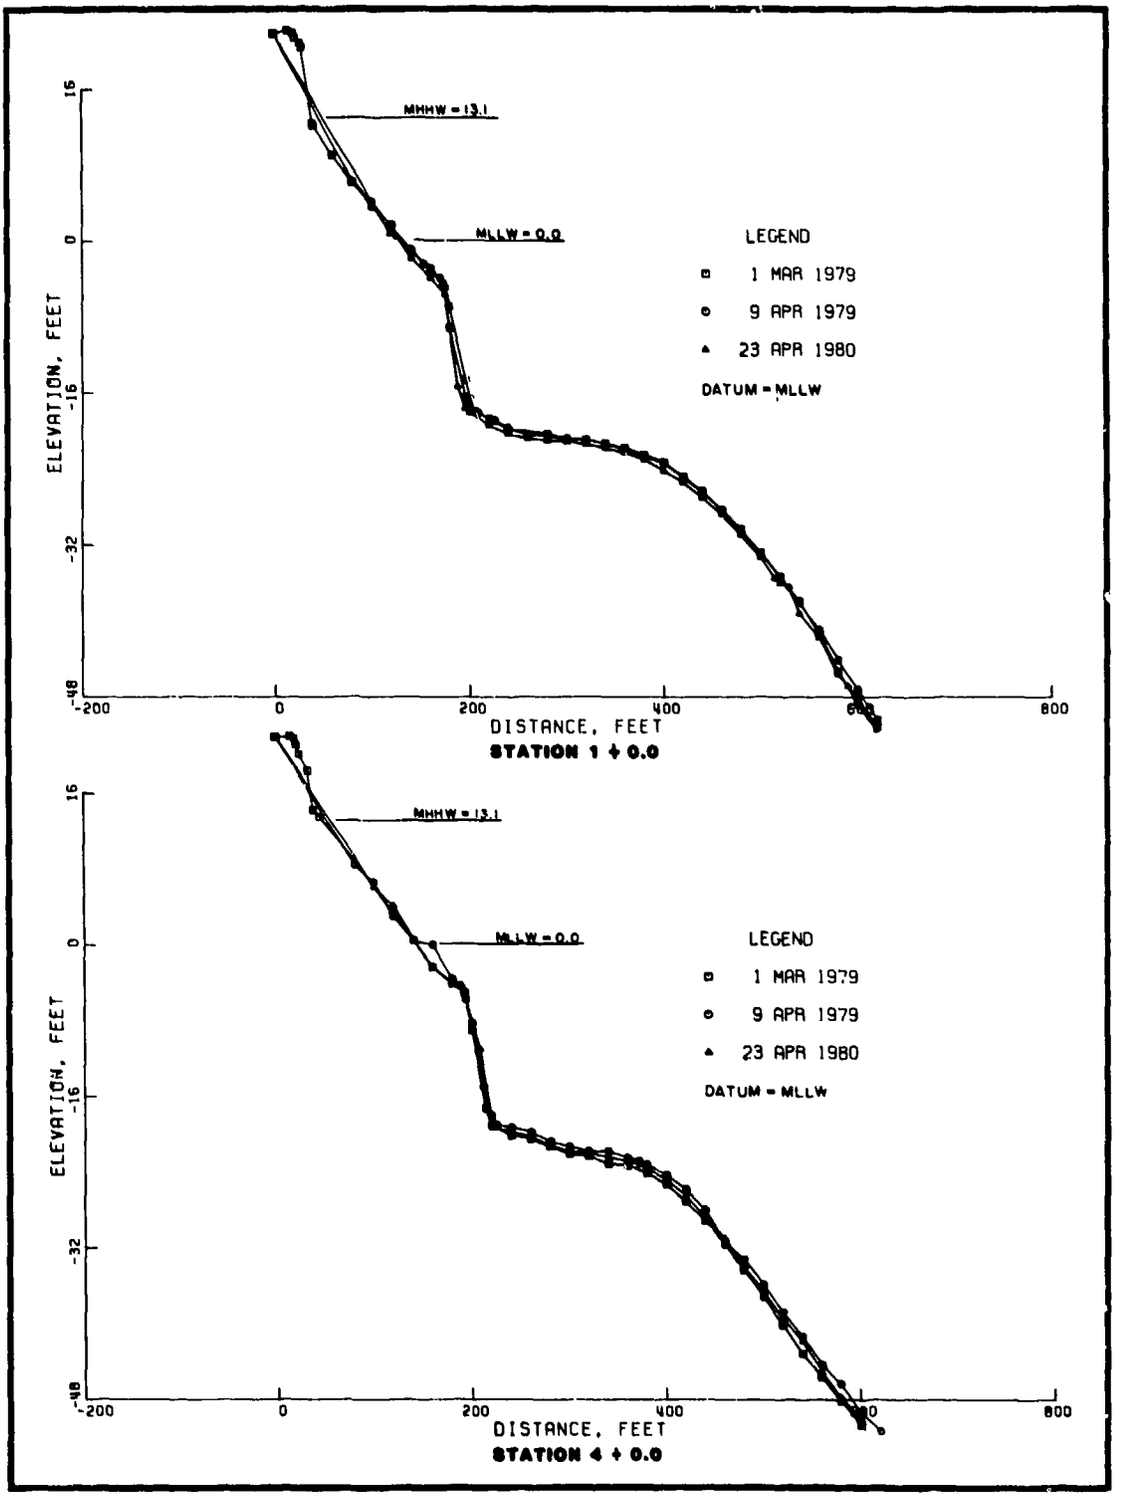
Figure 2-367. Typical profiles, Sunnyside Beach.

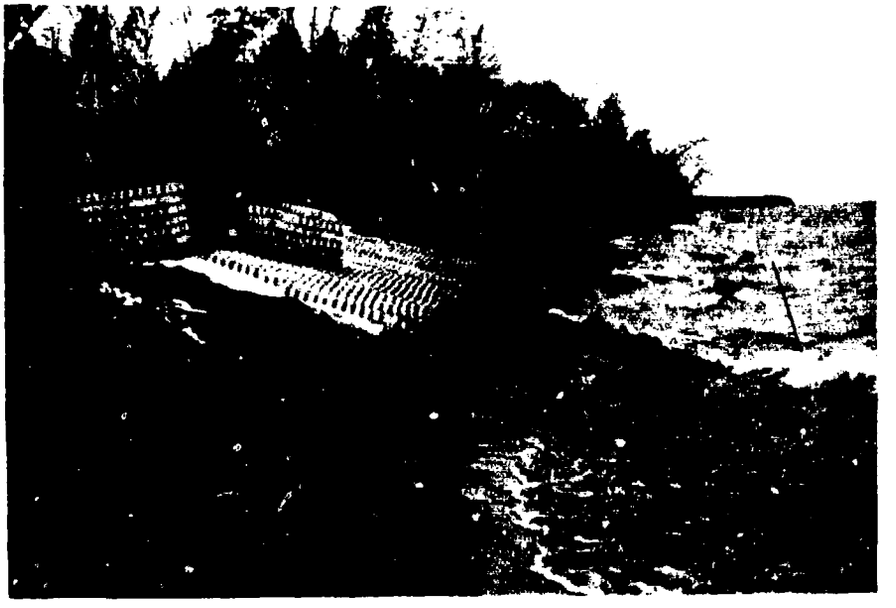
Figure 2-393. Wave and weather conditions causing difficult Turfblock placement, Port Wing, Wisconsin.

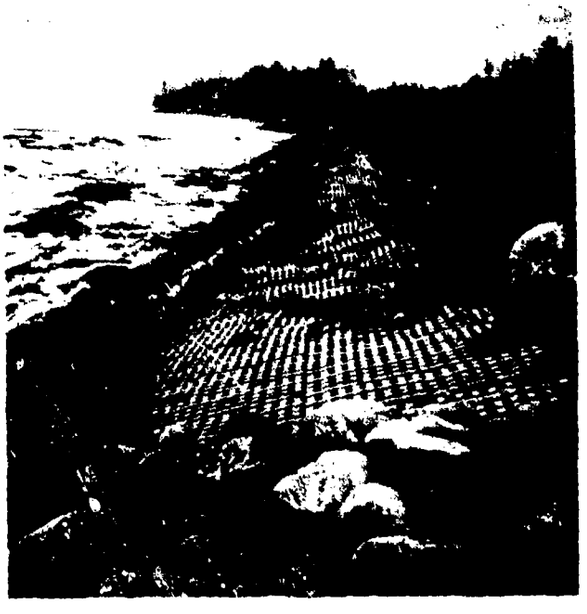
(a) Device 1 (Turfblock Revetment). A 2-day storm in early November 1978 generated waves of design height in Lake Superior that damaged the Turfblock revetment. Waves apparently overtopped the structure and displaced many of the individually placed units. The overtopping waves may also have transported material around or through the nonwoven filter fabric. The loss of base material could cause uneven settling of the Turfblocks, making them susceptible to displacement. The resulting rough and irregular cross section increased the likelihood for debris to lodge on the revetment (Fig. 2-402). Figure 2-403 (taken in May 1979) shows that only a small segment at the west end of the revetment remained intact. By September 1979 only minor changes were detectable since the November 1978 storm. Abrasion of the corners and edges of the blocks due to wave-borne debris impact became more obvious, and the filter cloth in exposed areas began to show wear. The runup of waves on this revetment was higher than on any of the others. By May 1980 a significant amount of accretion had occurred along the entire beach. The sand covered most of the abraded Turfblocks that were previously on the foreshore. The bank behind the blocks was considerably more eroded than it was in September 1979 (Fig. 2-404). Some of the exposed blocks deteriorated significantly (Fig. 2-405).

Figure 2-403. Intact western segment of the Turfblock revetment, Port Wing, Wisconsin, 7 May 1979.

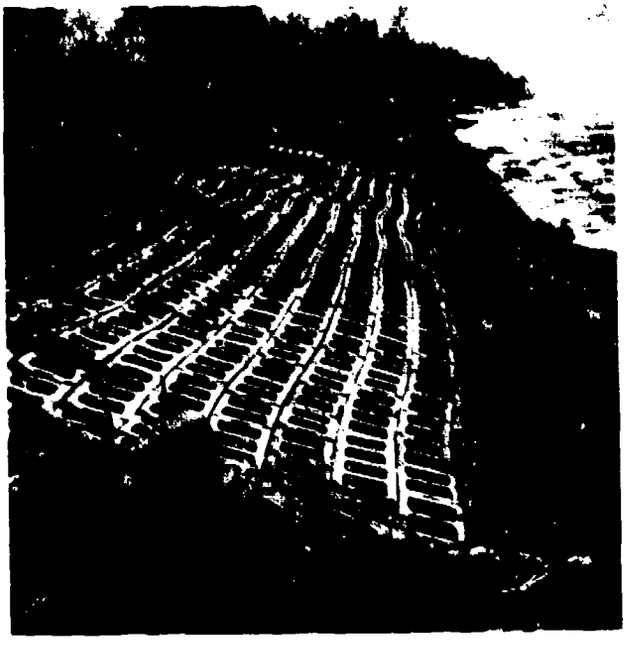
Figure 2-409. Large concrete-block revetment, device 3, Port Wing, Wisconsin, 7 May 1979.

Figure 2-410. Large concrete-block revetment, device 3, Port Wing, Wisconsin, 7 May 1979.

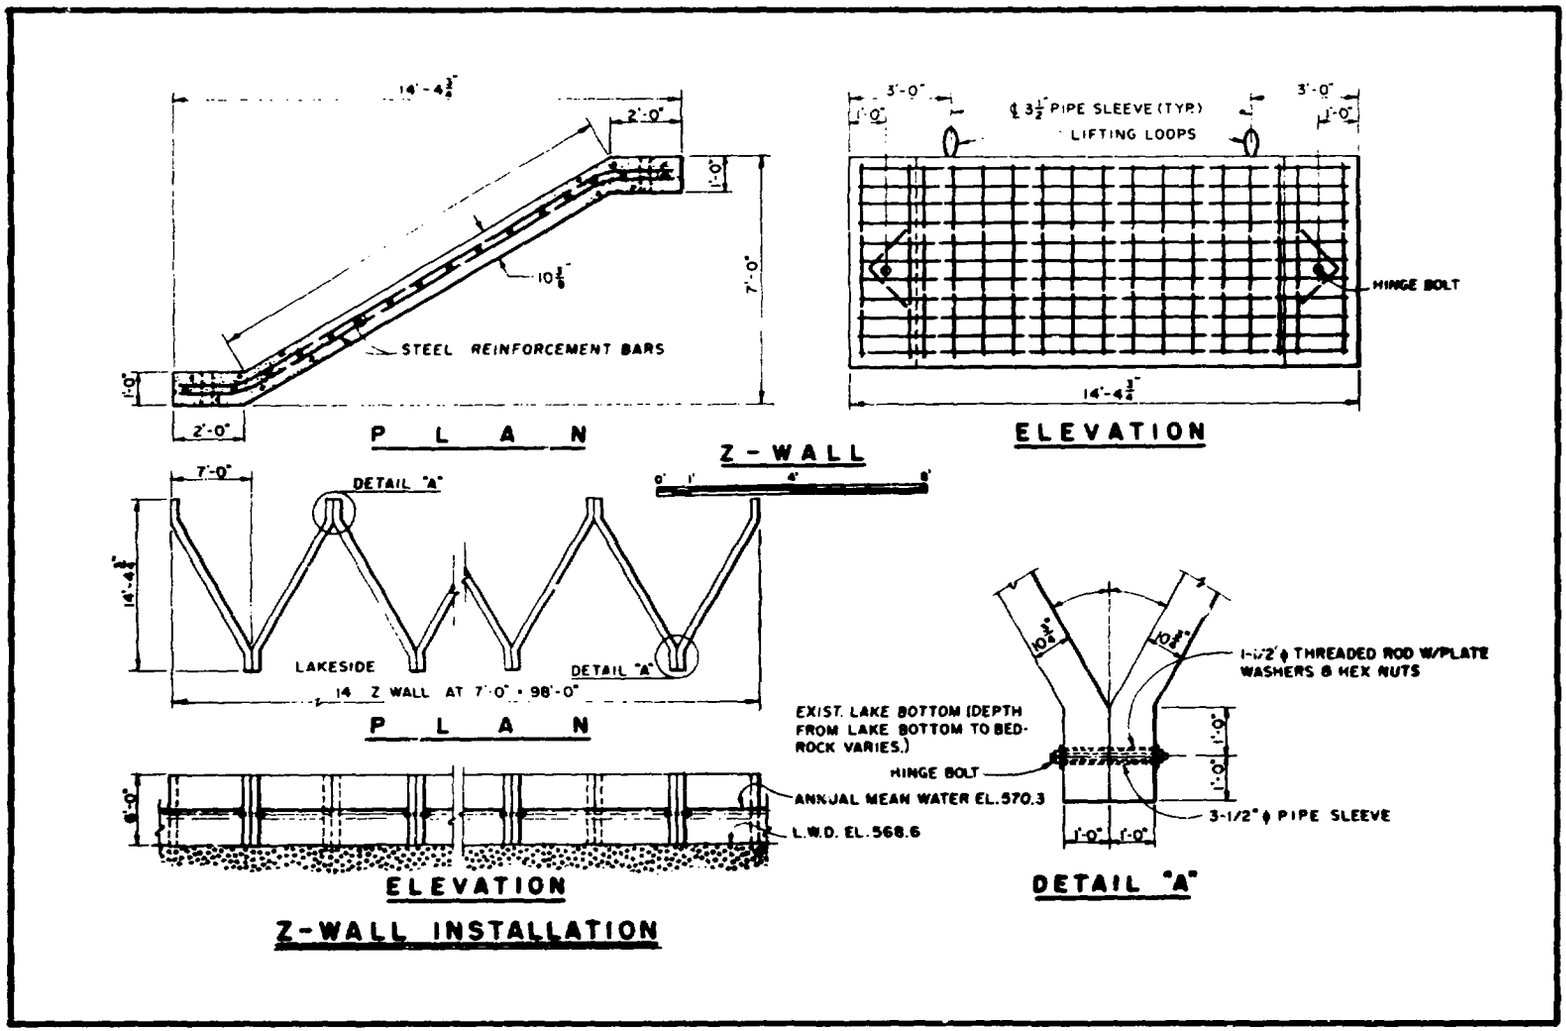
(c) Device 3 (Z-Wall Breakwater). About 700 feet east of device 2, a 98-foot Z-wall breakwater was constructed of steel-reinforced concrete panels set on edge in zigzag fashion and joined together with large hinge bolts (Fig. 2-426). Device 3 is composed of 14 panels, each 6 feet high, 14 feet long, and weighing 6.5 tons. The structure was placed about 100 feet from shore in about 3 feet of water. Device 3 tested the manufacturer's claim that wave uprush into the V-junctions of the panels at the back of the structure would jet sand over the top into the area behind it, building up a back berm.

Figure 2-426. Z-wall breakwater at Geneva site.

Sta-pods were undamaged, but the easternmost panel of the Z-wall had fallen off shortly after construction during the fall of 1978. On 6 April 1979, 50- to 60-mile-per-hour winds over Lake Erie generated waves that produced 5-foot breakers along the shoreline in the park area. A storm damage inspection on 12 April revealed that some gabion baskets were damaged and rockfill had been lost. Some of the top tier of gabions were misshaped, causing slight depressions in the profile, and the center of the structure had been pushed several inches shoreward. The westernmost panel of the Z-wall was rotated slightly and was leaning on the adjacent panel. No other structural damage was apparent.

The fallen east panel of the Z-wall was reinstalled in mid-May, but it fell off again about 1 week later, apparently as a result of the hinge bolt working loose as waves agitated the panel. The leaning west panel finally fell off in late June during a brief storm that produced near-design waves for a short period of time. Uneven panel settlement caused concrete to spall off the inner ends of the eastern panels, baring the reinforcing steel (Fig. 2-431). In late September 1979, the second panel on the east end dropped off, leaving 11 panels still standing.

(c) Device 3 (Z-Wall Breakwater). This installation demonstrated the vulnerability of the end panels of the Z-wall to design wave action. As noted by the District monitor, a heavier or more stable end panel is needed. The single-hinge bolt by which the panels are interconnected allows adjacent panels to settle nonuniformly but with limited tolerance. Where the tolerance limit is exceeded, adjacent panels tend to lean against or pull apart from each other, causing the concrete to spall in stress zones. The nut on the hinge bolt tends to loosen and unwind under wave agitation. A better hinge or a device to limit the movement of adjacent panels with respect to each other is needed. Near the end of the monitoring period, the District monitor noted that the force of the waves tended to open the landward panel joints and force debris into the gaps, causing stress concentrations. It is probable that continued exposure to these wave forces will cause the successive breakdown of end panel joints and the resultant successive loss of panels from the ends toward the center of the structure. The good functional performance of the Z-wall is worth further consideration if its structural deficiencies can be overcome, but the relatively high cost ($206 per linear foot) is somewhat excessive for a desirable low-cost structure. It is believed that all three structures, especially Sta-pods and Z-walls, are sensitive to bottom conditions with respect to their stability. The relation of bedrock to the structures can greatly influence structural stability.

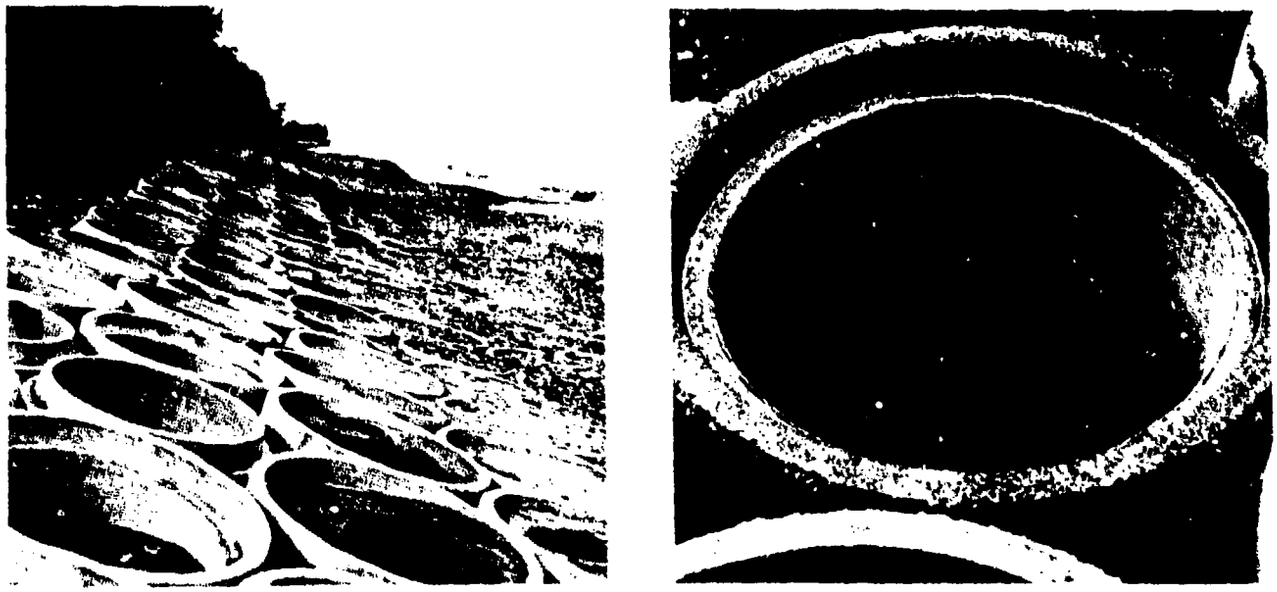
(c) Analysis. The Nami-ring revetment proved to be a good sand-accreting device, but because of its low height and resultant wave overtopping, it could not provide adequate bluff protection. The rings were displaced to some extent by wave action and ice thrust, but primarily by slumping of the clay bluff and upheaving of the revetment subgrade material. Because the tie rods in the lower west end of the revetment prevented ring displacement until the rings were covered with debris, it appears advisable that all rings be tied with steel rods at

Figure 2-488. Completed Nami rings at Little Girls Point, Michigan, 2 October 1974 (from Brater, 1974).

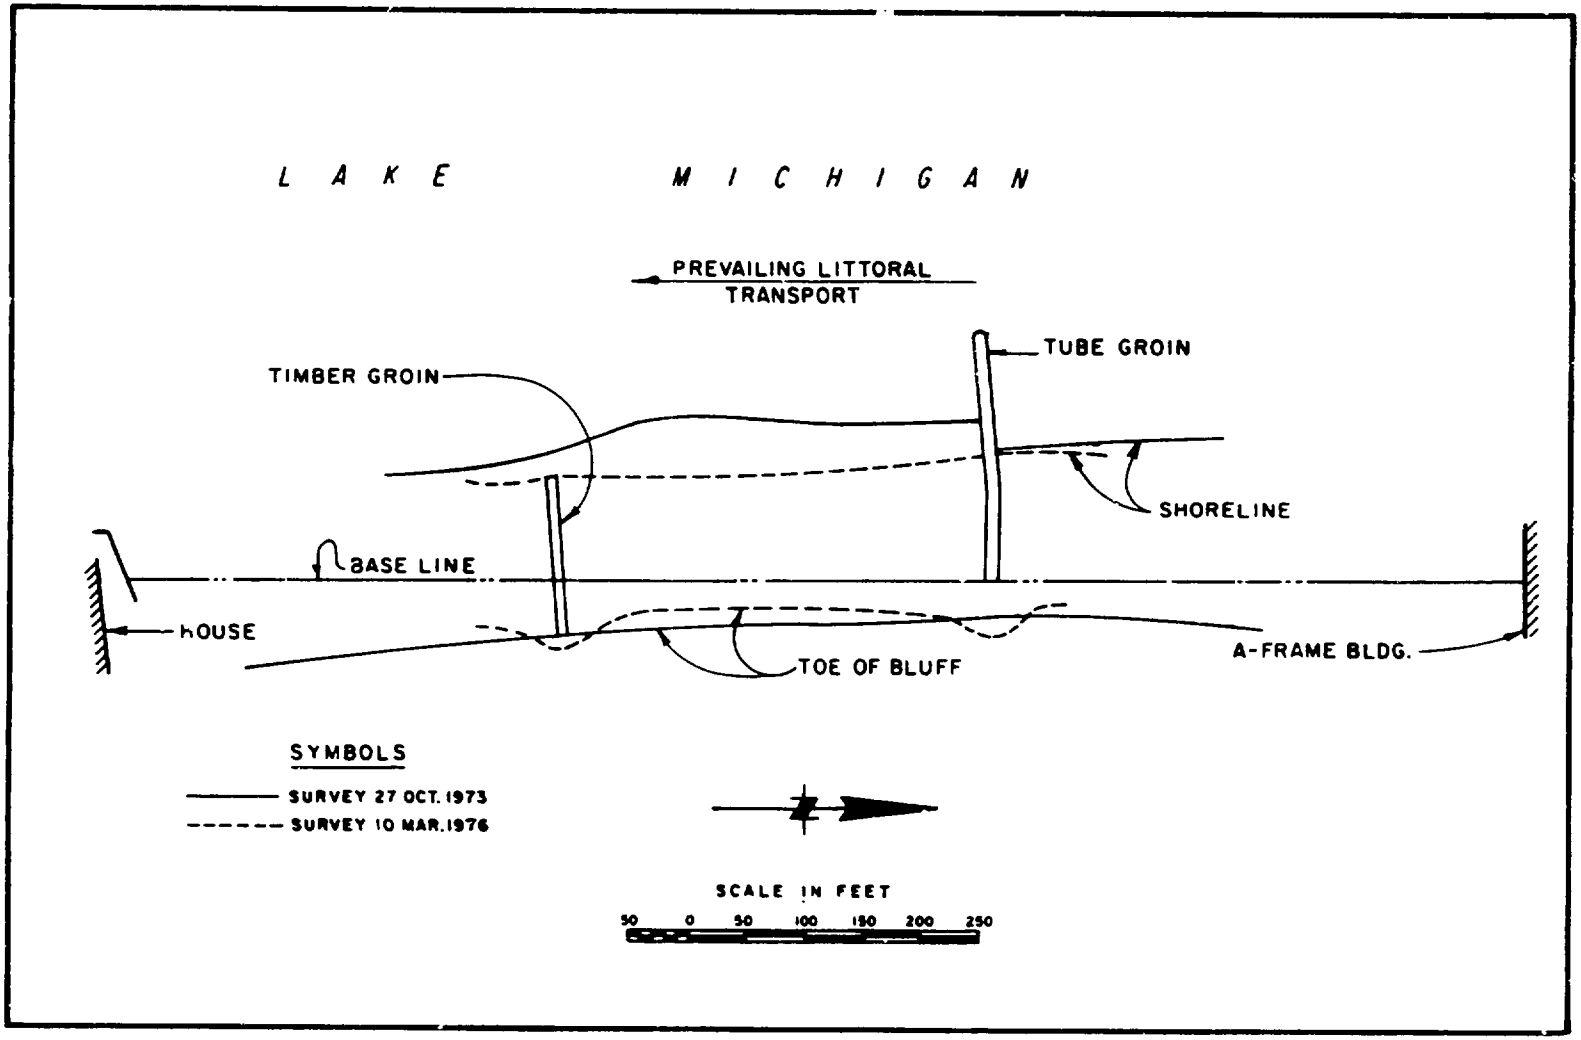
Figure 2-493. The Longard tube is shown in the foreground, the timber-pile groin in the background, Lincoln Township, Michigan, 10 October 1973 (from Brater, 1974).

(3) Performance. During the first year after construction, both groins successfully protected the beach by trapping sand. However, the Longard tube suffered moderate damage when about 30 feet of the lake end of the tube was lost and the whole structure settled about 3 feet along the centerline. The rate of settlement increased again in fall 1975 after remaining relatively stable for about 1 year. It has not been determined if this settlement was due to sand washing out of the tube from the lakeward end or to the tube sinking. The tube was still effective as a groin in trapping sand, thereby protecting the bluff, although some bluff recession has been recorded near this structure. However, in less than 3 years after installation its effectiveness was greatly reduced because of tears in the fabric and loss of sand. By summer 1979 a major part of the tube had been lost, and the groin was no longer functional.

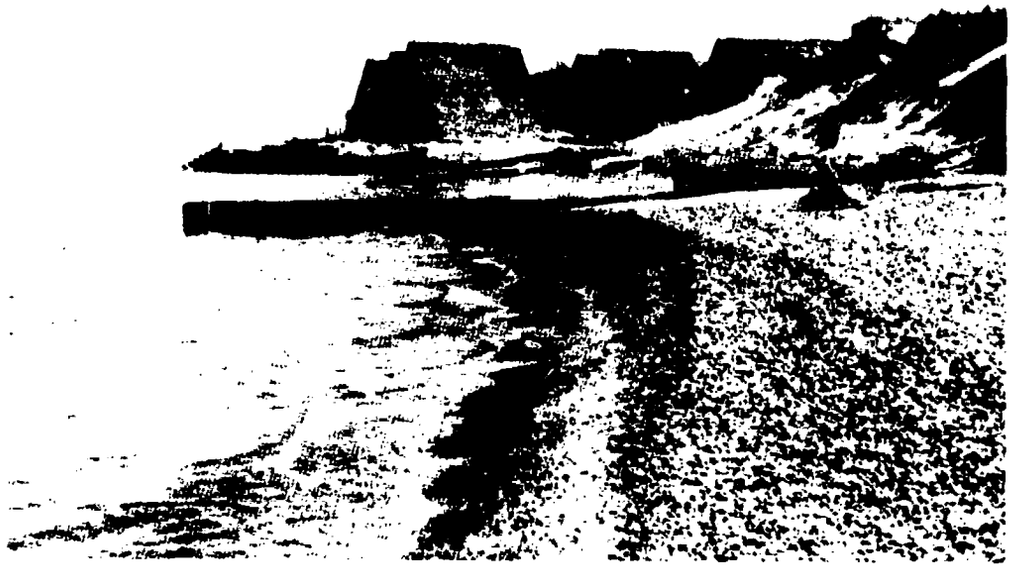
The timber groin performed well and showed no sign of deterioration (Fig. 2-494), thus providing additional evidence that wood is an excellent material for groin construction in the Great Lakes. An impervious timber-pile groin is an old and proven means of shore protection in areas where there is adequate littoral drift moving predominantly in one direction. The relatively wide spacing between the groins did not reduce their functional effectiveness, and the system has protected the site by trapping sand and raising the beach profile. Much of the sand retained by the Longard tube before it failed is still on the beach, and it together with that retained by the timber groin is still protecting the bluff, although some minor slumping has occured. This slumping is probably due to factors other than simply wave attack, such as wind erosion or heavy foot traffic on the bluff.

Figure 2-494. Timber groin in good condition, Lincoln, Township, Michigan, 6 May 1976 (from Brater, Armstrong, and McGill, 1977).

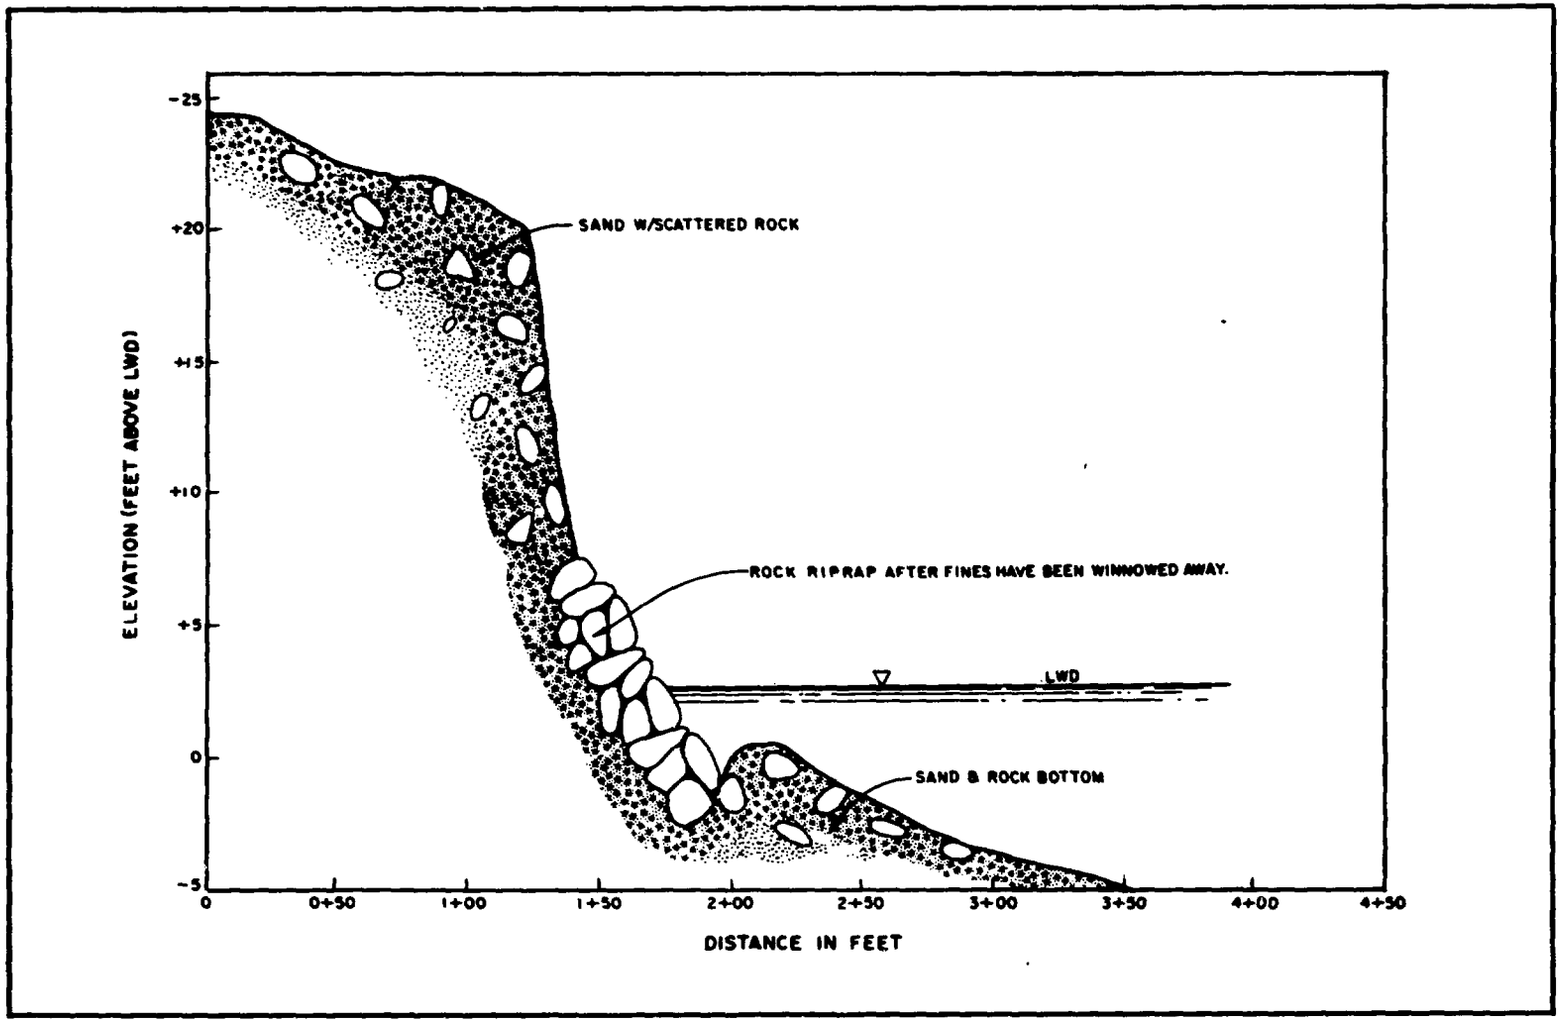
(2) Monitoring Project. The project comprises the riprapped toe of a high sandfill which extends from Scenic Drive out to the lake some 50 to 125 feet. The sandfill rises to a height of almost 25 feet above LWD; its slope is roughly 1 on 2 (Fig. 2-496). The sandfill contains some riprap-sized stones and small amounts of gravel, wood chips, and cinders (Fig. 2-497). Although the structure now has a riprap toe, it was not placed at the site as part of the original design. The toe actually resulted naturally from the selective sorting under wave action of the fill material which contains large stones with diameters ranging from 6 inches to 3 feet

Figure 2-496. Typical riprap section at Muskegon site.

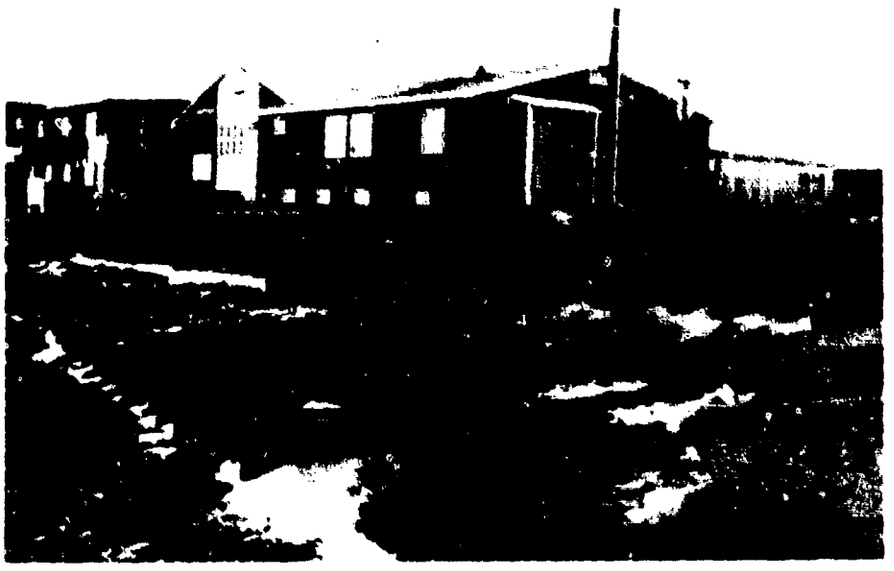
(a) Barrel Revetment. Construction of the 200-foot barrel revetment was nearly completed in September 1978 when inclement weather forced cessation of work for the winter. Many of the barrels needed to be filled to the top with sand and gravel, or capped on the upper tier (Figs. 2-546 and 2-547). The tiers were connected with four perpendicular diaphragms to create three closed cells with two open ends (upper Figure 2-543). By June 1979, considerable littoral drift was accumulating on the south side of the southern diaphram. Some gravel collected on the south sides of the remaining diaphragms, and minor erosion occurred on the downdrift sides of all diaphragms. The two northernmost cells showed evidence of beach sand and gravel filling in behind the seaward shore-parallel double row of barrels (Fig. 2-548). The tops of three of the uncapped barrels were deformed by ice pressure or debris impact. The barrels were located on the seaward row, two from the north end (Fig. 2-549), and one from the center north diaphragm (Fig. 2-550). The proposed sandbag caps were deleted from the construction schedule, and beach gravel alongside the revetments was used to top off the barrels. The construction was completed in August 1979. No other changes in structural alinement, material, or cross section were observed. The accretion and depletion patterns also remained unchanged through October 1979.

Figure 2-546. View of barrel revetment, Kotzebue, Alaska, 12 October 1978.

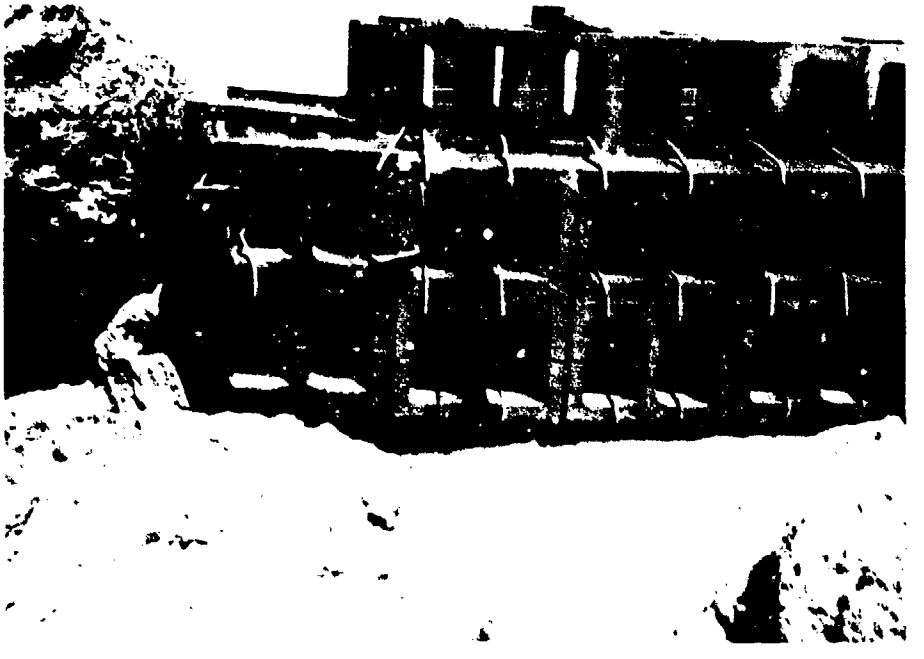
Figure 2-630. Landside of north end of Sandgrabber settling on the existing coral rock revetment, Bellows Beach, Hawaii, 5 September 1979.

Some structural performance problems developed at this site which a few comments might help to mitigate at future installations. First, since the sand at Bellows is fine grained, the settlement of the seaward side of the structure due to toe scour should have been anticipated, and bedding should have been provided or the foundation trench should have been excavated to the anticipated scour depth. Second, the Sandgrabber is not sufficiently flexible; it can be damaged by uneven settlement. This was clearly demonstrated at this site by comparing the north and south ends of the installation (Figs. 2-627 to 2-630). At the north end, the Sandgrabber settled on the adjacent, existing coral rock revetment and, due to inflexibility, was unable to conform to the scouring bottom (Fig. 2-630). As a result, the north end of the structure was damaged. This problem might have been avoided had the structure not settled as much, had the structure been more flexible, or had the north end of the Sandgrabber not been constructed such that it settled onto the rock structure. Third, if differential settlement of the Sandgrabber is anticipated, elastic "ties" of some sort might be substituted for the steel tie rods. This would eliminate the breaking of blocks that results from excessive stresses due to inflexibility of

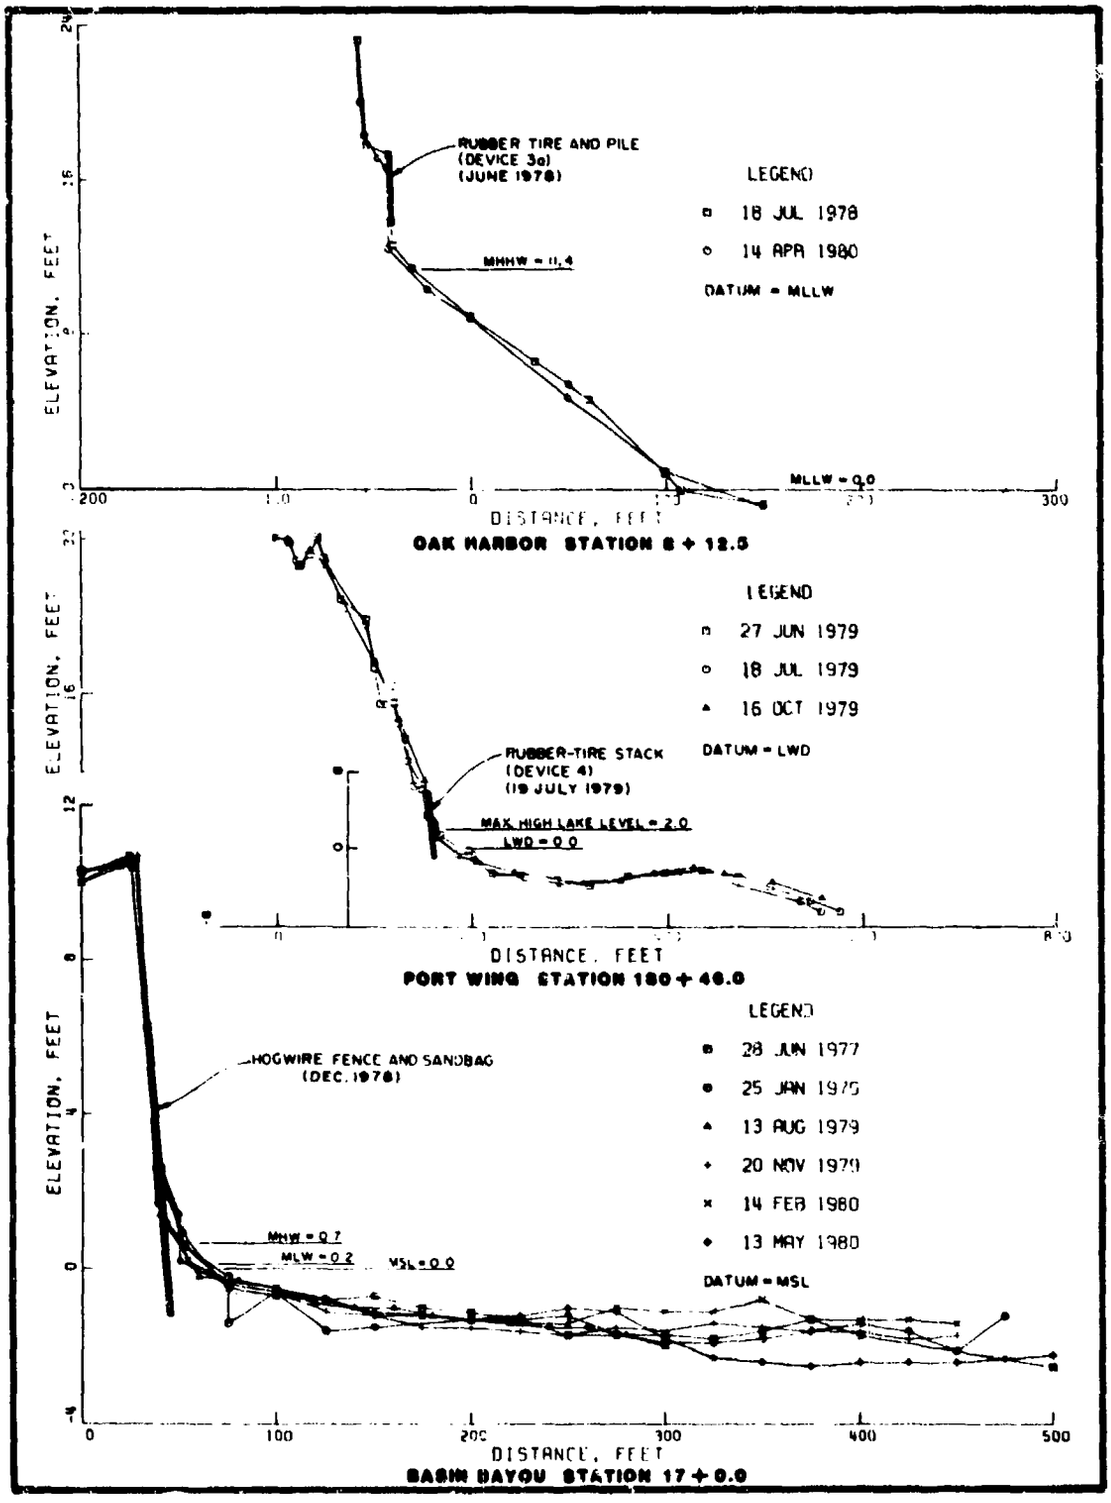
(2) Rubber Tire and Pile, Rubber Tire Stack, and Hogwire Fence and Sandbags. The profiles for these structures are shown in Figure 3-18. The rubber tire and pile bulkhead at Oak Harbor, Washington, despite being placed high in the tidal zone, was damaged by wave attack allowing the tires to collapse and settle and some of the gravel washed out. This damage did not seriously reduce its functional performance, as the profiles show that little material was eroded from behind the structure.

The rubber-tire stack bulkhead at Port Wing, Wisconsin, was progressively damaged by wave action. Despite the damage and the inability of this structure to sustain under wave attack, the profiles indicate that the structure did protect the upper bank from significant erosion.

Figure 3–18. Profiles of rubber tire and pile, rubber–tire stack, and hogwire fence and sandbag bulkheads.

The hogwire fence and sandbag bulkhead at Basin Bayou, Florida, was destroyed by Hurricane Frederic in September 1979 and the bank behind the structure was severely eroded. The erosion is not shown by the profiles because replacement fill was added before the profile was surveyed again. Without structural protection, another episode of high waves would surely cause measurable bluff erosion.

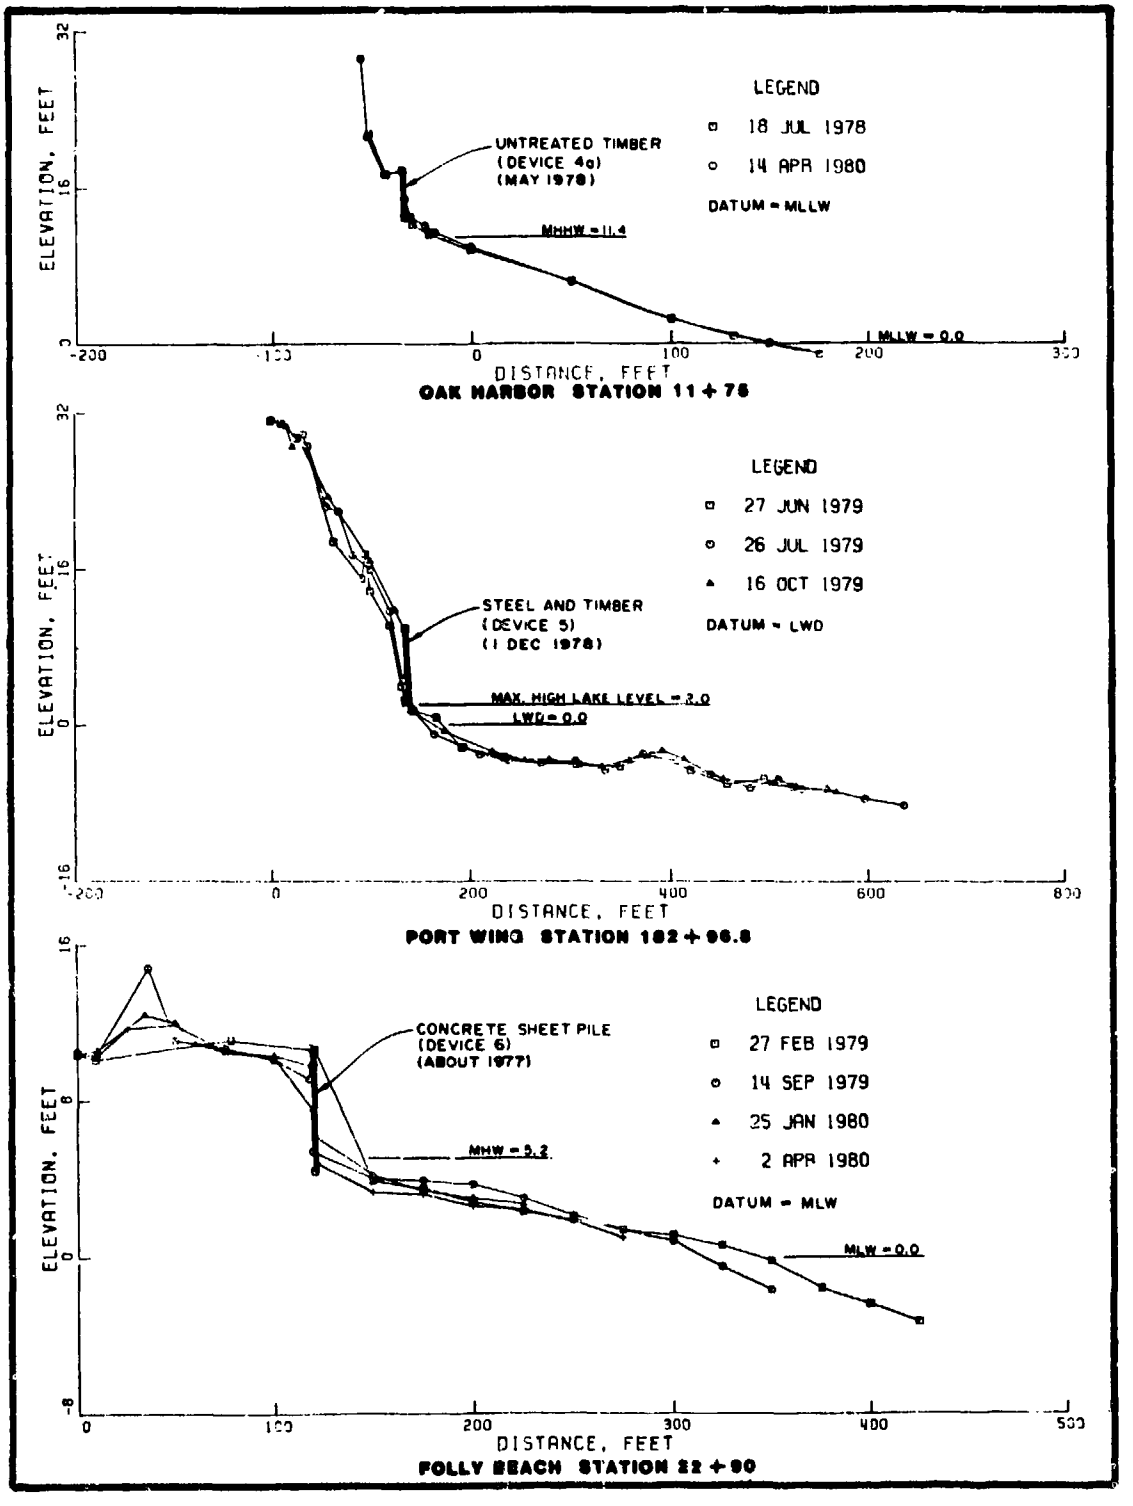
(3) Untreated Timber, Steel and Timber, and Concrete Sheet Pile. The untreated-timber bulkhead at Oak Harbor, Washington, was completely destroyed by wave action soon after its construction, and fill material behind the structure was removed. Figure 3-19 shows that although the structure was damaged and fill was lost, serious erosion of the bank behind it did not occur.

Figure 3-19. Profiles of untreated timber, steel and timber, and concrete sheet-pile bulkheads.

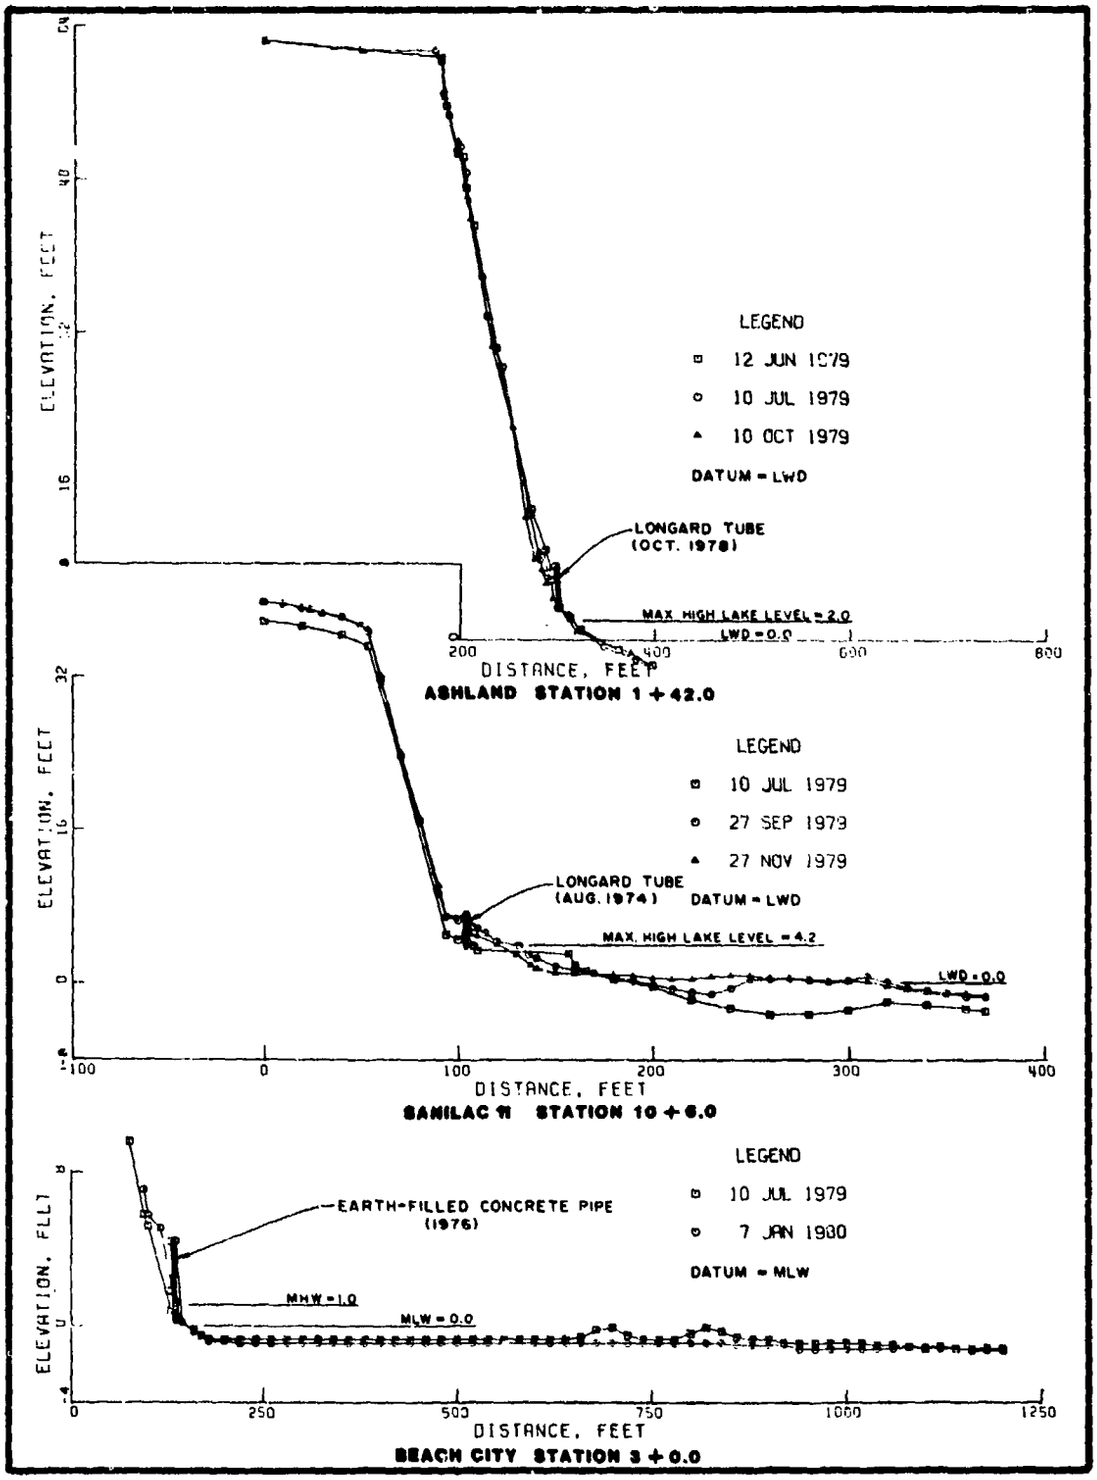
(4) Longard Tube and Earth-Filled Concrete Pipe. At Ashland, Wisconsin, the profiles are at the west seawall (device 9). Although this structure was damaged by debris and vandals it did not demolish the tube. In addition, the western end of the tube rolled slighly lakeward. The structure otherwise remained intact throughout the monitoring period. Figure 3-20 shows that some erosion occurred behind the structure, probably due to overtopping waves.

Figure 3-20. Profiles of Longard-tube and earth-filled concrete-pipe bulkheads.

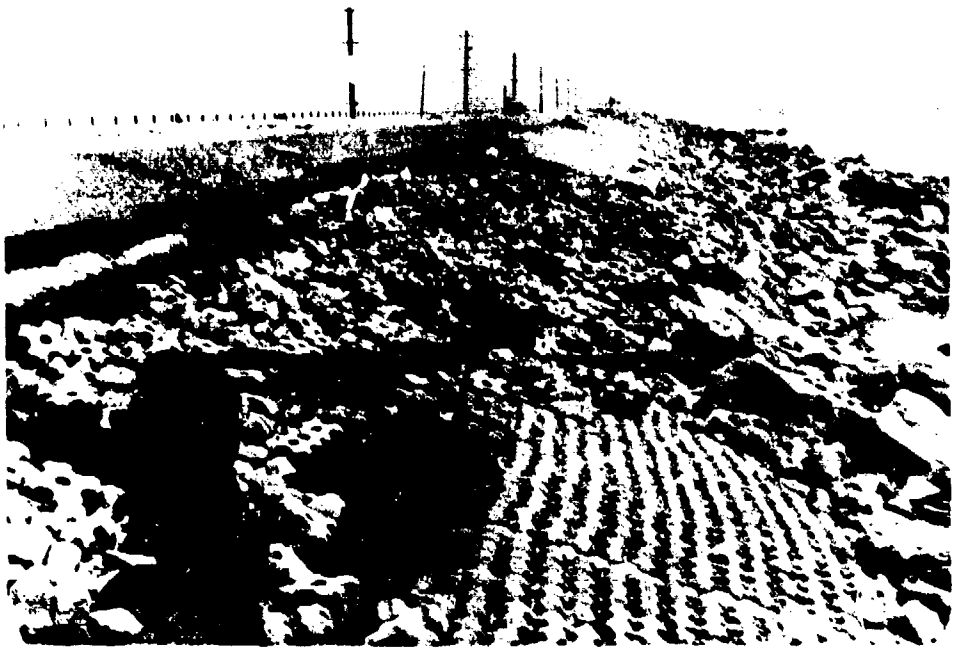
Figure 3-22. Gobi blocks displaced during a 1979 storm at Holly Beach, Louisiana, 16 April 1980.

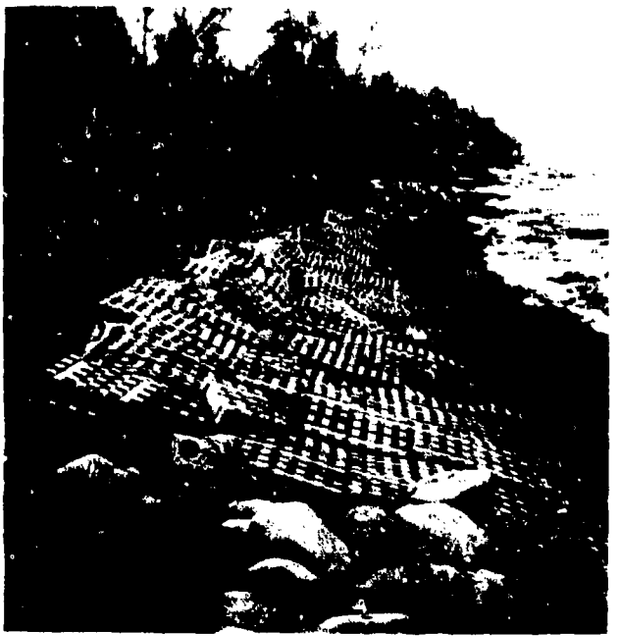
(2) Turfblocks. Turfblocks (Monoslabs) were used only at the Port Wing, Wisconsin, demonstration site in a revetment constructed in November 1978. The modules were placed over nonwoven filter cloth on a uncompacted granular fill containing large stones graded to a 1 on 3 slope. A few days after installation, the revetment was overtopped and badly damaged by storm waves on Lake Superior. After the storm, the modules were found to have been irregularly displaced and were covered with debris but not broken; the filter cloth was exposed in many places and the embankment slope was irregular, with evidence of sloughing in some areas. During the next 18 months, the revetment sustained little further damage, but displaced modules in the upper levels allowed high waves to erode the upper bank in a few places, and exposed surfaces of modules in the lower levels were severely abraded by wave-borne debris and cobbles (Fig. 3-23). Exposed areas of filter cloth had deteriorated badly. Poor subgrade preparation and possible filter cloth clogging was largely responsible for module displacement, and the abrasion due to cobble bombardment was not necessarily the result of defective concrete in the modules. Therefore, this one demonstration was not considered a fair test of the Turfblock revetment system. With proper installation in a less severe environment, there appears to be no reason why the system should not perform about as well as Jumbo blocks.

Figure 3-23. Displacement of Turfblocks, Port Wing, Wisconsin, 7 May 1979.
