Low-Cost Shore Protection

Final Report on the Shoreline Erosion Control Demonstration Program (Section 54)

1981

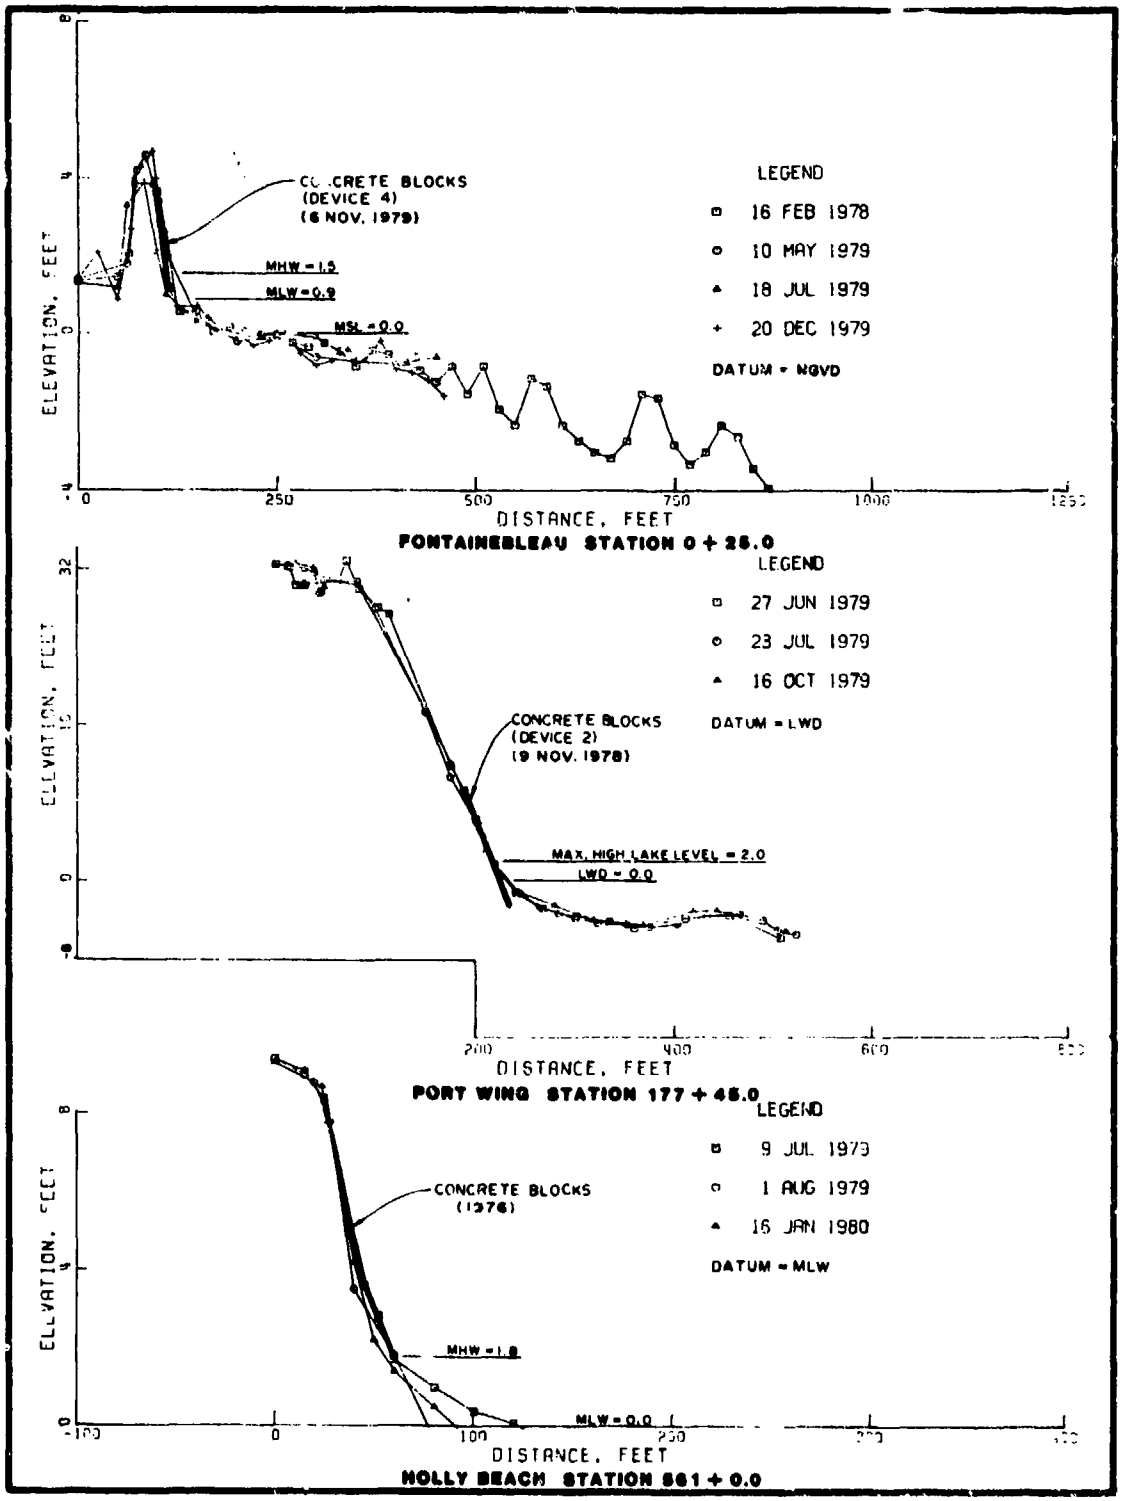
At Fontainebleau the profiles are at device 3, a revetment of standard construction blocks. The structure was damaged by vandalism and problems were encountered with displacement of blocks with their long axes placed parallel

Figure 3-42. Profiles of concrete-block revetments.

to the shoreline. This structure was completed in November 1979. Only one survey was made after the completion of the revetment, thus, the profiles do not give any information as to the effectiveness of the structure in retaining the beach.

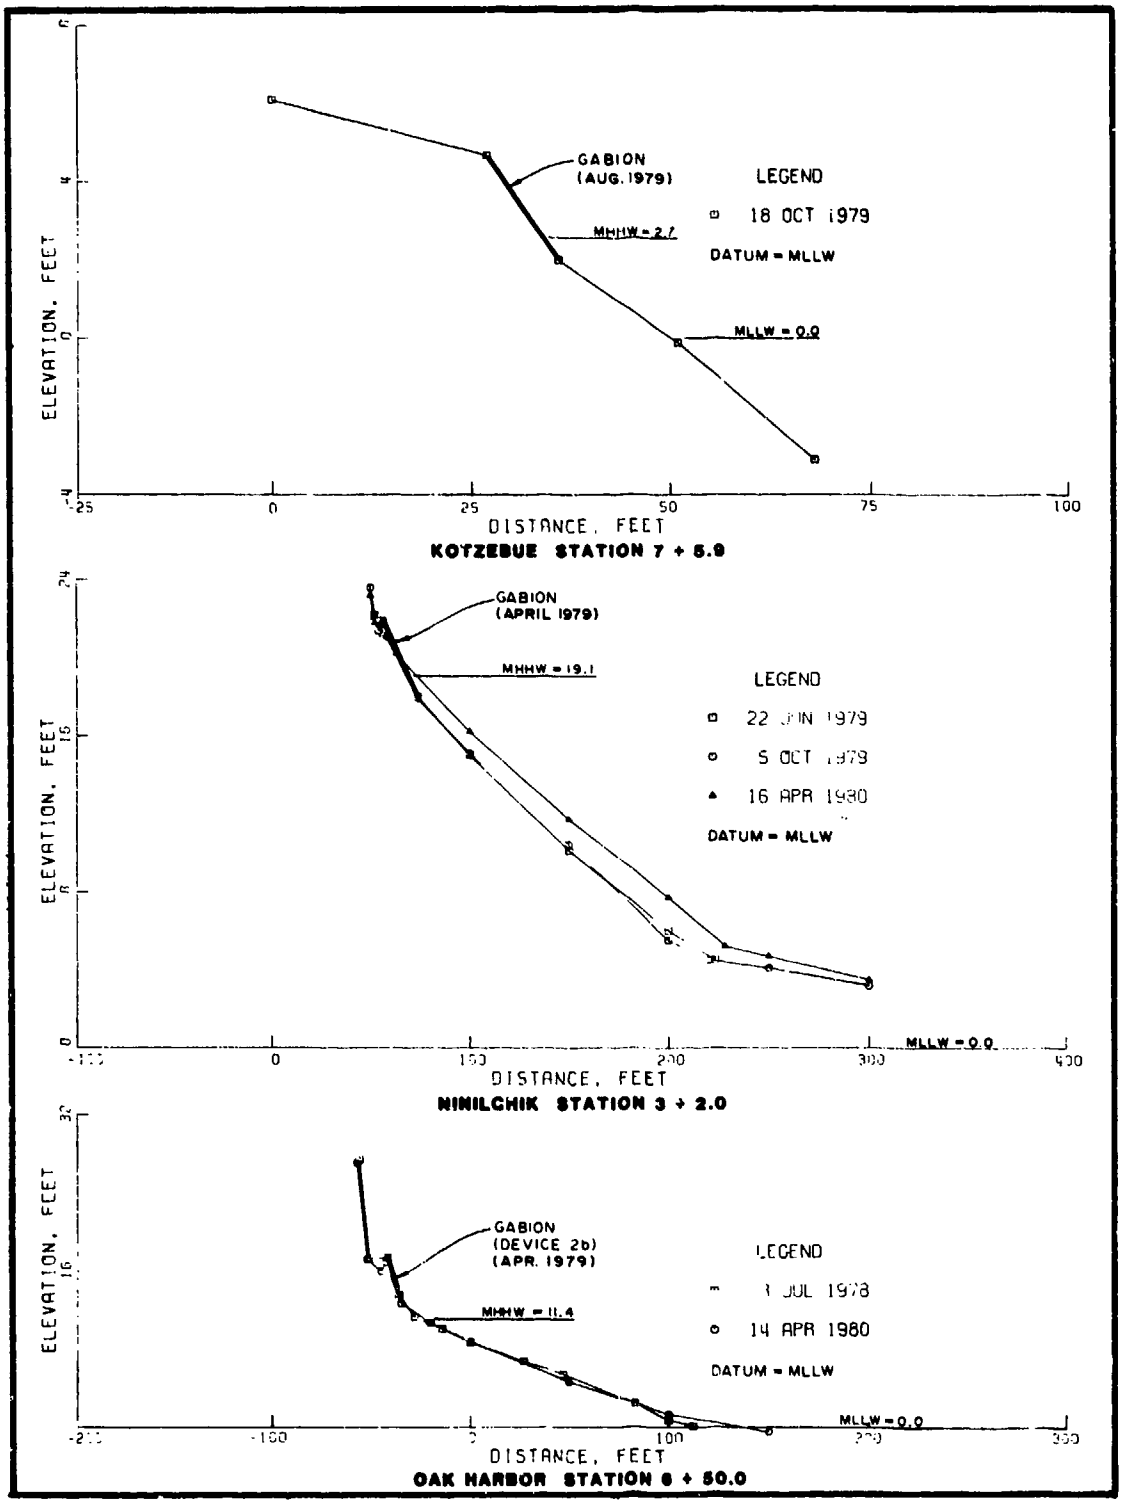
(5) Gabions. Profile analysis of gabion revetments were done at three sites--Kotzebue, Alaska; Ninilchik, Alaska; and Oak Harbor, Washington. The profiles are shown in Figure 3-46. The gabion revetment at Kotzebue suffered no structural damage to date, and the structure adequately protected the beach. The site, however, has not been surveyed since the initial time in October 1979, and thus the profiles offer no information as to the extent of erosion or accretion at the site.

Figure 3-46. Profiles of gabion revetments.

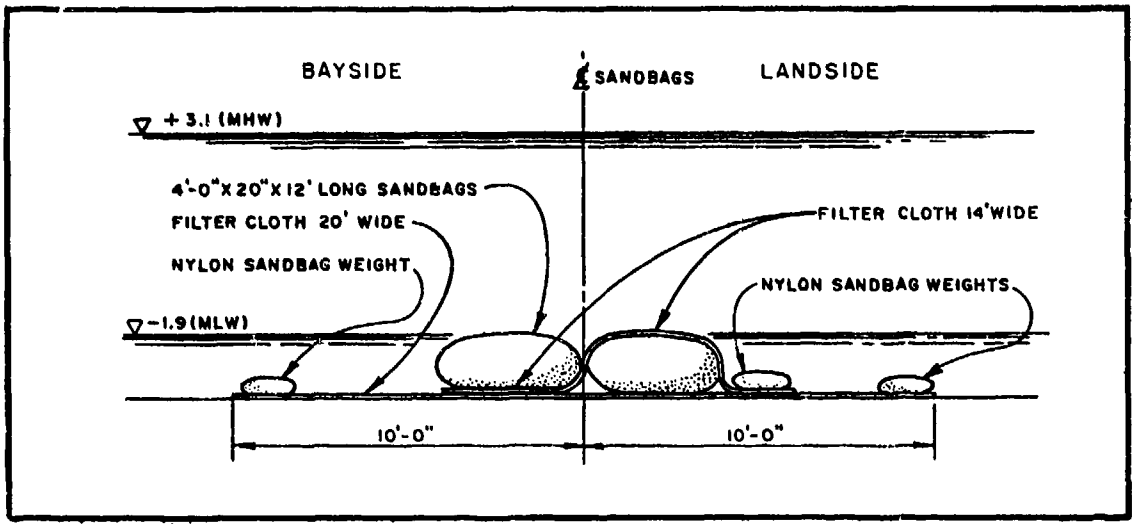
Figure 3-58. Typical sandbag section of sill at Slaughter Beach, Delaware.

Sections two bags across, composed of Advance Bags and Dura-Bags, were used to form part of the sill and the returns at Slaughter Beach, which were built to contain a perched beach (Fig. 3-58). There was some misalinement of the bags during the monitoring period (Fig. 3-59).

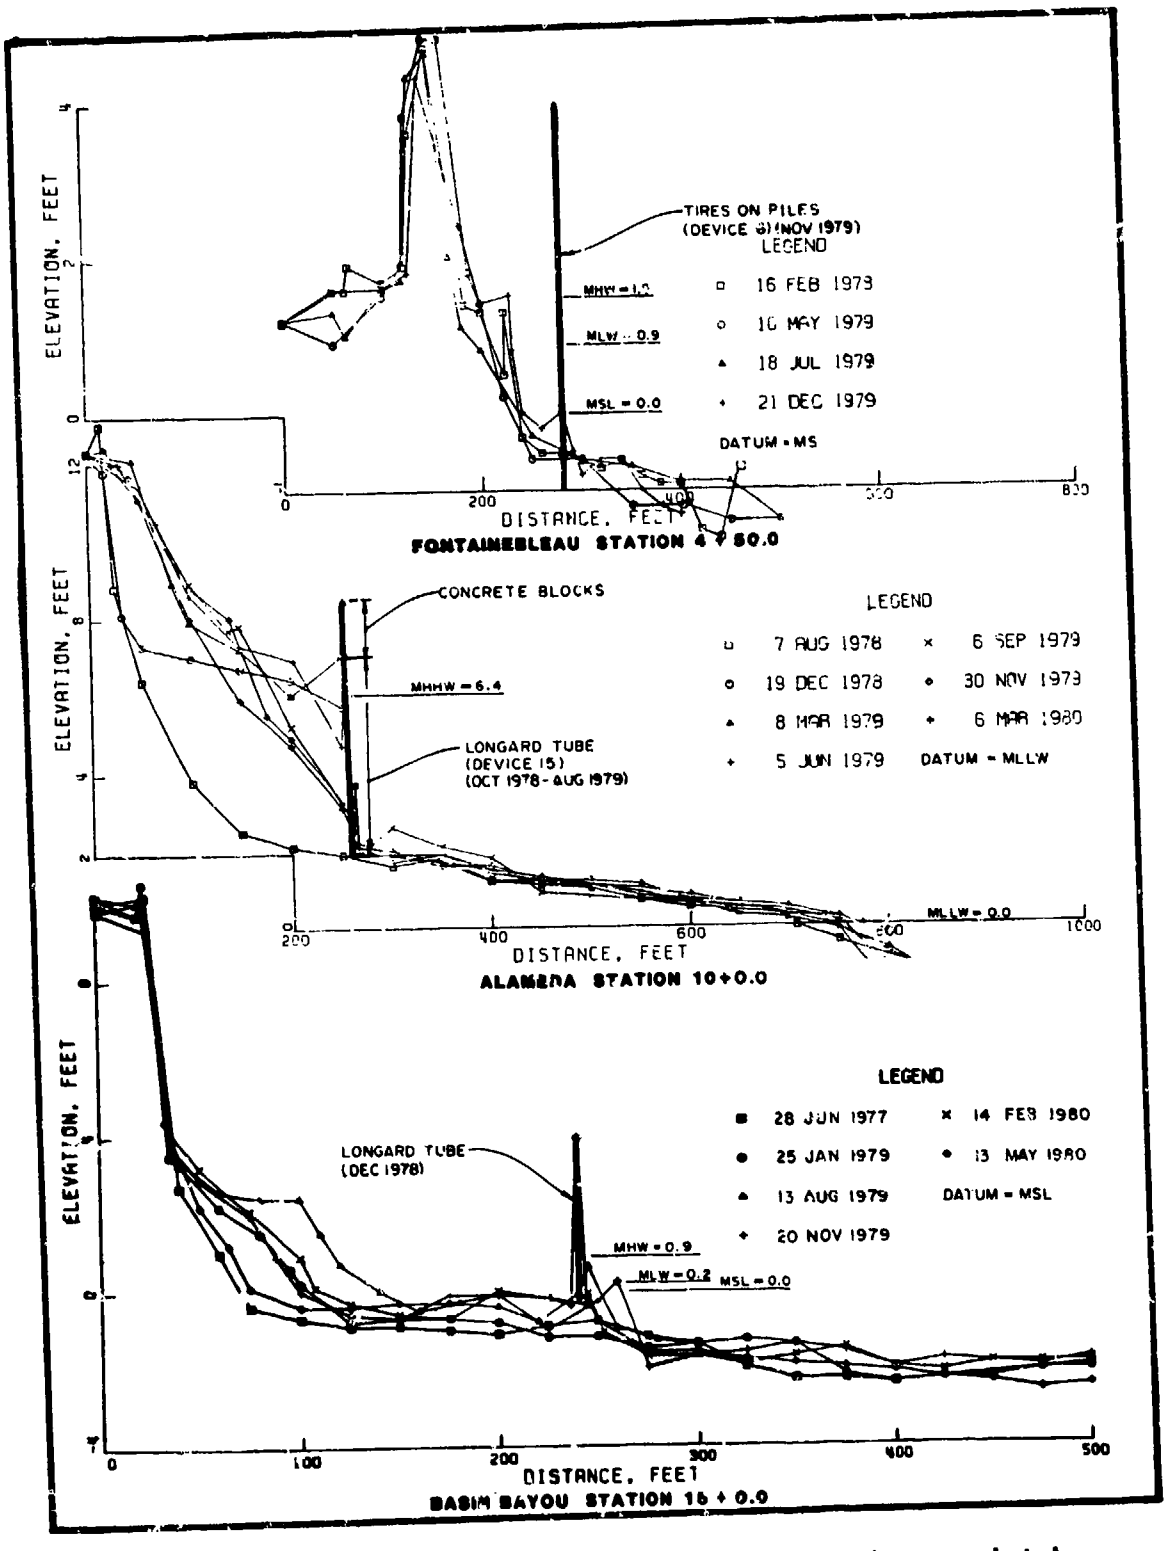
At Fontainebleau State Park, Louisiana, a breakwater was constructed of closely spaced timber piles driven into the lake bottom with tires stacked 4 feet high on each pile. This device adequately attenuated waves, and performed without any structural deterioration. The profiles at this site are somewhat erratic, but they show some accretion in lee of the structure.

A Longard-tube breakwater was demonstrated at Alameda, California. This structure was damaged by vandals and eventually could no longer retain the manmade sand tombolo that had been placed in its lee. Construction of this structure was completed in October 1978. The profiles show accretion in lee of the breakwater while the structure was intact, from December 1978 to June 1979. After June 1979, corresponding with the degradation of the structure, erosion of the tombolo continued through the remainder of the monitoring period.

Figure 3-75. Profiles of tires on piles and Longard-tube breakwaters.

Another Longard-tube breakwater was demonstrated at Basin Bayou, Florida. This structure was also damaged by vandals, although not as badly as at Alameda. This damage halted the formation of a tombolo which had been formerly in the breakwater's lee. The profiles for this site show that progressive accretion was evident just behind the structure. On the beach, however, the trend was more erratic with accretion from August 1977 through August 1979 followed by erosion thereafter. A new Longard tube was placed at the site in May 1980, but as this was the end of the monitoring period its effectiveness cannot be determined. Because Longard tubes are susceptible to damage by vandals (which seems to be unavoidable), the stacked tire on pole breakwater appears to be a more effective device in protecting the beach from erosion. Longard tubes work well, but once damaged their lifetime is greatly reduced.

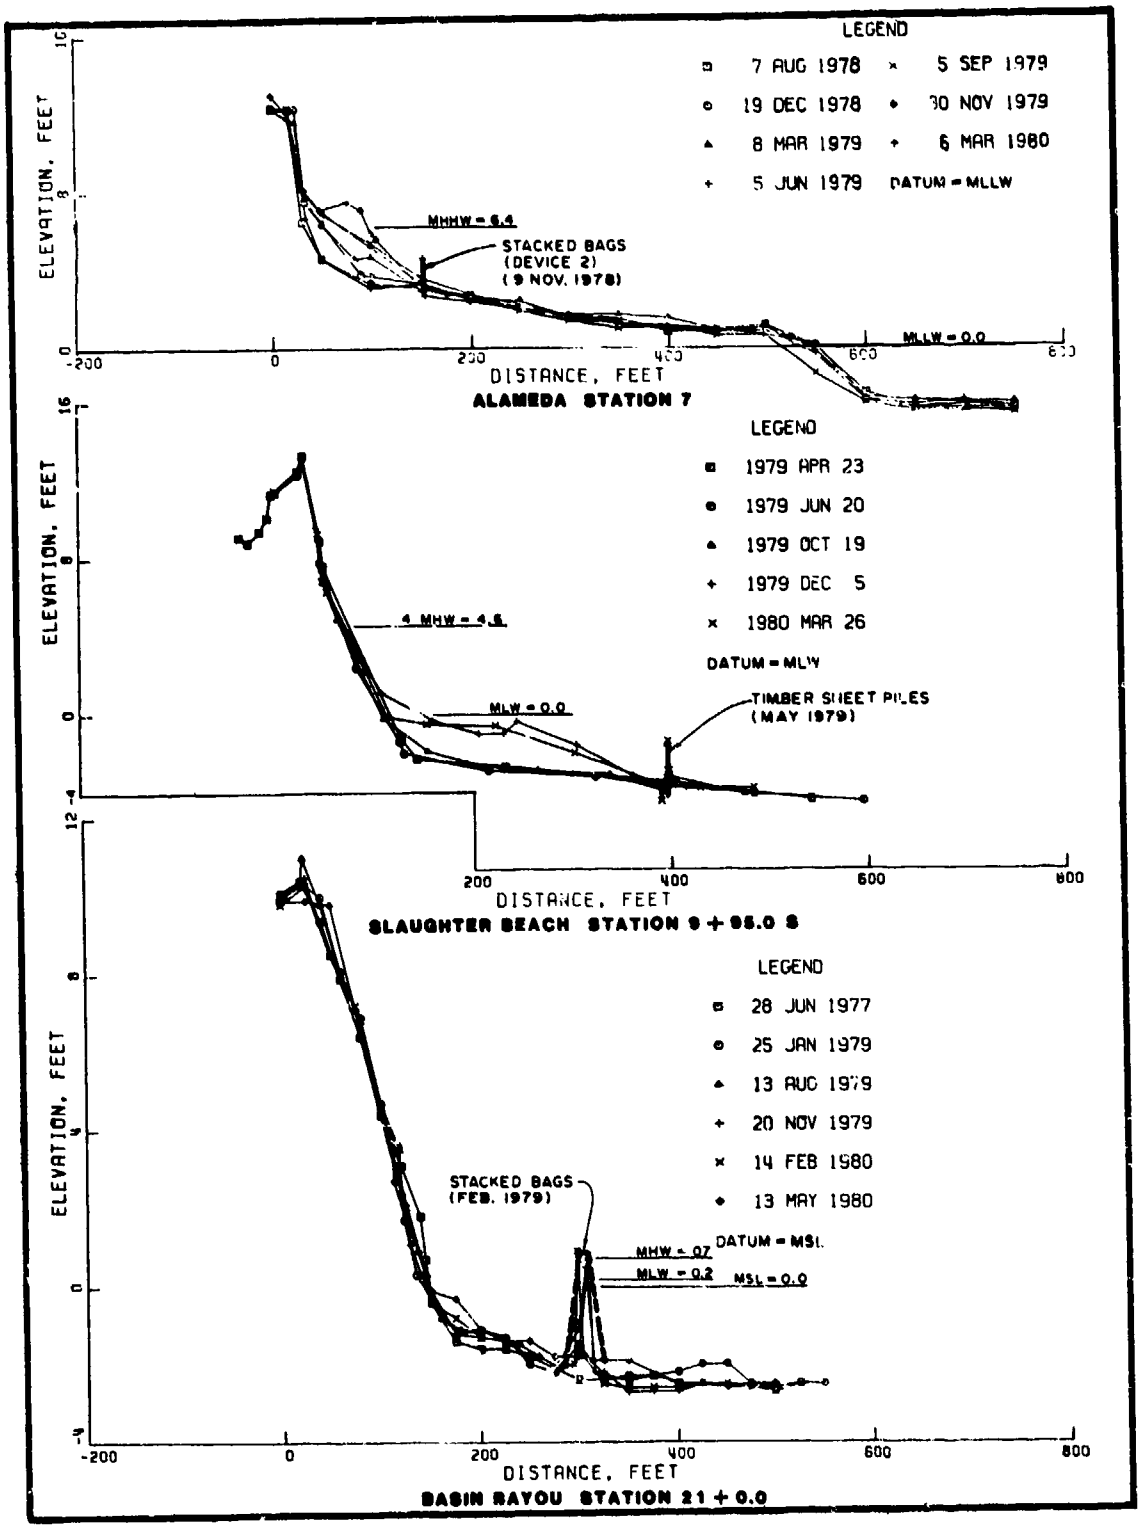
(2) Stacked Bags and Timber Sheet Piles. Profile analyses of these structures were done at Alameda, California; Slaughter Beach, Delaware; and Basin Bayou, Florida. These profiles are shown in Figure 3-76. A stacked-bag sill was demonstrated at Alameda, California, which consisted of sand-cement-filled bags made of nylon. This structure underwent some settlement, but proved to provide protection to the vegetated shoreline. The structure acted in conjunction with a groin. The profiles show accretion in lee of the sill, due to sand traveling over the groin being trapped by the sill.

At Kitts Hummock, the bags deteriorated somewhat, but the breakwater remained functionally effective. The profiles at this site show a progressive accretion in the lee of the breakwater.

The sandbag sill at Slaughter Beach performed reasonably well in retaining a perched beach, despite some misalinement of bags which occurred during the monitoring period. The profiles show that accretion was present behind the structure, particularly in the latter months of the monitoring period.

Figure 3-76. Profiles of stacked-bag sill, timber sheet-pile sill, and stacked-bag breakwater.

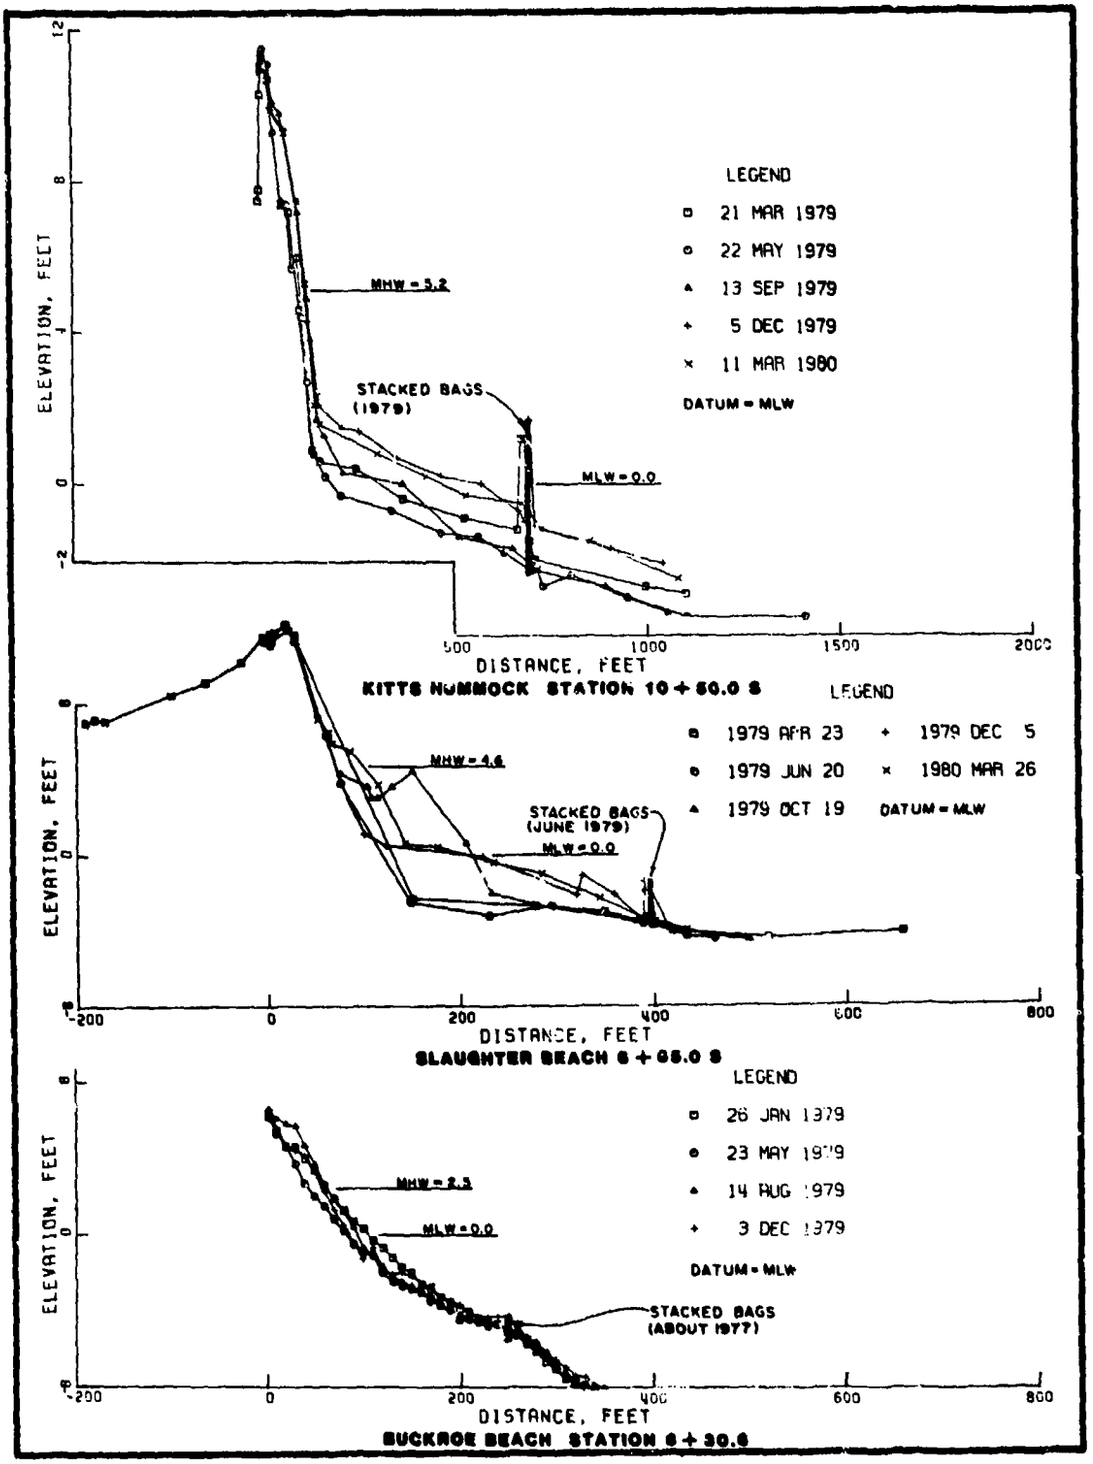
(3) Stacked Bags. Profile analyses of stacked-bag breakwaters (sills) were done at Kitts Hummock, Delaware; Slaughter Beach, Delaware; and Buckroe Beach, Virginia. These profiles are shown in Figure 3-77.

Figure 3-77. Profiles of stacked-bag sills.

At Buckroe Beach, the sandbag sill underwent some slight movement and separation of bags. This sill was placed between flanking groins to contain a perched beach. The profiles show that this structure had little effect on the beach in its lee.

The structures at Kitts Hummock and Slaughter Beach performed well, the latter undergoing deterioration but still containing the perched beach.

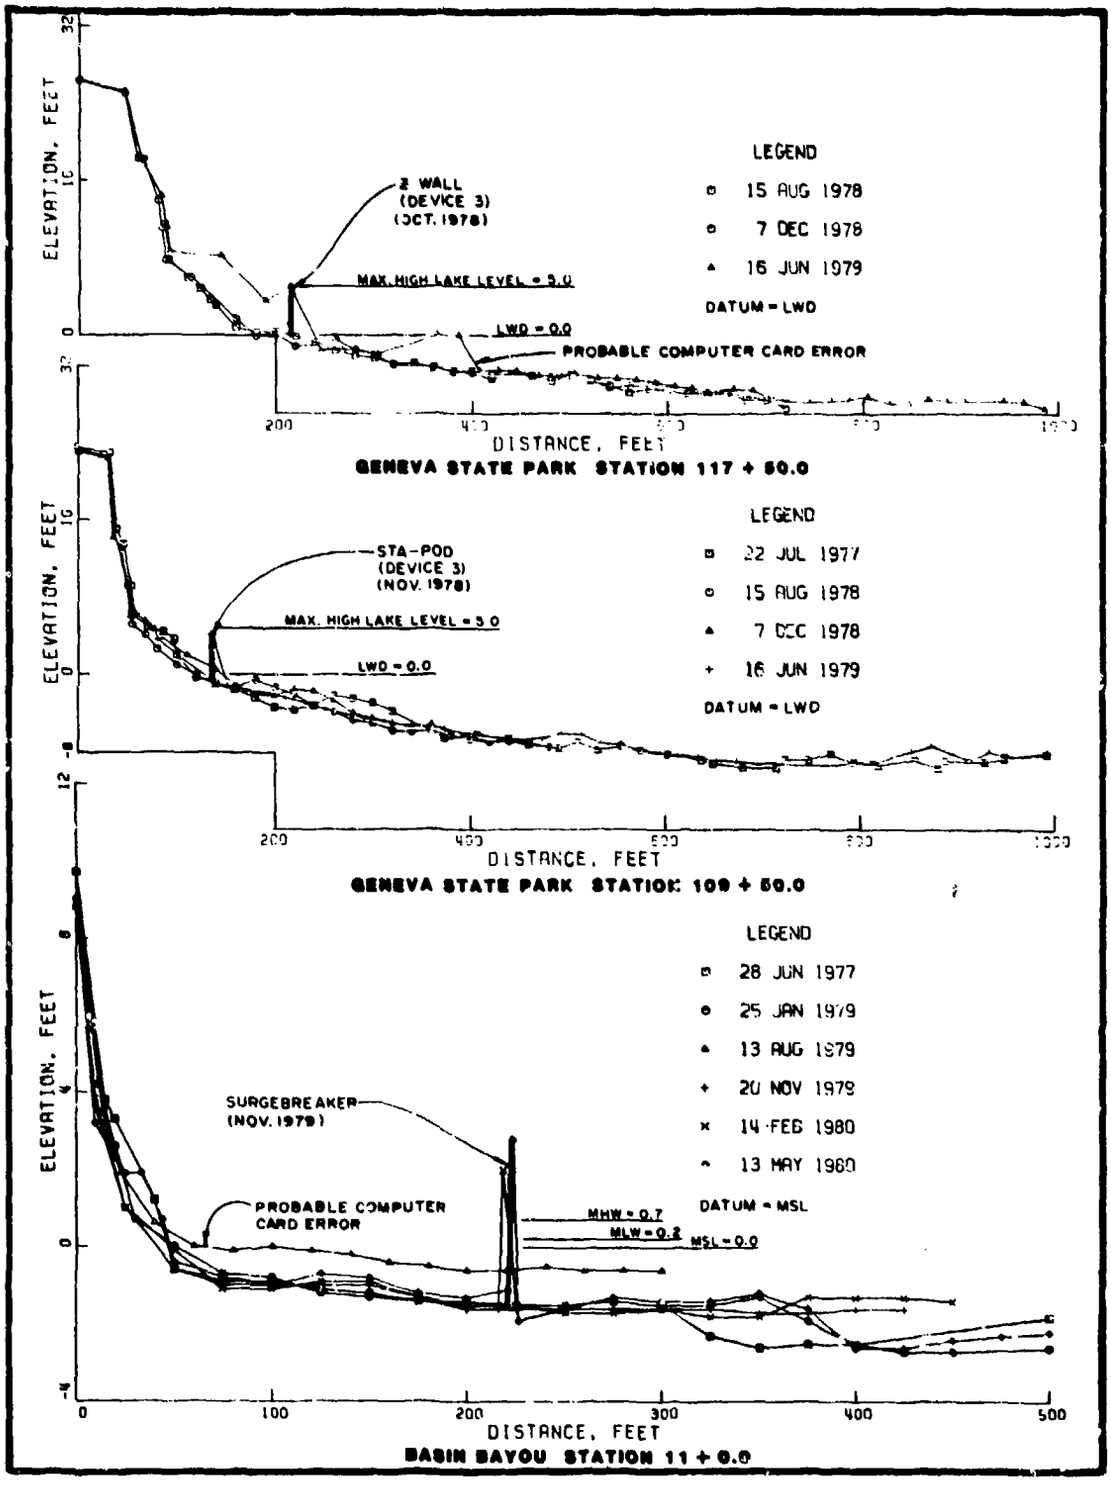
(4) Z-Wall, Sta-Pods, and Surgebreaker. Profile analyses of Z-wall, Sta-pod, and Surgebreaker breakwaters were done at two sites--Geneva State Park, Ohio, and Basin Bayou, Florida. The profiles for these structures are shown in Figure 3-78.

The Z-wall breakwater was demonstrated at Geneva State Park. Panels of this structure were broken off due to nonuniform settlement. The profiles show that this structure, despite damage, was successful in trapping sand.

The Z-wall breakwater at Geneva State Park was the most successful in trapping sand, but is prone to structural damage. The Sta-pod device appeared to be the least successful.

Figure 3-78. Profiles of Z-wall, Sta-pod, and Surgebreaker breakwaters.

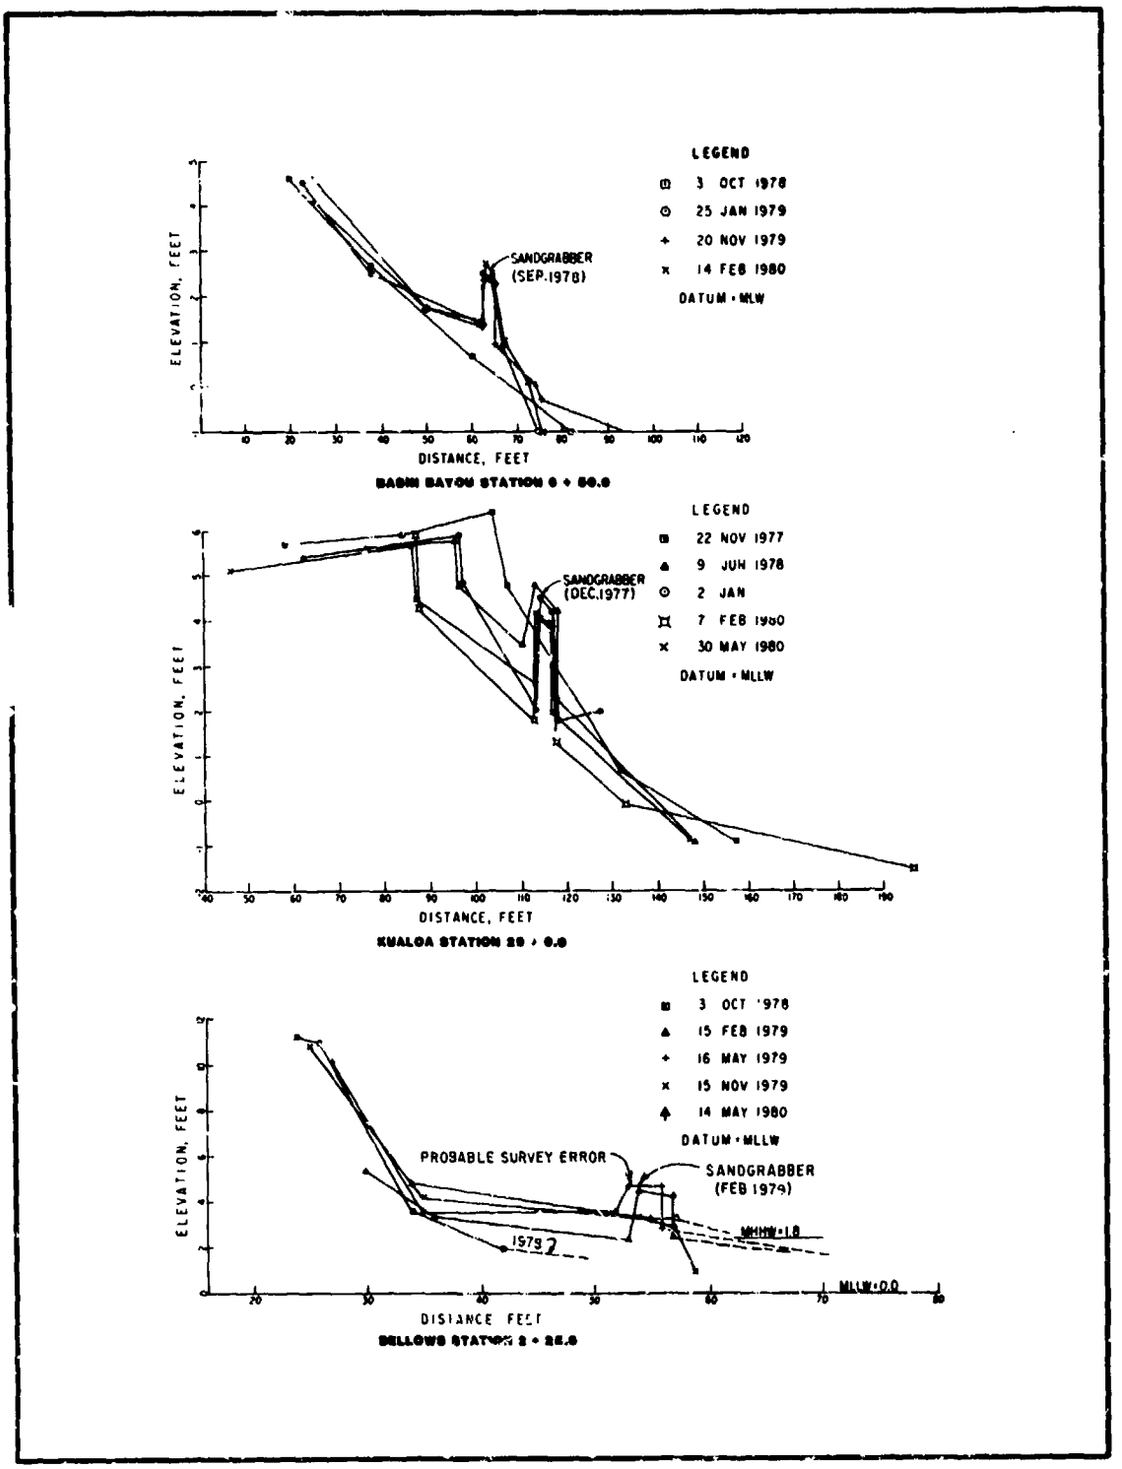
(5) Sandgrabber. A profile analysis was done on Sandgrabbers at three sites--Basin Bayou, Florida; Kualoa, Hawaii; and Bellows Air Force Station, Hawaii. The profiles for these sites are shown in Figure 3-79. At Basin Bayou, the structure suffered some damage, attributed to erosion of sand from under the toe causing seaward rotation of the structure and block breakage. The profiles show that sand has been trapped by the structure, but variations in the sand level behind the structure has also been present.

The Sandgrabber at Kualoa, although structurally damaged, maintained its shape while settling throughout the monitoring period. Although the profiles do not show it clearly, the Sandgrabber trapped sand both in front of and behind the structure throughout the period, but in doing so, caused considerable downdrift erosion.

The Sandgrabber at Bellows Air Force Station also trapped sand at the beach in its immediate vicinity. This structure, like the other Sandgrabbers, also suffered from toe scour and subsequent nonuniform settlement. The accretion present at the Bellows Sandgrabber (shown in the profiles) was not to the detriment of adjacent beaches as at Kualoa. This was due to the predominantly onshore-offshore littoral transport at the site.

Figure 3-79. Profiles of Sandgrabbers.

The profiles show that the Sandgrabbers all suffered from differential settlement due to toe scour. The Bellows Beach Sandgrabber appeared to be most successful in that it did not cause downdrift erosion.
