RADC-TR-82-43
Final Technical Report
March 1982

QUALITY ASSURANCE PROCEDURES FOR LSI

Martin Marietta Corporation

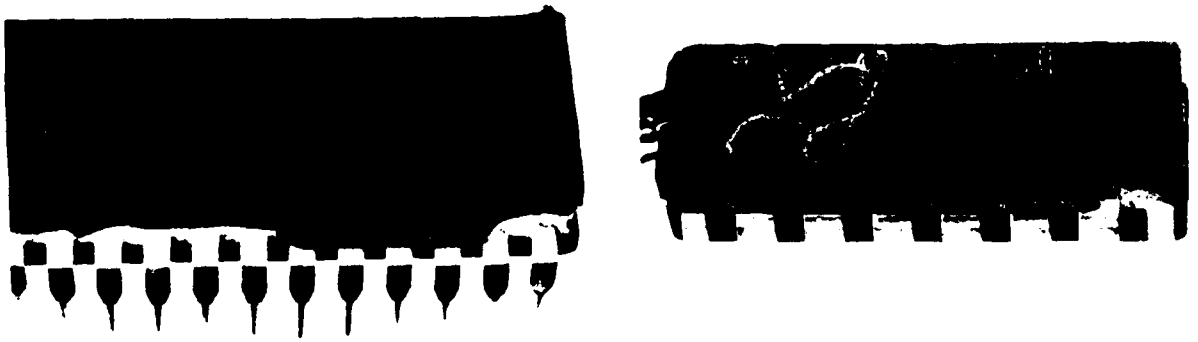
Figure 13. Exposed basis material.

Although several Lot C devices had chips into the seal area which exposed lead frame basis material, no corrosion was observed on any of the devices. This was attributed to the low efficiency of the moisture resistance test in activating corrosion since neither chemical contaminants nor electrical bias were present. Notwithstanding the lack of corrosion, these parts are considered unacceptable for use in equipment even if not discovered until after board mounting (Figure 13).

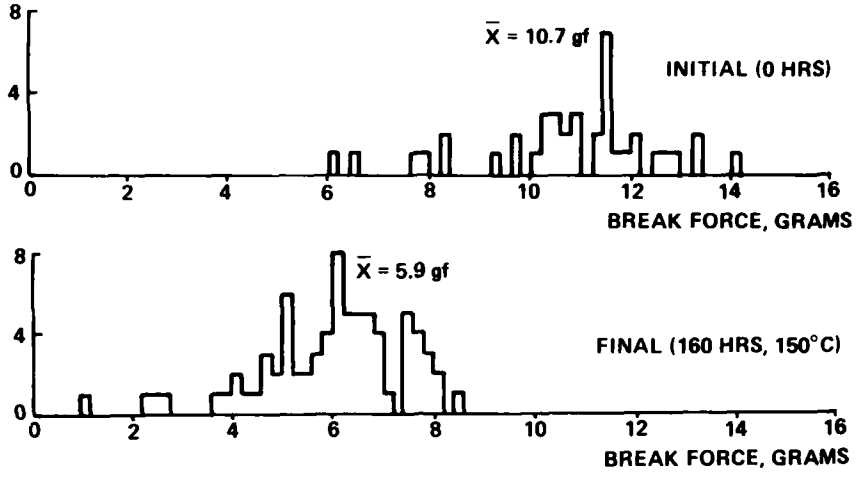
Figure 17. Expected degradation of Al wire bond strength on normal Au thick film.

The 39-percent decrease in mean bond strength in Figure 17 is attributed to the expected annealing of the aluminum. Since this gold thin-film system is not normally suitable for Al ultrasonic bonding, the wide dispersion of bond strengths is also expected and desired to produce a strength distribution appropriate to evaluate mechanical stress tests. The Au wire bond strengths shown in Table 16 are representative of normal product.

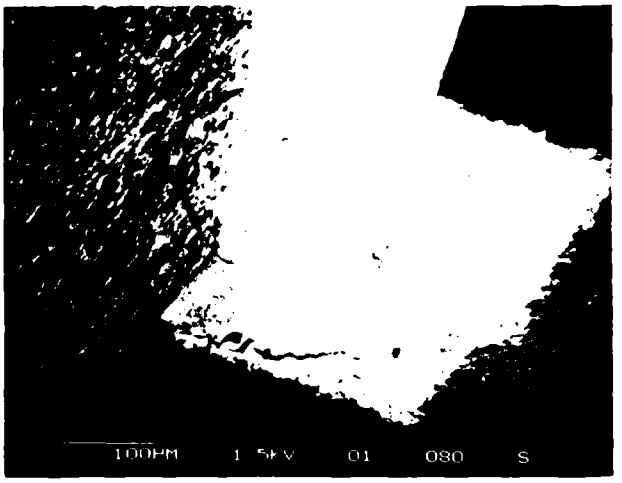
Figure 23. Loss of thick-film adhesion during temperature cycling.

Figure 23 depicts a typical problem which can be attributed to insufficient adhesion between the thick-film metallization and the ceramic substrate. This example, taken from an internally funded study, shows a platinum-gold solder pad which has begun to lose adhesion after 50 temperature cycles in a ceramic chip carrier assembly test. This type of cracked appearance, which is actually thick-film liftoff, is also typical of that seen around some capacitor solder terminals following temperature cycling.

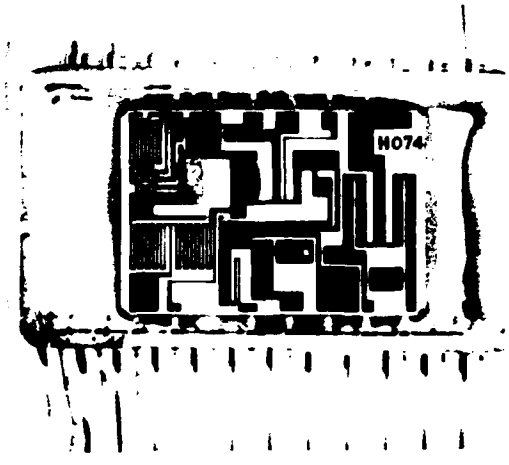
Figure 31. Chip capacitor separation at 30 kg constant acceleration.

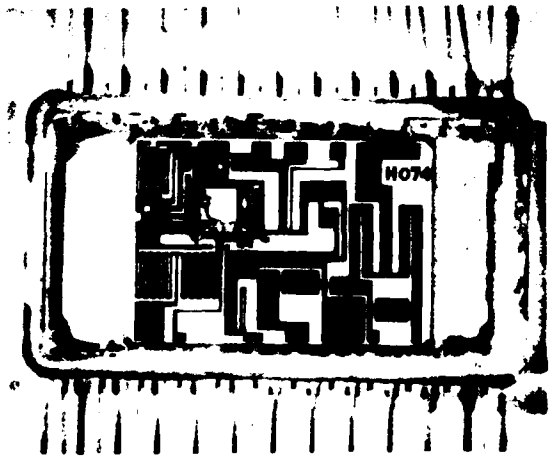
Figure 32. Ceramic chip capacitor fracture at 50 kg constant acceleration.

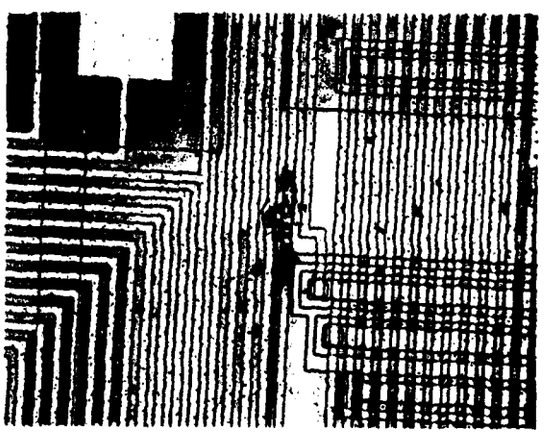
Figure 40. Leakage path, 40-pin Sidebraze, SN 124.

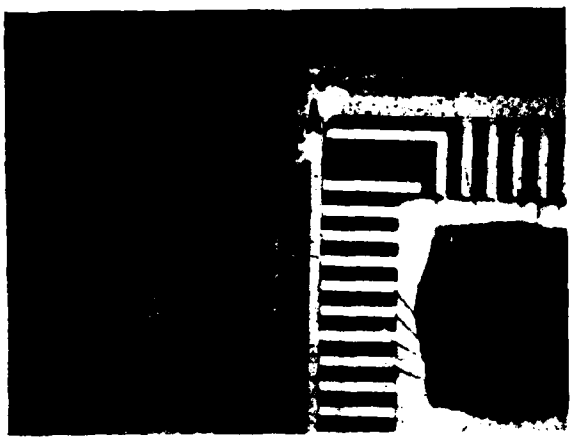
Figure 42. Solderseal leak, 40-pin Sidebraze, SN 124.

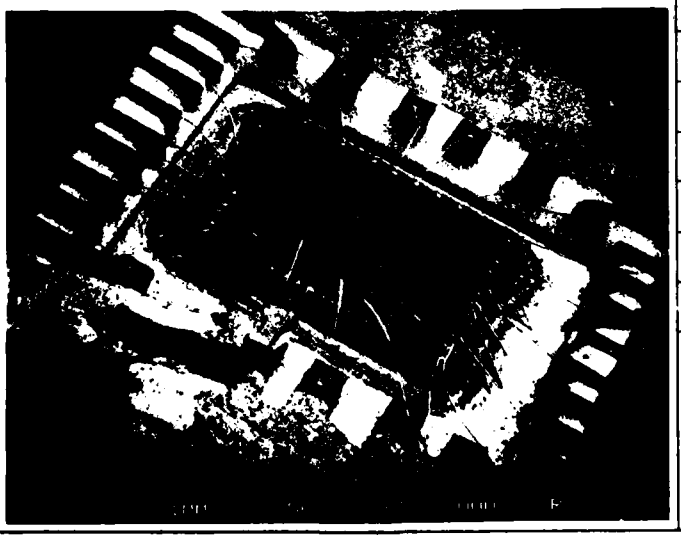
PHOTO 1 10X

OVERALL VIEW

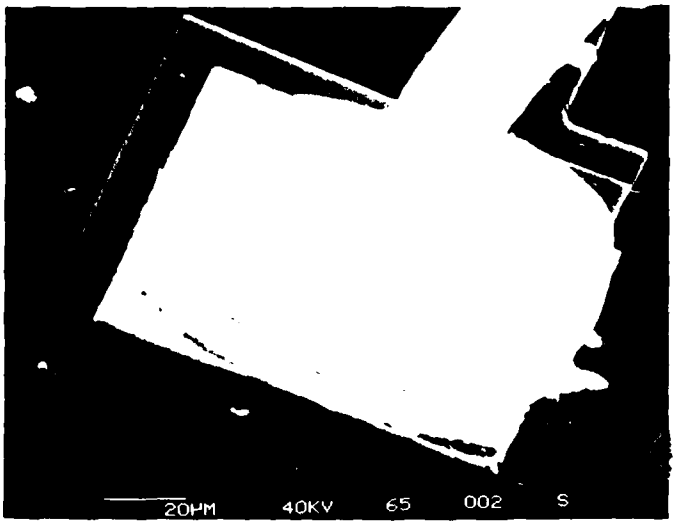
PHOTO 2 SN 065 750X

THIS SCANNING ELECTRON MICROPHOTOGRAPH (SEM) SHOWS IN GREATER DETAIL THESE FORMATIONS.

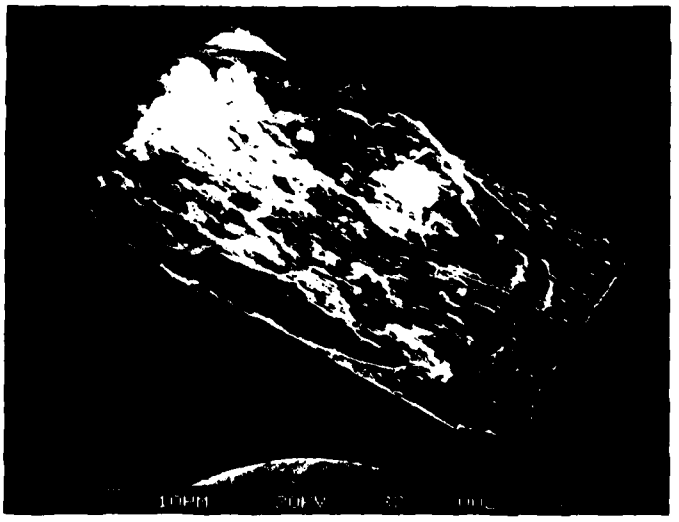
PHOTO 3 SN 037 800X

THIS SEM. VIEW SHOWS A BOND BALL HAD SEPARATED FROM ITS BOND PAD DURING TESTING. NOTICE THE REMAINING INTER-METALLIC FORMATION.

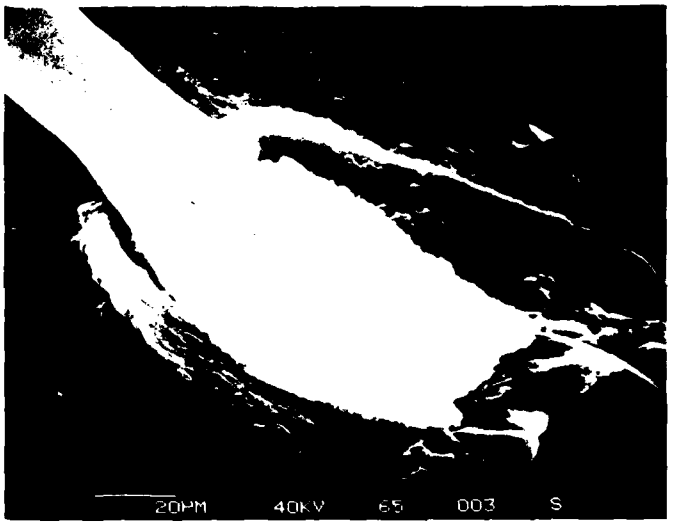
PHOTO 5 SN 065 700X

THIS IS AN S.E.M. PHOTO OF THE SAME TYPE OF BOND. THE HEEL AND FOOT ARE NO LONGER CONTINUOUS. NOTICE THE INTERMETALLIC FORMATIONS UNDER THE HEEL, ALSO.

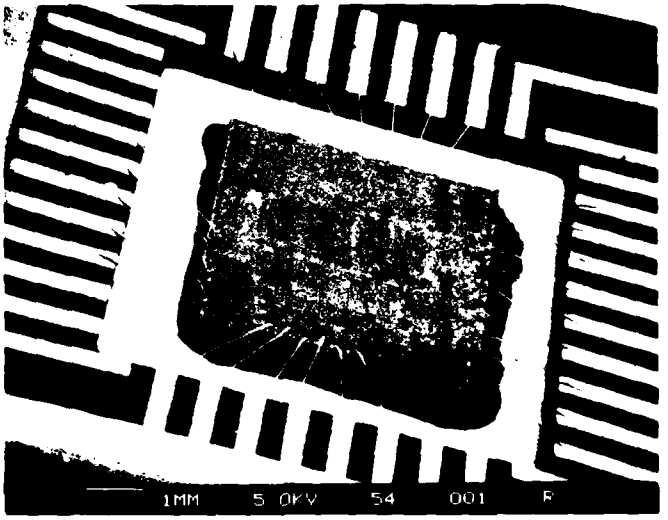
PHOTO 1 10X

OVERALL VIEW

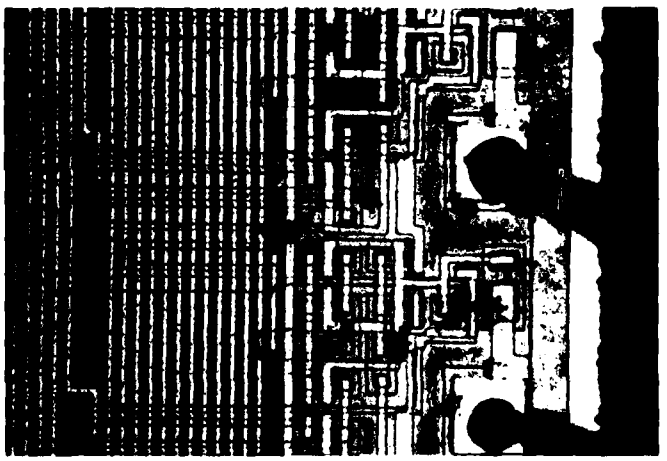
PHOTO 2 128X

SURFACE PARTICLES

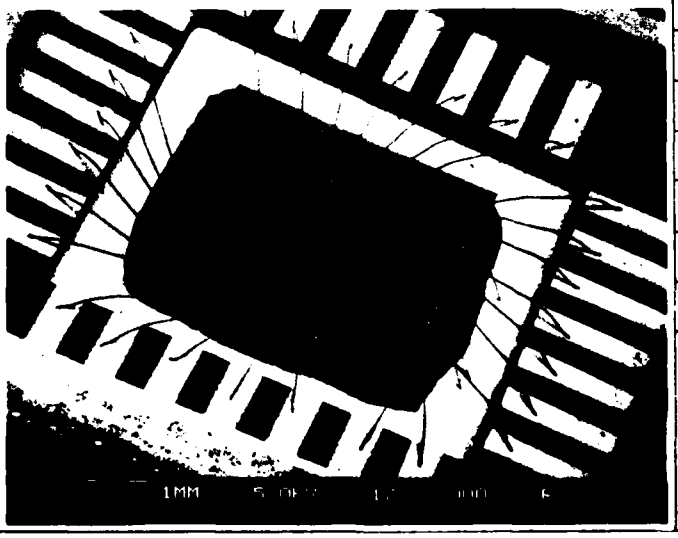
PHOTO 1 10X

OVERALL DIE CAVITY

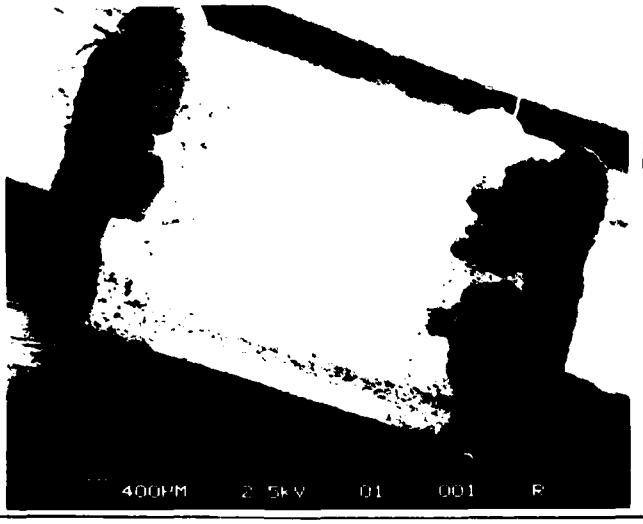
PHOTO 2 22X

CAPACITOR WITH EPOXY AT BOTH ENDS.

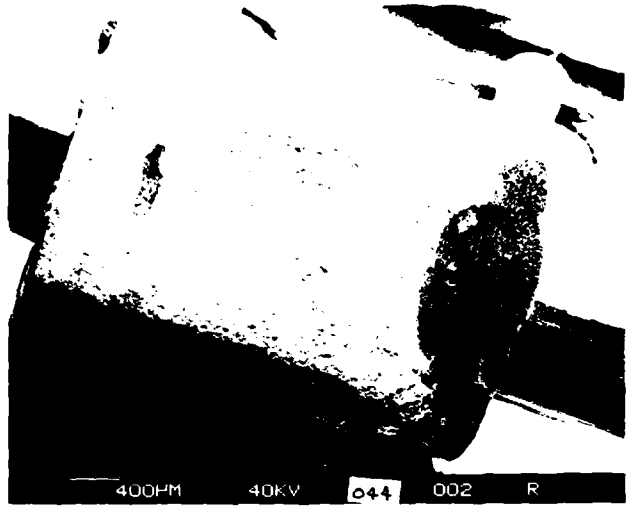
PHOTOGRAPH 2 21X

BOTTOM OF LOOSE CHIP CAPACITOR.

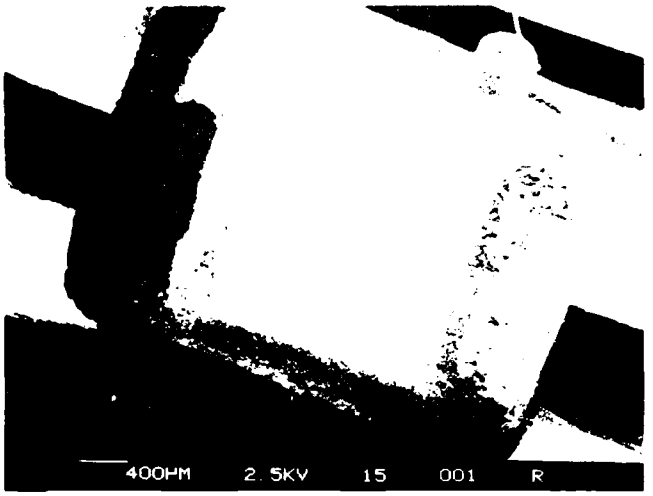
PHOTOGRAPH 1 20X

BOTTOM SIDE OF LOOSE CHIP CAPACITOR

THE CHIP CAPACITOR MOUNTING WAS STILL INTACT AS SHOWN IN PHOTO 1. THE BASE BOND WIRE WAS GONE FROM THE TRANSISTOR CHIP. THE FOOT SEPARATED FROM THE BOND PAD DUE TO POOR LOCATION AS SHOWN IN PHOTOS 2 AND 3.

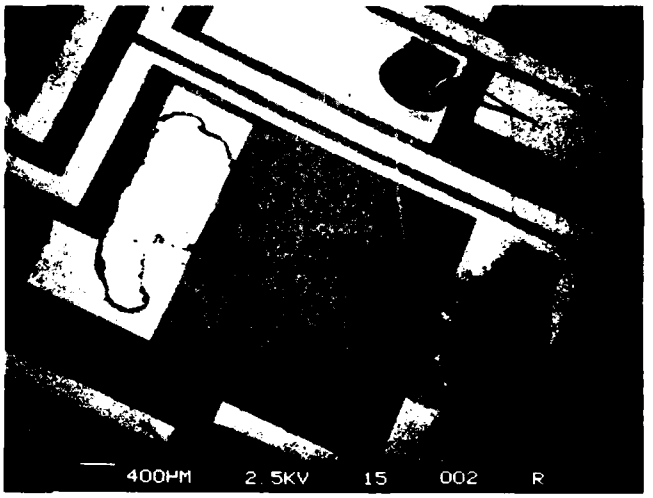
PHOTOGRAPH 2 15X

ORIGINAL MOUNTING SITE OF CAPACITOR

NOTE LIFTED GOLD BOND BALL ON DIODE CHIP

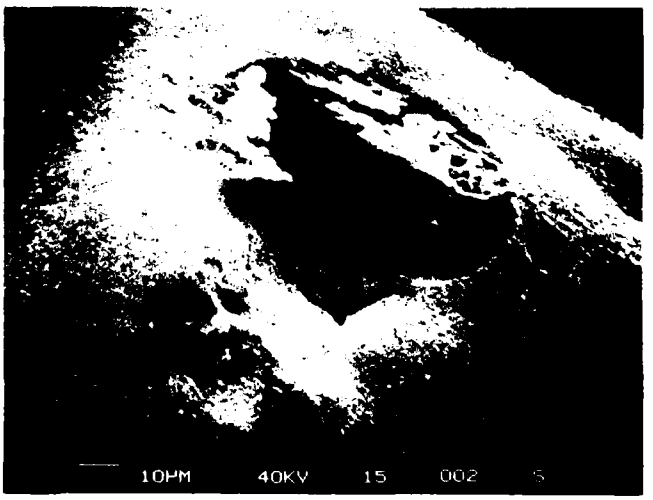
PHOTOGRAPH 3 700X

METALLIZATION WHERE BOND BALL HAD BEEN ATTACHED SHOWS ∠20% EFFECTIVE BOND AREA AS WELL AS TORN WINDOW METALLIZATION.

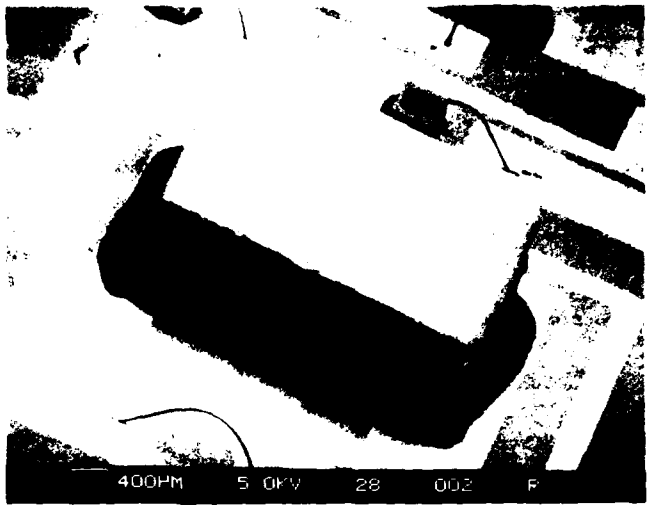
PHOTOGRAPH 1 18X

CHIP CAPACITOR WHICH SURVIVED TESTING.

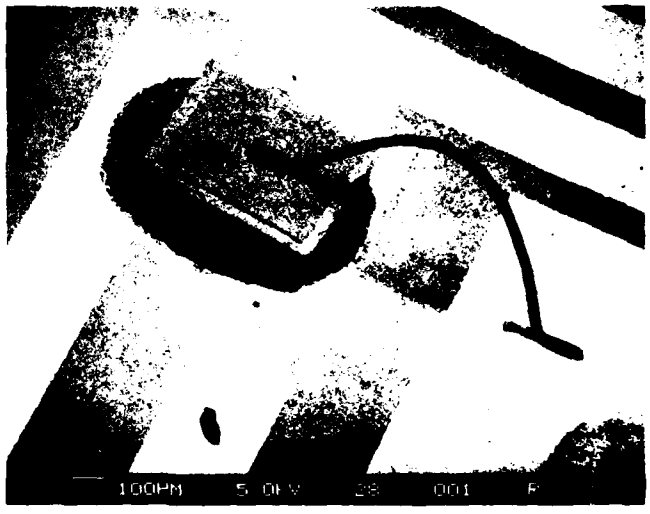
PHOTOGRAPH 2 65X

BASE BOND WIRE LIFTED FROM TRANSISTOR.

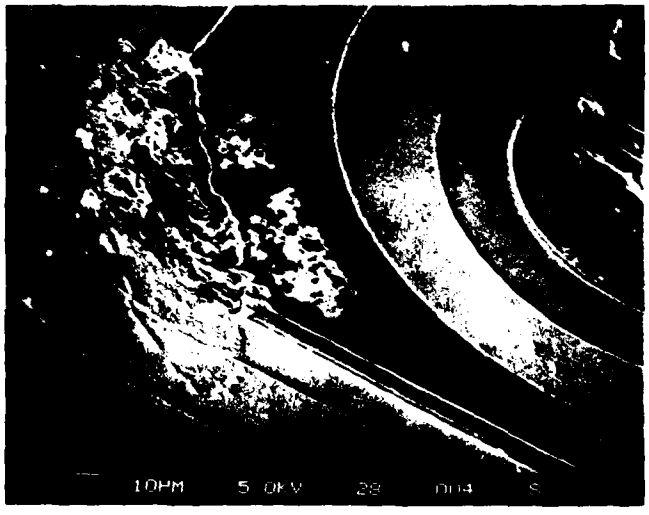
PHOTOGRAPH 3 550X

BOND FOOT IMPRINT SHOWS POOR LOCATION.

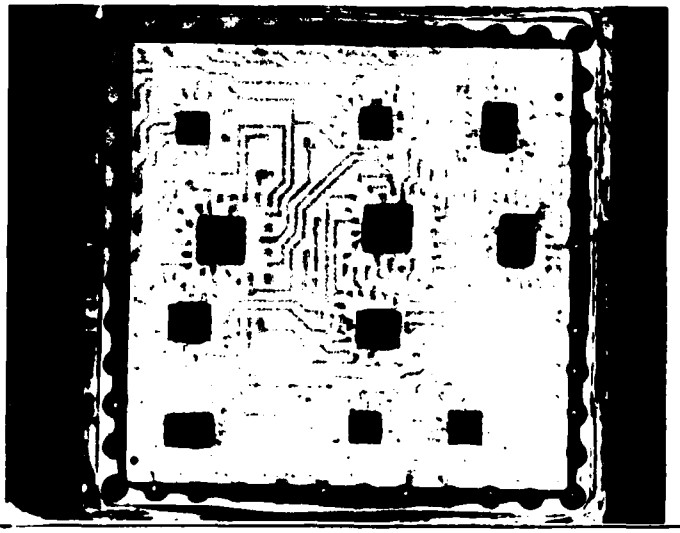
PHOTO 1 2.7X

OVERALL VIEW
